Mount Nansen Bridge - Overview

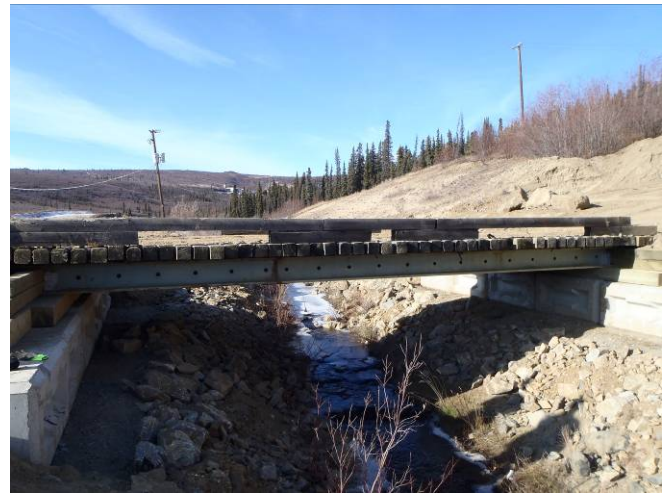
Mount Nansen Bridge - Elevation

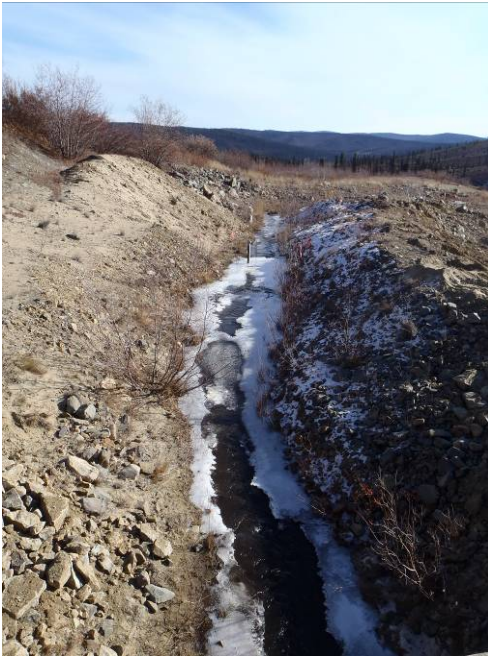
Downstream View

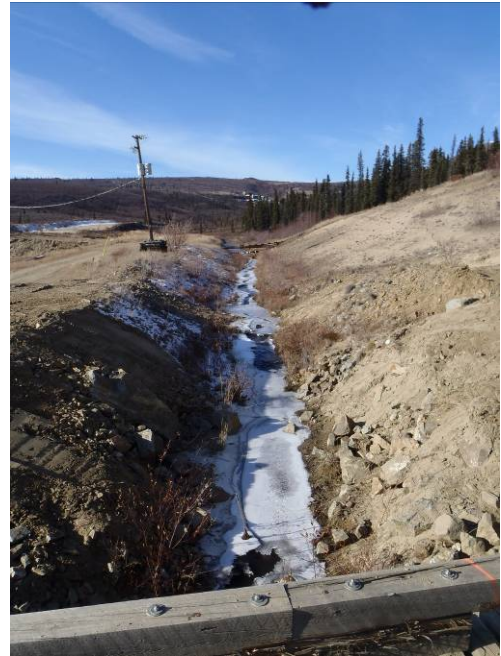
Upstream View

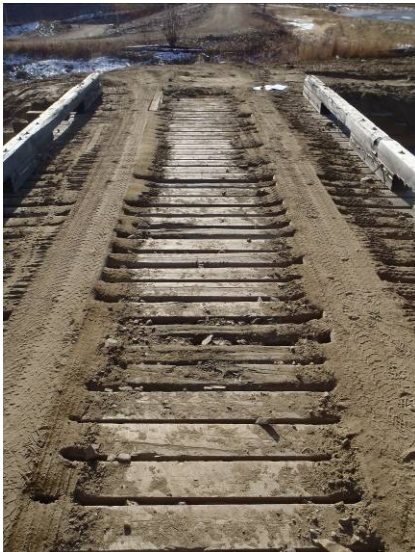
Deck surface

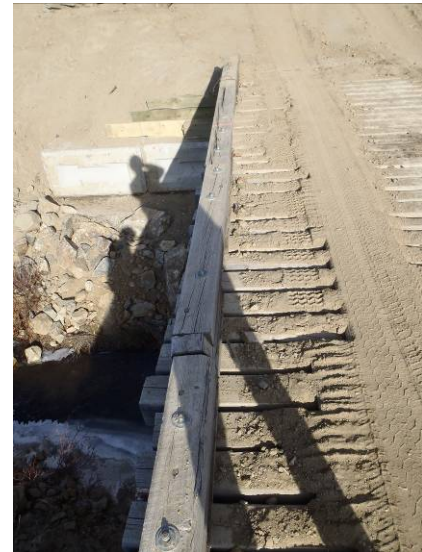
Parapet – Longitudinal cracks

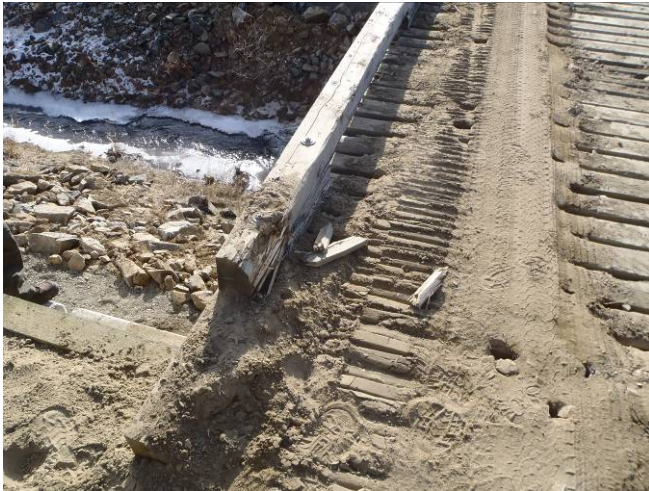
Damaged parapet - Upstream

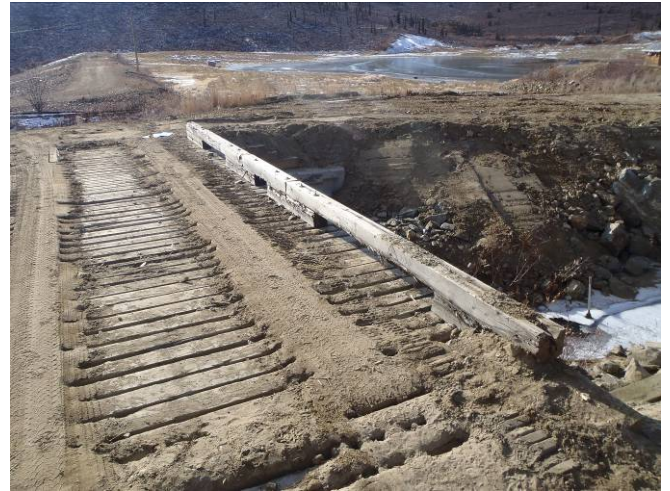
Damaged parapet - Downstream

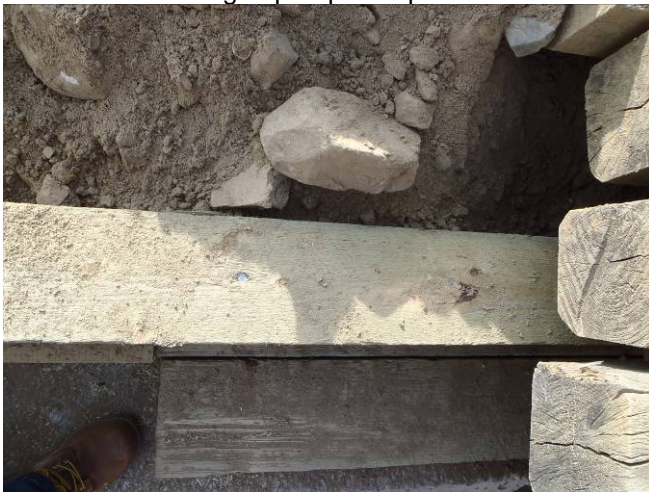
Fixed timber ballast wall

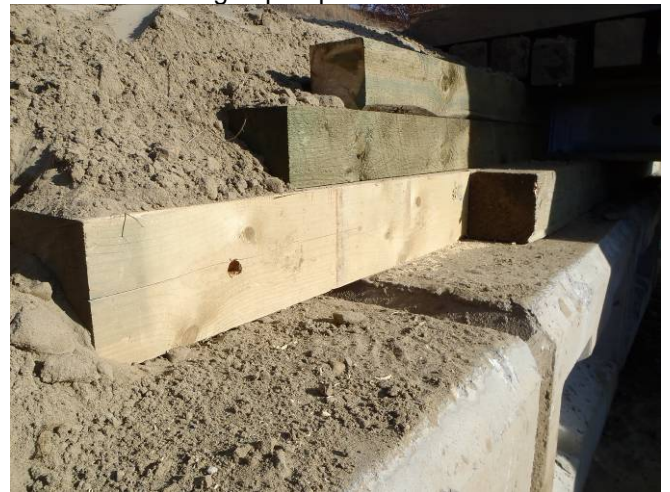
Timber ballast wall – loose and non-treated end-timber blocks

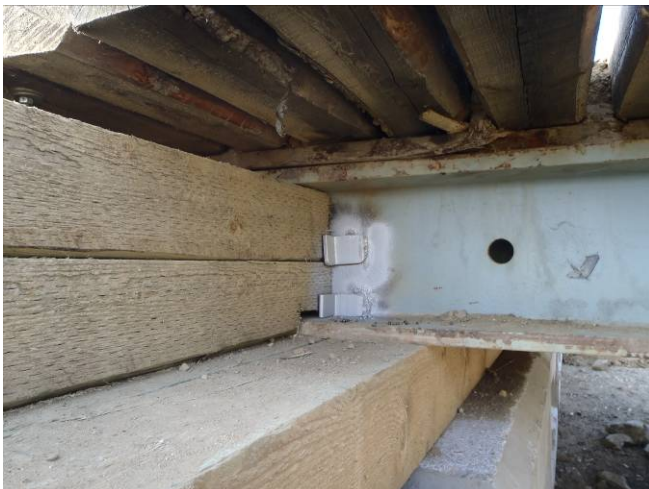
Steel girder to outer ballast wall connection

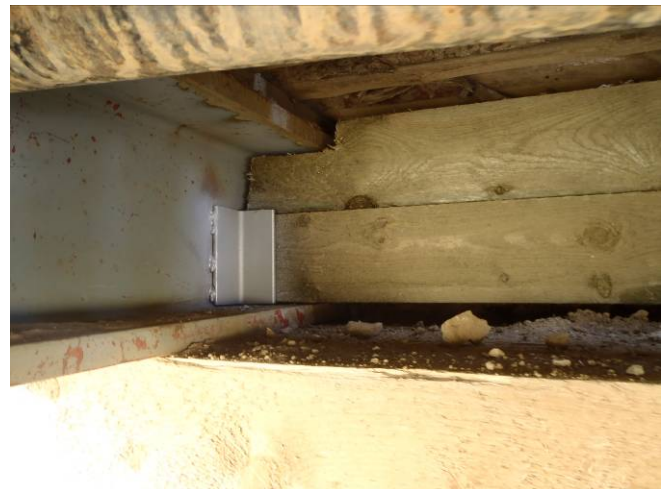
Steel girder to inner ballast wall connection

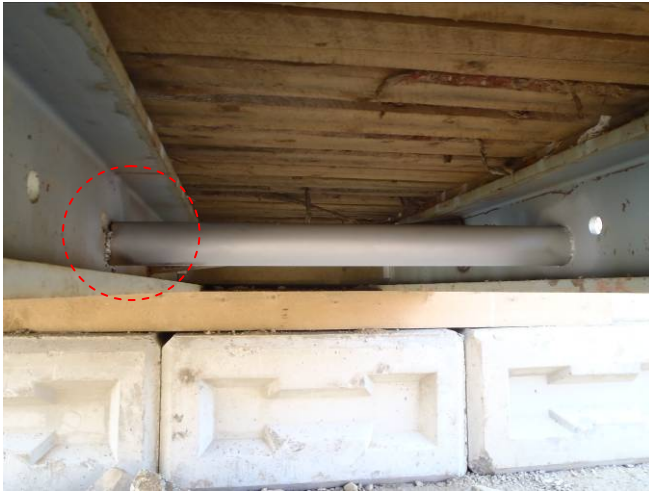
Steel pipe diaphragm – welding in bad condition

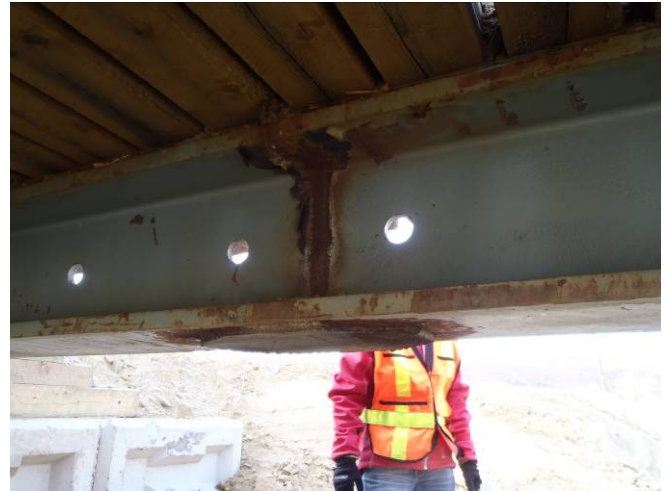
Weld splice in girder

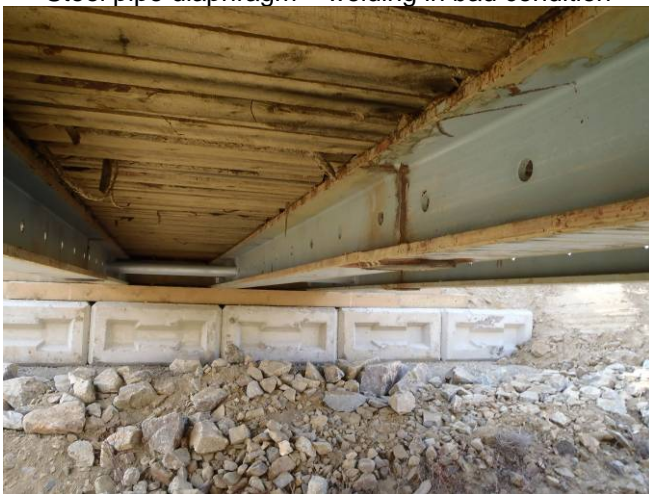
Steel girders

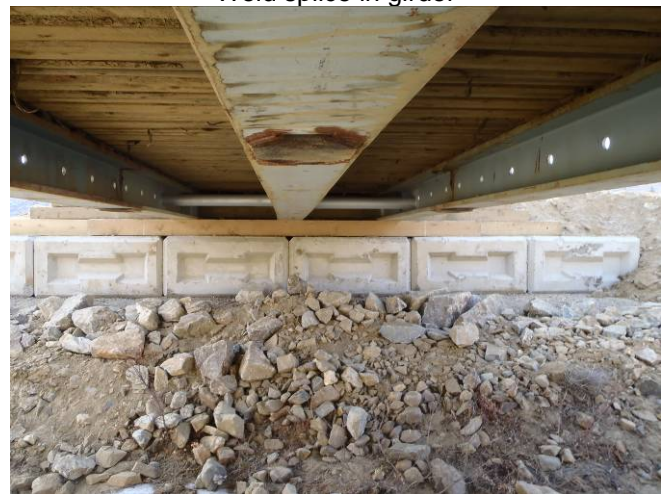
Underside of bridge

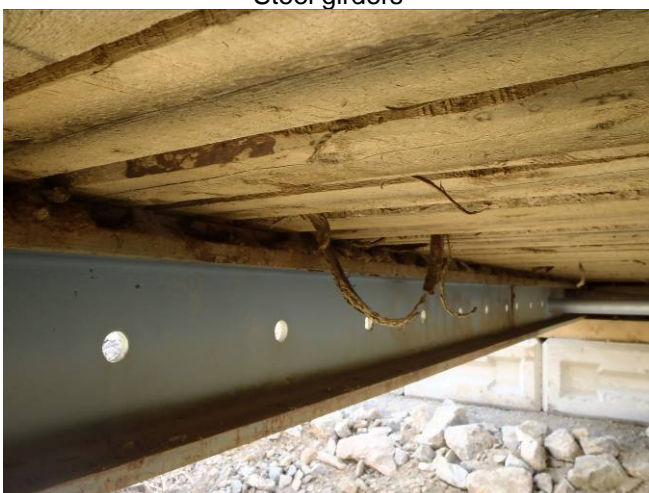
Deteriorated timber plank between top of steel girder and deck

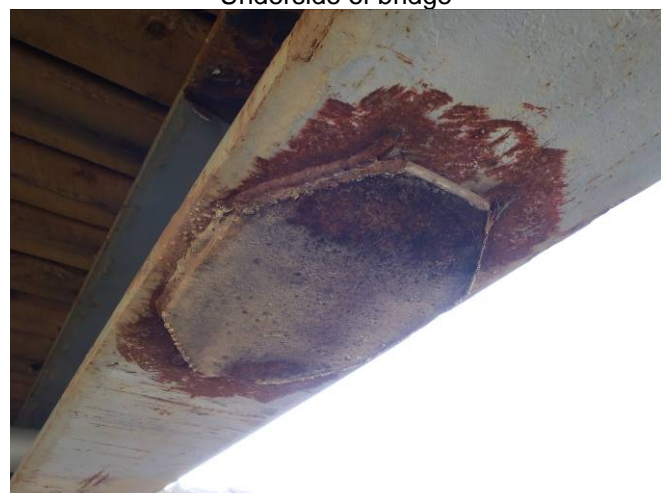
Poor quality previous weld repair

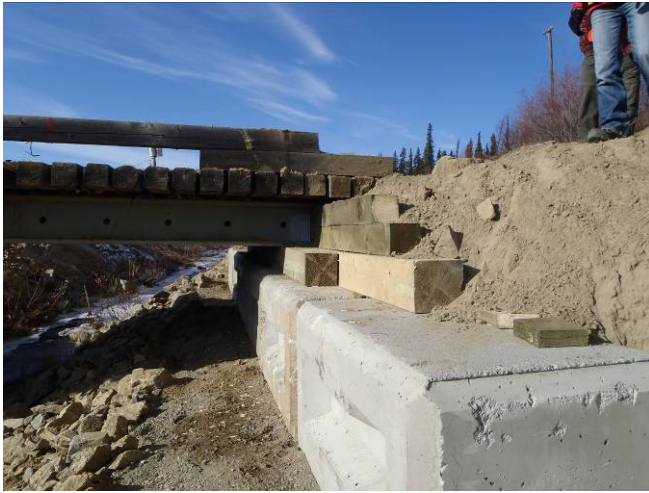
Concrete lock blocks

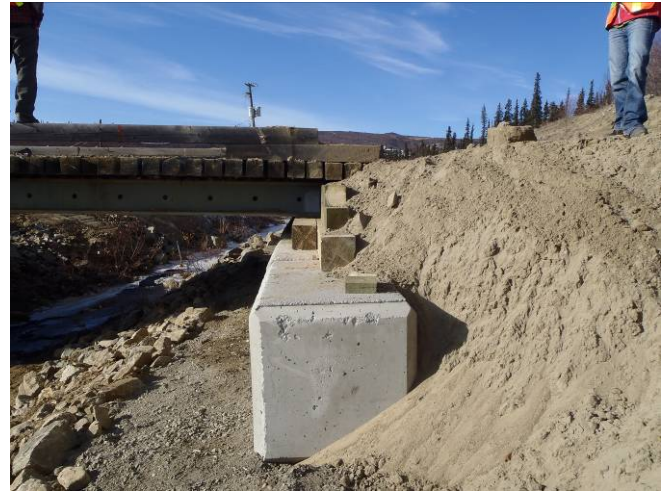
Loose soil in the embankment sides
