**Mt. Nansen Mine Site Bridge Repair:  
Photo Log of sub-structure implementation  
October 2011**

**This document highlights the key modifications of the bridge sub-structure using photos and brief descriptions of each.**

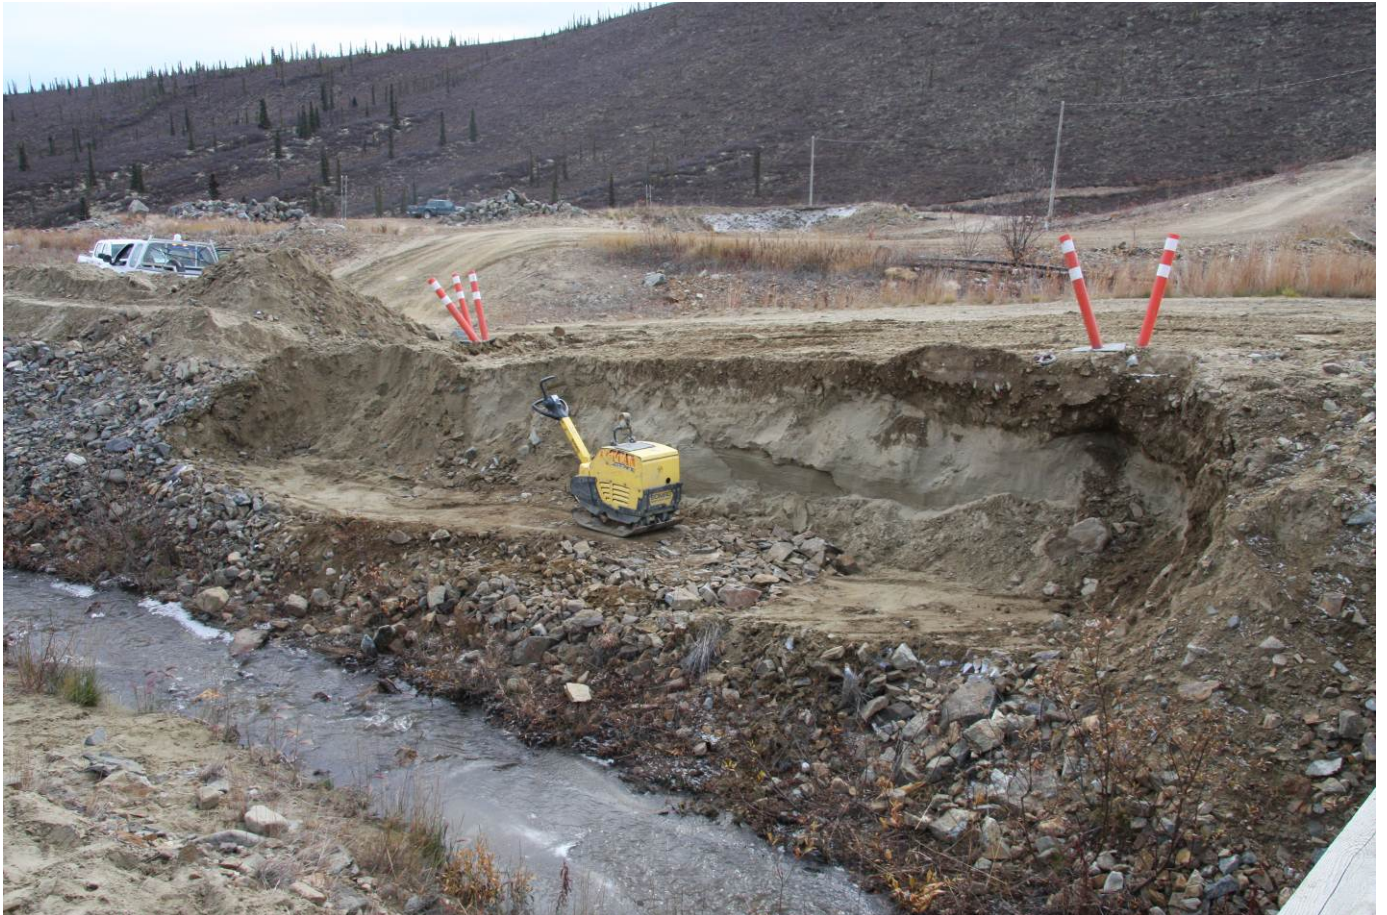
**Photo 1**

**This is the area where the bridge will be re-located. The area had been excavated, then had course material added and thoroughly compacted (existing material comprised mostly of sand)**

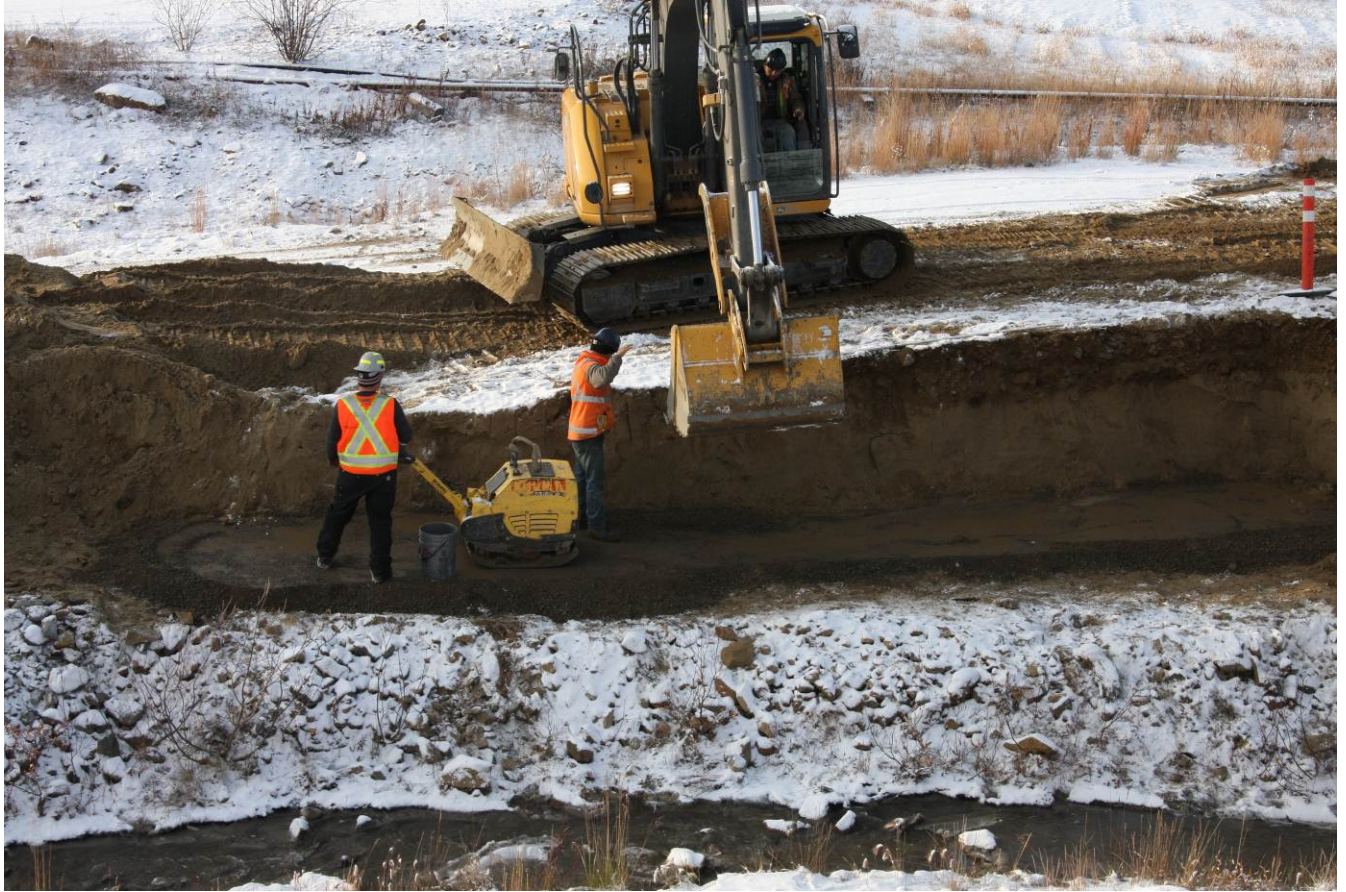
Photo 2

The first of three individual lifts of gravel applied by excavator and thoroughly compacted by COP CAN staff.

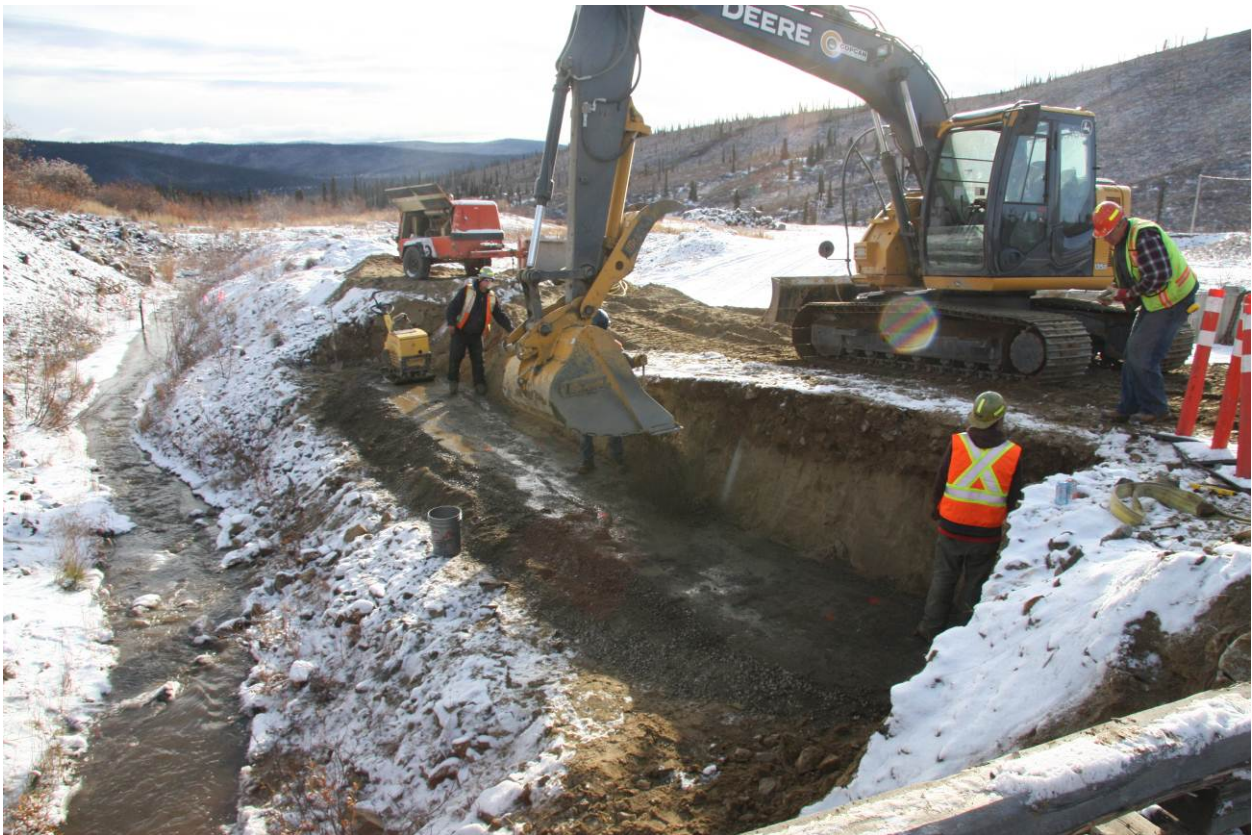
**Photo 3**

**The third and final lift of gravel applied, levelled and compacted. This process was mirrored on the opposite side of the diversion channel and levelled with a builders level.**

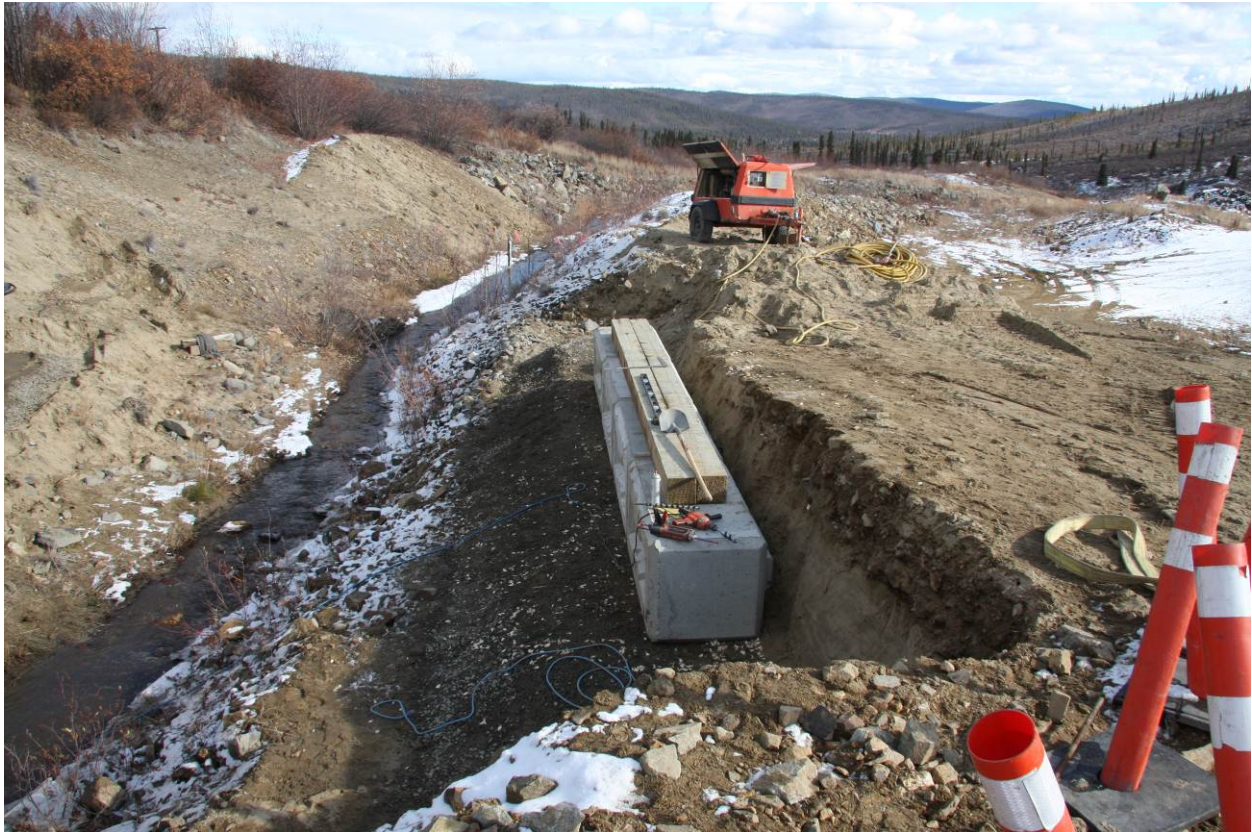
**Photo 4**

**Lock blocks positioned and levelled in place. Double 8in X 8in timbers used for I-beams to anchor in proper position.**

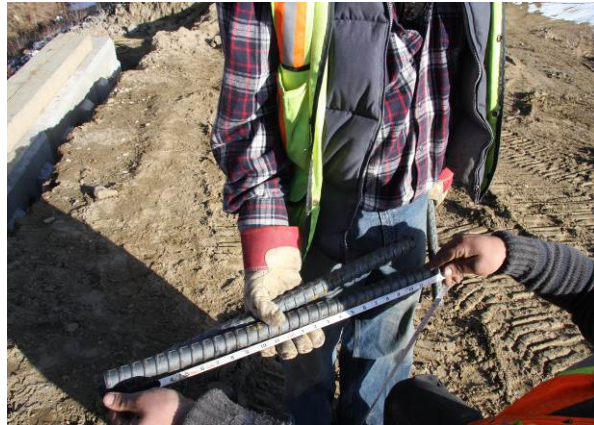
**Photo of re-bar pins (photo also taken by Colin Urquhart)**

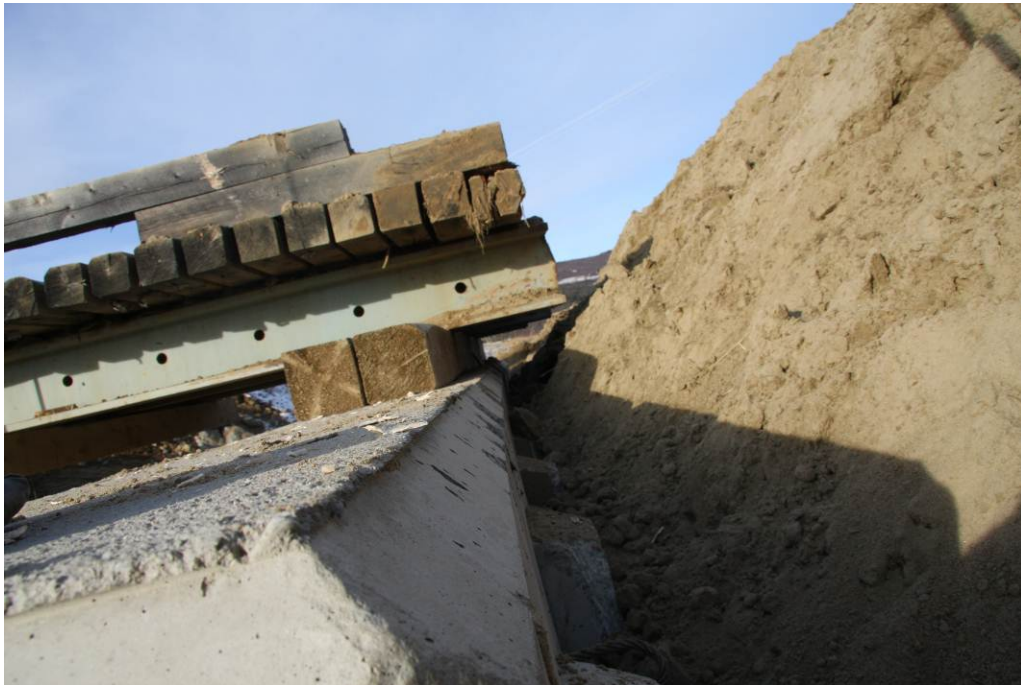
**Photo 5**

**Bridge has been moved in to its final position**

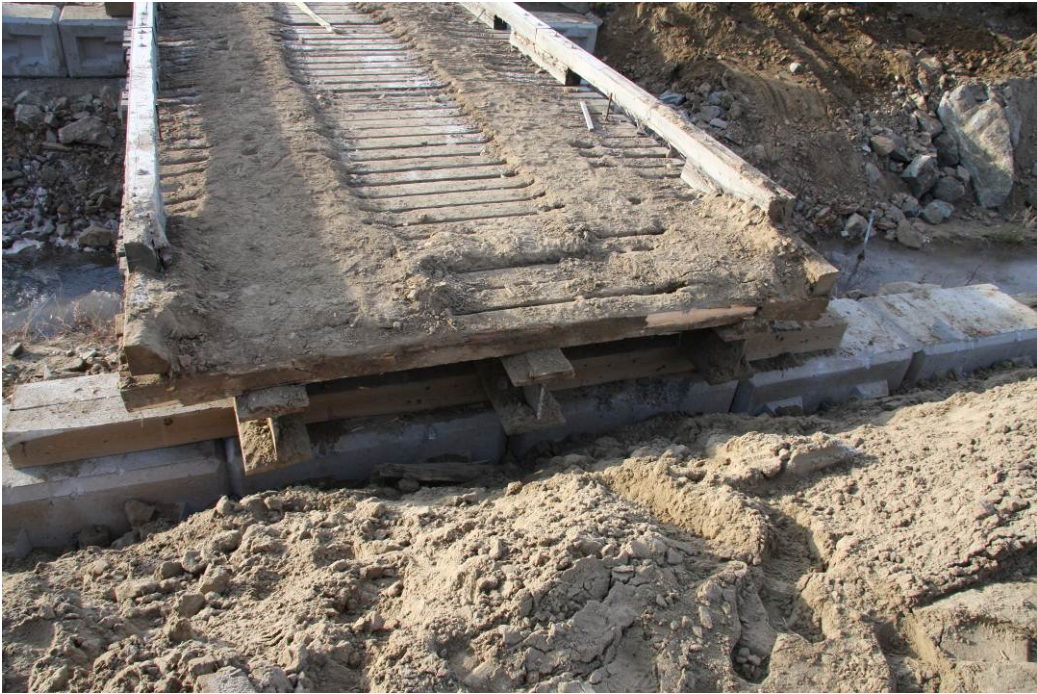
**Photo 6 (opposite side of the diversion channel)**

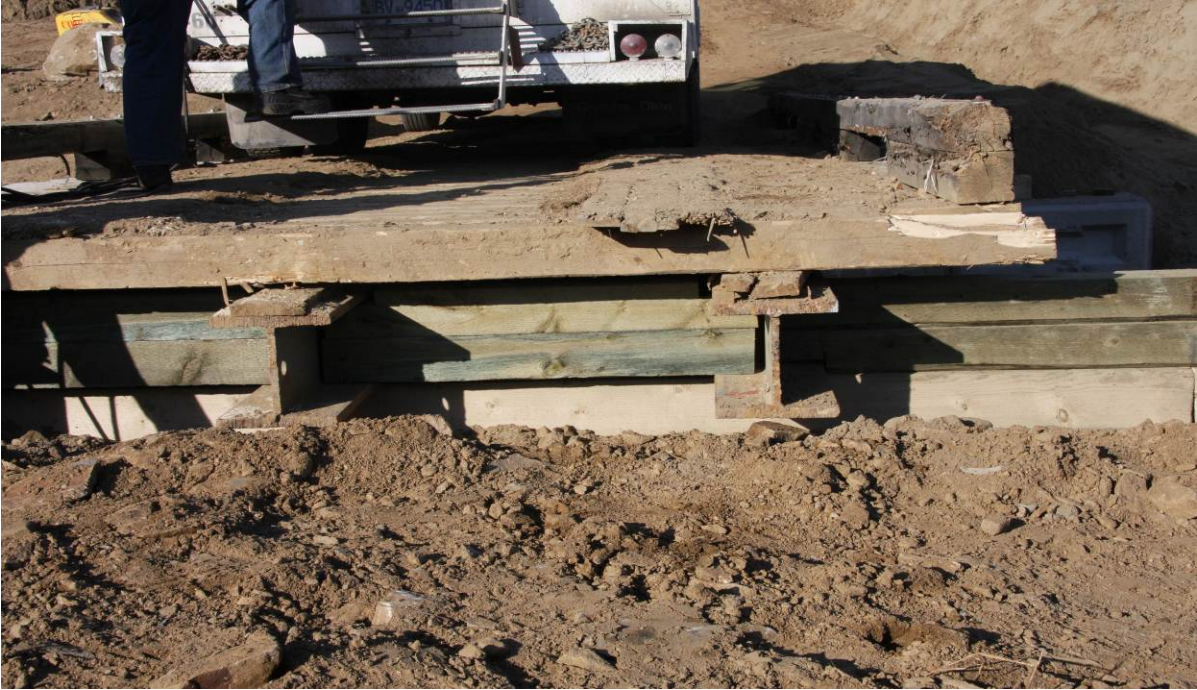
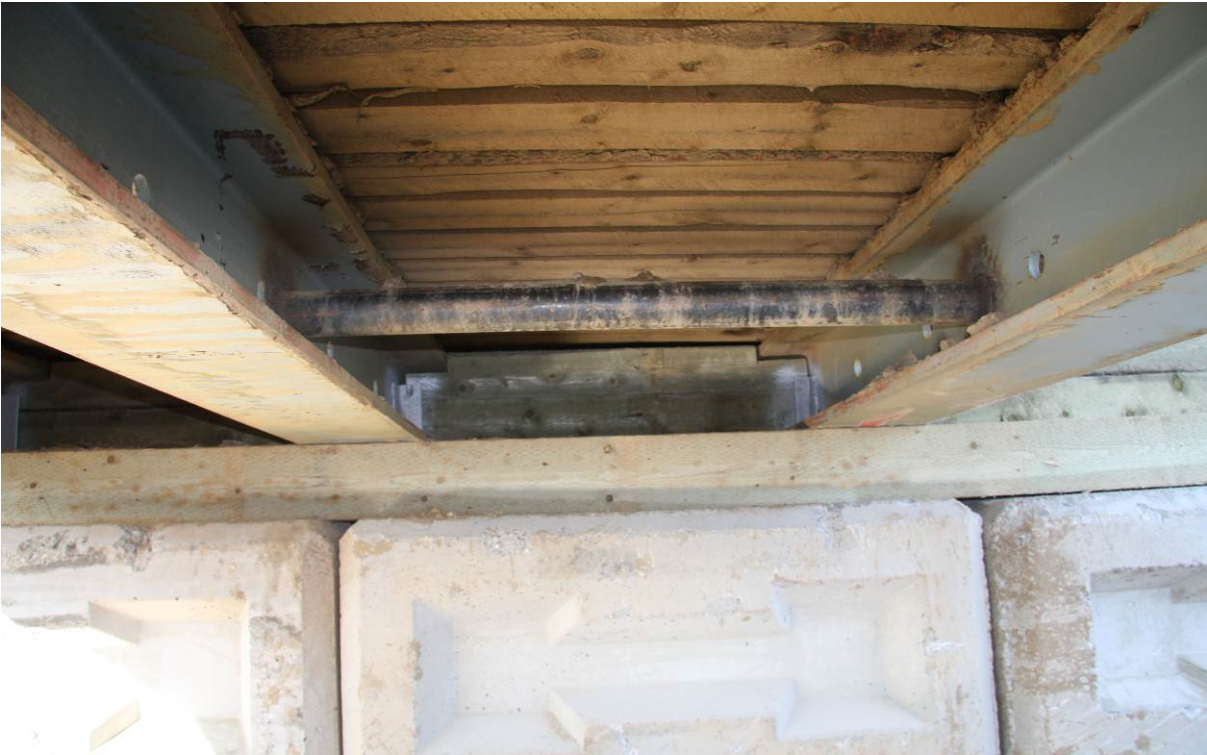
Photos 7 and 8

Timbers were added on one end to carry the load, as the I-Beams were various lengths. The following photos were taken at various angles to document the timbers placed between the beams for structural support, as well as the brackets welded to the beams to ensure the timbers do not move.

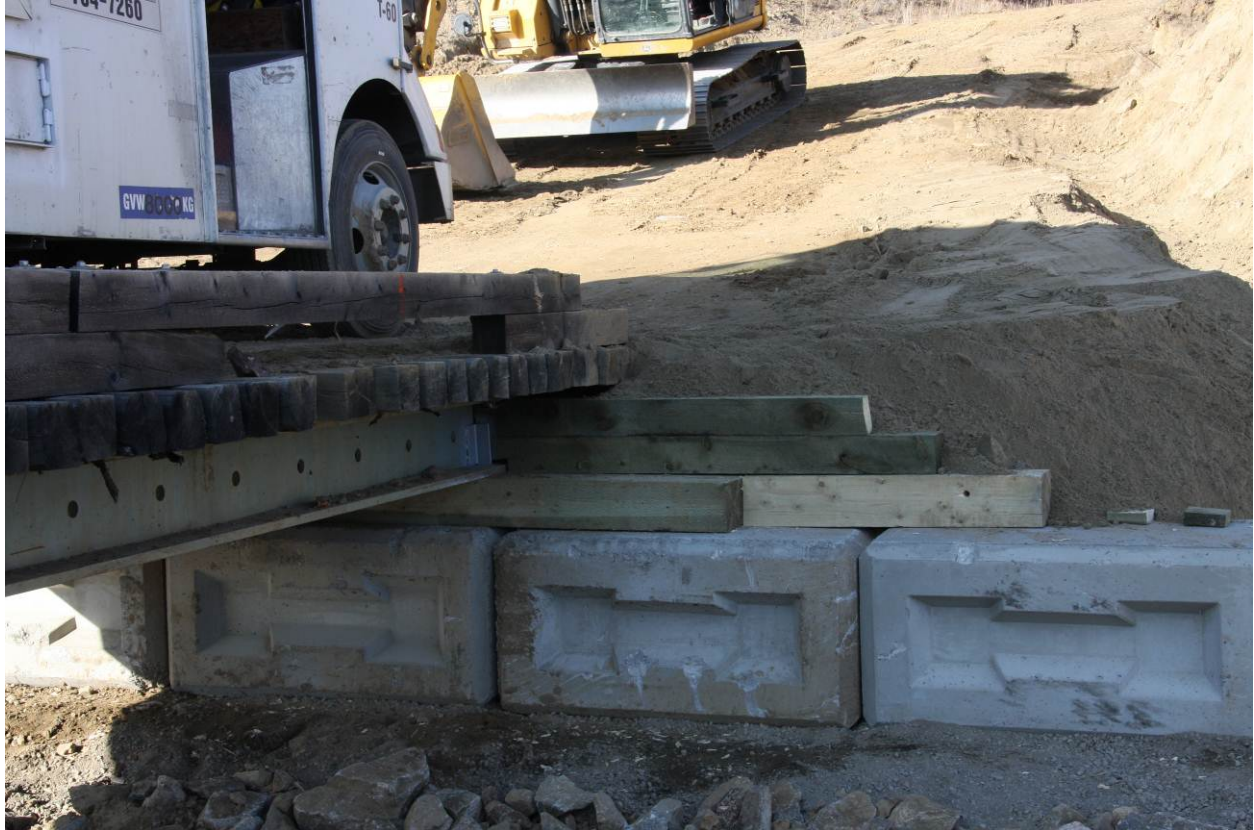
Photo 9

Additional photo documenting the timbers and brackets welded to the I-Beams to keep the timbers in the proper location.

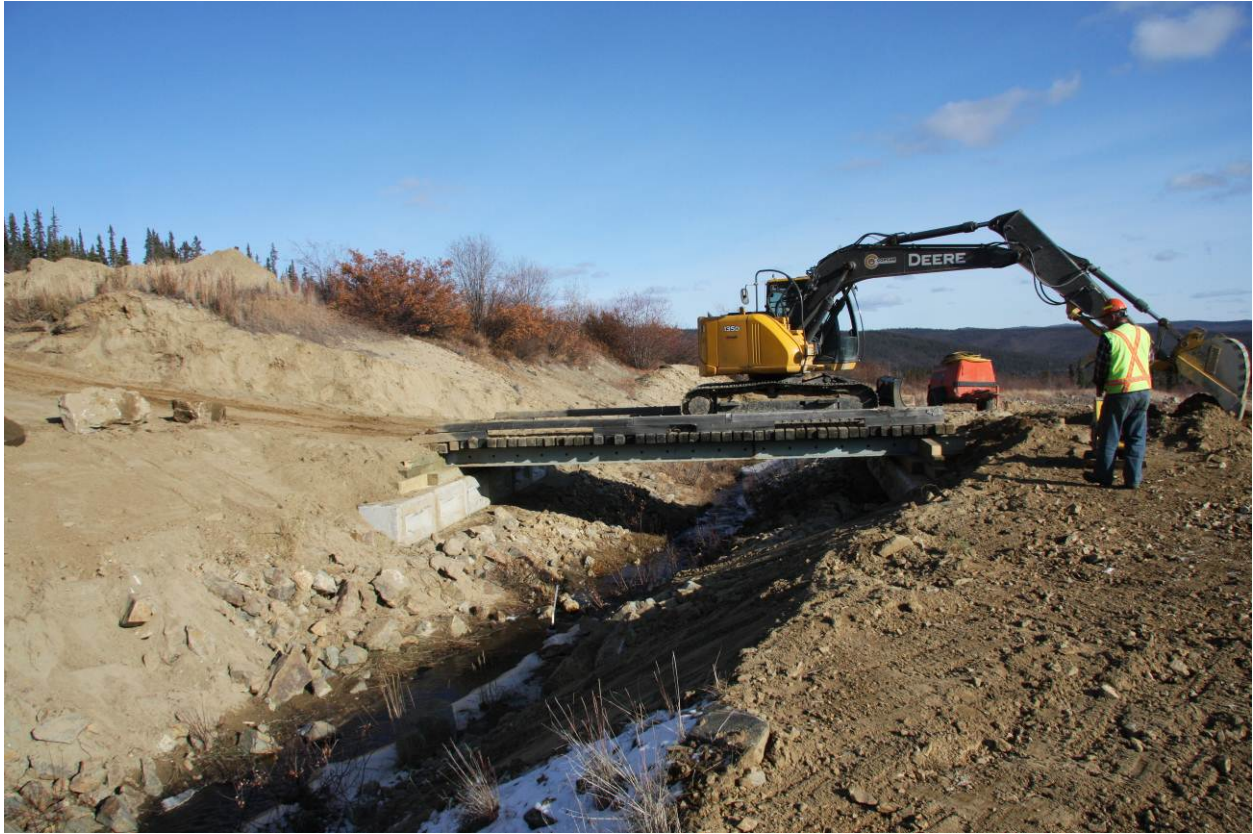
Photo 10

The bridge in its final position with the excavator adjusting the approach angles and cleaning up the disturbed areas.
