To: Mr. Jeff Moore
c:
From: Mr. Charles Hunt, P.Eng.
Ms. Sarah McAuley, E.I.T.
Date: July 29, 2016
Memo No.:
File: 704-ENG.ROCK03020-01

Subject: Mt. Nansen Pit Wall Stability Assessment

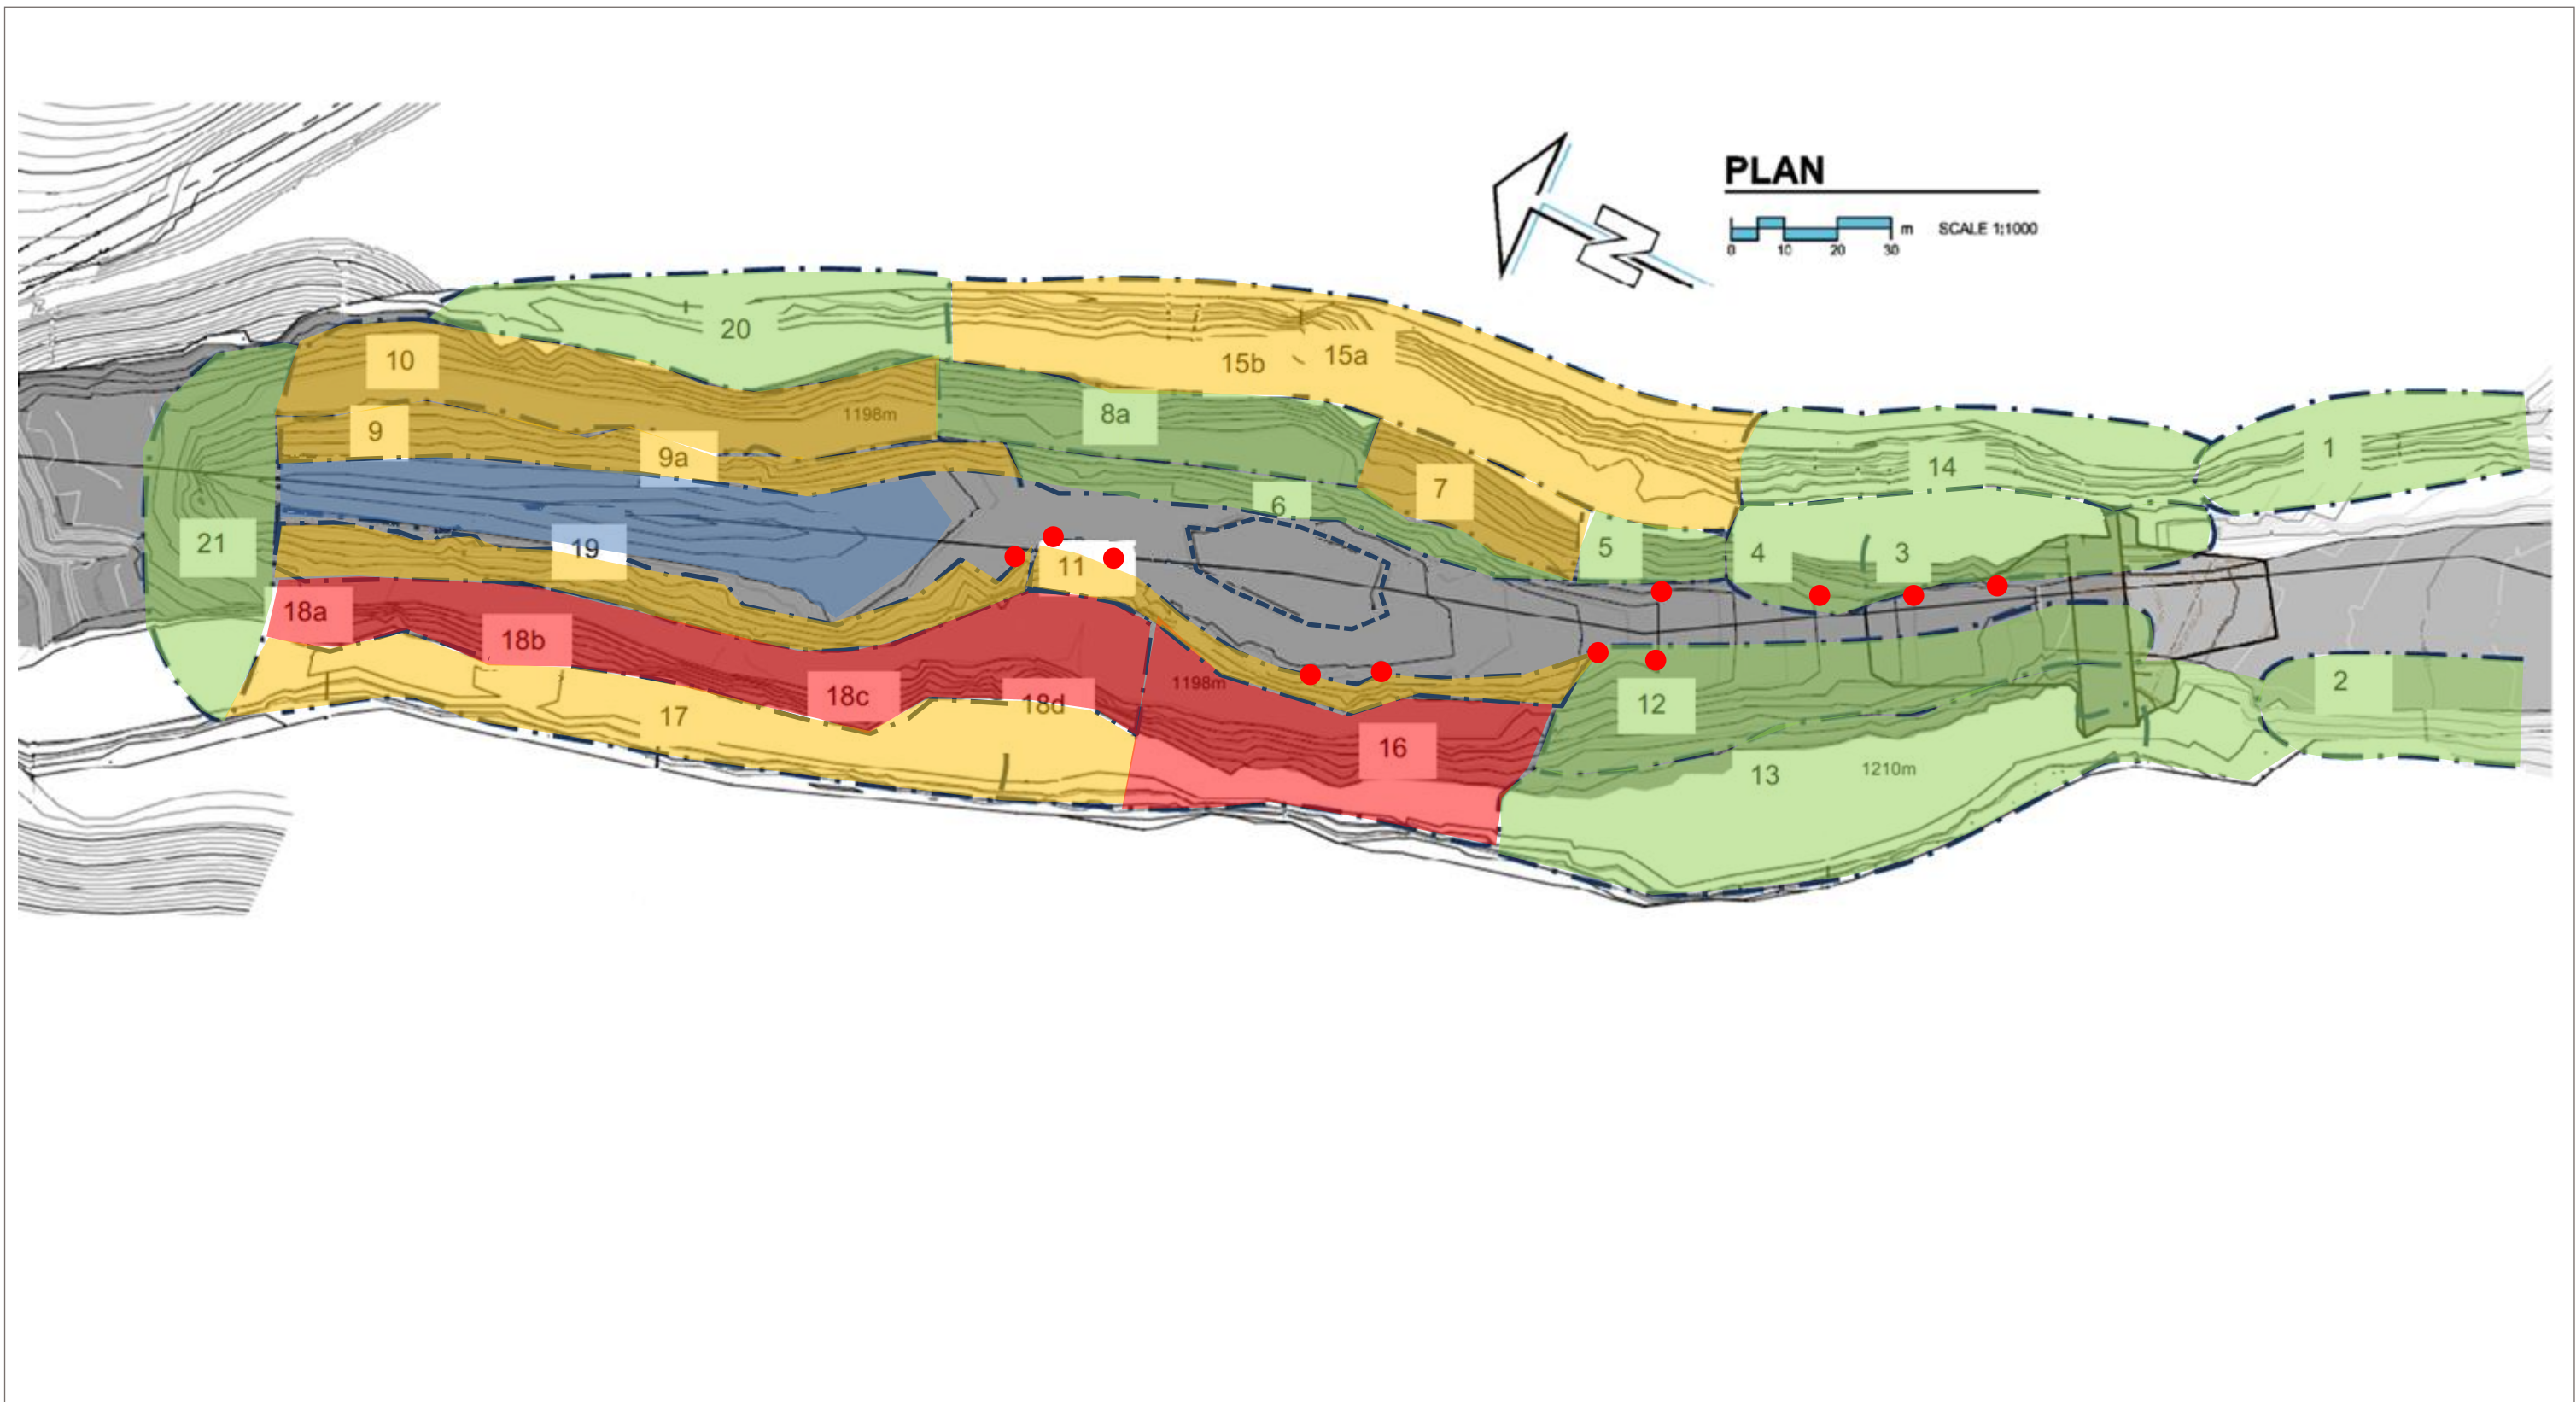
The area in grey on Figure 1 is the area where controlled access and spotters are required to aid in observing potential rock fall (ie the area outside the prescribed zones and outside of 3 m away from the toe of the slopes). This area is some 200 m in length, and on average 10 m wide (even if one considers the flooding of the southern ephemeral ponding area). There are therefore 2000 square metres where rock fall might occur, during water sampling, 4 of these square metres might be occupied (assuming a 4 person crew). If a given rock fall traverses or occupies 15 square metres then the probability of someone being struck in an occupied cell is $1.5 \times 10^{-5} (4/2000) \times (15/2000)$. The overall probability therefore is estimated to be $(9.86 \times 10^{-3}) \times (1.5 \times 10^{-5}) = 1.5 \times 10^{-7}$.

Rock Fall Observation	Pit Sectors
Minimal Change Observed	1-6, 8, 12-14, 20, 21
Minor Rock Fall	7, 9, 10, 11, 15, 17, 19
Major Rock Fall	16, 18

Outline of Pit Sectors and Amount of Rockfall Observed

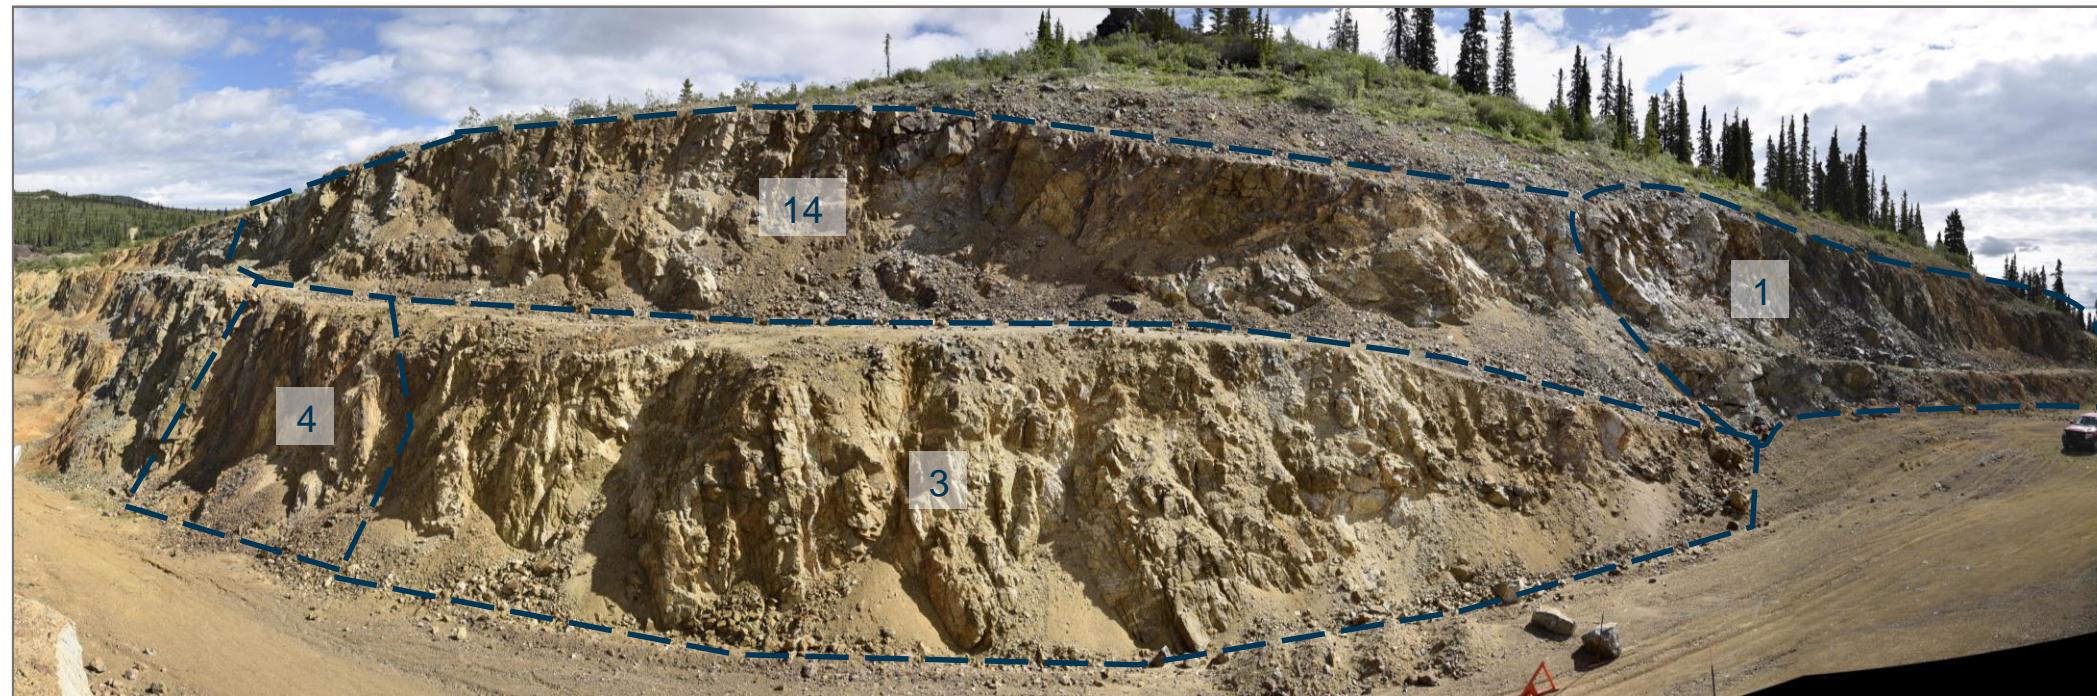
14	No changes noted – personnel should not be at the base of Sector 1 as they should be in the middle of the pit entrance	1, 2, 3
15	Some rock fall noted, contained on catchment bench	2, 3, 4, 5
16	Major rock fall noted	7, 8
17	Some erosion noted within soil deposit in this sector	6, 7, 8
18	a Tension cracks noted, rock dilation, through rock failure, and major rock fall	6, 7, 8
	b Major erosion of gullies within soil noted	6, 7, 8
	c Major rock fall noted however failure is imminent	6, 7, 8
	d Major evidence of rock fall	6, 7, 8
19	Difficult to identify changes as the lake level has changed dramatically, assumed as minor rock fall	6, 7, 8
20	No changes noted	4, 5
21	No changes noted – material is re-handled waste rock	6

Photo 1: Overview of sector 1, 3, 4, and 14 (taken June 23, 2016).

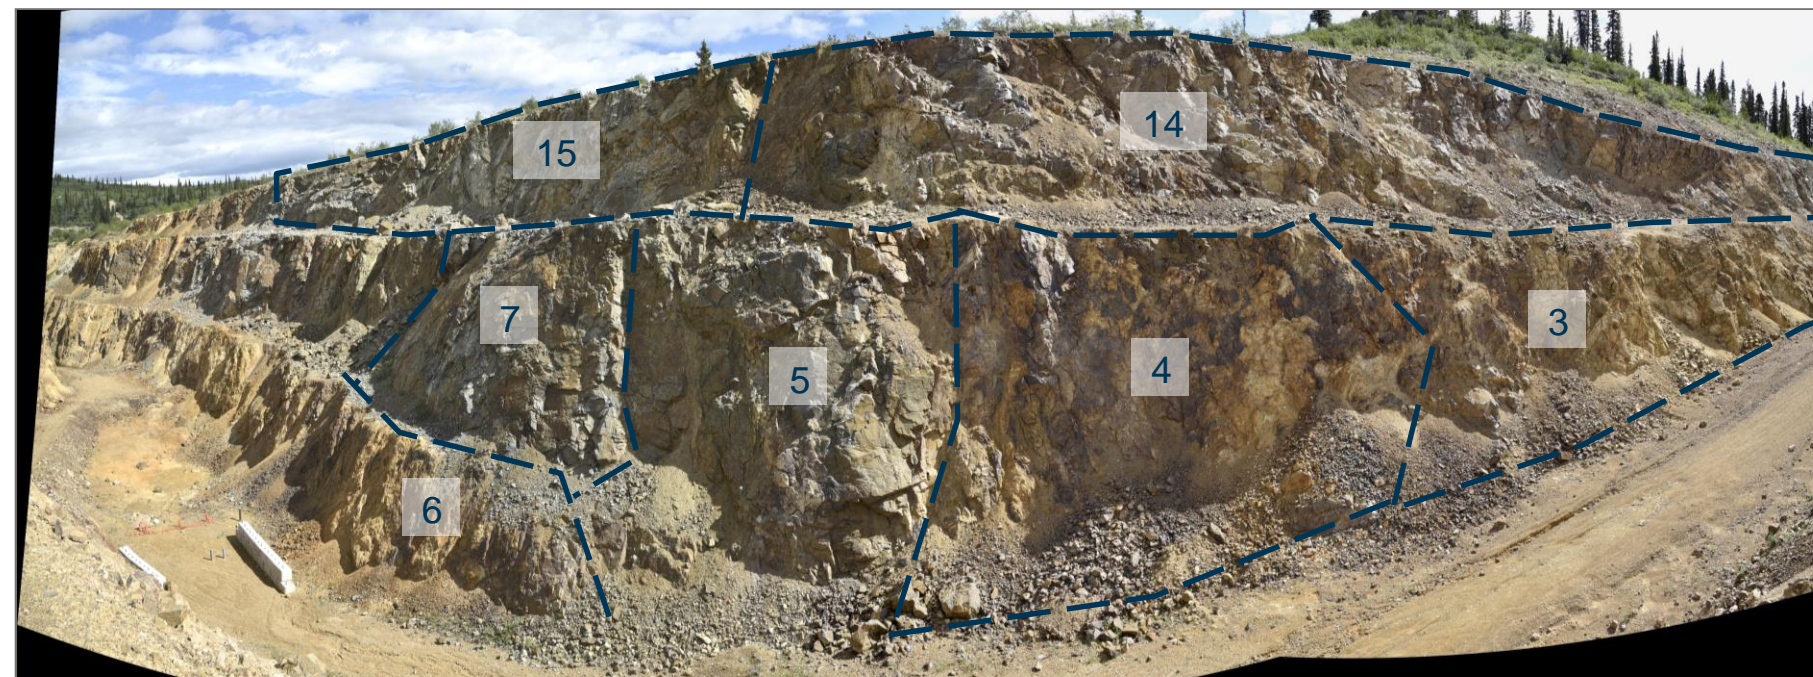
Photo 2: Overview of sectors 3, 4, 5, 6, 7, 14, 15 (taken Jun 23, 2016).

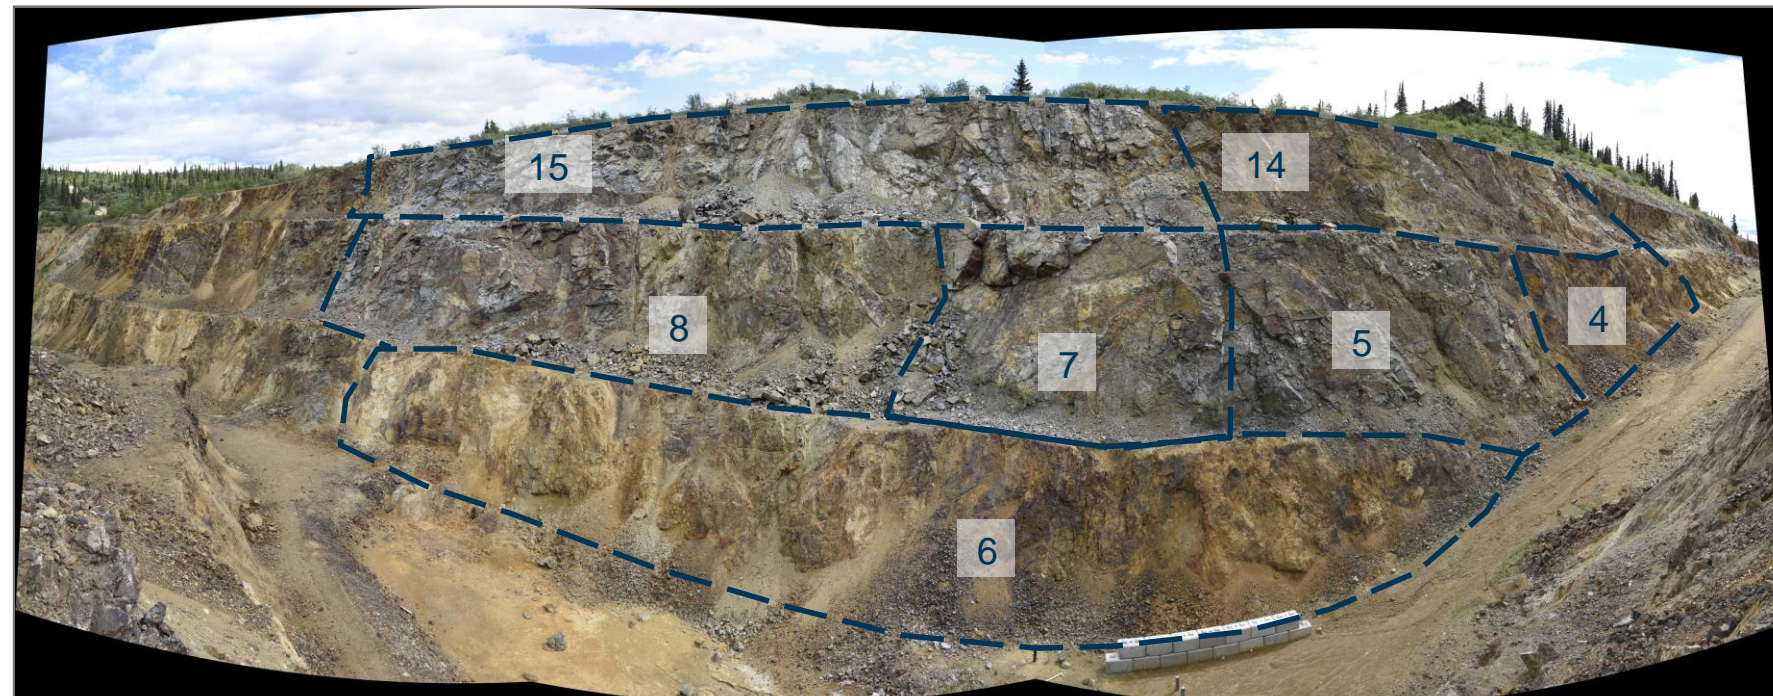
Photo 3: Overview of sectors 4, 5, 6, 7, 8, 14, 15 (taken June 23, 2015).

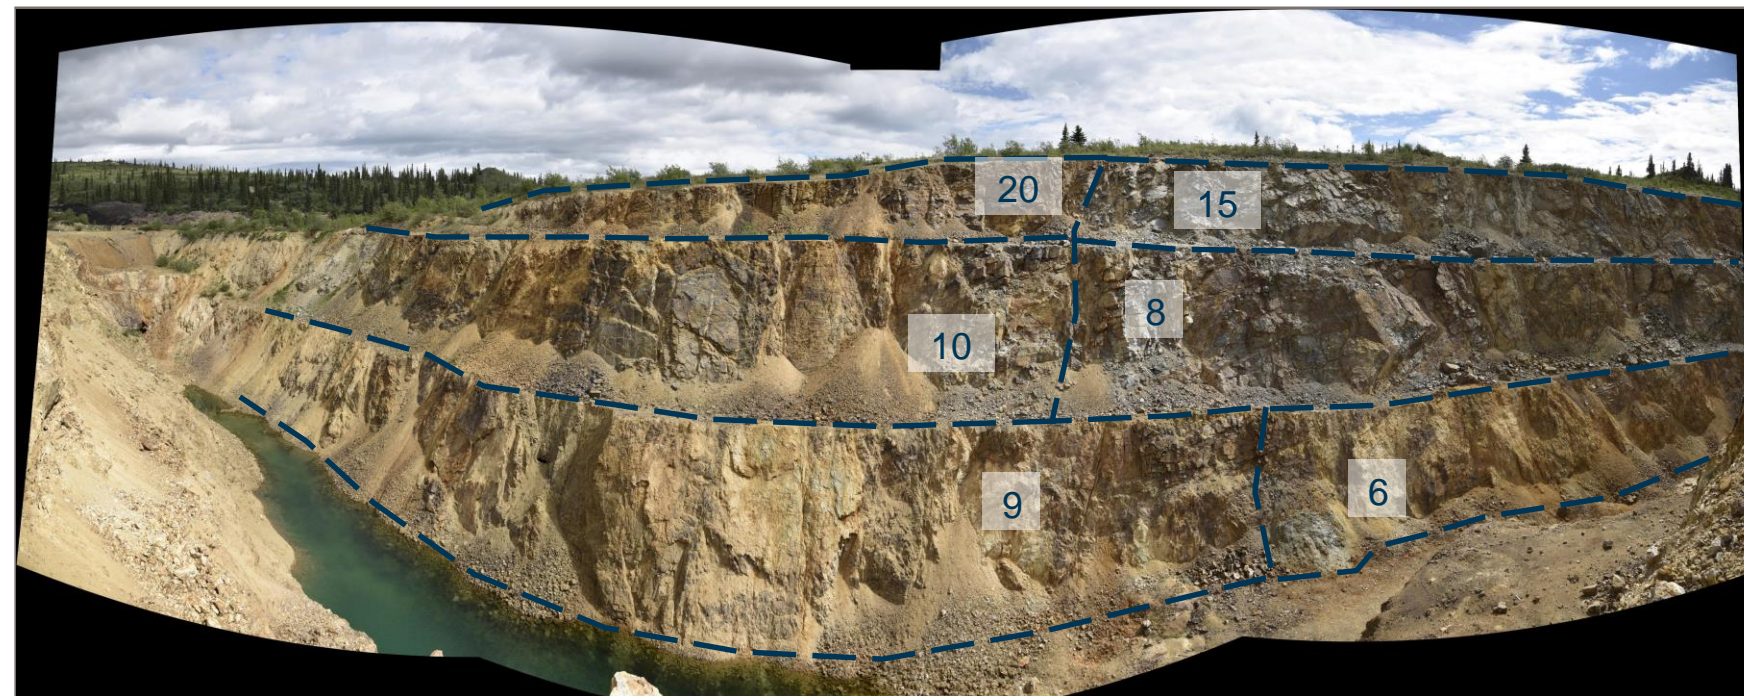
Photo 4: Overview of sectors 6, 8, 9, 10, 15, 20 (taken June 23, 2016).

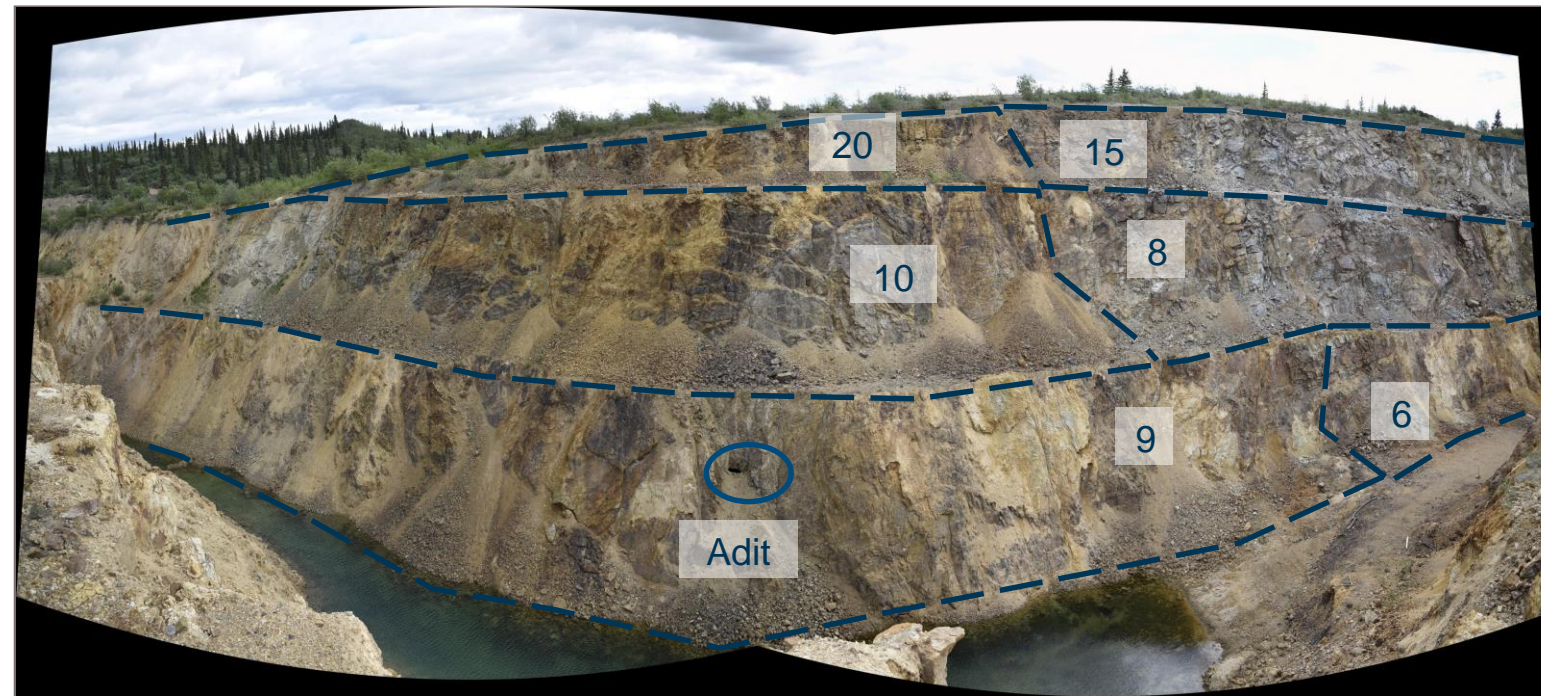
Photo 5: Overview of sector 6, 8, 9, 10, 15, 20 (taken June 23, 2016).

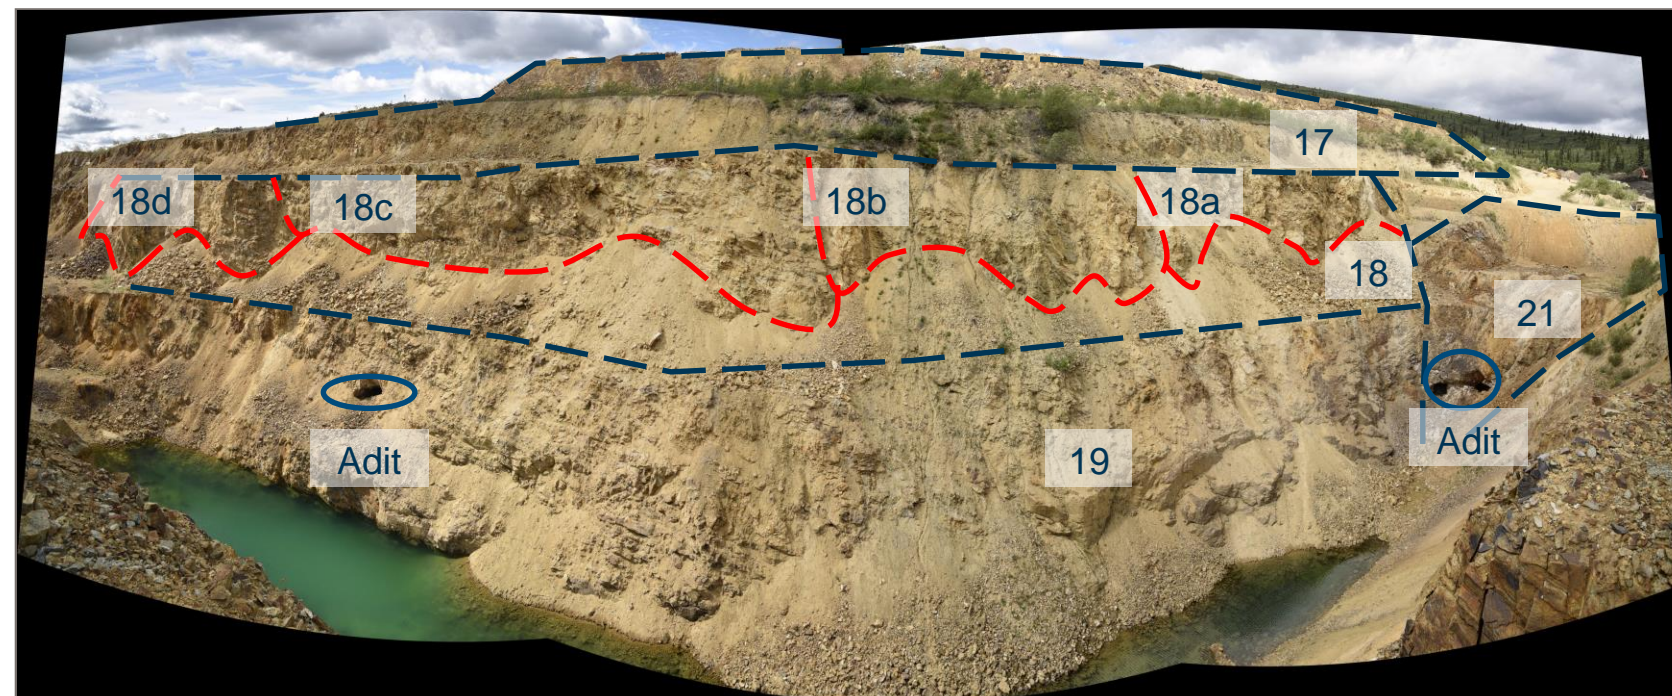
Photo 6: Overview of sector 17, 18, 19, 21 (taken June 23, 2016).

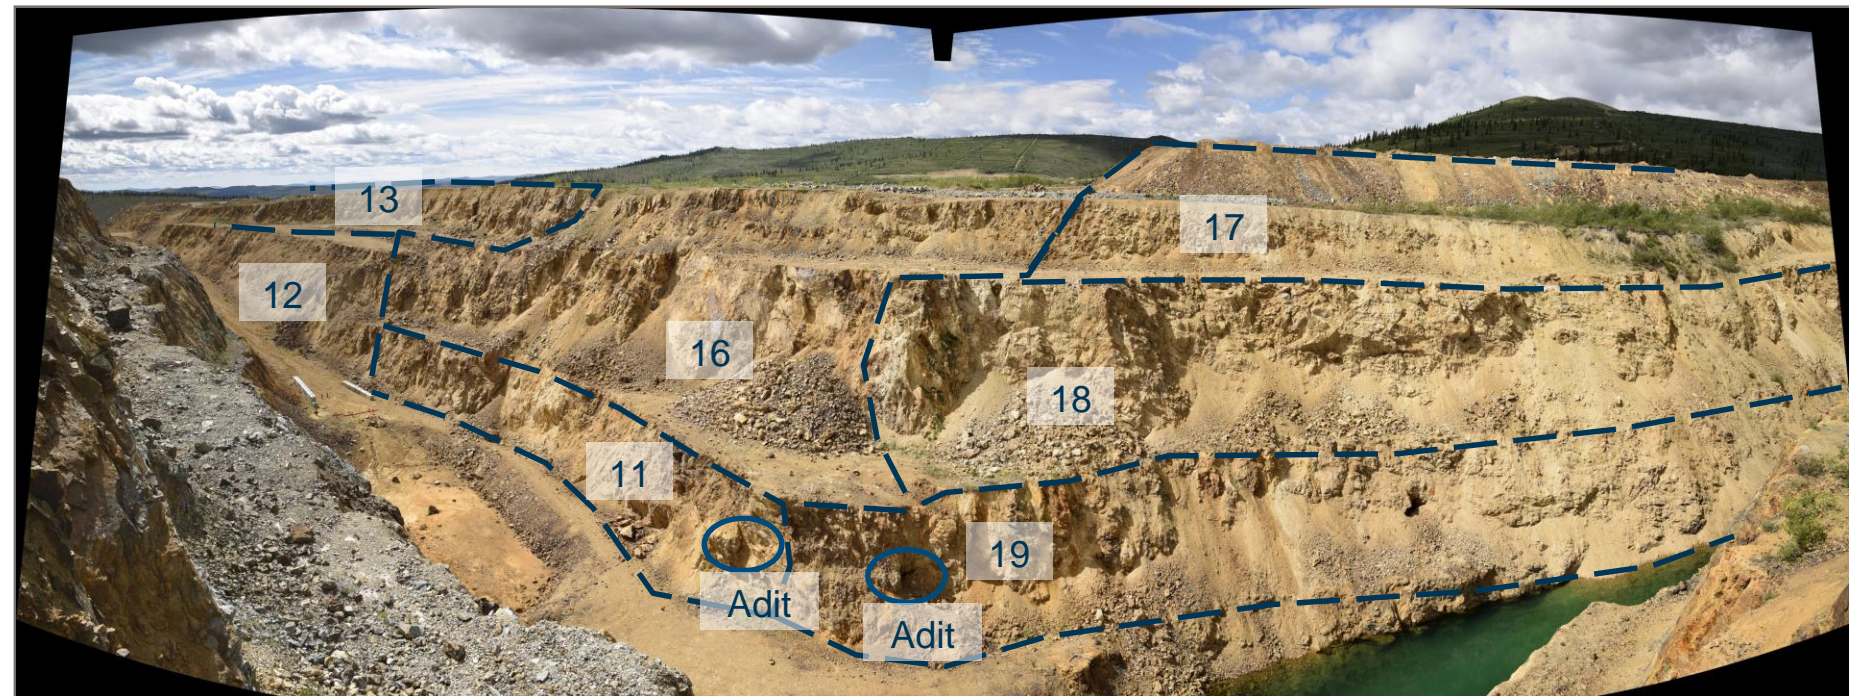
Photo 7: Overview of sector 11, 12, 13, 16, 17, 18, 19 (taken June 23, 2016).

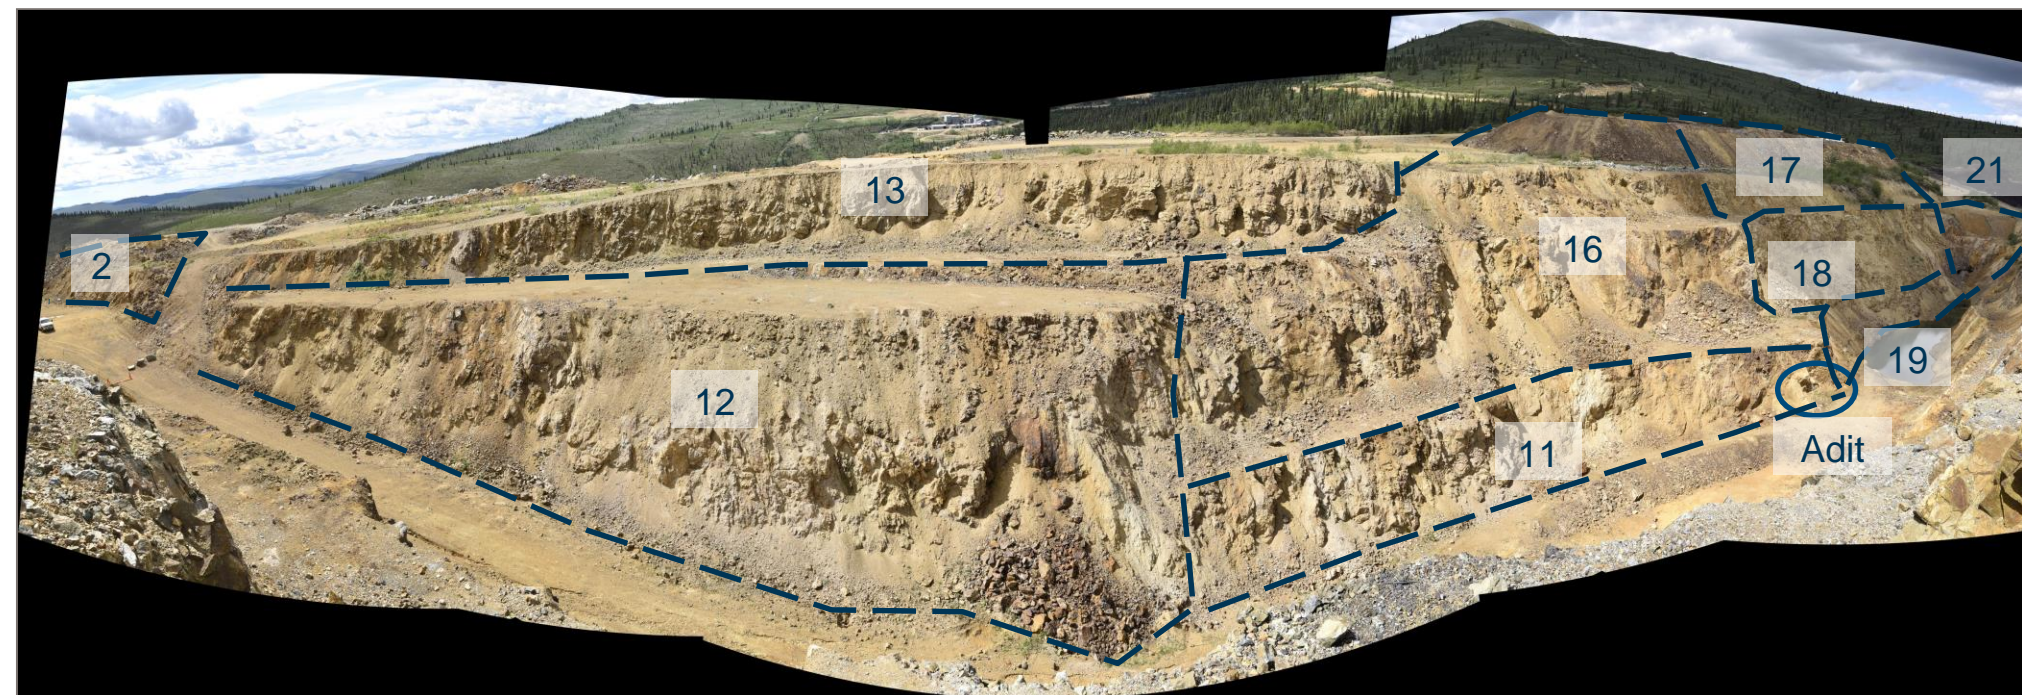
Photo 8: Overview of sector 2, 11, 12, 13, 16, 17, 18, 19 (taken June 23, 2016).

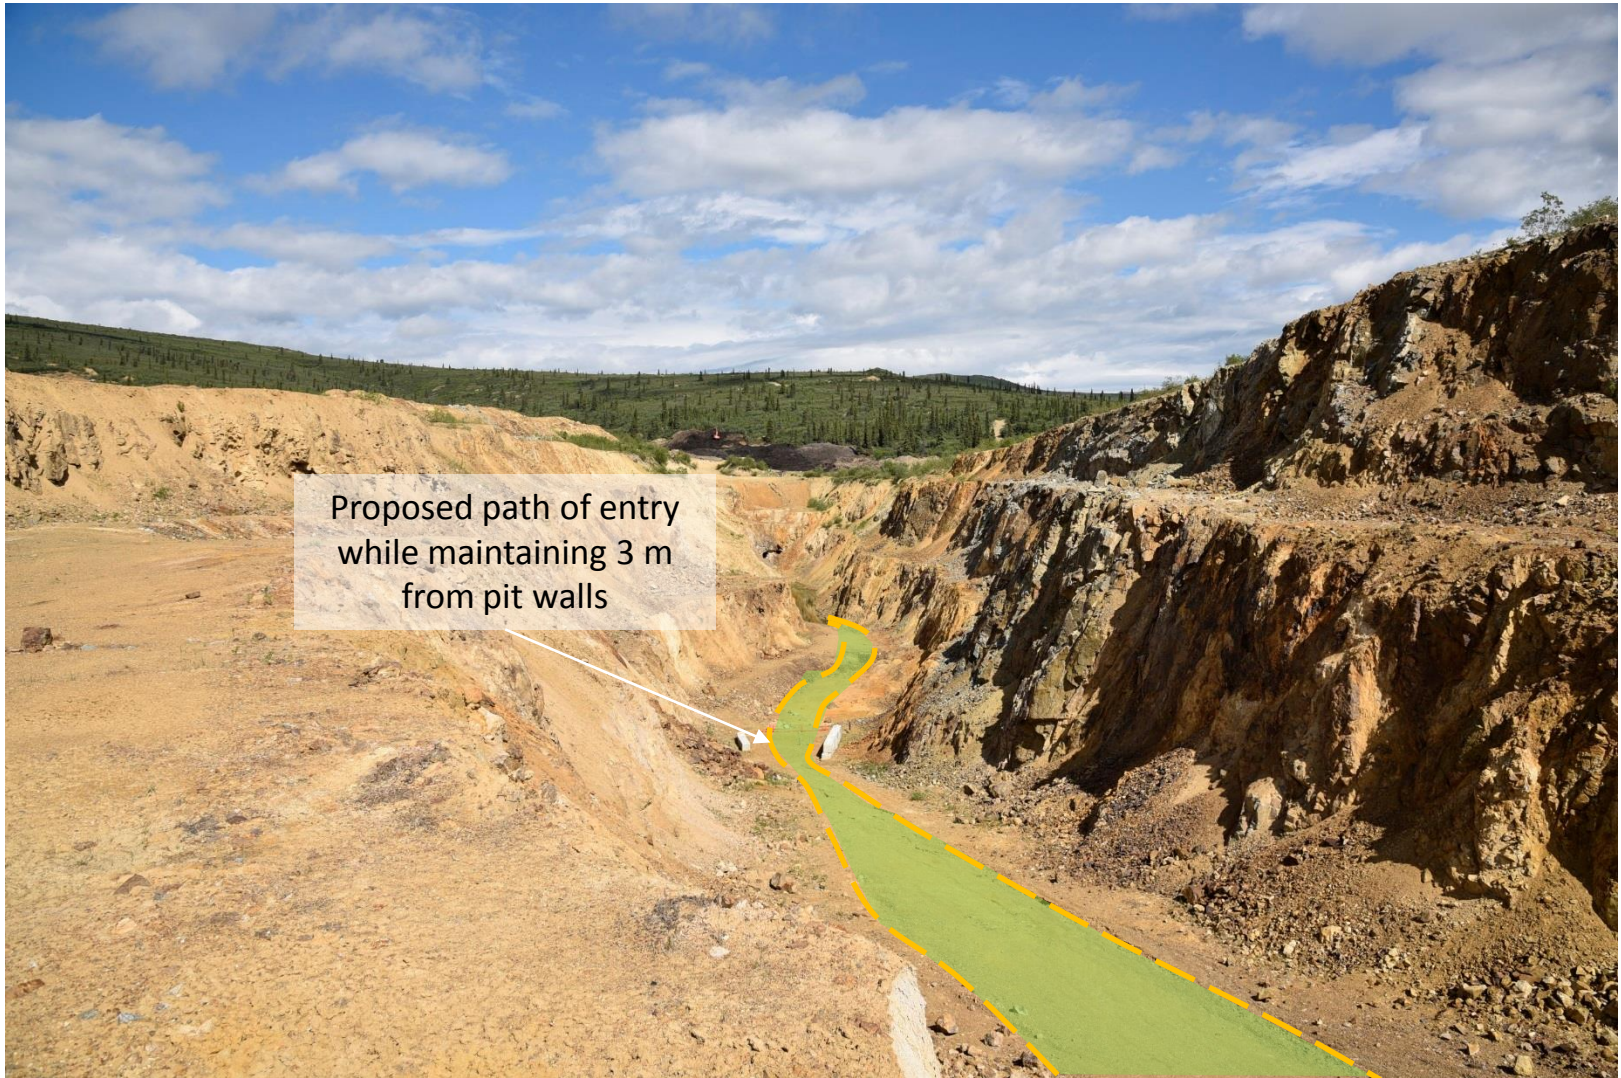
Photo 9: Overview of entry path that should be taken into the pit. Personnel should not come within 3 m of pit walls. Photo taken June 23, 2016

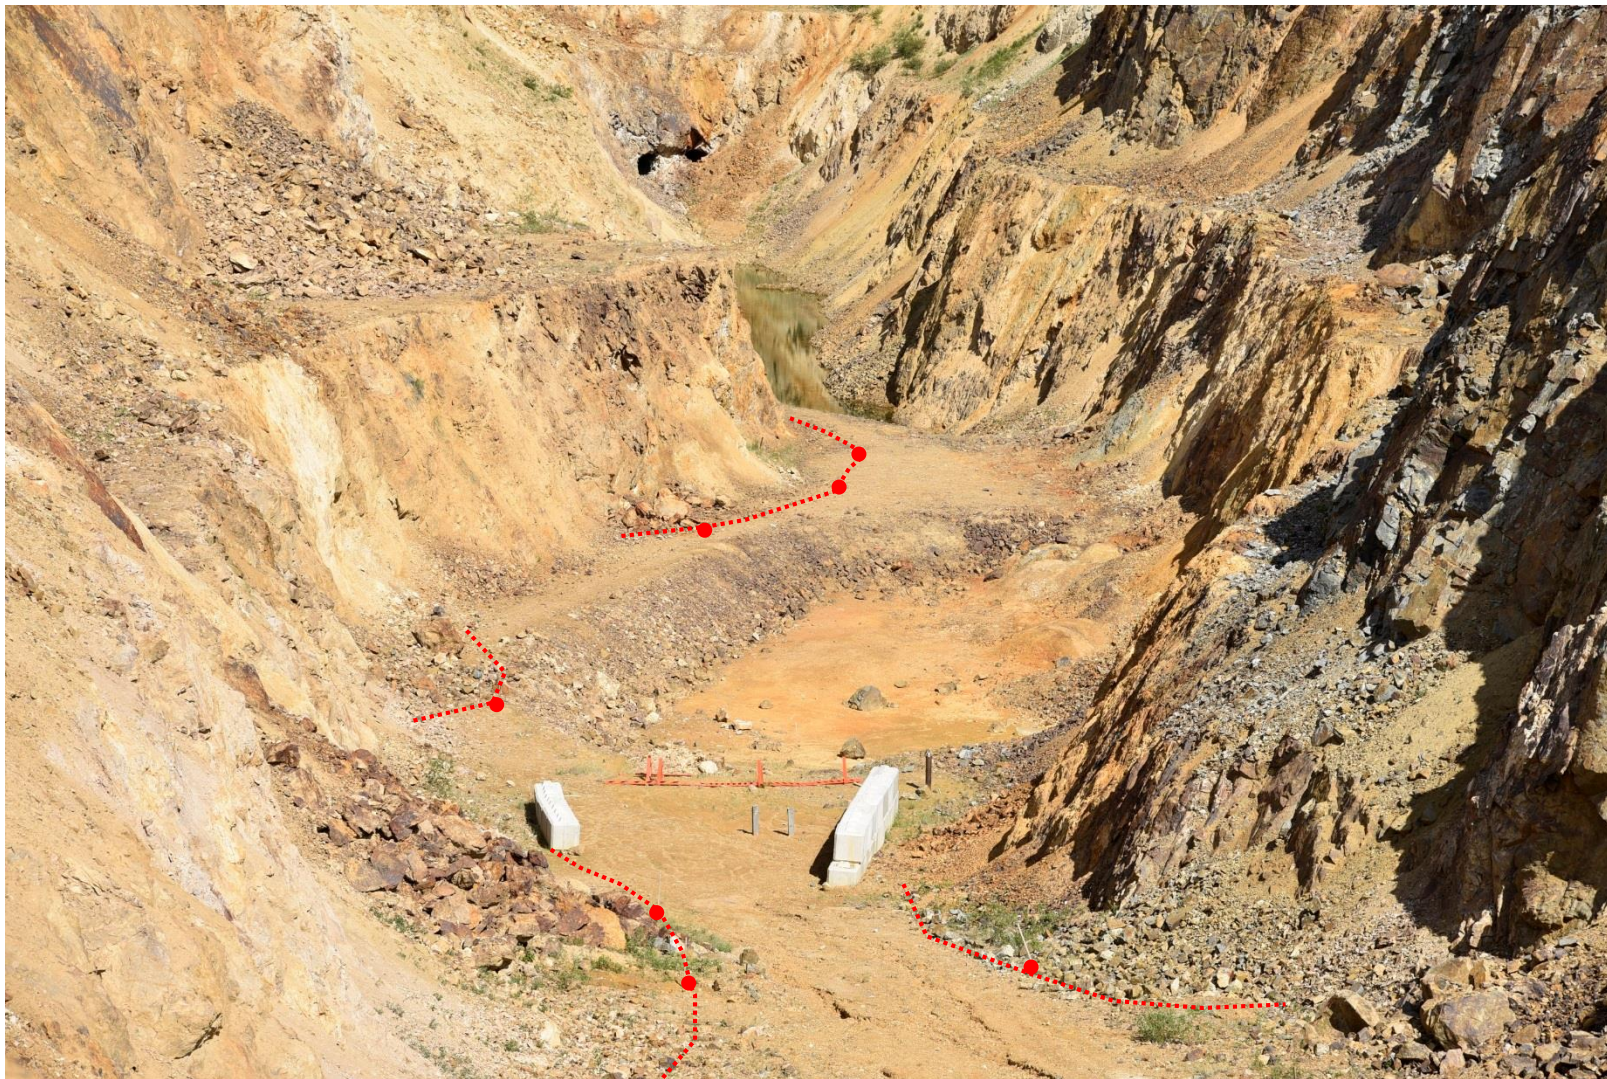
Photo 10: Location of “Rock Fall” stakes. Photo taken June 23, 2016

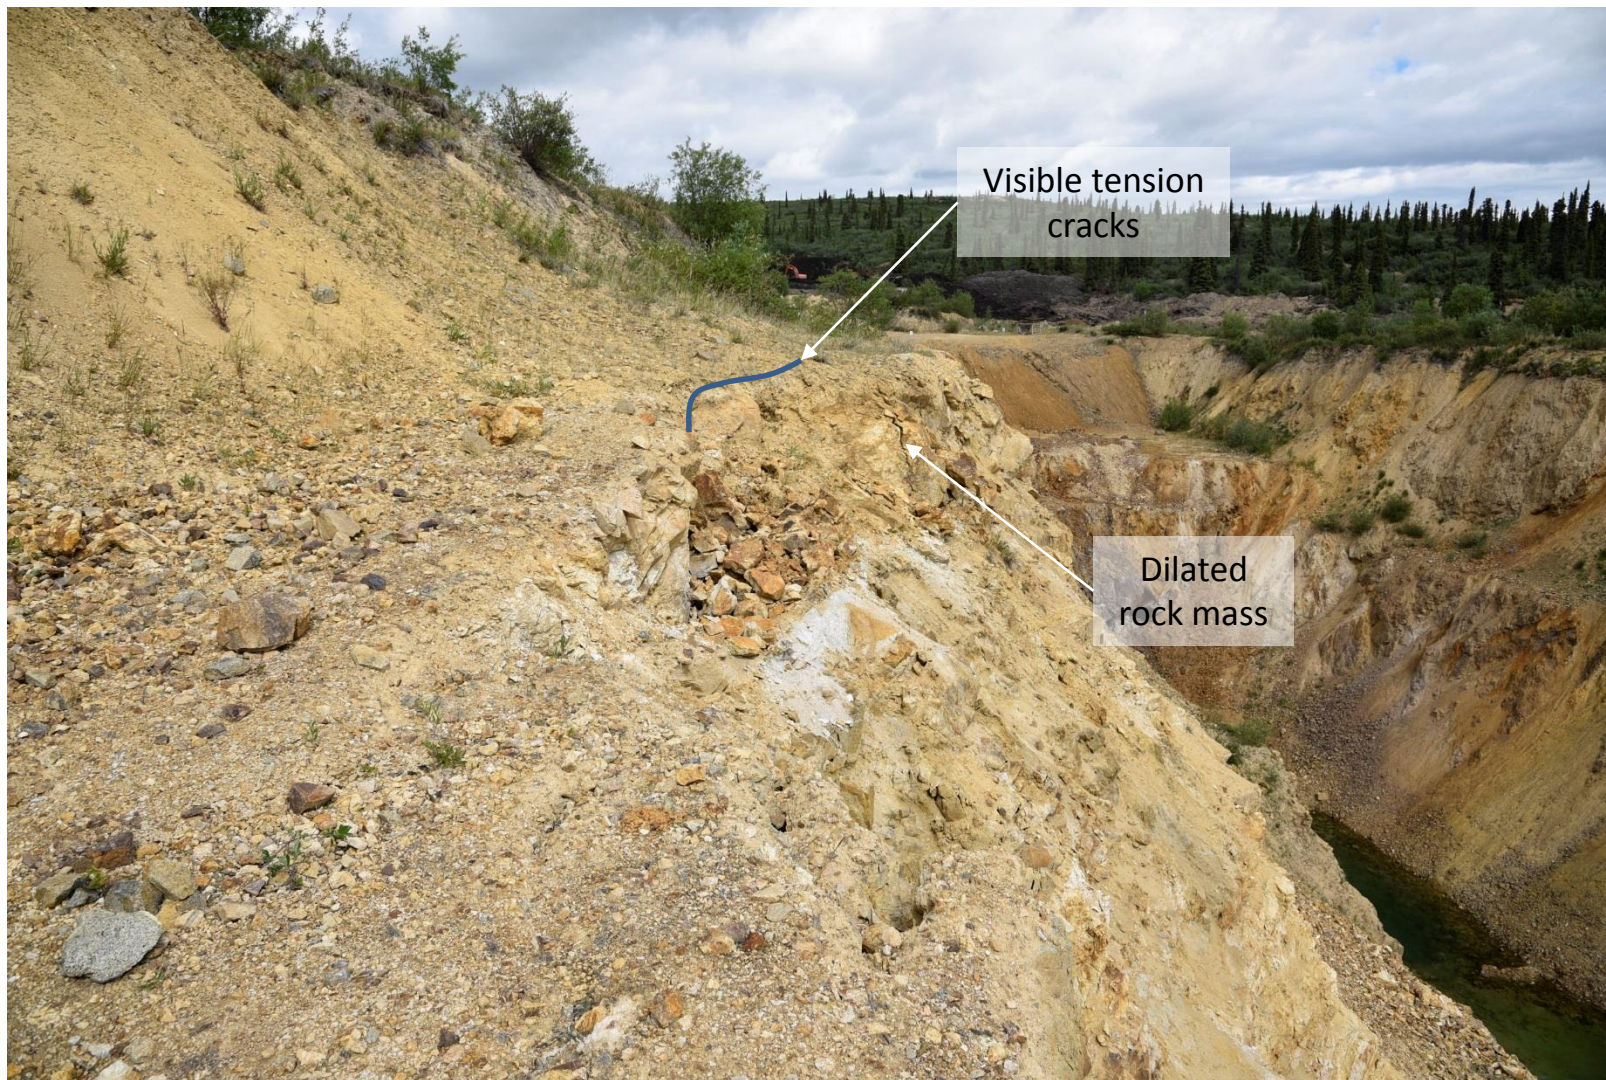
Photo 11: Area above sector 18 showing dilated rock and tension cracks indicating imminent failure. Photo taken June 23, 2016

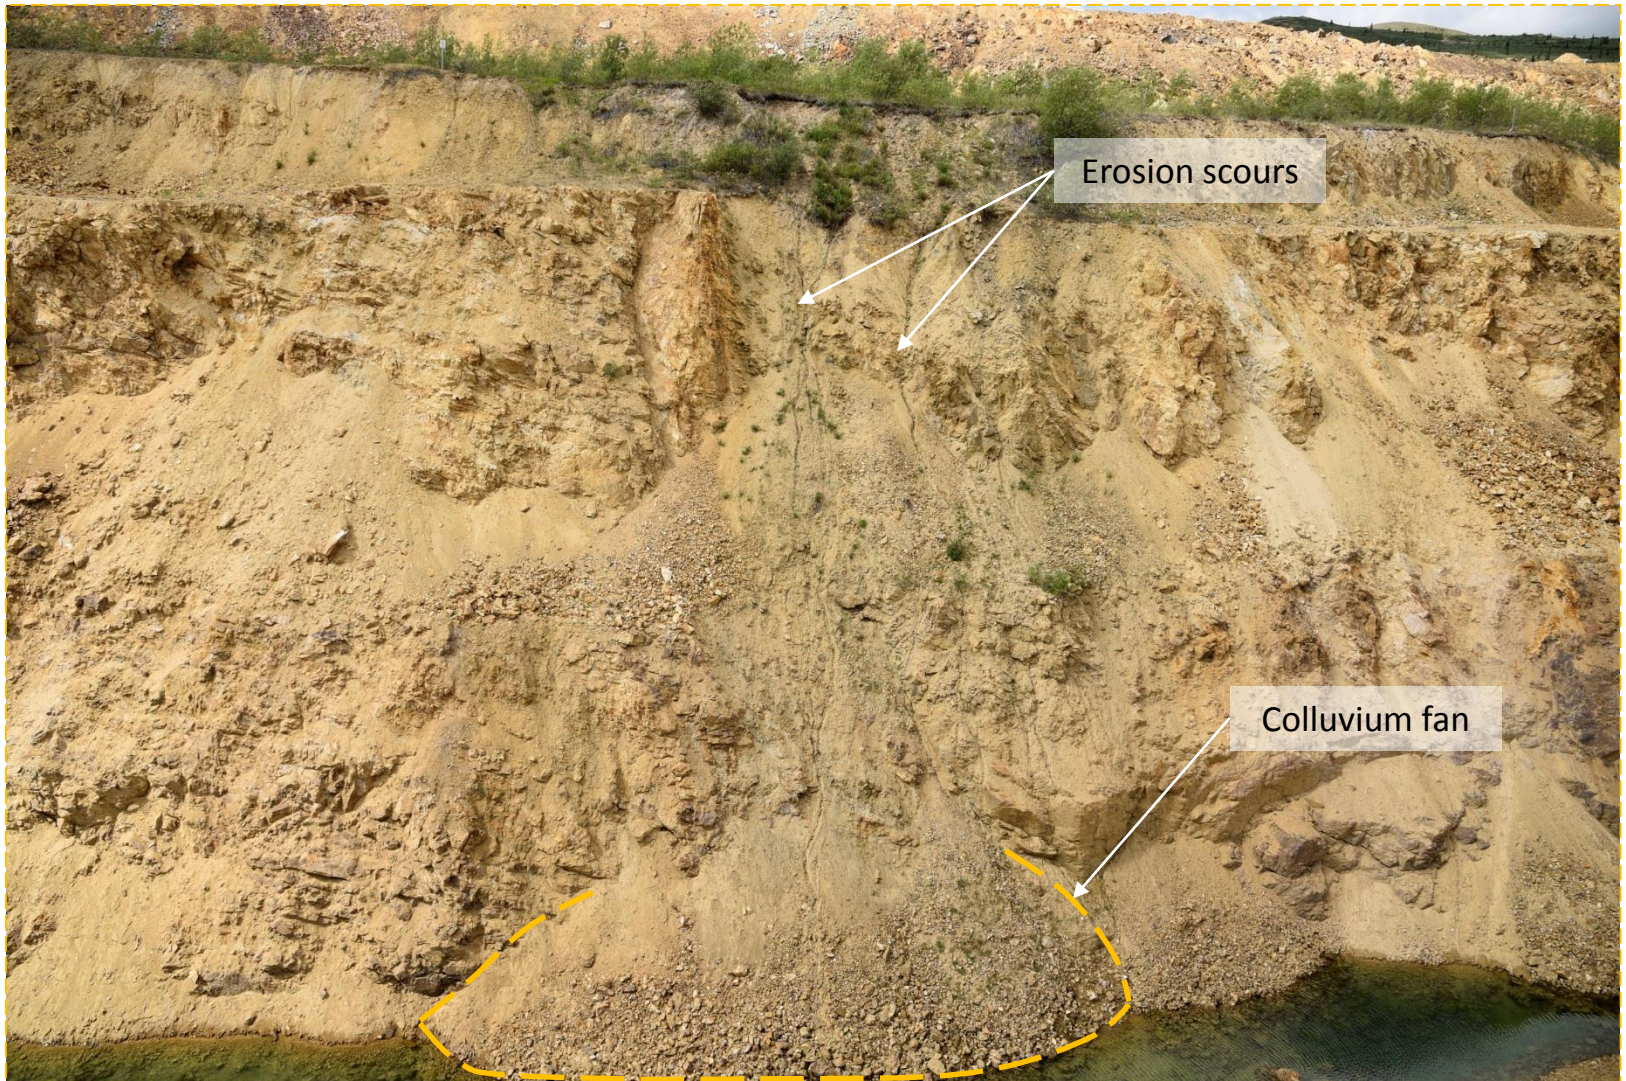
Photo 12: Sector 18b showing deep erosional scours, colluvium fan show material migration. Photo taken June 23, 2016

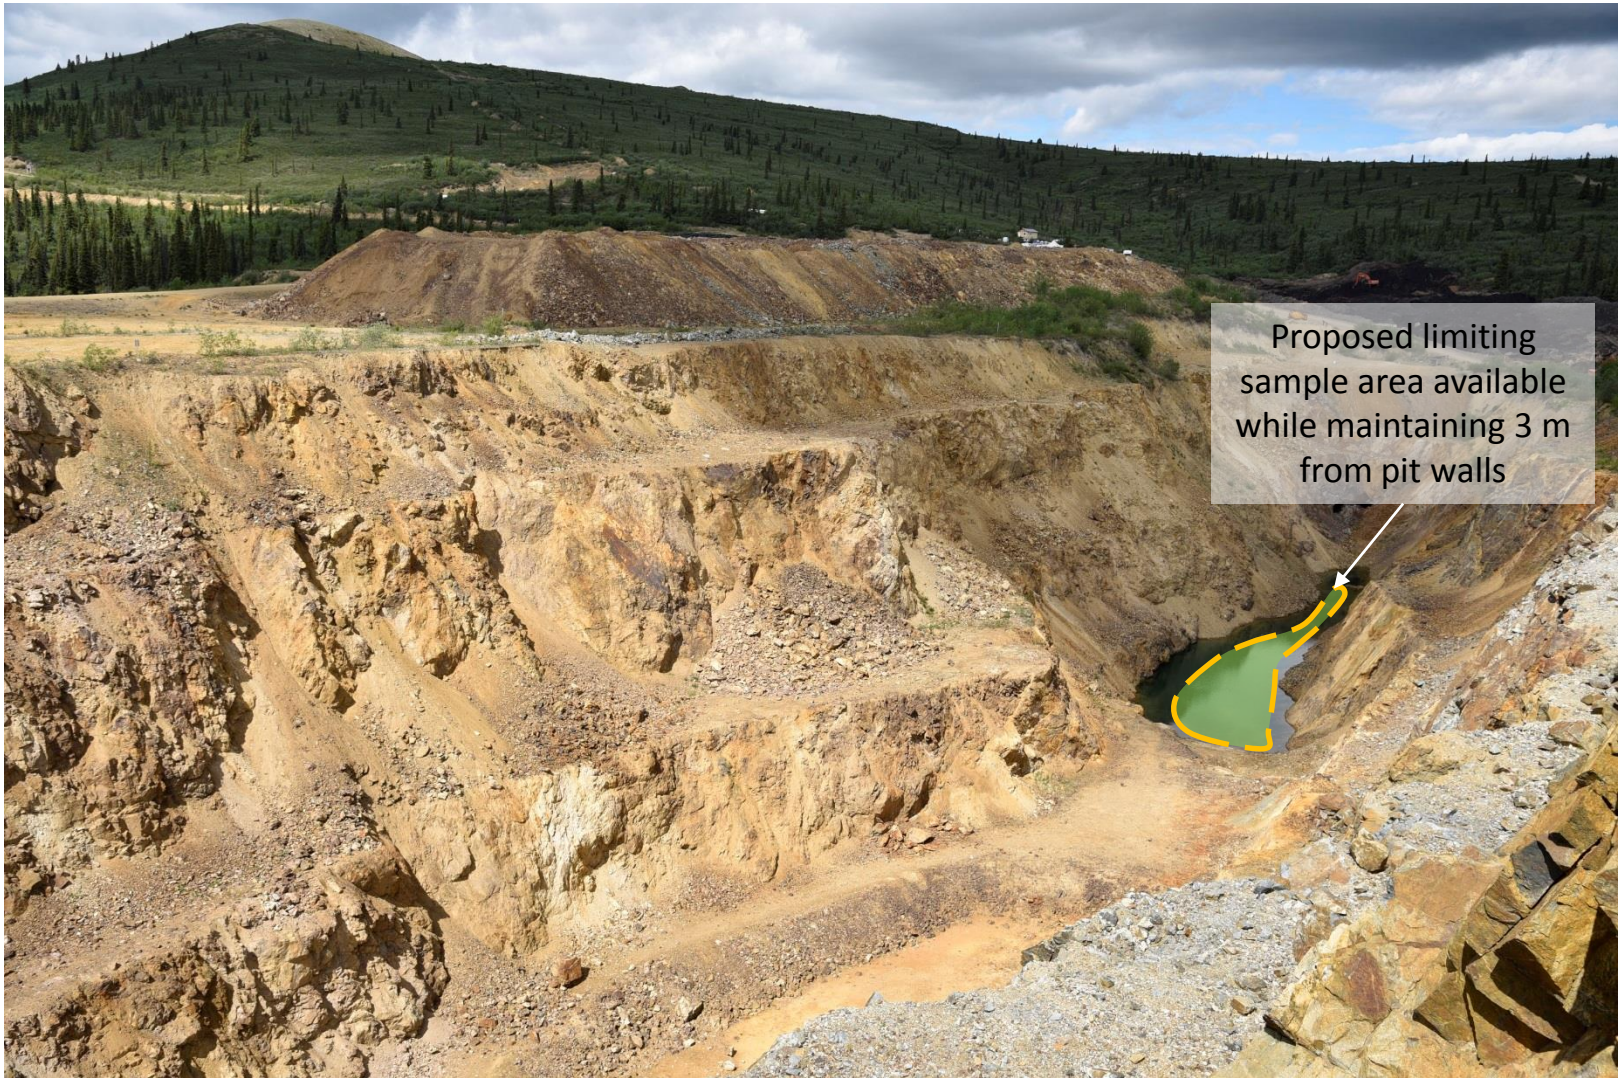
Photo 13: Maintain 3 m from pit walls while undertaking profile sampling within the pit lake. Photo taken June 23, 2016
