To: Mr. Jeff Moore
c:
From: Mr. Charles Hunt, P.Eng.
Ms. Sarah McAuley, E.I.T.
Date: July 29, 2016
Memo No.:
File: 704-ENG.ROCK03020-01

Subject: Mt. Nansen Pit Wall Stability Assessment

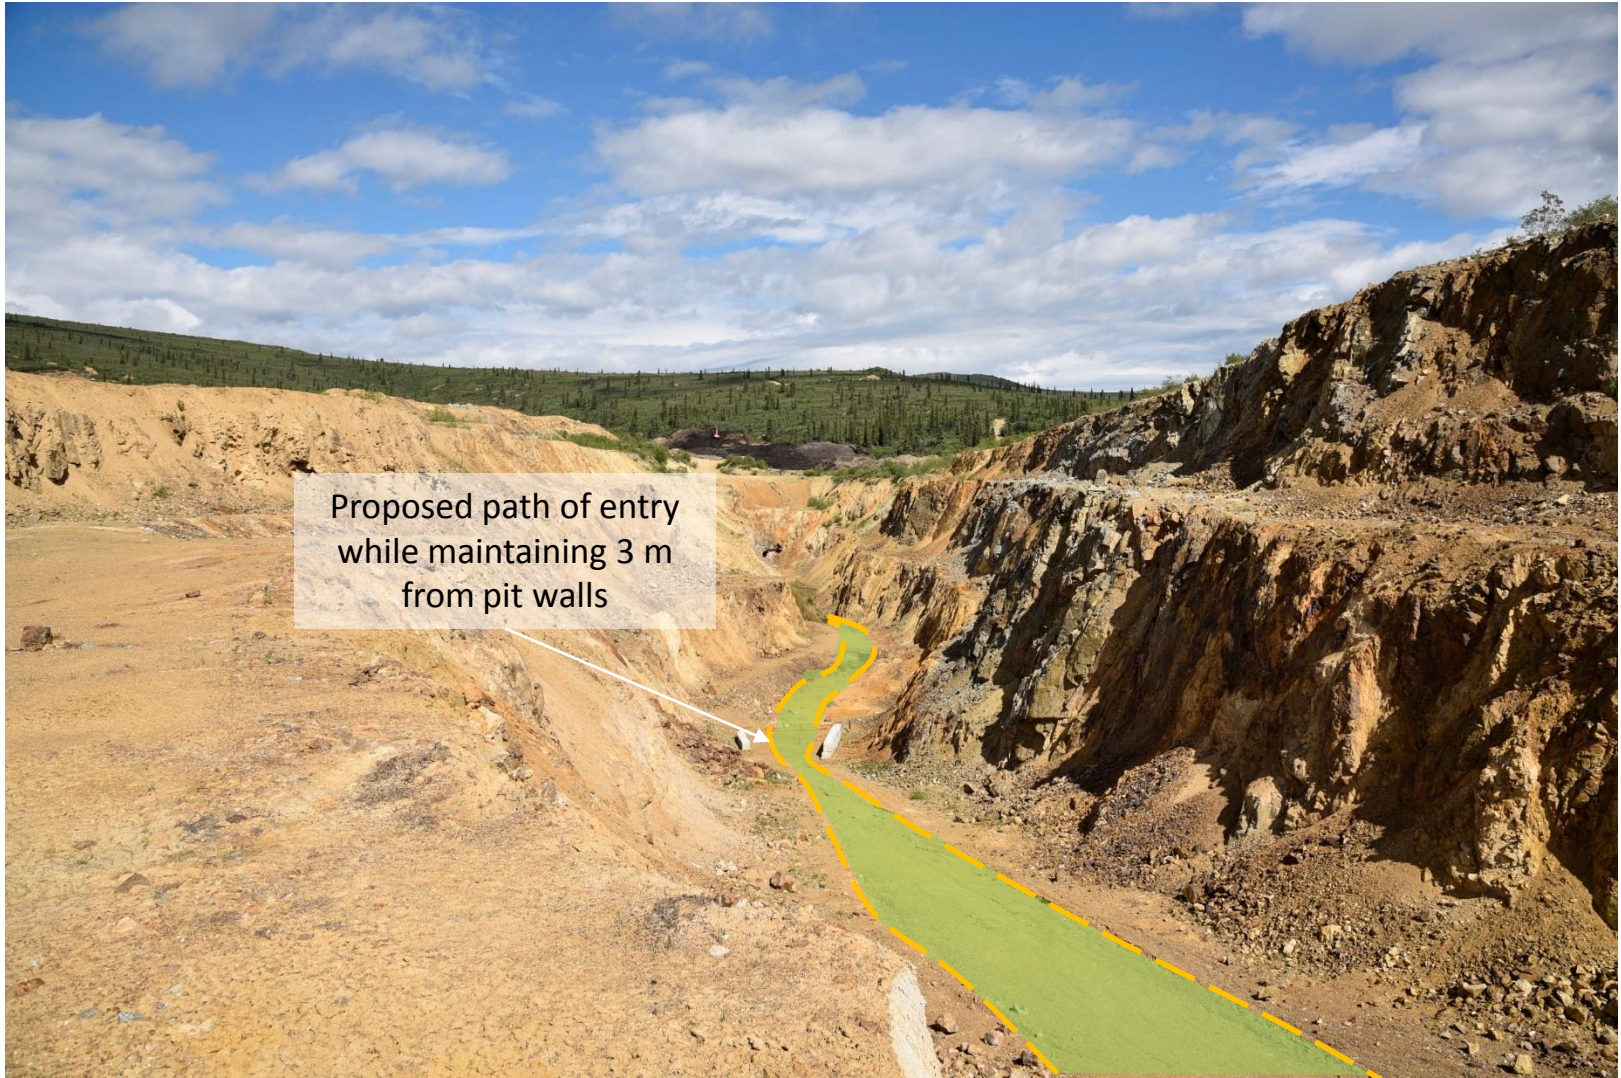
Photo 1: Overview of entry path that should be taken into the pit. Personnel should not come within 3 m of pit walls. Photo taken June 23, 2016

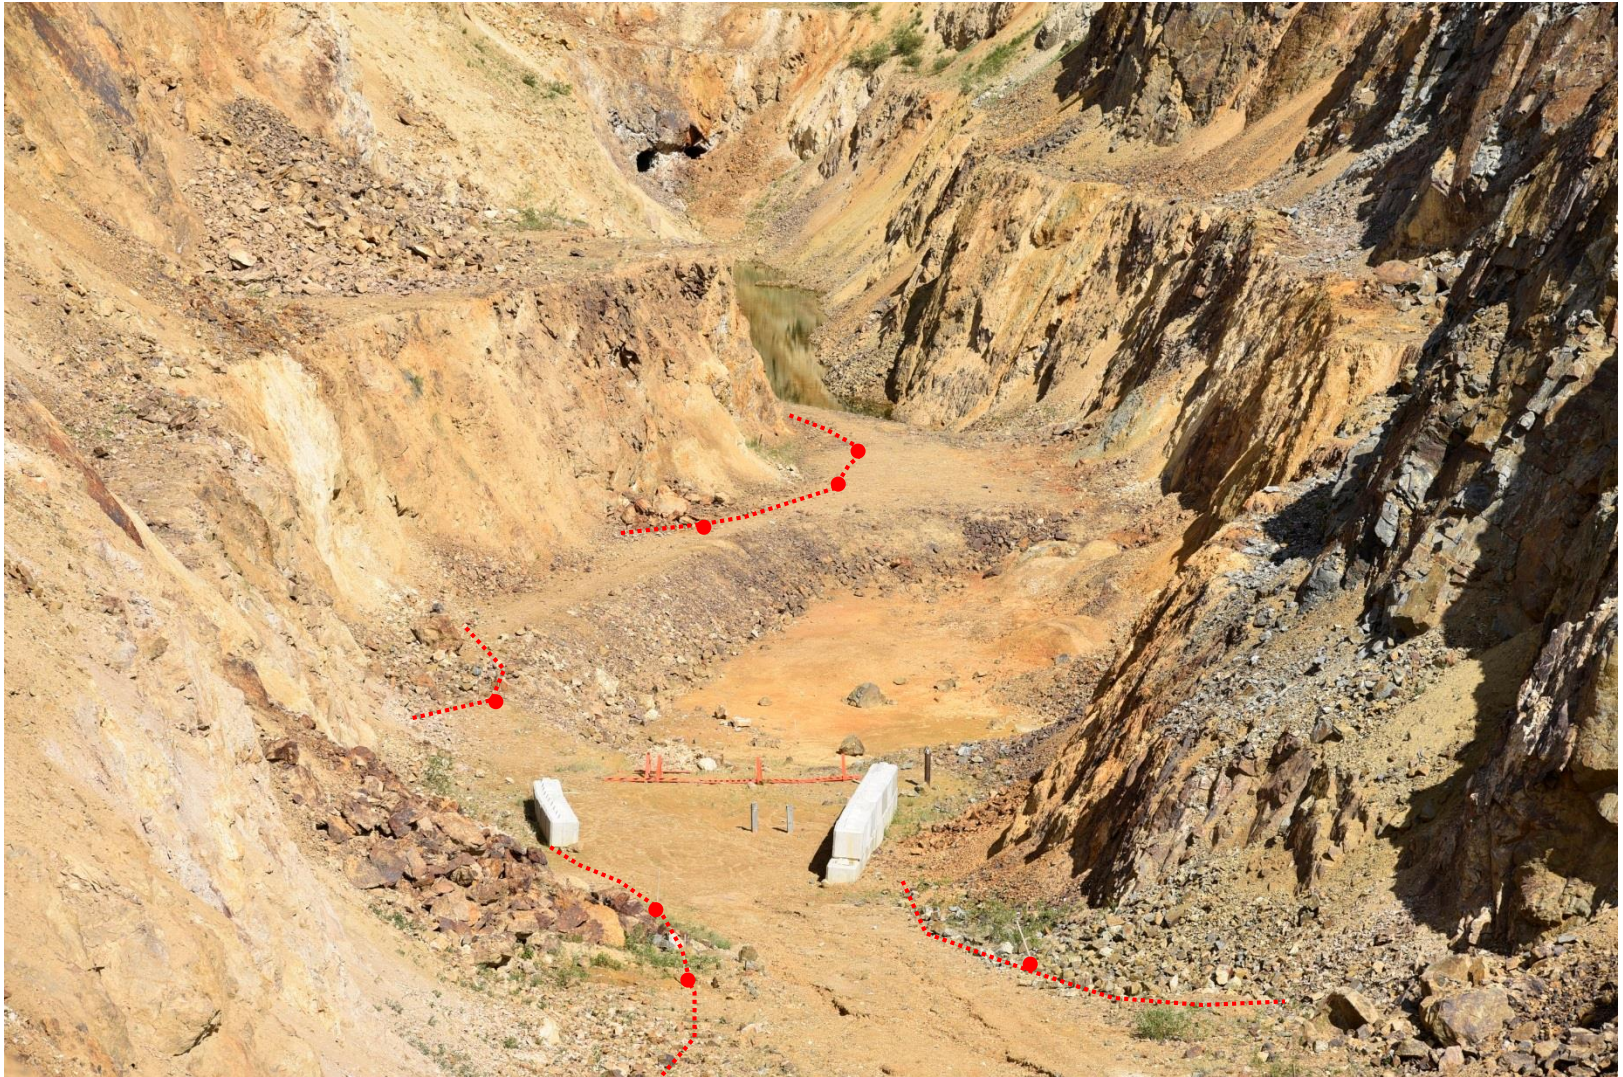
Photo 2: Location of "Rock Fall" stakes. Photo taken June 23, 2016

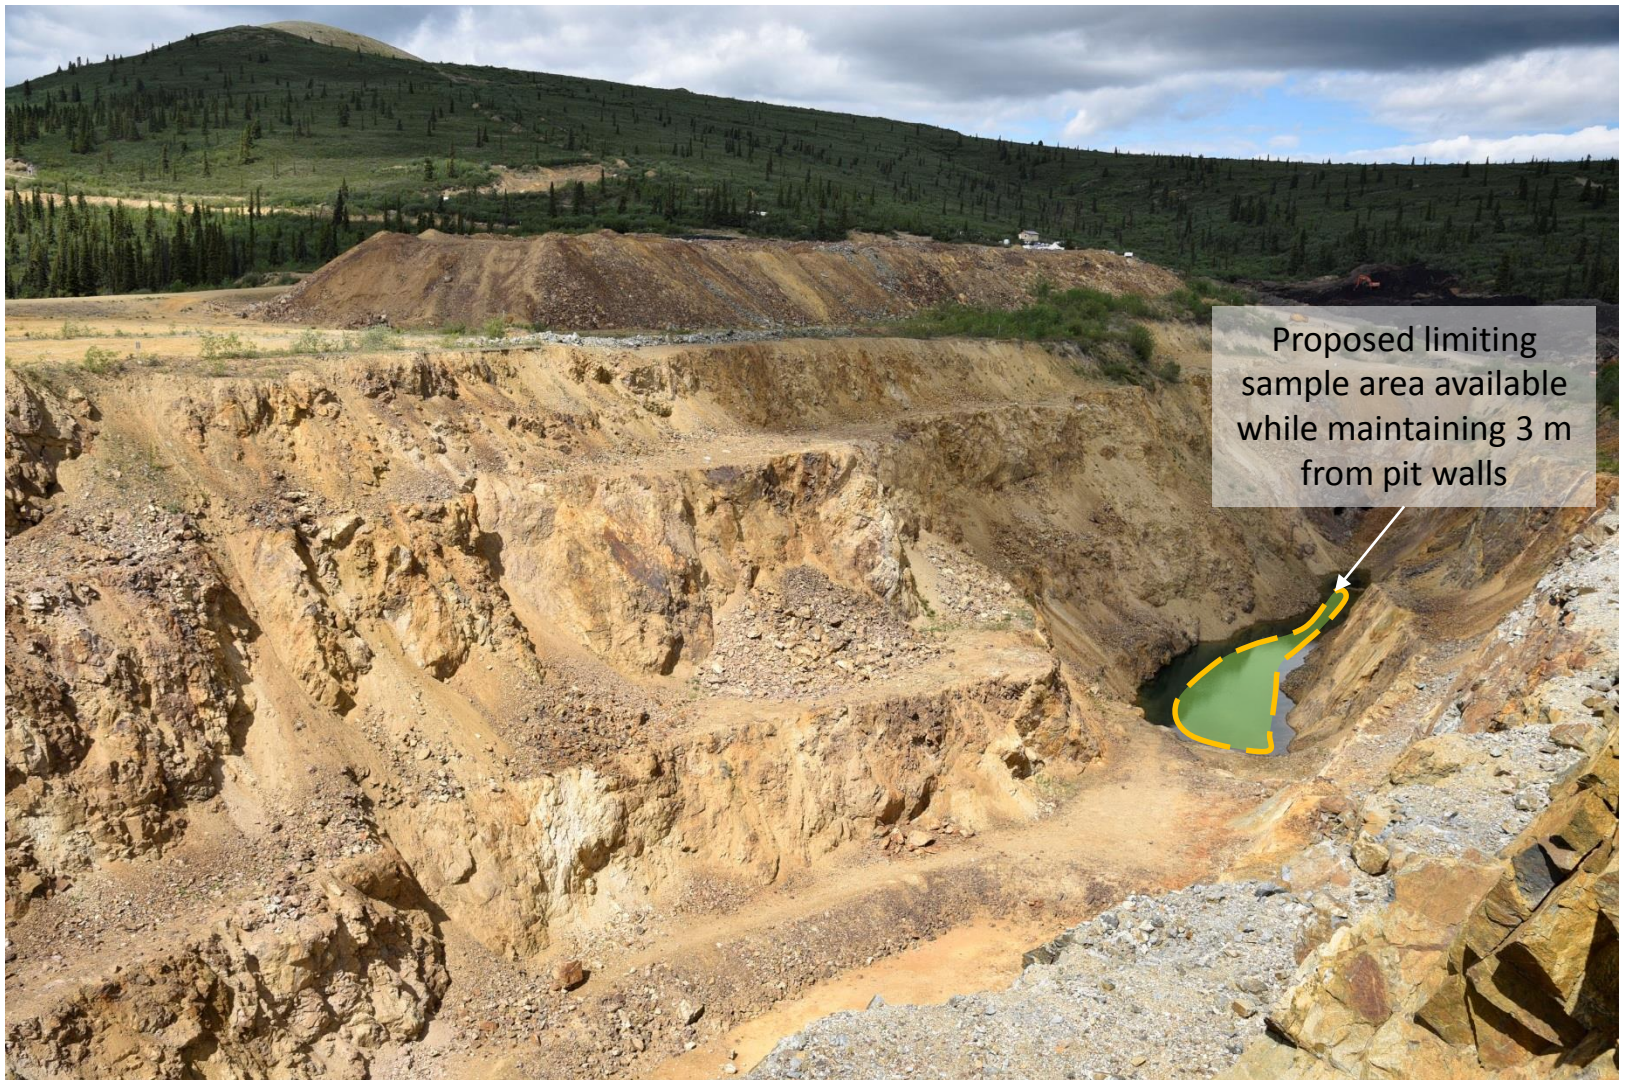
Photo 3: Maintain 3 m from pit walls while undertaking profile sampling within the pit lake. Photo taken June 23, 2016
