Report To  
CYPRUS ANVIL MINING CORPORATION  
On  
1982  
PERFORMANCE MONITORING  
Of The  
DOWN VALLEY TAILINGS PROJECT  
Faro Yukon

February, 1983

822-2021

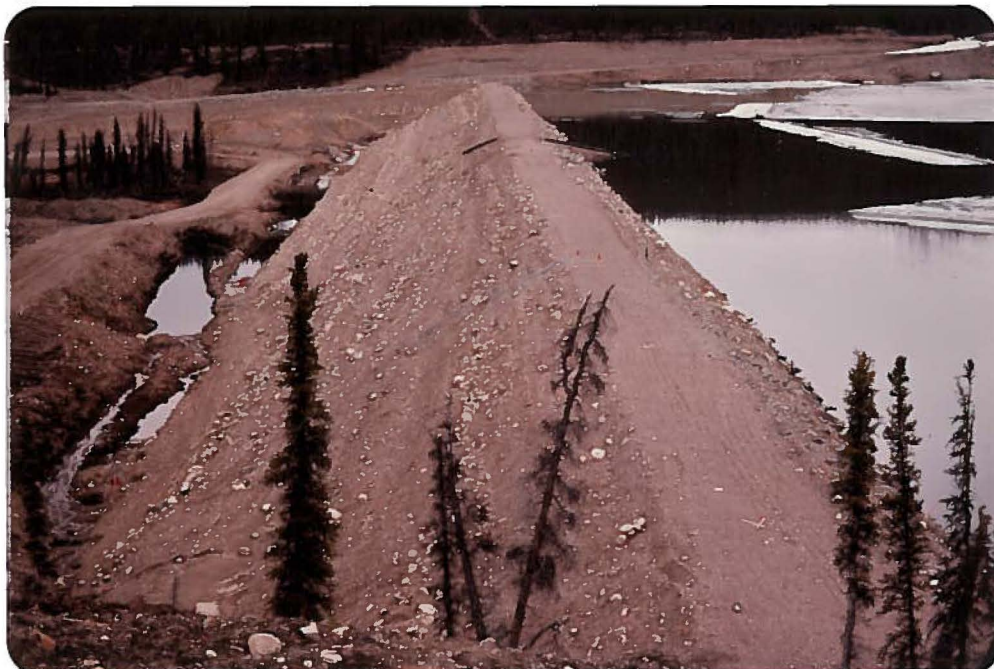
View looking NNE along CVD crest c. 1 June at full impoundment. Note installations at crest and at toe at Sta 0+570 in foreground (as flagged by red casing). Note seepage collection at dam toe.

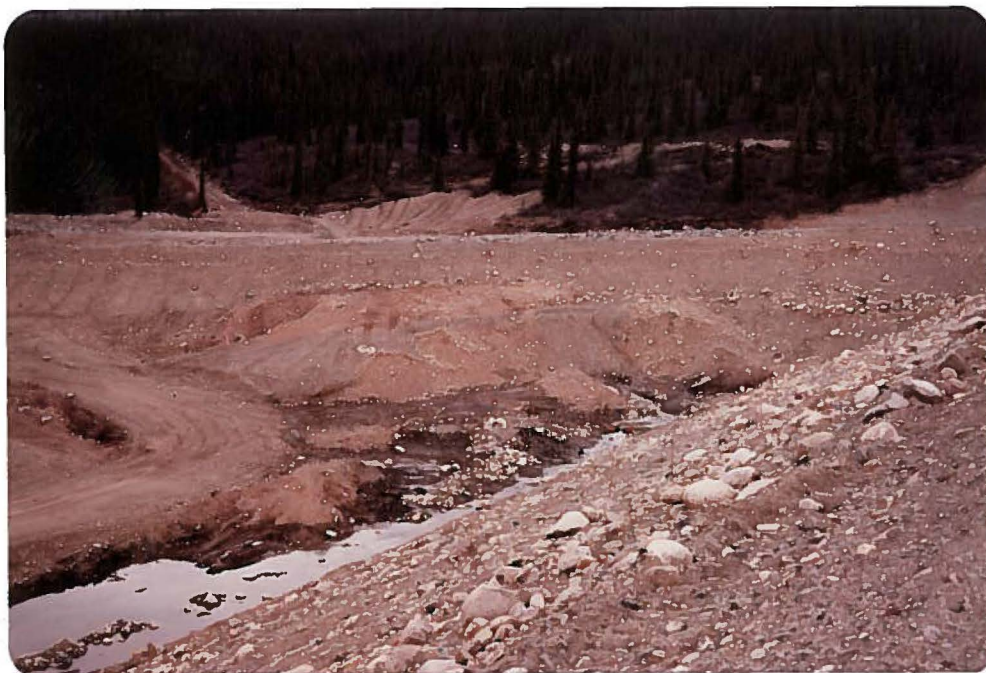
View north showing north abutment area where seepage emerges at downstream toe. Weir No. 1 (Sta 0+215) is near beginning of seepage. (c. 1 June 1982)

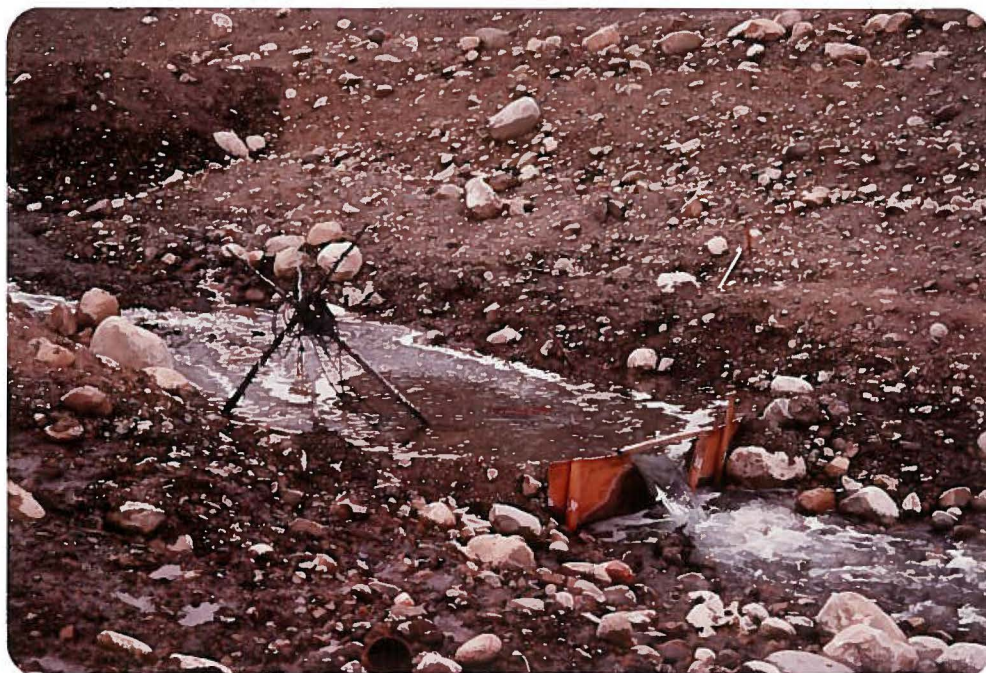
Closeup view of weir No. 1 (1000 i.g.p.m. approx.) showing also observation point for pneumatic piezometers at Sta 0+210.

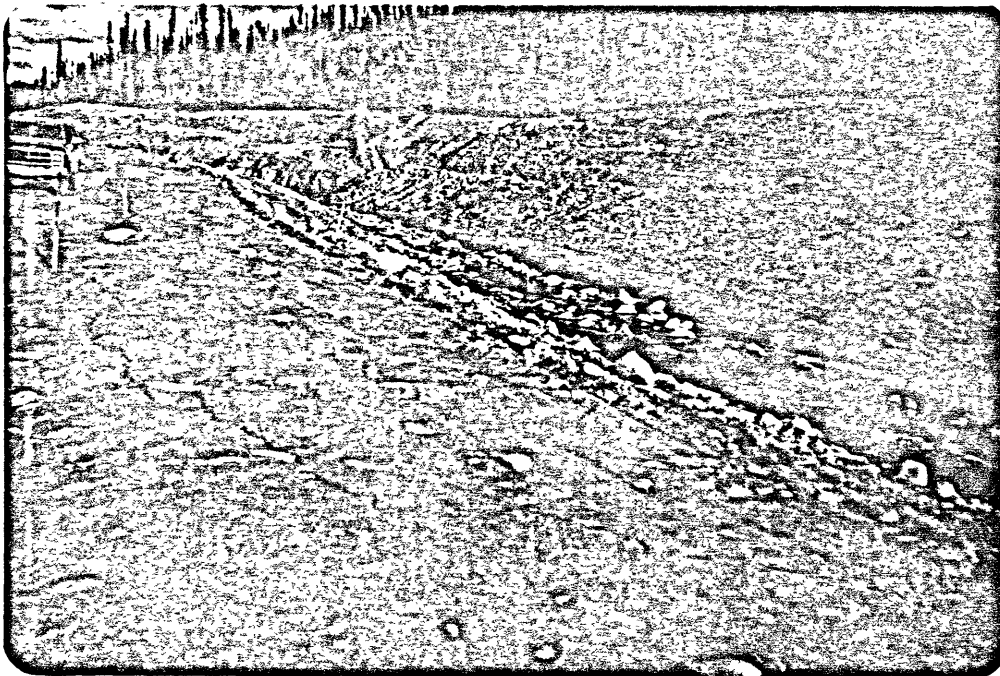
Station 1+838 to 1+885 viewed upstream \*

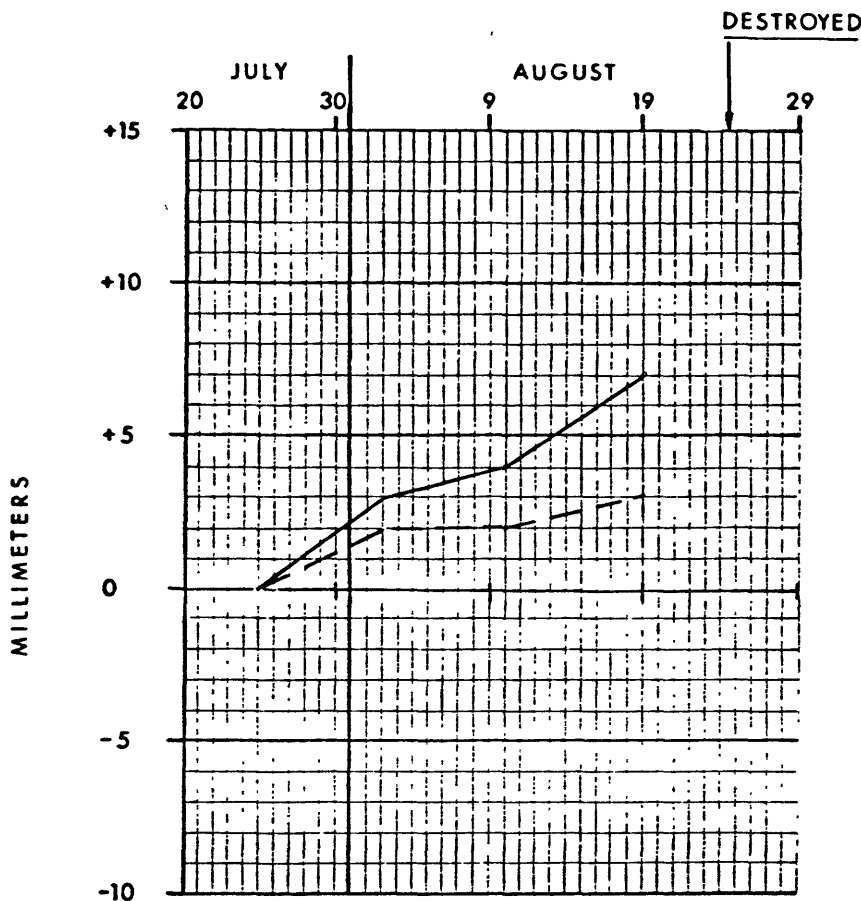
Figure 3

GRAPH SHOWING INFORMATION RELATIVE TO CRACK  
AT LOCATION 0 +444 ALONG CANAL DYKE CREST

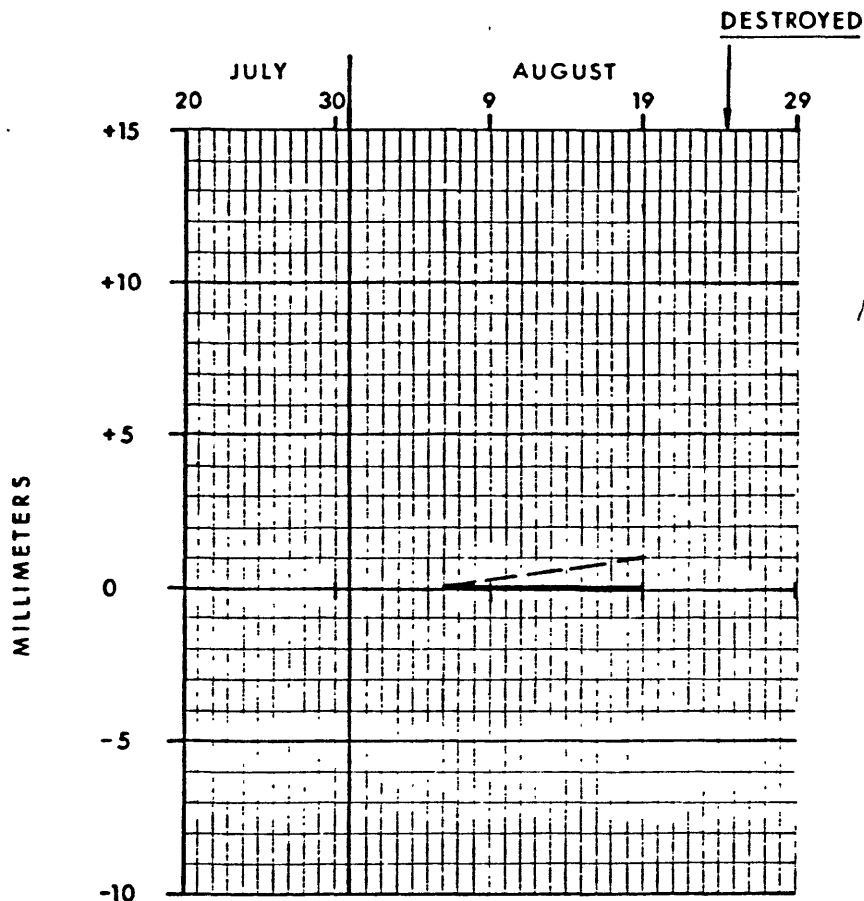
Figure 4

# GRAPH SHOWING INFORMATION RELATIVE TO CRACK AT LOCATION 0+444 ALONG CANAL DYKE CREST

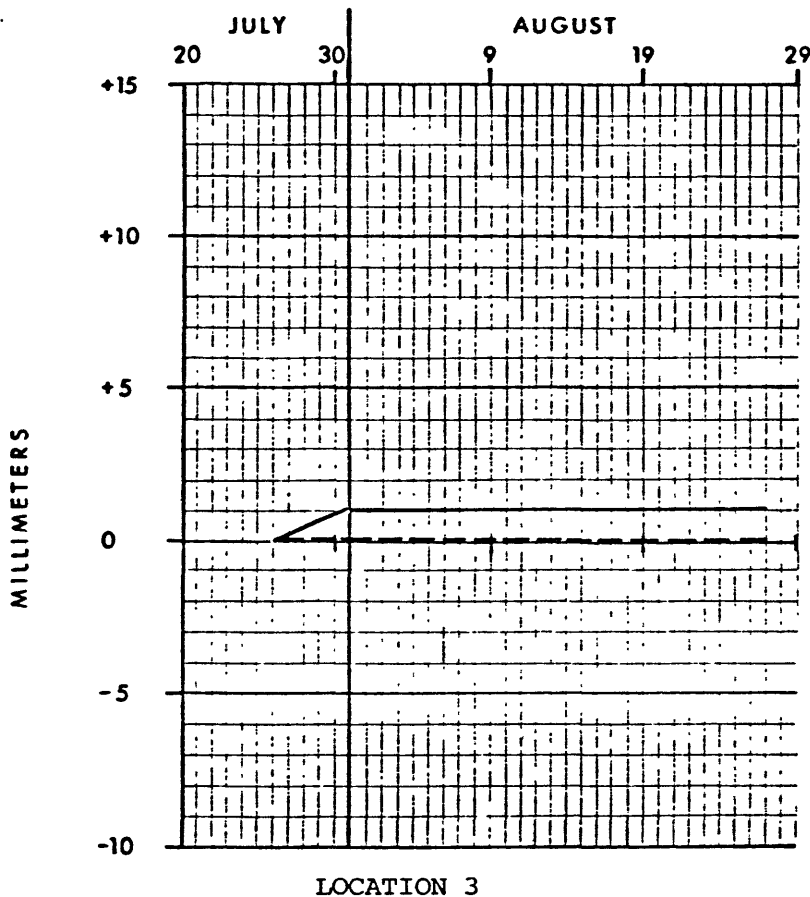
Figure 5

GRAPH SHOWING INFORMATION RELATIVE TO CRACK  
AT LOCATION 1+324 ALONG CANAL DYKE CREST

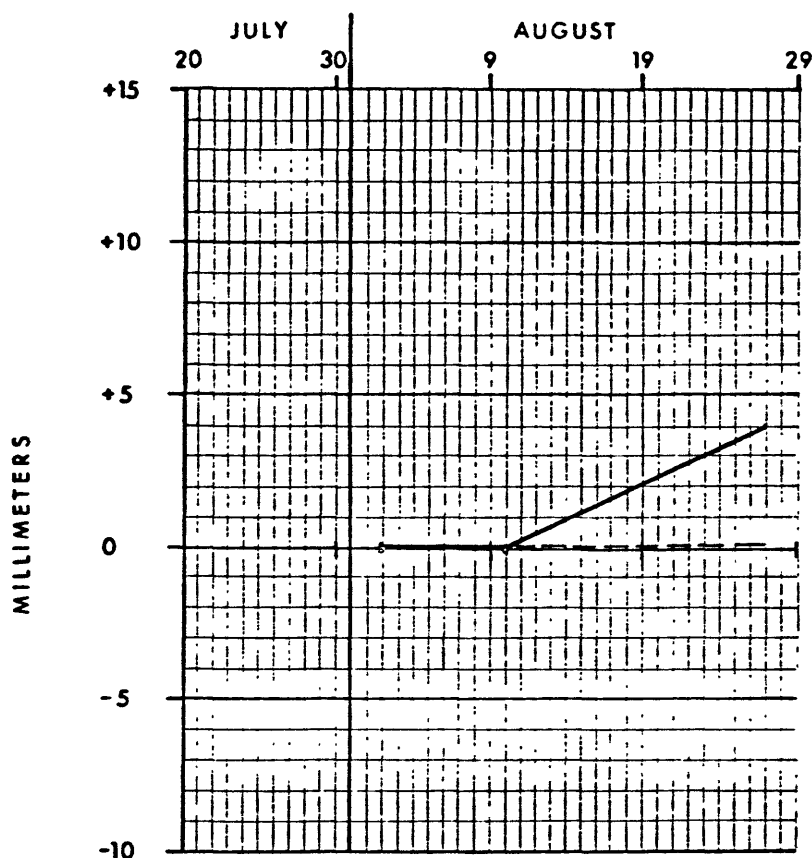
Figure 6

GRAPH SHOWING INFORMATION RELATIVE TO CRACK  
AT LOCATION 1+562 ALONG CANAL DYKE CREST

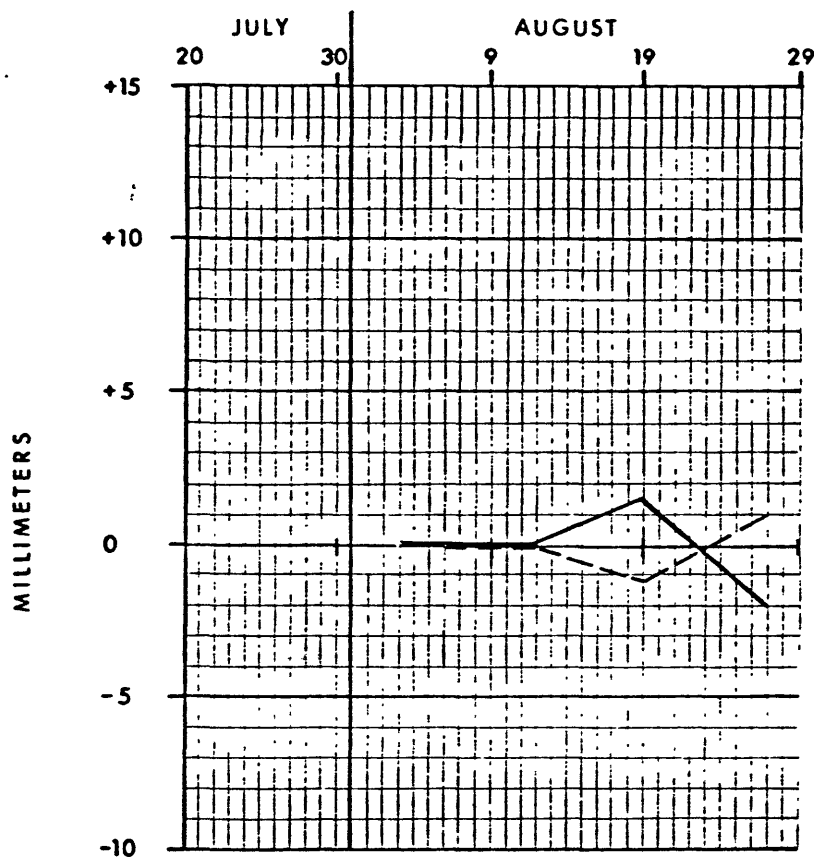
Figure 7

GRAPH SHOWING INFORMATION RELATIVE TO CRACK  
AT LOCATION 1+620 ALONG CANAL DYKE CREST

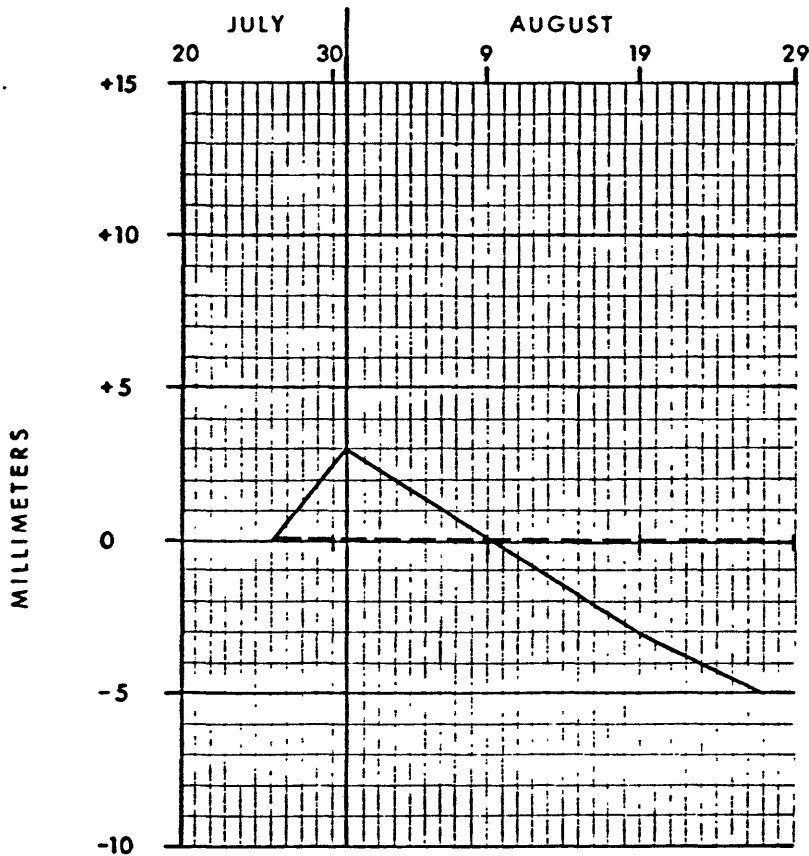
Figure 8

GRAPH SHOWING INFORMATION RELATIVE TO CRACK  
AT LOCATION 1+814 ALONG CANAL DYKE CREST

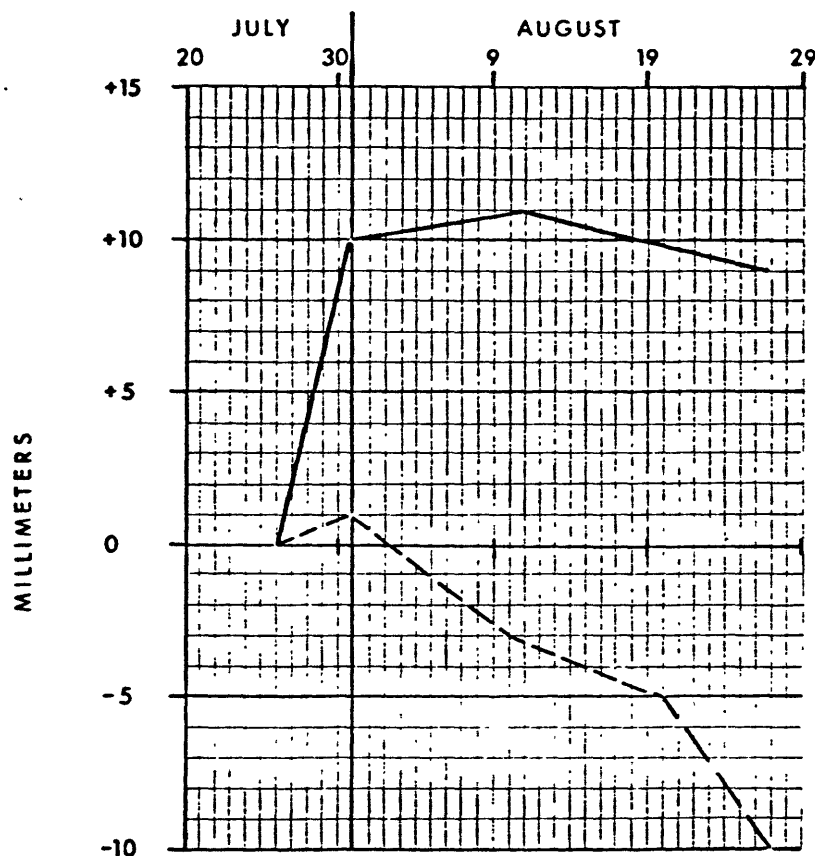
Figure 9

GRAPH SHOWING INFORMATION RELATIVE TO CRACK  
AT LOCATION 1+870 ALONG CANAL DYKE CREST

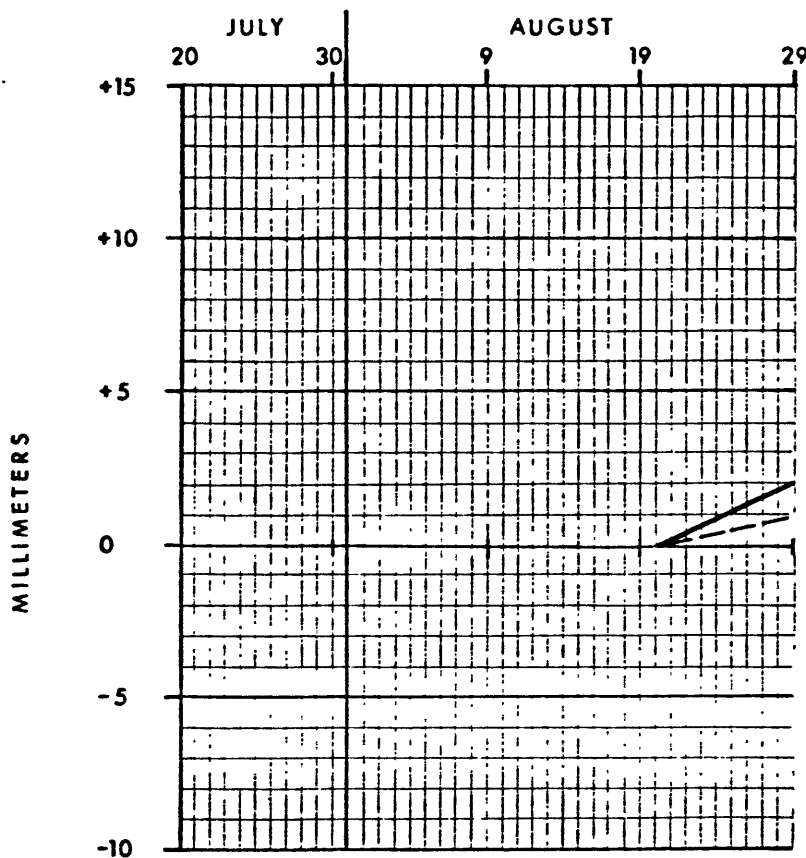
Figure 10

GRAPH SHOWING INFORMATION RELATIVE TO CRACK  
AT LOCATION 1+910 ALONG CANAL DYKE CREST

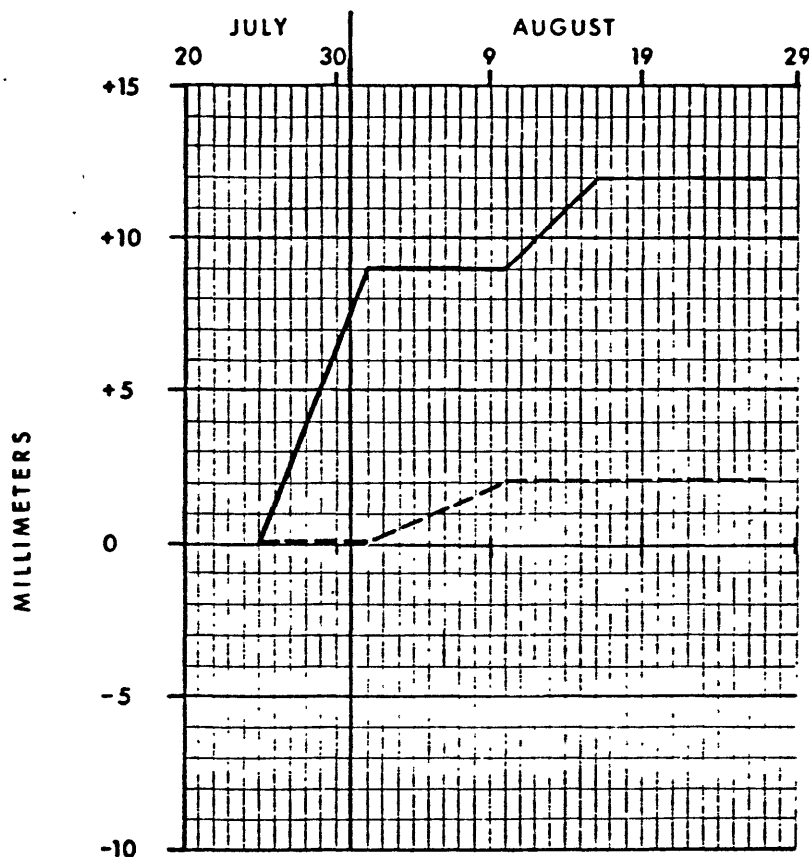
Figure 11

# GRAPH SHOWING INFORMATION RELATIVE TO CRACK AT LOCATION 1+983 ALONG CANAL DYKE CREST

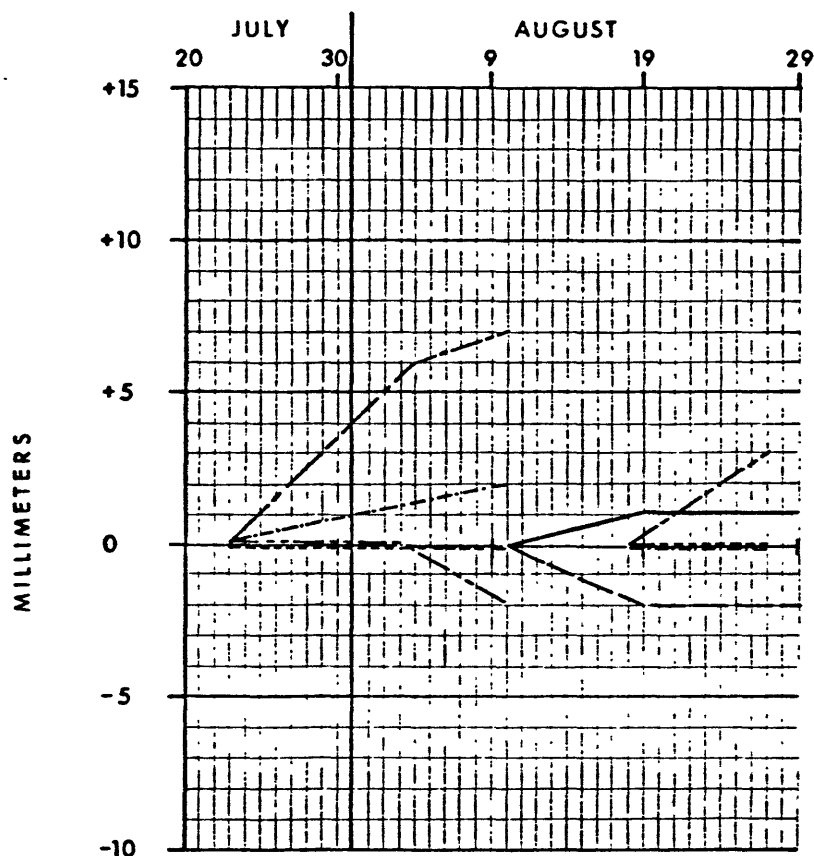
Figure 12

# GRAPH SHOWING INFORMATION RELATIVE TO CRACK AT LOCATION 2+143 ALONG CANAL DYKE CREST

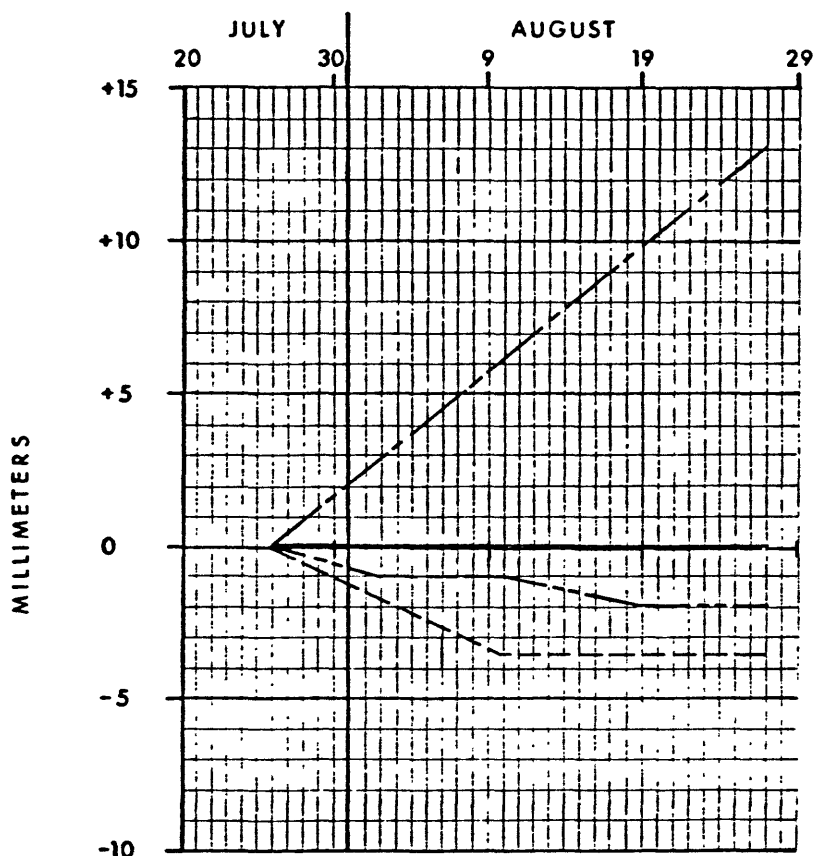
Figure 13

GRAPH SHOWING INFORMATION RELATIVE TO CRACK  
AT LOCATION 2+183 ALONG CANAL DYKE CREST

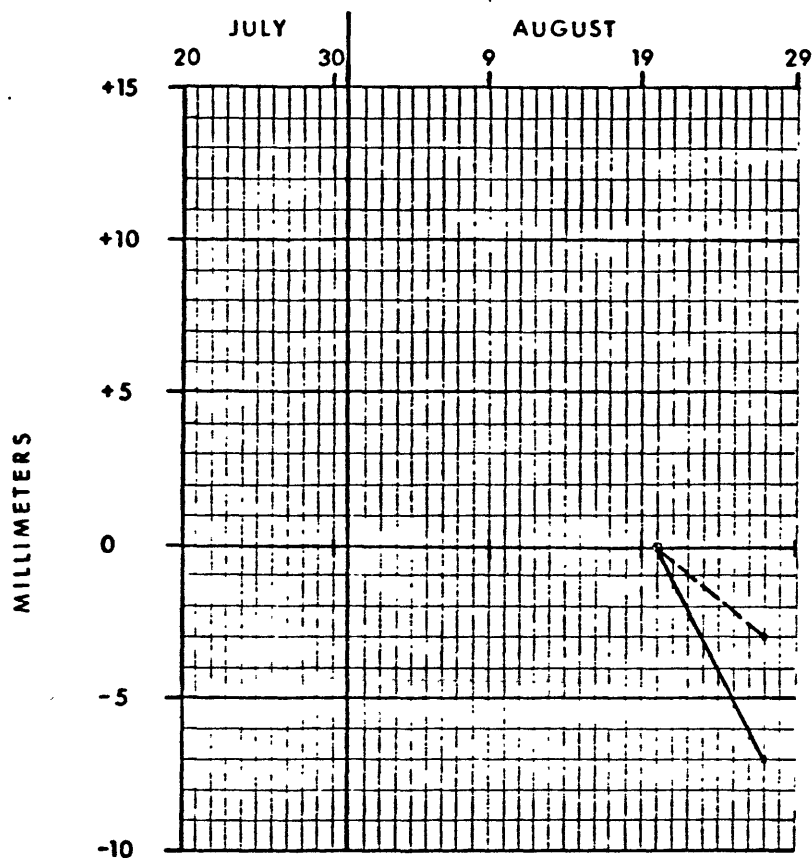
Figure 14

GRAPH SHOWING INFORMATION RELATIVE TO CRACK  
AT LOCATION 2 + 220 ALONG CANAL DYKE CREST

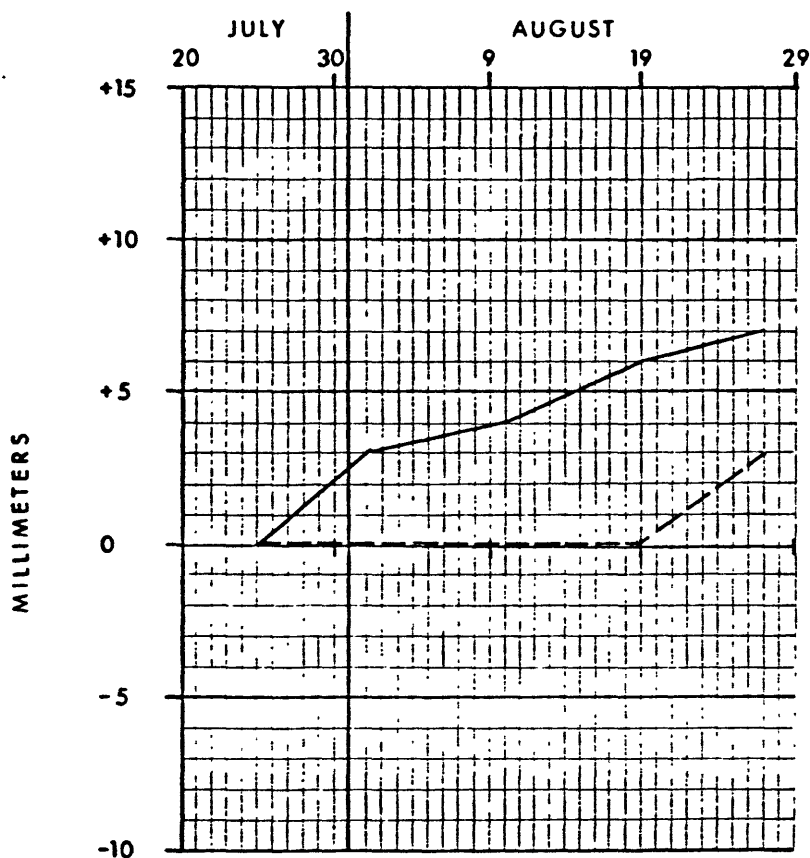
Figure 15

GRAPH SHOWING INFORMATION RELATIVE TO CRACK  
AT LOCATION 2+365 ALONG CANAL DYKE CREST

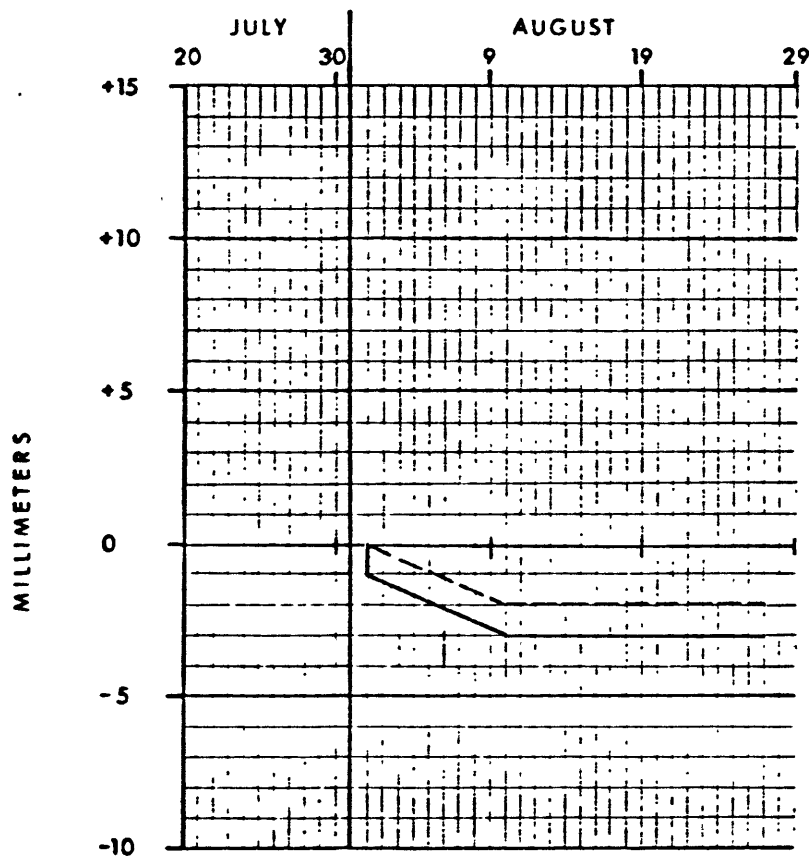
Figure 16

GRAPH SHOWING INFORMATION RELATIVE TO CRACK  
AT LOCATION 2+400 ALONG CANAL DYKE CREST

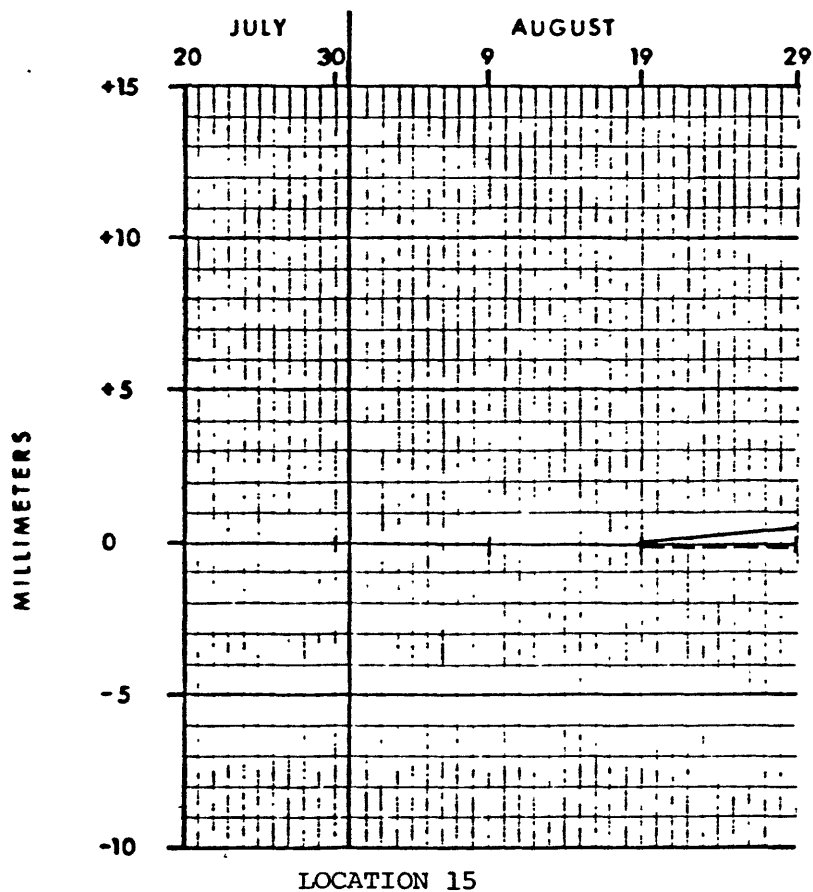
Figure 17

GRAPH SHOWING INFORMATION RELATIVE TO CRACK  
AT LOCATION 2+460 ALONG CANAL DYKE CREST

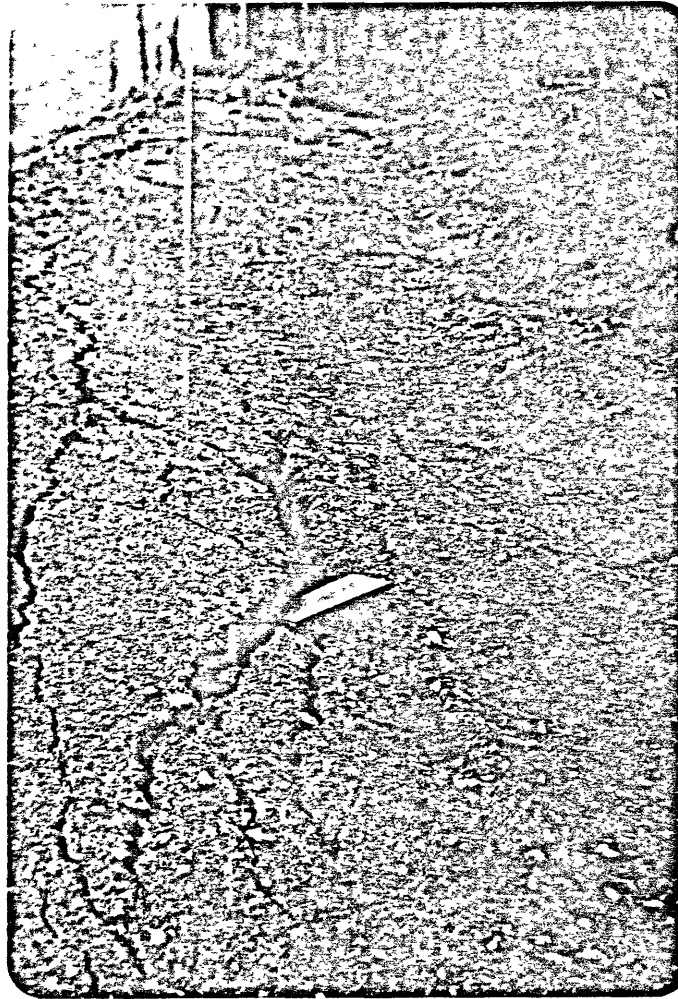
Thermal liner fill at station 2+900 (approx.) viewed  
upstream (notebook size 8½" x 11")

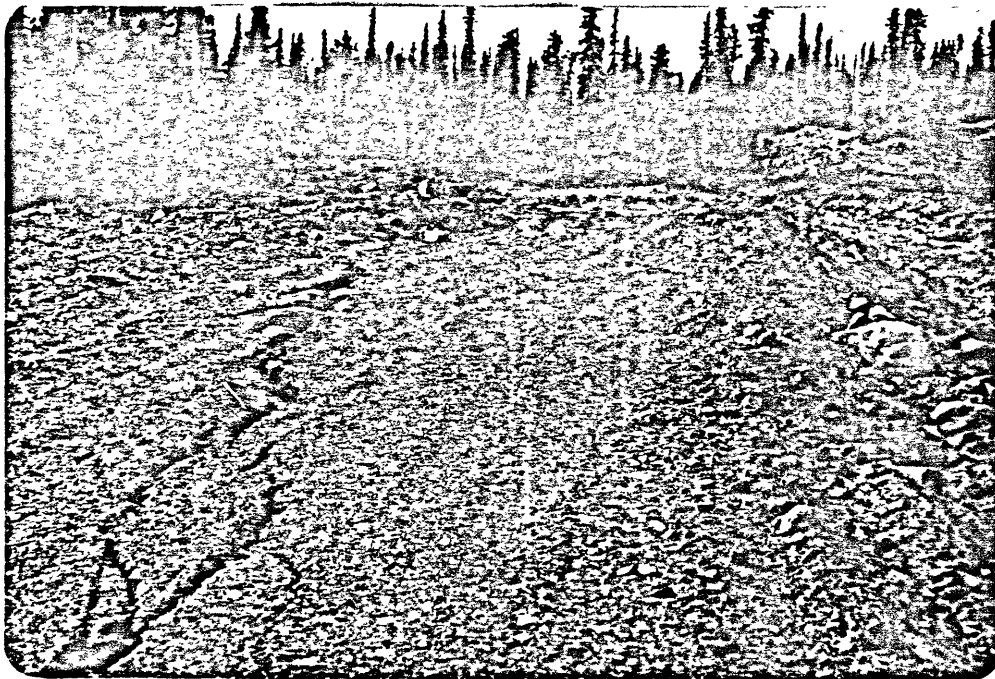
An example of fill response to foundation settlement (taken at about station 0+400 looking downstream which is beyond the reach of the ditch shown in the above photo).
