**ANVIL RANGE MINING CORPORATION  
INTERIM RECEIVERSHIP  
PHASE 1 BORROW SOURCE SURVEY**

**DELOITTE & TOUCHE INC.**  
Suite 1900, 79 Wellington Street West  
Toronto, ON M5K 1B9  
Canada

**STEFFEN ROBERTSON AND KIRSTEN (CANADA) INC.**  
Suite 800, 580 Hornby Street  
Vancouver, B.C. V6C 3B6  
Tel: (604) 681-4196 • Fax: (604) 687-5532  
E-mail: [vancouver@srk.com](mailto:vancouver@srk.com) Web site: [www.srk.com](http://www.srk.com)

AUGUST 2002

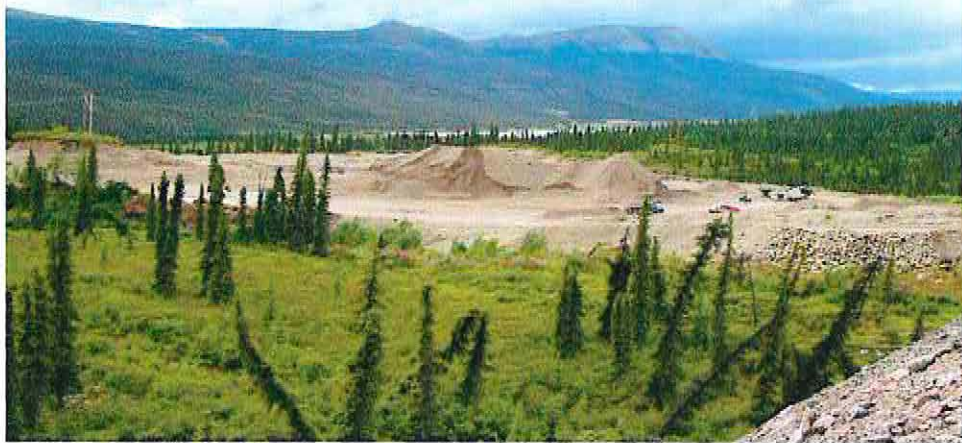
**Photo 1: Haul Road Borrow Site**

The haul road borrow site is located just off the Vangorda-to-Faro haul road, near the North Fork Rose Creek rock drain outlet (Photo 1, Figure 2). Bond (2001) mapped the site as glaciofluvial complex (Gx). Local contractors are currently screening 10,000m<sup>3</sup> of cobbles and boulders (20, 40 and 60cm gradations) for lining of the Faro Creek diversion around the north side of the Faro open pit.

According to laboratory gradation tests, the material is greenish brown, poorly graded sand with gravel (SP). The cobble and boulder component was not sampled and tested in the laboratory. The deposit has been worked over a wide area (80,000m<sup>2</sup>) and there appears to be substantial remaining reserves, possibly between 150,000m<sup>3</sup> to 300,000m<sup>3</sup>. This material can be processed for both coarse grained riprap material as well as fine-grained granular fills.

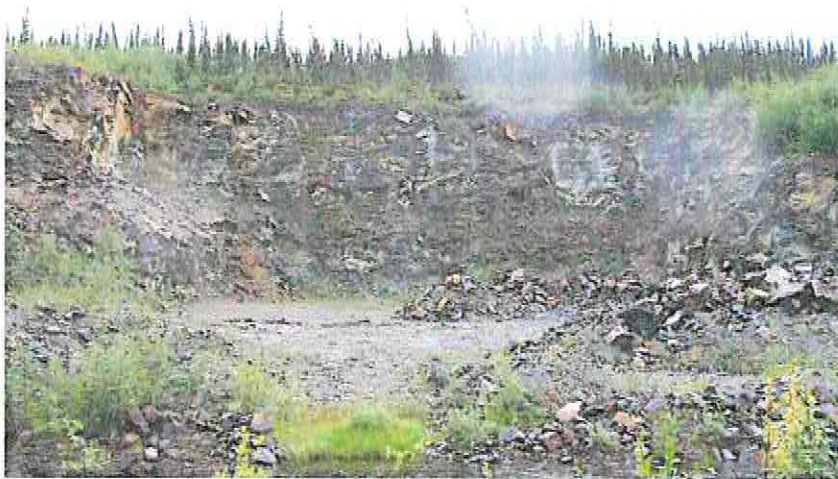
**Photo 2: Rose Creek Diversion Quarry**

The Rose Creek diversion quarry is located on the south side of the Rose Creek Diversion Channel, opposite the Intermediate Tailings Dam (Photo 2, Figure 2). Approximately 30,000m<sup>3</sup> of phyllite schist riprap has been quarried from the site to line the Rose Creek Diversion Channel. The schist is variably strong to very strong, slightly weathered (some moderately weathered) with closely to moderately widely spaced joints which produce cobble to boulder-sized blocks. This rock is of variable quality (fair to good) but the quarry could clearly be expanded with further outcrops noted upslope of the quarry face. The Rose Creek Diversion Channel currently cuts off access to the quarry.

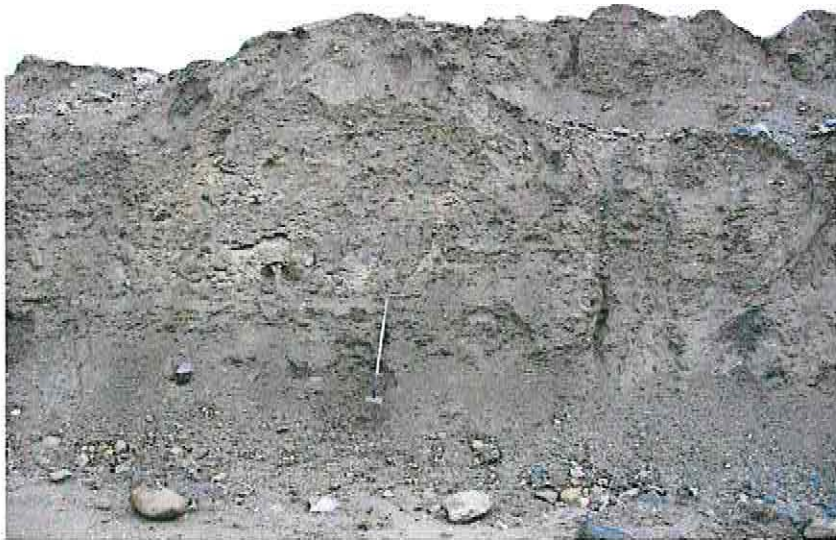
Granular material has been taken from three main borrow sites located between the North Wall Interceptor Ditch and north bank of the Intermediate Tailings Dam (Figure 2). These materials are mapped by Bond (2001) as a complex of colluvium veneer (Cv) and till blanket (Tb). The total area disturbed by borrow activity is approximately 250,000m<sup>2</sup>. Scattered rock outcrops (closely fractured schist) were noted throughout the area. Both granular and low permeability (till) soil materials exist within these areas and probably both were borrowed for construction of the tailings facilities.

A sample taken from the uppermost borrow was rated as poorly graded sand with silt and gravel (SP-SM), which is probably indicative of the surficial colluvium (Cv) material. Typical till blanket (Tb) materials exposed in the lower middle borrow site are shown in Photo 3. There appears to be an abundance of till materials remaining at these borrow sites, but not much clean granular material.

**Photo 3: Till blanket (Tb) material exposed at the Tailings Borrow Site**

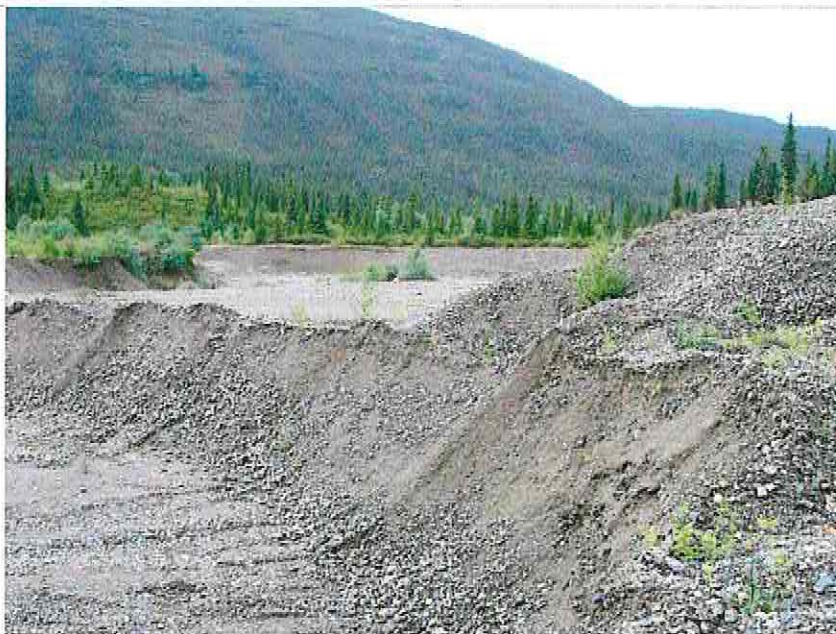
The Rose Creek borrow site is located approximately 1km downstream of the Cross Valley Dam (most westerly dam at the Rose Creek tailings storage facility) on the right bank of Rose Creek (Photo 4, Figure 2). The borrow site includes three existing borrow areas located within alluvial fan (Af) and glaciofluvial plain (Gp) deposits. The materials, excluding the cobble and boulder fraction, consist of poorly graded gravel with sand (GP) and silty gravel with sand (GM). There are frequent cobble-sized clasts and occasional boulders.

The three existing borrow sites cover a combined area of approximately 120,000m<sup>2</sup>. Assuming an average depth of 3m over an available reserve area of 500,000m<sup>2</sup>, there may be up to 1.5 million (M) m<sup>3</sup> of general granular fill available at the site. Much of the area appears to be mined out and, therefore, underlying and adjoining reserves will need to be proved by more detailed site investigation, test pitting and laboratory testing.

**Photo 4: Rose Creek Granular Borrow Site**

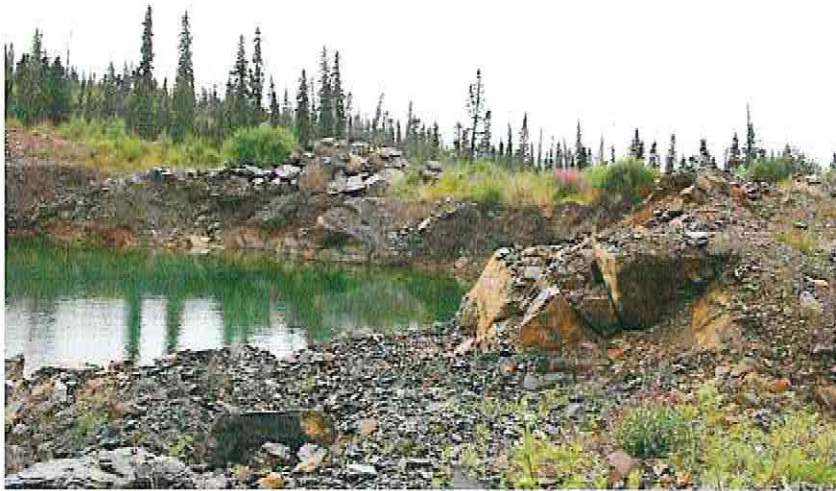
**Photo 5: AEX Creek Schist Quarry**

The AEX Creek schist quarry is located in AEX Creek approximately 650m west of the ore haul shop. The old rock quarry site, which is now infilled with water (Photo 5, Figure 4), is mapped as till veneer overlying bedrock (Tv-R). The rock quality is variable and comprises approximately 70% slightly to moderately weathered, closely jointed, strongly foliated, strong schist and 30% slightly weathered, widely jointed, weakly foliated, very strong schist. Approximately 10,000m<sup>3</sup> of material appears to have been extracted from this quarry with a minor stockpile of the stronger rock remaining. Another 10,000m<sup>3</sup> of good rock may not be obtainable by drill and blast methods but the occurrence of good rock is patchy.

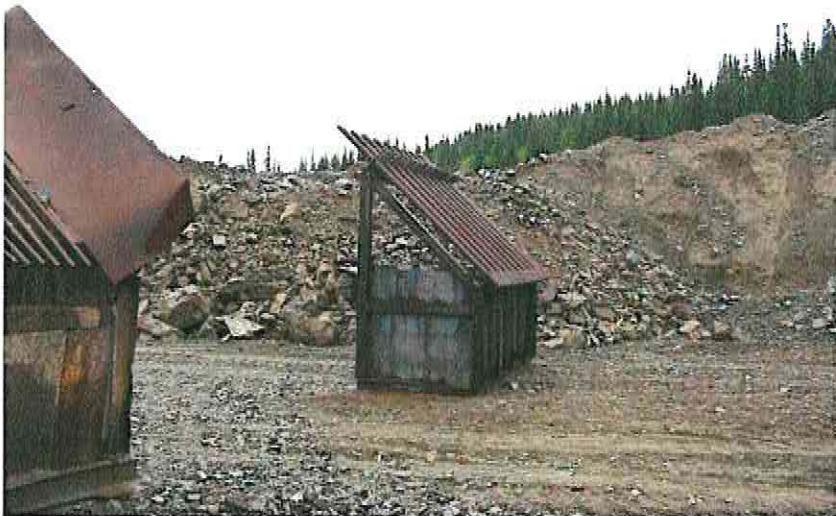
**Photo 6: Grum Dump quarry material and screens**

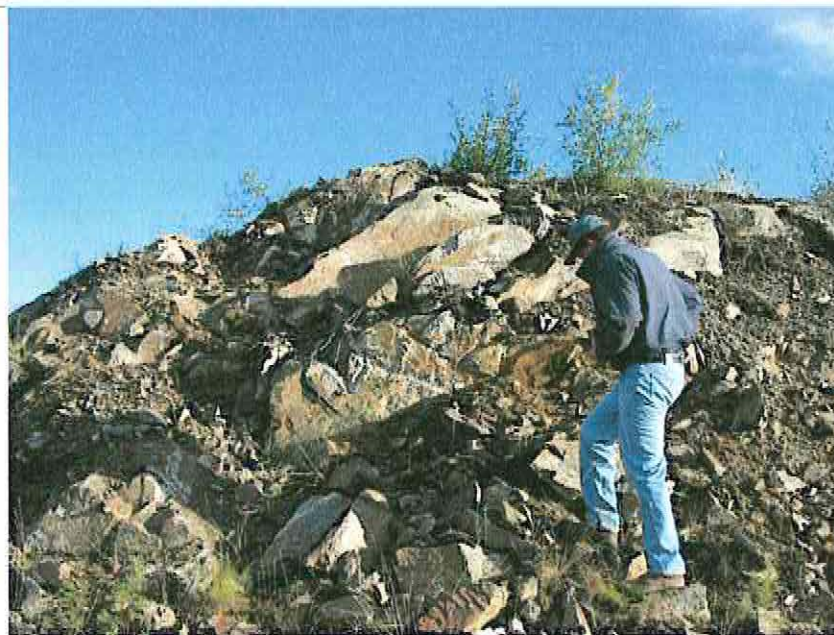
**Photo 8: Faro Mine Road Outcrop**

Extensive outcrop of granitic bedrock was visited on the Faro Mine Road at the old Vangorda-Grum turnoff (Figure 4). Outcrop ridges can be seen scattered over a wide area approximately 500m by 500m. The rock is generally slightly weathered and strong to very strong with moderately widely to widely spaced joints (Photo 8). Joint surfaces are planar-rough and moderately persistent (2-3m+) with iron staining and no infill. This appears to be a very good potential rock quarry site, which is reasonably close to both mine areas.
