March 23, 2010

Phase 1A Geotechnical Slope Stability Assessment of the East Wall of the Grum Pit, Faro Mine, Yukon

Project Number: 09-1426-0021

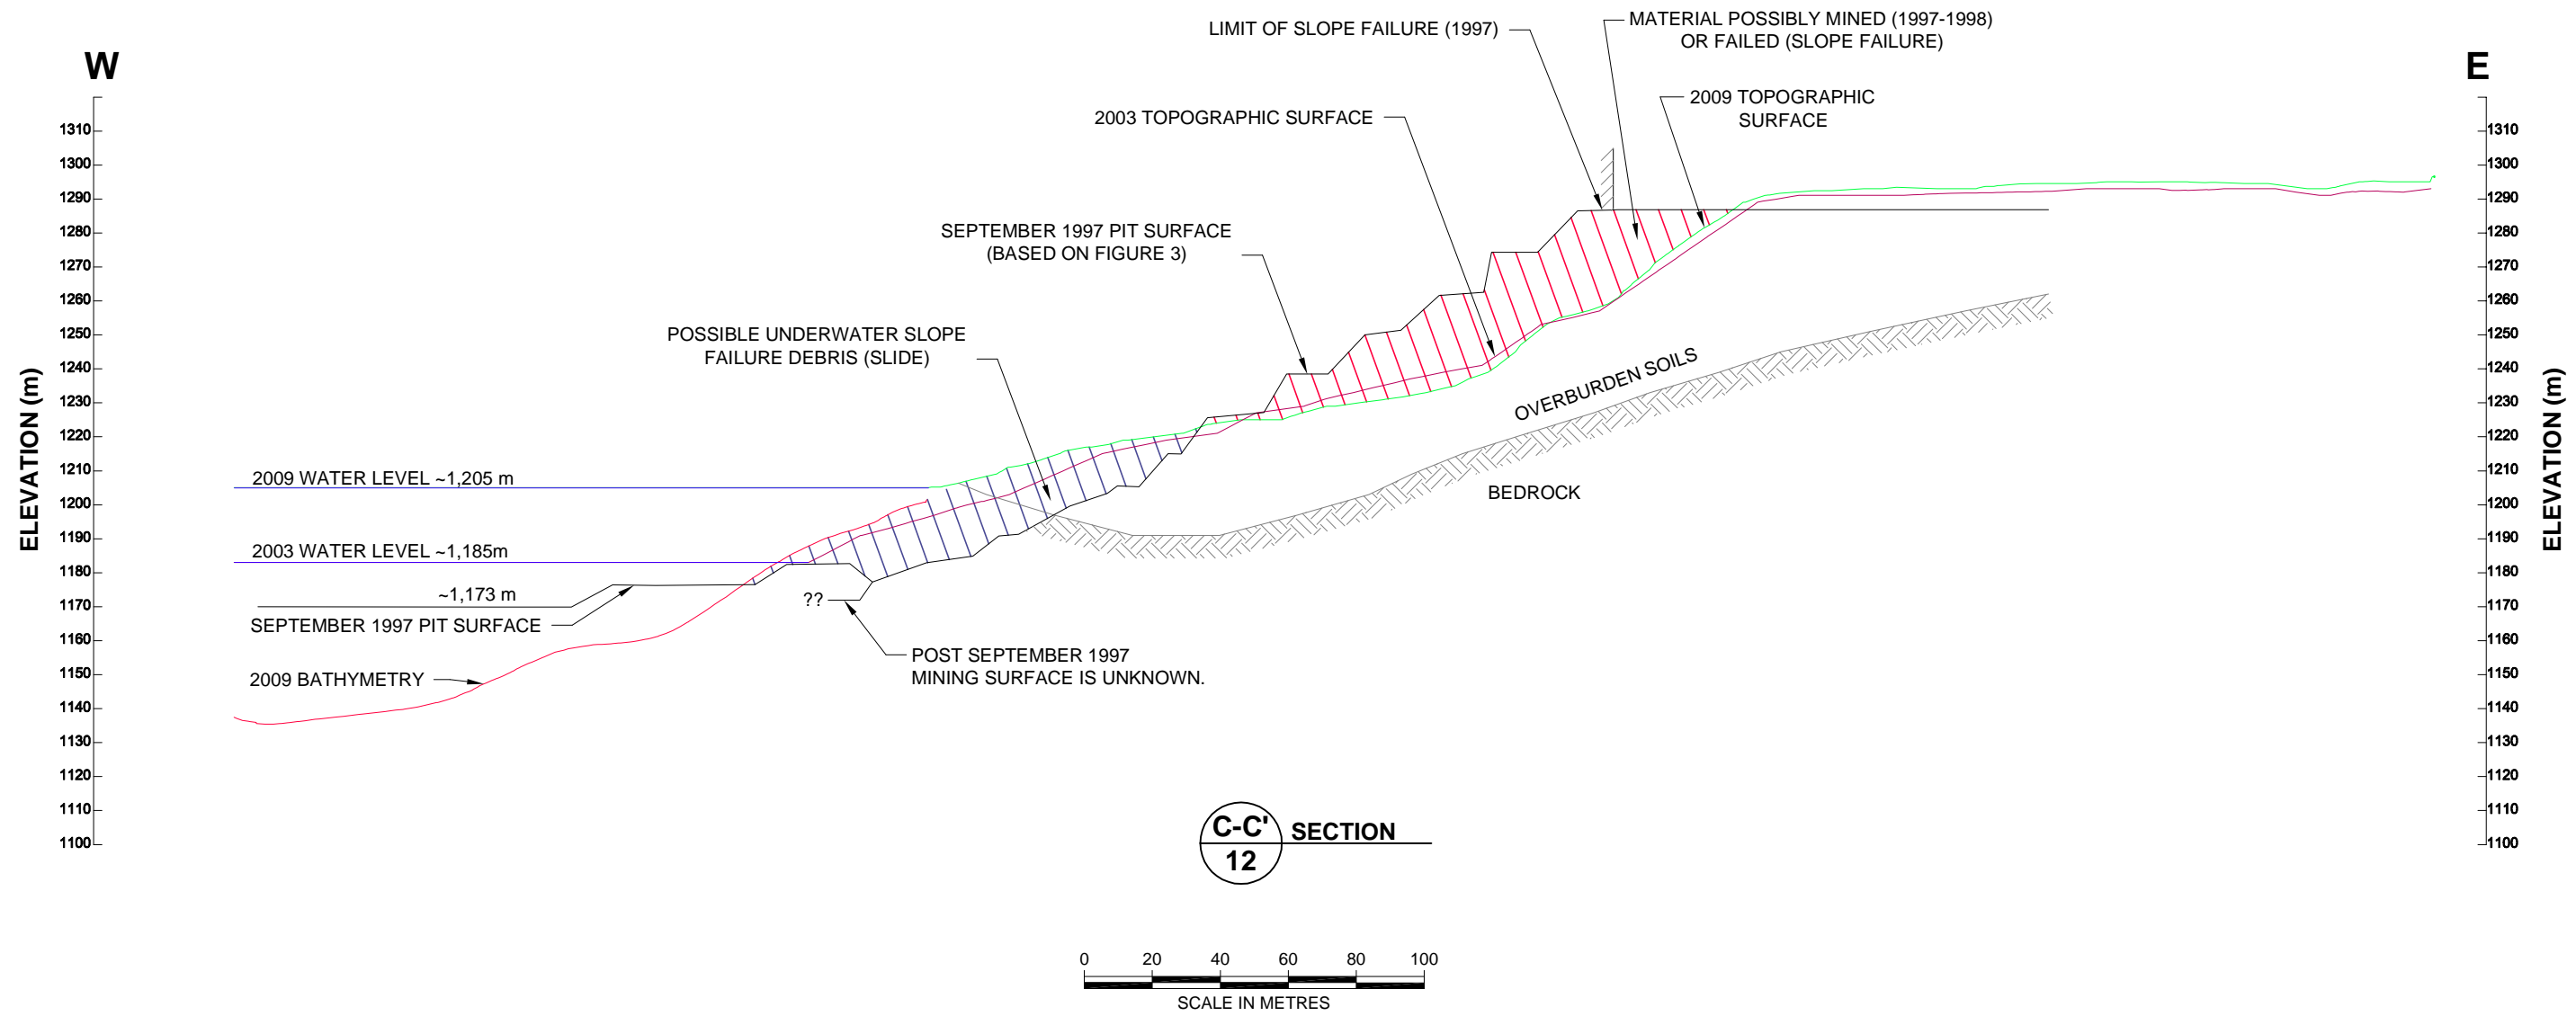
Greater Vancouver Office, BC		FIGURE 13

A review of the cross-sections shows a significant difference in the surface topography between the 1997 pit surface and the most recent topographic surveys (2003 and 2009) in the upper portion of the pit wall. This can be seen on the cross sections of Figures 13 and 14. The 1997 crest of the east wall was located to the west of the 2003 crest and the current crest. This would suggest that additional mining was carried out between the 1997 failure and the 1998 shut-down. Based on field observations it would appear that the crest of the 1997 slope was mined back behind the failure scarp that developed at that time, and that some of the failure debris was probably removed from the upper portion of the slope. Since the pit plans at the time of mine shutdown are not available, it has not been possible to assess the change in the ground surface since that time.

In addition, the cross-sections of Figures 13 and 14 also indicate that failure debris have accumulated underwater in front of the originally mined rock slopes, as indicated by the bathymetry and the 1997 pit surfaces. The failure debris appears to have reached the pit floor forming a shallower underwater slope that is continuous with the slopes within the instability area above the water surface. The failed slopes exhibit inclinations of approximately 23 degrees and 27 degrees measured on cross-sections A and B, respectively.

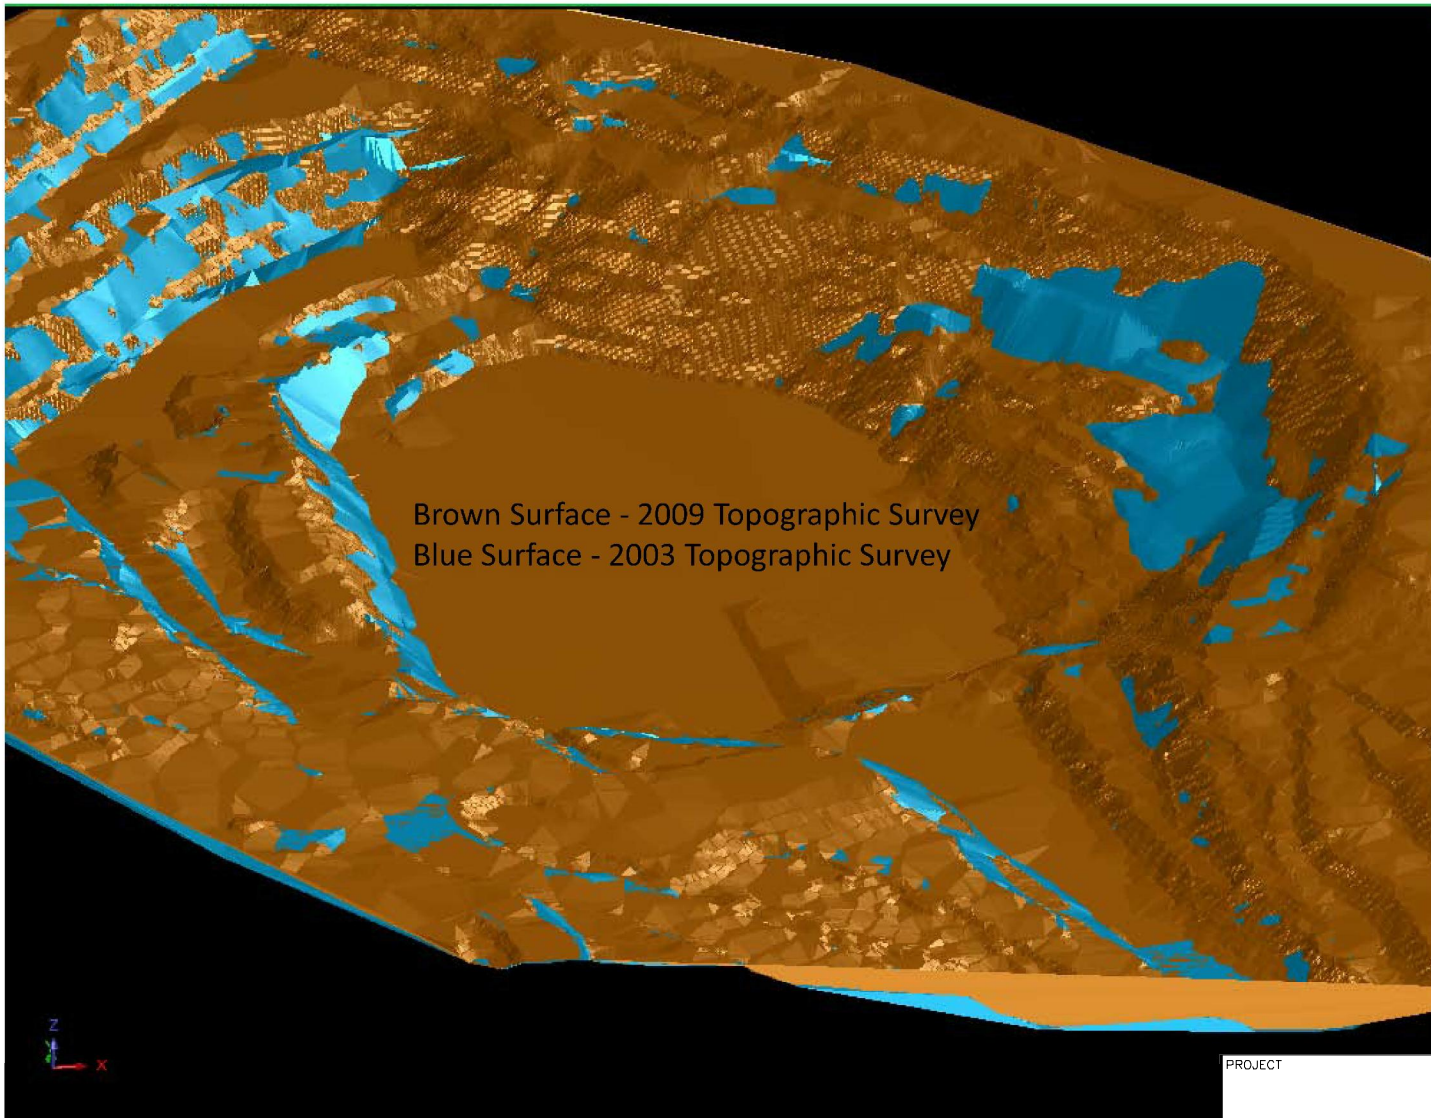
PROJECT No. 09-1426-0021			PHASE No. 2000		
DESIGN	LP	05NOV09	SCALE	NTS	REV. --
CADD	NS	05NOV09	FIGURE 15		
CHECK	AVC	23MAR10			
REVIEW	AVC	23MAR10

The 2003 and 2009 topographic plans were imported into SURPAC and 3D surfaces were created. The 2003 and 2009 surfaces were combined, as shown in Figure 15. A comparison of the two topographic surfaces within the east wall instability area shows the 2009 surface is located below the 2003 surface in the upper portion of the failure zone. This appears to indicate downward movement or settlement of that area since the 2003 survey. In the lower portion of the failure zone, the 2009 surface is observed to be above the 2003 surface, which could indicate ground heave or deformation with translational movement to west since the 2003 survey. The differences between the 2003 and 2009 surfaces are also observed on the cross-sections shown in Figures 13 and 14. Based on a comparison of the 2005 and 2009 photographs, which is discussed in Section 5.3, it is evident that the original failure mass has continued to move into the pit, and that additional instability has occurred behind the original failure back-scarp.

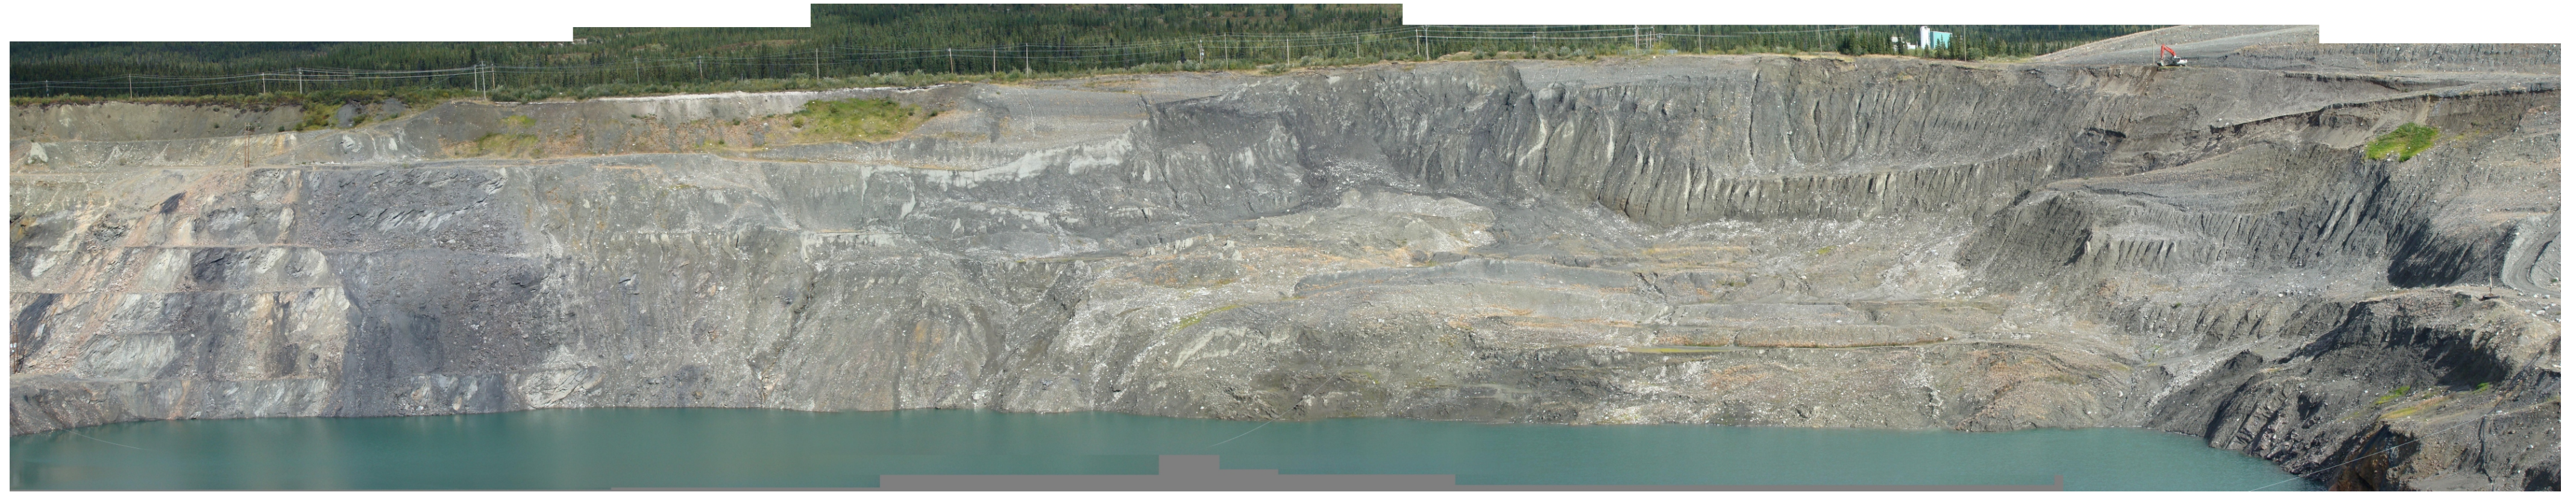
Photograph 2 : East Wall.

The initial extent of the instability is shown on Figure 3, and the initial failure was approximately 300 metres long in a north/south direction. Based on field observations and a comparison of 1997 topography versus 2003 topography, it would appear that a portion of the failure debris at the crest of the slope was mined out, and that the slope behind the back-scarp was laid back. The size of the failure zone has increased since 1997, and the failure is now approximately 350 metres long. The large scale slope instability zone now extends almost the entire length of overburden soils exposed on the east wall of pit wall (Photographs I-1 to I-3).

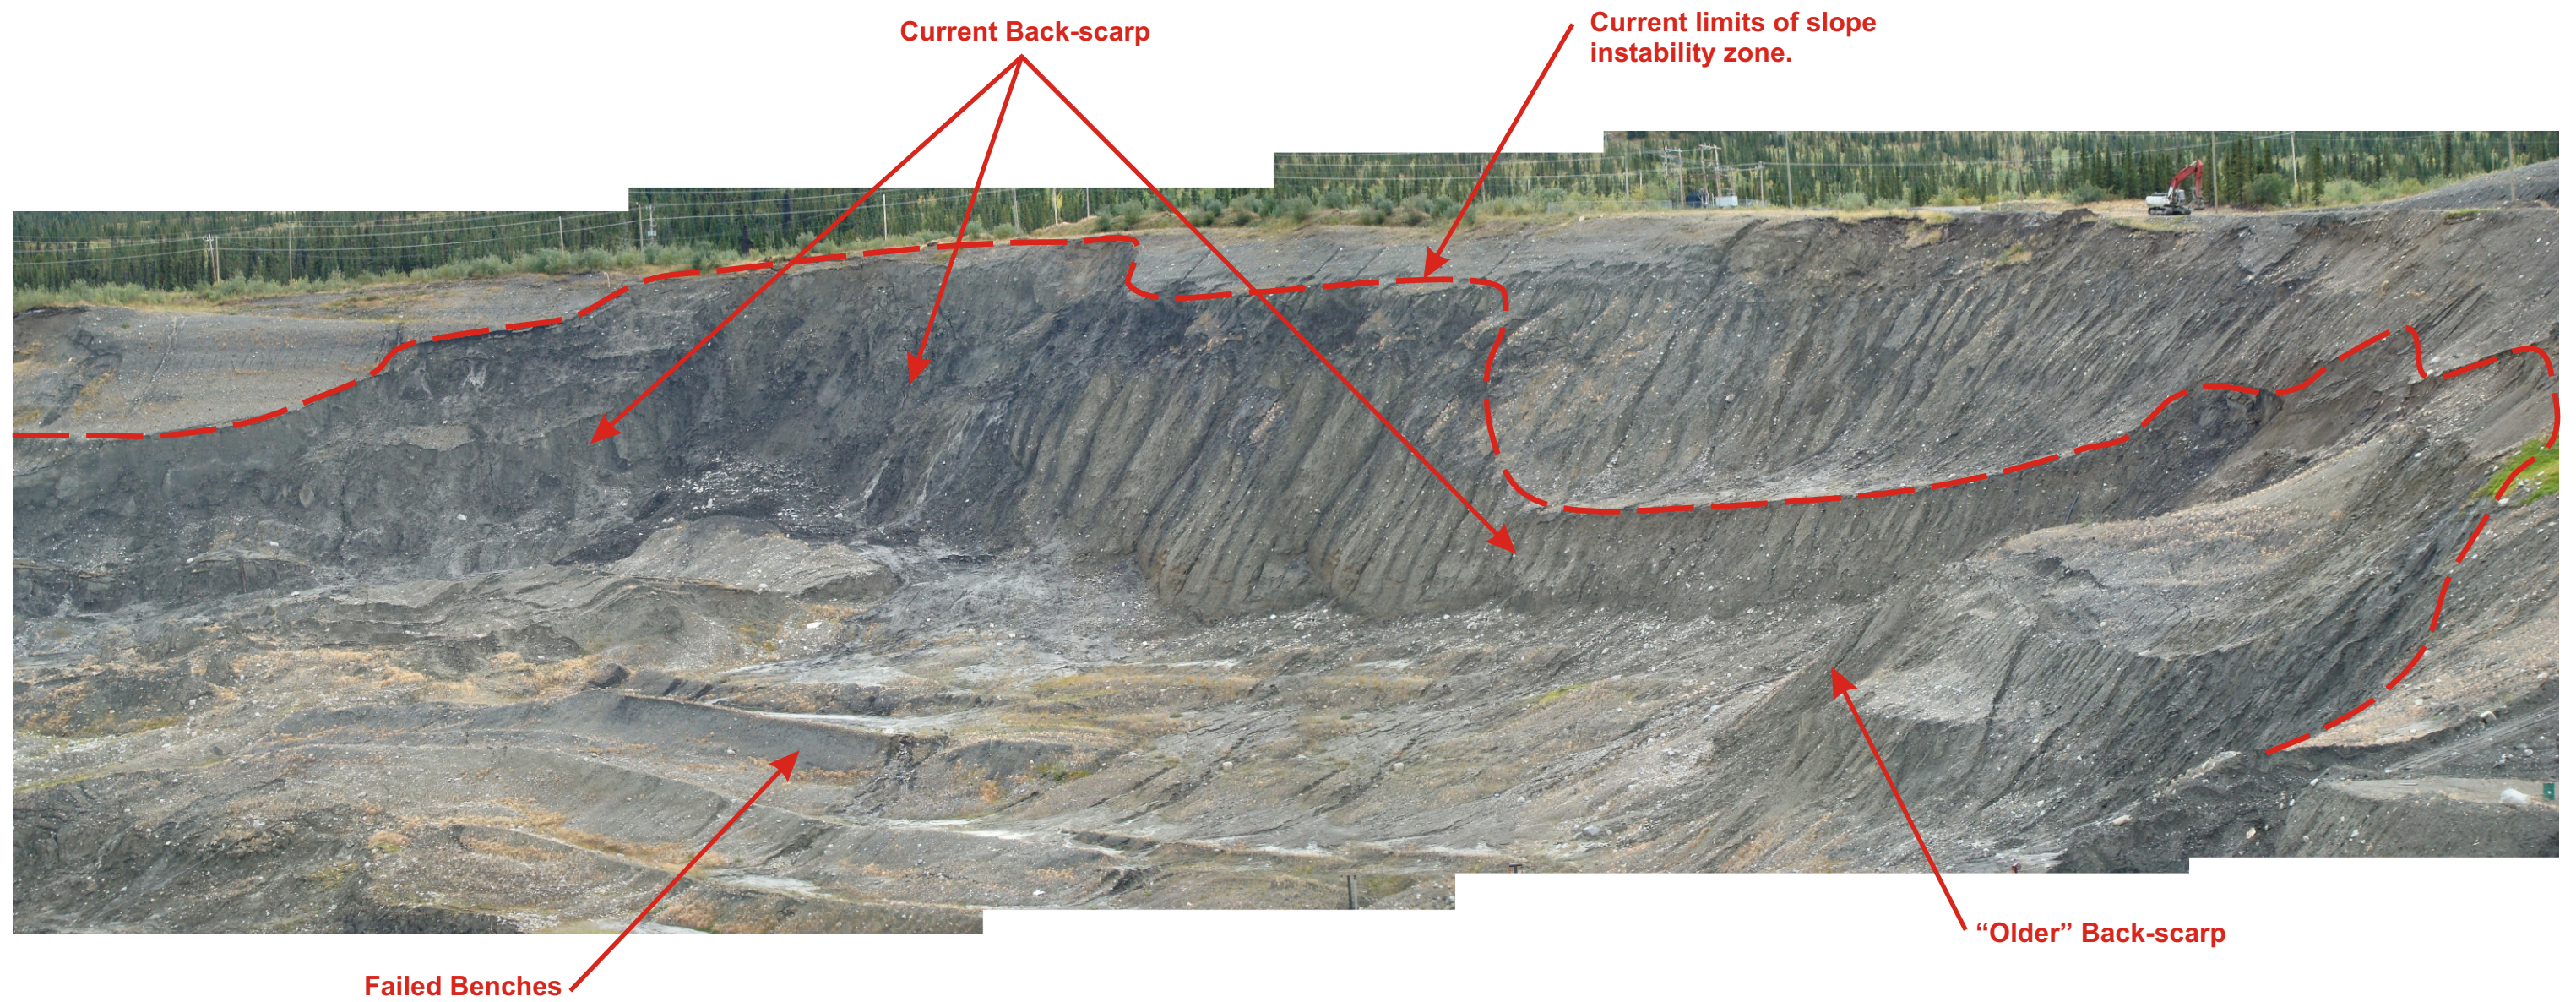
The failed overburden soils bounded by the back-scarp have undergone large deformation and settlement, which has resulted in a large area of subsidence in the failure zone. The original catch-benches that were excavated on the slope have been largely destroyed. In the central portion of the failure zone, remnants of the originally excavated catch-benches indicate signs of rotational slide failure, with resulting downward movement into the pit (Photographs I-4 and I-8).

Photograph 4 : East wall instability (August, 2009)

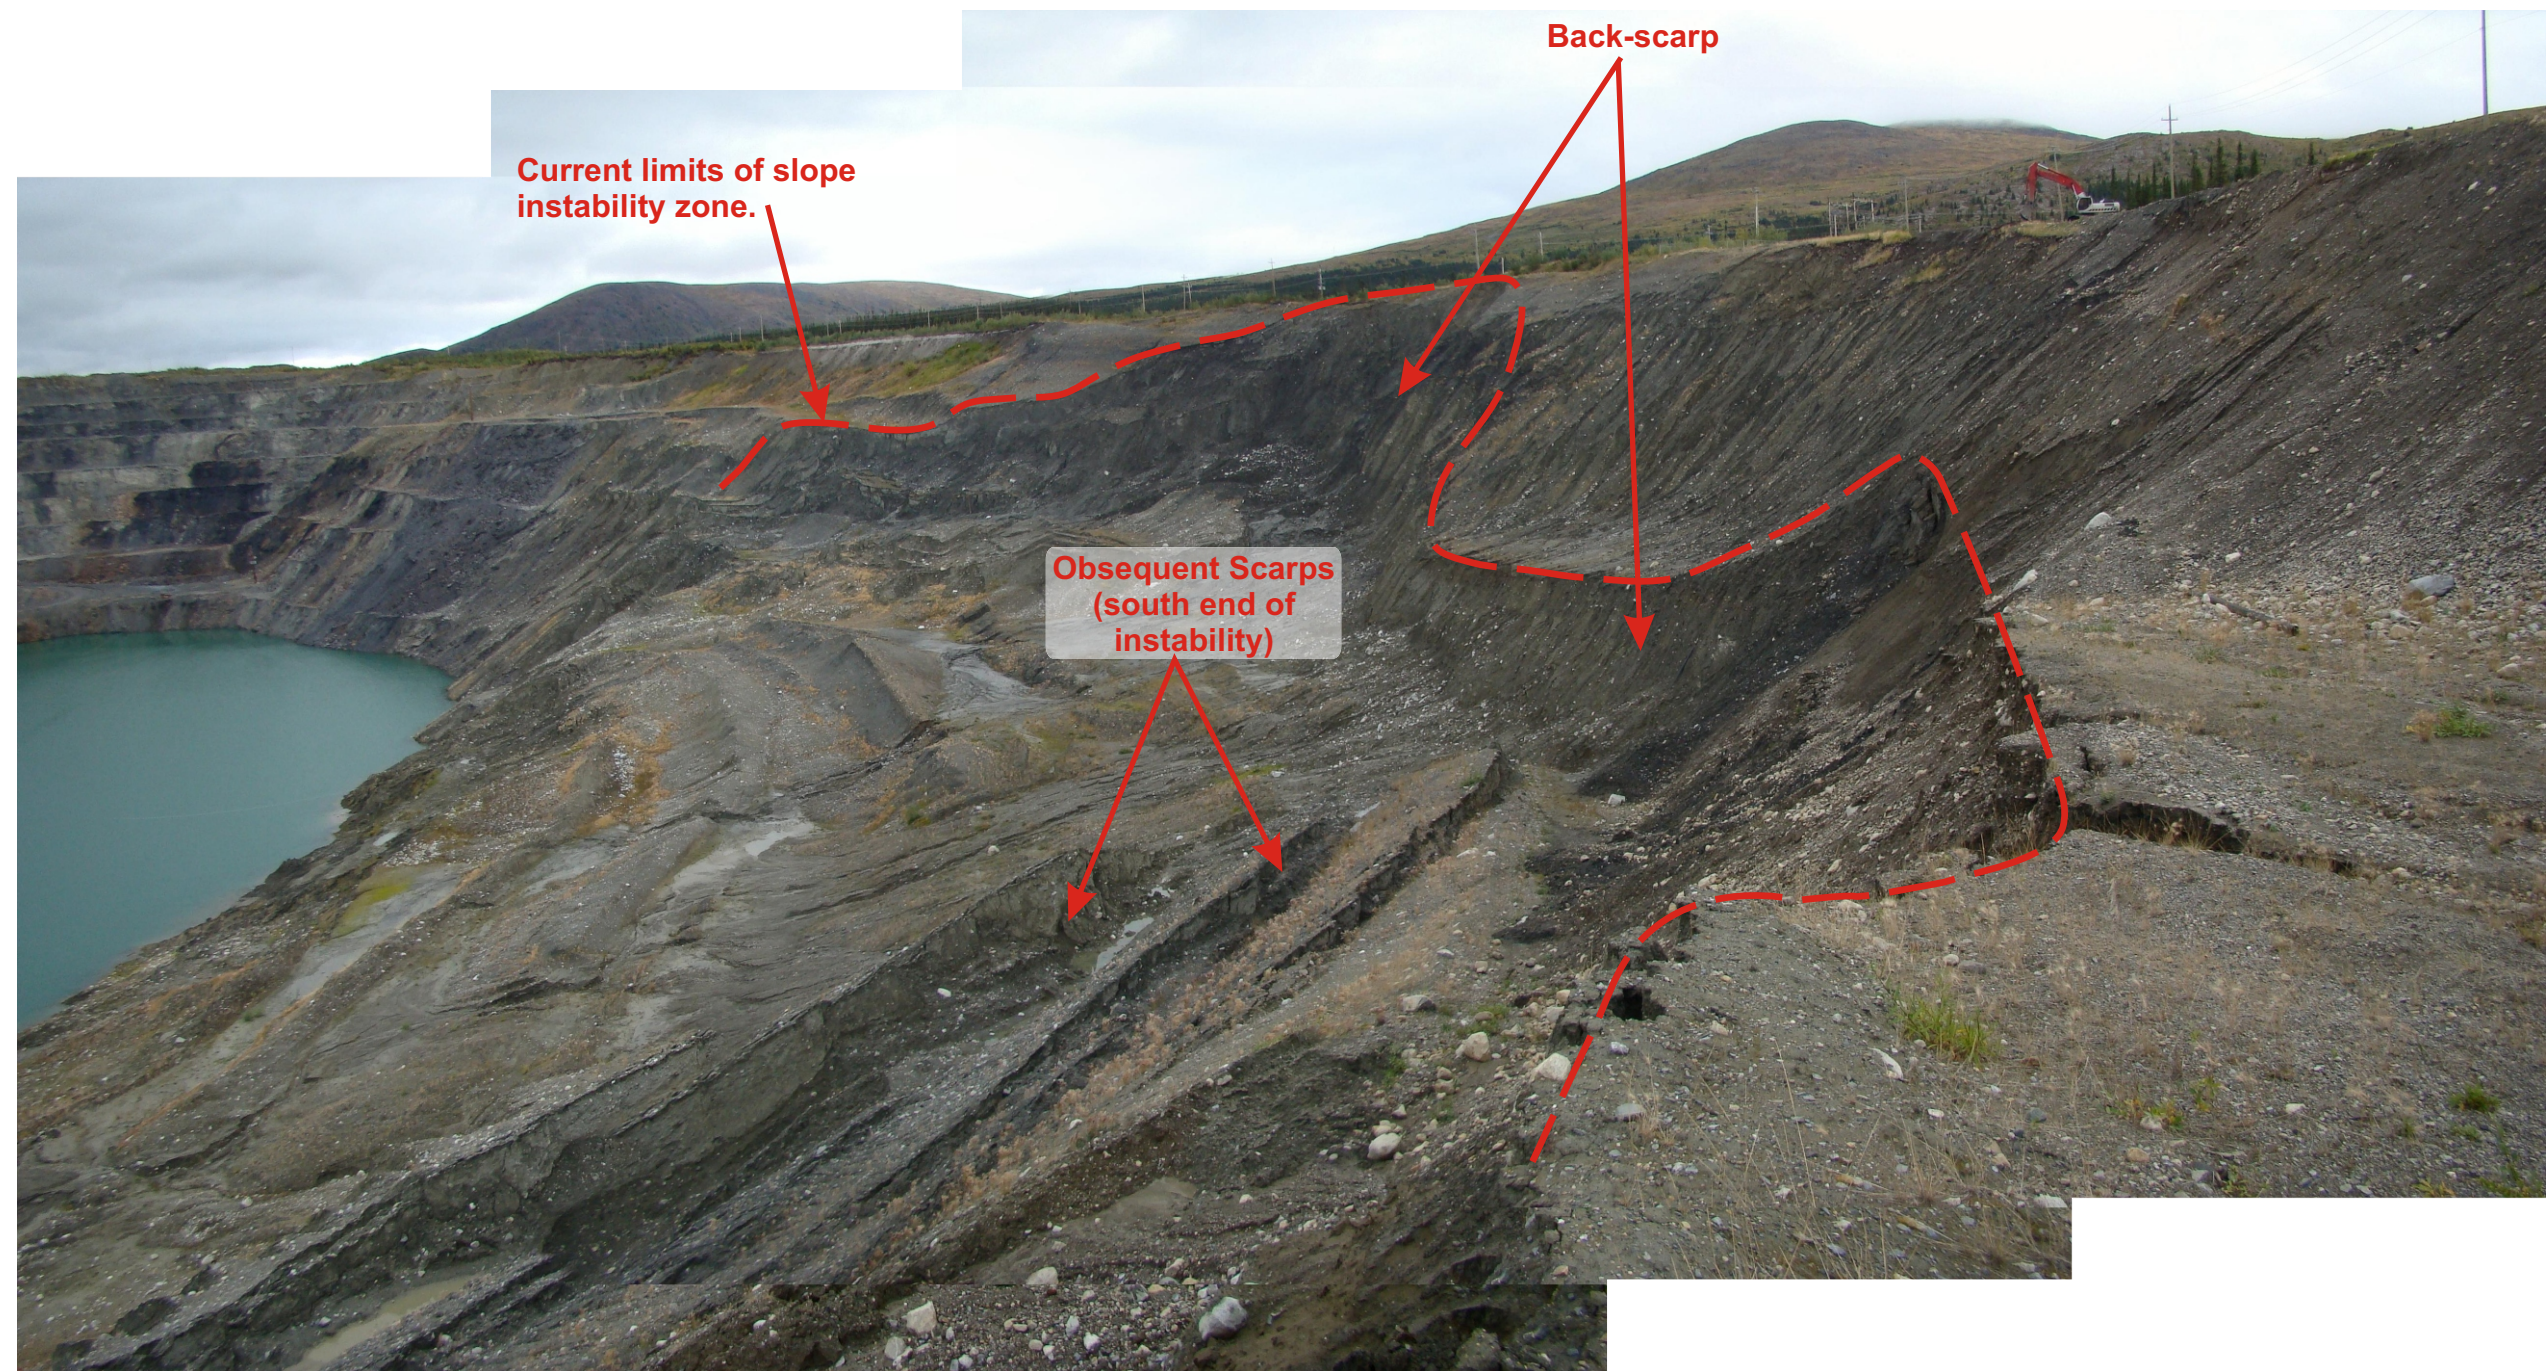
In the same area along the south end of the instability zone, a series of obsequent scarps and graben structures are observed below the current back-scarp and above remnants of a previous back-scarp (Photographs I-5 and I-9). These structures have developed as the slope instability progressed further south forming the obsequent ridges and graben features in between the two back-scarps.

Photograph 5 : East wall instability looking north (August, 2009).

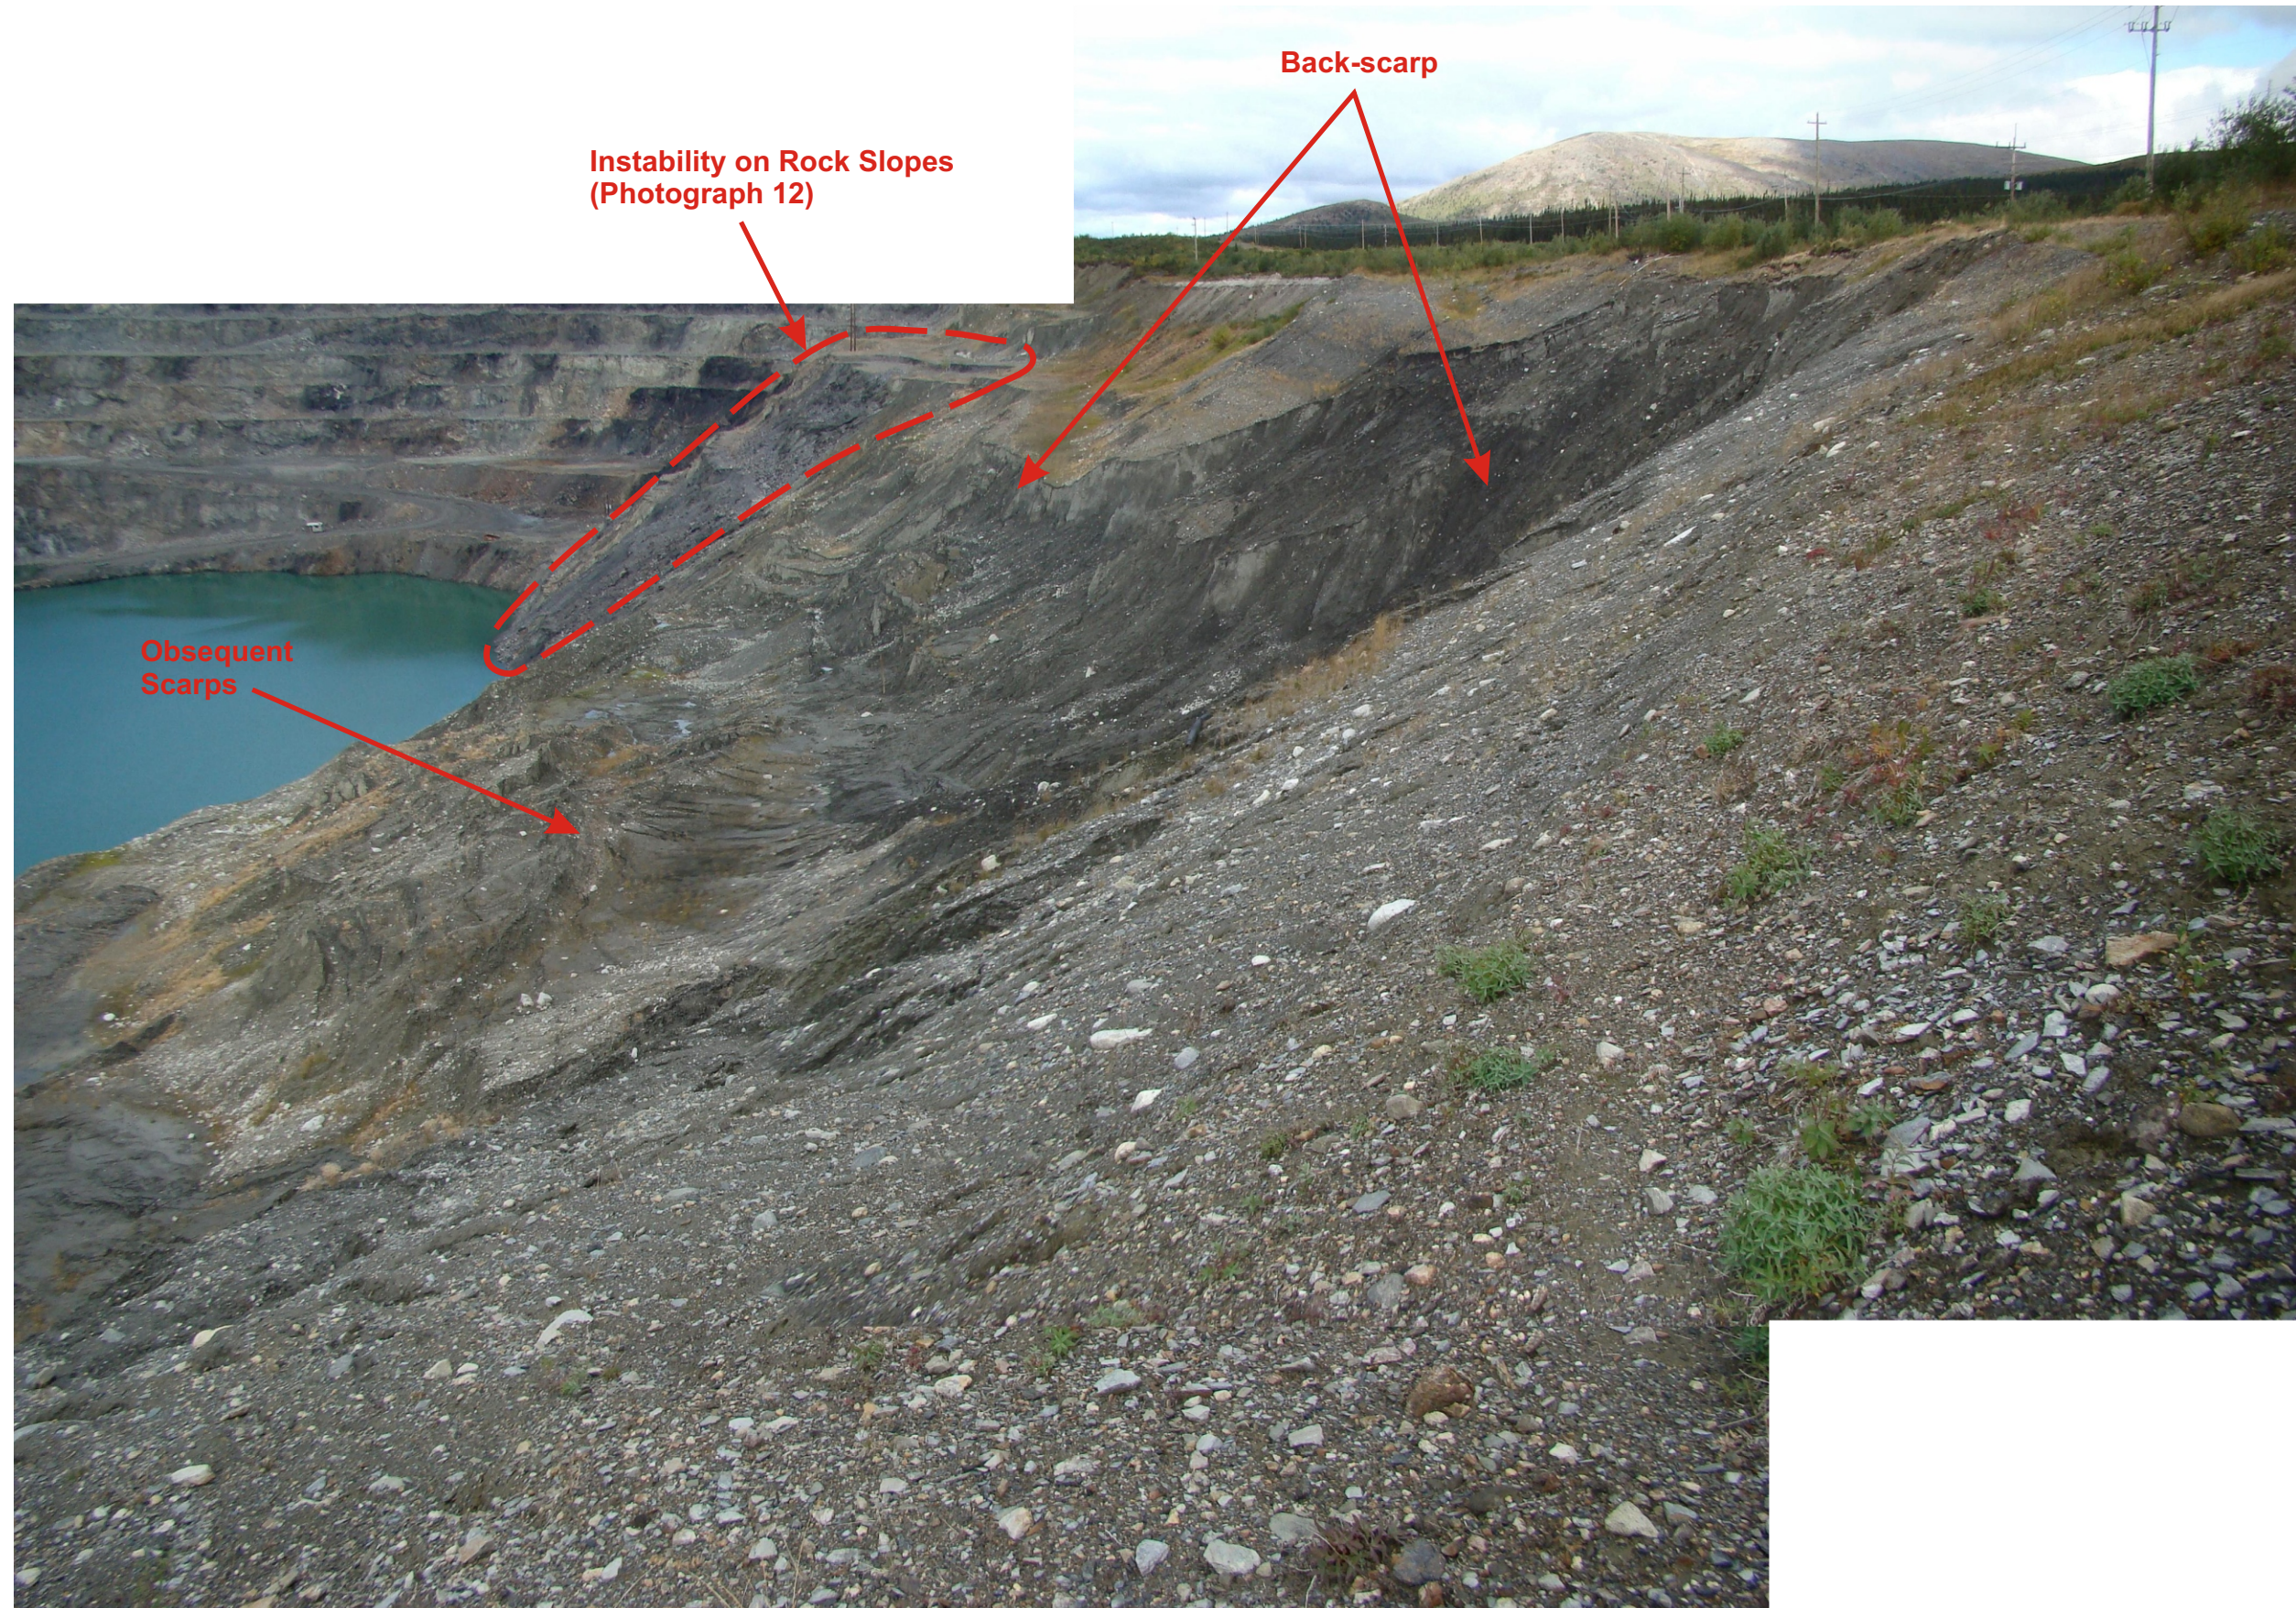
On the north portion of the east wall, just to the north of the overburden failure zone, the rock slopes also exhibit signs of instability (Photographs I-6 and I-12). The bench rock slopes exhibit poor stability performance with loss of catch-benches due to sliding on the pervasive westerly dipping rock fabric. Multi-bench rock slope instability has also developed on gray phyllites that occur adjacent to the main instability zone on the overburden soils. The bench slopes excavated on the gray phyllites have failed with settlement and loss of the catch-benches. Continuous cracks are observed behind the crest of the upper bench on phyllites with approximately 1 meter vertical drop (Photograph I-12). Structural orientation mapping data collected during the site inspection is presented on the stereonet of Figure 10. This limited orientation data set was obtained by mapping of a few rock exposures along the north end of the east wall. The pervasive westerly dipping foliation, *i.e.*, schistosity or fissility, represents the dominant geological discontinuity that is characteristic of the rock masses exposed along the east wall.

Photograph 6 : Back-scarp looking north (August 2009).

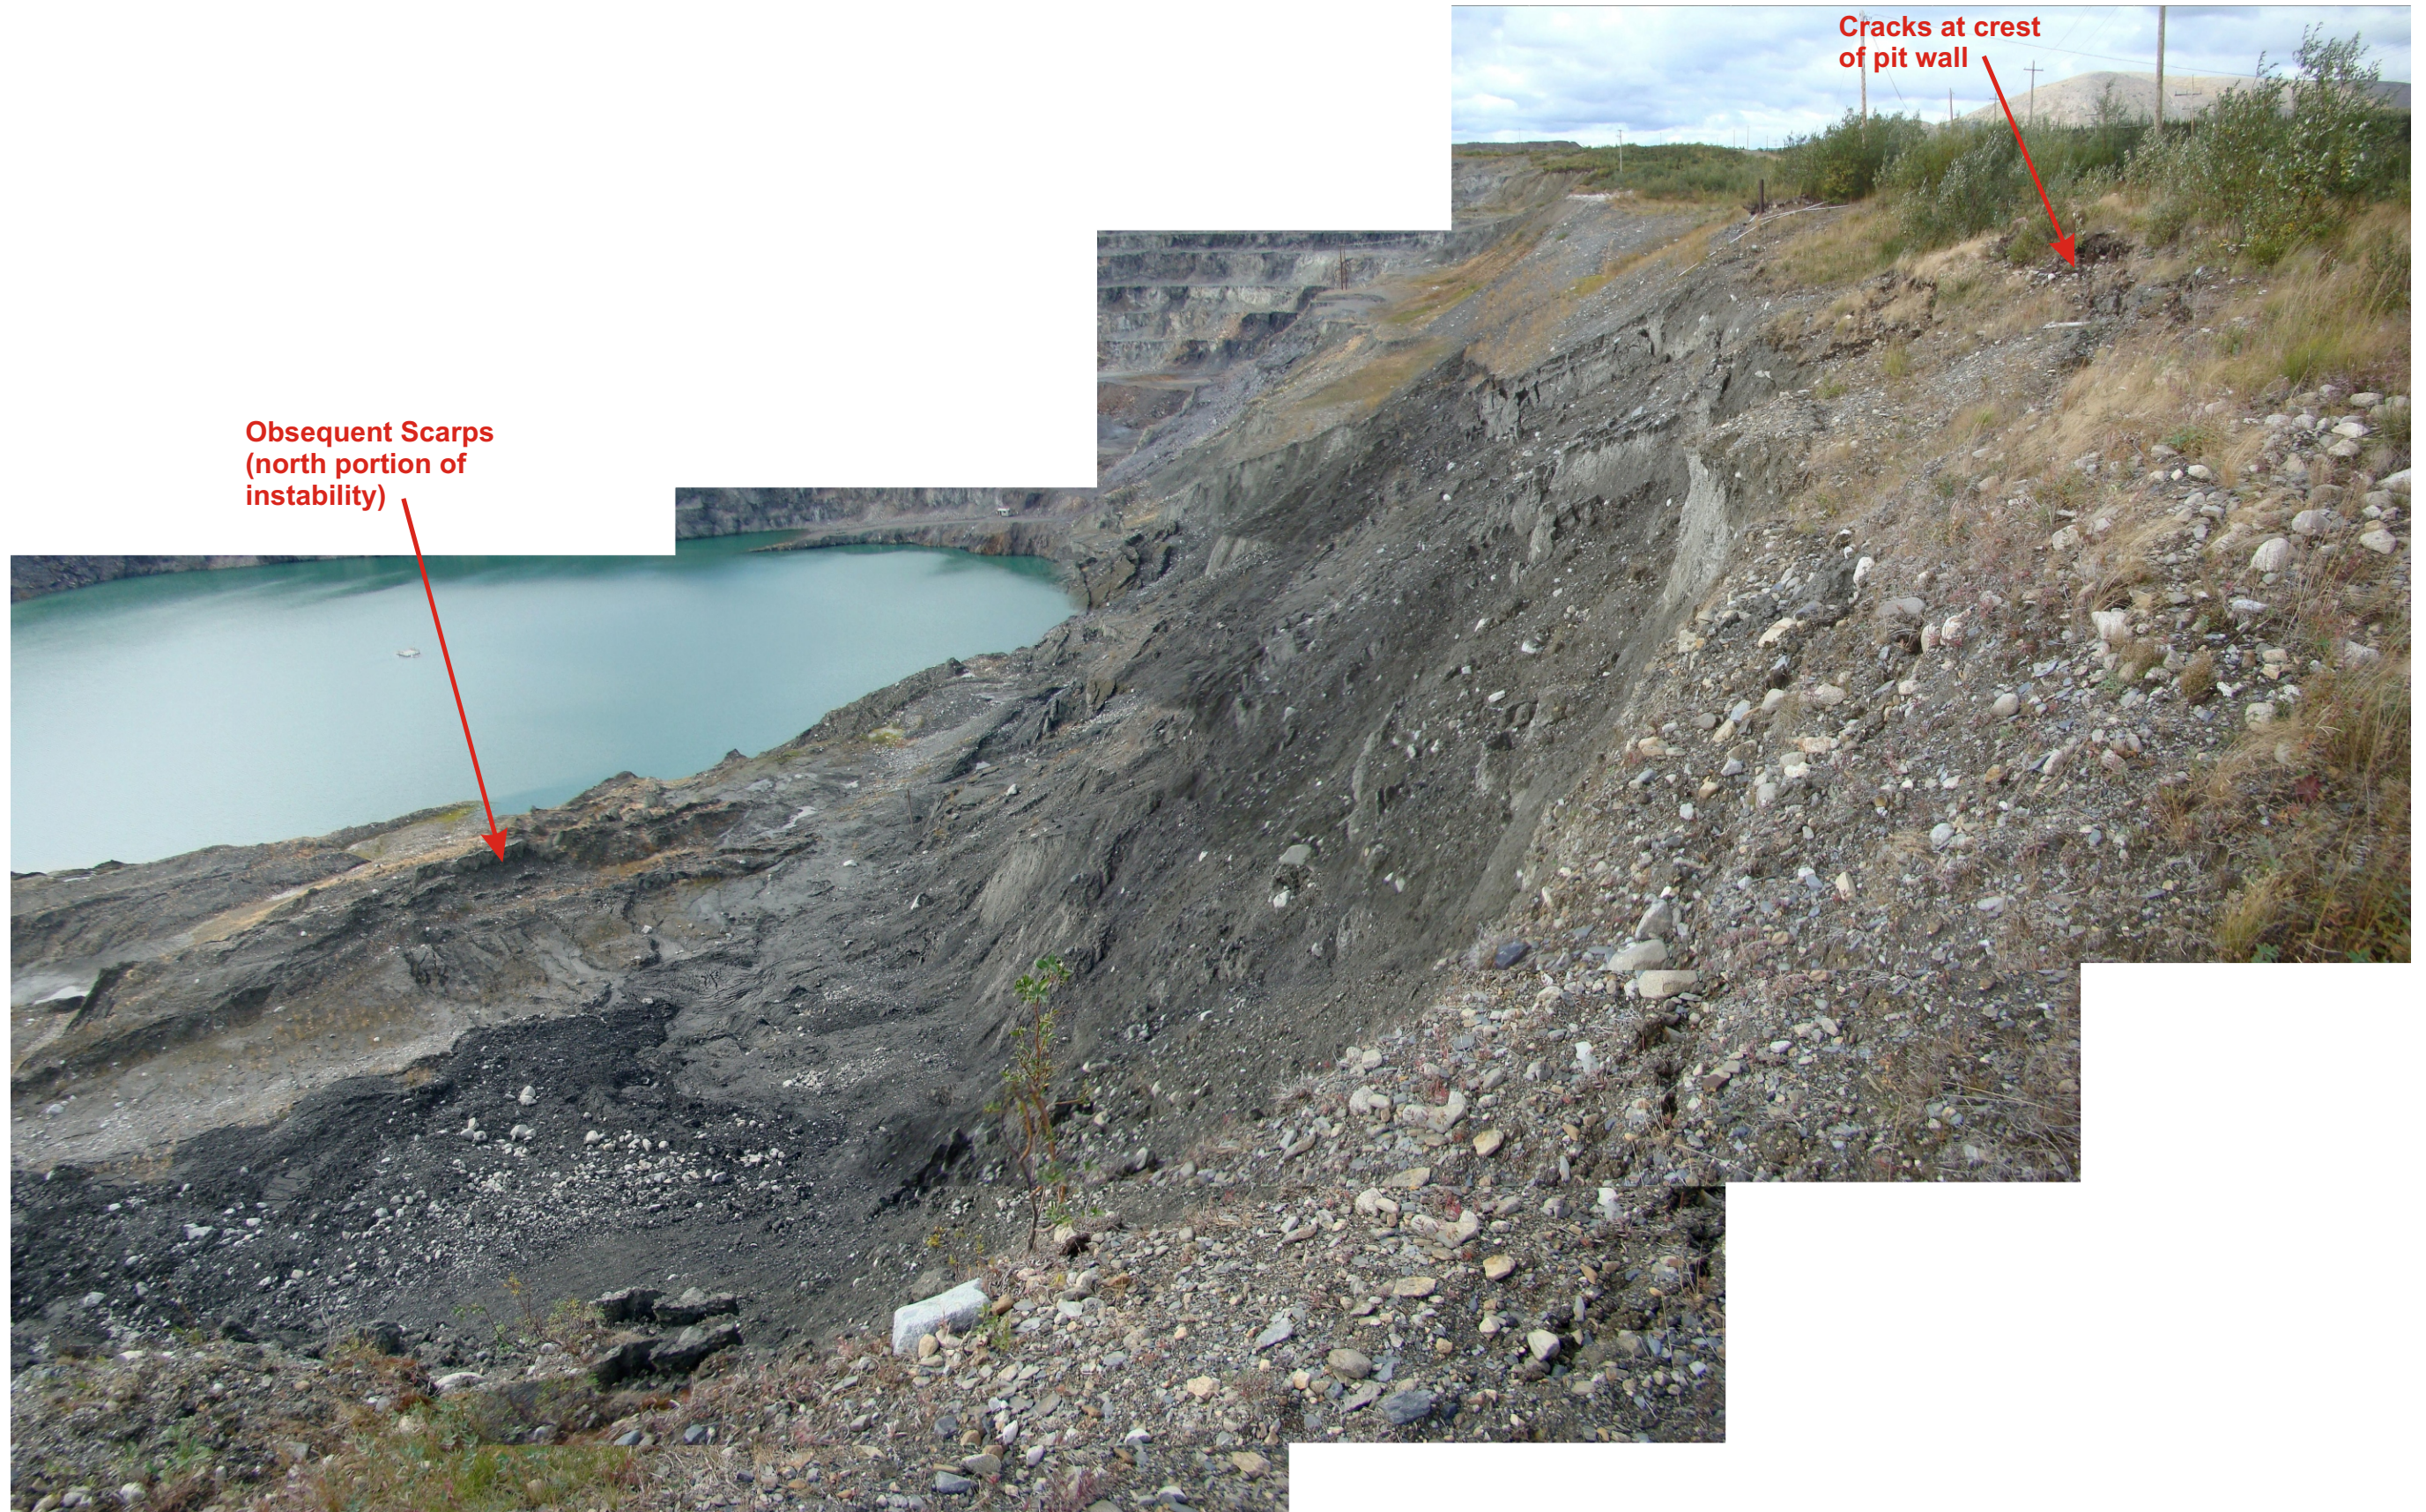
In the north-central portion of the failure zone, older obsequent ridges and graben features (Photographs I-7, I-10 and I-11) are also observed within the failed ground. These features probably represent previous stages of slope instability with regressive failure developing further east of the initial slope failure. These features in the north-central portion of the failure zone occur on higher ground than the main failure area in the central portion of the failure zone where rotational slide failure appears to have been dominant. In addition, the failure slope below the area where these features are observed has deformed to a steeper slope than observed in the most central part of the failure zone. This observation is also indicative that the failure materials accumulated in the lower slope in that area have been pushed by the subsequent failure of the upper slope. Therefore, it is possible that the slope instability was originally initiated in the central portion predominantly as a rotational slide where the maximum overburden thickness was exposed by the excavation of the pit wall. Subsequently, the initial slope failure progressed with regressive failures expanding the initial limits of the instability zone to south and north possibly into areas of shallower bedrock, as well as extending to the east and to the upper portion of the east wall.

The walk over inspection carried out along and behind the crest of the east wall indicated that the slope instability has reached the crest of the pit wall above the north-central portion of the failure zone, as observed on Photograph I-7. In this area, the slope in the overburden soils has failed up to the crest of the pit wall with tension cracks developed near the crest of the wall. These tension cracks extend only a few meters behind the crest of the wall, and no tension cracks were observed further away from the crest.

Photograph 7 : Crest of east wall looking north (August, 2009).
