March 23, 2010

Phase 1A Geotechnical Slope Stability Assessment of the East Wall of the Grum Pit, Faro Mine, Yukon

Project Number: 09-1426-0021

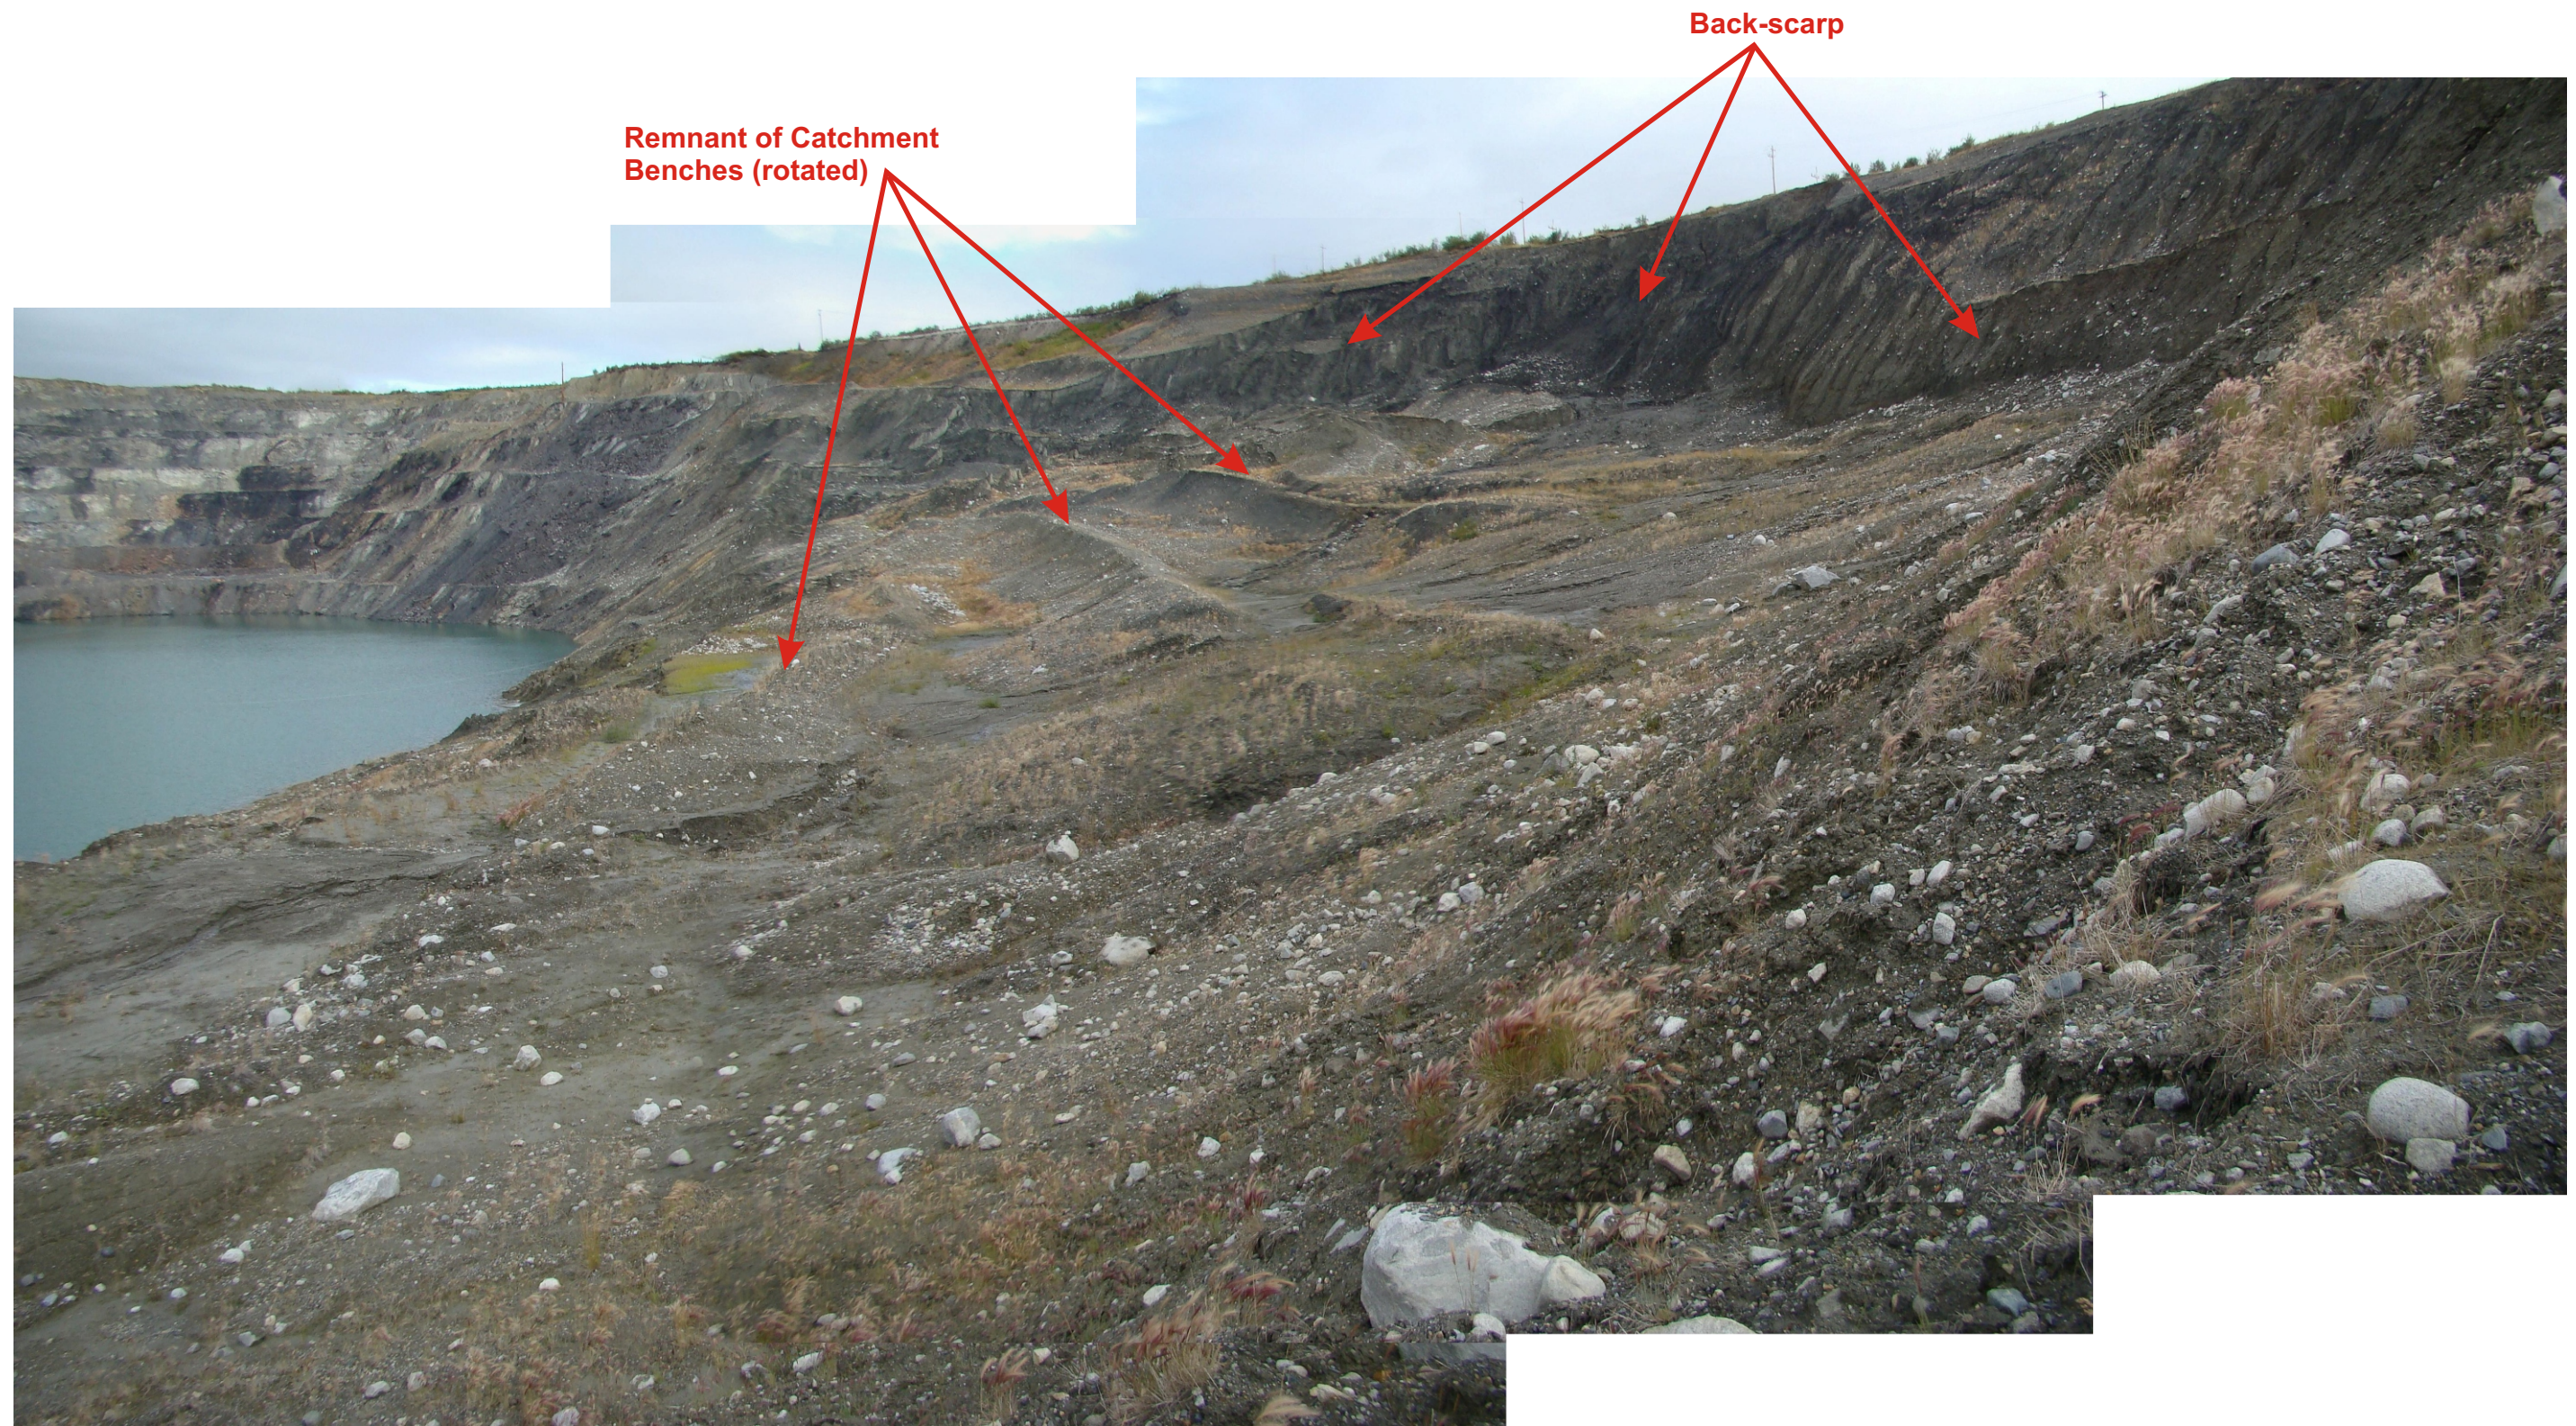
The failed overburden soils bounded by the back-scarp have undergone large deformation and settlement, which has resulted in a large area of subsidence in the failure zone. The original catch-benches that were excavated on the slope have been largely destroyed. In the central portion of the failure zone, remnants of the originally excavated catch-benches indicate signs of rotational slide failure, with resulting downward movement into the pit (Photographs I-4 and I-8).

Photograph 8 : East wall instability (August 2009).

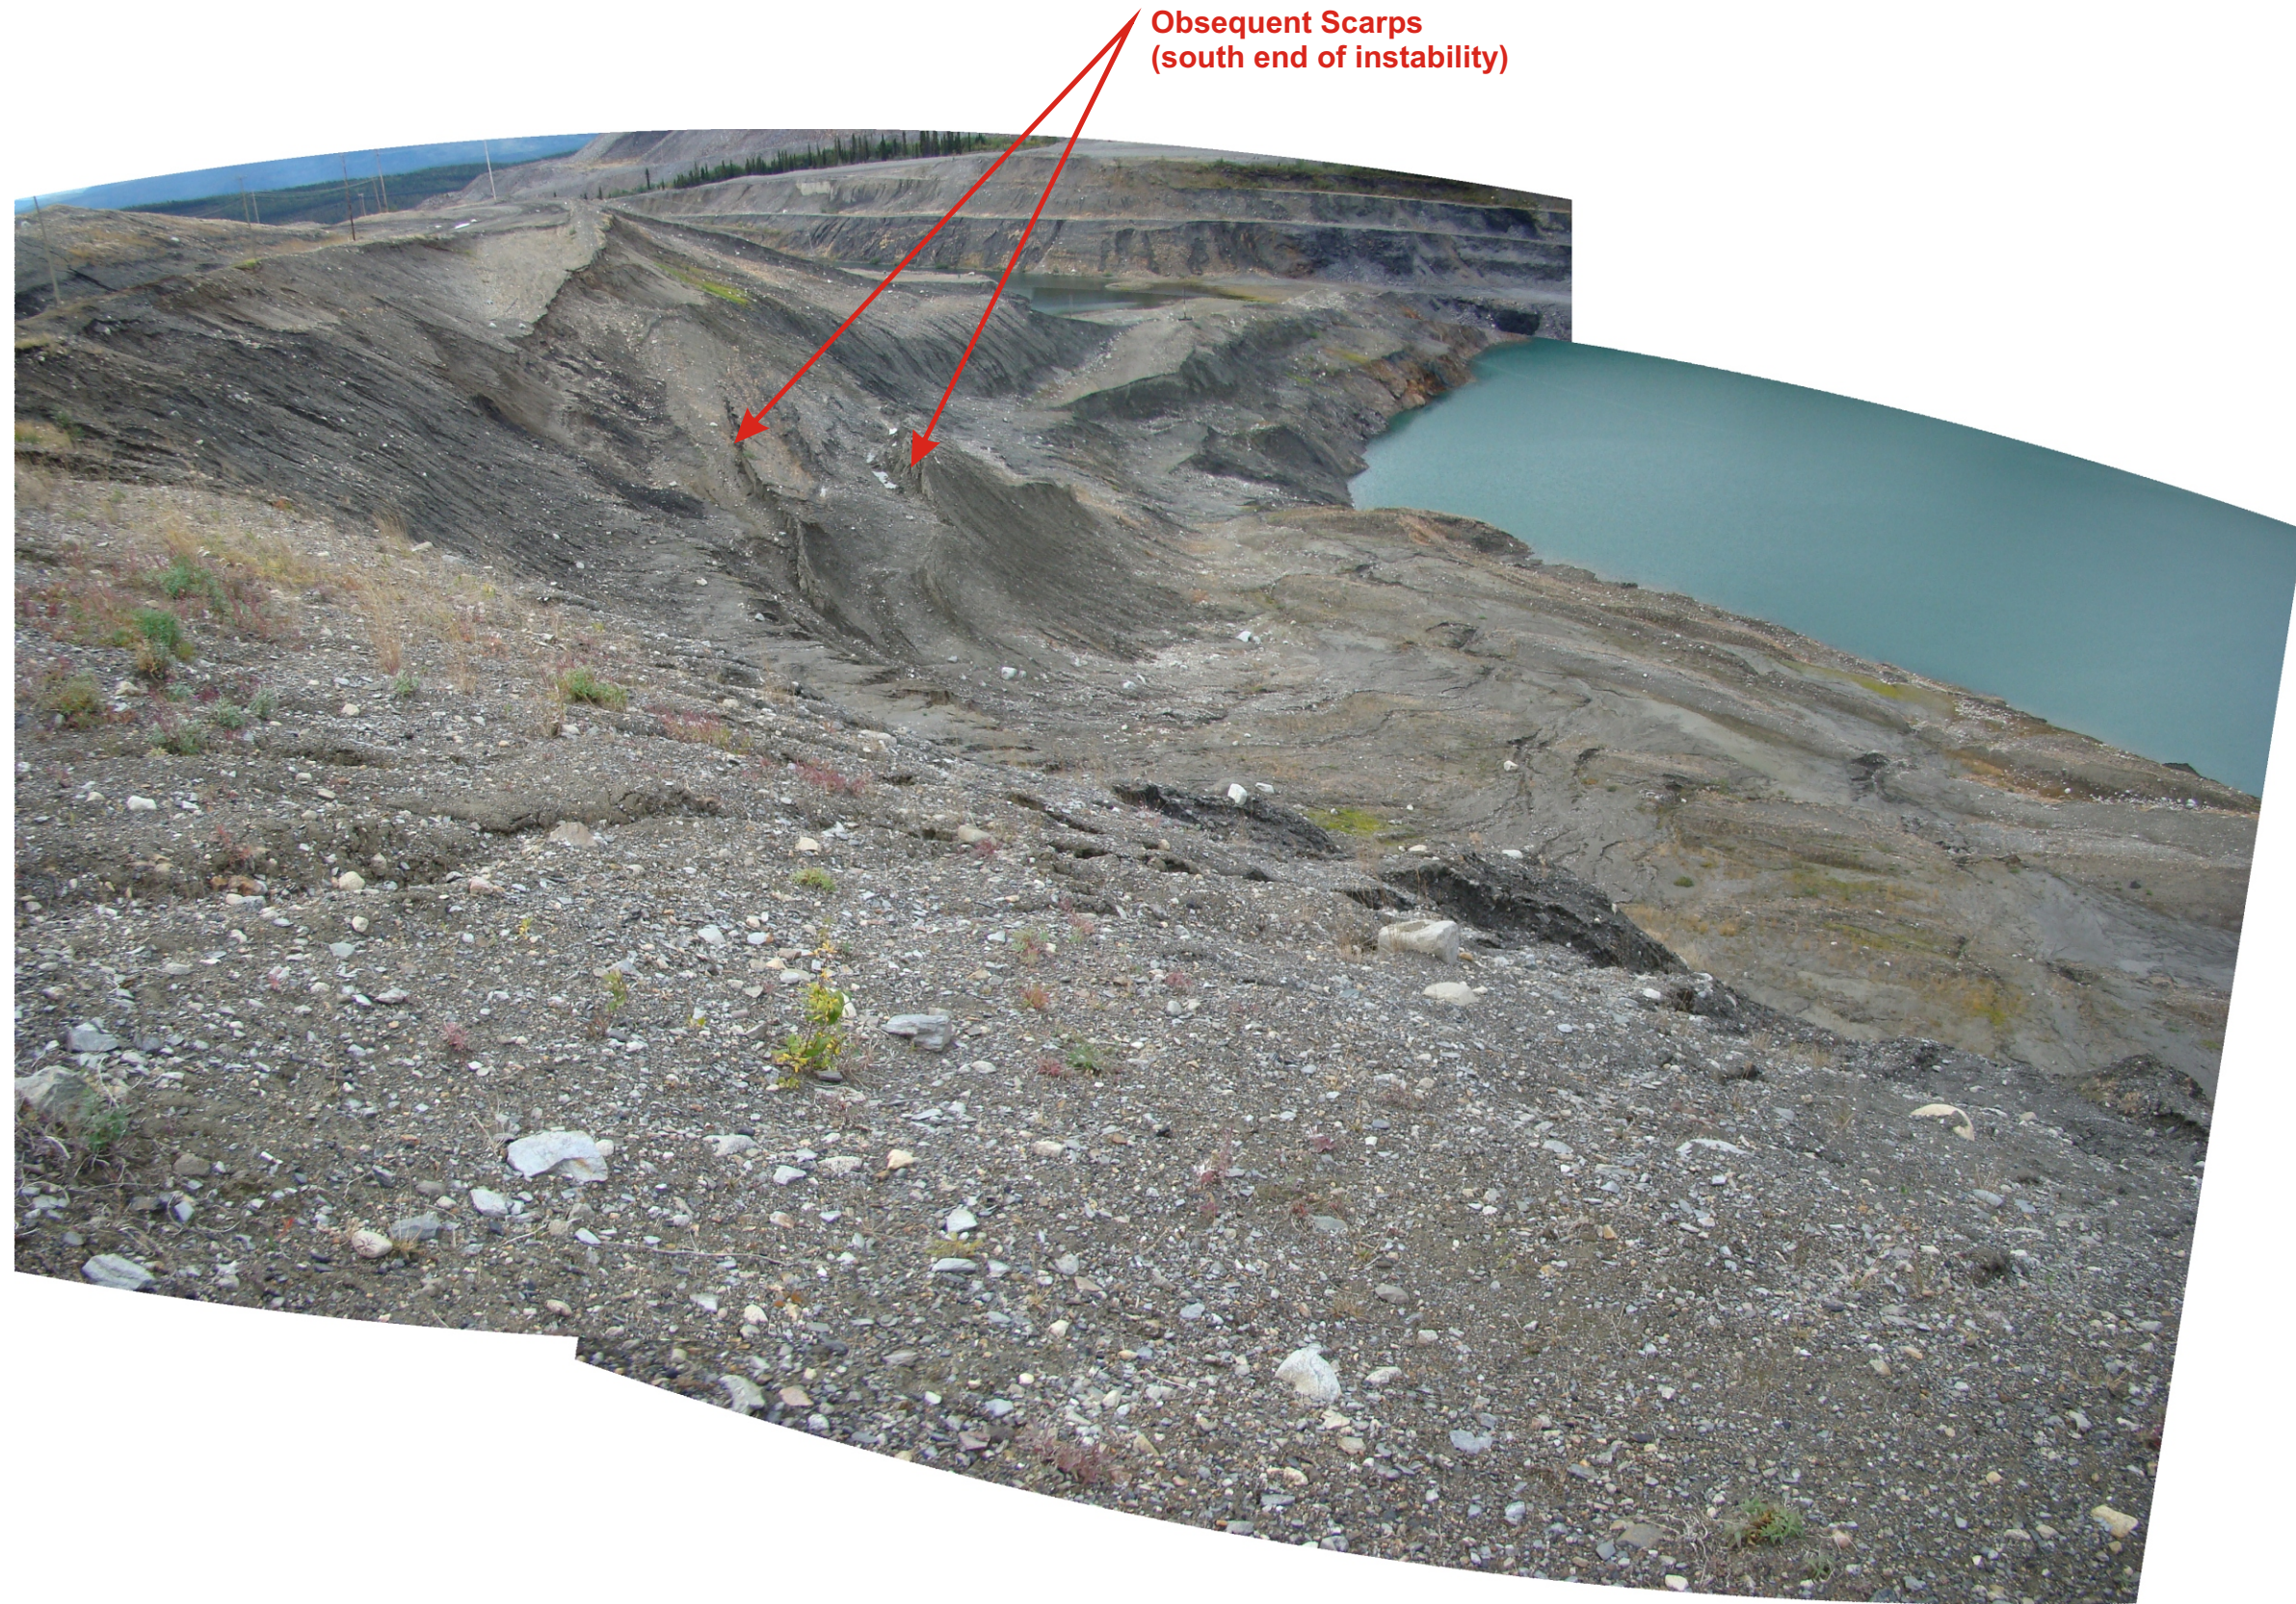
At the south end of the instability zone (Photographs I-9), cracks are visible along and below the edge of the upper ramp defining the current south limit of the slope instability area. The remnants of a previous back-scarp that was observed in 2005 is also observed at the south end, and the scarp is defined by a steep face immediately above the main failure mass on the lower portion of the wall (Photograph I-4 and I-10). This previous back-scarp at the south end of the instability zone is clearly visible on photographs taken in 2005, shown in Appendix II, and defined the south limit of the instability zone at that time. Consequently, the observation of the upper back-scarp indicates that the instability zone has migrated further south since those photographs were taken in 2005.

In the same area along the south end of the instability zone, a series of obsequent scarps and graben structures are observed below the current back-scarp and above remnants of a previous back-scarp (Photographs I-5 and I-9). These structures have developed as the slope instability progressed further south forming the obsequent ridges and graben features in between the two back-scarps.

Photograph 9 : East wall instability looking south (August, 2009).

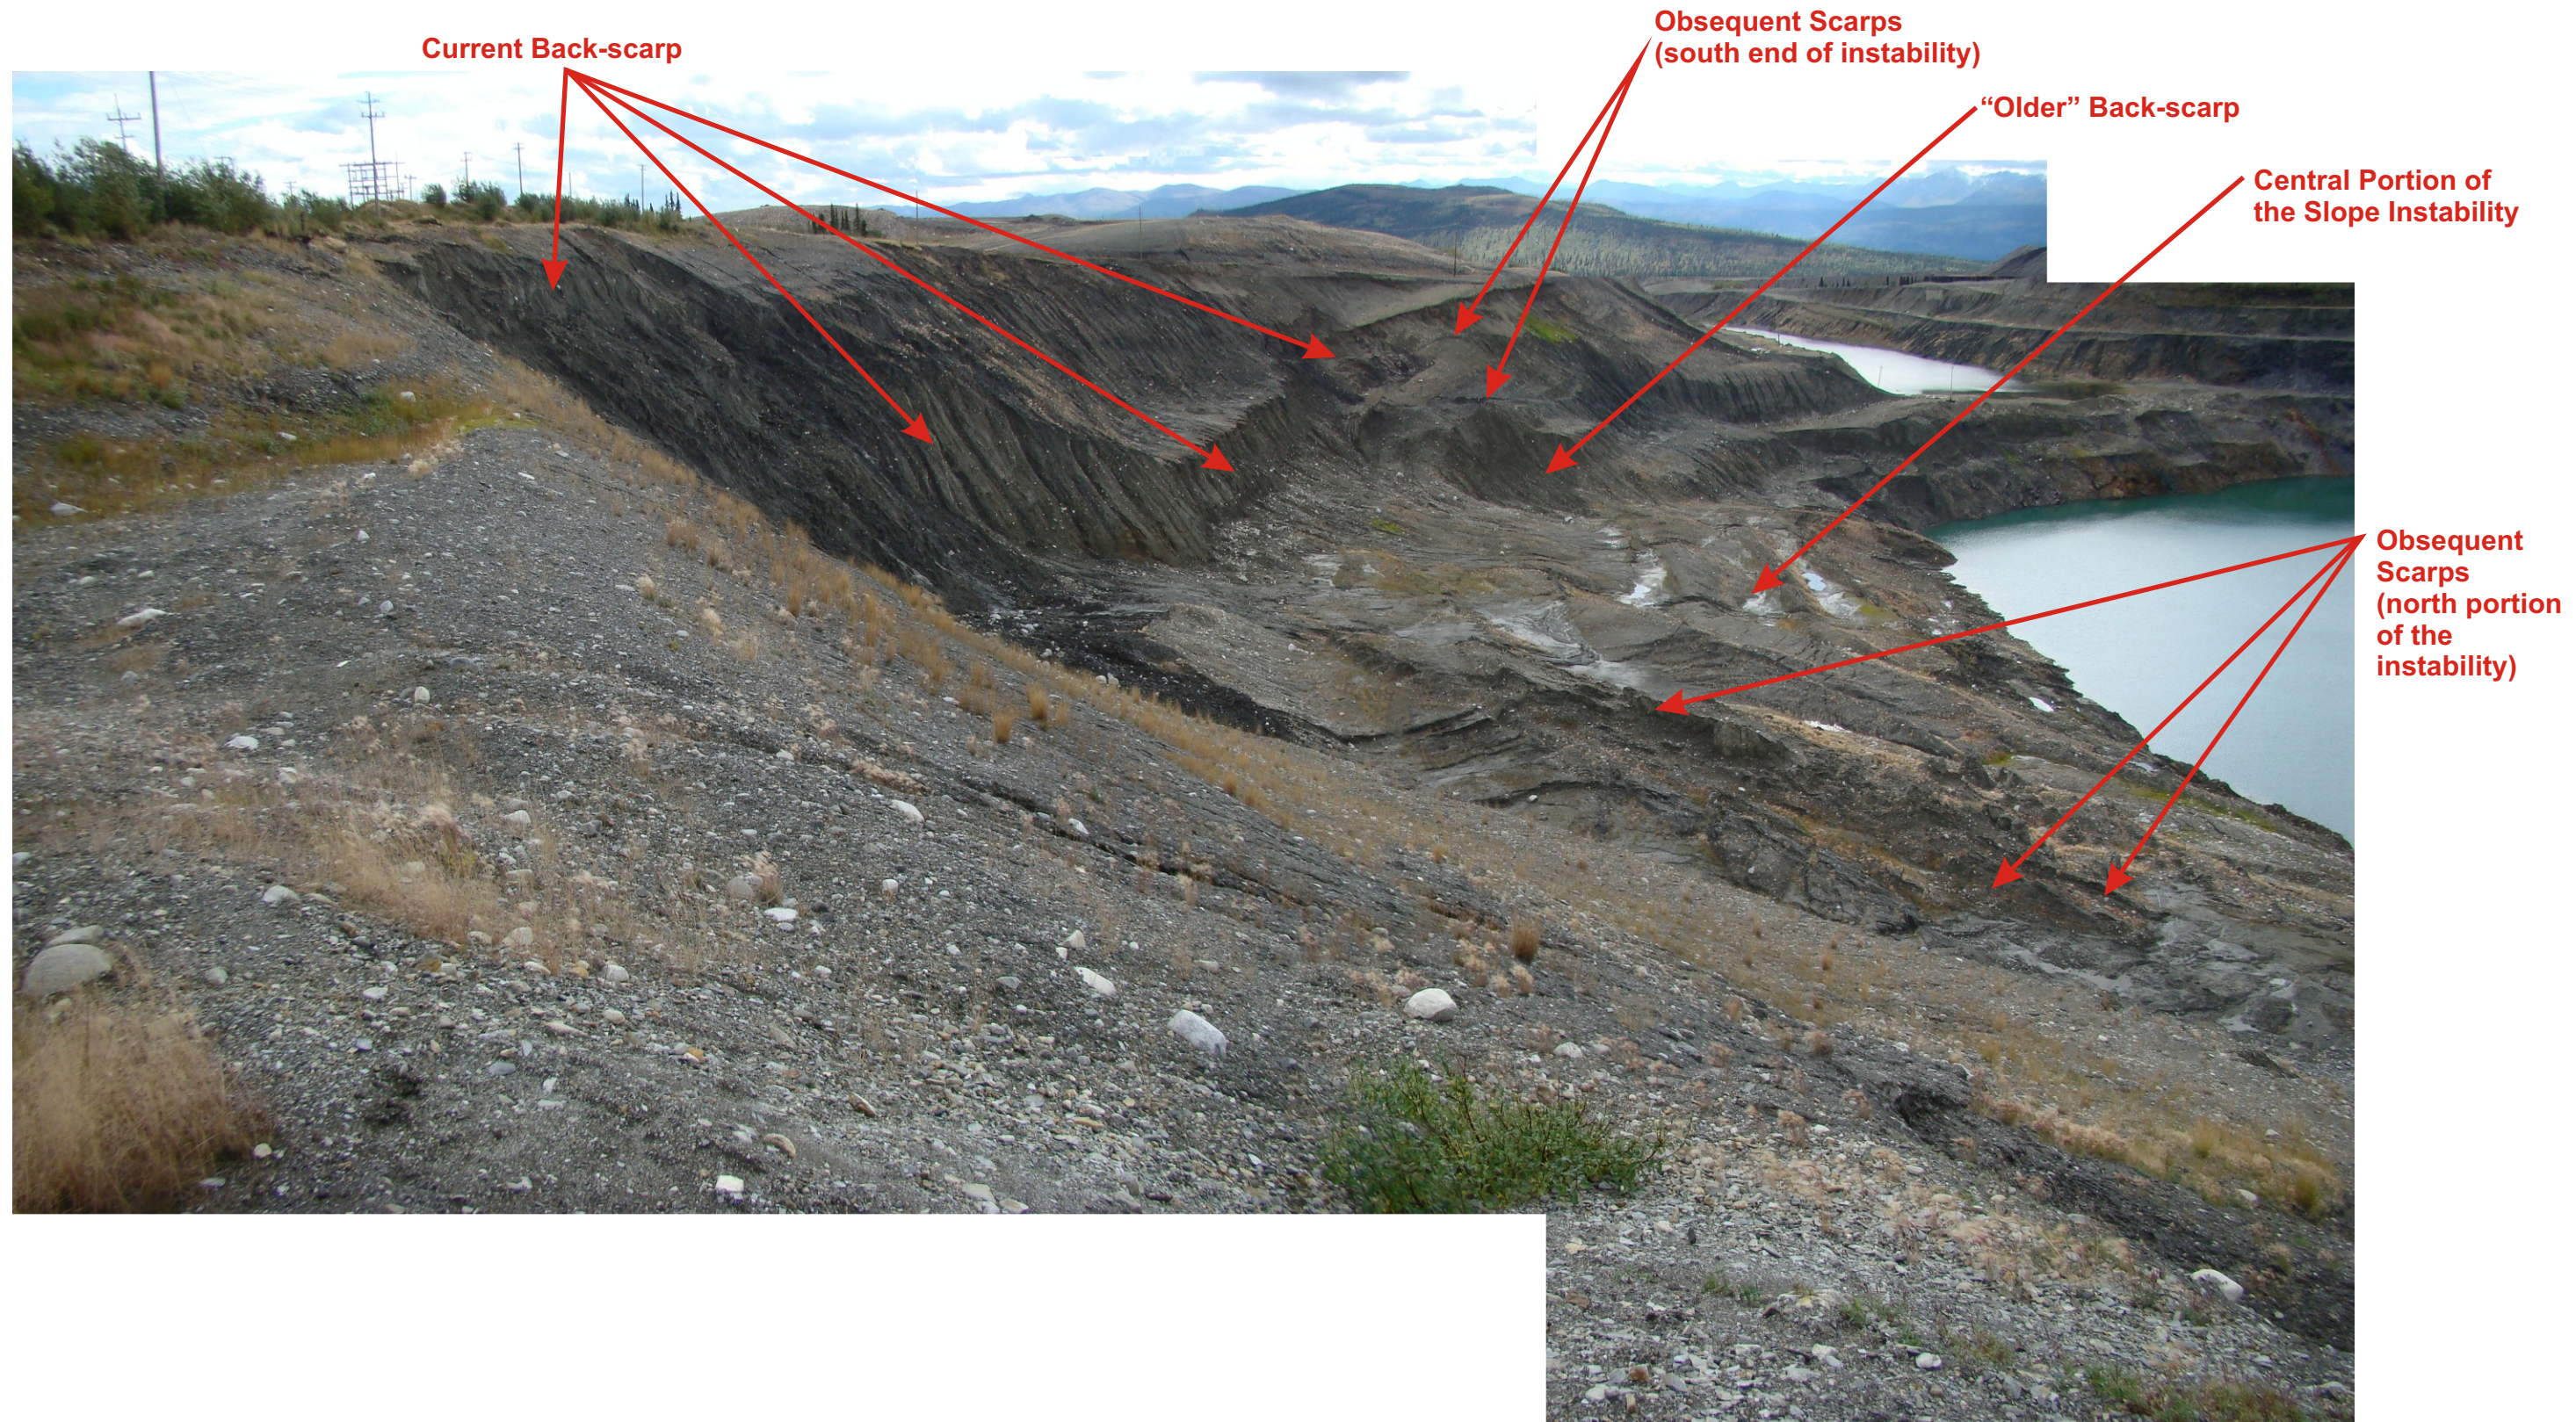
In the north-central portion of the failure zone, older obsequent ridges and graben features (Photographs I-7, I-10 and I-11) are also observed within the failed ground. These features probably represent previous stages of slope instability with regressive failure developing further east of the initial slope failure. These features in the north-central portion of the failure zone occur on higher ground than the main failure area in the central portion of the failure zone where rotational slide failure appears to have been dominant. In addition, the failure slope below the area where these features are observed has deformed to a steeper slope than observed in the most central part of the failure zone. This observation is also indicative that the failure materials accumulated in the lower slope in that area have been pushed by the subsequent failure of the upper slope. Therefore, it is possible that the slope instability was originally initiated in the central portion predominantly as a rotational slide where the maximum overburden thickness was exposed by the excavation of the pit wall. Subsequently, the initial slope failure progressed with regressive failures expanding the initial limits of the instability zone to south and north possibly into areas of shallower bedrock, as well as extending to the east and to the upper portion of the east wall.

Photograph 10 : Crest of east wall looking south (August, 2009).

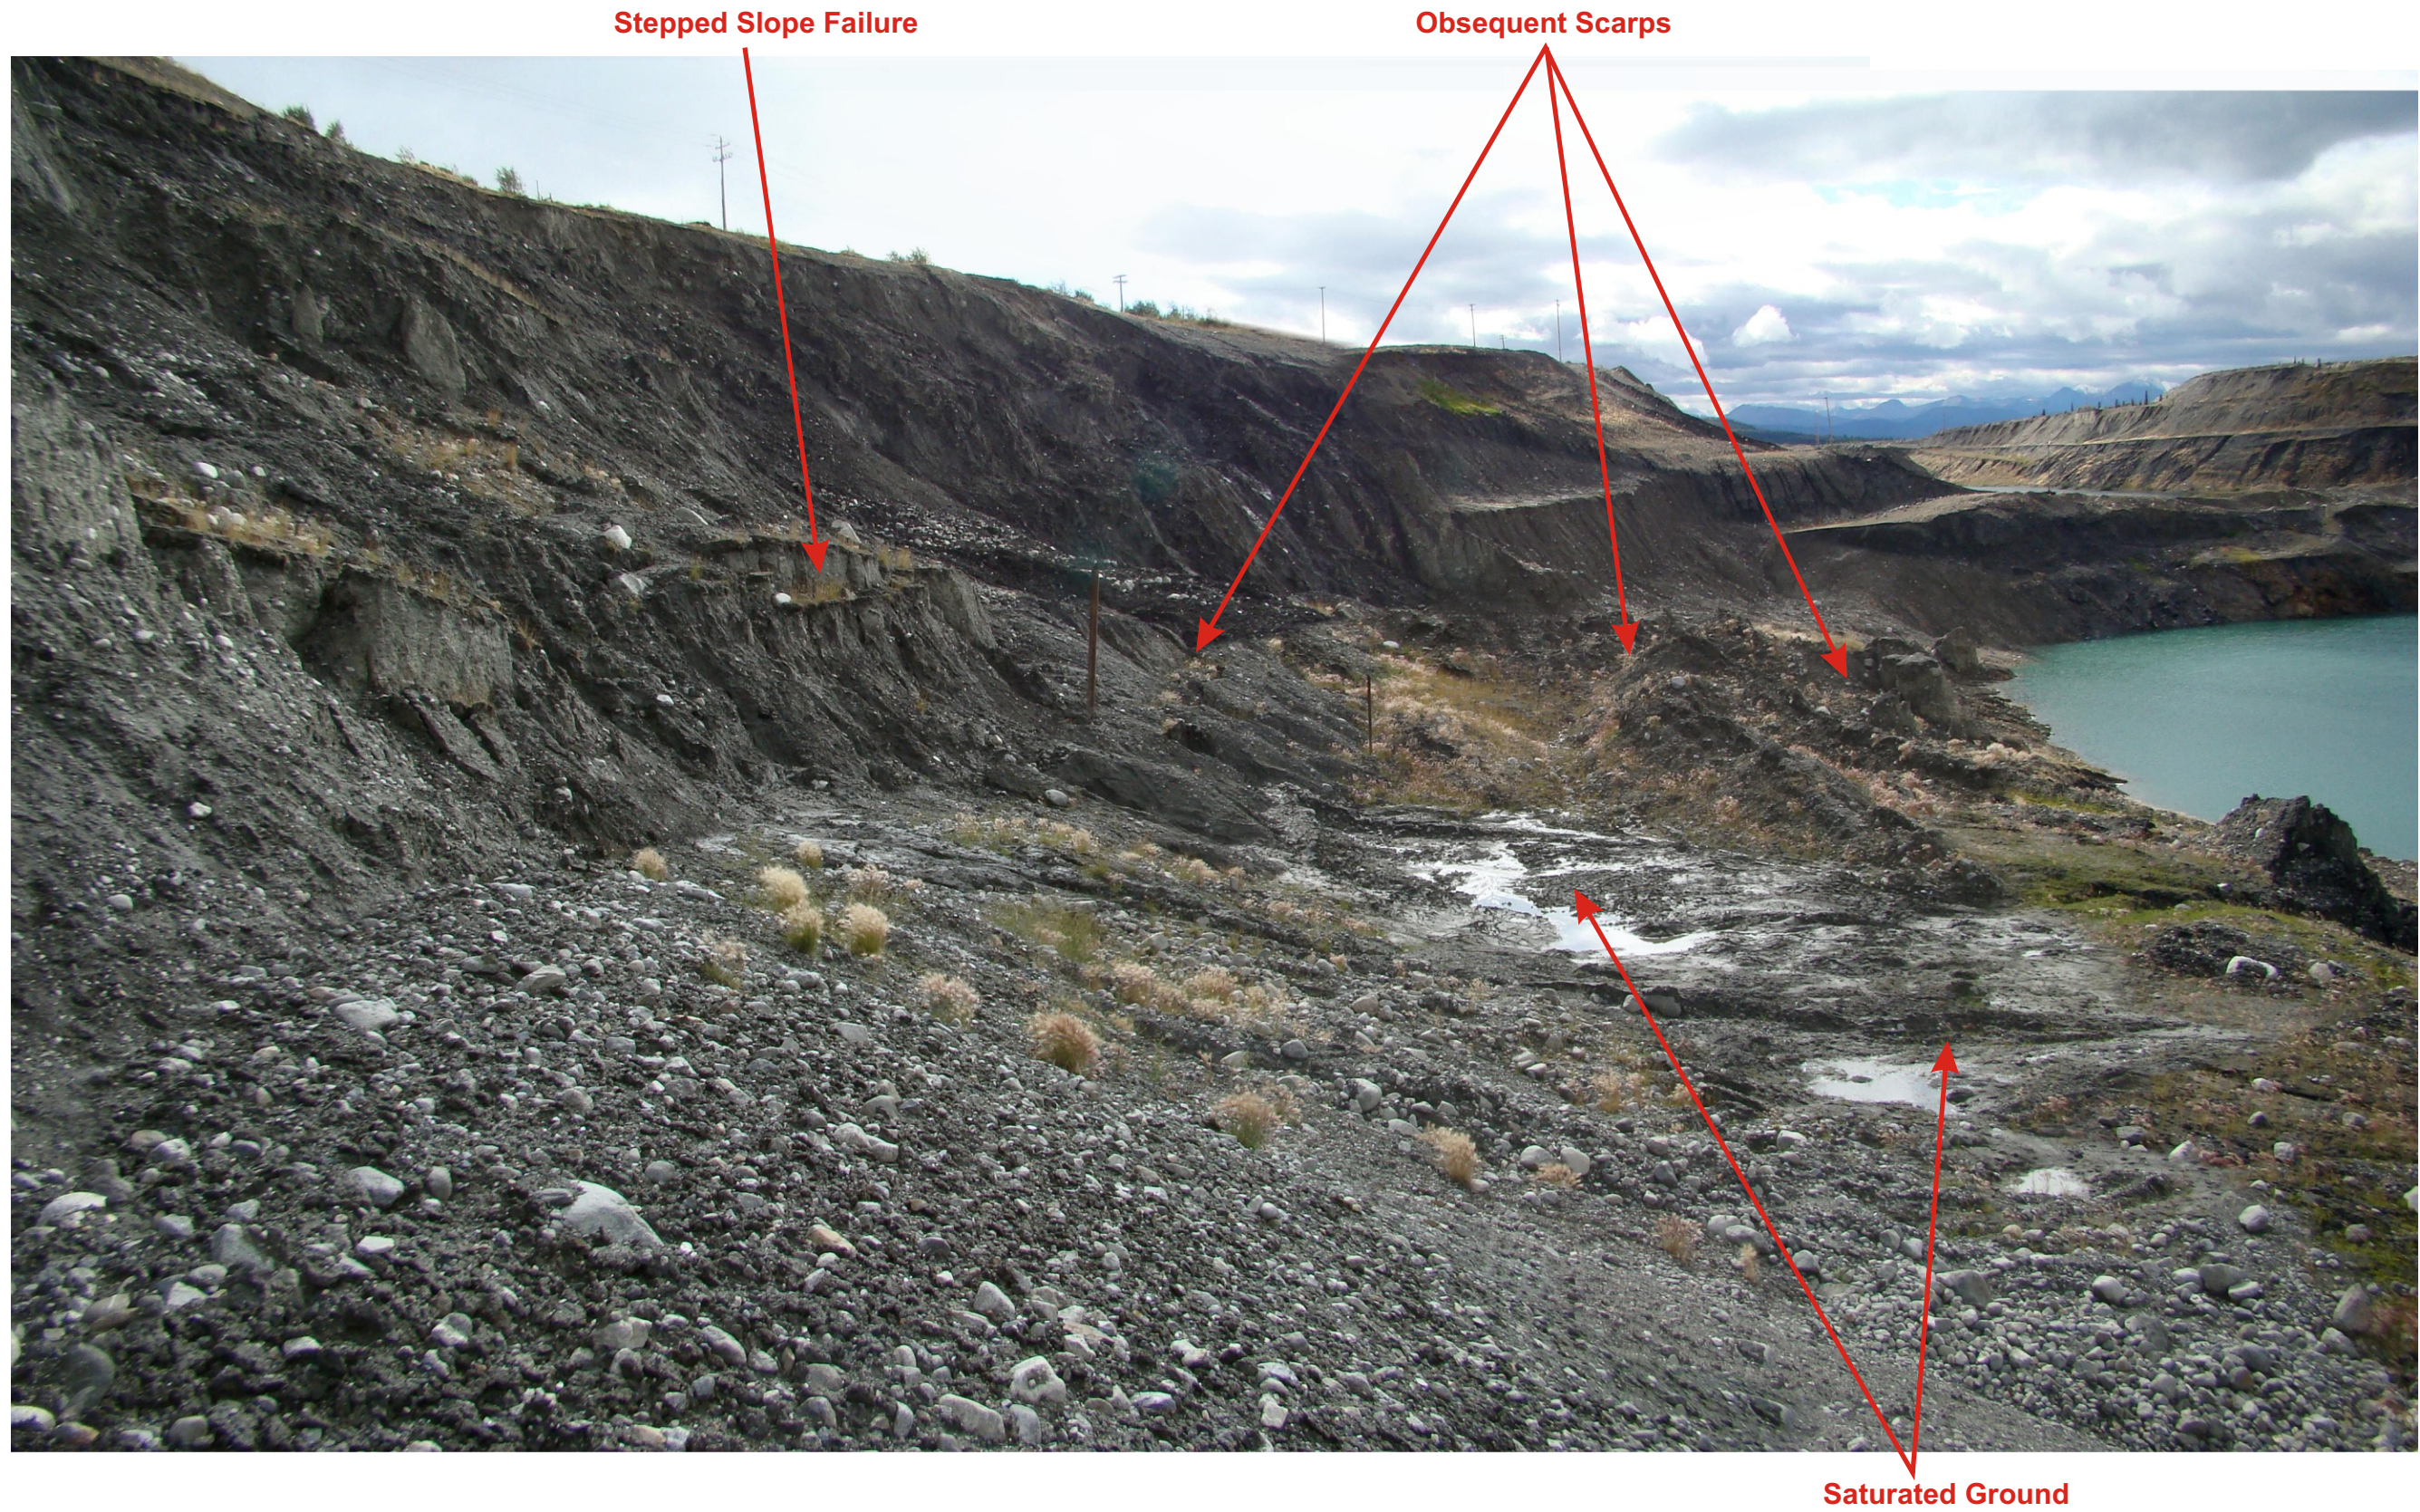
Photograph 11 : East wall instability looking south (August, 2009).

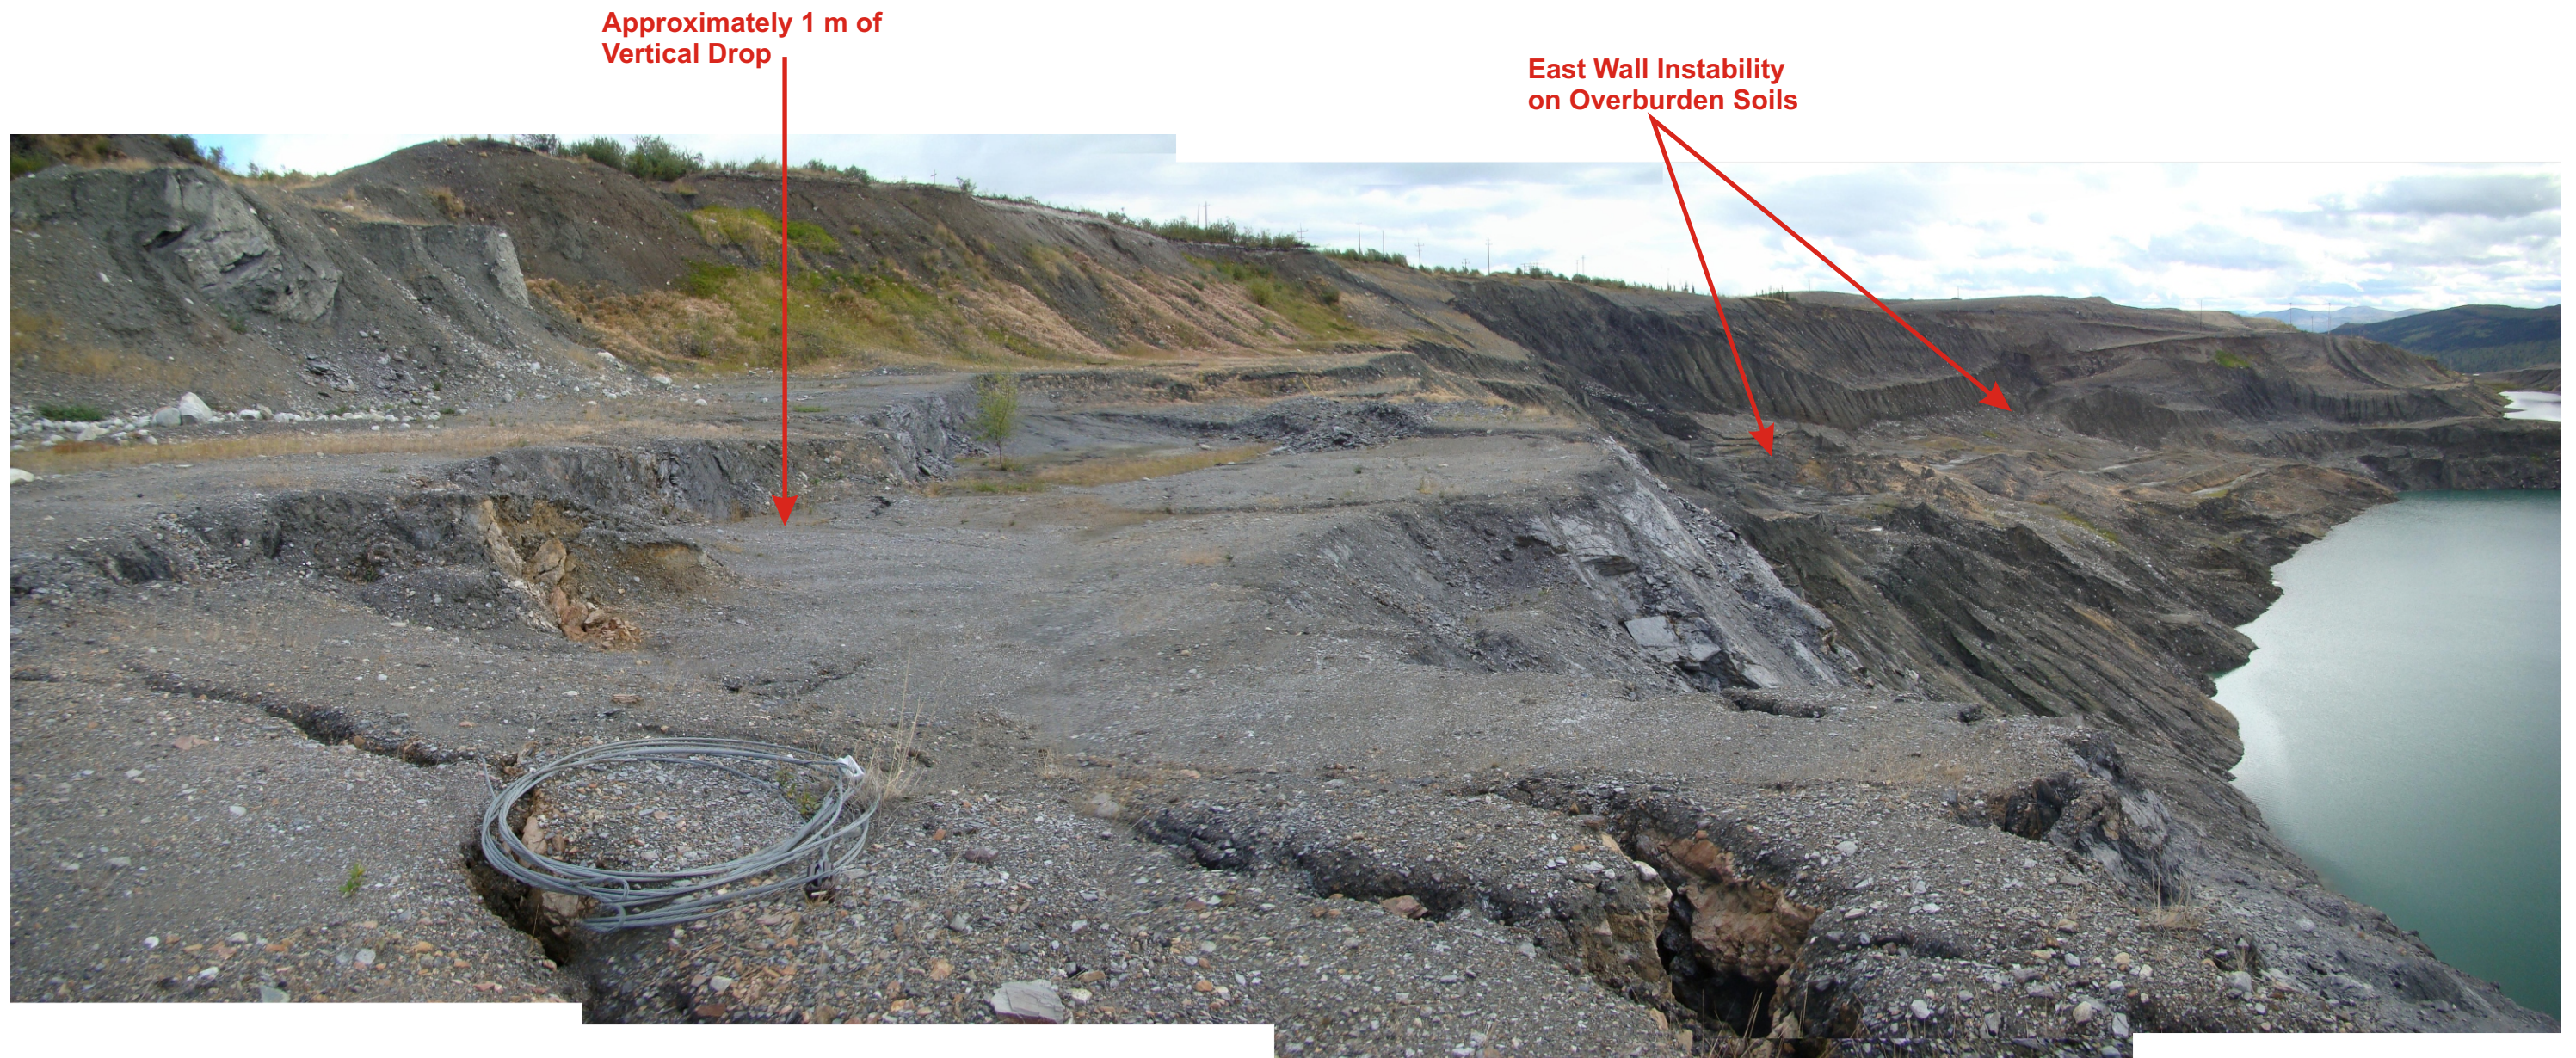
On the north portion of the east wall, just to the north of the overburden failure zone, the rock slopes also exhibit signs of instability (Photographs I-6 and I-12). The bench rock slopes exhibit poor stability performance with loss of catch-benches due to sliding on the pervasive westerly dipping rock fabric. Multi-bench rock slope instability has also developed on gray phyllites that occur adjacent to the main instability zone on the overburden soils. The bench slopes excavated on the gray phyllites have failed with settlement and loss of the catch-benches. Continuous cracks are observed behind the crest of the upper bench on phyllites with approximately 1 meter vertical drop (Photograph I-12). Structural orientation mapping data collected during the site inspection is presented on the stereonet of Figure 10. This limited orientation data set was obtained by mapping of a few rock exposures along the north end of the east wall. The pervasive westerly dipping foliation, *i.e.*, schistosity or fissility, represents the dominant geological discontinuity that is characteristic of the rock masses exposed along the east wall.

Photograph 12 : Instability on rock slopes in the north portion of the east wall (August, 2009).

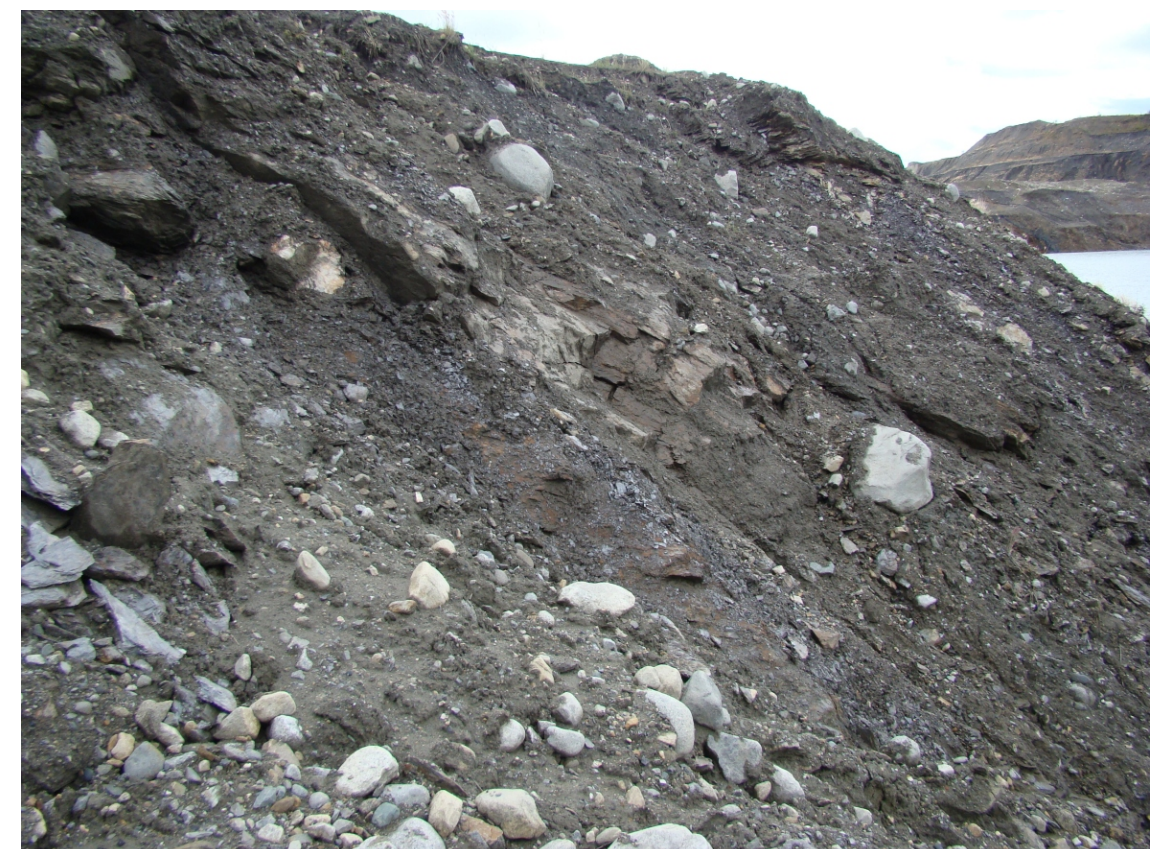
At the north end of the overburden instability zone, above the in-pit lake, bedrock is exposed along an erosion gully where the failed soils from the upper wall have been partially eroded (Photograph I-16). The exposed schist/phyllites exhibit a pervasive foliation that dips at 30 to 40 degrees to the west (245° dip-direction). Overall, these rocks exhibit signs of relaxation with open fractures developed mostly along the dominant schistosity and joints. However, it is not evident if failure of the bedrock has had a significant role in the overall instability mechanism of the soil slopes, or if limited deformation of the bedrock along the lower wall occurred as a result of been pushed by the failure of the overburden soils.

Photograph 16 : Rock exposed on the lower wall at the north limit of instability.
