March 23, 2010

Phase 1A Geotechnical Slope Stability Assessment of the East Wall of the Grum Pit, Faro Mine, Yukon

Project Number: 09-1426-0021

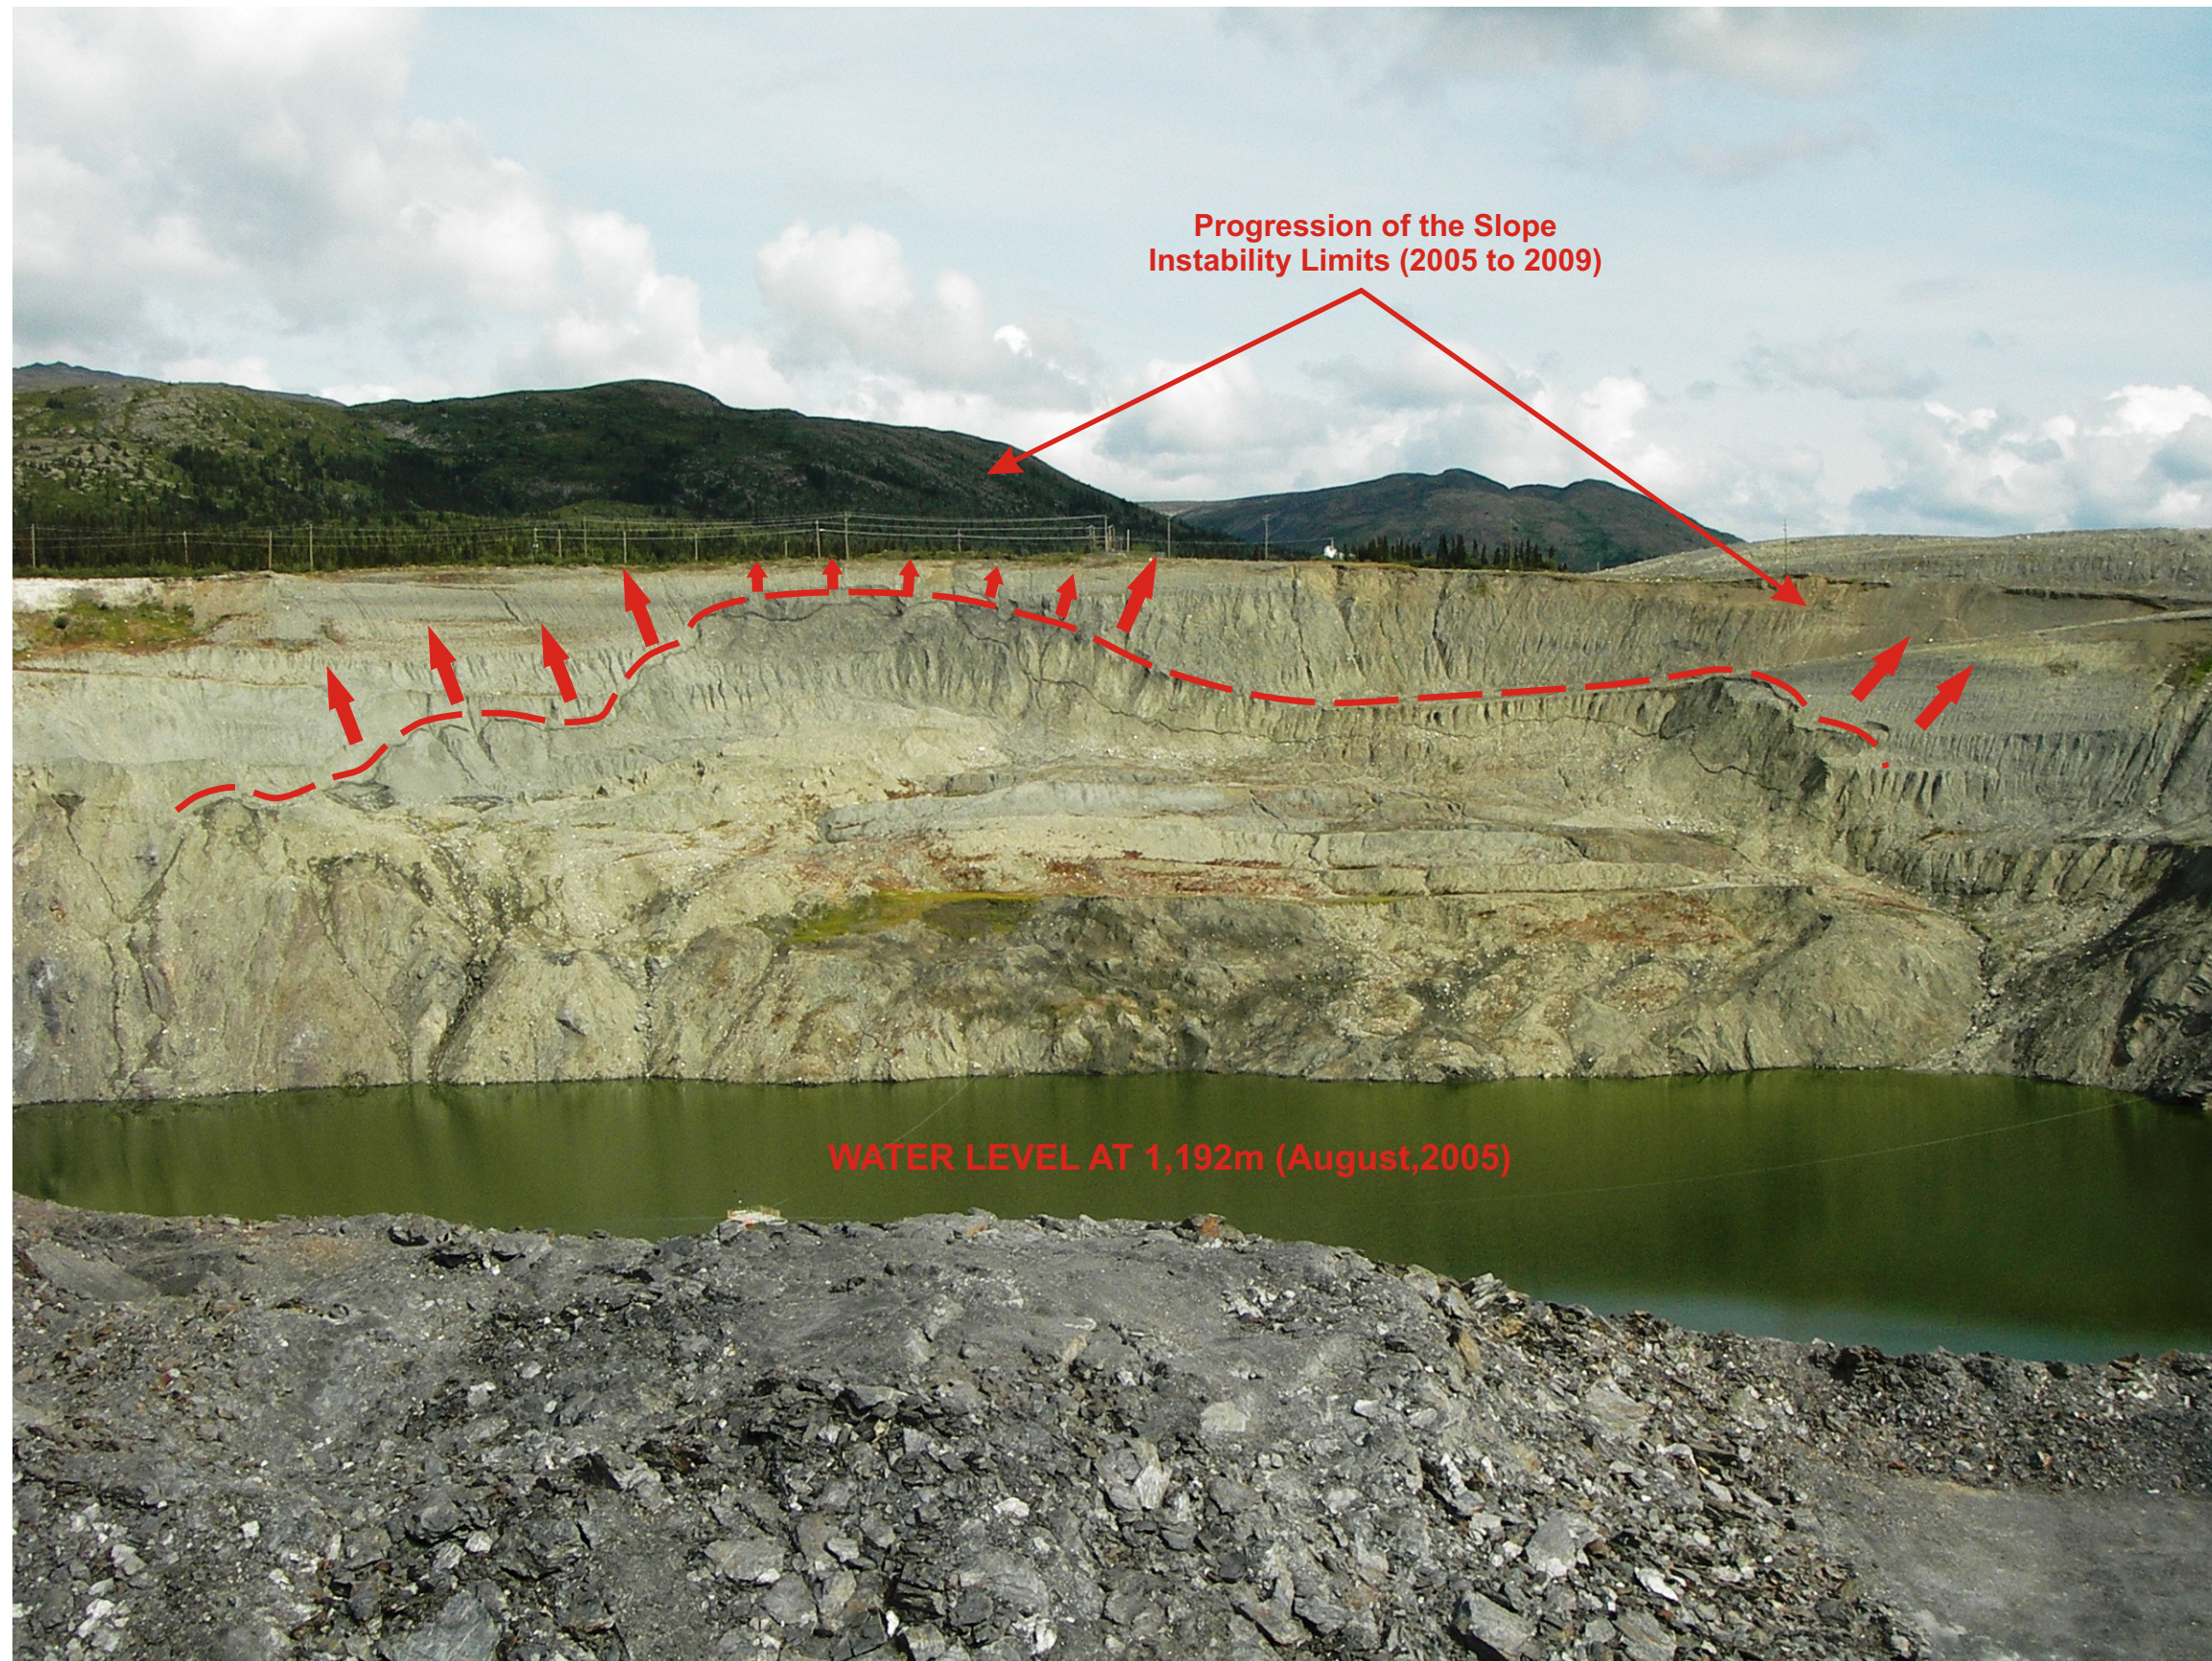
- The photographs taken in 2005 show that the slope failure had not yet fully extended to the crest of the pit wall (Photographs II-1 and II-5). However, since 2005 the failure zone has expanded further to the upper wall and has reached the crest of the east wall (Photographs II-2 and II-6). Apparently, regressive slope failures have affected the back-scarp since 2005.

- The instability zone has expanded north beyond the boundaries observed in 2005 (Photographs II-1 and II-5). Since 2005, the slope instability has advanced into the upper benches in overburden soils on the north side of the east wall (Photographs II-2 and II-6).

- The instability zone has also expanded south beyond the boundaries observed in 2005 (Photographs II-1, II-3 and II-7). Since 2005, the slope instability has advanced into the overburden soil slopes at the south end of the east wall (Photographs II-2, II-4 and II-8). The 2005 photograph clearly shows the instability zone bounded by the back-scarp located along the lower portion of the slope, while the recent inspection indicate that the instability has progressed further to the south. The recent photographs show the current limits of the instability zone to be defined by a more recent failure scarp that is located above the back-scarp observed in 2005. In addition, obsequent scarps and graben features have developed in the area between the 2005 and 2009 failure scarps.

Photograph 1 : East wall instability (2005).

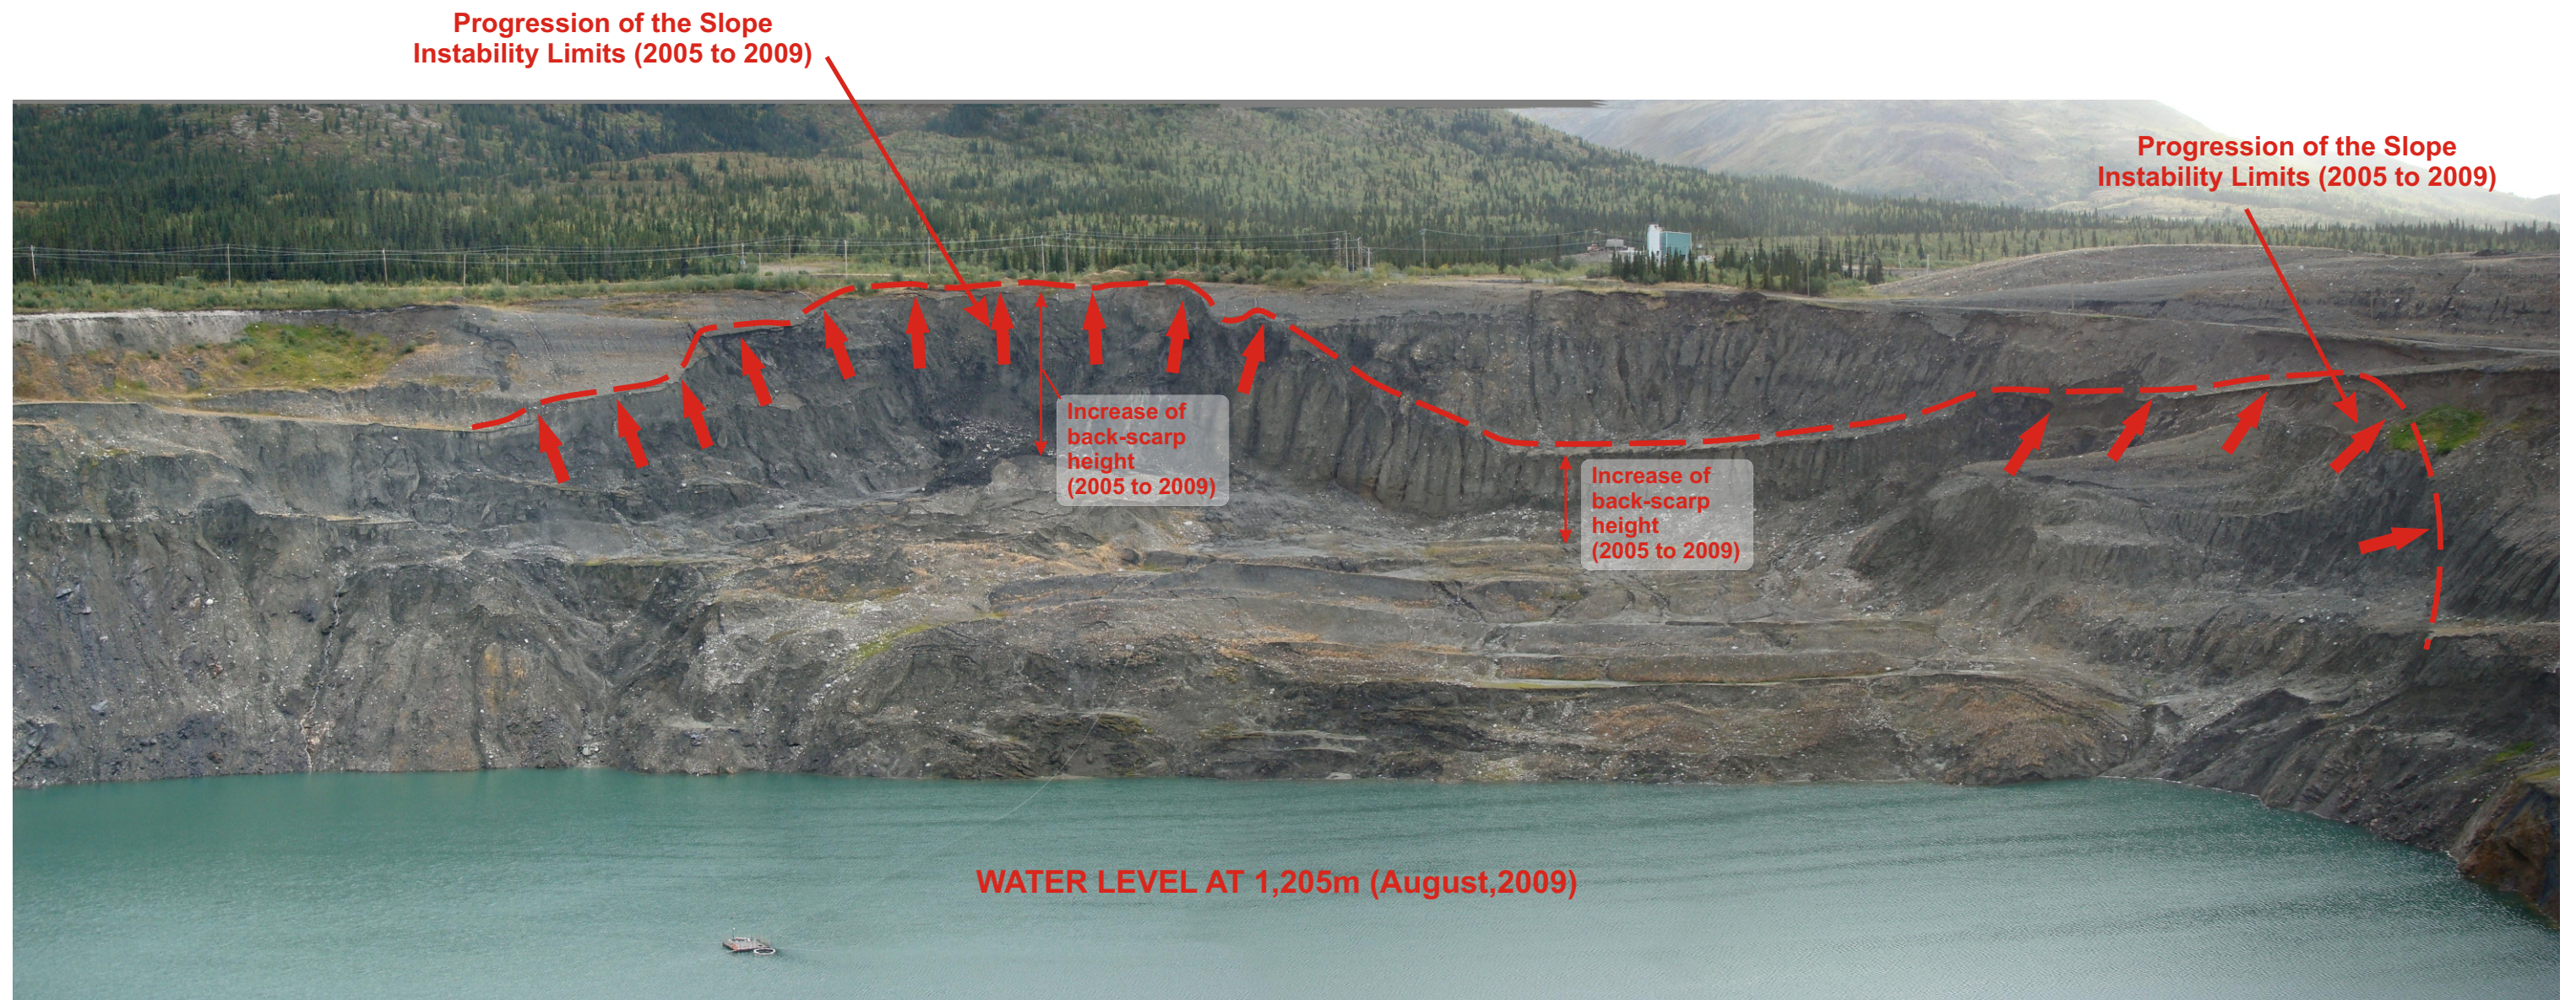
Photograph 2 : East wall instability (2009).

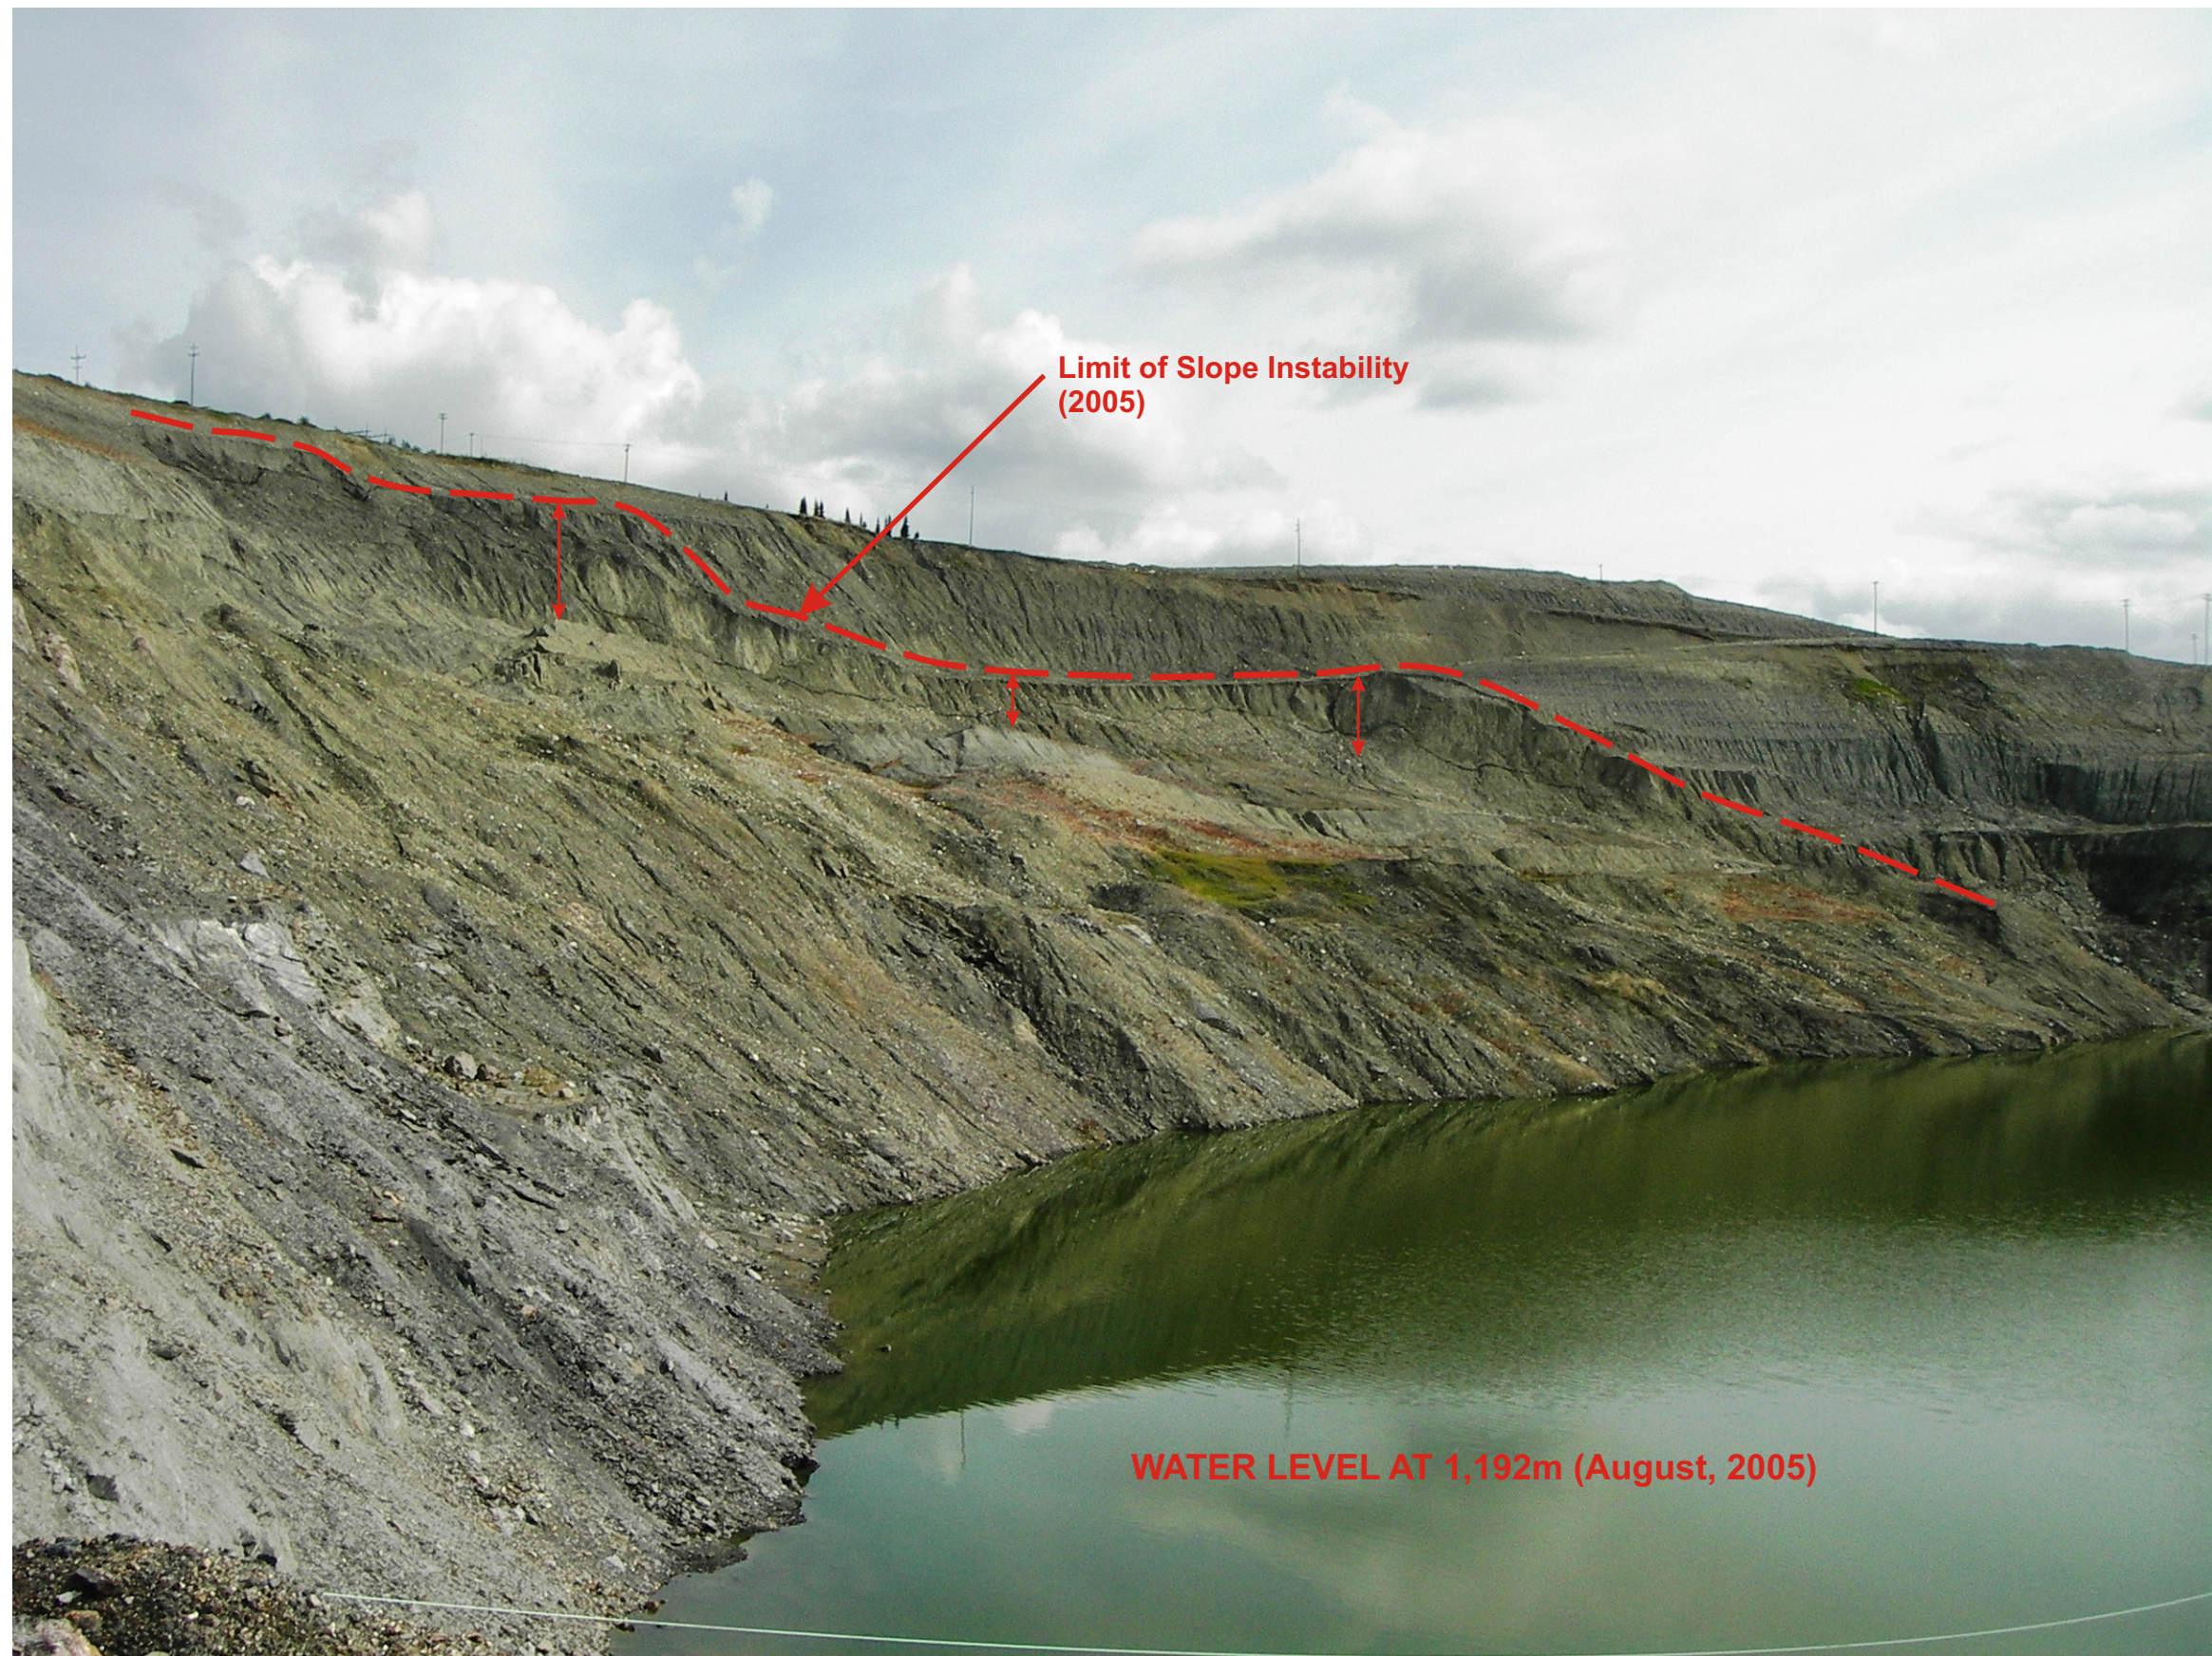
- Finally, the comparison of the 2005 (Photograph II-3) and recent photographs (Photograph II-4) also indicates that large displacement has occurred within the failure mass, with significant increase of the height of the back-scarp.

Photograph 3 : East wall instability looking south (2005).

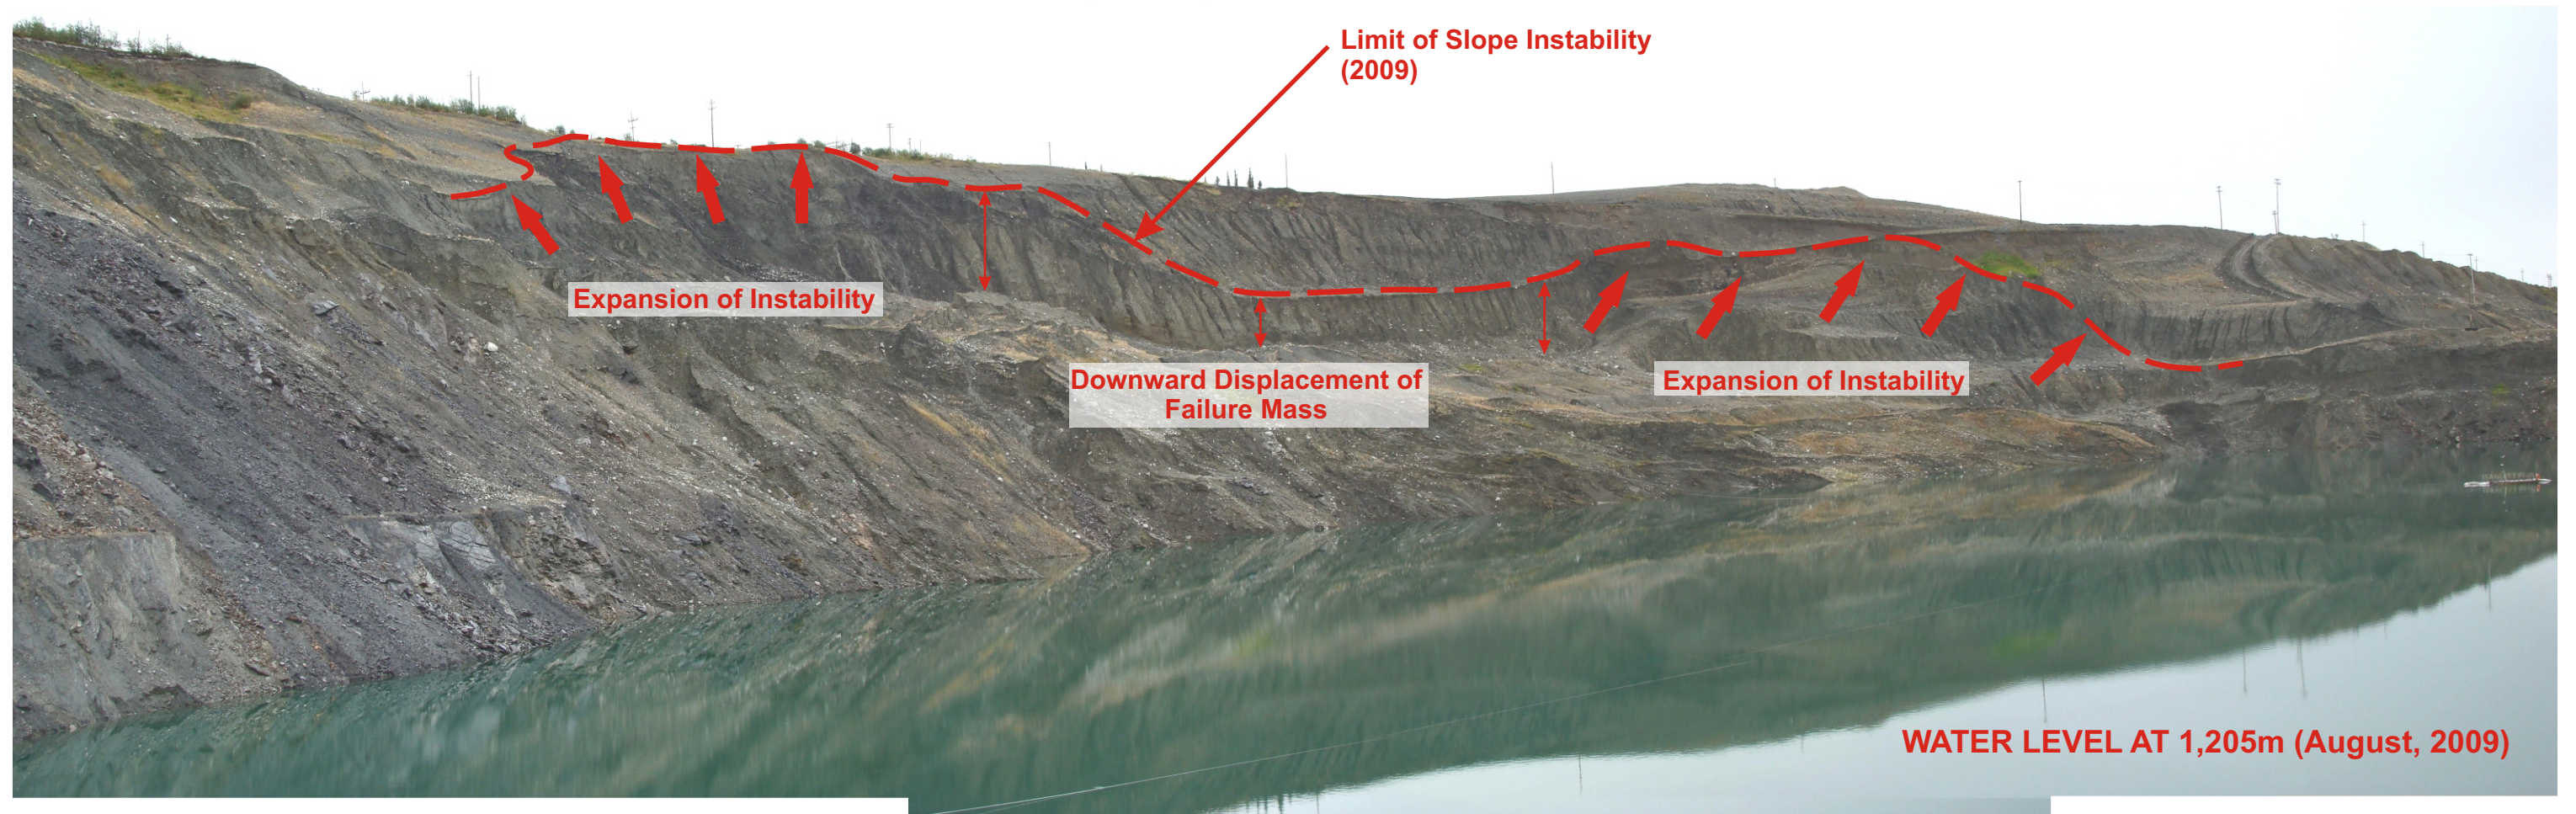
Photograph 4 : East wall instability looking south (2009).

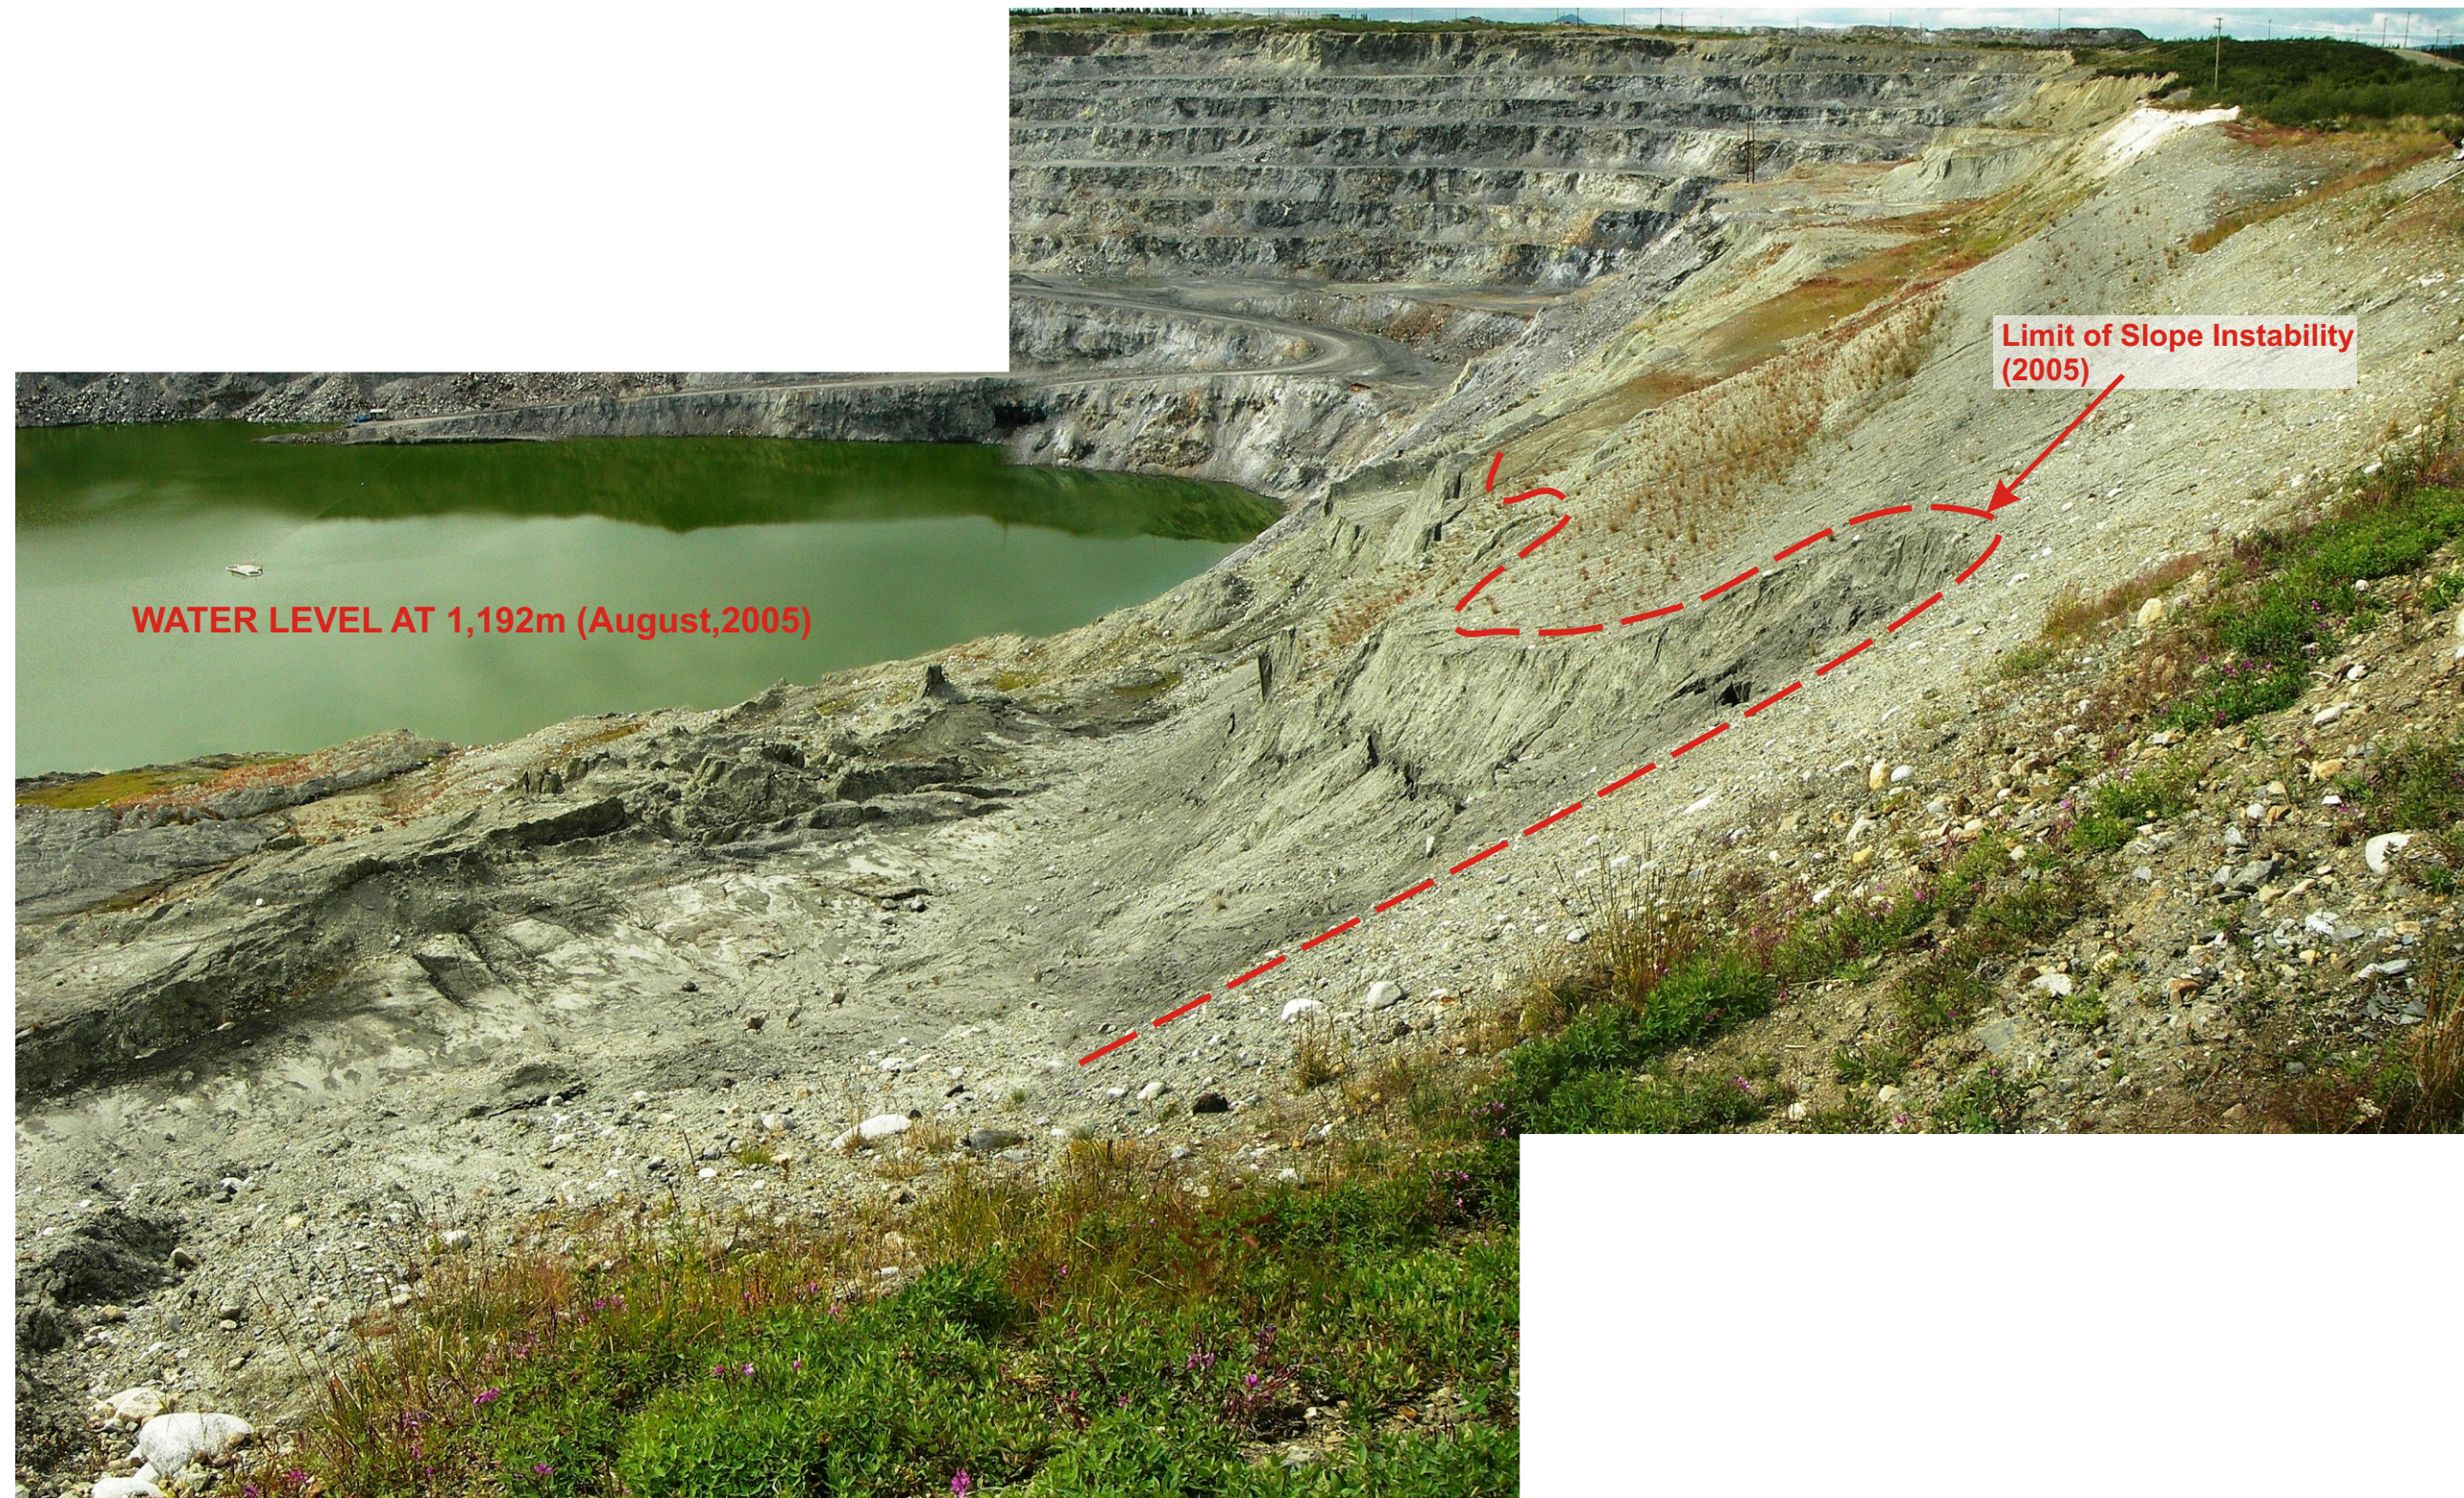
Photograph 5 : East wall instability. Crest of the pit wall looking north (2005).

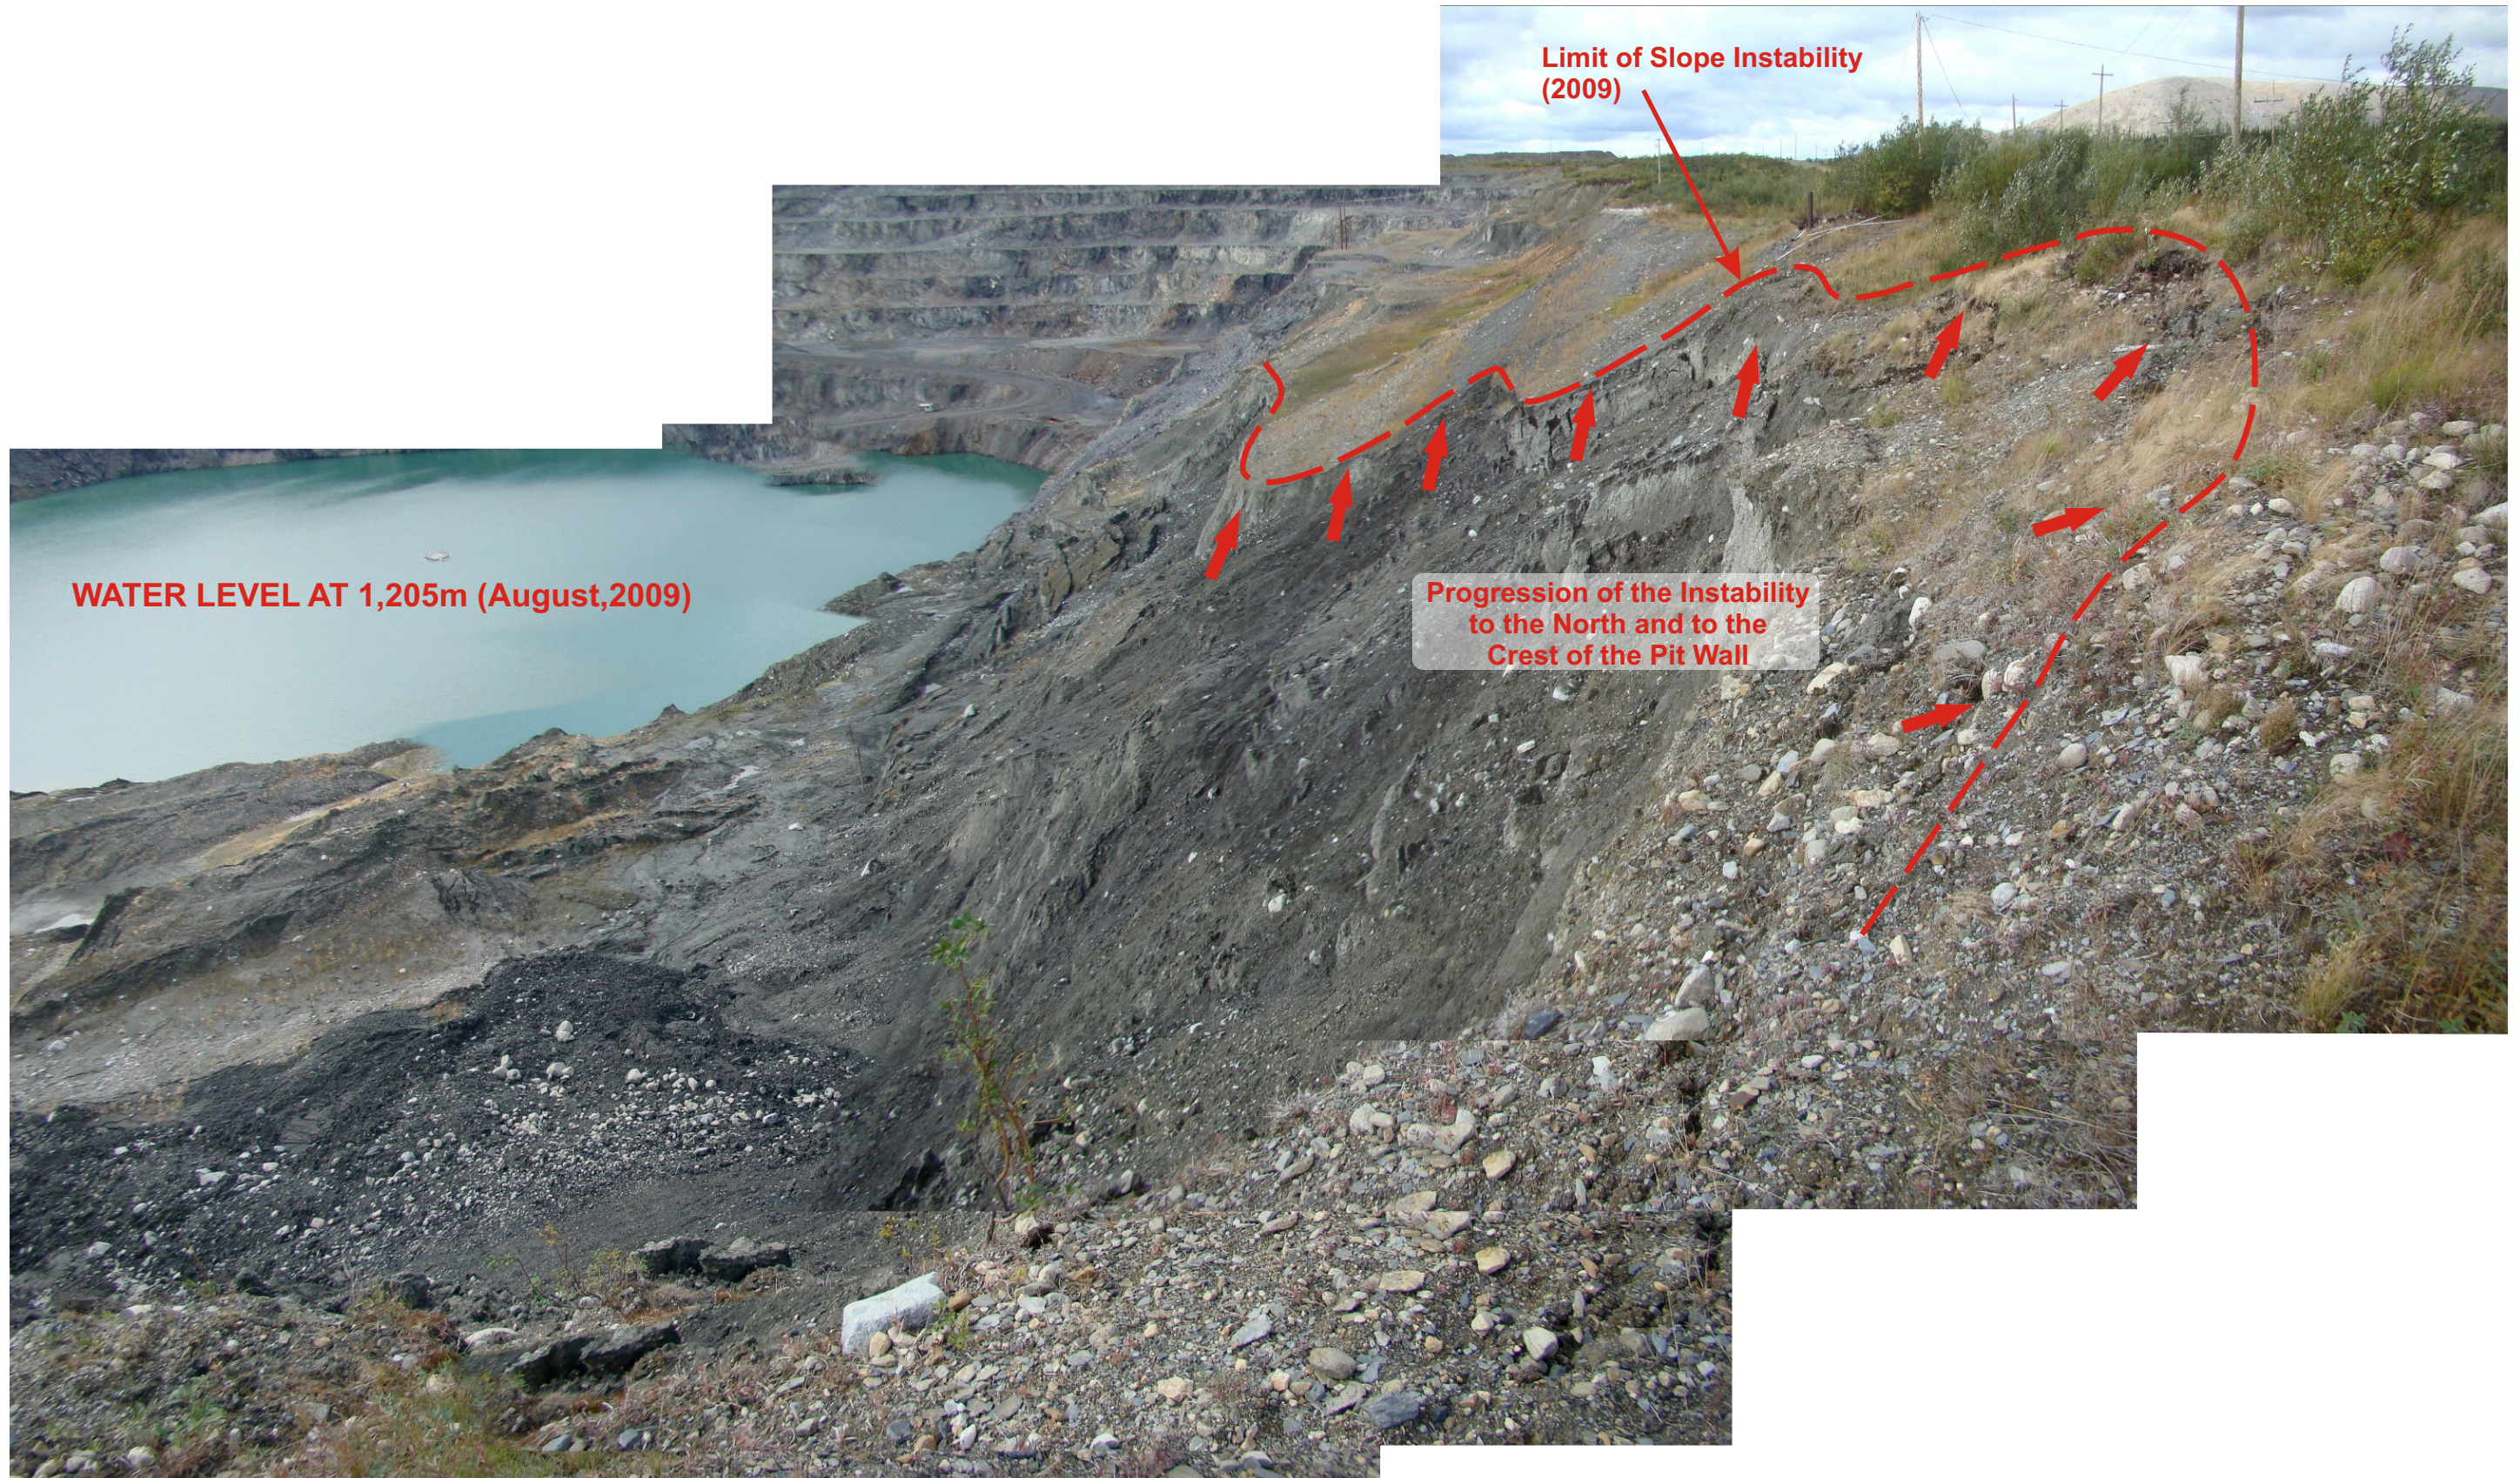
Photograph 6 : East wall instability. Crest of the pit wall looking north (2009).
