March 23, 2010

Phase 1A Geotechnical Slope Stability Assessment of the East Wall of the Grum Pit, Faro Mine, Yukon

Project Number: 09-1426-0021

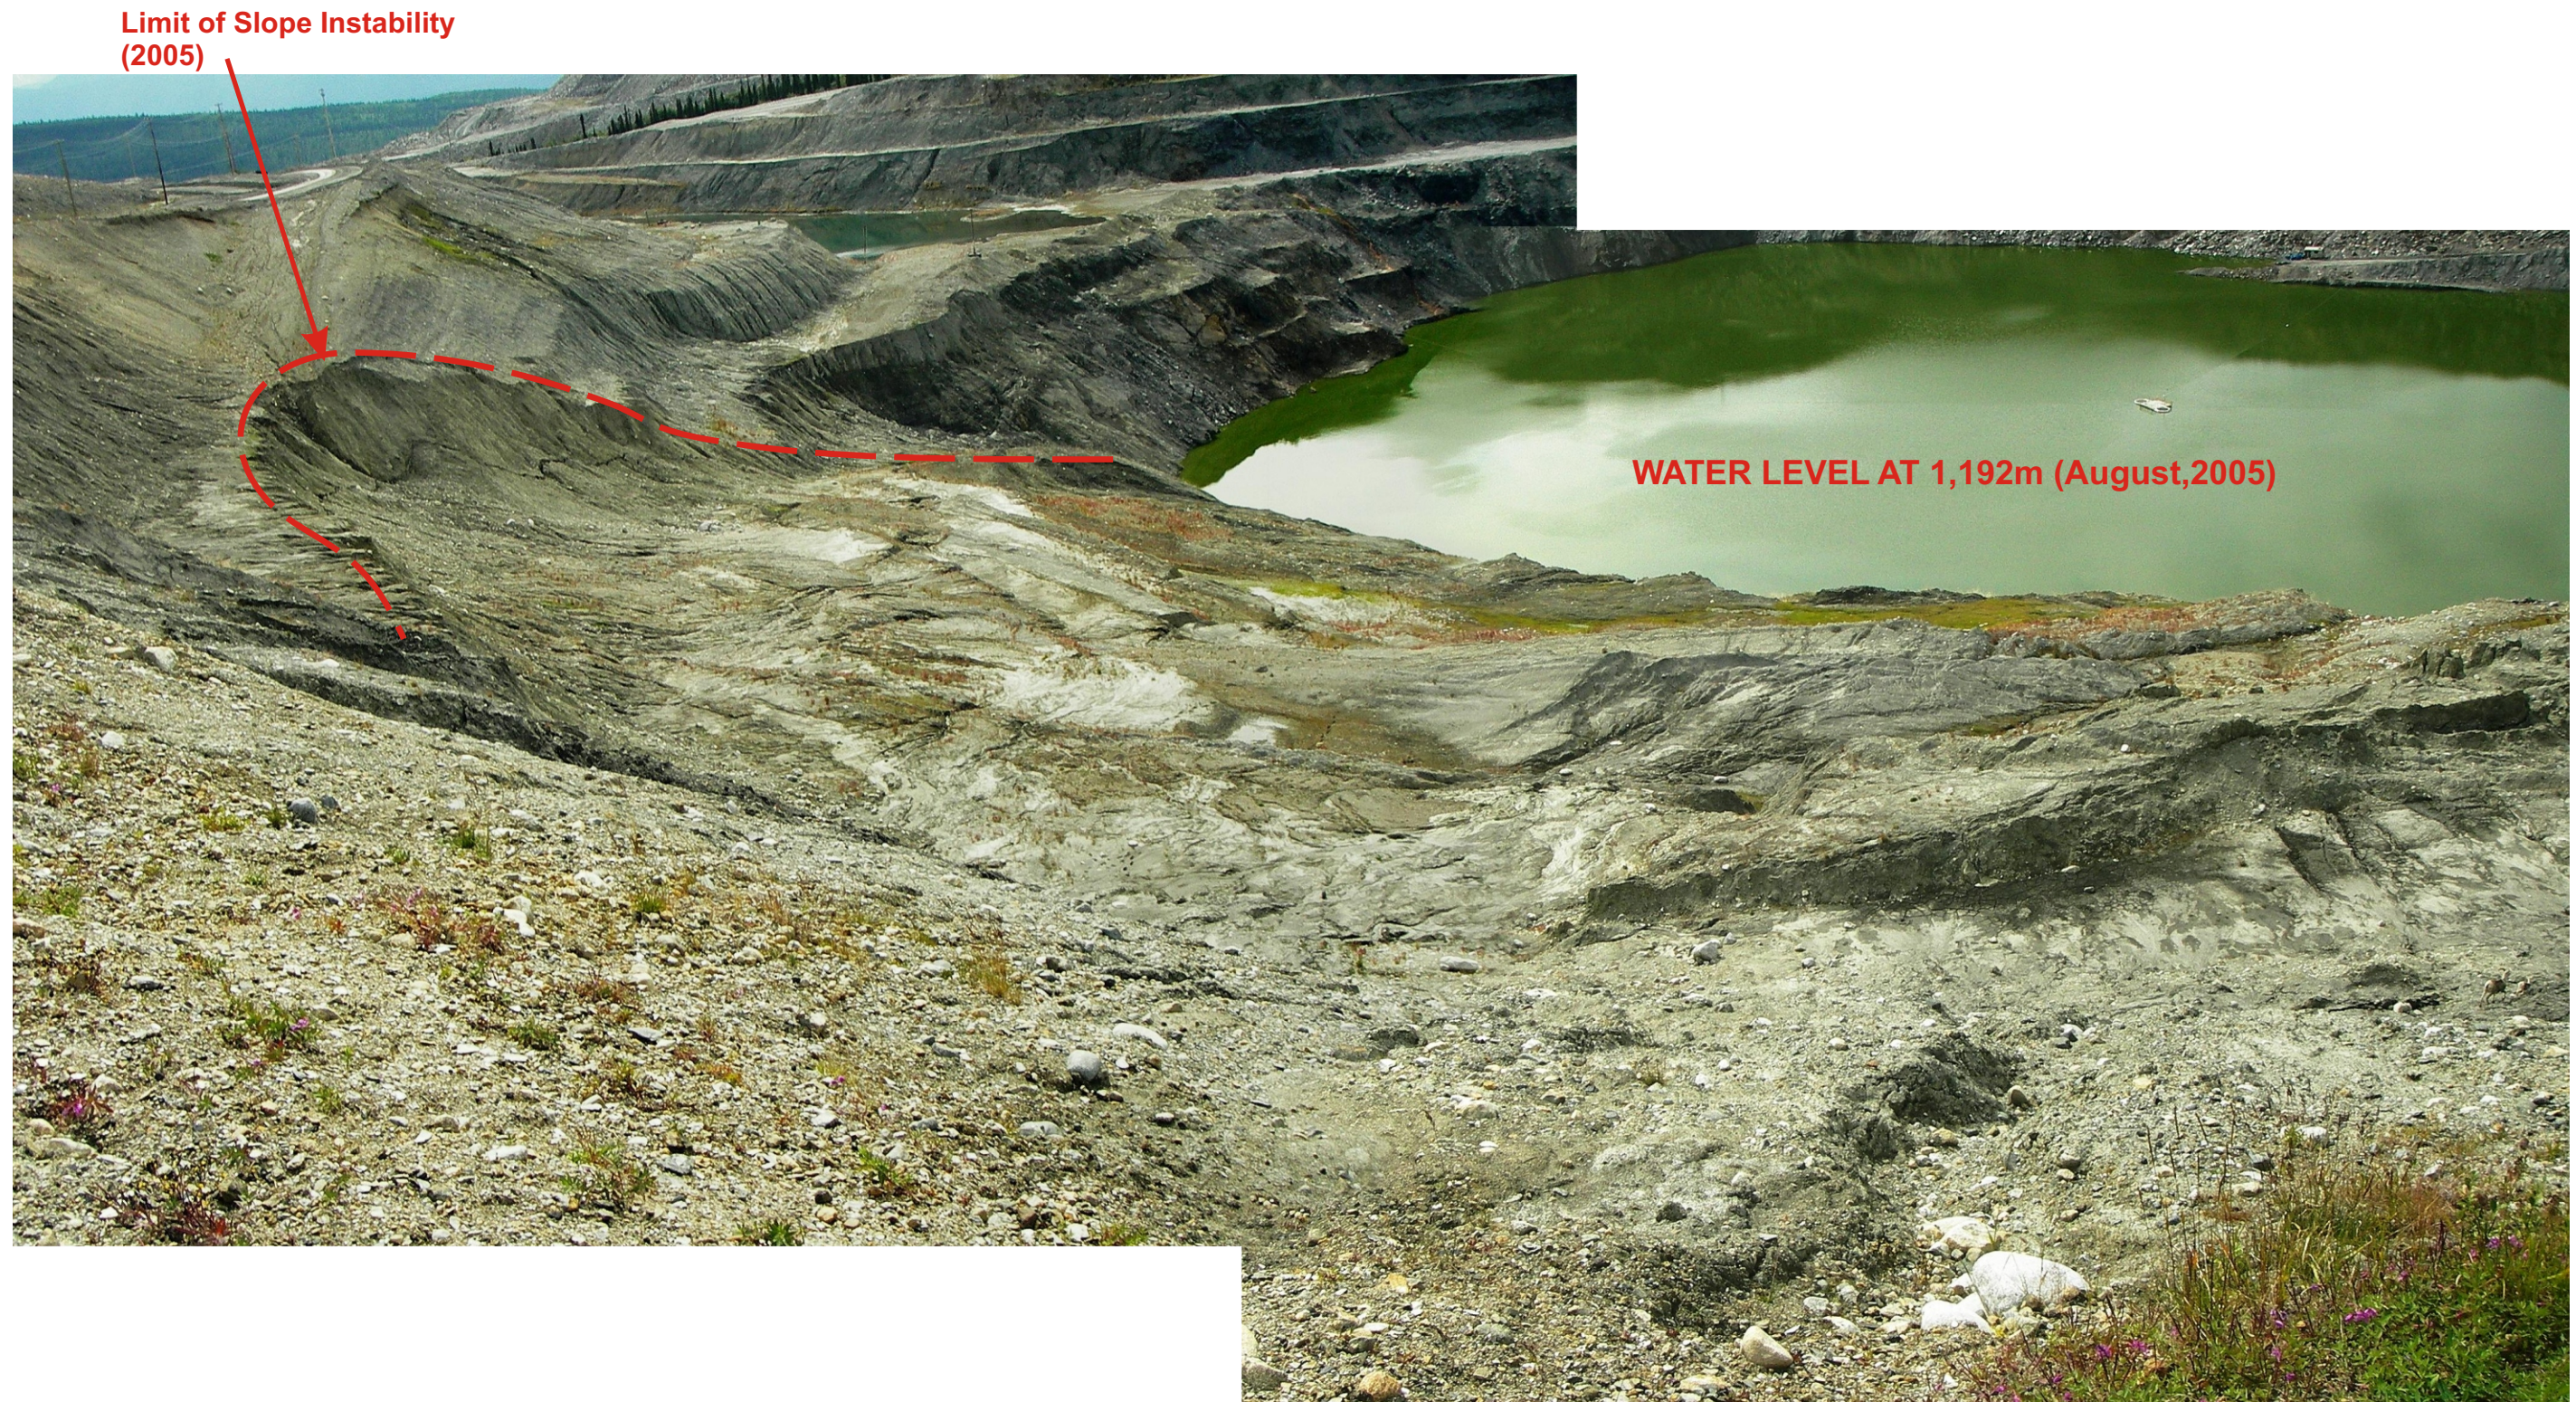
- The instability zone has also expanded south beyond the boundaries observed in 2005 (Photographs II-1, II-3 and II-7). Since 2005, the slope instability has advanced into the overburden soil slopes at the south end of the east wall (Photographs II-2, II-4 and II-8). The 2005 photograph clearly shows the instability zone bounded by the back-scarp located along the lower portion of the slope, while the recent inspection indicate that the instability has progressed further to the south. The recent photographs show the current limits of the instability zone to be defined by a more recent failure scarp that is located above the back-scarp observed in 2005. In addition, obsequent scarps and graben features have developed in the area between the 2005 and 2009 failure scarps.

Photograph 7 : East wall instability. Crest of the pit wall looking south (2005).
