MEMORANDUM

TO: Byron O'Connor, Project Manager; Eric Domingue, Project Manager
DATE: November 3rd, 2013
FROM: Tracey Parkin; Environmental Coordinator
SUBJECT: Elevated Zinc Levels in Rose Creek

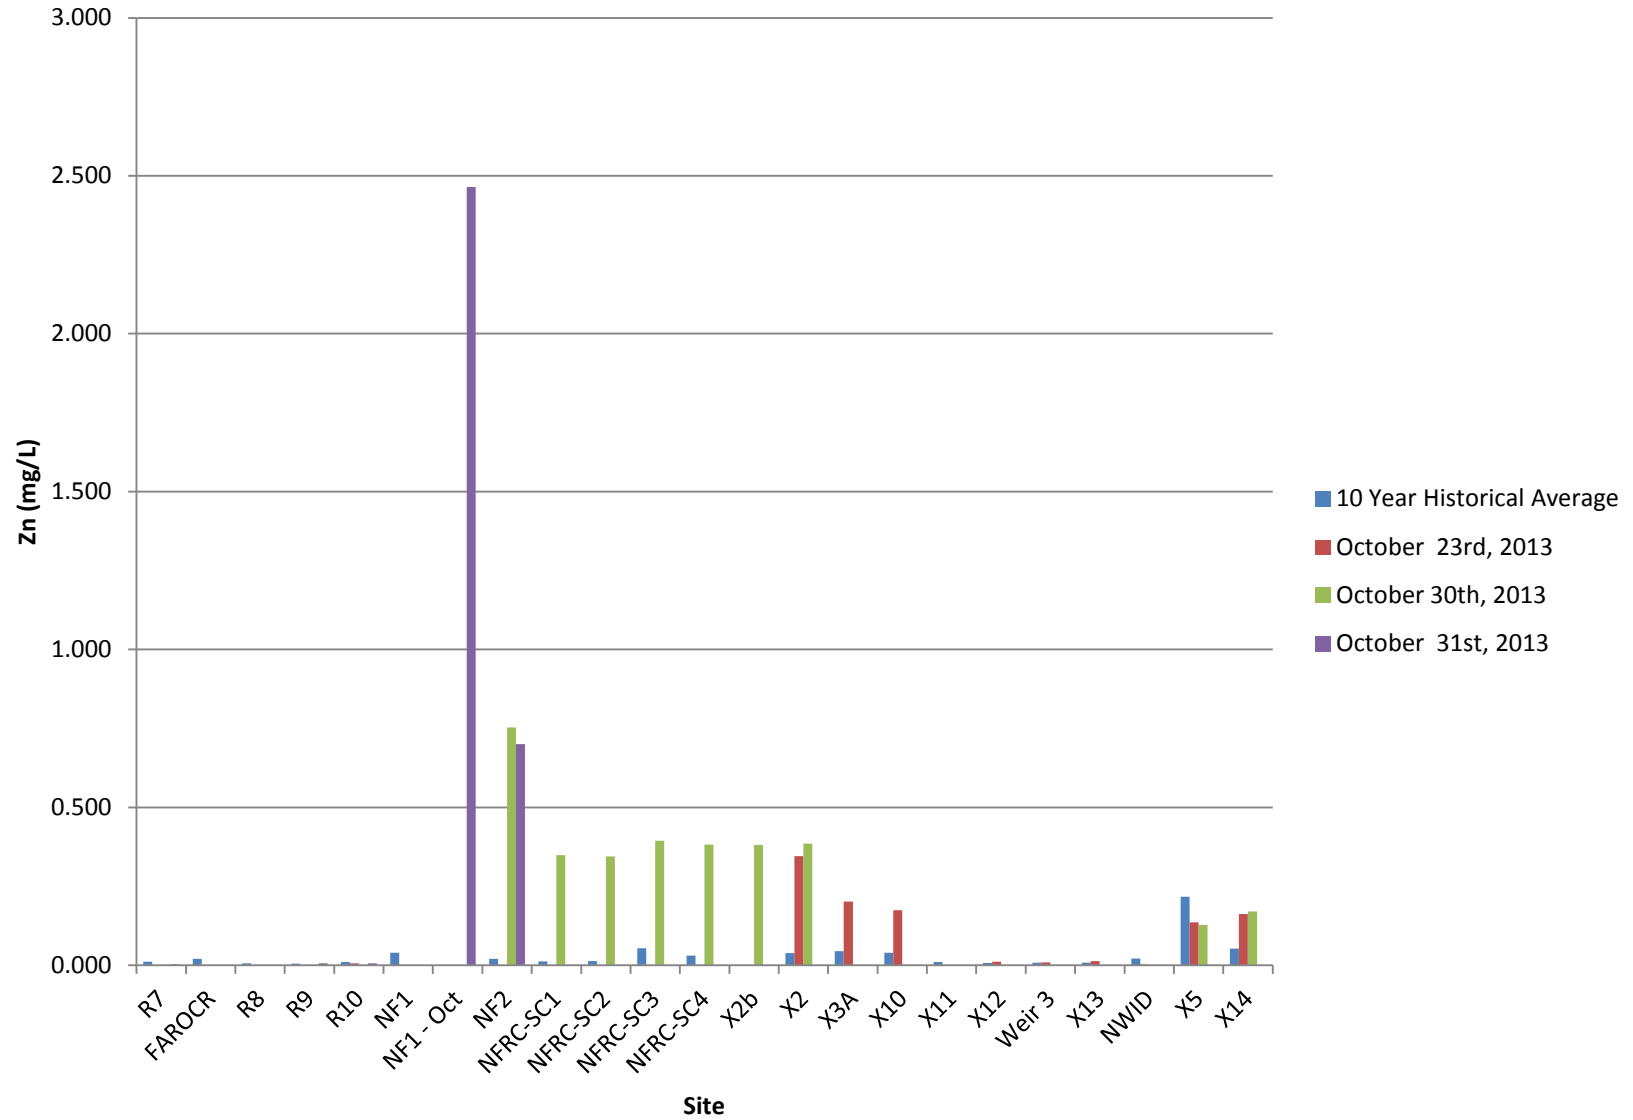
Figure 3: Rose Creek - Total Zinc

On October 31st, 2013, samples were collect at X2, X5 and X14 with results remaining consistent. Analysis of the October 30th, 2013, additional monitoring revealed that Zinc levels at NF2 were higher than downstream Rose Creek results and approximately 35 times historic results, therefore the source of the elevated Zinc levels is higher upstream than the S-Wells and possibly the North Fork Rock Drain.

Zinc analysis took place on November 1st, 2013 and revealed that R7 – R10 zinc values remained within historic range, NF1 – Oct was approximately 62 times higher than NF1 historic values and NF2 confirmed the original result.
