Assessment & Abandoned Mines
Ministry of Energy, Mines and Resources
FARO MINE COMPLEX
SITE-WIDE ELECTRICAL ASSESSMENT

INTERIM REPORT

Rev 0, Original Issue 31 August 2016
Rev 1, Minor Corrections Issued 29 November 2016

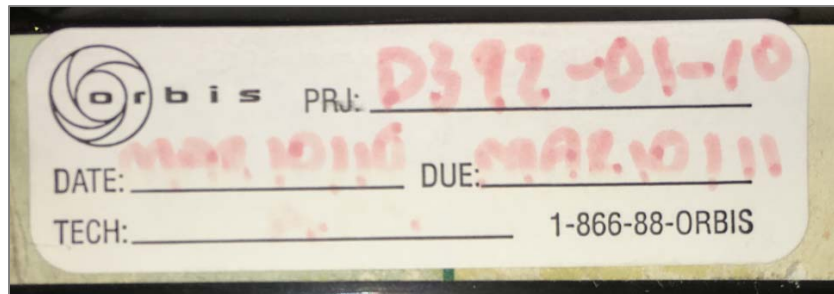
- Protection relays (and likely the Circuit-Breakers) have not been tested since 2011. Testing is now past due, especially given the age and condition of this equipment.
- StruthersTech is able to perform this testing during our next visit to site, subject to the practicality of taking a power outage on each 4160V circuit.
- If an outage is not practical, this work could be postponed until the winter season and performed by any suitable contractor when the water treatment processes are more easily interrupted.

The most recent testing labels found onsite were applied by Orbis Engineering in March 2011.

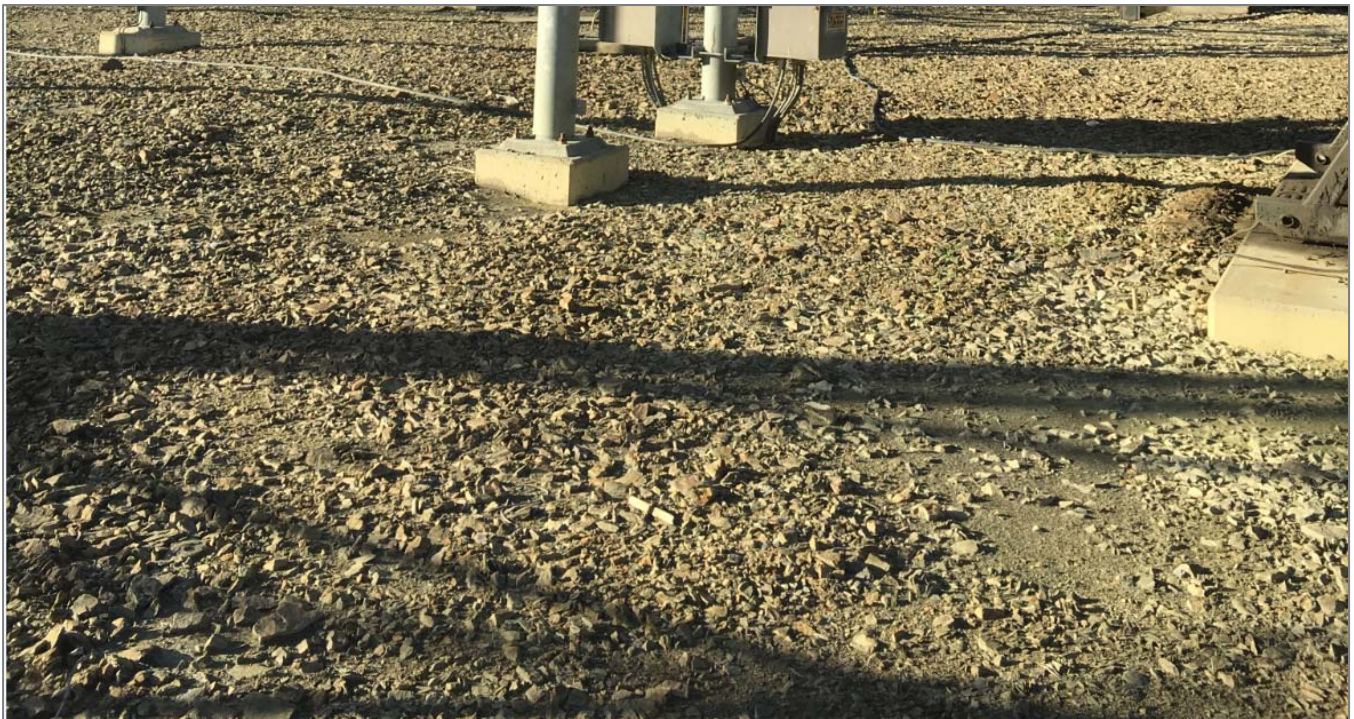
Conditions inside the main 138kV YEC substation are not as bad as other areas, but we recommend it could use an overlay of fresh insulating gravel.

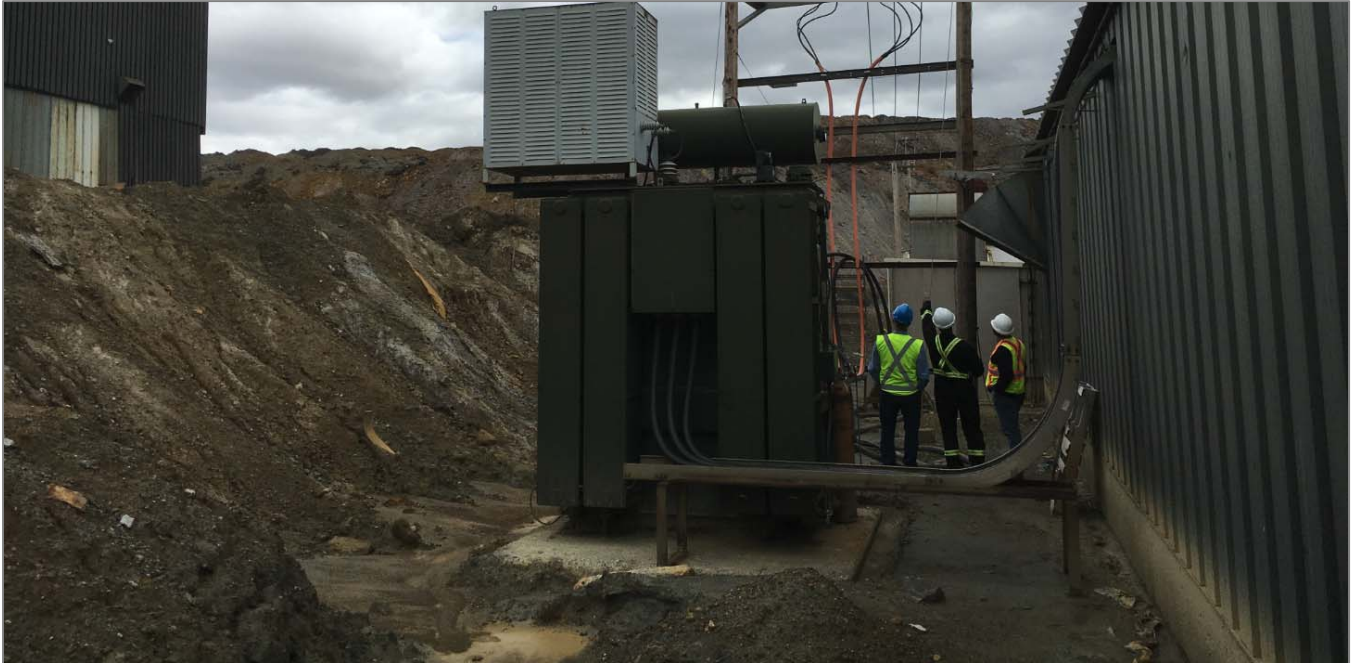
Soil conditions around the T3 isolation transformer are non-compliant. Recommended solution is simply to remove T3 from service as soon as practical.

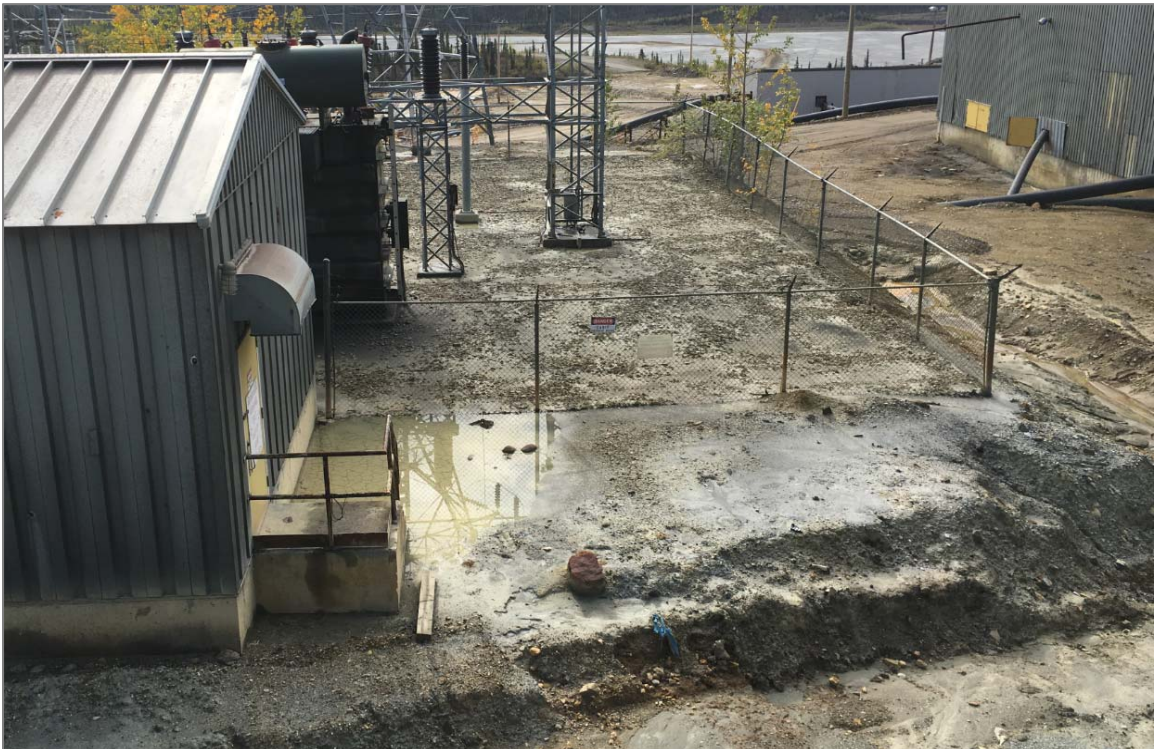
Virtually every such location at the site is non-compliant in this regard. Accumulation of fines, mine waste and vegetation has severely degraded the integrity of this insulating layer. Of particular note, the rear entrance door to main substation E-House #1 is surrounded with standing water containing high mineral content from the mine waste.

Soil conditions and standing water around the back of the 138kV substation are non-compliant, particularly at the rear entrance to E-Room #1. Given that the front door access is available, an immediate short-term solution is to red-tape and post notices at this entrance on both sides of the rear door.

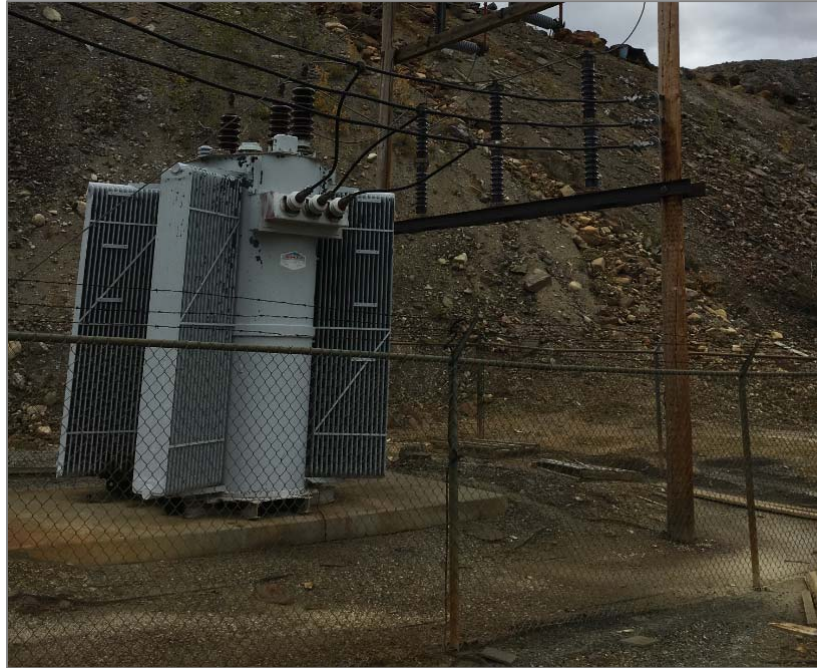
The 69kV Step-Up Station requires a fresh layer of insulating gravel for code compliance.

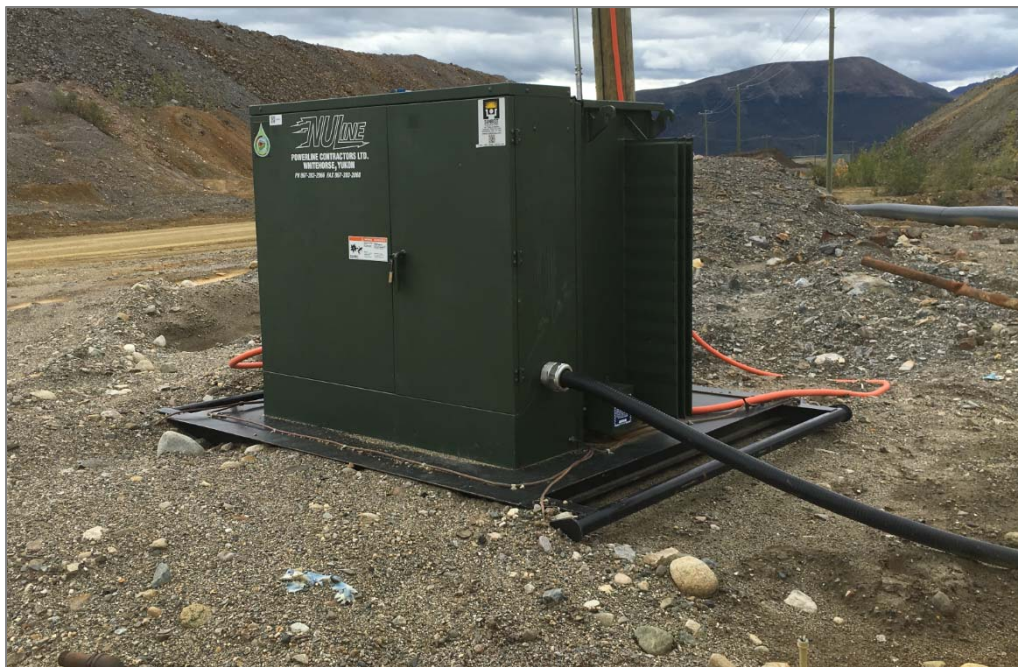
The 4160V step-up transformer at the Faro Pit standby generator appears to be compliant with a 4-rod grounding grid and a layer of relatively clean gravel spread around it...

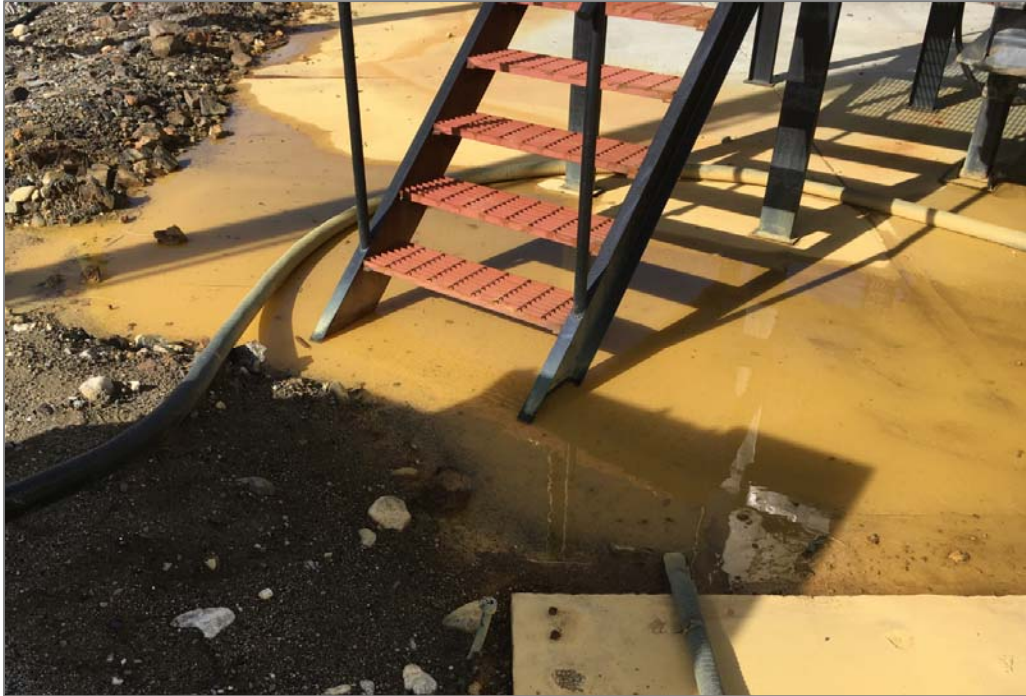
... but the grid and gravel do not extend around the 600V generator that is electrically tied to the HV transformer. Shown here, the access steps and handrails to the generator enclosure are in standing water and do not appear to be directly bonded to the station ground.

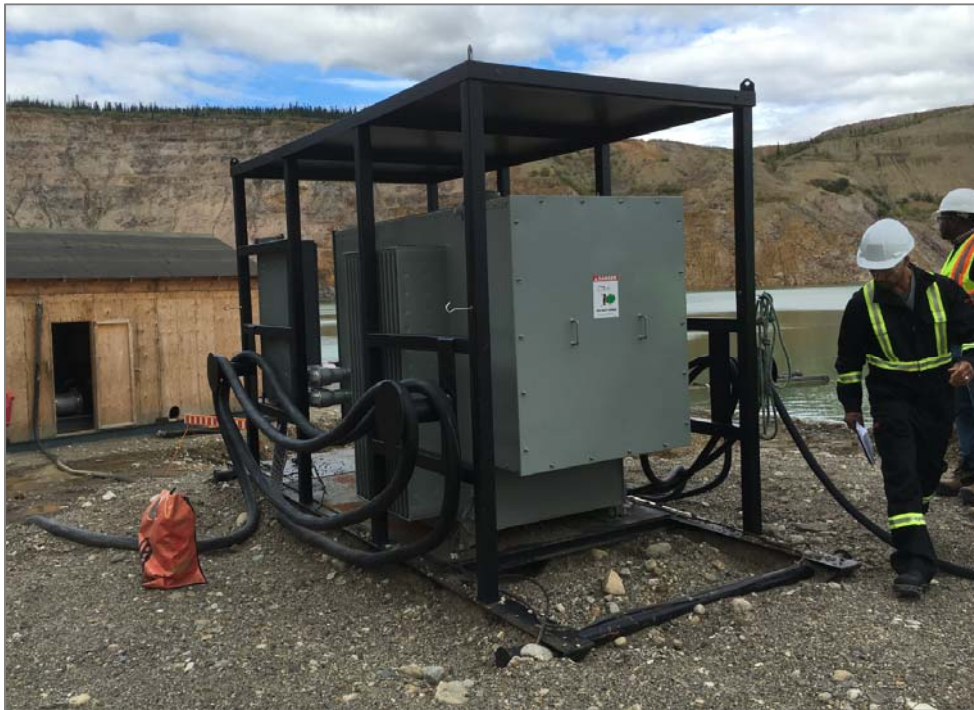
4-Rod ground-grid and clean gravel spread at the 4160V Faro Pit pump station are done well.

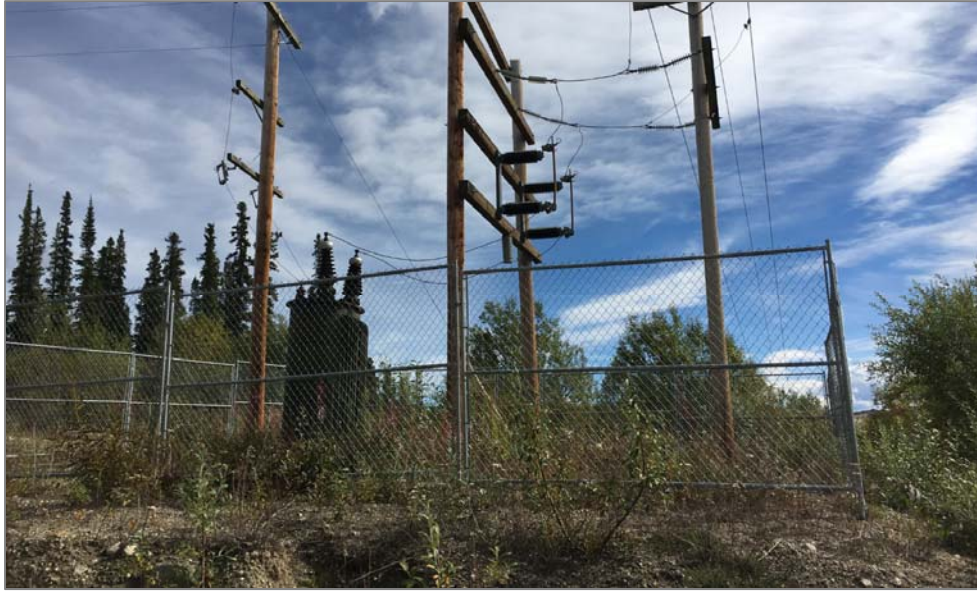
Soil conditions at the 69kV Repeater Station Tap-off are not bad, but vegetation removal is recommended.

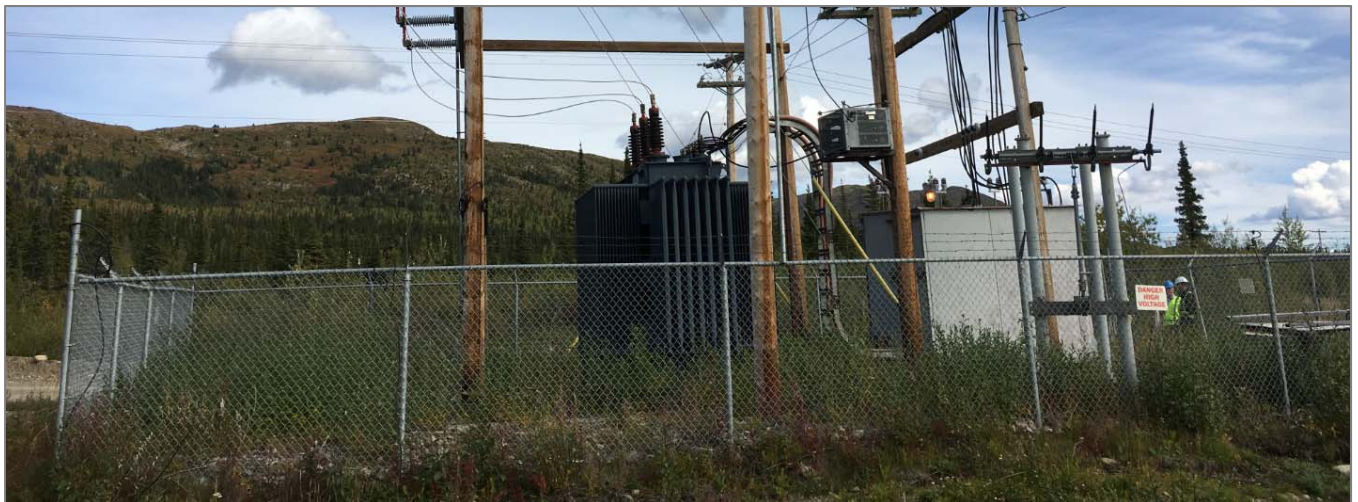
The Van Gorda 69kV step-down station requires vegetation removal and some fresh gravel. The nearby “remote grid” should also have vegetation removal and fresh gravel around the fenceline perimeter.

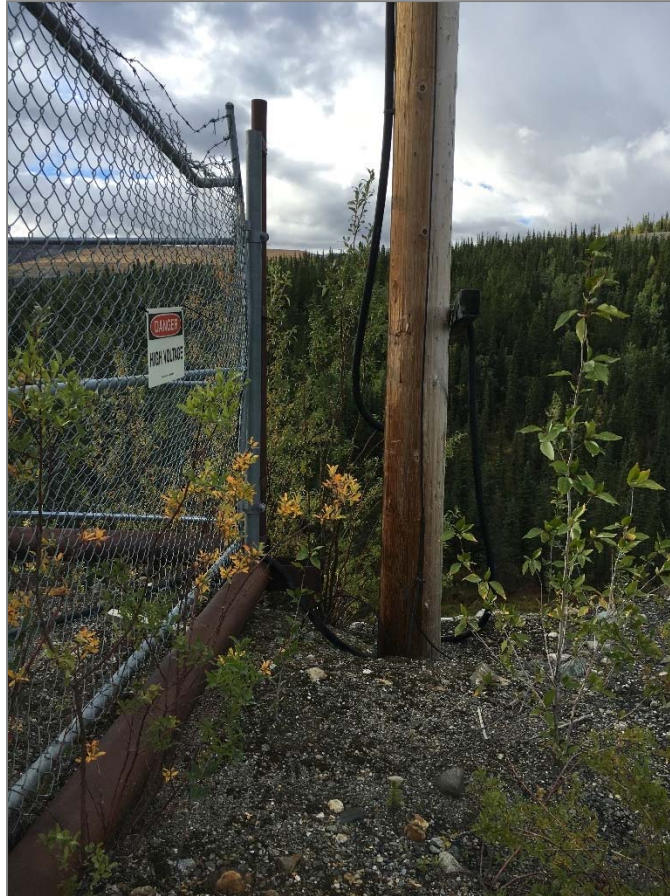
Some vegetation removal and clean gravel required at the 4160V Little-creek Transformer Station.

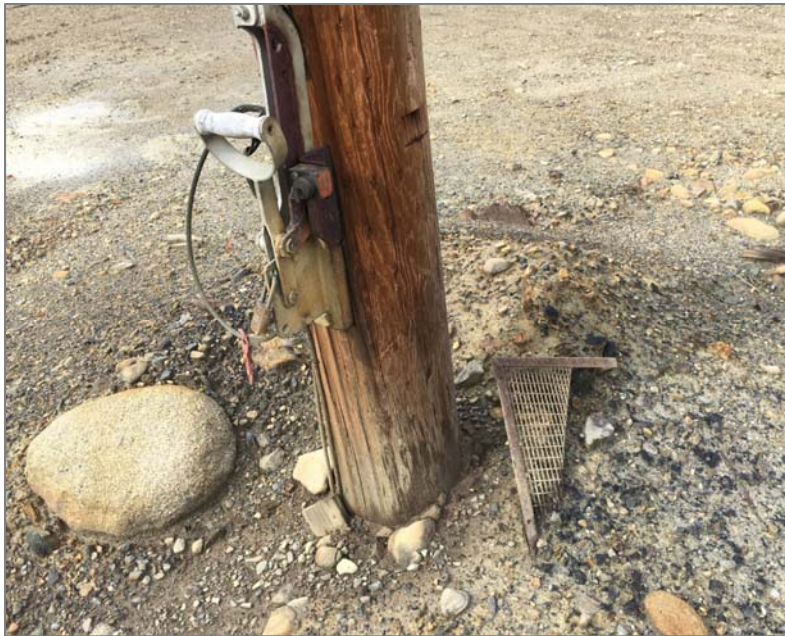
*Clearly damaged and non-compliant ground-mat below an overhead 4160V switch.
Located nearby the Miller Skid.*

We recommend that site purchase one or more temporary grounding mats that the electrical workers can connect and use when performing switching operations, until the condition of each grounding mat can be verified and/or repaired to an acceptable state.

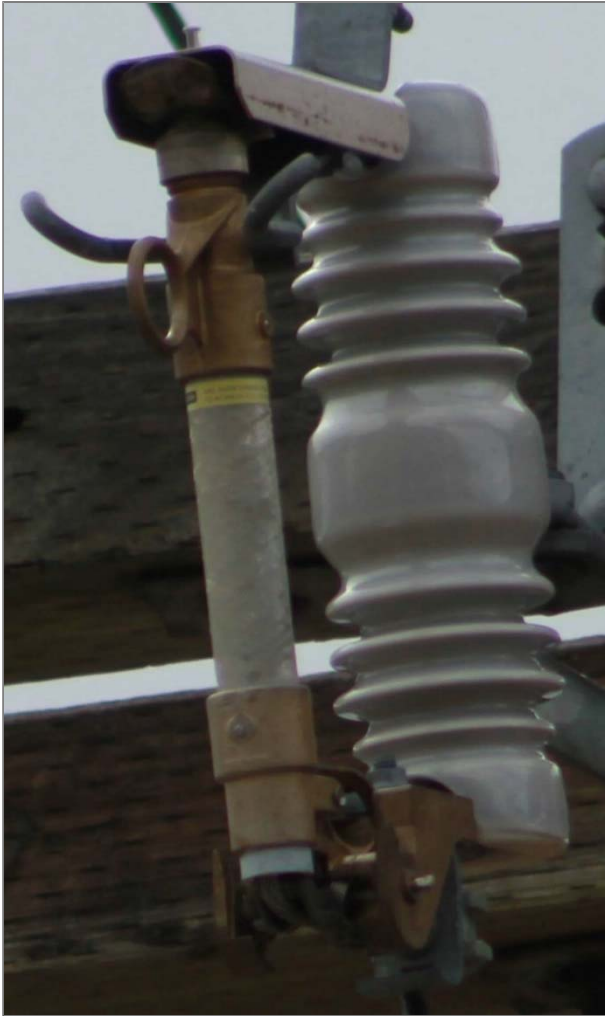
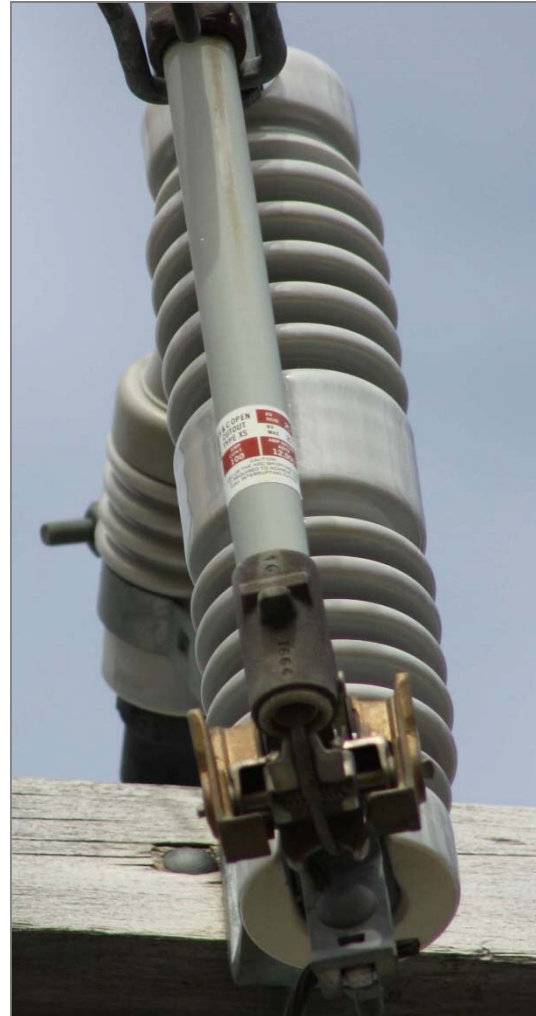
Left: This 100A S&C Type XS fuse is improperly sized for the 225kVA transformer at the Van Gorda WTP

Transformer rated amperage at 4160V is just 31A, code allows a maximum standard fuse size of 50A. The oversized fuse results in excessive arc-flash hazard on the 600V side of transformer due to slow clearing time.

With the above points in mind, we will be producing a list of recommended replacement fuses and holders for operating locations that could be changed by an overhead line contractor.

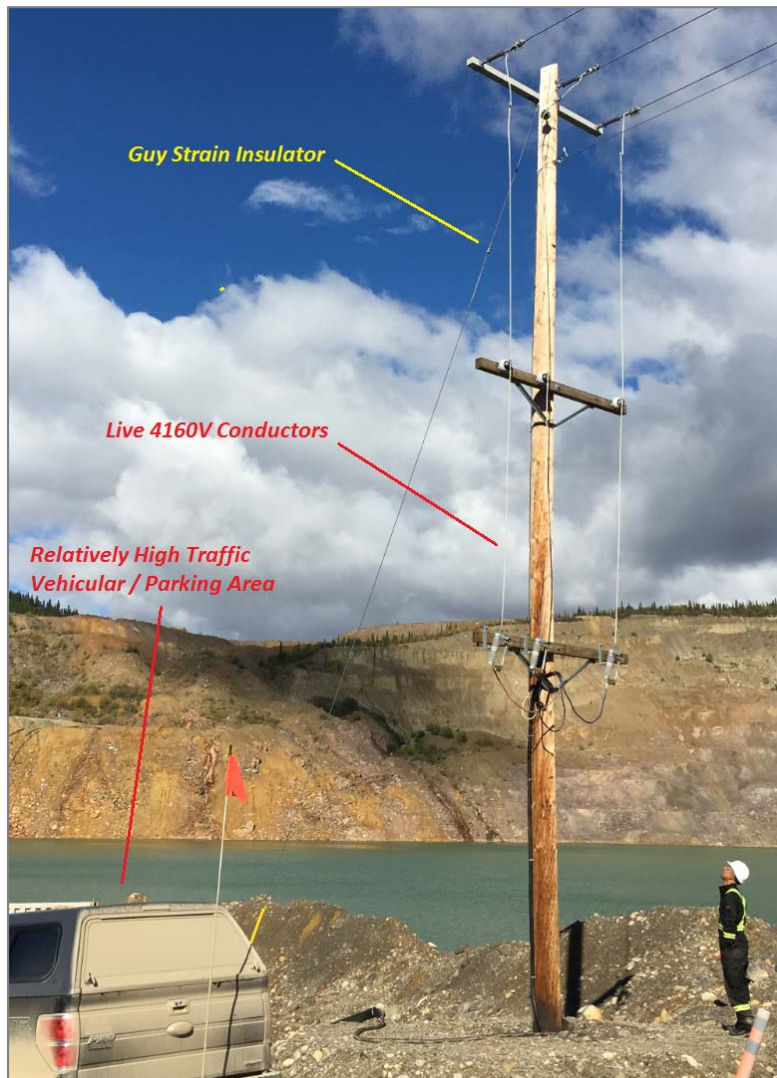
Of particular concern is the installation at the Faro pit pumping station. This one presents a higher risk than most as the guy-anchor is located directly adjacent to a vehicle parking area.

Improperly Installed Guy-Strain Insulator at Faro Pit. The 5kV fuses have been installed at a low elevation for convenience, but this causes additional risk of Phase-to-Guy contact if a vehicle hits the guy-wire. Recommend adding another guy strain insulator at lower elevation and/or raising the 5kV fuses. Concrete no-post or lock-block barriers could also be placed around the guy-anchor for an immediate improvement.

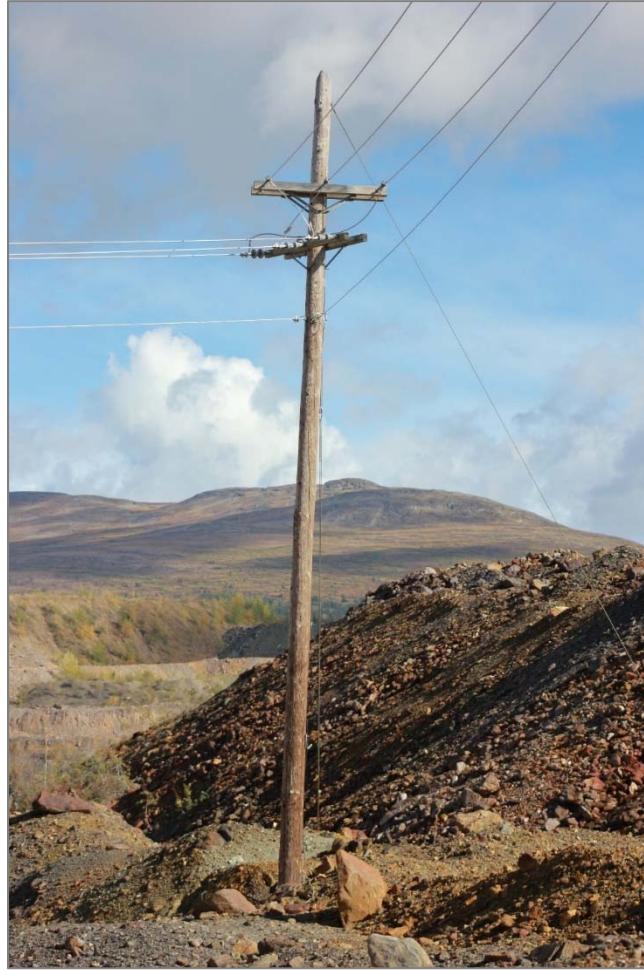
This pole, one span upstream of the Faro pit pump is heavily loaded due to the angle of the two lines. It is one of the older poles on site (1970's vintage) and is showing clear signs of rot and spiral fractures. It should be slated for replacement as it is not expected to last another 10 years.

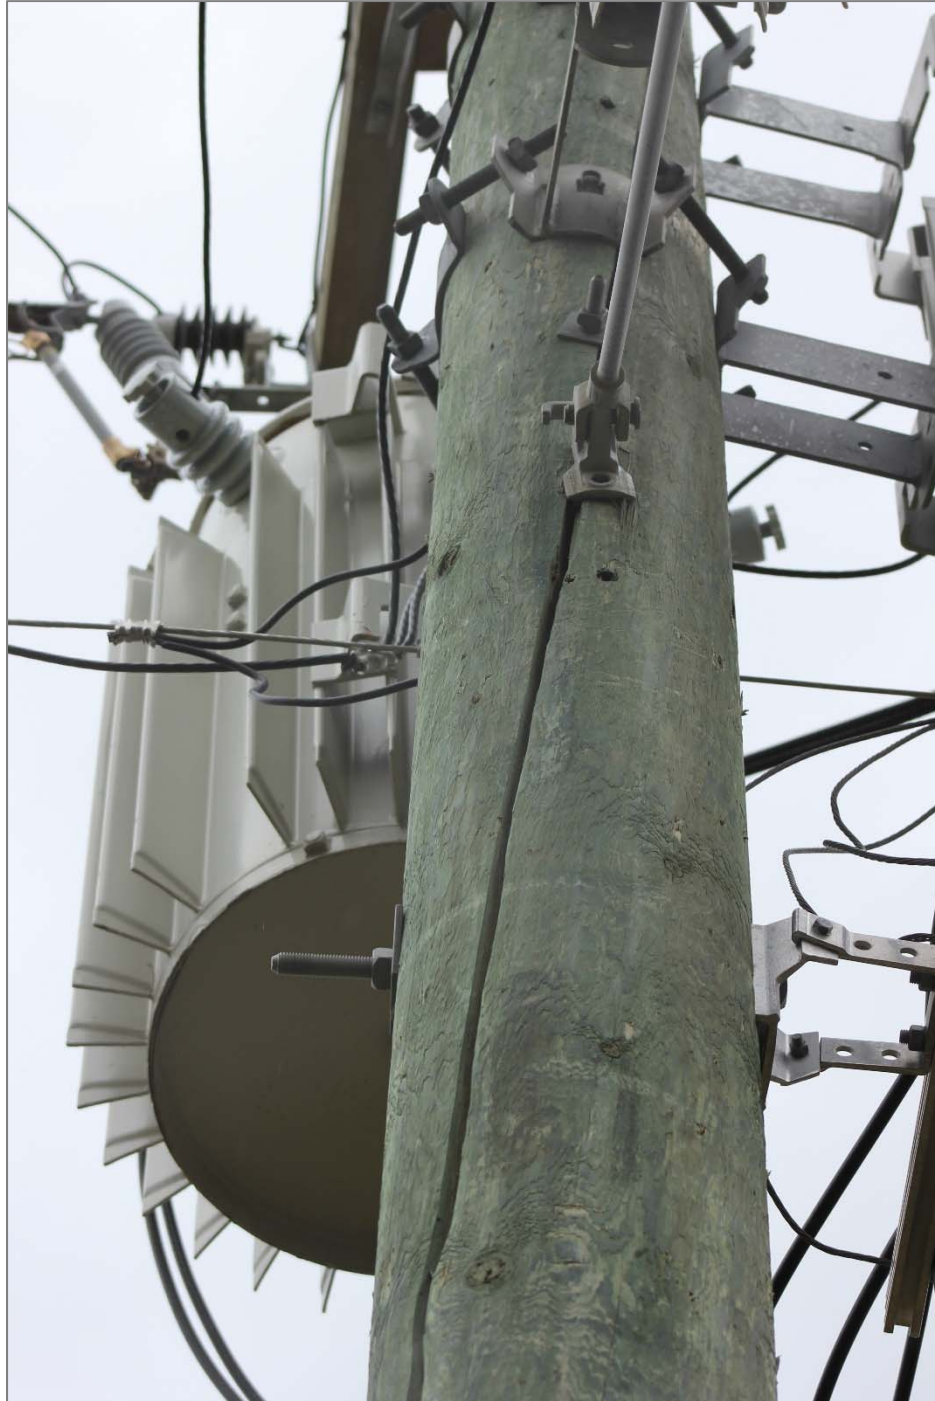
This relatively new pole at the Intermediate Pond supports the 3 x 167 kVA pole-top transformers and is heavily loaded to the design limit of it's class. A severe crack (>25mm wide) has appeared in the pole and extends almost the entire length. The crack is too large for in-situ repairs (split-bolting) and we recommend the pole be replaced at the earliest possible opportunity. The crack has likely occurred due to improper drying of the pole after treatment by the pole manufacturer, in combination with the heavily loaded application.

- Schedule the replacement of the severely cracked wood pole supporting the transformers at the Intermediate Pond. This pole is at elevated risk of failure, especially if exposed to high wind loading.

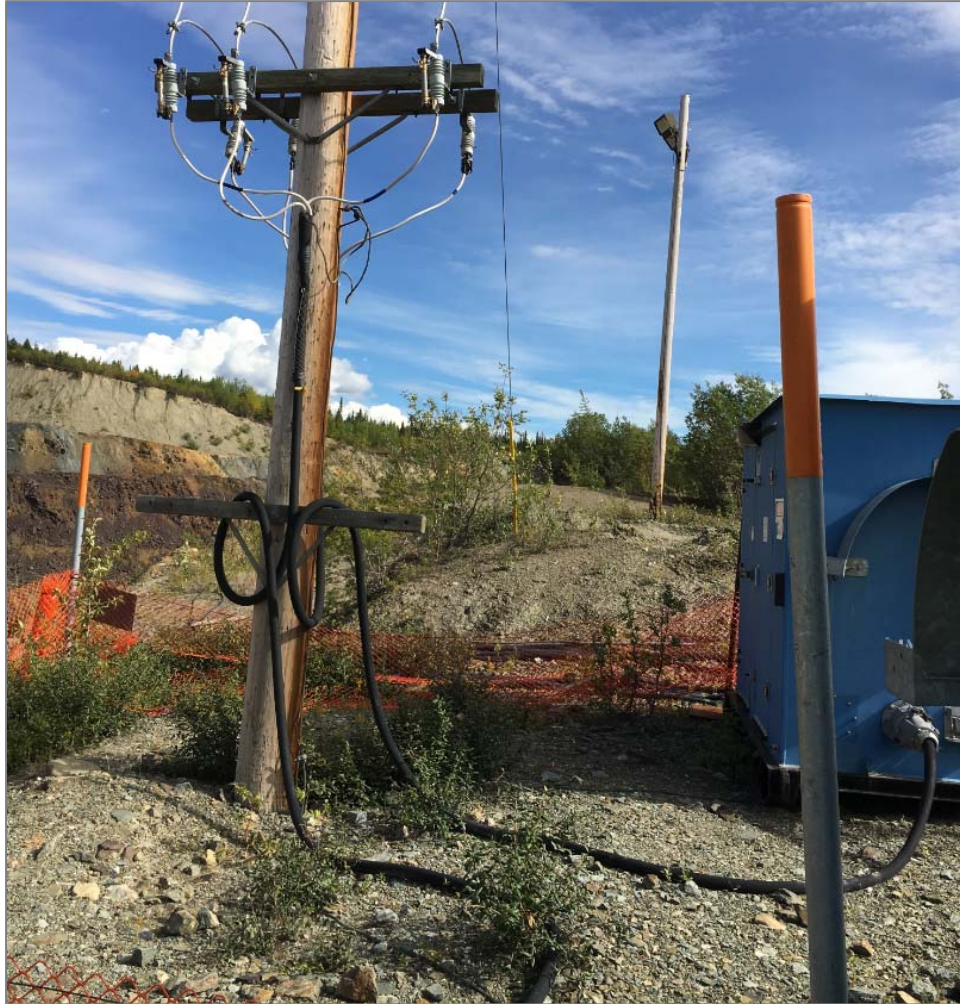
Direct connection of 4160V trailing cable couplers to overhead lines are one of the more serious code infractions noted at the site. These couplers at the Van Gorda pump station are padlocked to reduce the risk of disconnection under load but are still non-compliant.

We recommend the immediate application of padlocks to all couplers as an interim measure, and replacement of these plugs with hard-wired connections at the earliest practical opportunity.

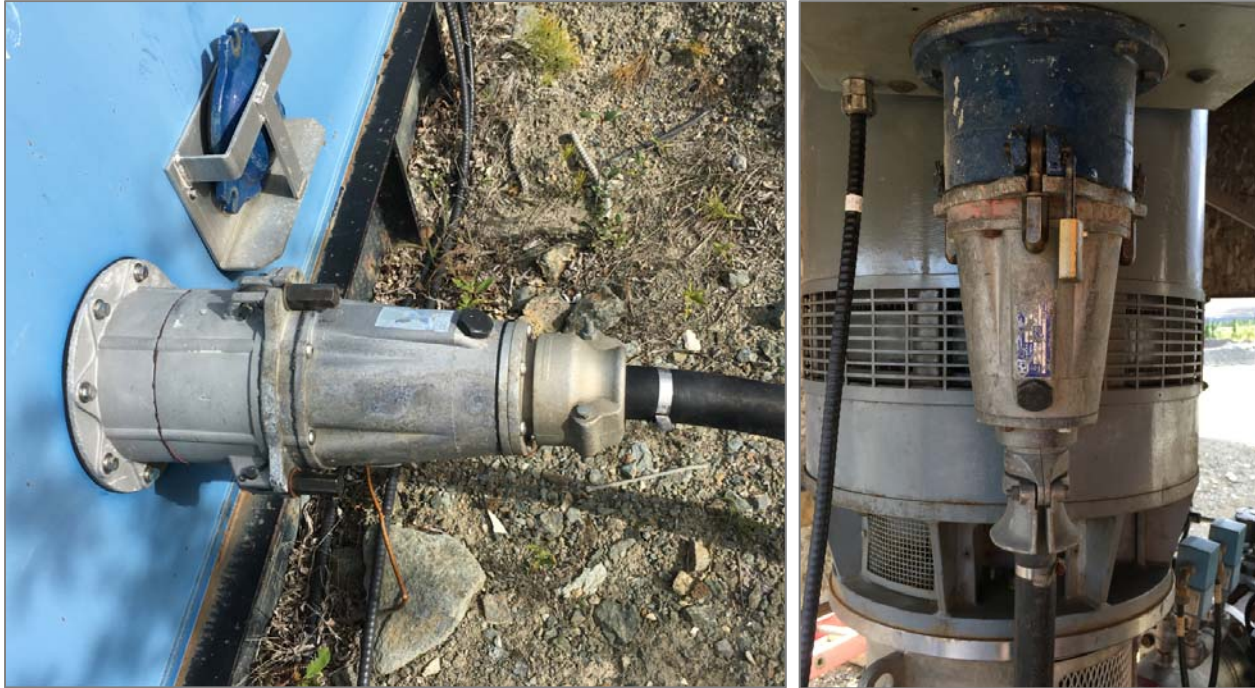
Outgoing 4160V connectors to the Van Gorda pumps are also non-compliant, as the upstream ground-fault / ground-check relays are out of service.

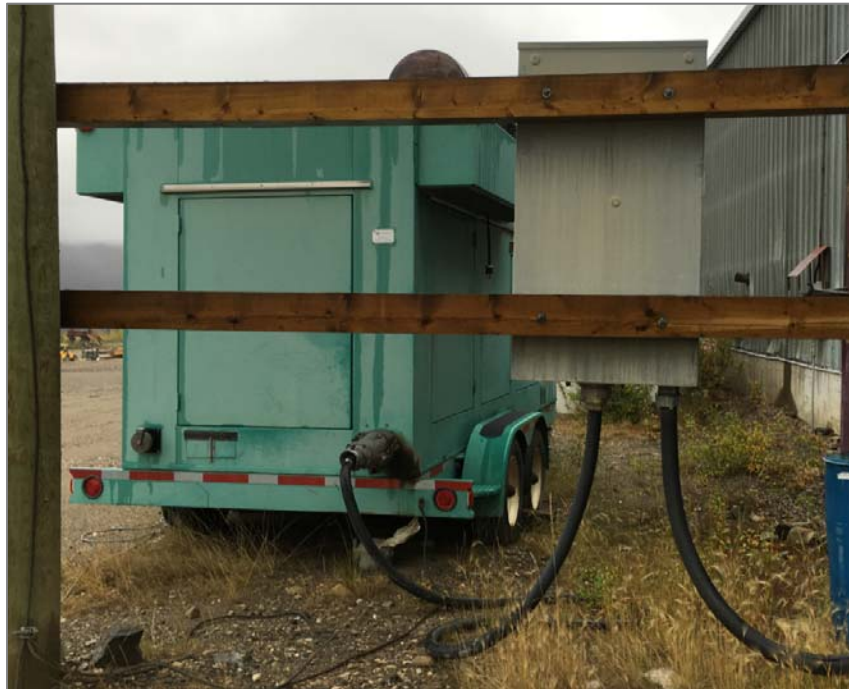
Backup Generator at the Norcan Shop uses a mining coupler without adequate ground-fault / ground-check protection. At 600V it presents a lower risk but is still non-compliant.

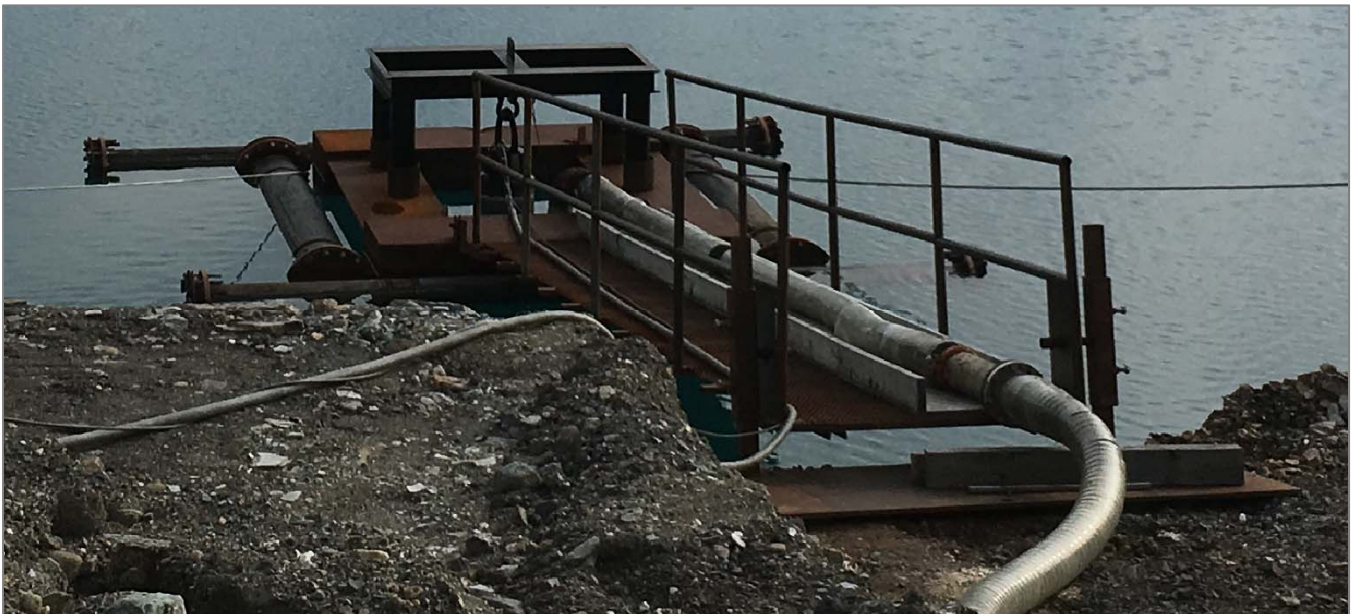
The Grum pit pump is fed from a 5A neutrally-grounded 600V system, but there is no ground fault protection at the resistor or inside the pump starter enclosure.

Although the electrical terminals of the Grum pit pump are above water, the rest of the motor / pump combination are below water and therefore classified as a submersible pump requiring sensitive ground fault detection. We will need to take a short outage of the pump to inspect the interior of the motor starter, and confirm if this protection is present.

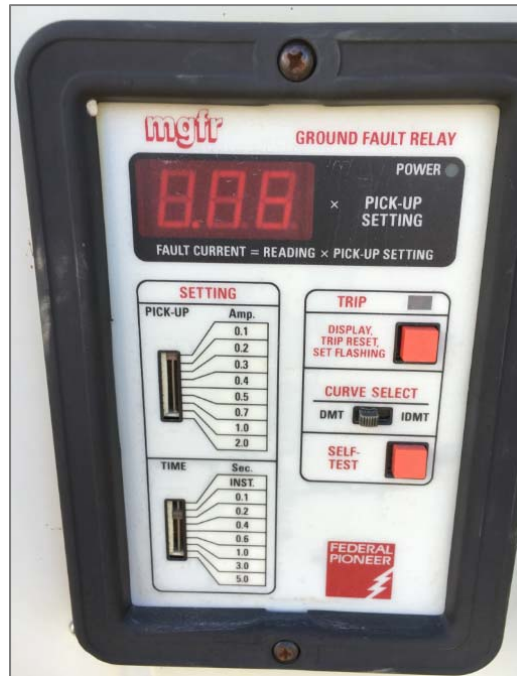
The Groucho Pond pump is also on a 5A neutrally grounded 600V system without ground fault protection. There is an MGFR ground fault relay in place, but it is out of service.

Ground Fault Relay at Groucho Pond is Out of Service

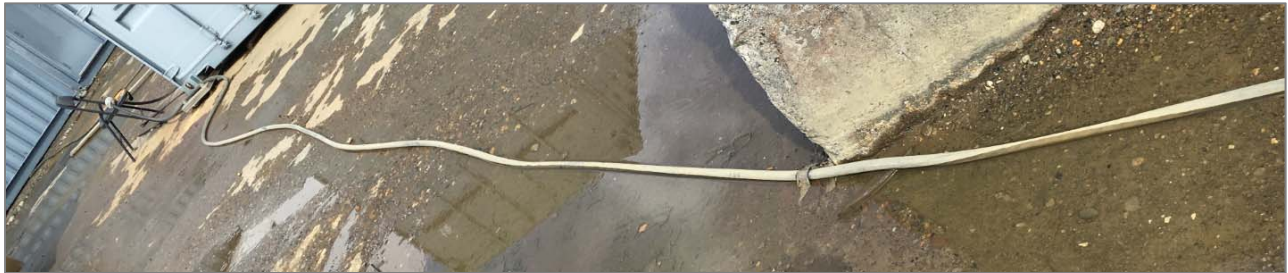
of the water, but it is only one tripping hazard away from being accidentally disconnected under load and/or landing in the water.

IWTP: Temporary (>1 week) Power Cable Routed Through Pedestrian Area in Standing Water

- This poses an immediate safety hazard that is a simple item to fix if the correct materials are purchased. We recommend the following:
 - Route the cable (use another extension, if required) out of the way of pedestrian traffic, and out of the standing water.
 - Use a coupler with all of the correct fittings, such that the male and female plugs are locked with the threaded outer ring.
 - Couplers exposed to the outdoor elements should be on circuits with Ground Fault Interrupt (GFI) breakers and/or be tested regularly for assured-grounding.
 - If the shipping container is to remain powered for an extended length of time, the temporary cabling should be replaced with permanent cabling.

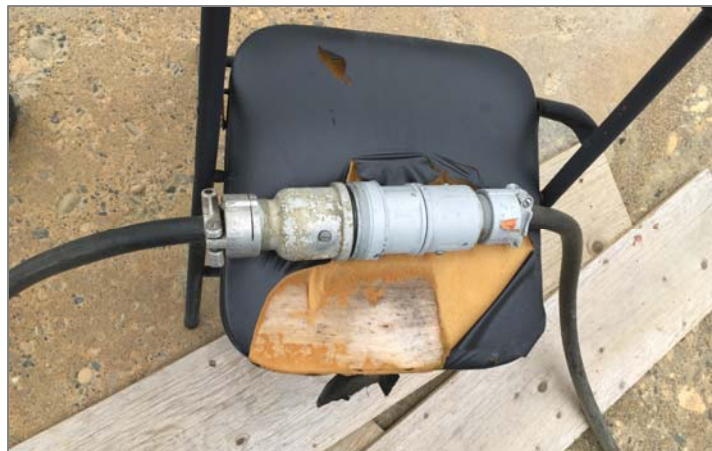
Cable Coupler is missing the Threaded Locking Ring

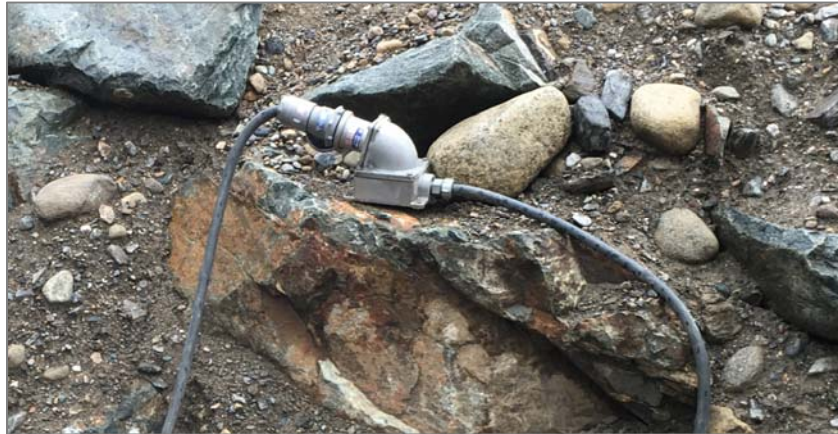
- A similar but less serious issue was noted at the Baker Tank at the Cross Valley Pond. Workers have used a male cord plug with a female wall-mount receptacle as the two fittings on an extension cord assembly.

Wall-mount Receptacle being used as an Extension Cord End at the Filter Station near the Int. Pond

If the Baker Tank is going to remain energized for an extended length of time, the extension cords should be replaced with permanent protected cabling.

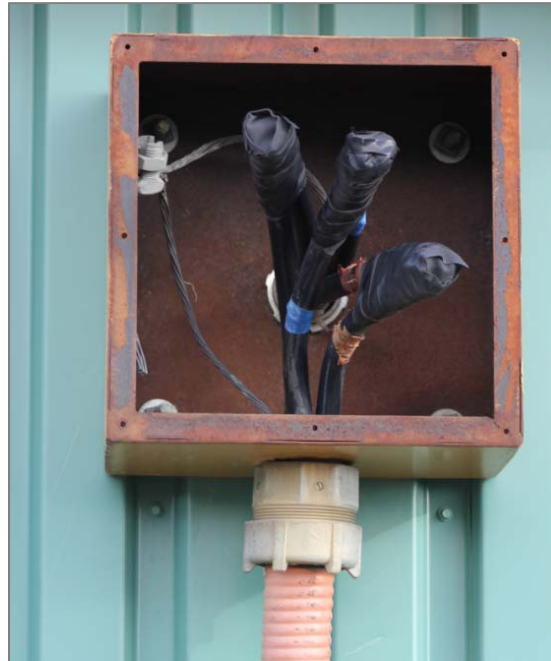
- Junction-box cover is missing from the 600V entrance terminal at the Little Creek electrical room. Taped connections are exposed. The safety hazard is obvious and easily avoidable by the trained mine personnel, but a new cover should be arranged regardless.

600V Junction box with missing cover at Little Creek electrical room.

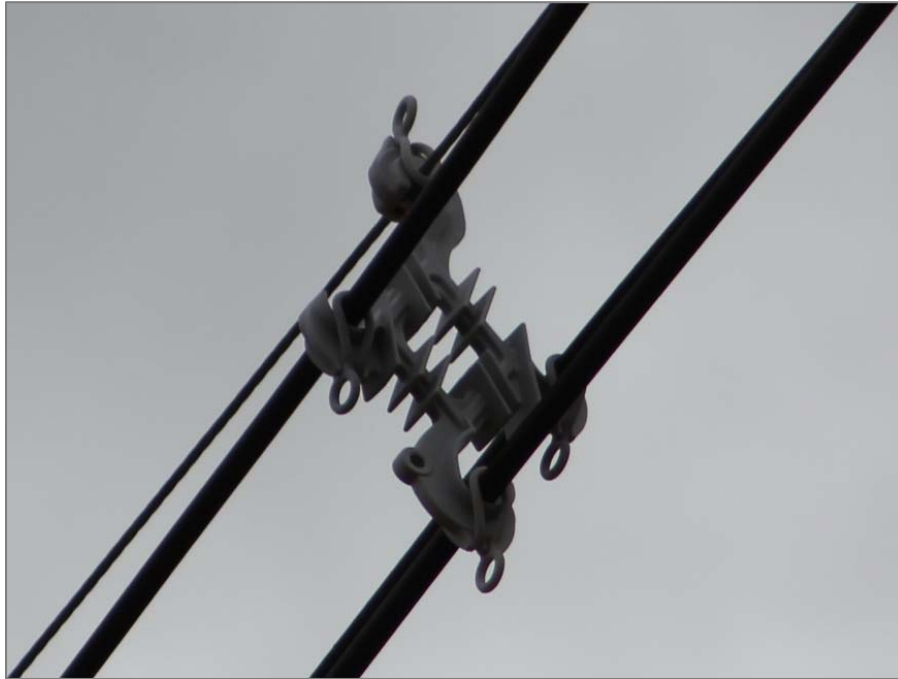
Bundled Multiphase Insulators used for 7 spans of Line near Faro Pit are Notoriously Unreliable

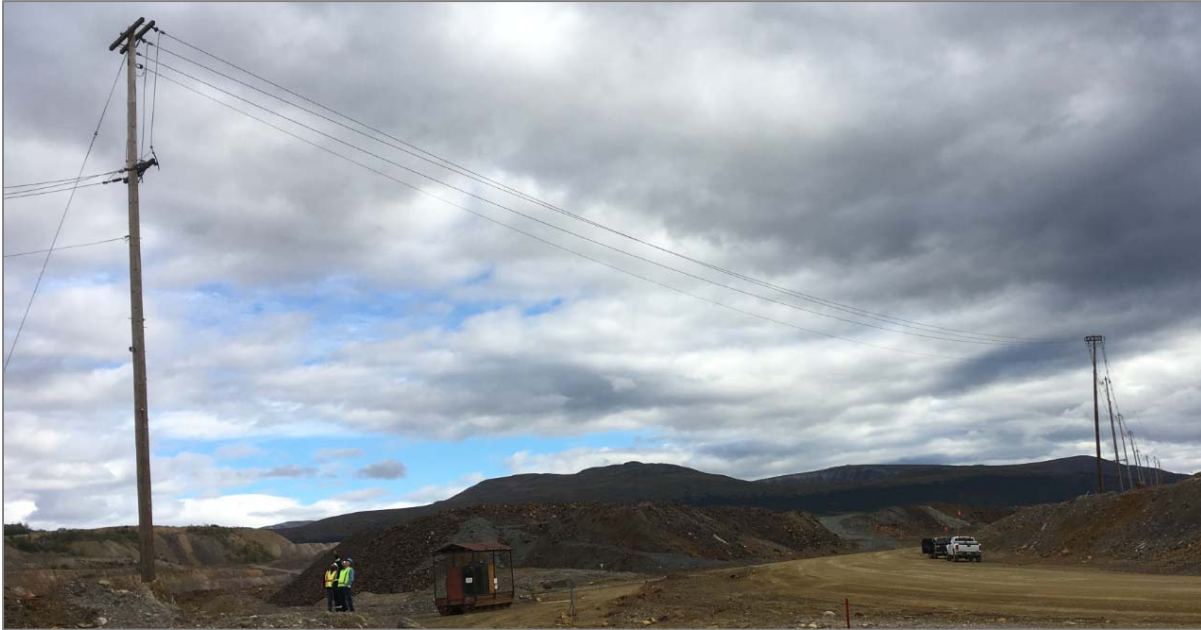
This long 4160V span near the Faro Pit has insufficient phase to phase clearances, at high risk of flashover during high winds and inclement weather.

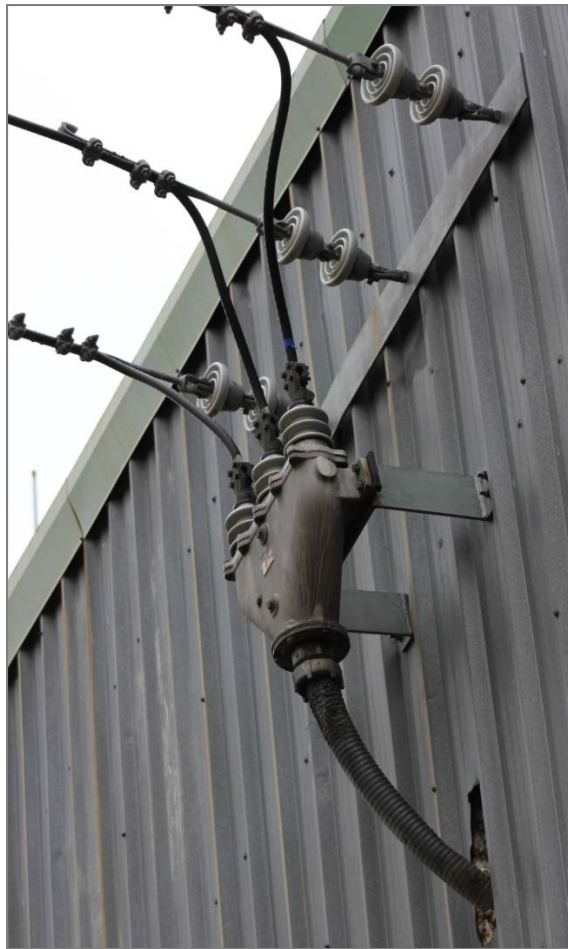
Faulted 4160V Cable Entering the Faro Workshops

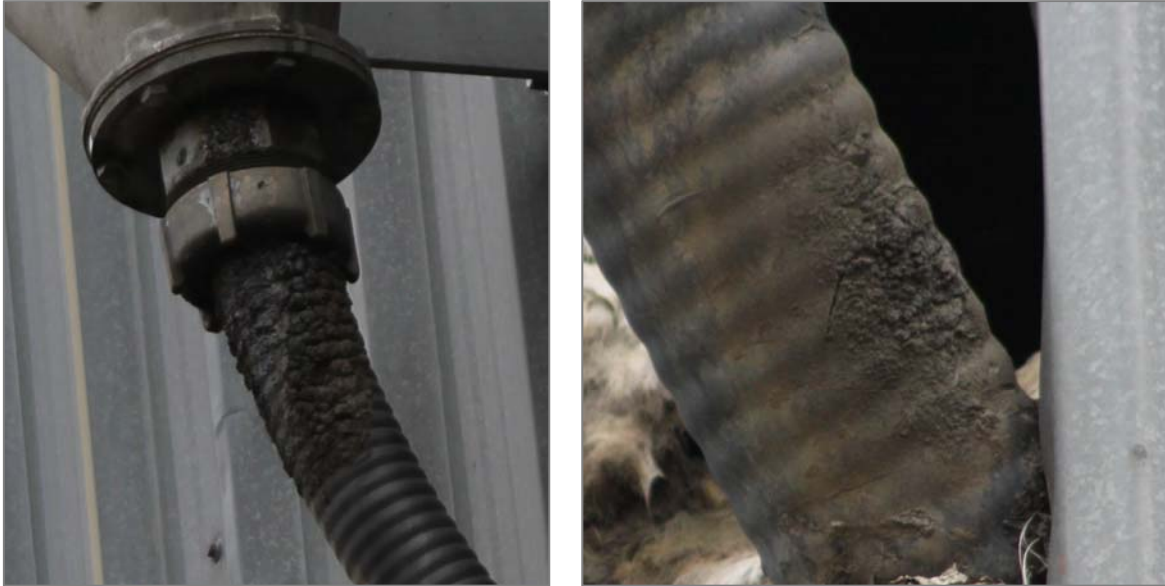
Close-up Photo's of Faulted 4160V Cable Entering the Faro Workshops
