Assessment & Abandoned Mines
Ministry of Energy, Mines and Resources
FARO MINE COMPLEX
SITE-WIDE ELECTRICAL ASSESSMENT

INTERIM REPORT

Rev 0, Original Issue 31 August 2016
Rev 1, Minor Corrections Issued 29 November 2016

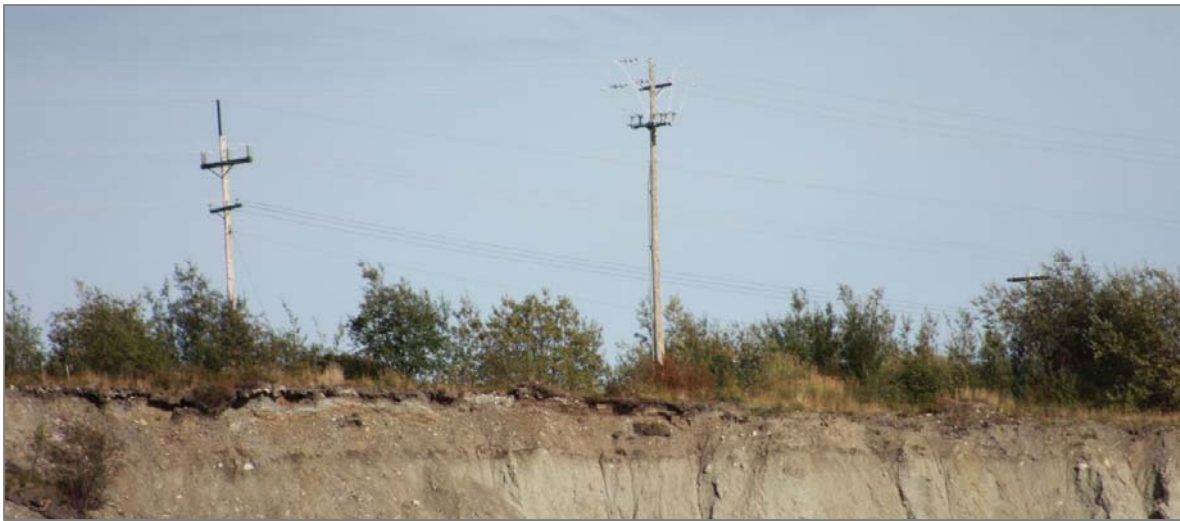
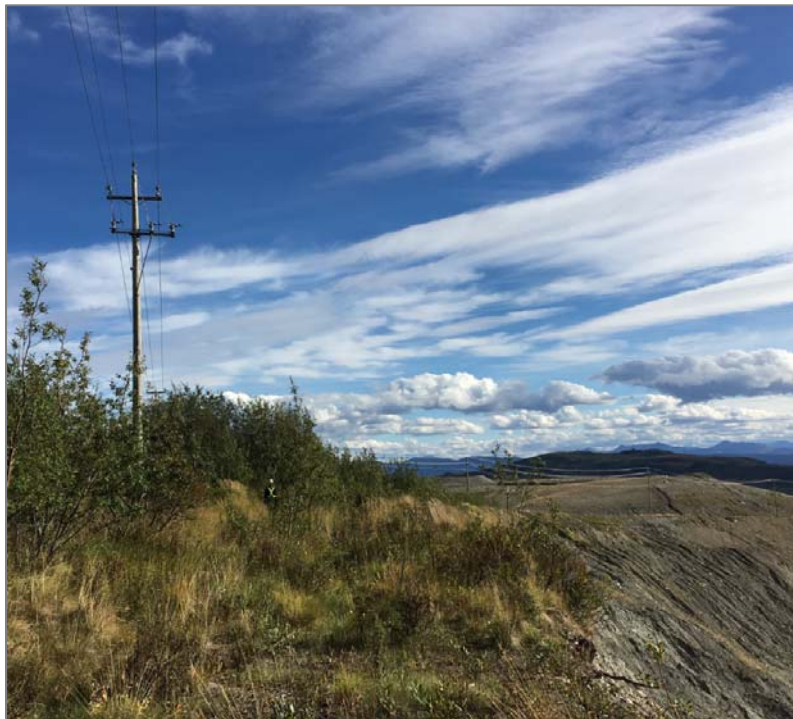
Worst-case distance from 4160V line to Grum pit-wall occurs on this particular pole, and is approximately 15m. (Optics in the photograph are somewhat deceiving). A closer view of the same pole is shown below. Note the size of the Engineer in the photograph for a reference scale:
