TECHNICAL MEMO

Date: November 28, 2009

Re: **Summary of Groundwater Monitoring Activities at the Faro Mine Complex for the 2009 Season**

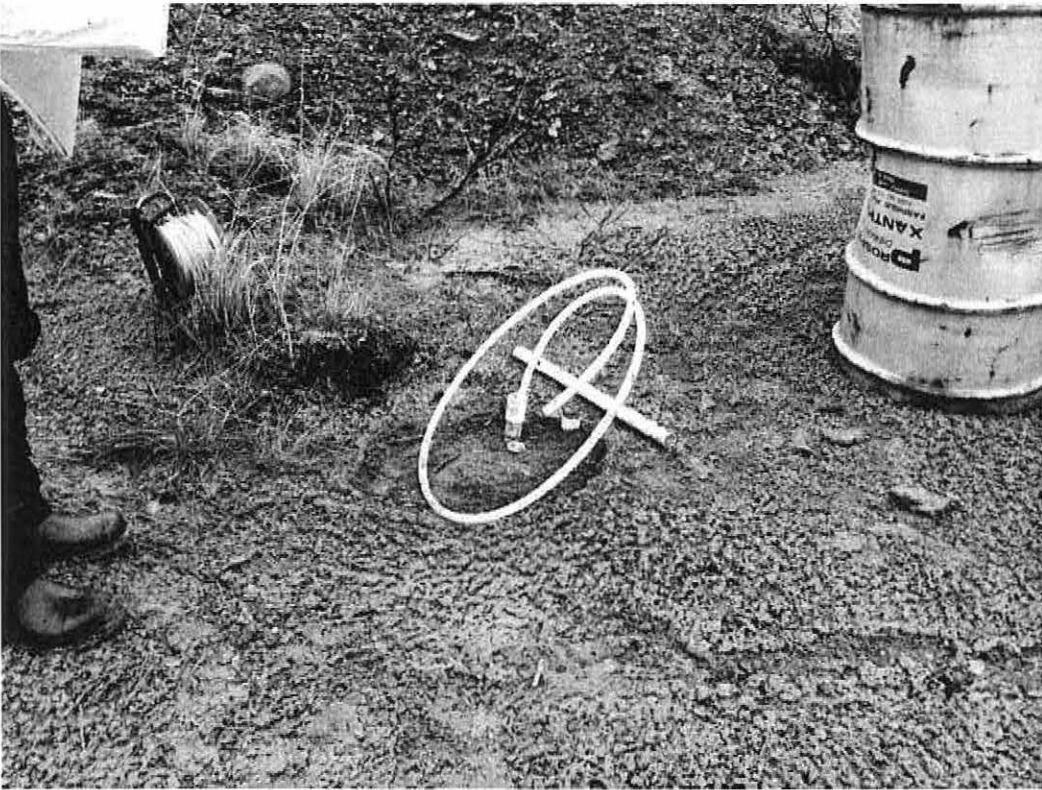
Well #	Issue and Suggested Maintenance
BH1	Broken at ground level, pipe should be extended and protective steel casing should be installed if monitoring of this well is continued.

BH1 on May 30th, 2009.

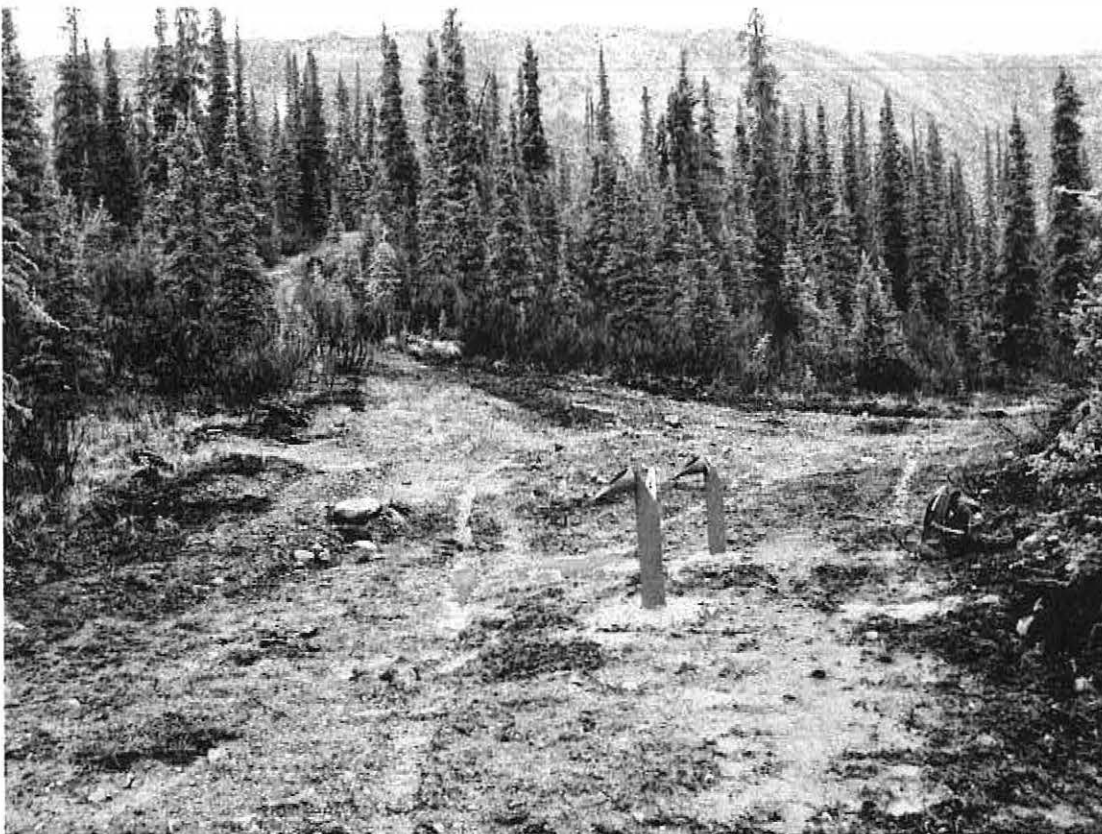
The conventional wells SRK08-13A and 13B were frozen on every sampling event. This photo was taken on May 30, 2009.

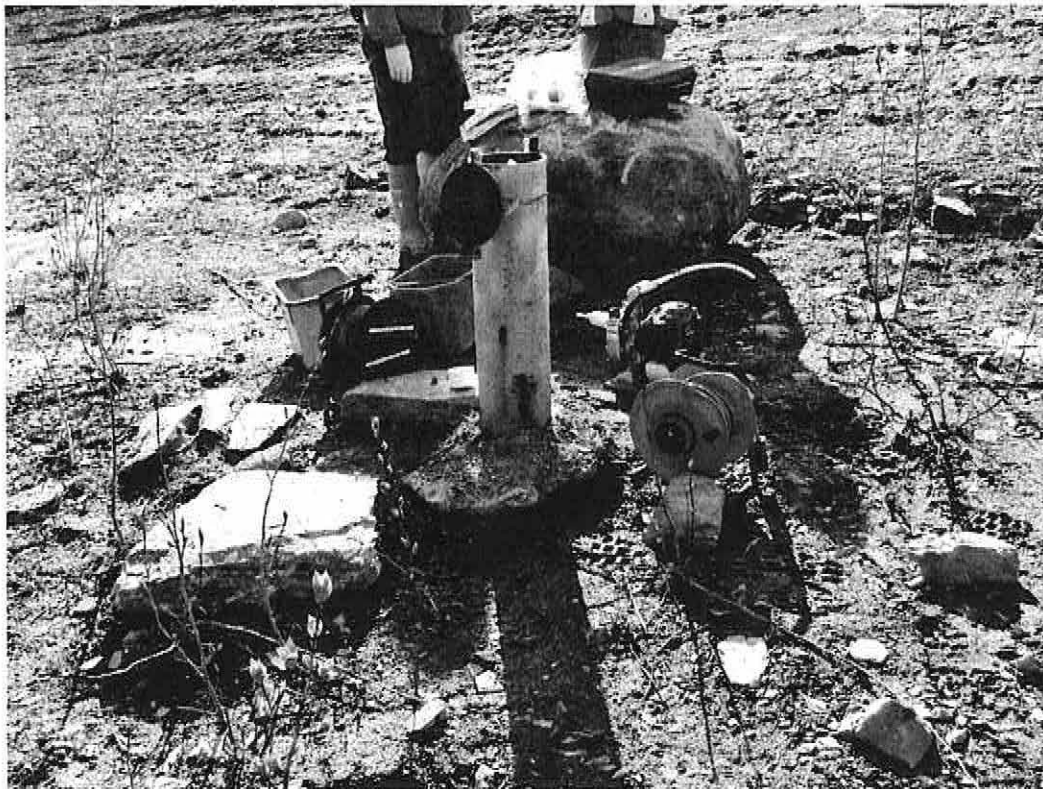
Frost jacking at P2001A and B on May 31, 2009.

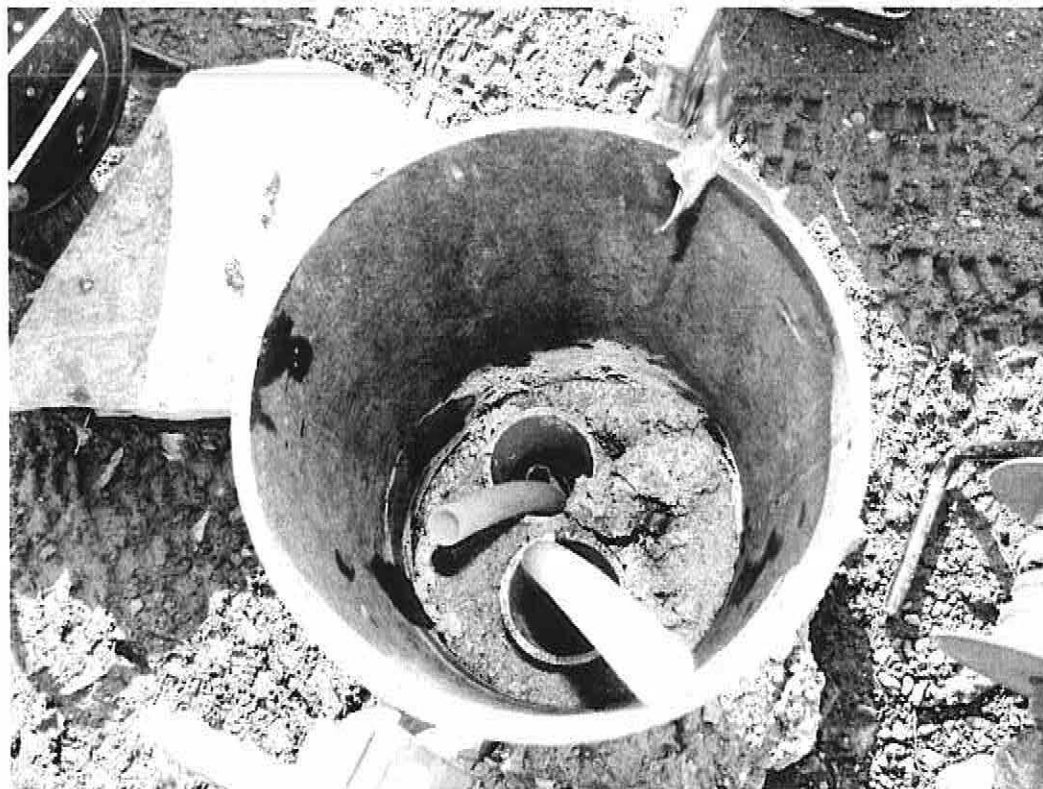
Inside P2001A and B – silica sand and bentonite inside the annular space has been pushed up to above the top of pipe, May 31, 2009.

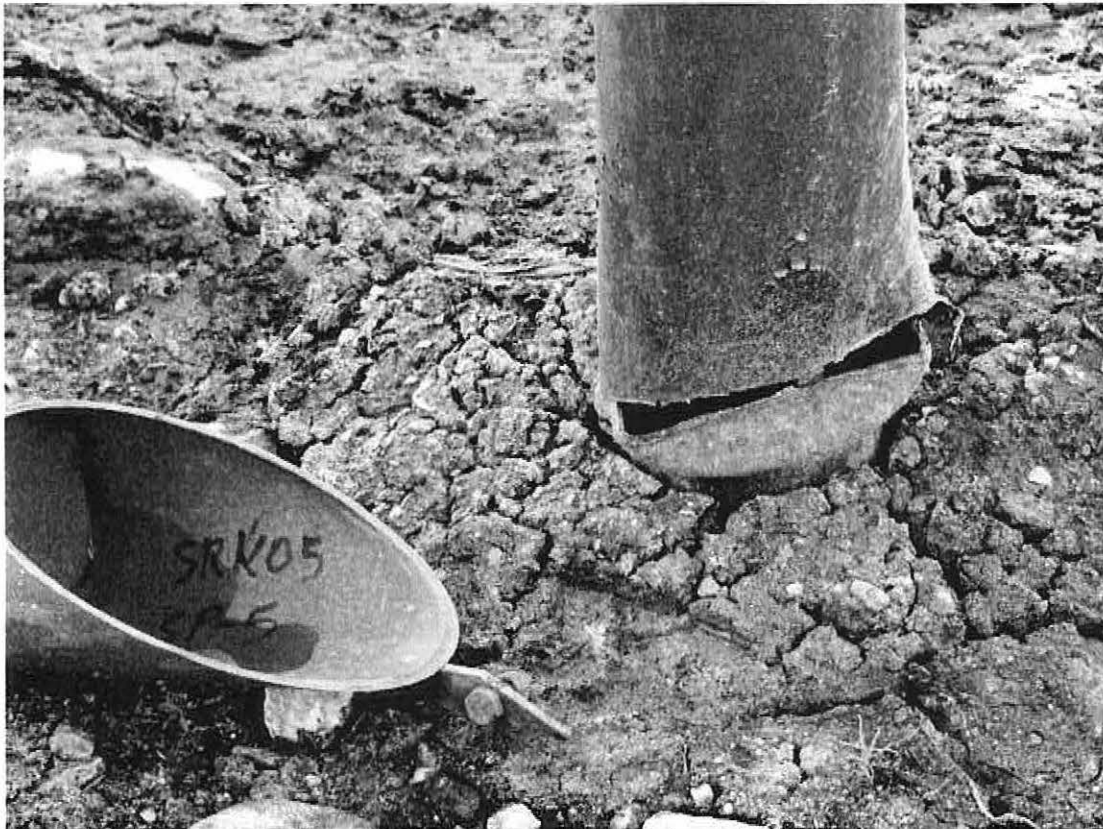
SRK05-SP5	The steel casing was broken and the well was damaged however the well was repaired by the September sampling, although a protective steel casing is still required.
X16B	AECOM was going to use their down-hole camera to check the well construction competency but due to a malfunction with the unit, photos could not be obtained.
X18B	The depth to bottom has changed significantly suggesting that the well has sloughed in at some point, DTB on Sept 6 was 10.76 m whereas it should be around 23 m. There is good yield however it is questionable whether the water being sampled is originating from the required and designed depth.

The casing and well of SRK05-SP5 had been damaged prior to May 30th, 2009.

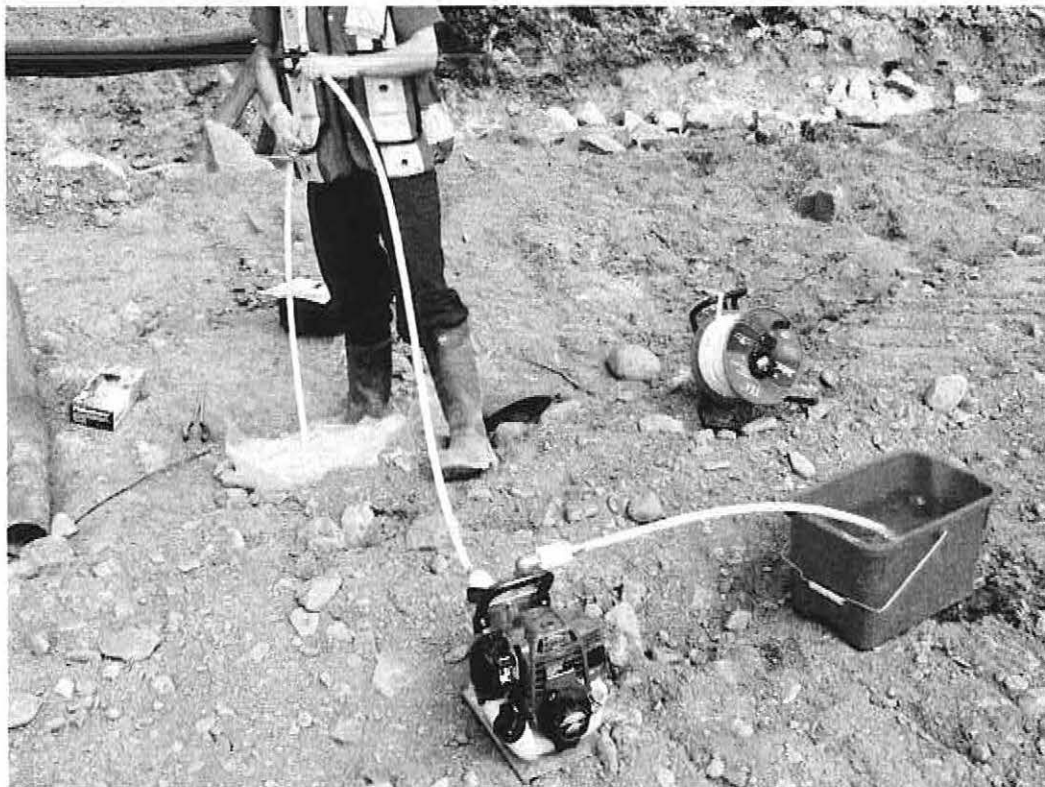
Carefully sampling SRK05-SP5 on August 4th, 2009 prior to the repair of this well.

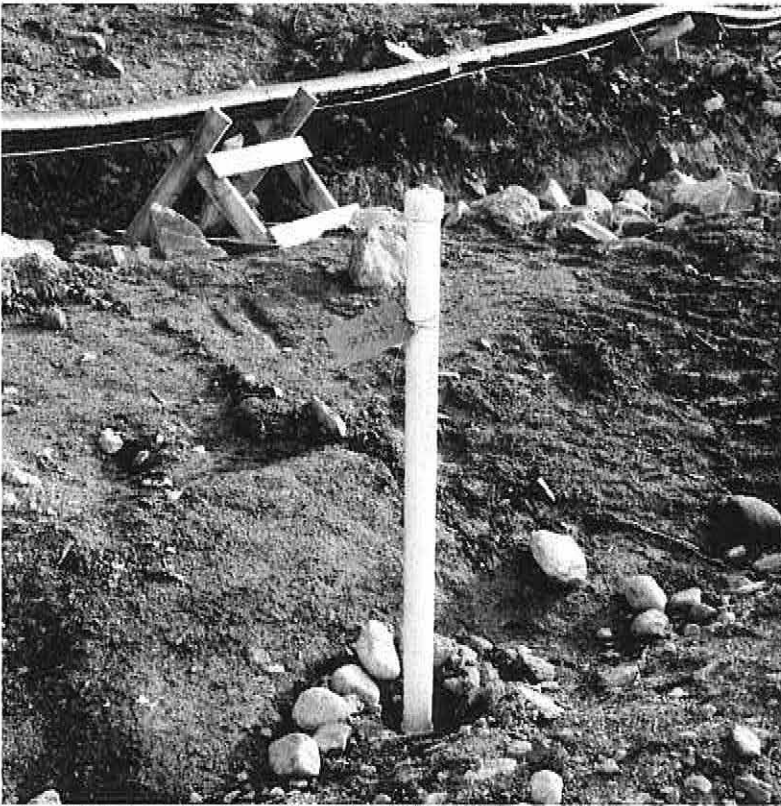
The repaired monitoring well, SRK09-SP5, Sept 11, 2009.
