**Subject: Treatment Pond Construction Inspection**  
**Galkeno 300 Adit – near Keno City, Yukon**

As requested, this letter provides a summary of the inspection services provided by EBA Engineering Consultants Ltd. (EBA) during the construction of the water treatment pond for Galkeno 300 Adit discharge water.

NEW WATER TREATMENT POND  
GALKENO 300 ADIT - GALENA HILL, YUKON

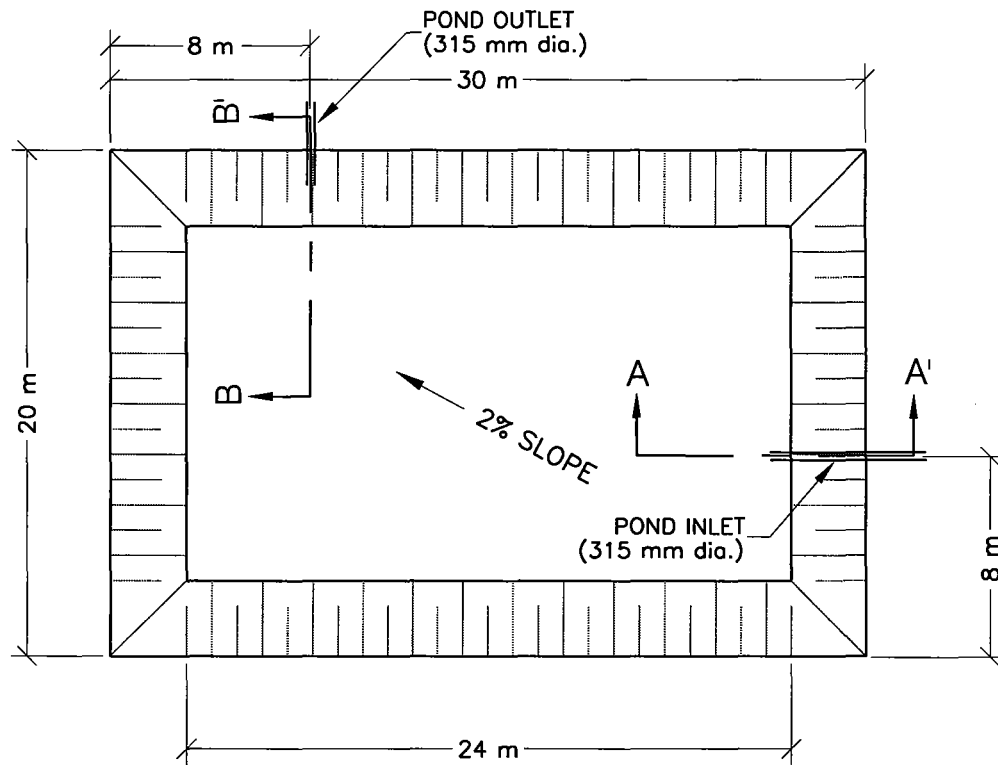
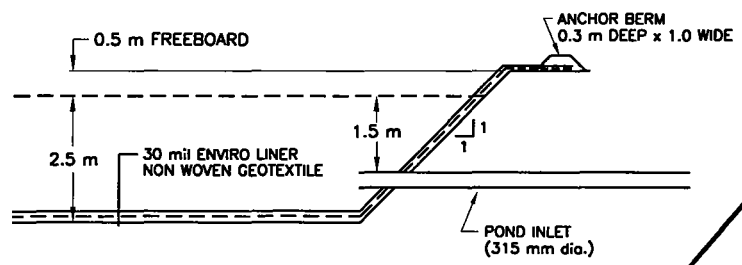
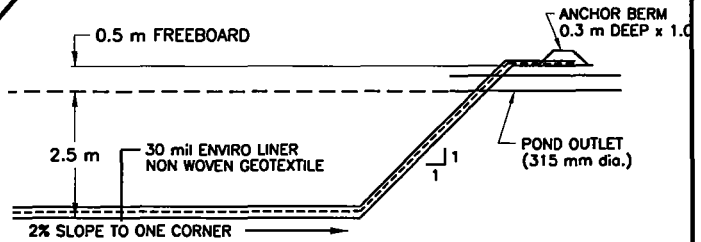
PROJECT NEW WATER TREATMENT POND GALKENO 300 ADIT - GALENA HILL, YUKON						
CLIENT ACCESS CONSULTING GROUP			TITLE PLAN AND CROSS-SECTIONS ASBUILT						
DATE	APRIL 2004	DWN.	JSB	CHKD.	JRT	FILE NO.	1200076	DRWG.	FIGURE 2

the exception of the method of securing the liner around the edge of the treatment pond. The proposed key trench to be used to secure the geotextile and Enviro-liner around the edge of the treatment pond was abandoned as excavating the still frozen ground was not possible without first heating and hoarding, which turned out to be a slow and lengthy process when first used to thaw the ground for the treatment pond.

Instead, the liner and geotextile were pinned down with 2x4 studs nailed into the ground with 200 mm spikes. The overlap was then folded over itself and covered with a 300 mm high by 1000 mm wide "berm" constructed of material excavated from the treatment pond.
