Vangorda Creek Diversion Inspection Report June, 2004

Project Reference Number:
SRK 1CD003.56

July 2004

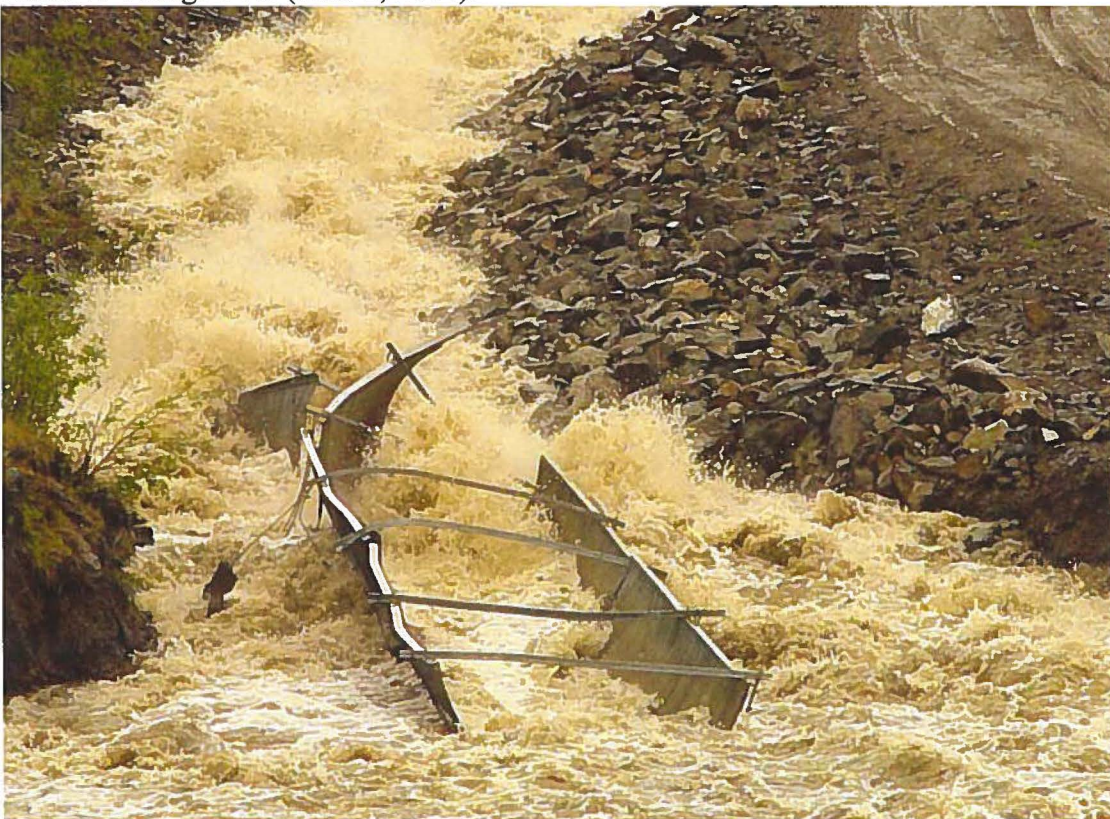
Photo 8: Flume sections at entrance to Plunge Pool (June 8, 2004).

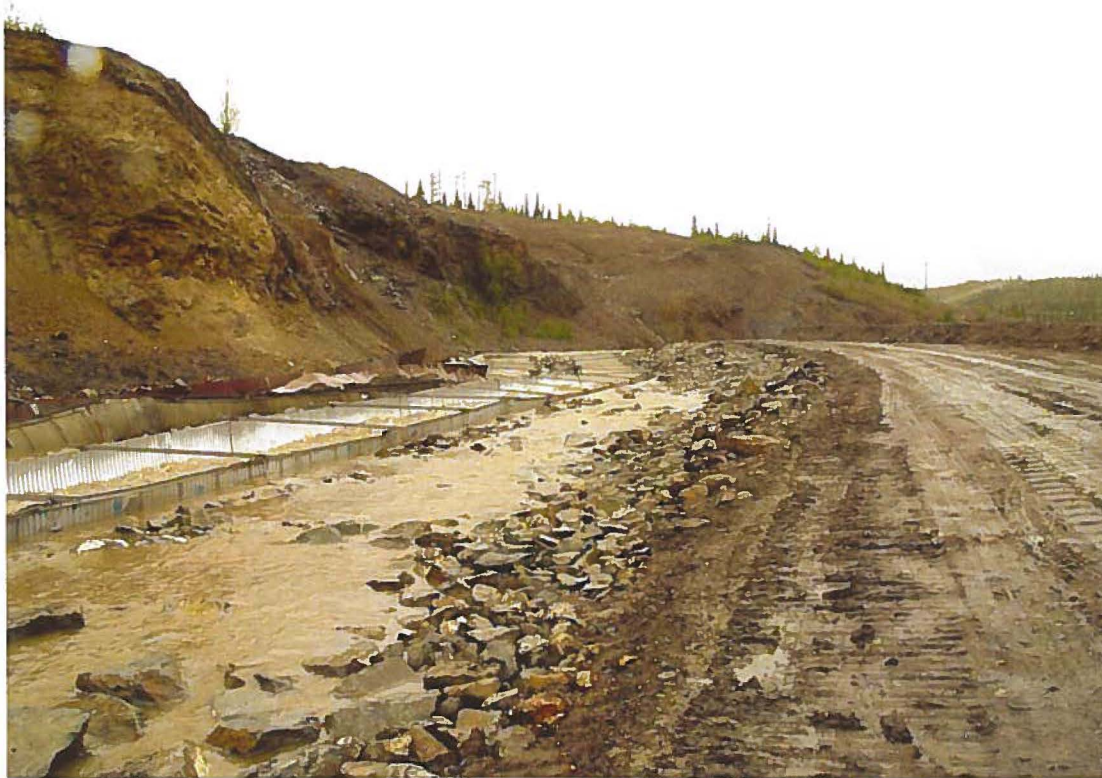
Photo 11: New flume section with old flume still in place (June 8, 2004).

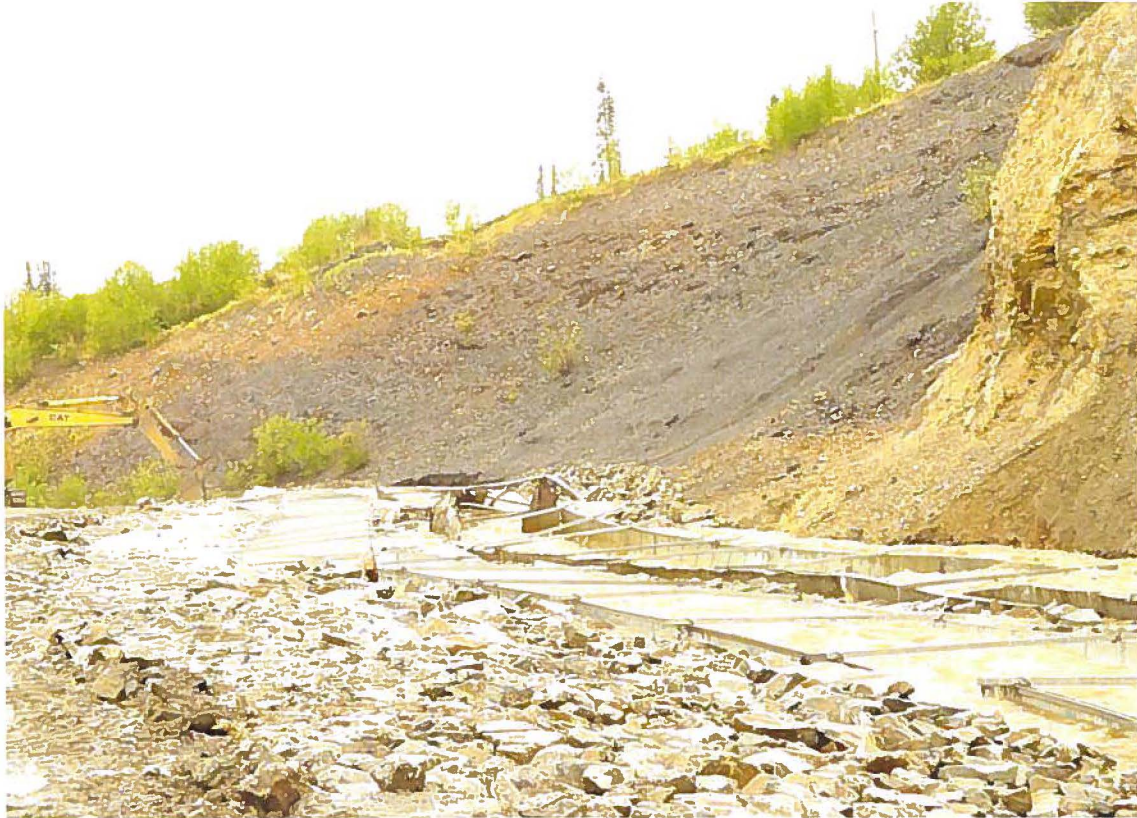
Photo 13: Backhoe restraining flume section from lifting (June 8, 2004).

- Immediately following the observation at 5:45 am of the flume condition, Anvil Site Supervision arranged to have the backhoe, which was in the area, walked up to the midpoint of the flume where the flume sections were lifting and the boom was extended out and the bucket was utilized to hold down the flume and prevent it from being destroyed by the fast moving water.

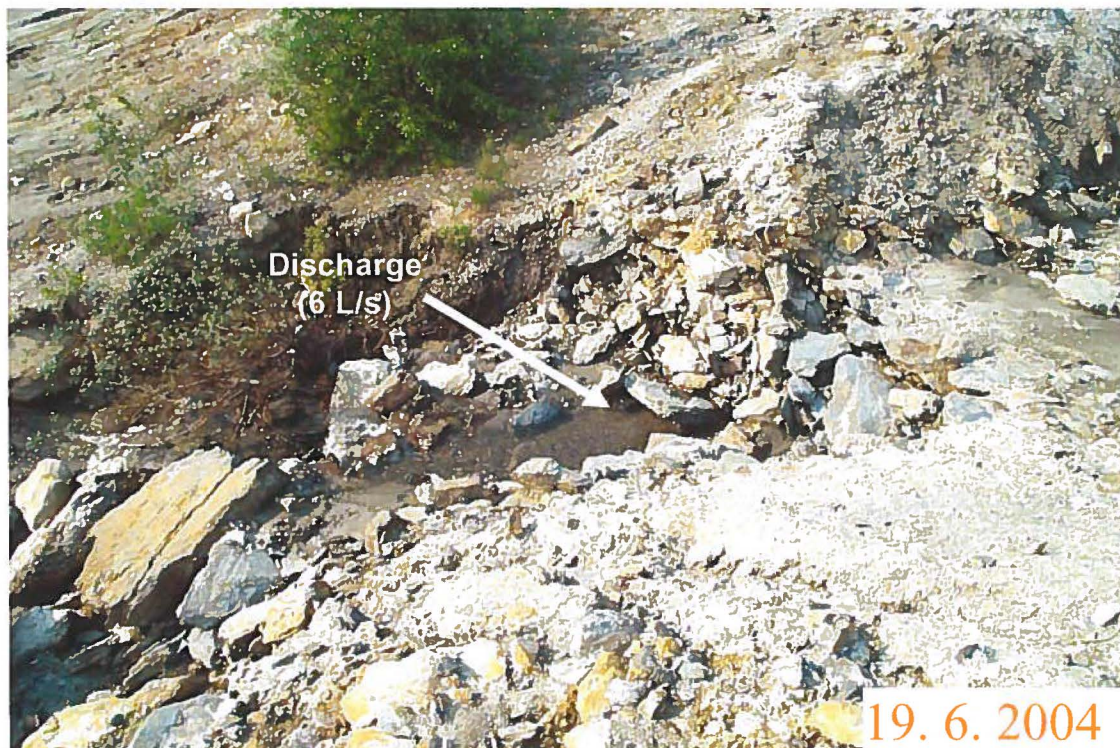
Following the June 8, 2004 flood event, several smaller rainfall events occurred, which generated runoff in the surrounding drainage ditches and culverts. The drainage ditch, which runs along the haul road towards the Vangorda Pit, flows into a culvert at a low point in the road. From the culvert, the flow discharges via a gully that runs alongside the drop structure into the Vangorda Pit. As the weather conditions improved and the runoff diminished, mine staff discovered a discharge from northwest corner of the pit wall. With further investigation, it was found that the discharge was originating from a spring in the gully that runs alongside the drop structure. The discharge zone was located on the bedrock surface at the edge of the pit (Photo 1). It had not been identified previously because it had been masked by the runoff from the surrounding area. The flow rate was estimated to be about 6L/s (see Photo 16). The drop structure and the gully are shown in Photos 17 and 18.

Photo 16: Discharge zone below drop structure.

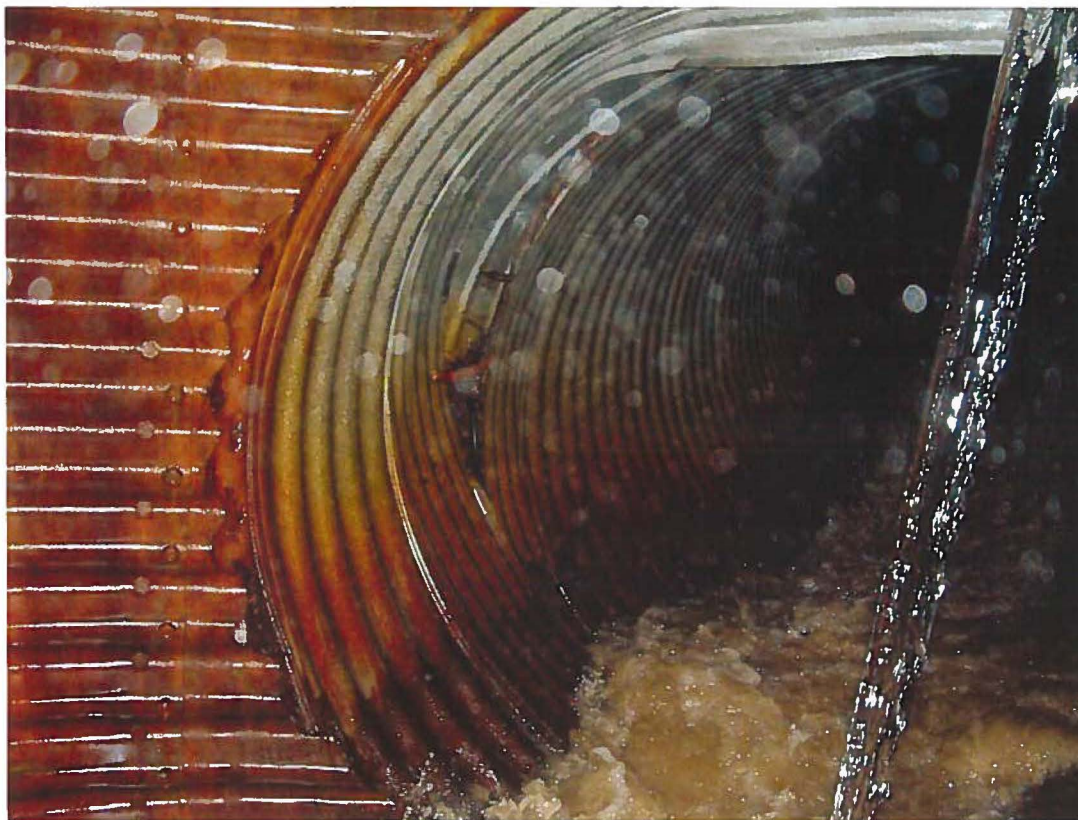
Once inside the drop structure, it was discovered that the leak was in fact caused by a separation in the coupling just inside the 2000mm pipe (see Photos 19, 20, 21 and 24). Damage to the crown of the 2000mm nipple was also observed. As water was still flowing into the drop structure at the time of the inspection, no attempt was made to inspect the base of the drop structure below the invert of the 1600mm culvert. However, a visual inspection of the 1600 joint did confirm that there had been no damage to this culvert.

Photo 19: View of joint separation in 2000mm Ø culvert taken from inside of 3000mm Ø drop structure

Planning for the repair to the damaged joint in the 2000mm pipe should be initiated immediately. Parts and materials to carry out the repair should be purchased as soon as possible. The repair work, however, should be conducted under dry conditions with no flow in the system. Consequently, this work would be carried out during the low flow period, which normally occurs late July or early August.

The repair to the damaged joint would likely involve excavating around the joint and installing a larger collar with a rubber gasket. An attempt could also be made to straighten and weld the damaged sections of the pipe from both the inside and the outside of the pipe and then encasing the joint in concrete.

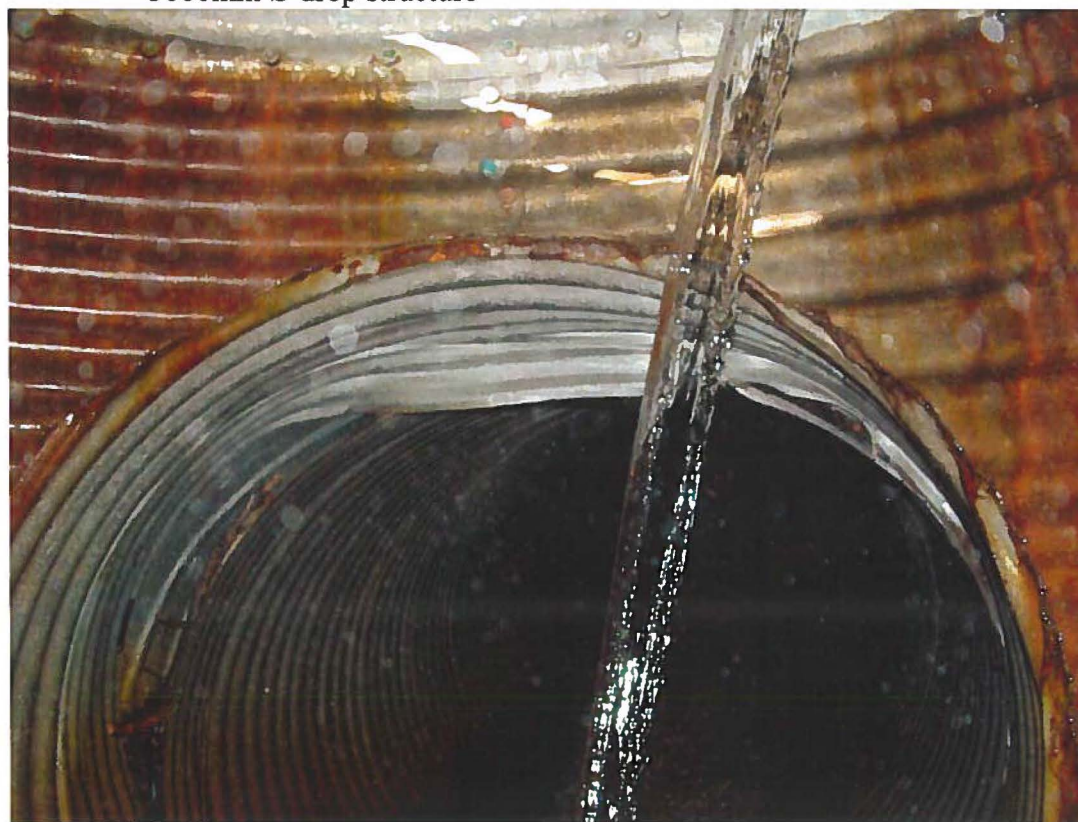
Photo 20: View of buckling in the crown of the 2000mm nipple.

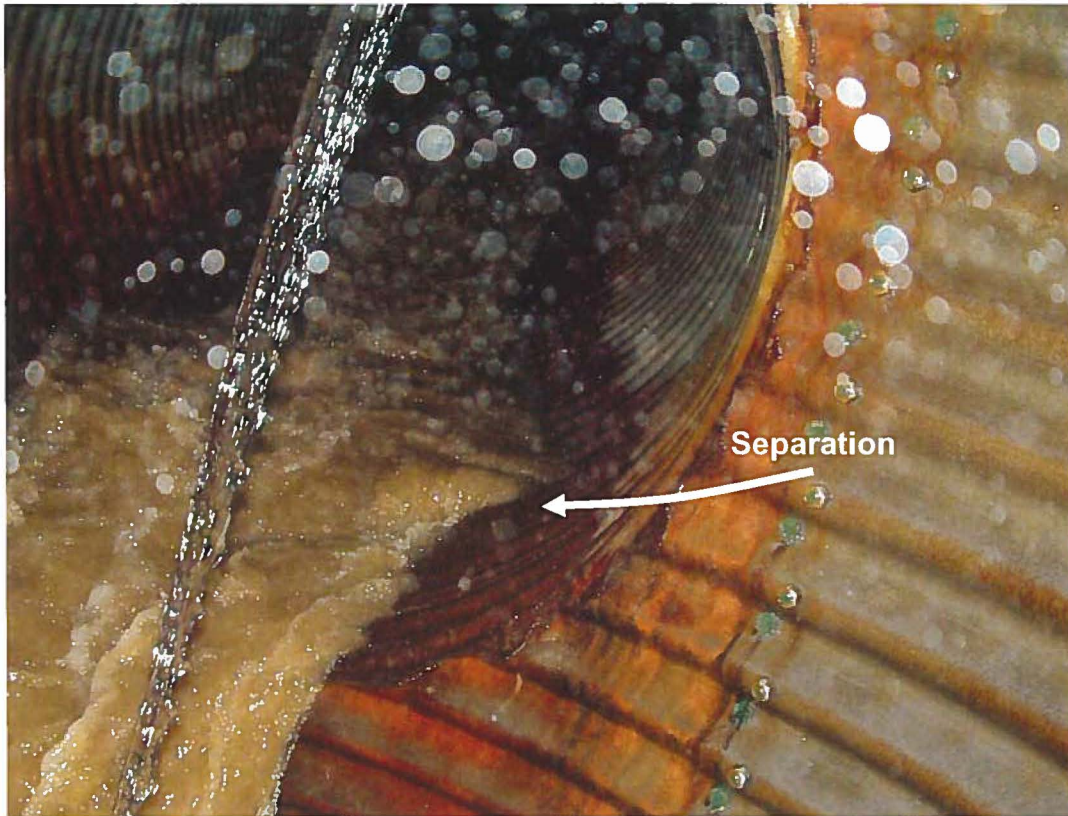
Photo 21: View of joint separations in the 2000mm Ø culvert.

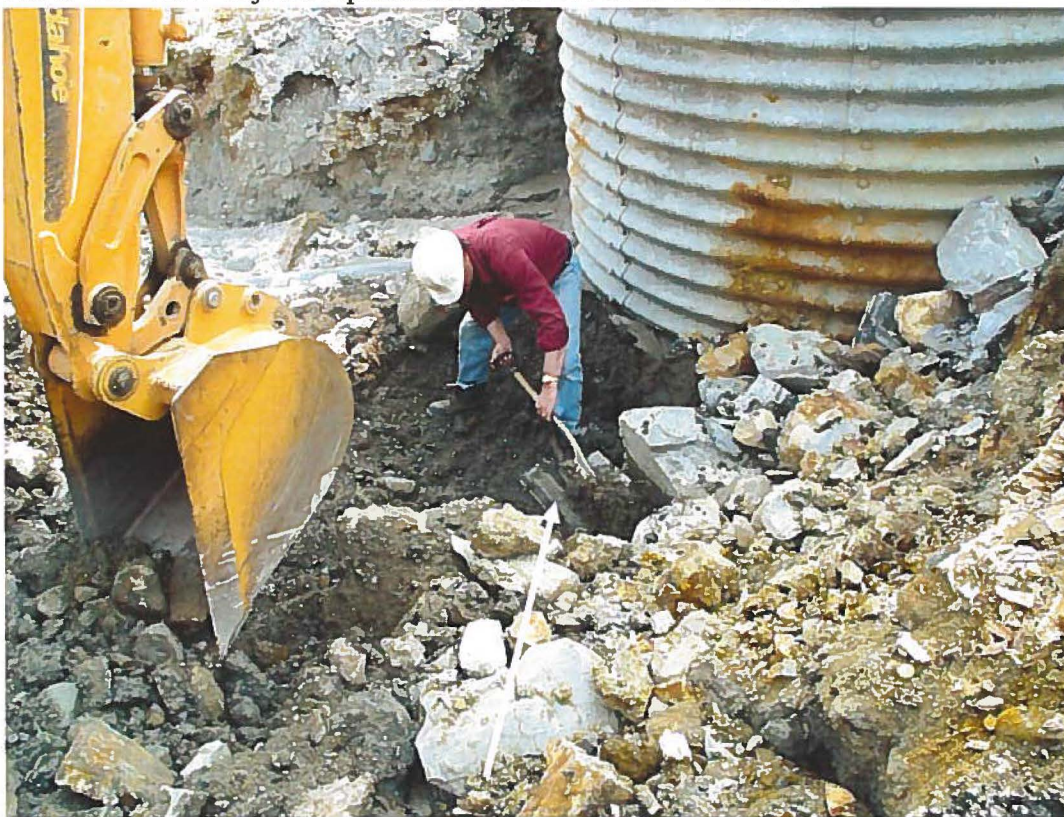
As possible remedial measures to correct the damage to the coupling would include replacement of a section of the 2000mm pipe and re-establishing the coupling, the crown of the pipe was exposed at the location of the joint to assess the nature of the coupling and its precise location (See Photos 22 and 23).

Photo 22: Exposed crown of separated joint in 2000mm Ø culvert.

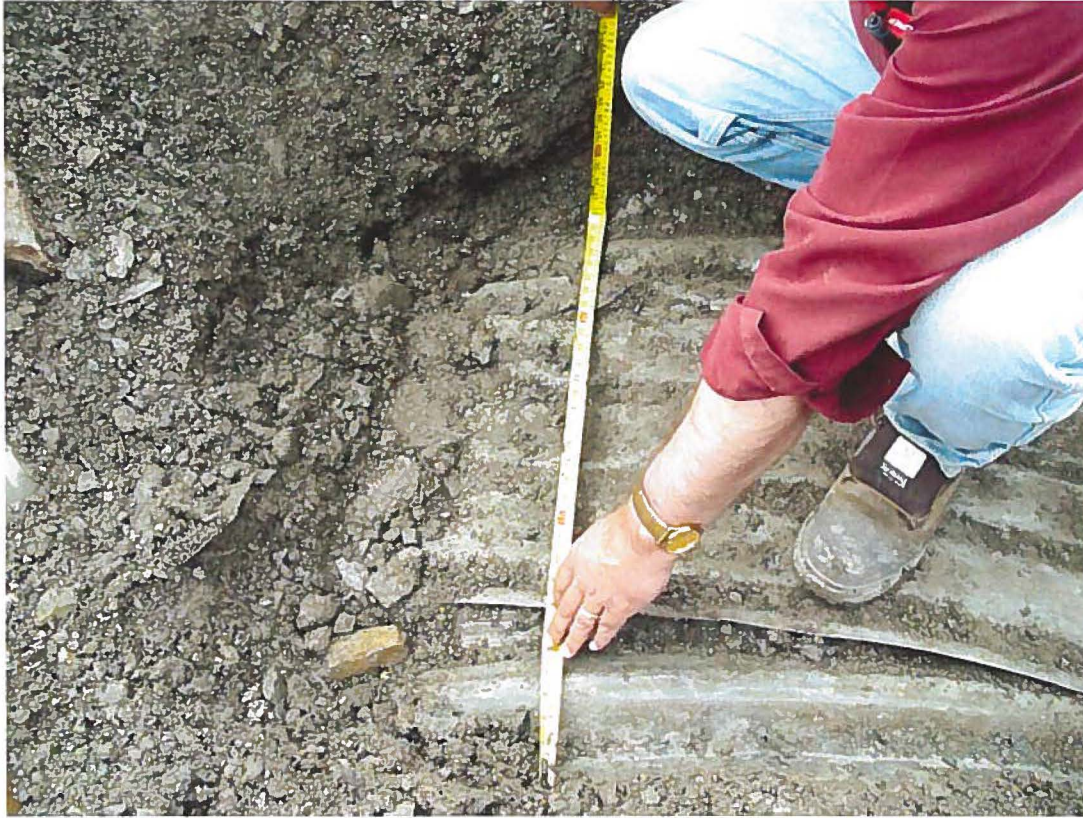
Photo 23: Coupling at 2000mm Ø joint with nipple.

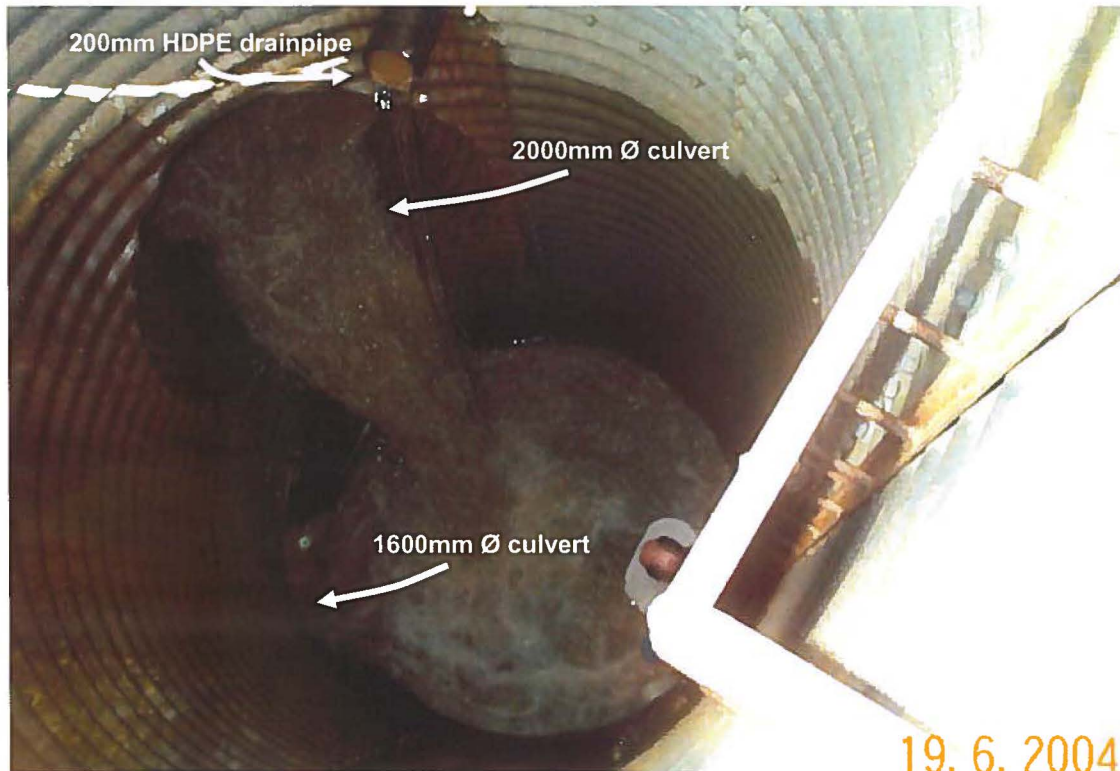
Photo 24: View of drop structure

During the repair work, an inspection of the base of the 3000mm pipe should be carried out as well as a more thorough inspection of the 1600mm culvert.

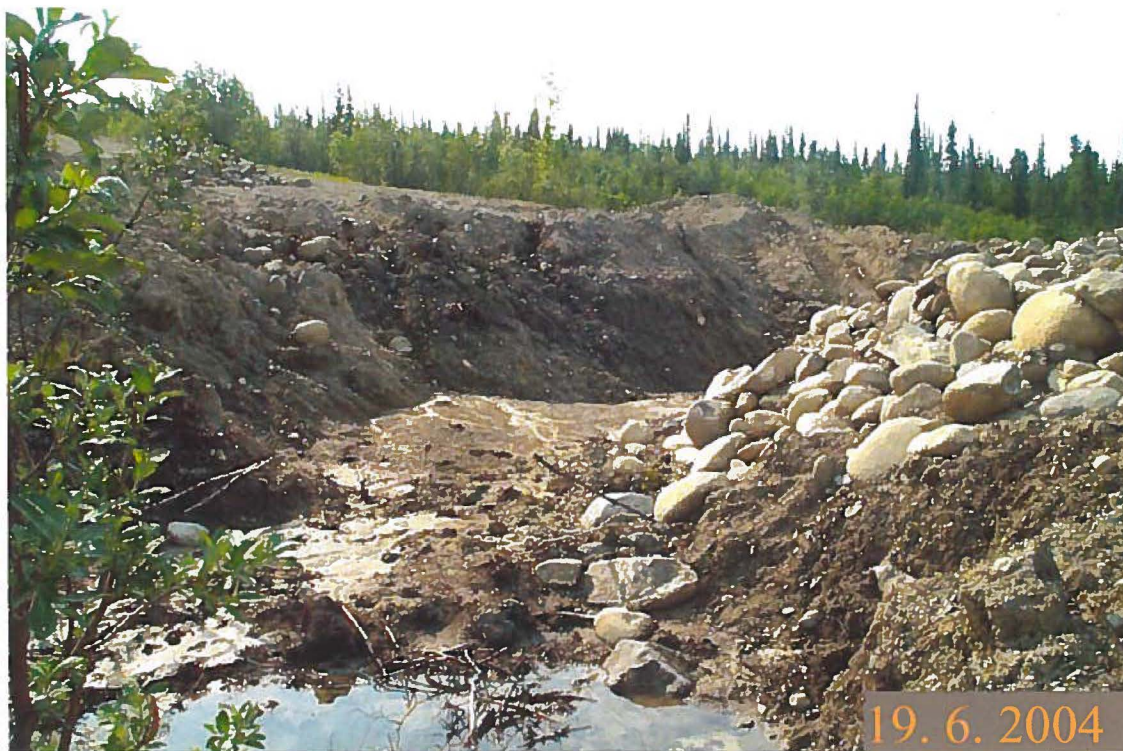
Photo 25: Excavated channel on south abutment of headworks embankment.

It is recommended that the breached section in the south abutment of the headworks embankment be replaced with an engineered overflow spillway to the Vangorda Pit. The purpose of the spillway would be to provide additional security for the diversion channel over the next 5 to 10 years until implementation of the Final Closure and Reclamation Plan. It is recommended that the spillway consist of two 1m diameter CSP culverts installed at an invert elevation 4 metres below the crest of the existing embankment. Under these conditions, flow in the overflow spillway would begin to spill into the Vangorda Pit once the flow exceeds the current system design capacity of $10\text{m}^3/\text{s}$. This would provide additional protection against overtopping of the embankment during a more extreme event than the June 8, 2004 flood. The spillway would also provide additional security for the flume and the energy dissipation system. Figure 13 illustrates the flow capacity of the proposed combined system and the impact of the spillway on the overall system.

In order to prepare a final design for the spillway and to confirm the hydraulic capacity of the existing system, it is recommended that a survey be carried out at the headworks embankment and around the area of the breach.

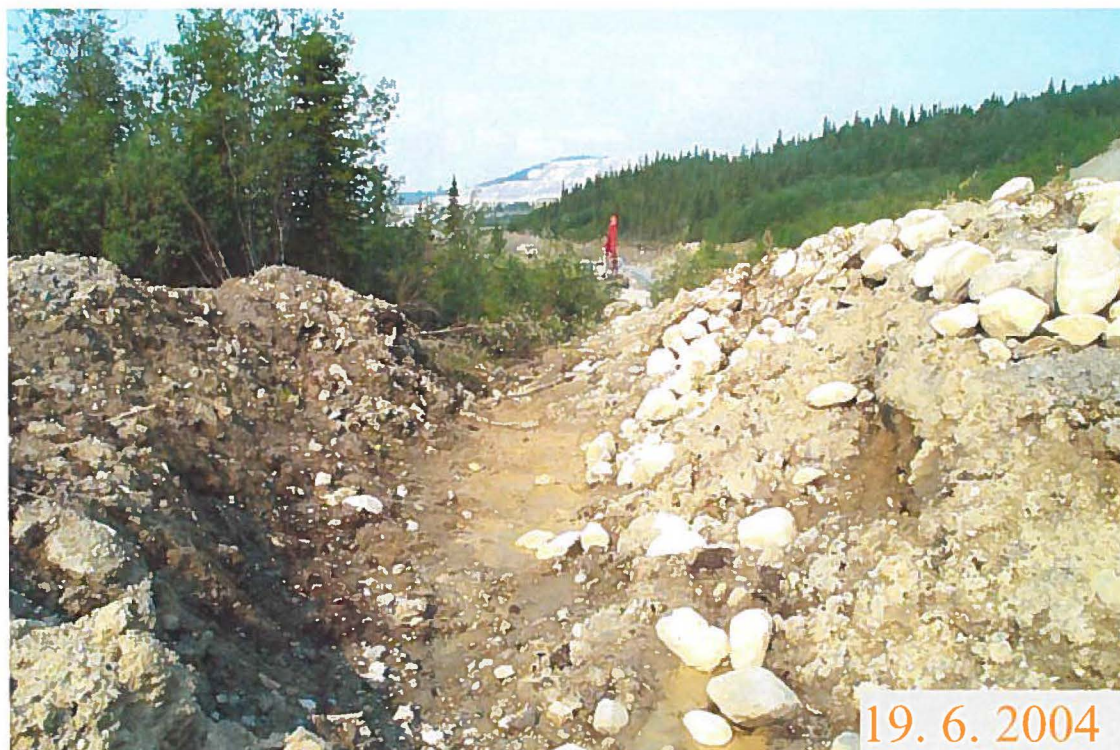
Photo 26: Excavated channel on south abutment of headworks embankment.

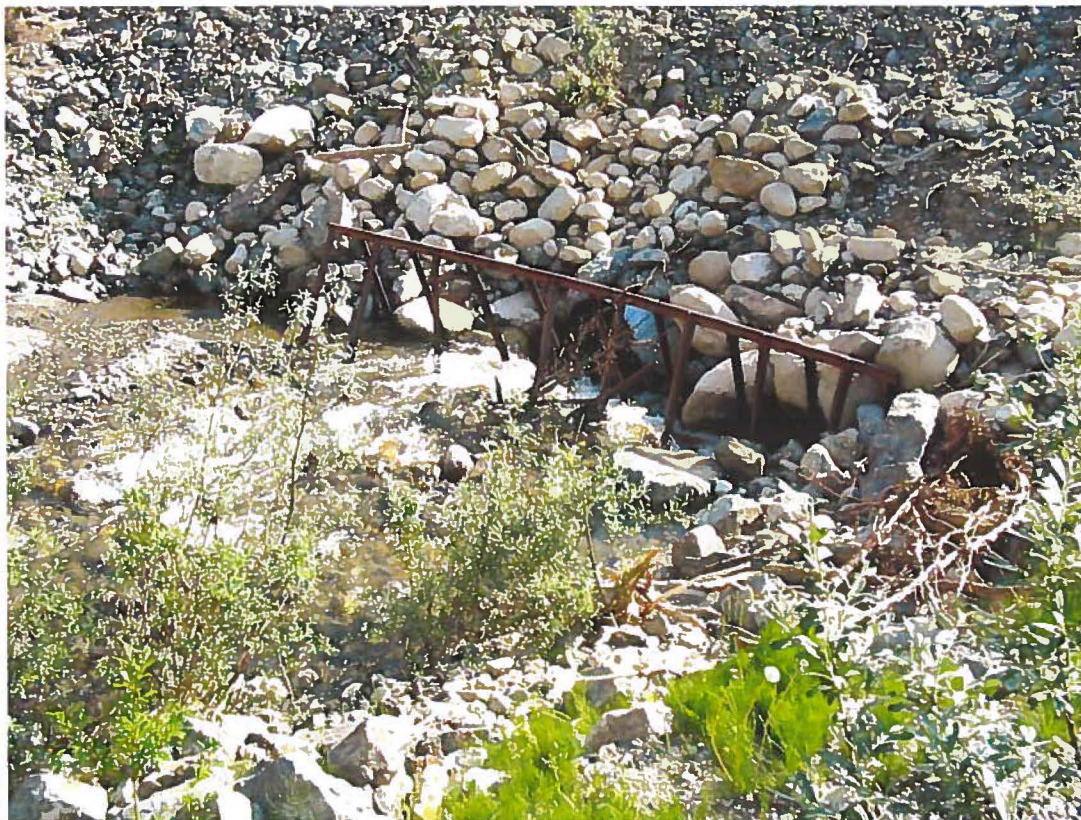
Photo 27: Trash rack at inlet to 1800mm Ø culvert at headworks embankment.

SRK also recommends that the cobbles and debris that have accumulated at the entrance to the 1800mm diameter culvert be removed.

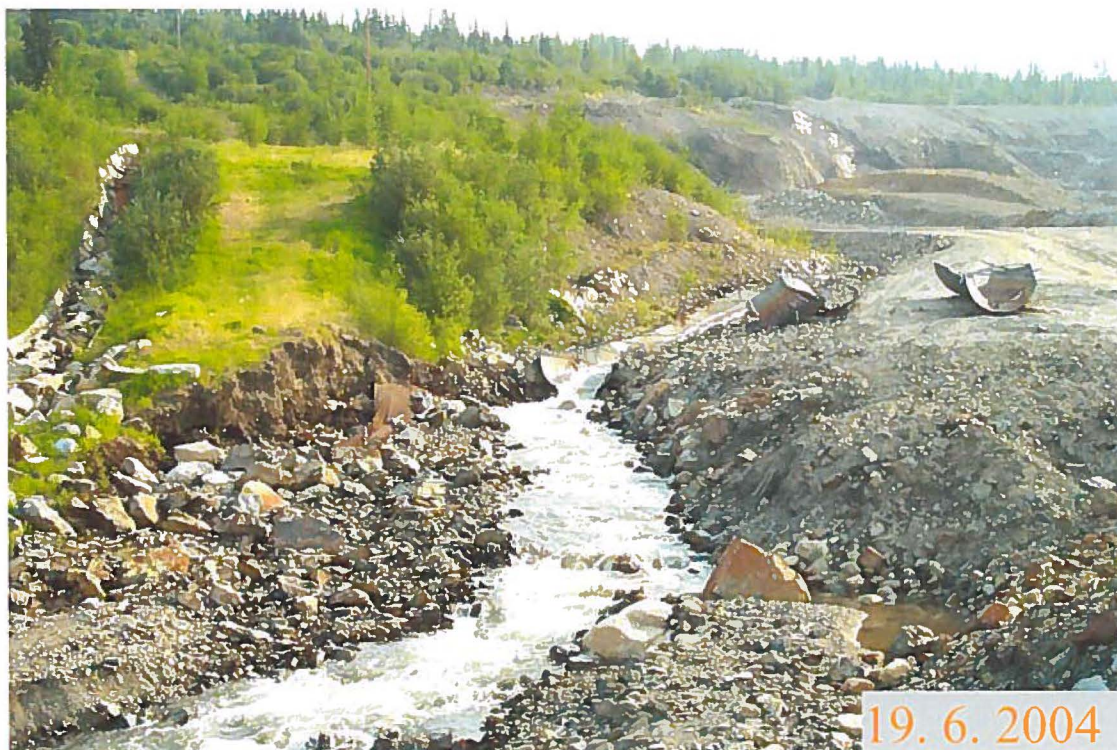
During the peak of the flood, water accumulated in the plunge pool at the outlet of the flume and the headwater rose to about 1.2 to 1.5 metres above the crown of the 2000mm culvert. The rising waters caused erosion of the bank adjacent to the flume access road. Deloitte carried out temporary remedial work on the bank by placing several loads of granular material to prevent further erosion (Photo 28). Two of the end sections of the flume were badly damaged during the flood and have been removed (See Photo 28).

Photo 28: Plunge Pool at bottom of flume.

Following the assessment, SRK will provide recommendations on restoration of the existing flume and channel. It is anticipated that these recommendations will include replacement of a number of flume sections, reconstruction in some places of the channel section, removal of the obsolete flume sections, replacement of riprap where required and repairs to the damaged flume joints. SRK will also provide recommendation on the plunge pool which will likely include removal of the debris and alluvial deposit in the bottom of the pool and restoration of the riprap protection around the sideslopes.

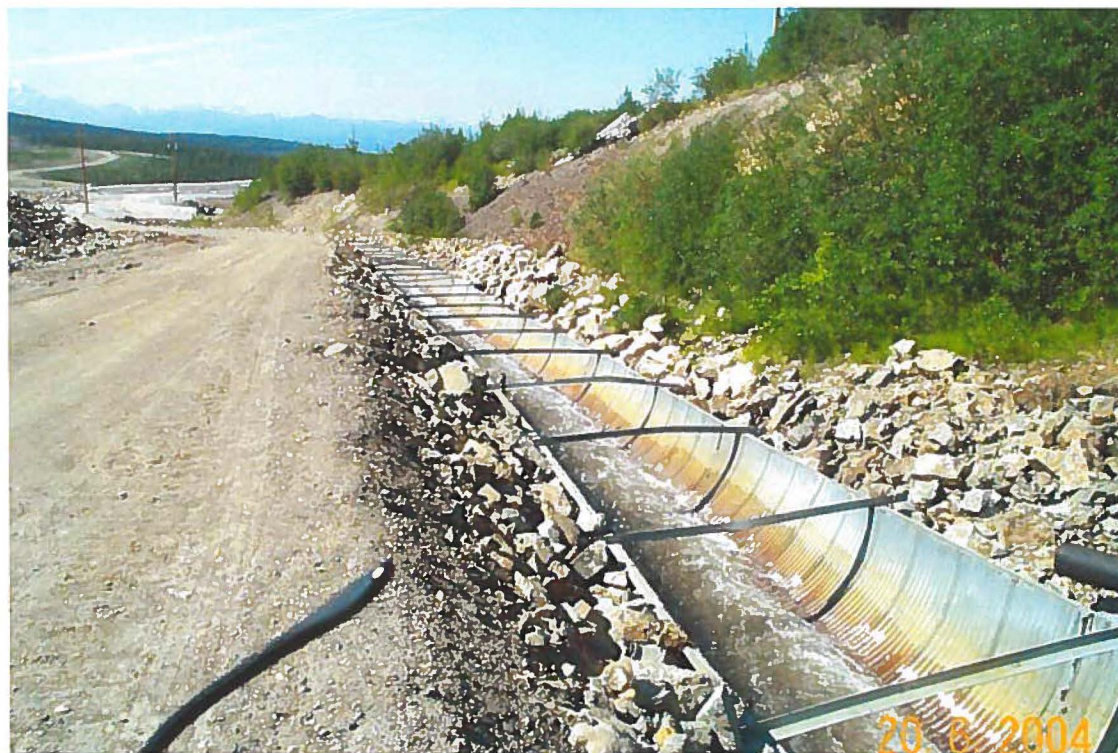
Despite the high flows the flume experienced, overall the facility performed in accordance with the original design (Photo 30). However, many of the cross braces were buckled during the flood and some of the joints between the 6m flume sections have weakened (Photo 29). Some of the anchor ties that hold the flume sections down loosened and lifting of some flume sections was experienced. Photo 13 shows one particular flume that was lifting during the flood and was held down by an excavator. It is currently held down using a heavy steel canopy (Photo 33). It is believed that the lifting was a result of high velocity flow on the uphill side of the new flume section.

Photo 30: Transition between lower and middle reaches of flume and channel.

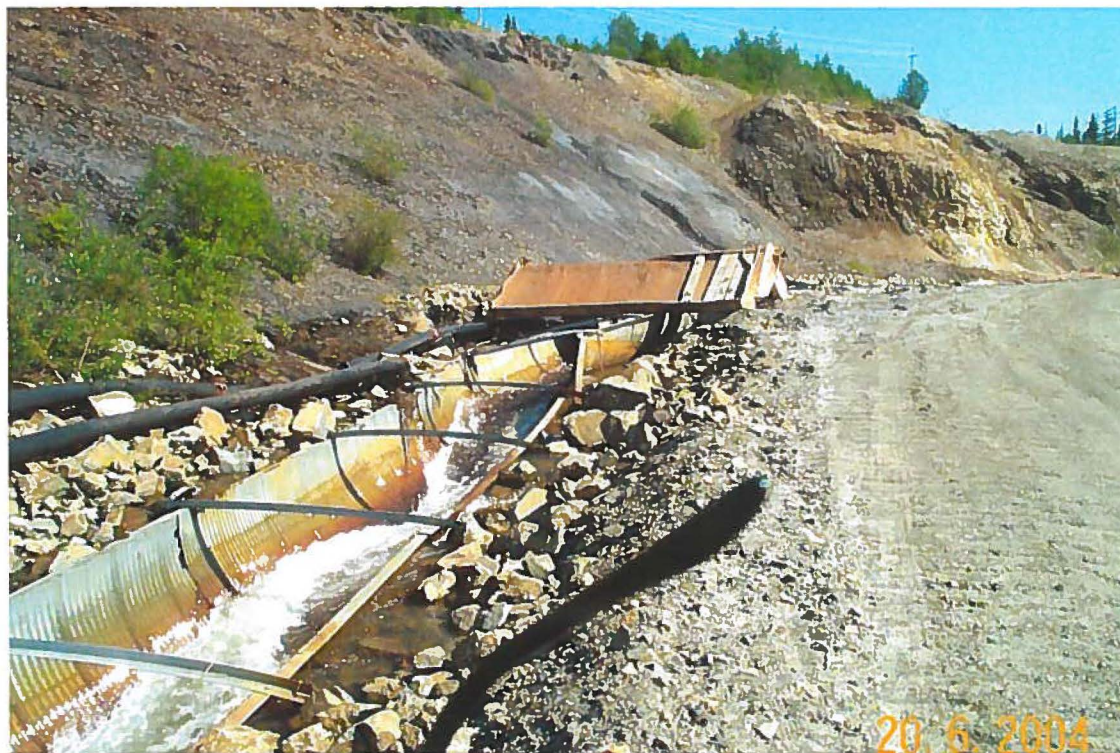
Photo 32: Section of flume that experienced most severe lifting during flood.

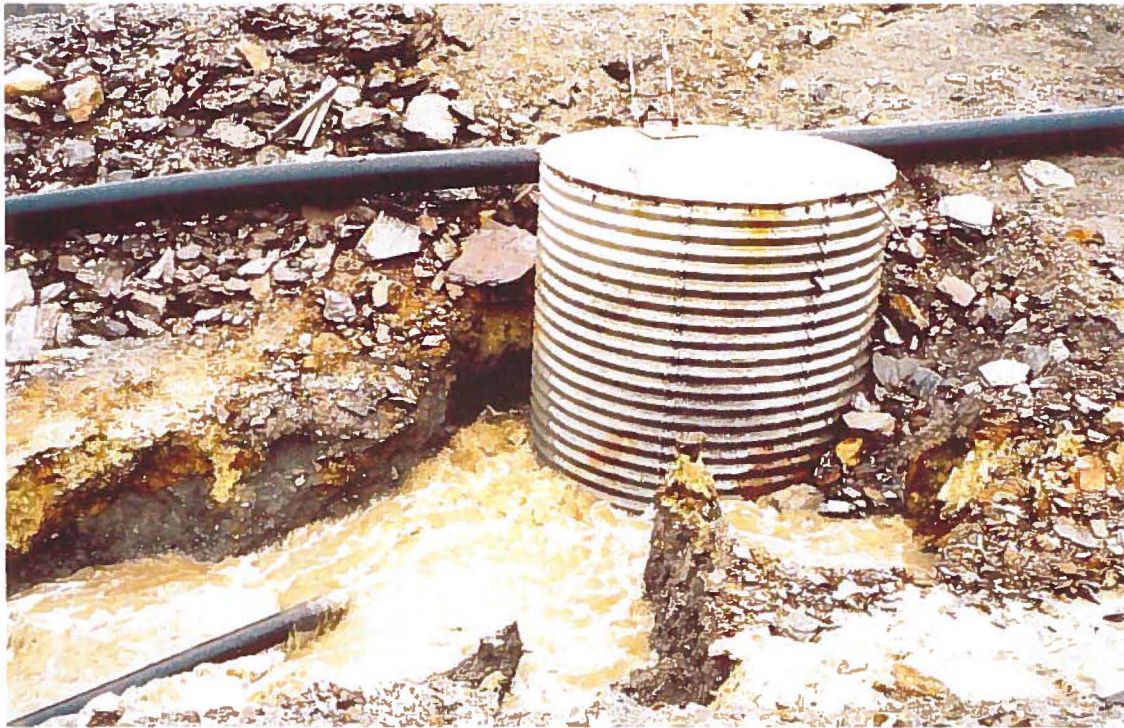
Photo 37: Drop structure during flood event. (June 8, 2004)

- The water running through the flume ditch was observed to be within 30 cm of overtopping the road running alongside the flume system.
- The drop box was inspected during the event and a significant amount of water (approximately 30%) was flowing from around the drop box into the Vangorda pit as the drop box capacity had been exceeded.
