DELOITTE AND TOUCHE INC.  
AS INTERIM RECEIVERS FOR  
ANVIL RANGE MINING CORPORATION

1998 ANNUAL ENVIRONMENTAL REPORT  
FOR WATER LICENCE IN89-002  
VANGORDA PLATEAU

MARCH 1999

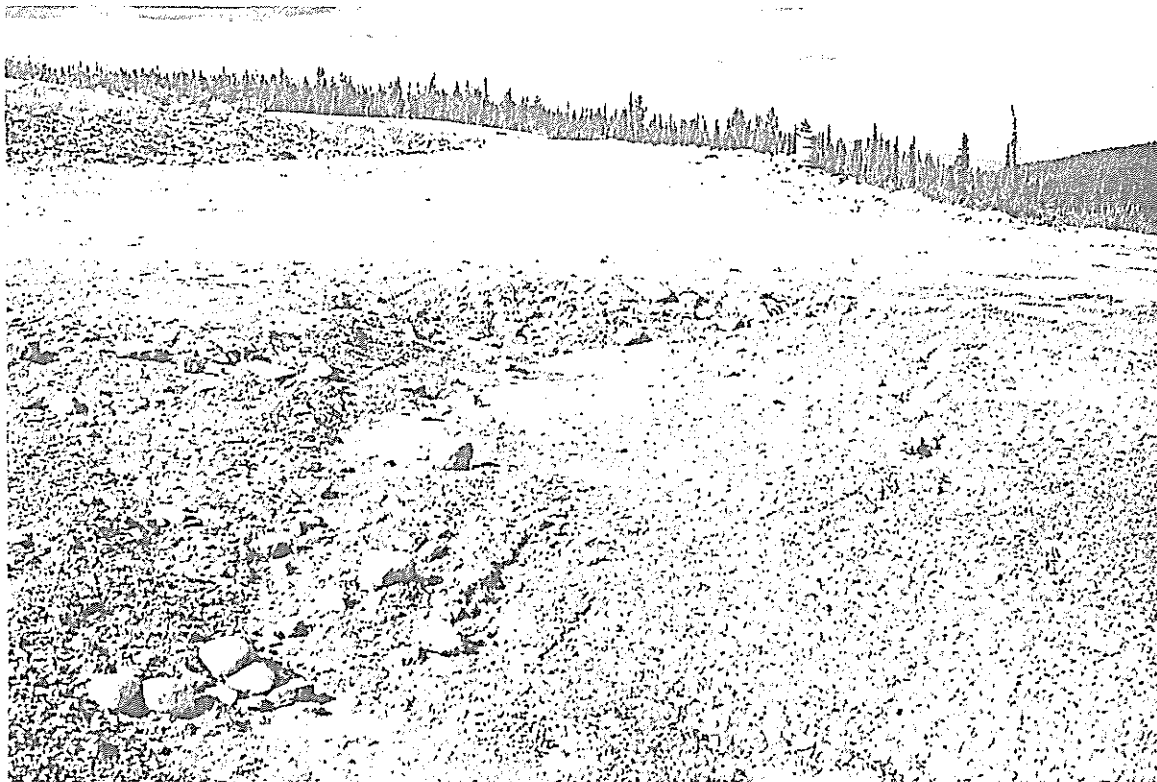
At the outlet of the seepage channel and at the south abutment of the Little Creek Dam, a small depression still exists causing ponding of water (Photo 1). The remaining sections of the dyke show no signs of settlement, cracking or sloughing.

Photo 1 - Small depression at south abutment of Little Creek Dam.

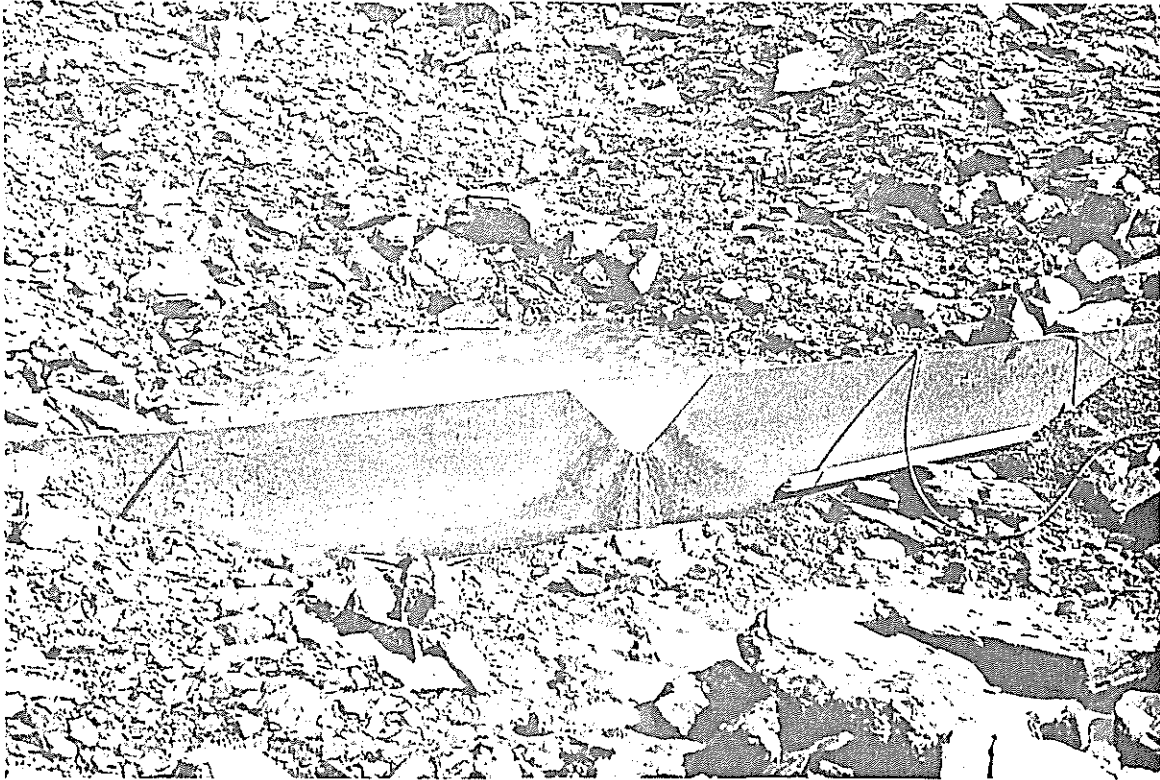
During this years inspection, flow was observed in Drains 3, 5 and 6 only. The v-notch weirs used to monitor the flow, are functioning adequately. However maintenance is required at Weir 6. Large erosion gullies have developed in the starter dyke above Weir 6 caused by runoff from the access road above the weir (Photo 6). Silt has built up behind the weir and is impeding the flow through the notch. The eroded material has also covered the outlet of the transverse drain. Weirs 2, 3 and 5 are shown in Photos 2, 3 and 4 respectively.

Photo 3 - Weir at drain 3.

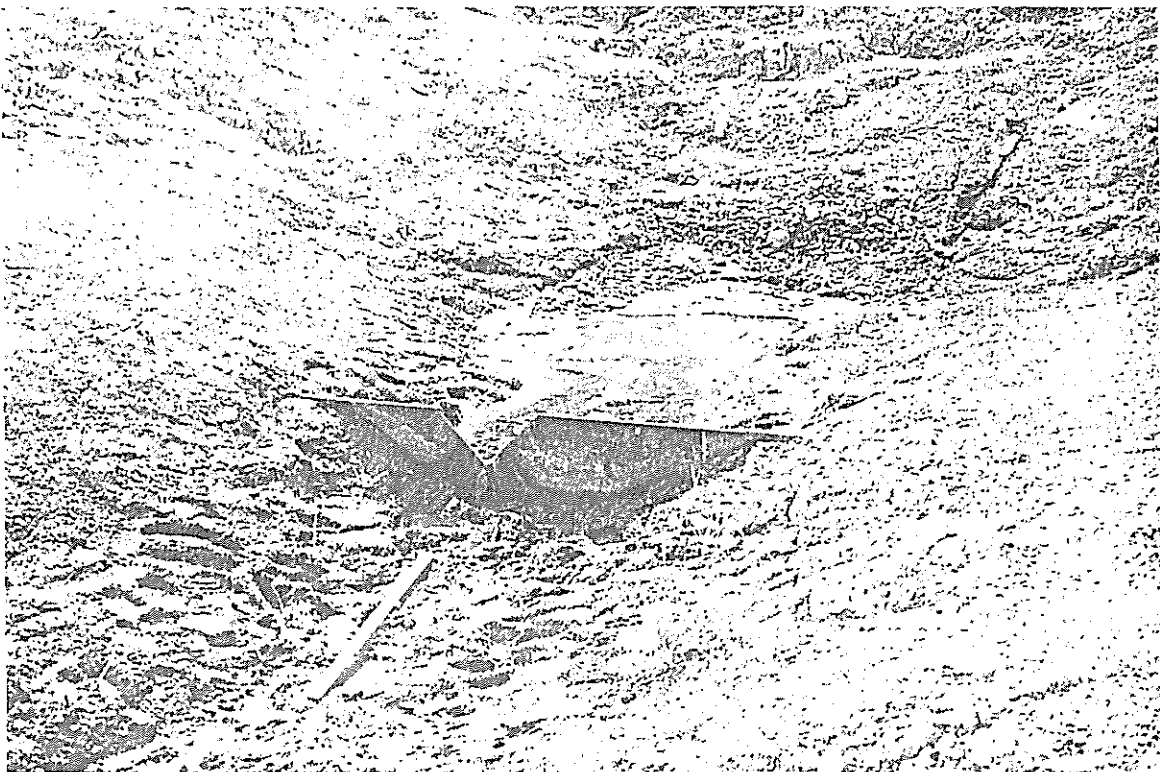
Photo 4 - Weir at drain 5.

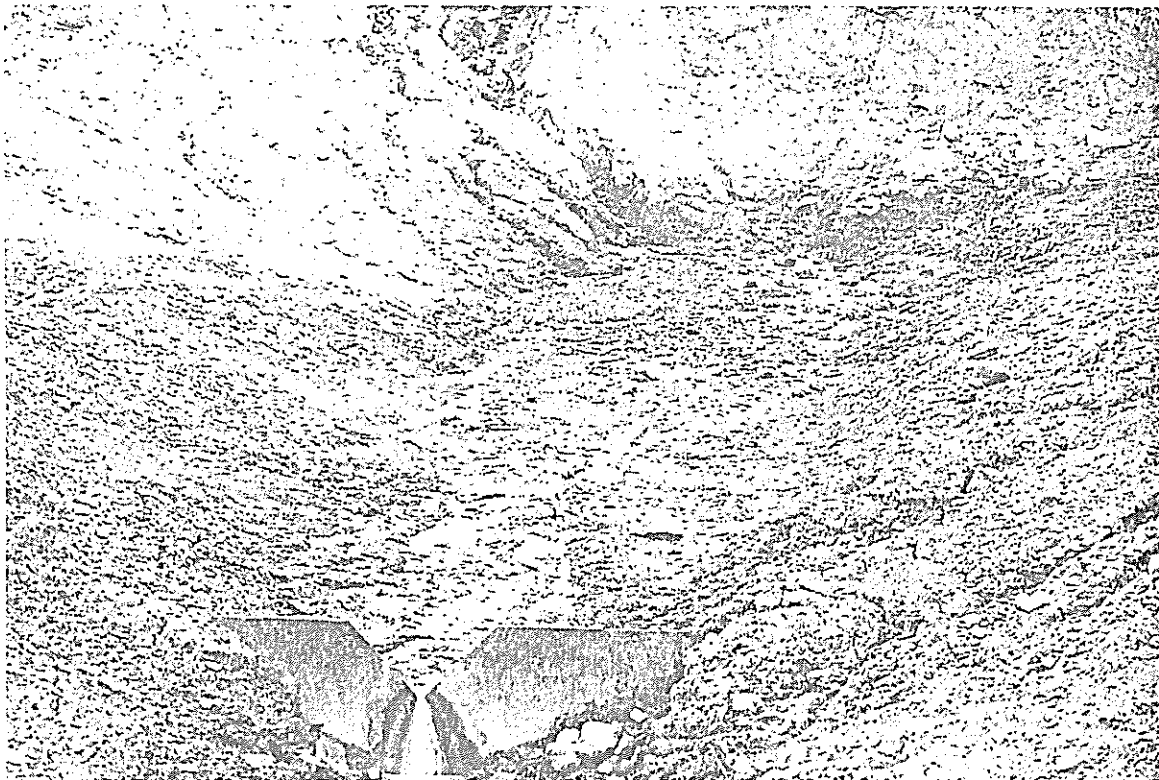
Photo 5 - Weir at drain 6.

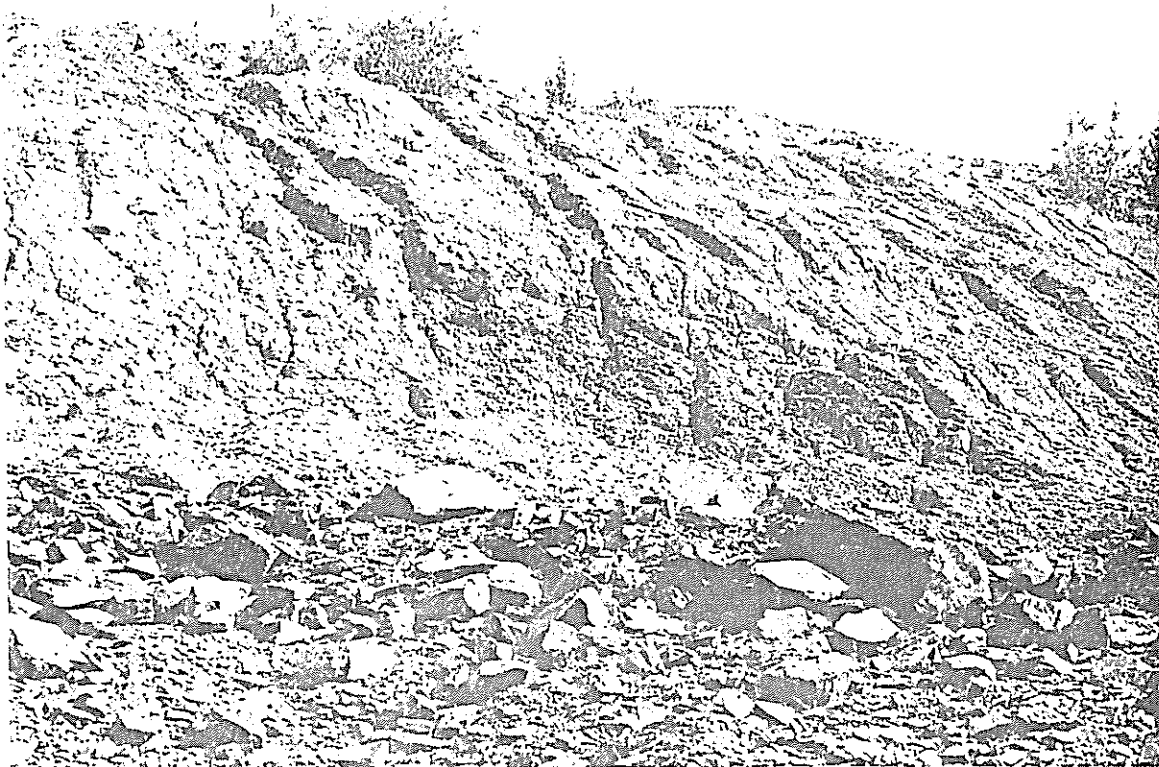
Photo 6 - Excavation above weir 3.

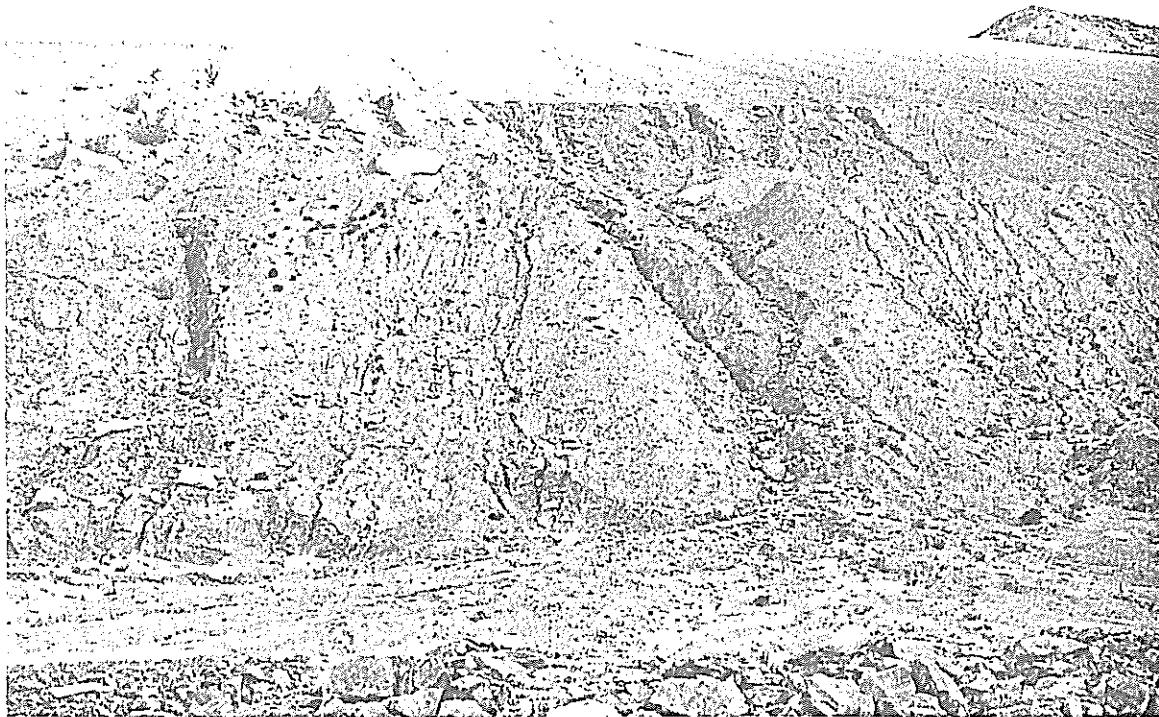
The till cover that was placed over the regraded waste rock on the south side of the Vangorda Dump has performed well with only a limited amount of erosion. There is one area at the toe of the till cover where erosion of the original till starter berm has occurred and causes a build-up of sediment and fines, which overflows into the seepage collection channel (Photos 7). The erosion is caused by runoff from the till cover and resloped areas, which concentrates in the area where till placement was terminated in 1994. This problem will be resolved once the till cover is completed and runoff is allowed to flow more uniformly across the slope.

Photo 7 - Erosion of till dyke below till cap.

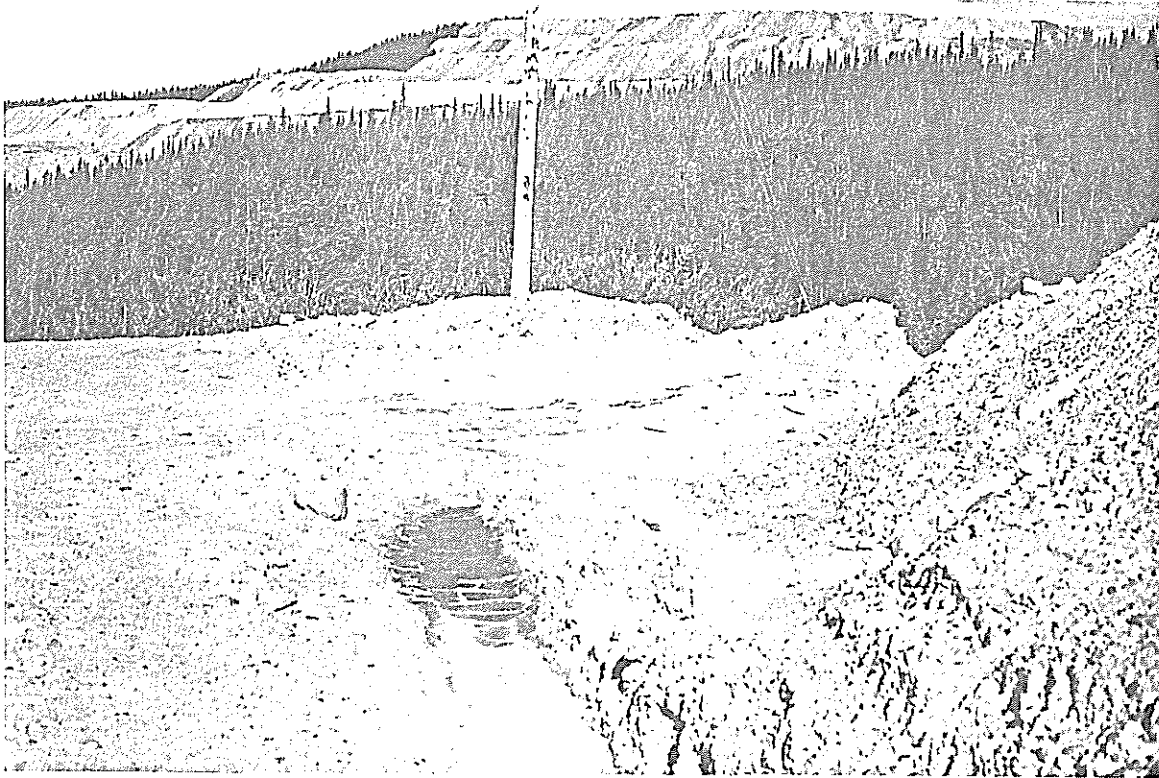
Photo 11 - Ponding of runoff from Little Creek Dam approach road.

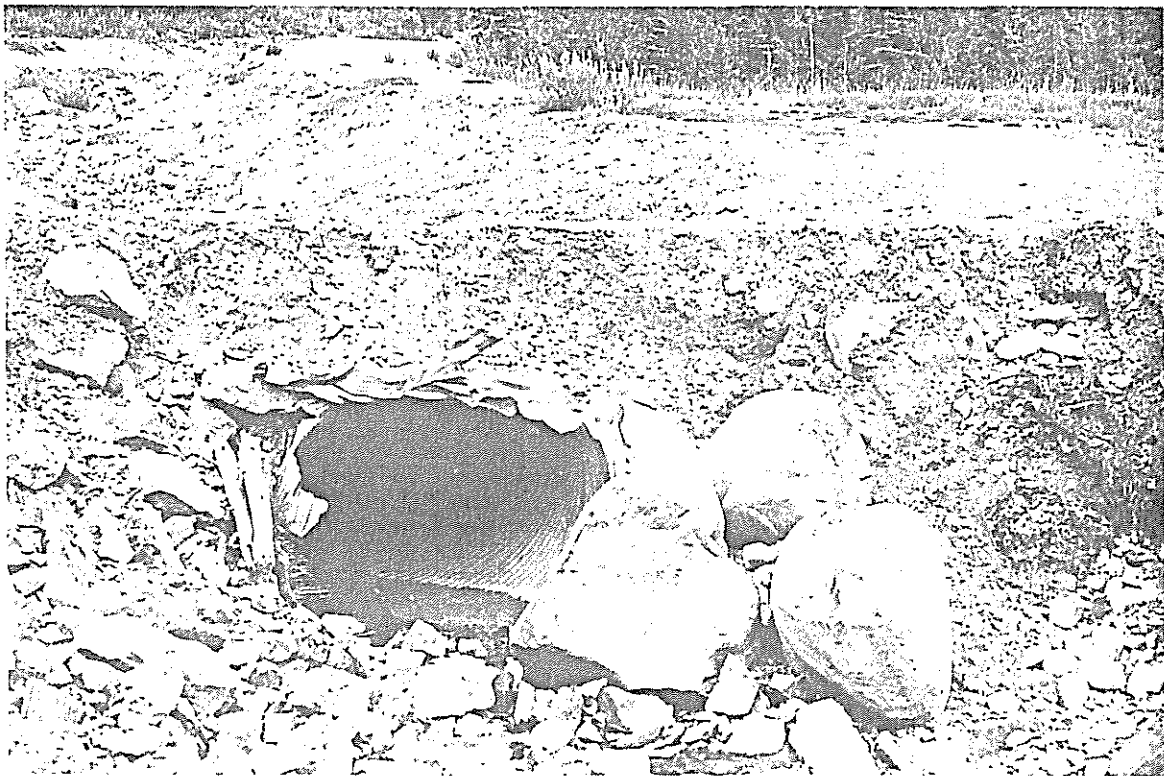
Photo 24 - Outlet of damaged culvert adjacent to Sheep Pad Settling Pond.
