**2002 Vangorda Plateau Annual
Environmental Report
Water Licence IN89-002**

Reference: GLL 22943 date: March, 2003

**2002 ANNUAL INSPECTION
WASTE AND WATER MANAGEMENT FACILITIES
VANGORDA MINE
YUKON TERRITORY**

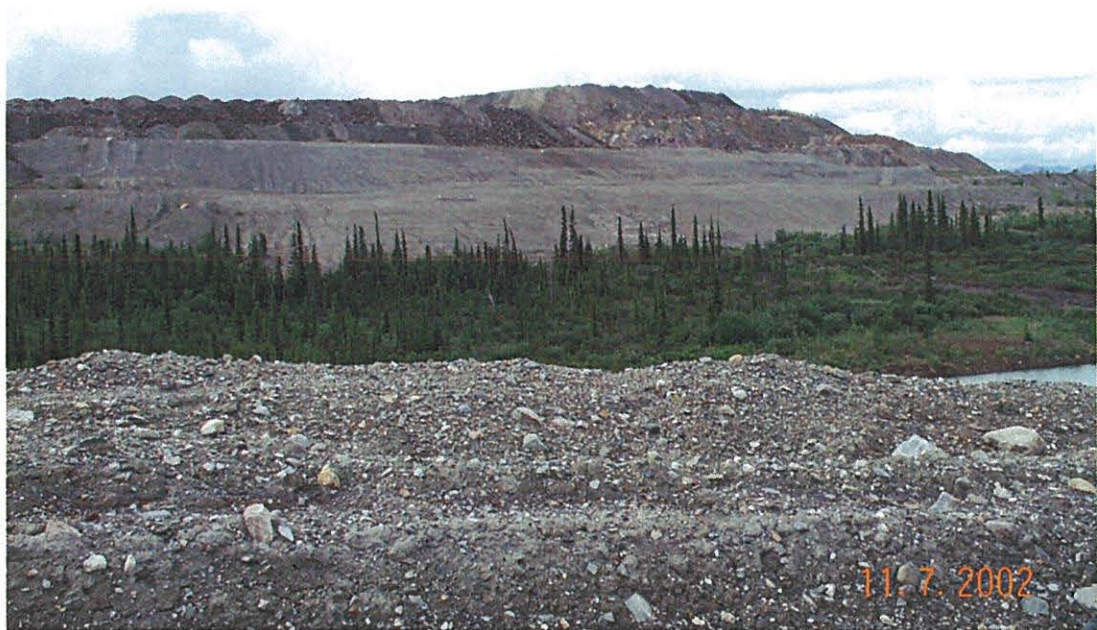
Photo 2: View looking south of the resloped area of the till starter dyke

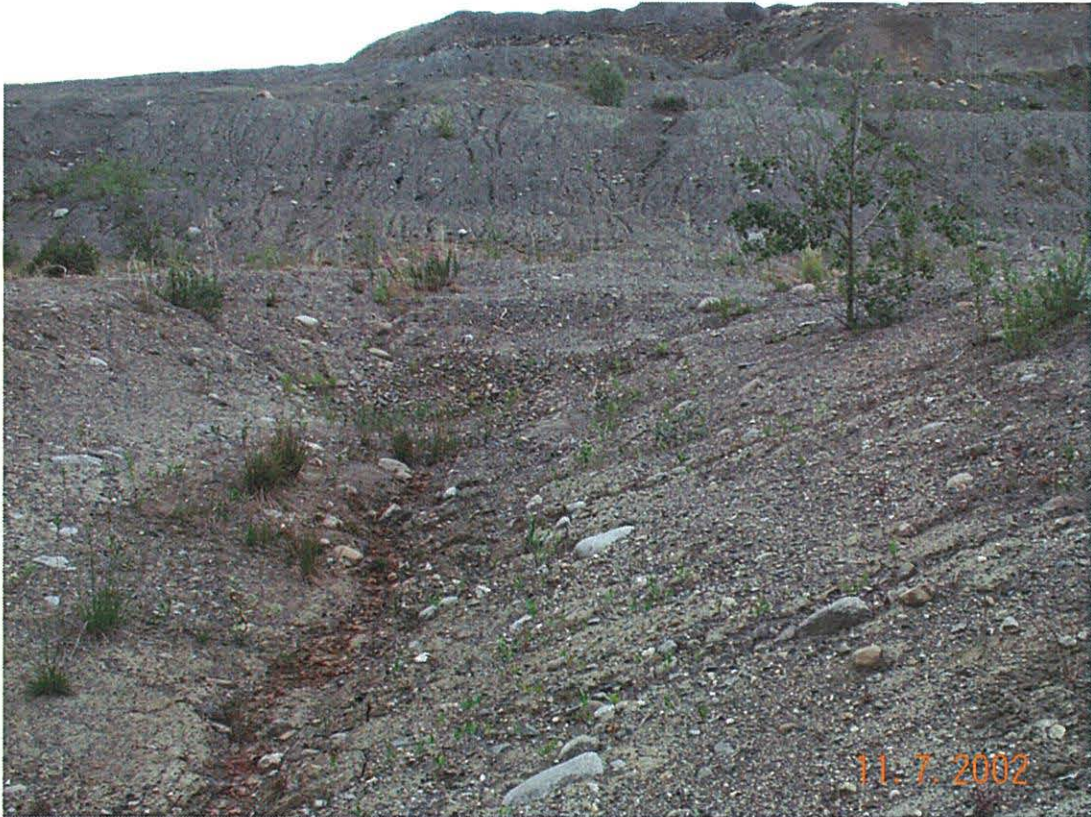
Seepage flow was sampled, in 2002, once (June) at drain #2 and twice (June and September) at drains #3, #5 and #6. No flow was present at drain #1 (V28) and this drain is considered inoperable. No flow was observed at drain #4 (V31). Flow at drain #2 (V29) has typically been intermittent and present only during some freshets and has not been sampled regularly. The flows observed at drain #3 and drain #5 (V32) are typically consistent through the spring/summer/fall season but winter flows are erratic. The flow at drain #6 (V33) has been erratic in the past. However, maintenance/ cleaning of sloughed soil in the vicinity of the drain from 1999 to 2001 has improved the flow characteristics.

Photo 7: Drain #4

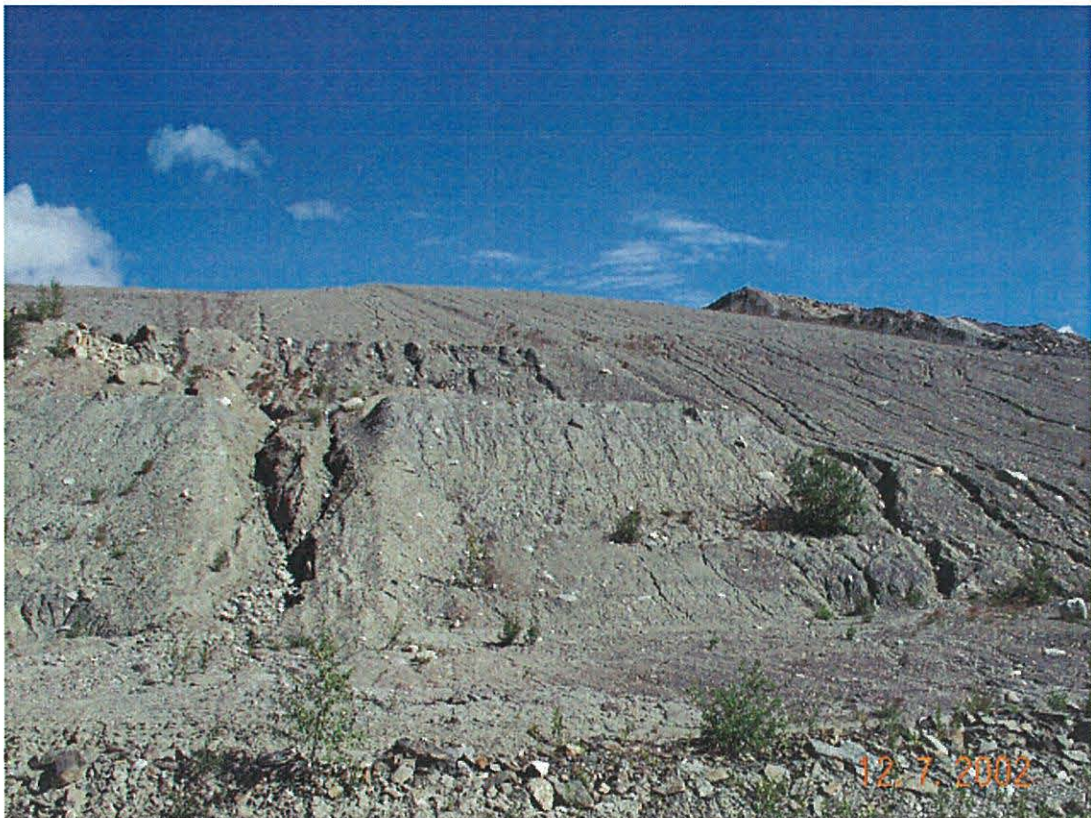
Photo 12: Erosion gullies at toe of till cover on south side of the Vangorda Dump

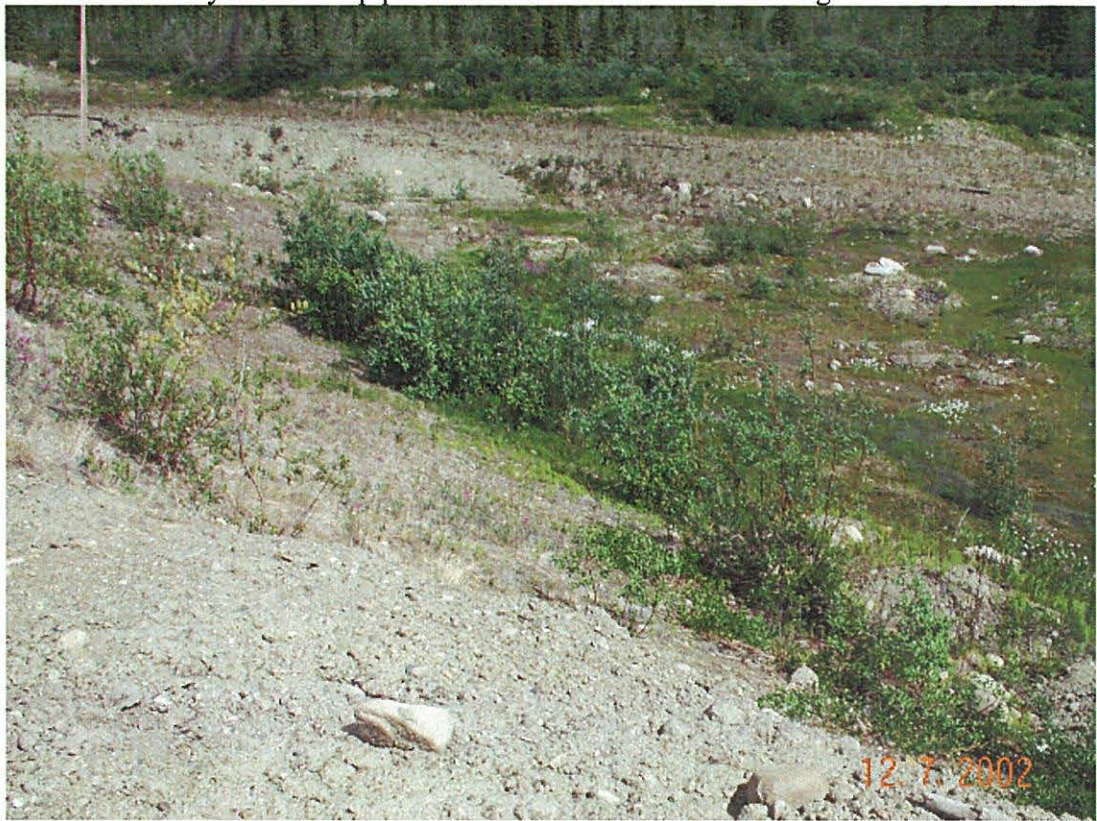
Photo 24: Seepage area at the south end of the Sludge Pond

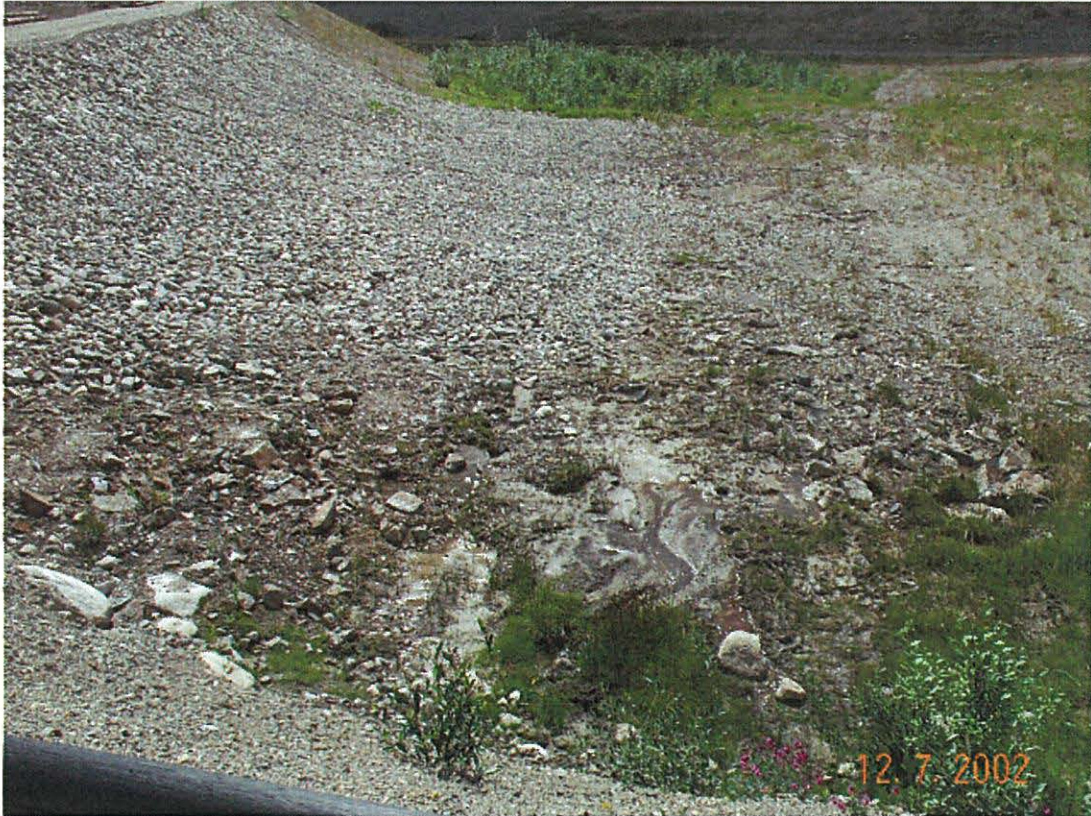
Photo 25: Seepage zone at the north toe of the sludge dyke.

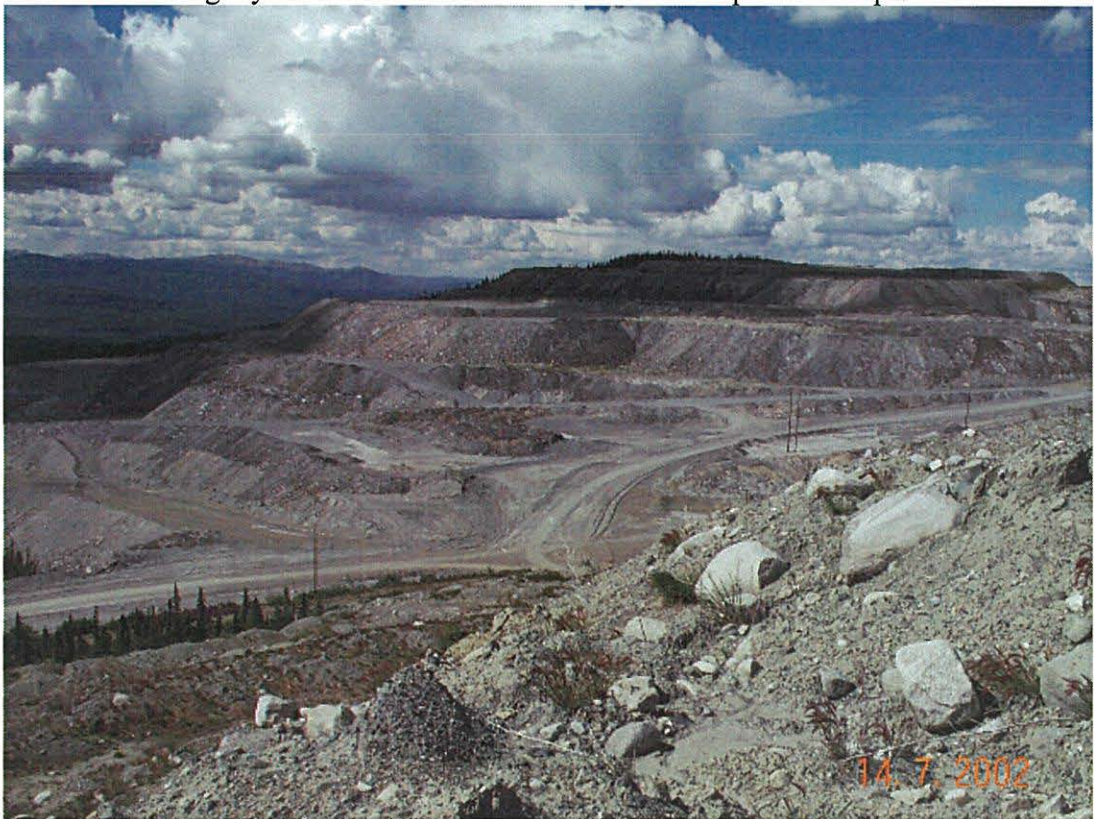
Photo 27: Erosion gully in lower bench of the Grum waste dump above Seep #1

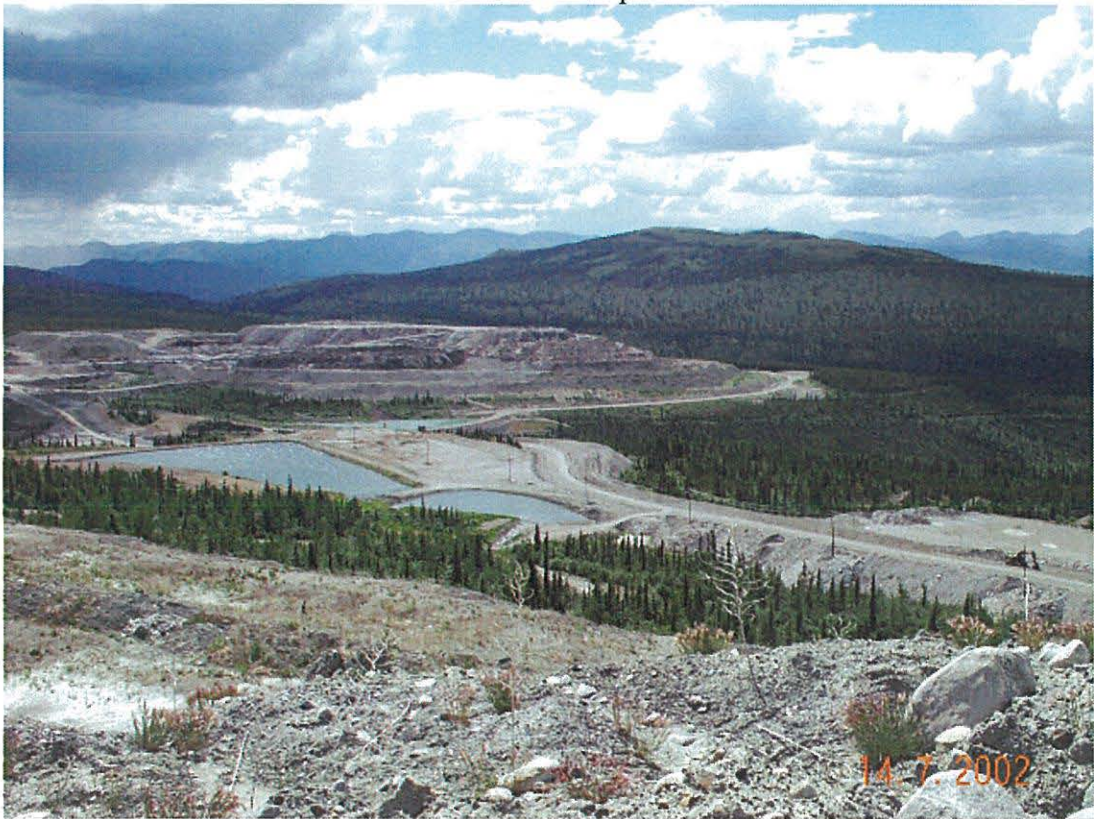
Photo 31: Settlement of the waste rock on Grum Dump

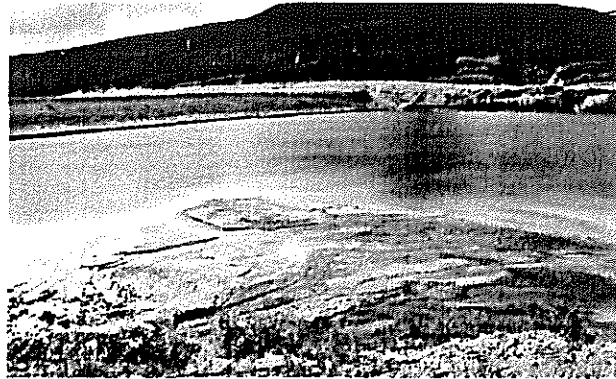
The polishing pond behind the Cross Valley dam is the receiving body for water flowing out of the Intermediate dam impoundment and from the Faro Pit water treatment plant. A large sediment beach had built up over time at the northeast corner of the pond, which limited the effectiveness of the polishing pond.

To resolve this issue, the sediments were removed from the polishing pond and relocated into the Faro Pit. A layer of lime was then placed on the area that had previously been the sediment beach and secured in place by a layer of ice. This ensured the remaining sediments would not be dislodged during spring freshet. The system is now working effectively.
