**FLAME & MOTH (#18)**  
**(MINFILE# 105M 14)**

Public Works And Government Services Canada	Travaux publics et Services gouvernementaux Canada	designed by:	date:
		conçu par:	
Architectural & Engineering Services Western Region		drawn by:	Nov. /99
		dessiné par:	C.S.
Drawing title: <b>Flame and Moth Site #18 Site Assessment</b> Yukon Territory		approved by:	
		approuvé par:	
Titre du dessin: project no. no. du projet:		revisions:	
		125-12.01	
		dwg. no. dessin no.	1 of 2

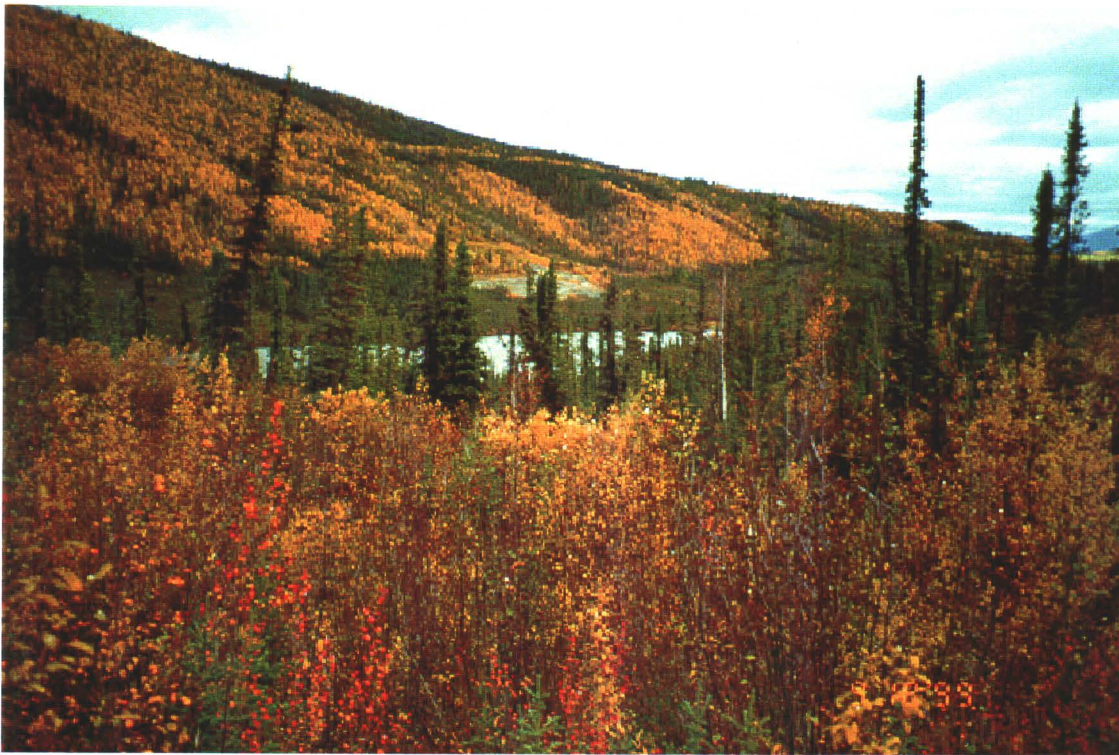
The site is immediately west of Keno City and the main solid waste dump site. The area slopes gently towards Christal Lake approximately 750 m to the northwest (photo 18-1). Surrounding properties are heavily forested with typical subalpine features although most of the vegetation has been removed from this site. Drainage from the main pit is to the west and drainage from the trench is to the north west. Surface runoff from both areas is eventually into Christal Lake.

Photo 18-1: Forested area and Christal Lake in background north west of site.

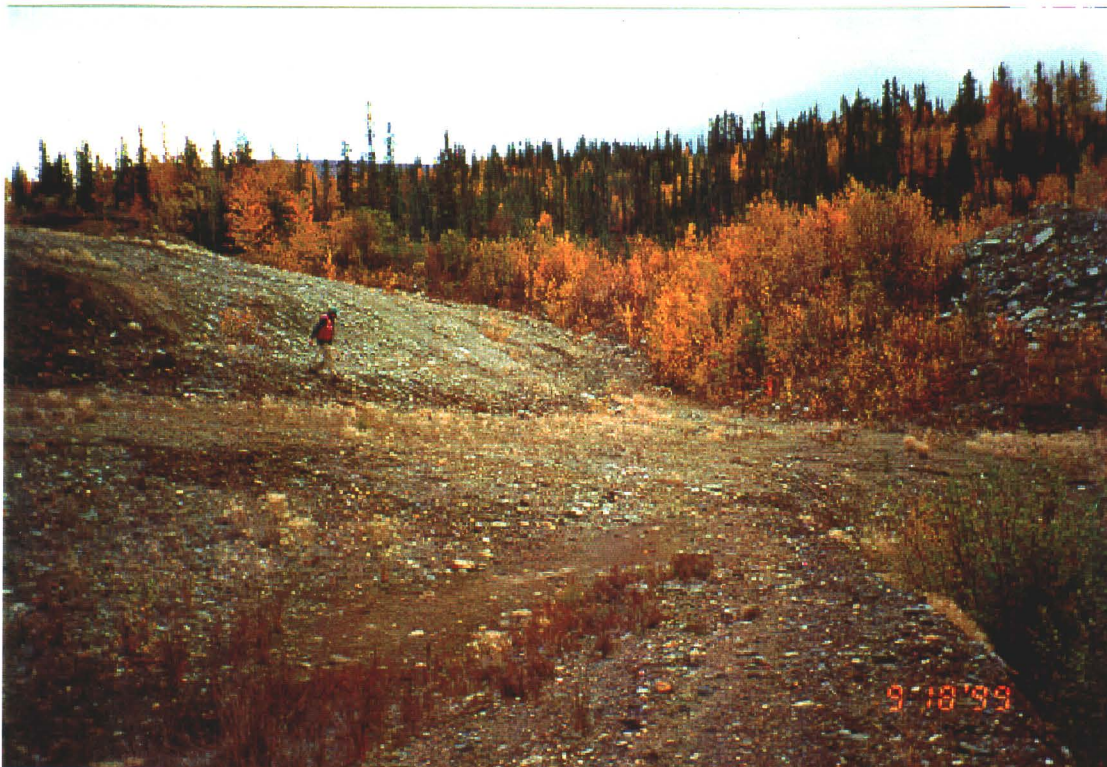
Open Pits (photo 18-2)

Open pit mining was in progress when the operation was closed, however very little ore was produced. There are no benches cut into the rock. The boundaries of the mineralized area and pit outline are not clear.

Condition: The site is fairly level, and appears to be stable. Some dump slopes are steep but of minimum height.

Photo 18-2: Waste rock area near north end of main site.

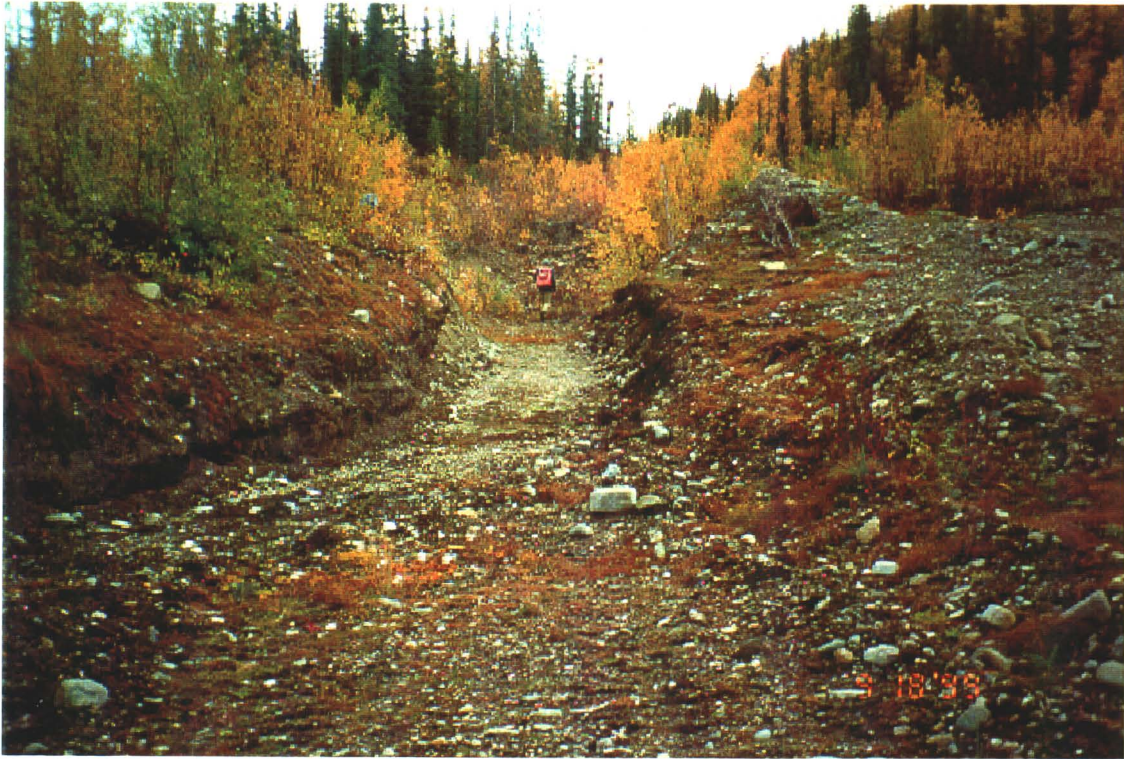
Trenches (photo 18-3)

Trench is a long thin bulldozed pit, aligned in an east-west orientation. More development has occurred at the east end of the trench where placer mining appears to have occurred in the recent past. Only a small amount of bedrock is exposed.

Condition: The site is level and drainage slopes towards the west end of the site. Slopes appear stable.

Photo 18-3: Bulldozed trench at second site.

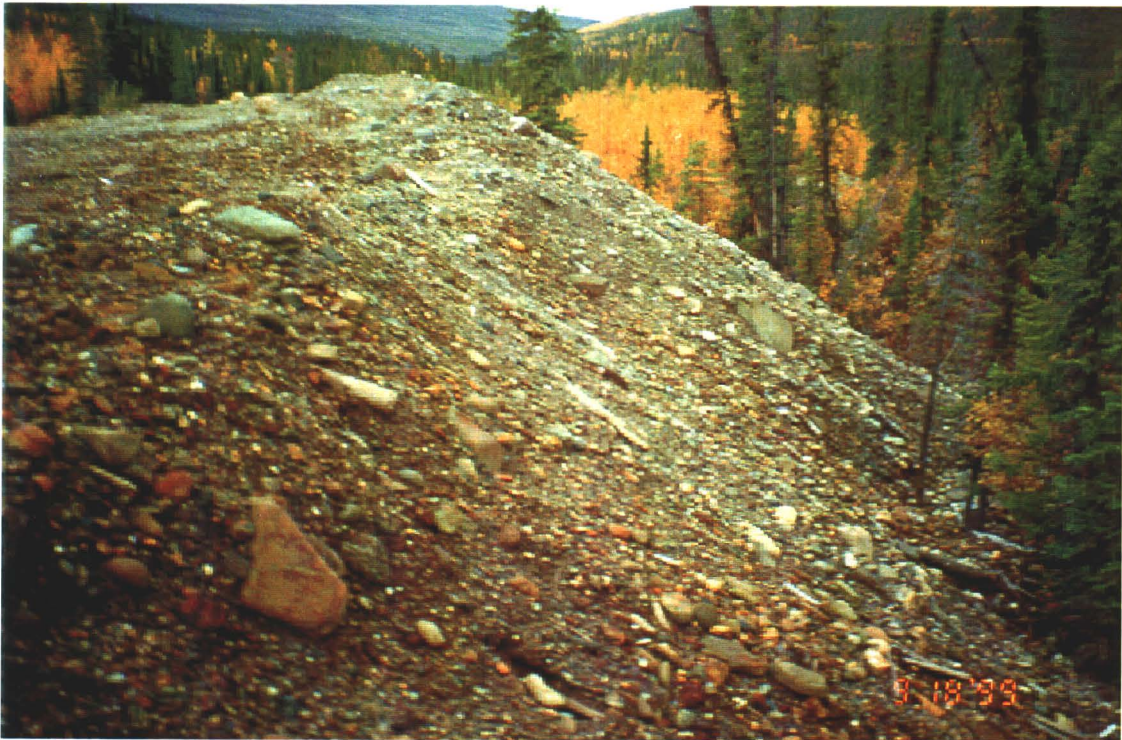
General Description: Open pit development has produced four lobes of waste rock. The two northwestern lobes are dominantly barren overburden (photo 18-4). The northeastern lobe, site of sample 02, is composed of mixed mineralized material and overburden (photo 18-5). The southern lobe, site of sample 03, is dominated by barren quartzite. The waste rock dumps are partially revegetated, except near well-mineralized areas. Vegetation is well established where there is fine-grained material or moisture traps. There is no apparent drainage at the site, as it is dominated by well-drained gravel. Oxidation related staining of the waste rock is apparent at the northeastern lobe of waste.

Photo 18-4: Large waste rock pile slope at north end of main site.

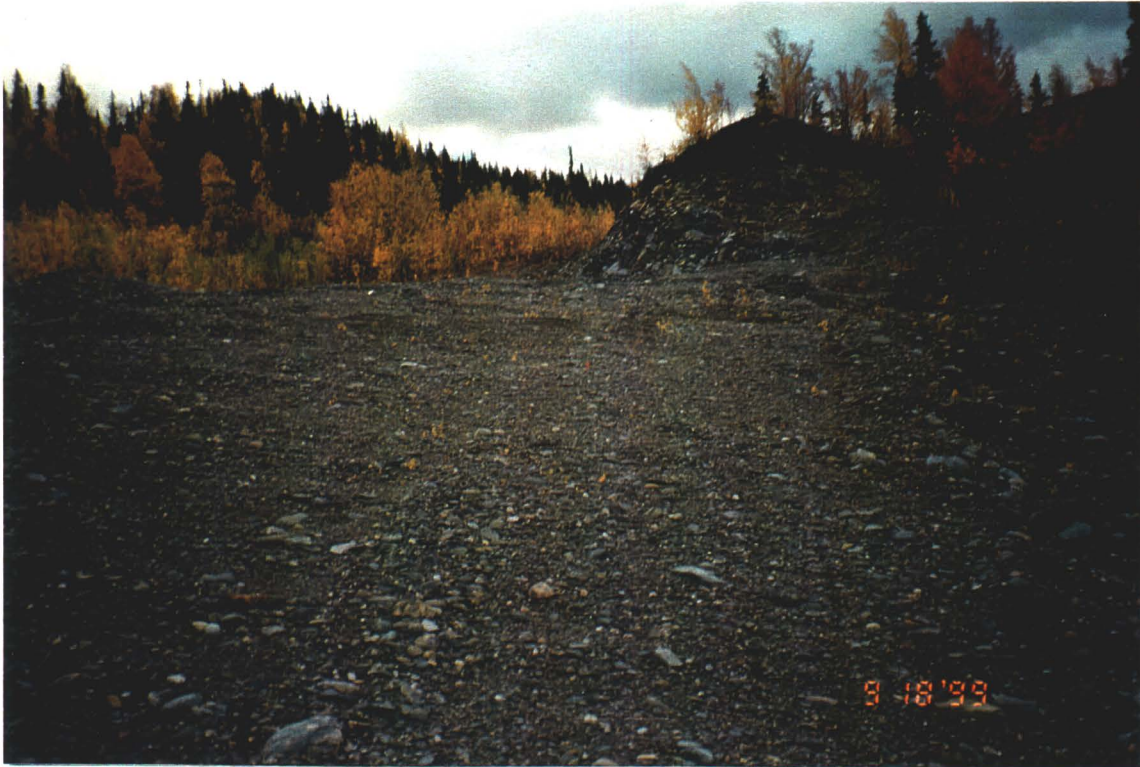
Photo 18-5: Leveled area at main site. Note rock outcrop on right side of photo.

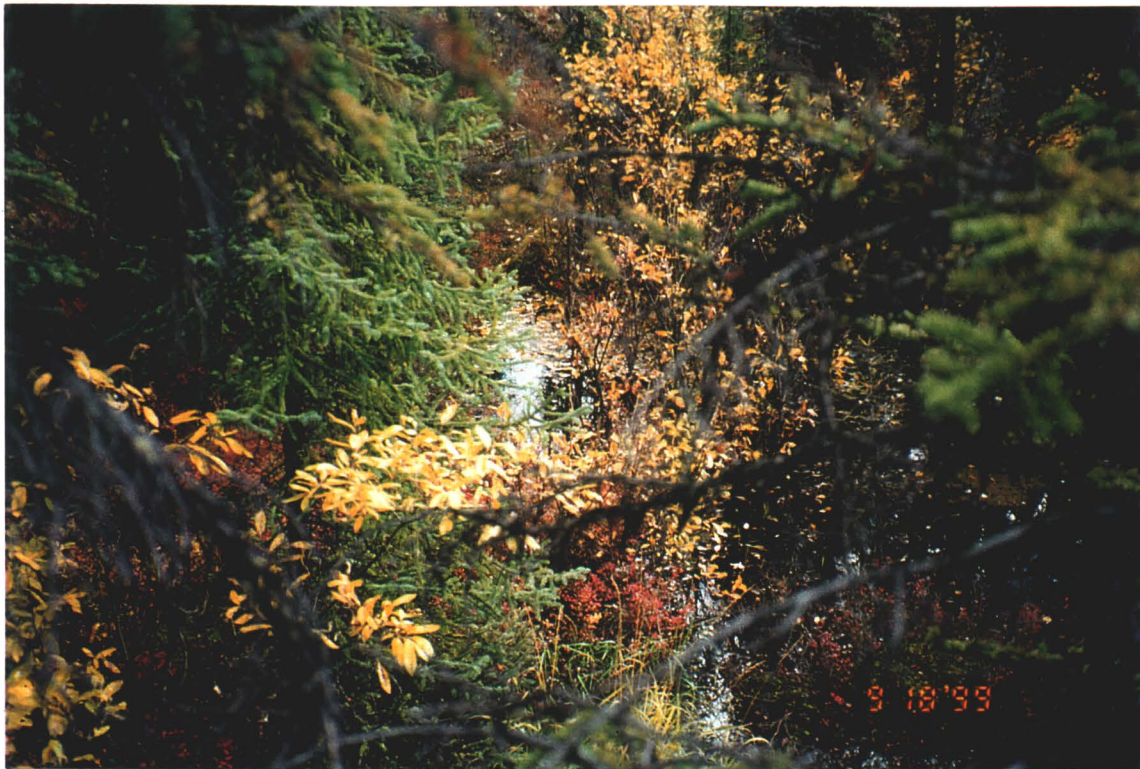
There was evidence that water had ponded in the north trench in the recent past, however, it was dry during the site visit. The north trench area drains northwest towards Christal Lake, a distance of approximately 750 m (photo 18-1). Surface runoff from the site enters a pond immediately north west of the site (photo 18-6), which discharges into a small creek flowing into Christal Lake. A water sample (18-WQ-Str-CD-01) and duplicate (18-WQ-Str-CD-02) were collected from the pond. Laboratory and field analyses are provided in Attachment B.

Photo 18-6: Creek runoff to north west of trench site.
