PRELIMINARY INVESTIGATIONS OF
PETROLEUM SPILLAGE,
HAINES-FAIRBANKS MILITARY PIPELINE, ALASKA

Warren E. Rickard
and
Frederick Deneke

April 1972

CORPS OF ENGINEERS, U.S. ARMY
COLD REGIONS RESEARCH AND ENGINEERING LABORATORY
HANOVER, NEW HAMPSHIRE

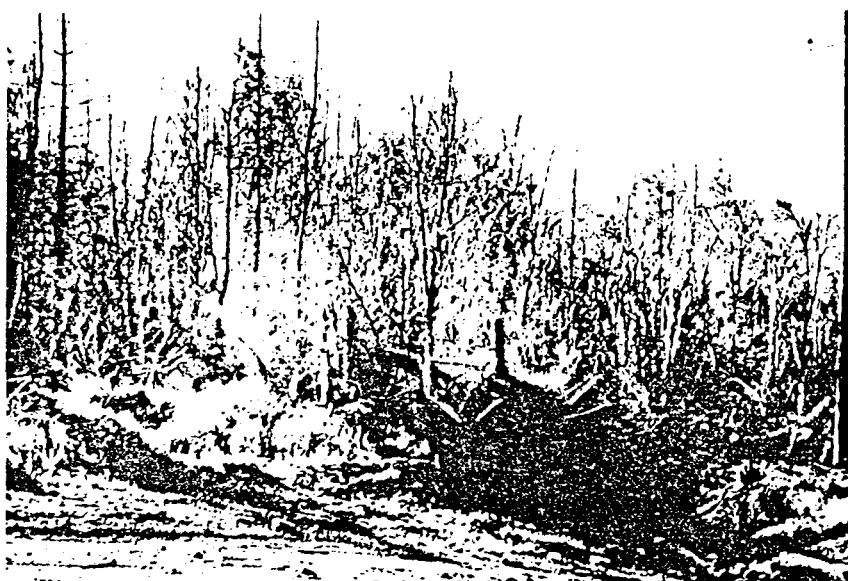
MP 1.9, 20 June 1968. External corrosion of the pipe caused a weak spot and under pressure a hole developed in the pipe resulting in fuel spraying 100 feet into the air and saturating the surrounding vegetation and soil. The spray was blown downwind for 100-120 feet. An estimated 100 barrels of jet fuel (JP-4) were lost. All vegetation the fuel came in contact with was killed, including hemlock (*Tsuga heterophylla*), spruce (*Picea glauca*) and balsam poplar (*Populus balsamifera*). A soil pit dug in the gravelly substratum in the middle of the kill area had a strong fuel odor down to the 50-cm depth. A small stream passing through the area had some oil film on the surface. Some new growth of woody plants was noted, and a few annuals were beginning to reestablish on the banks of the small stream.

Figure A1. Spill area at MP 2. The road and electric line have been installed since the initial spill.

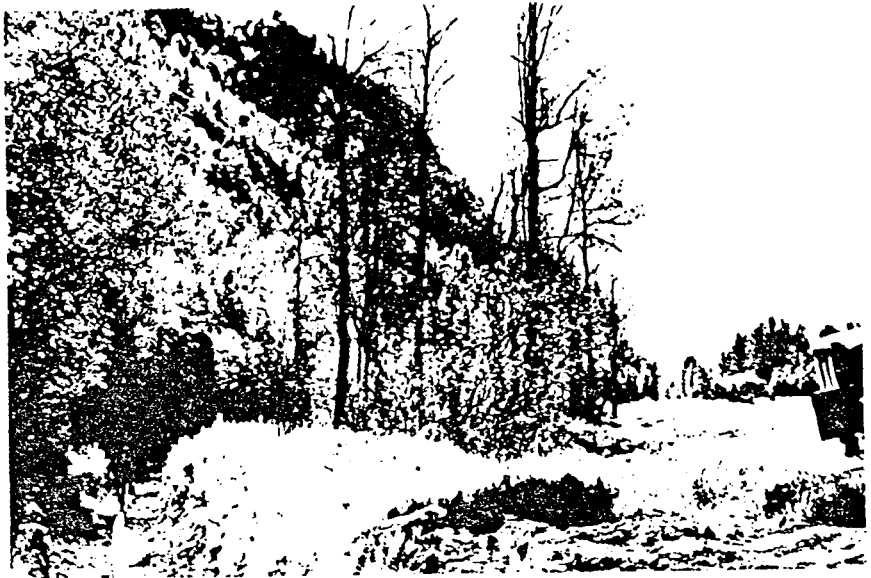
MP 17.7, 3 December 1968. A small corrosion leak in a buried portion of the pipe resulted in an estimated loss of 800 barrels. The pipe had to be excavated for a great distance before the high pressure leak could be found. Fuel soon filled the excavated trench and was subsequently pumped into a tank and burned off numerous times throughout the winter. Some large cottonwoods and alders in a nearby depression were killed back, apparently from the effects of the fuel. Currently two of ten large cottonwoods have a few leaves in some upper branches. In addition, a number of new branches are growing out from the bases of the alders. However, the interior of the stand was devoid of lower canopy vegetation whereas adjacent areas showed luxuriant growth.

Figure A3. A small leak at MP 17.7 saturated the soil in swale where large cottonwoods are growing.

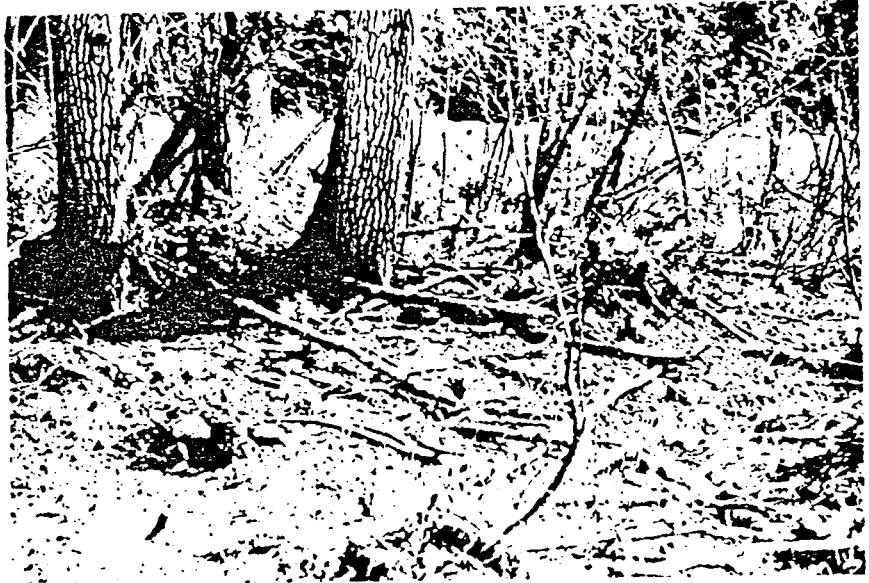
Figure A4. Closeup of interior of the cottonwood stand at MP 17.7 showing some willow and alder growing out from base of original trunk.

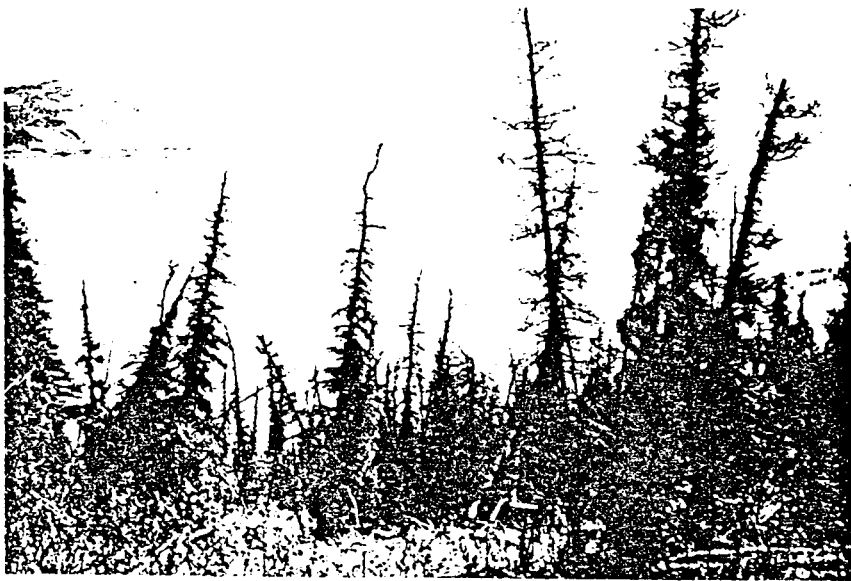
MP 197.1, 30 January 1956. This area is on a north- to northeast-facing steep slope with the pipe nearly ¼ mile from the bottom of the slope. The fuel was allowed to run down the slope when the line was cut for purging. All species of vegetation were killed at the time of the spill. Some grass is growing in an old Cat trail that traverses the area but very little other new vegetation is evident. A few small white spruce 6 to 12 inches tall are growing at scattered locations within the area. There is at least one area where the surface organic mat has been washed away leaving a small depression 10 to 12 feet in diameter. Other visible evidence of slope movement is present in 2- to 4-inch cracks which can be seen where the organic mat has pulled apart. Strong petroleum odors were found in all three soil pits placed on the slope. Some hummocks have moss and Labrador tea growing on them within the area. The lower portion of the slope has been cleared for construction of a telephone line and several small white spruce are growing there.

Figure A10. Overall view at MP 197.1 looking downslope during a 1956 spill.

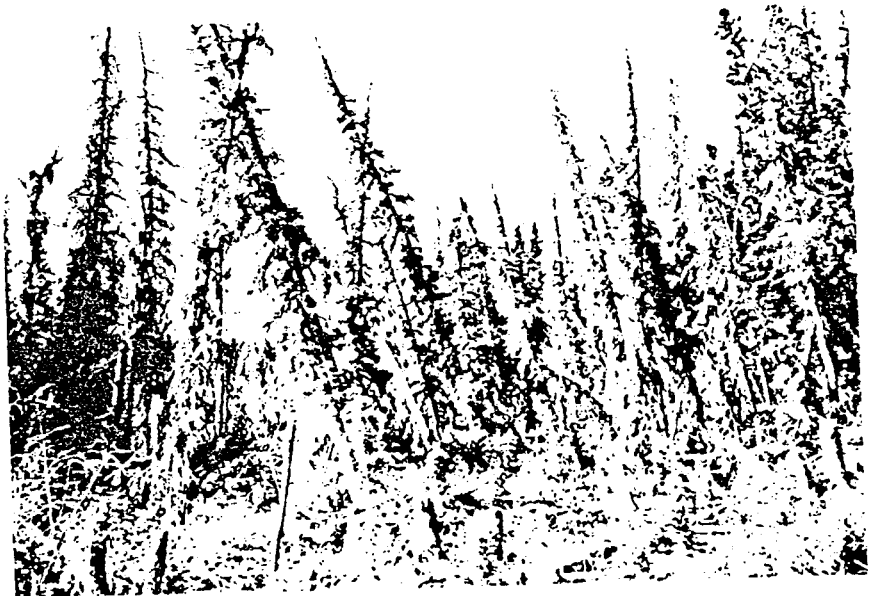
Figure A12. Looking upslope at MP 197.1 into kill area. Small spruce are growing in the cleared area at the base of the slope.

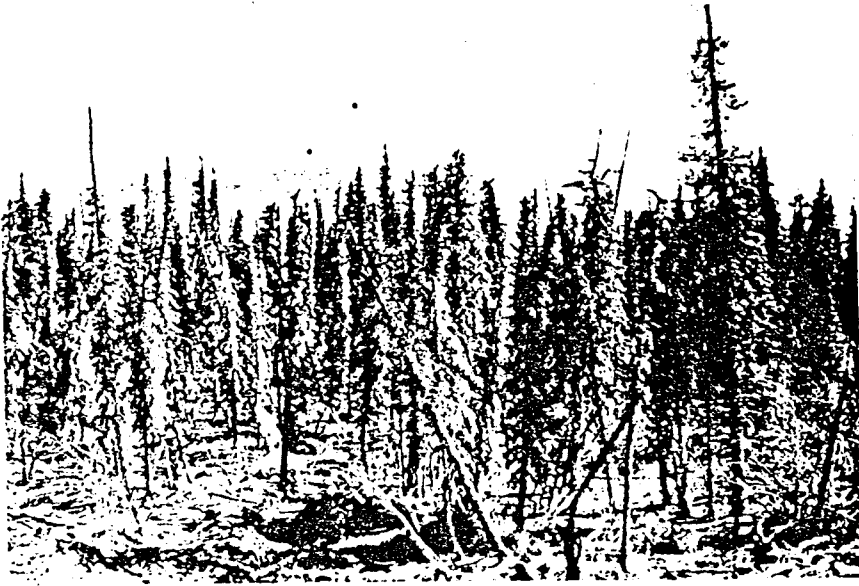
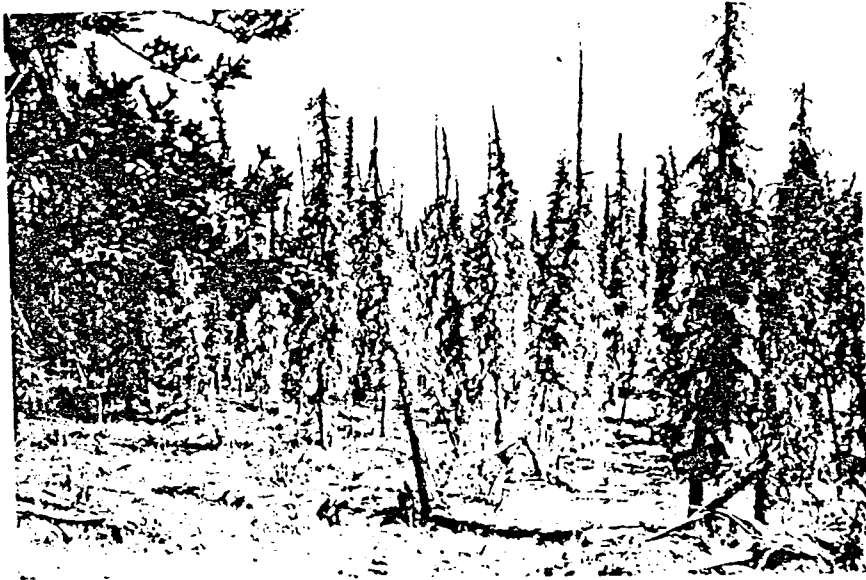
MP 207.6, 2 February 1956. This is a large area 200 feet wide near the pipe and forms an inverted V-shape 700-800 feet down a gentle slope. The area could be called a small watershed basin. Vegetation is completely lacking in the center of the main spill area. Three soil pits were placed in the kill area and on the fringe. Odors of petroleum were present in all three with the soil frozen at 20 cm.

Figure A13. View of 1956 line cuts at MP 207.6.

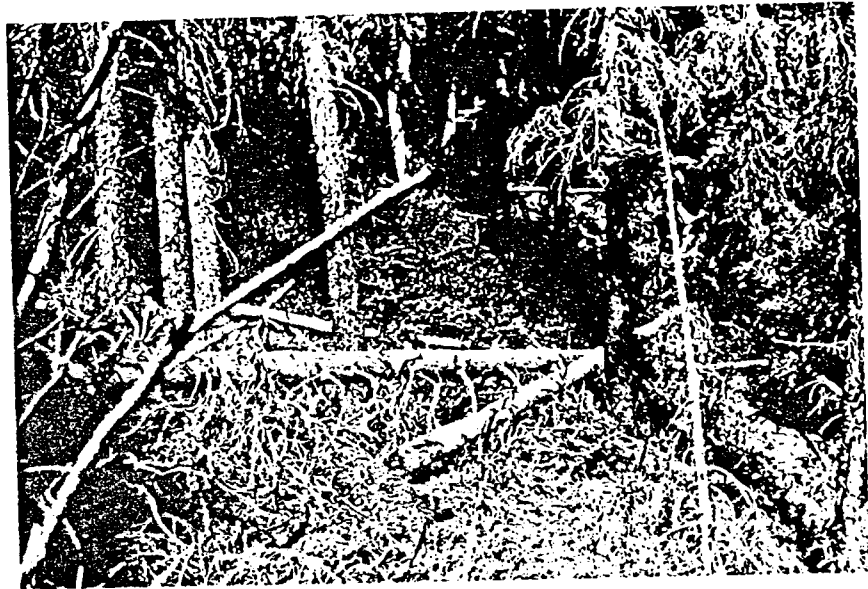
Figure A15. A sharp boundary exists between the spillage and non-spillage area as shown in this photograph from MP 207.6.

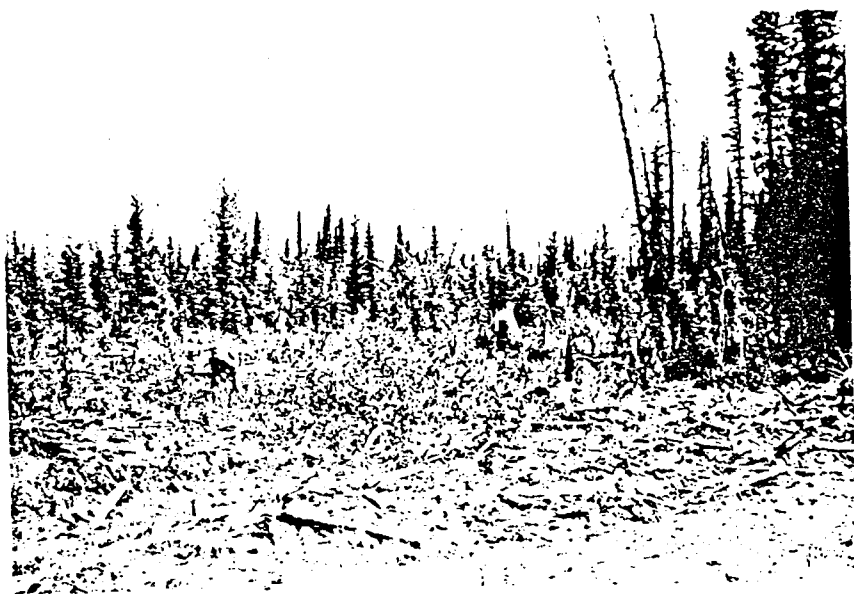
MP 217.1, 9 February 1956. Spillage here was over an area 100 feet wide and 300 feet long on a very gentle slope. The soil appears to be very well drained. A fire had apparently covered the entire area prior to the spill as many fallen spruce were present. Areas outside the spill have good spruce and moss growth. Within the spill area a number of small spruce, labrador tea and other plants are growing. Of all the 1956 spill sites this one had the most abundant amount of vegetation.

Figure A16. A line cut at MP 217.1 during 1956 retarded new growth in an area burned prior to the fuel spill.

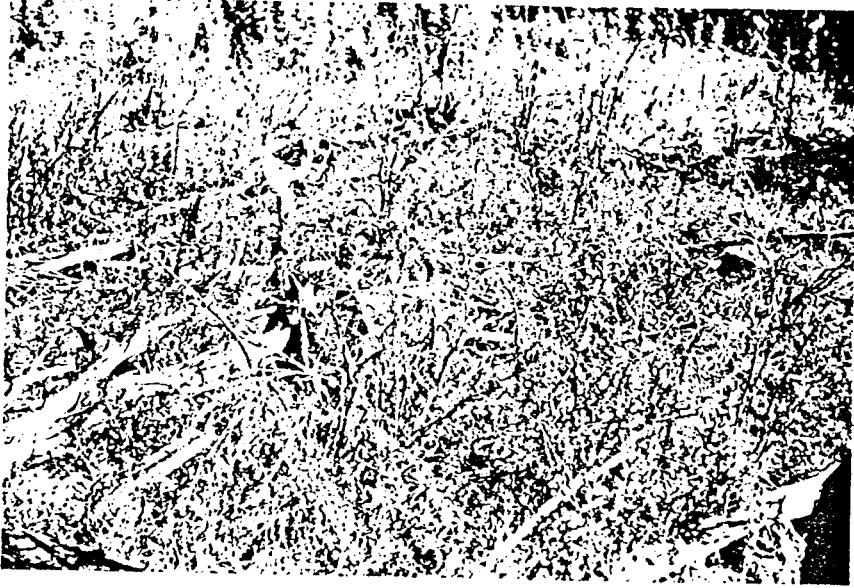
Figure A17. The interior of the MP 217.1 spill is covered with considerable recent growth.

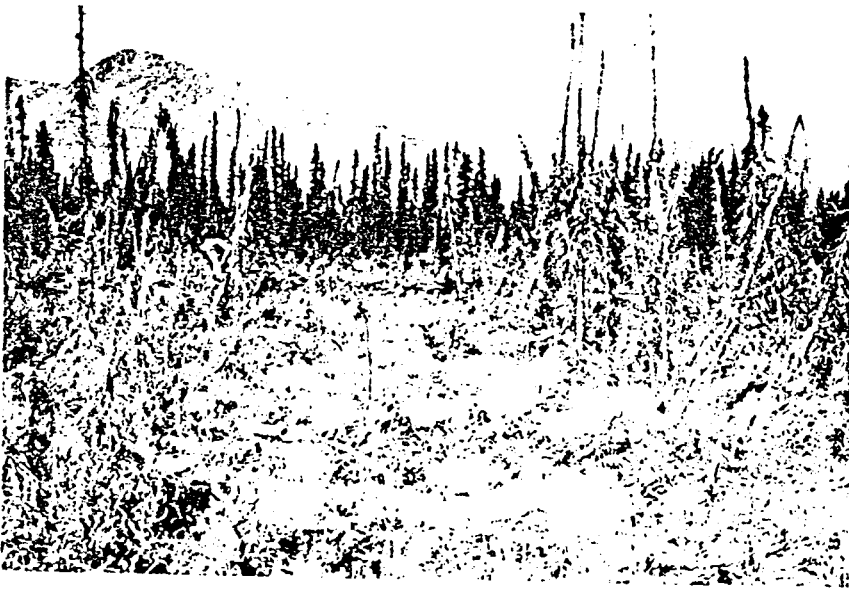
MP 273.2, 29 February 1956. This is a rather large spill area at least 250 feet in diameter. The pipe was purged into a small drainage area on the 1-2° slope. All vegetation, of which black spruce predominates, was apparently killed at the time. The main drainage area now has vegetation growing in it. However, in those areas not directly in the drainage basin no vegetation has yet become established. A soil pit was placed in both living and dead areas.

Figure A18. A spill at 273.2 has little new growth except in the drainage basin that traverses the area.

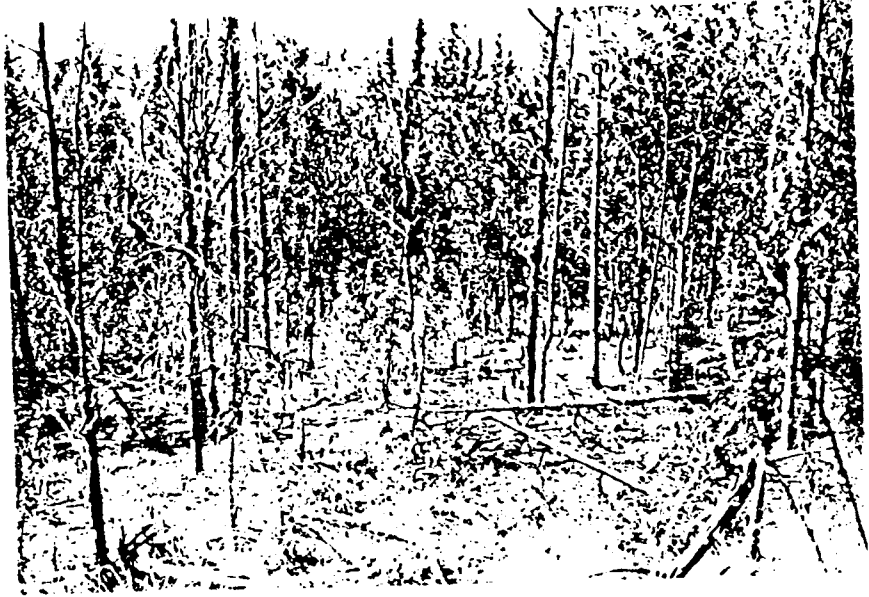
MP 382.5, 16 March 1956. Fuel spilled at this location was gasoline, called Mo Gas by the Petroleum Distribution Office. The site is on a very steep 40° south-facing slope. Soil is a well drained silt loam and contains a layer of fine volcanic ash. The spill killed aspen 4 to 6 inches in diameter and all the surface cover. Brumus, small aspen, fireweed and bearberry are growing at scattered locations within the area. Soil pits from mid-slope gave a strong odor of gasoline.

Figure A19. Downslope view of area at MP 382.5.
