SUBJECT: Corrosion Studies Report, Dezadeash Lake Area, Haines-Fairbanks POL

CONTENTS

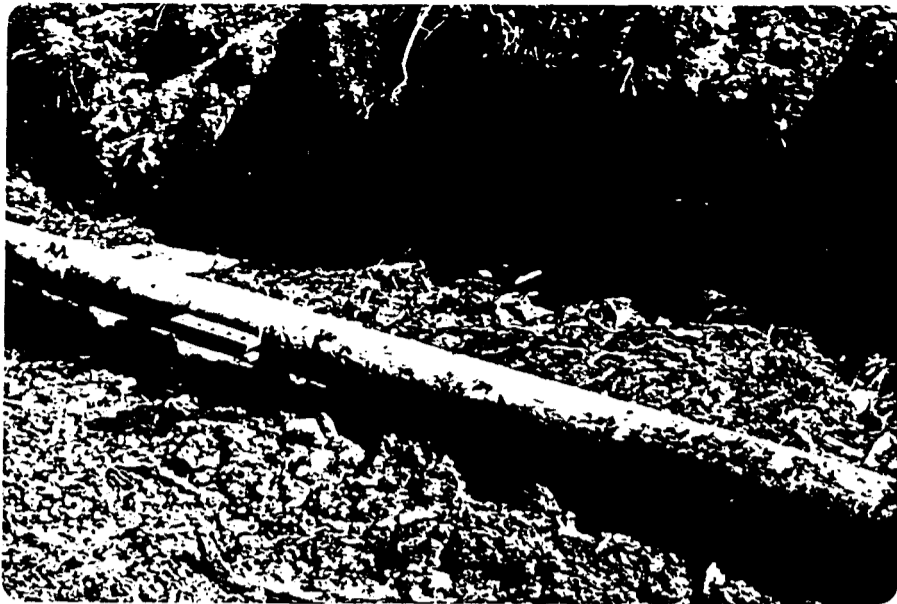
Photo #1

This shows the location of the leak in the Desadeash Lake area at Pipeline Milepost 119.1. Note the abundance of fine grain soils and organic materials adjacent to and underlying pipe.

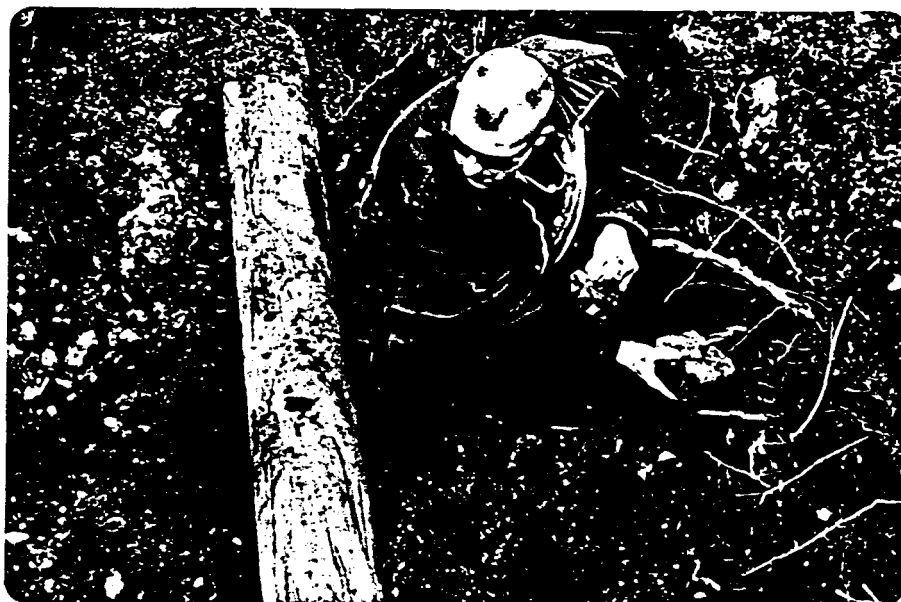
Photo #3

Shows an area uncovered at approximately Mile Post 119.06.  
The fill material around the pipe is generally sandy gravel  
and corrosion in this particular area is relatively negligible.

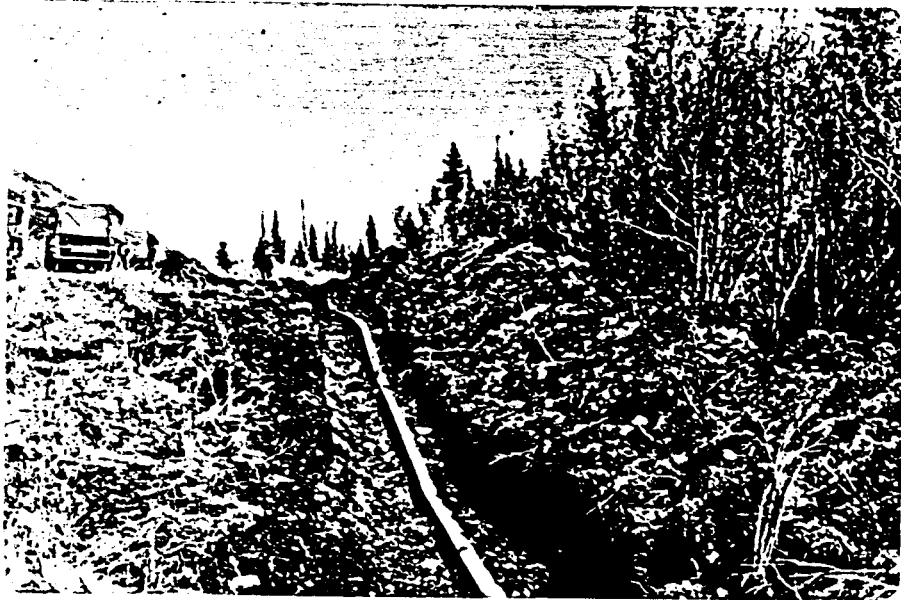
Photo #5

The above photo shows the uncovered petroleum line from approximate Mile Post 119.7 to Mile Post 119.11. This section of the line contains many localized areas of corrosion. The corroded areas were concentrated where varnish has been removed from the original pipe and where fine grain soils existed adjacent to the pipe. Generally the severe corrosion occurred on a horizontal line approximately  $90^{\circ}$  from the bottom of the pipe and on areas where the varnish had been removed by normal welding procedures.

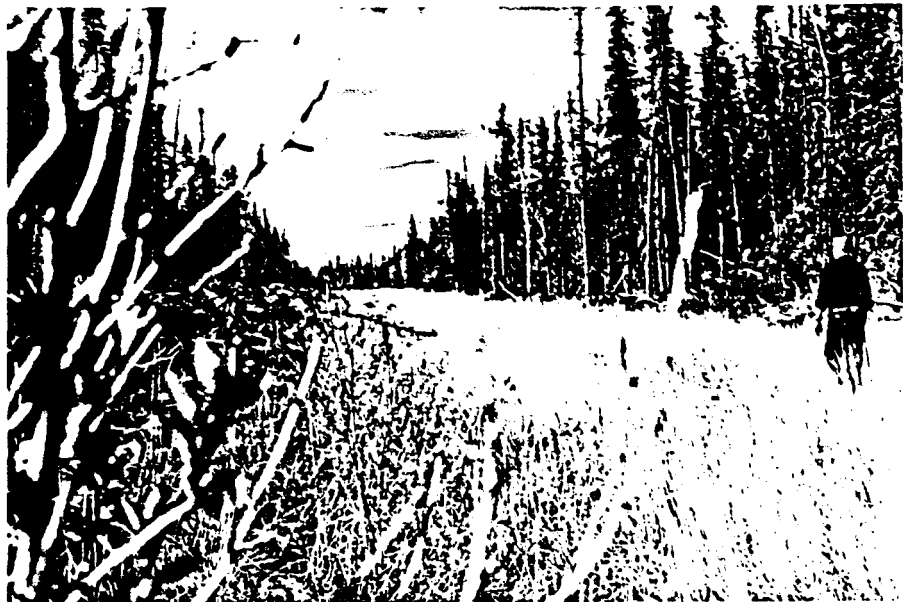
Photo #7

This photo taken at pipeline Mile Post 122 shows well drained soils with the pipe line laying on a thin bed of muskeg. No excessive corrosion was noted where the topography such as is shown above existed.

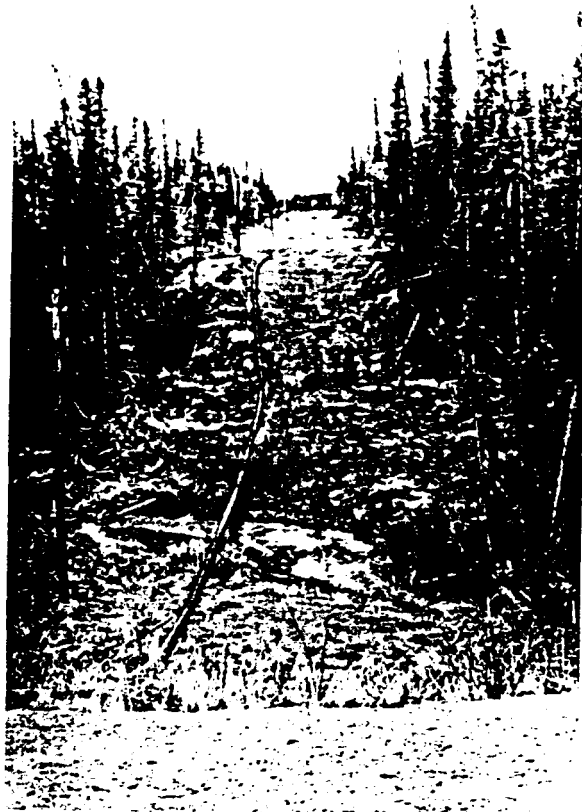
Photo #8

Soil conditions in this stream crossing at Mile Post 122.8 are generally gravelly in nature. It is doubtful that the waters of this particular stream are corrosive. A short section of line found imbedded in the gravels below the flowing water showed little or no deterioration.

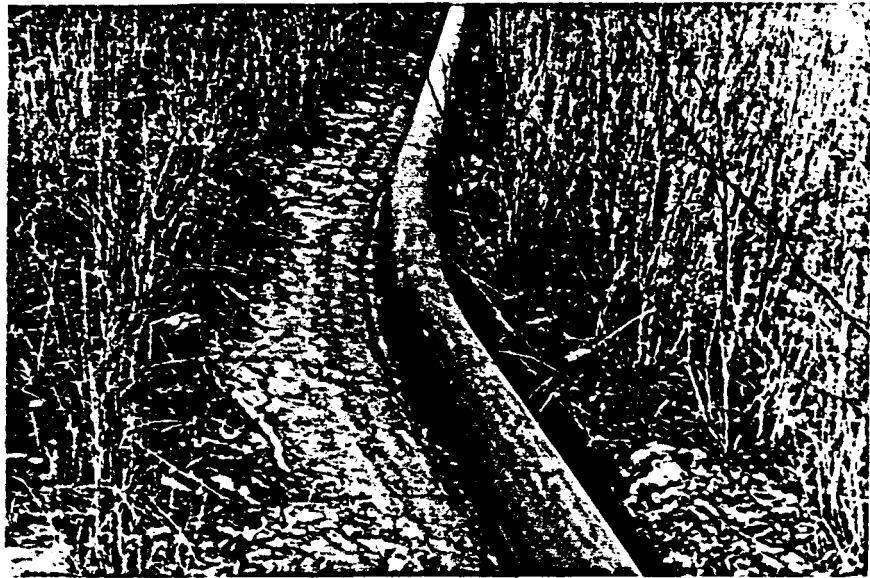
Photo #9

Line movement such as is shown in the above photo contributes to pitting if the soil conditions are favorable for corrosion. A slight film of rust removed from the pipe is shown below and adjacent to the left hand side of the pipe. No excessive corrosion was noted in this particular area.

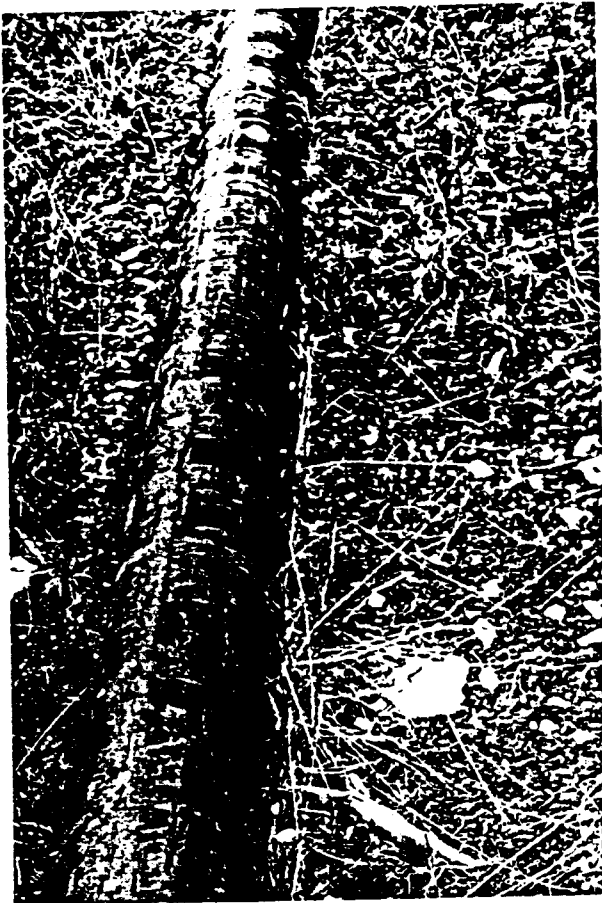
Photo #10

This picture taken at Pipe Line Mile Post 120.5 demonstrates areas that may corrode under favorable conditions. These are areas where the handling and/or manufacturing of the English steel shows removal of the original protective varnish. Areas similar to this are shown in Photos 1, 2 and 4 and under the environmental conditions are highly susceptible to concentrated corrosion.
