**PRELIMINARY ASSESSMENT  
OF THE  
CALLISON WASTE METAL/  
OLD QUIGLEY  
LANDFILL SITE**

**Arctic Environment Strategy - Action on Waste**  
Department of Indian Affairs and Northern Development  
Whitehorse, Yukon

J. Gibson & Associates  
Whitehorse, Yukon

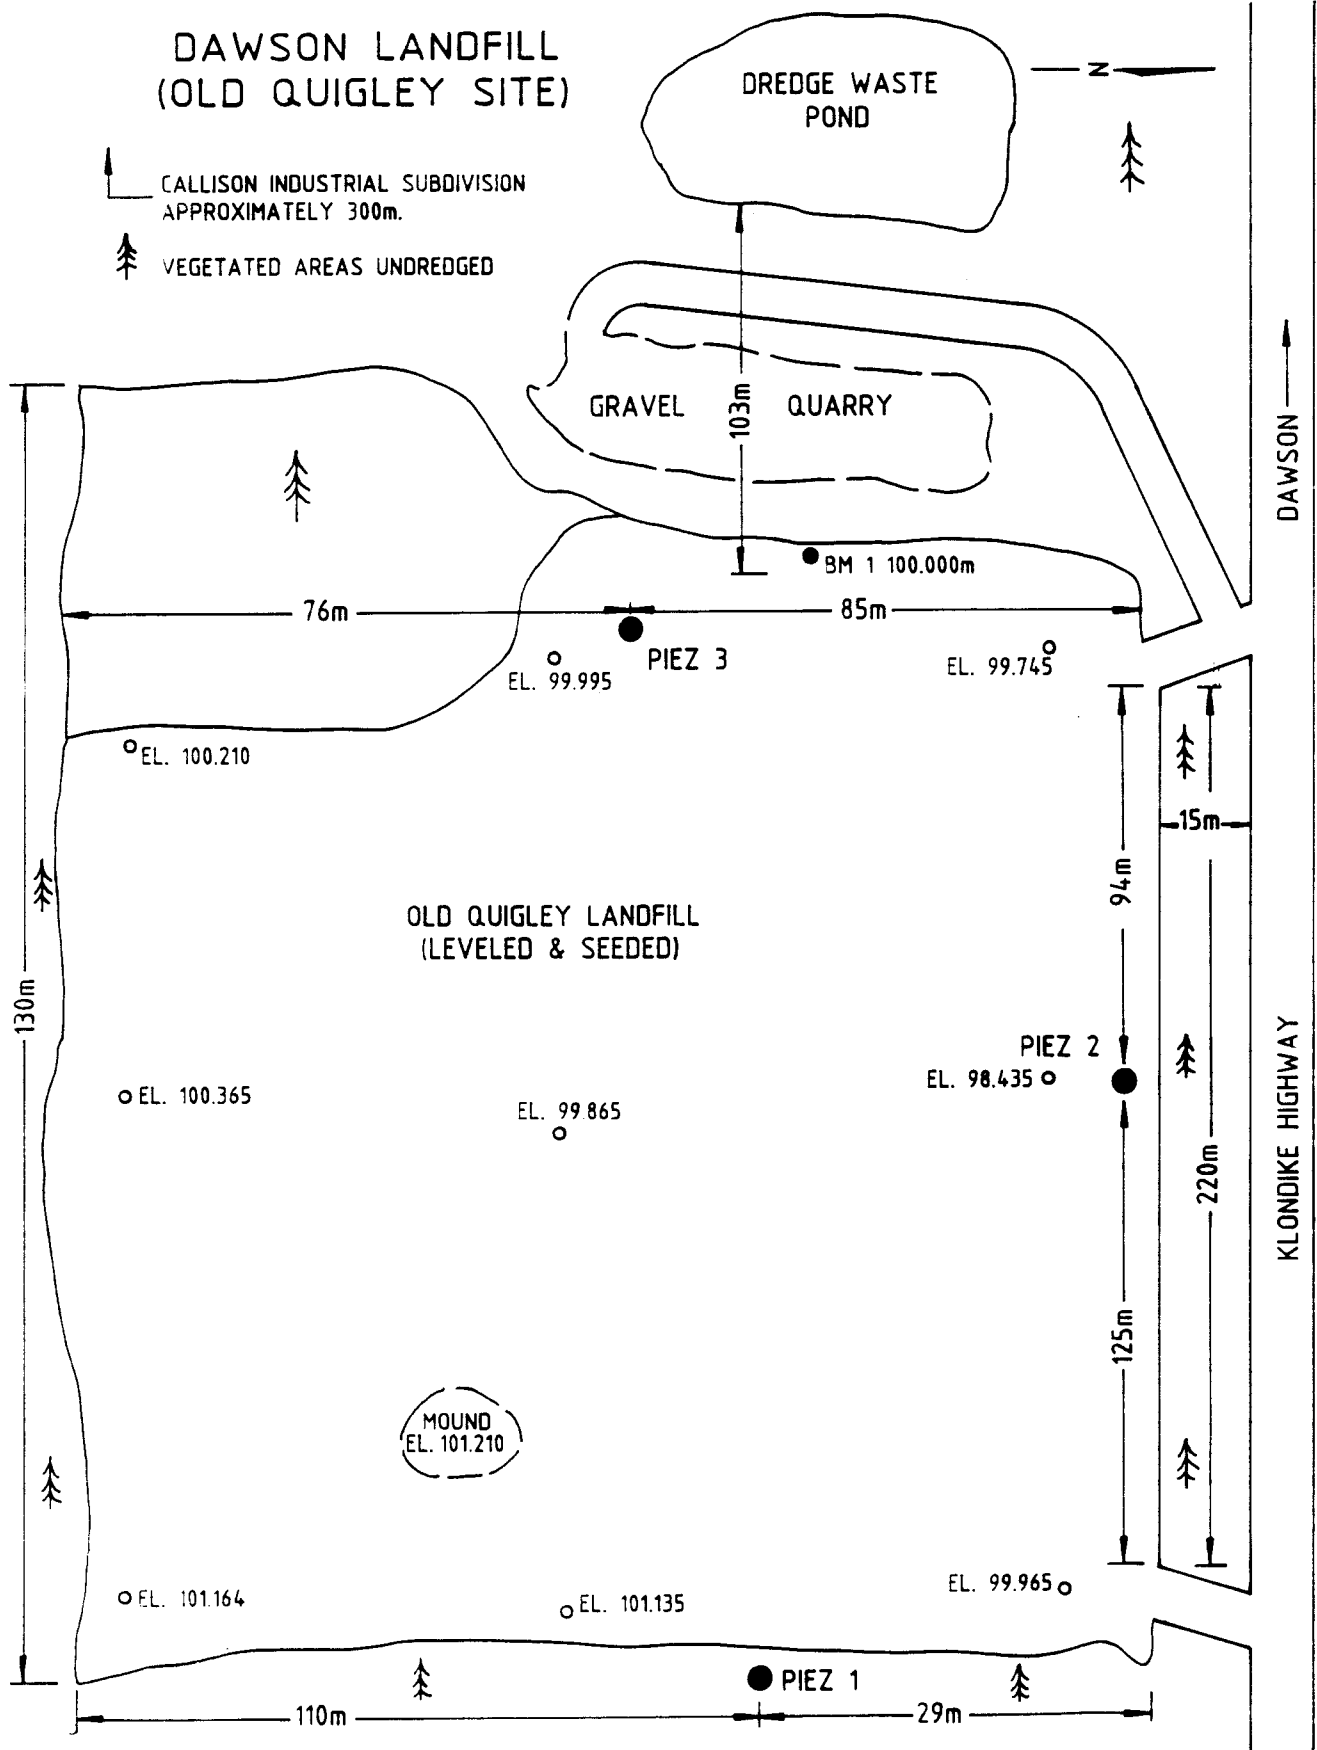
1. Site mapping - documenting dump size, slopes, features and surrounding topography. *(Figure 2)* A site profile and water level profile was done by level circuit *(Figure 3)*.
2. Water sampling - Seven water quality stations were established at or near the Callison dump site. Sample station locations are shown in both Figure 1 and 2.

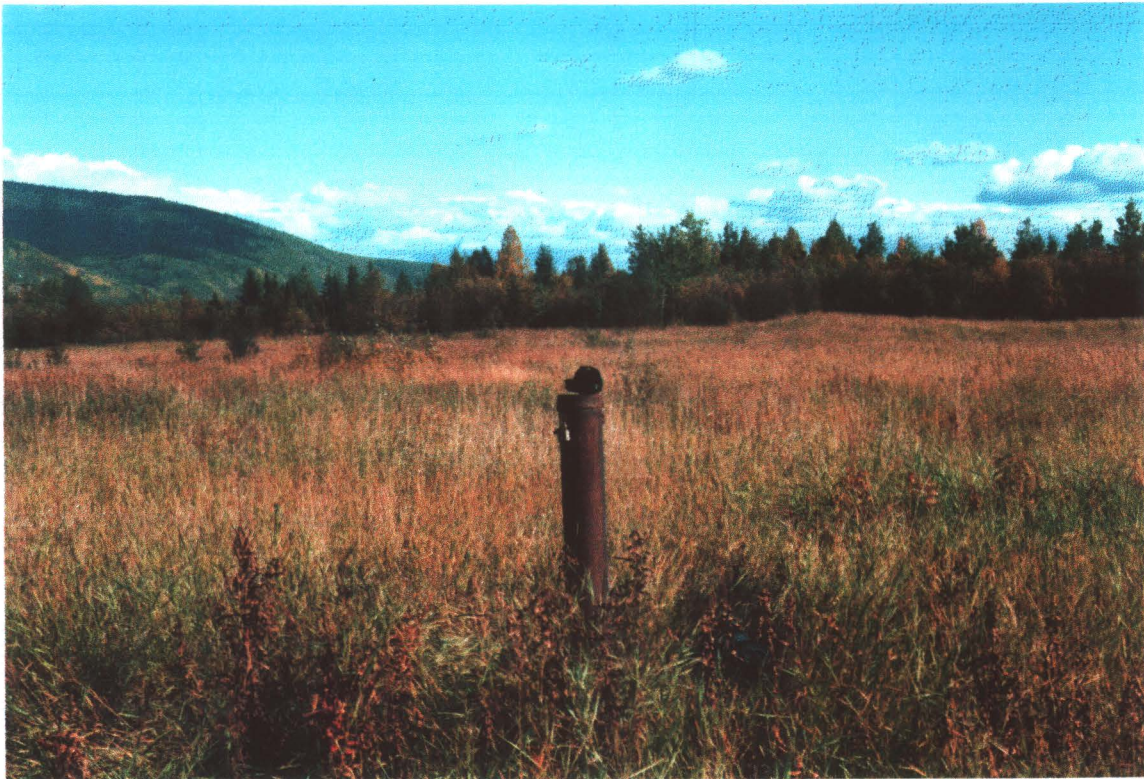
Organochlorine concentrations for all parameters included were below their respective detection limits with the exception of methoxychlor in sample Dawson #3 (standing water in monitoring well #3 at western edge of site). The concentration of methoxychlor detected in sample Dawson #3 was 0.58 ug/l (ppb).

Figure 5: Callison Dump - Piez #3 with abandoned dump in background

The pesticide is likely absorbed to soils/sediments in the area surrounding the western edge monitoring standpipe (Piez #3).

Although the area's groundwater meets existing drinking water guidelines for all analyzed parameters with the exception of iron and manganese, monitoring for the continued presence of the organochlorine methoxychlor should continue. A monitoring schedule of annual or biannual sampling and analysis should be sufficient.
