**VENUS MINE TAILINGS**

**Study of Remedial Options**

PB 6535 0101

MARCH 1994

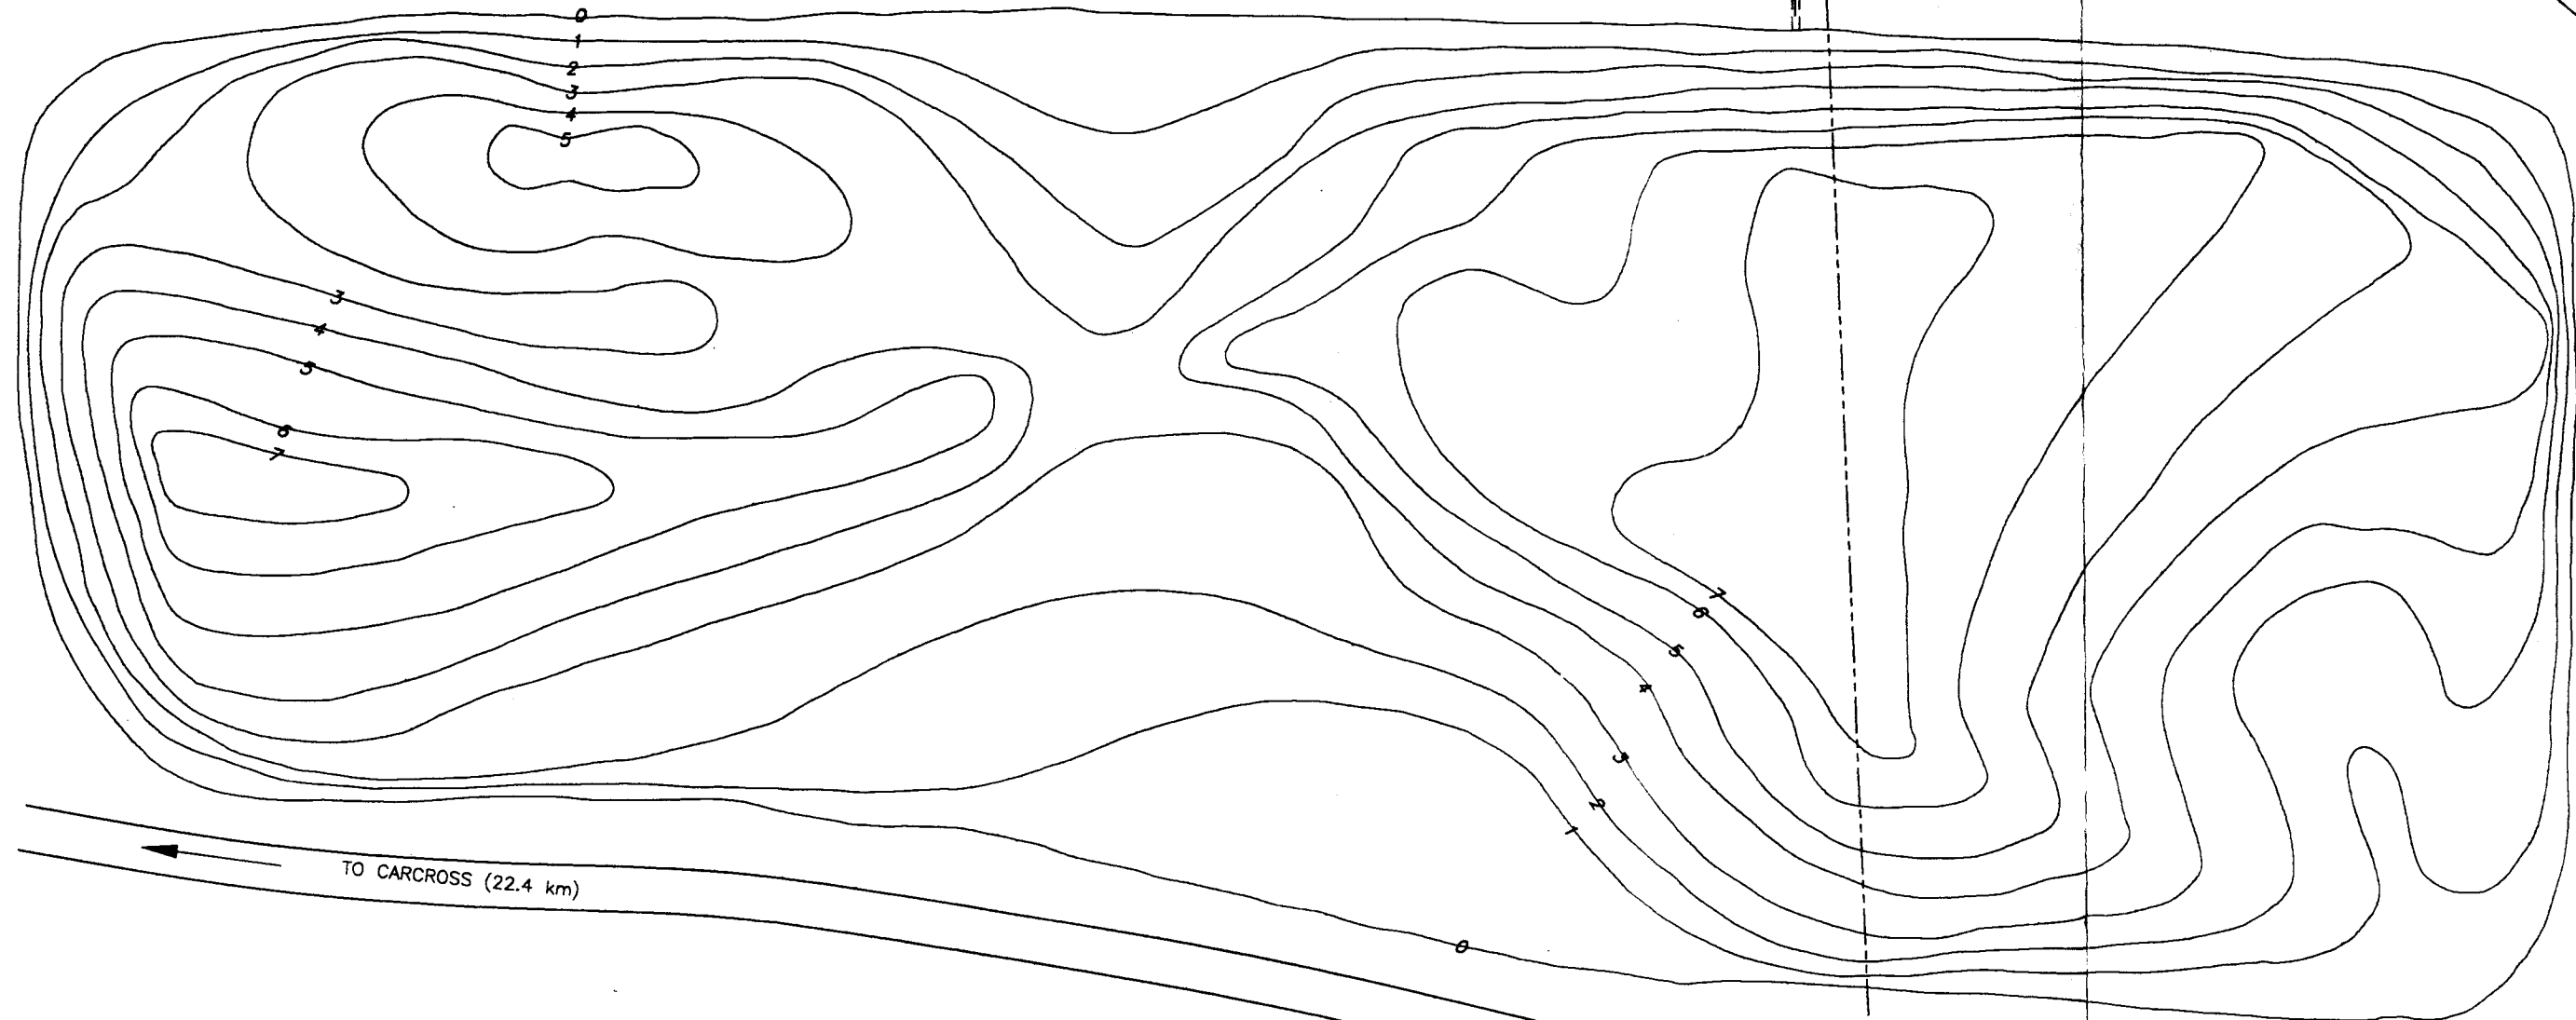
PROJECT <b>VENUS MINE TAILINGS STUDY</b>			
TITLE <b>'OLD' VENUS MINE TAILINGS SITE DEPTH CONTOURS</b>			
DATE OF ISSUE	PROJECT No.	DWG. No.	REV.
	PR8535 01	FIGURE 2

Observations made during the site visit indicate that some volume of tailings has also been eroded into the lake from the south-east corner of the site. An excavation through the perimeter dike was made to allow easy access for removal of tailings as discussed. The dike excavation permits the erosion and transport of the fine material during periods of intense runoff, such as storms and spring melt. The result is that an unknown volume of tailings may now exist in the lake further reducing the tonnage presently at the site.

Figure 2 illustrates the observed depth of the tailings as recorded during the auger sampling campaign. Analysis of samples at various depths in each of the 22 holes lead to a reported overall precious metal grade (UKHM) for the tailings of 0.09 oz/ton Au (gold) and 1.31 oz/ton Ag (silver). It was observed that some holes had a sufficiently low grade at depth to make them unattractive for reprocessing. Therefore, the total amount of tailings for reprocessing is reported as roughly 36,800 tons (33 400 tonnes). A volume calculation using the depth of tailings with the UKHM cutoff grade yielded a volume of 22 100 m<sup>3</sup>. At a density of 1.4 tonnes/m<sup>3</sup> the amount of tailings above that cutoff is calculated to be 34,100 tons (30 100 tonnes). A reprocess amount of 33 000 tonnes has been assumed for the evaluation of option 2b, using the grades specified by UKHM.

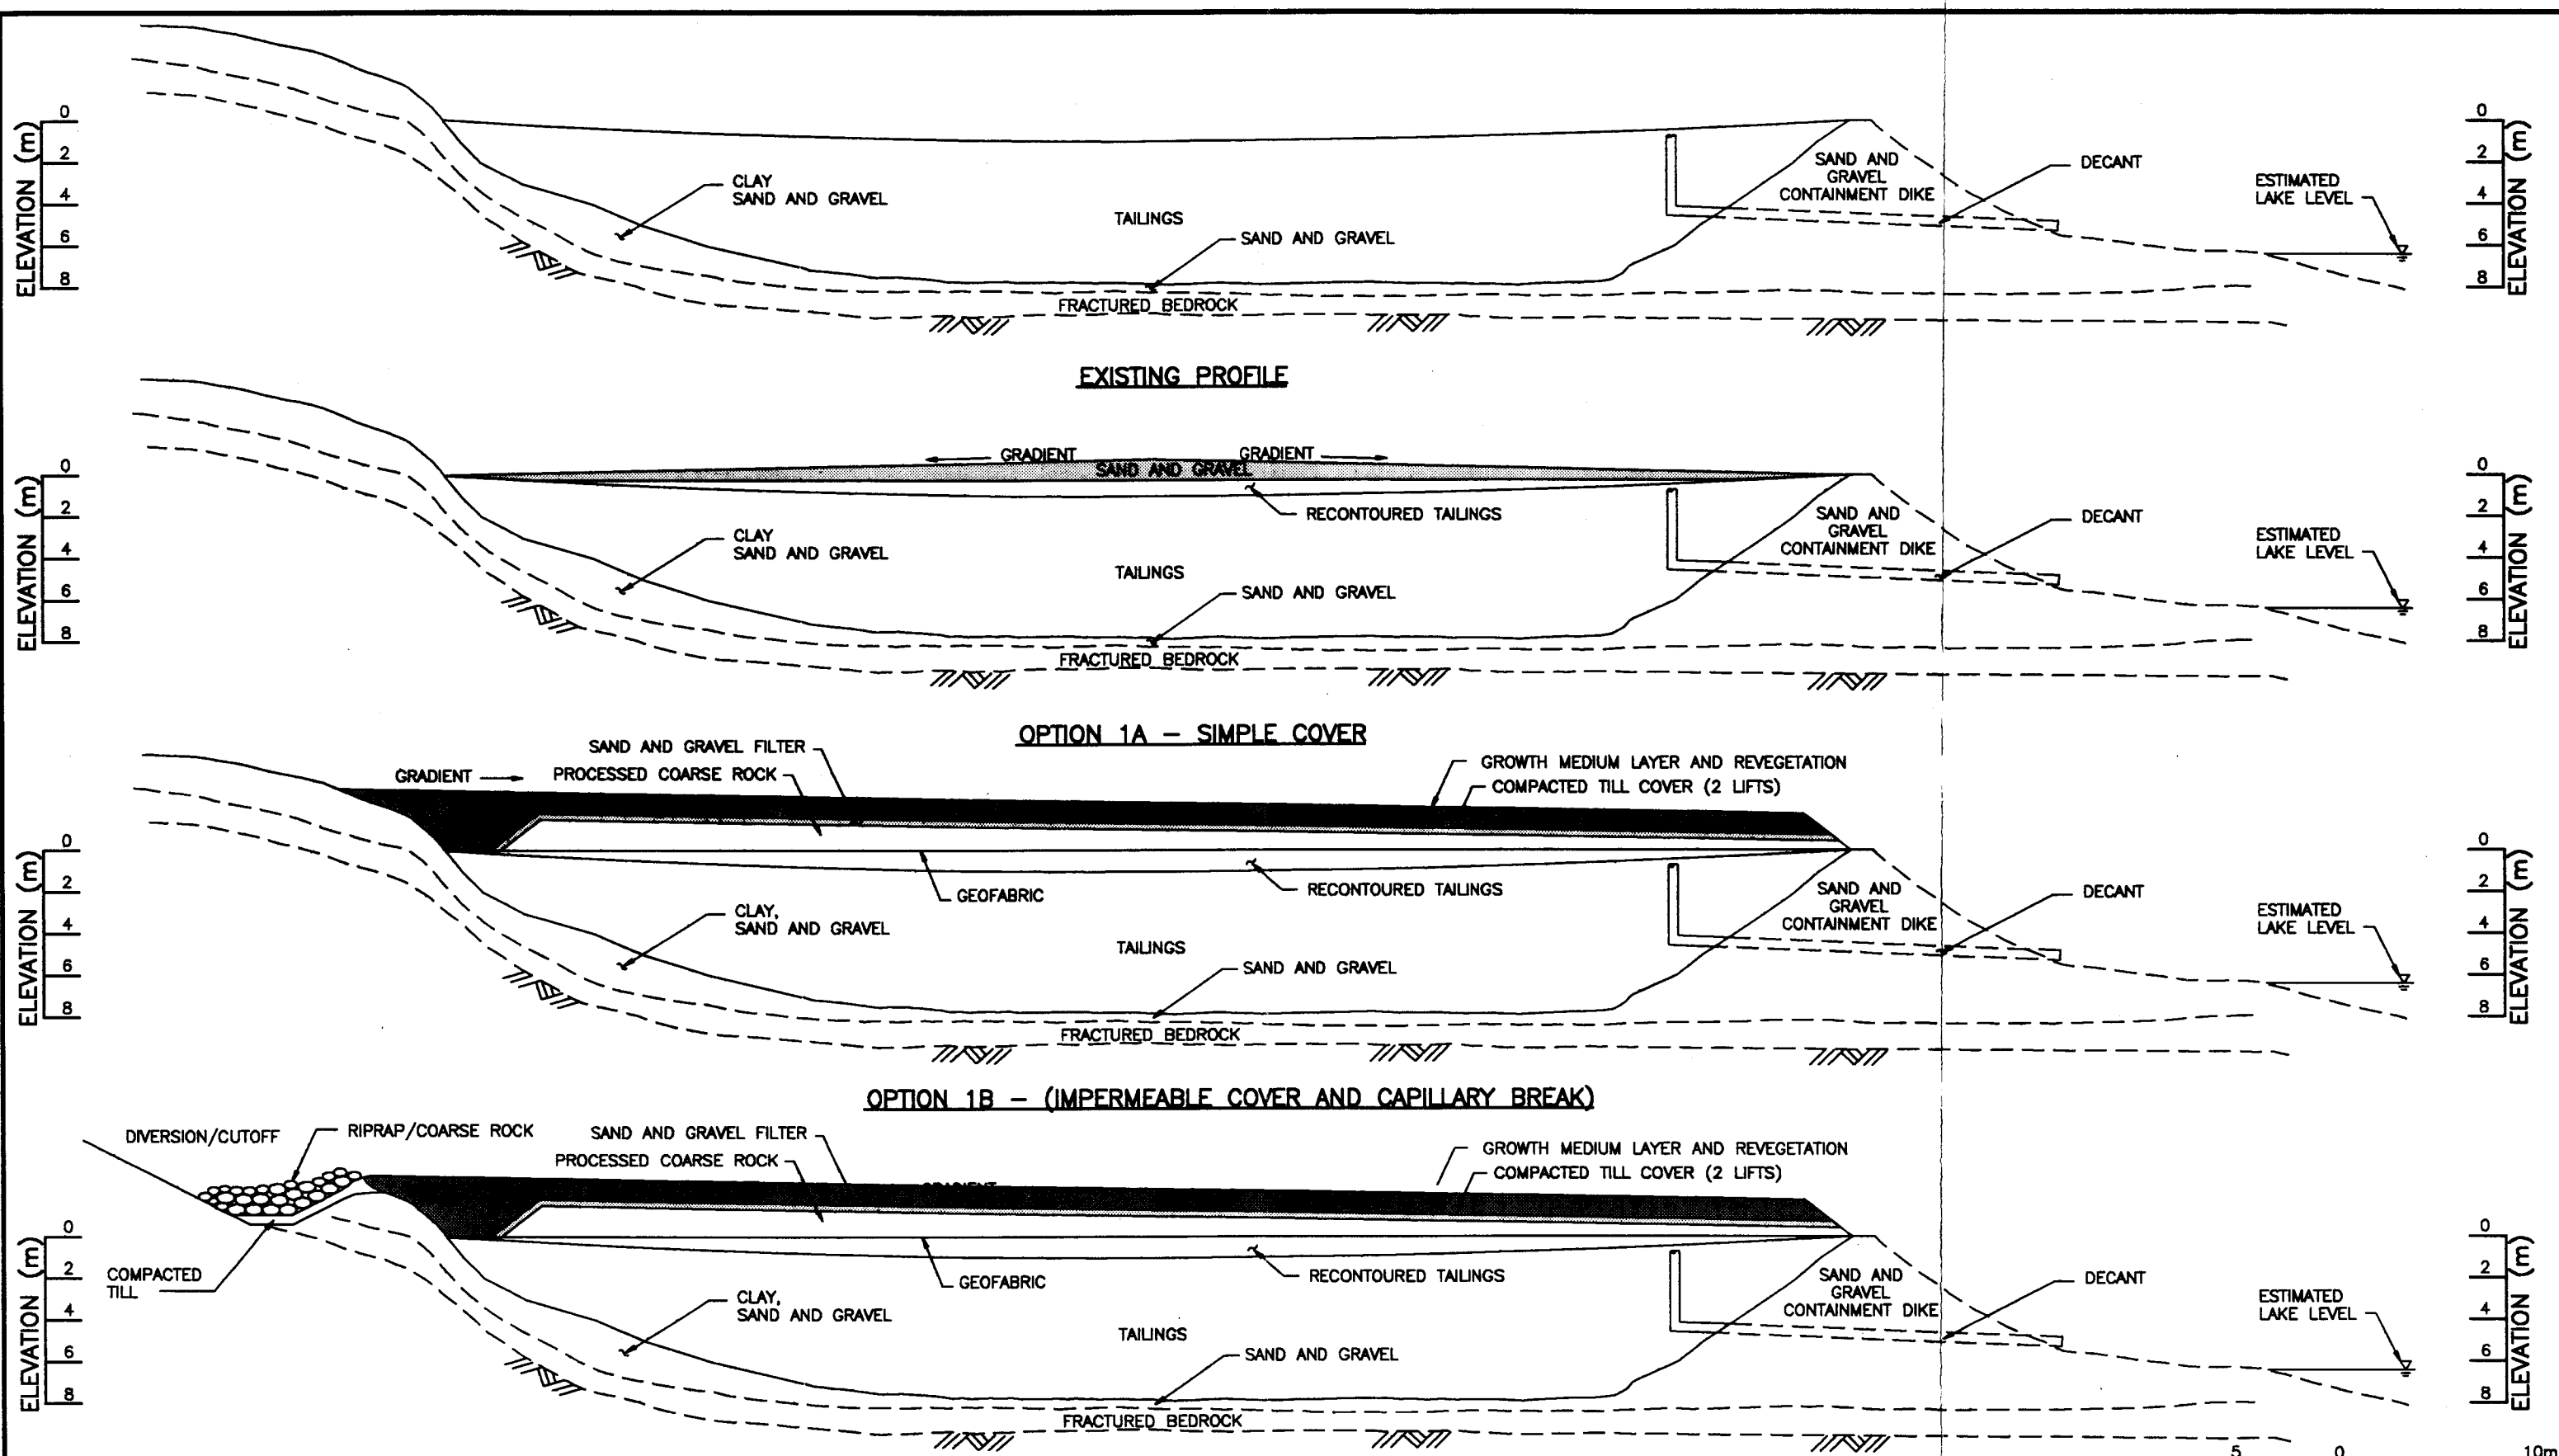
The coarse rock layer would be placed on a geofabric which will effectively filter the tailings. While the thickness of this layer varies (as shown on Figure 3), the average thickness is 1.5 m. The drain material will also produce a trafficable surface upon which the till would be placed. Compaction of the till under appropriate moisture content conditions will produce a plastic impermeable cover capable of sustaining minor deformation, with a long useful lifetime.

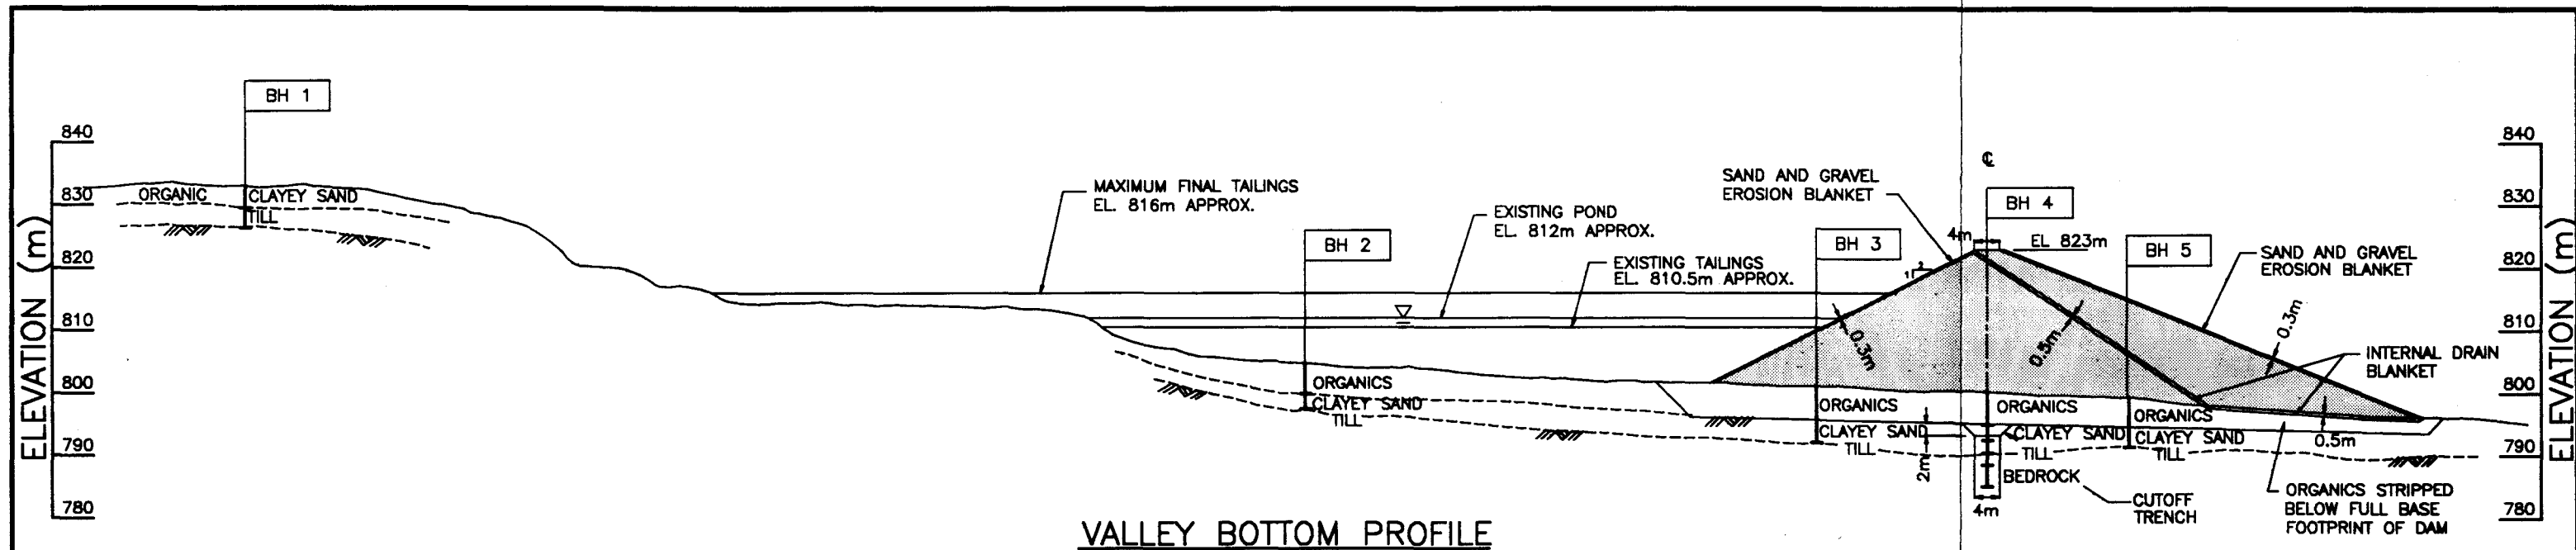
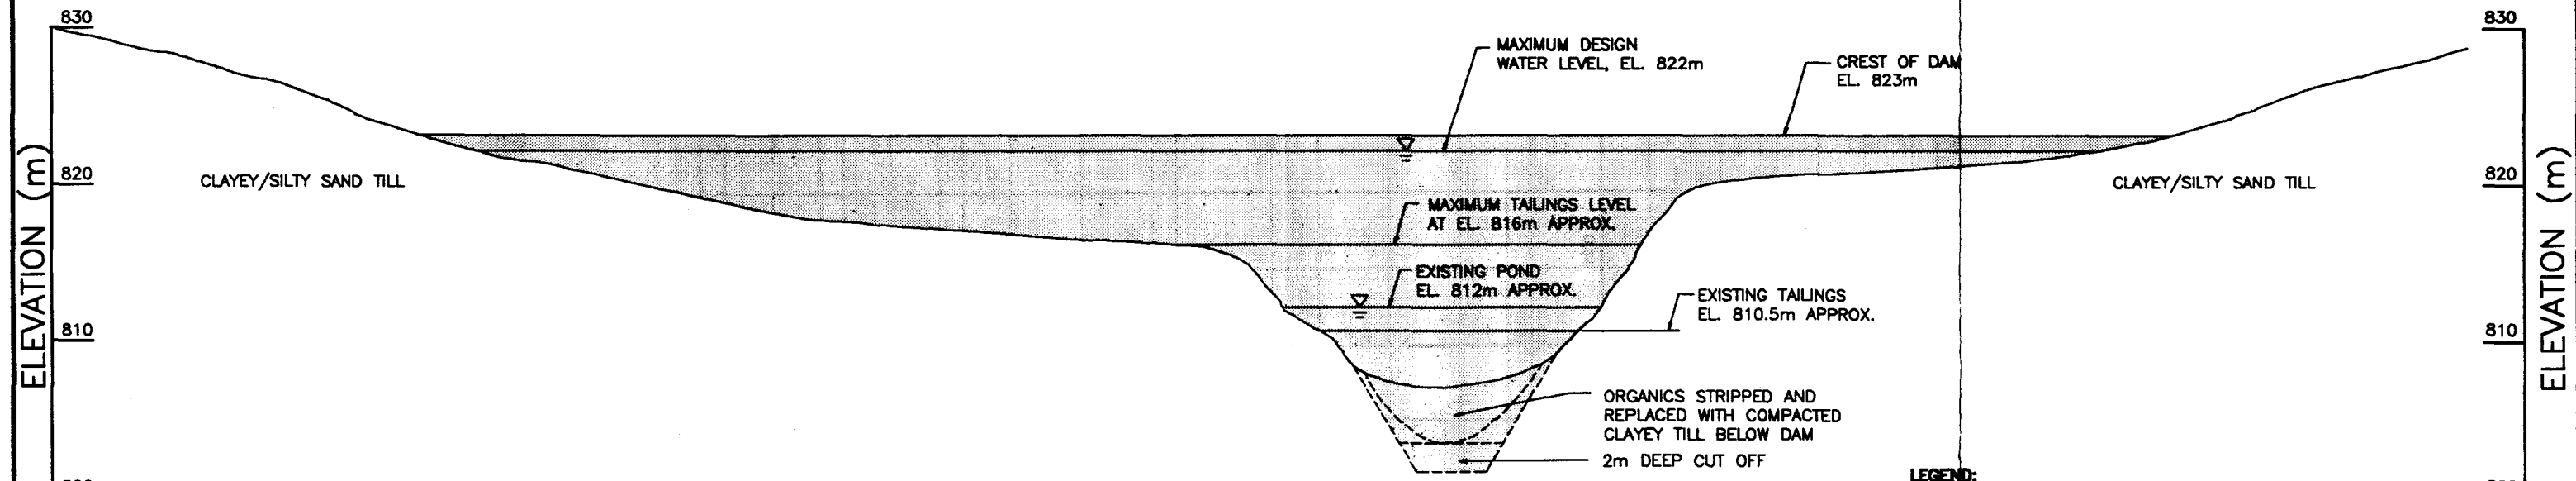
VALLEY BOTTOM PROFILE AND DAM CENTRE  
LINE PROFILE

Drawing D-1001 shows the design sections of the new tailings impoundment and tailings dam. The conditions of the tailings impoundment and the construction of the tailings dam are described in the following sections.

Assessment of the dam design concludes that the upstream slope of the dam is too steep given the shallow thickness of gravel slope protection, and the fact that the dam may retain water for long periods of time. Saturation of the upstream till slope, effects of freeze-thaw, and seasonal fluctuations of the pond level could cause shallow instability and failure of the upstream slope. It is noted that cracks were reported by Geocon at the upstream crest of the main dam of the fresh water pond (west side of highway) in 1983. Instability of the tailings dam may not have occurred to date because of the low pond levels maintained in the impoundment.

No problems with seepage through the tailings dam are reported in the available information. However, unusual seepage would not be expected at the low pond levels maintained behind the dam. Seepage will increase as the pond level is raised and more of the dam length impounds water. A small, concentrated seepage leak at the downstream toe of the fresh water pond dam was noted soon after filling in 1981. In 1983, the seepage was estimated to be 0.3 l/s. Minor seepage was also noted by SRK in 1988 at the toe of the polishing pond downstream of the main tailings dam.
