**REPORT ON THE ENVIRONMENTAL
CLEANUP AND RECOVERY OF
DERELICT BARRELS FROM WATSON LAKE,
YUKON TERRITORY**

NOVEMBER 23, 1994

**FTI PROPOSAL NUMBER: P-1583
DIAND CONTRACT NUMBER: 94-0076**

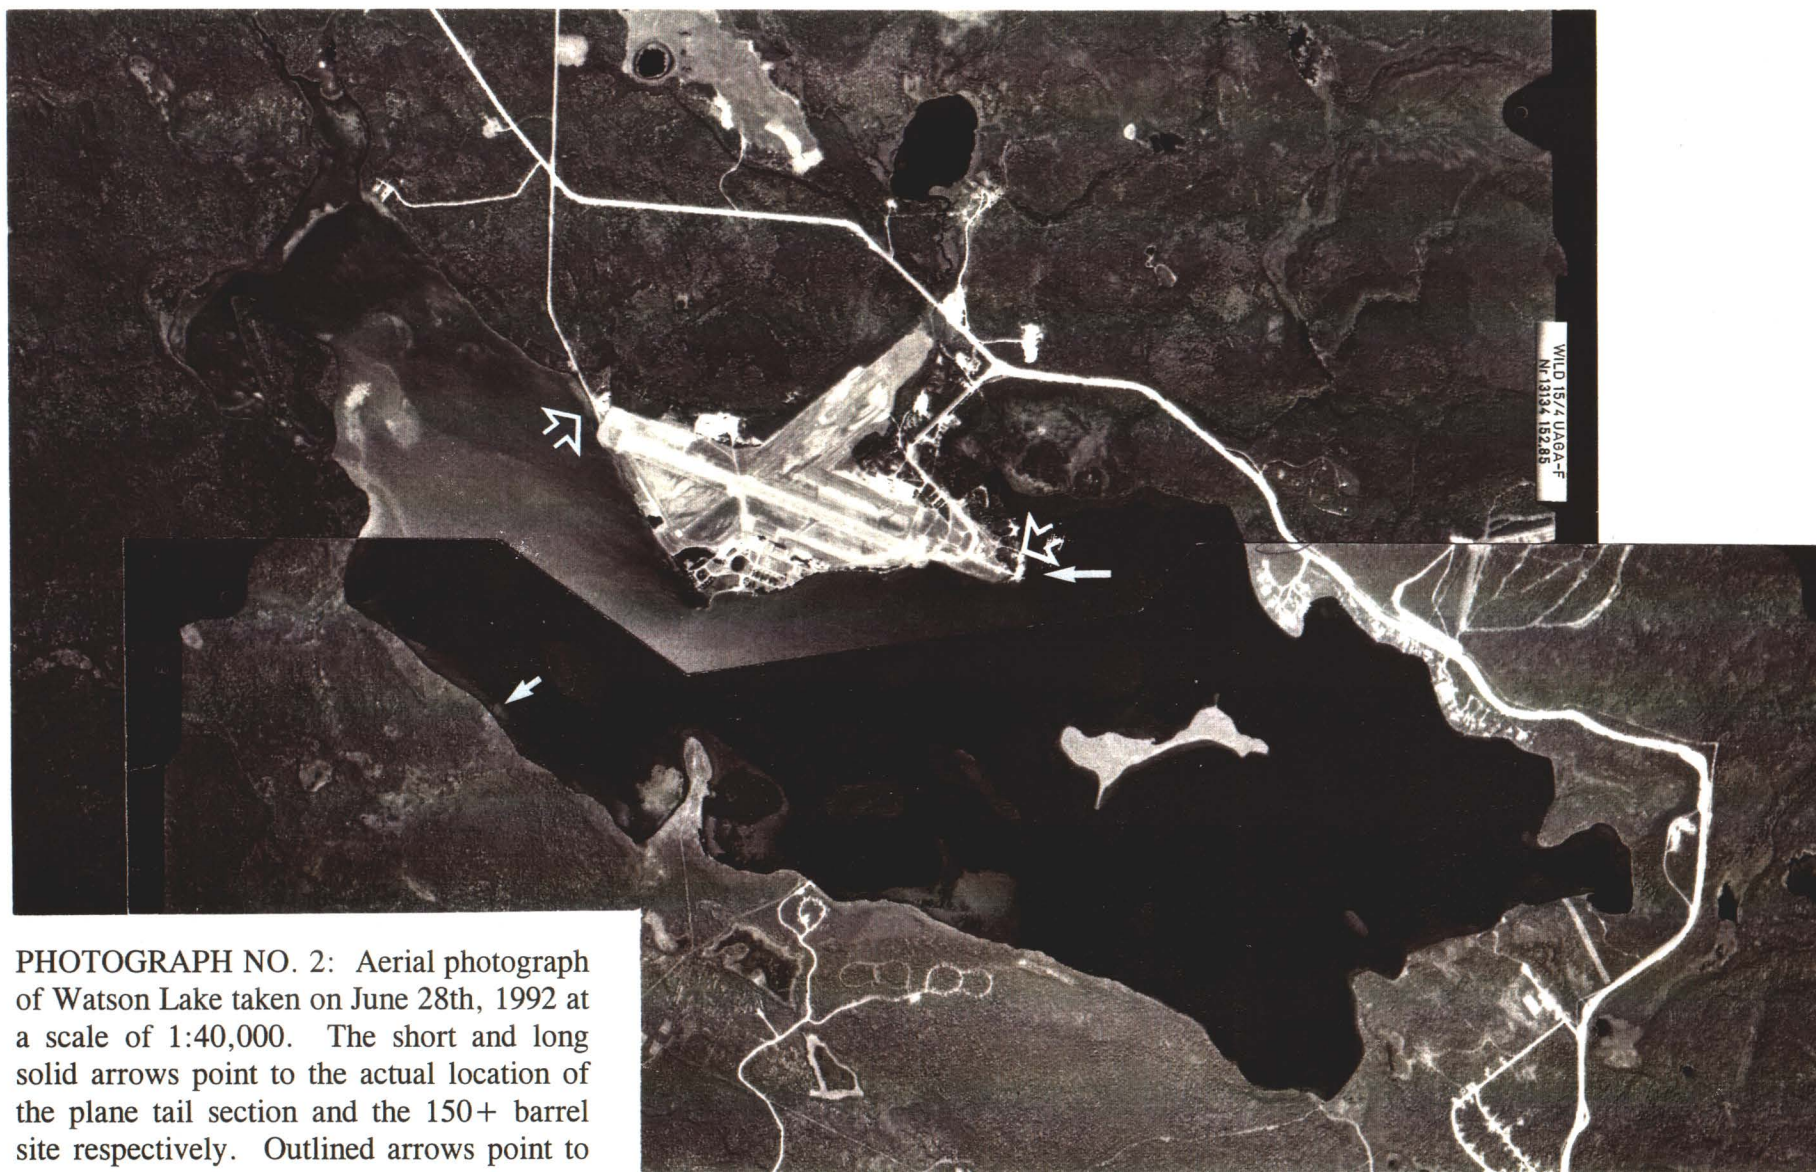
The initial task set for the FTI project team was to relocate the barrels identified in the 1991 FBD survey. Test plots of the plane tail section and the 150+ barrel site using the longitude and latitude positions provided in the 1991 FBD survey revealed significant variances between the actual and reported locations. In the case of the plane tail section the difference between the actual site and 1991 FBD GPS reported location was 1500 m, and, according to the FBD longitude and latitude fix of the 150+ barrel site it is located up on dry land at the Initial Attack Base, not in the lake, see Photograph No. 2.

PHOTOGRAPH NO. 2: Aerial photograph of Watson Lake taken on June 28th, 1992 at a scale of 1:40,000. The short and long solid arrows point to the actual location of the plane tail section and the 150+ barrel site respectively. Outlined arrows point to the approximate longitude and latitude positions given in the 1991 FBD survey.

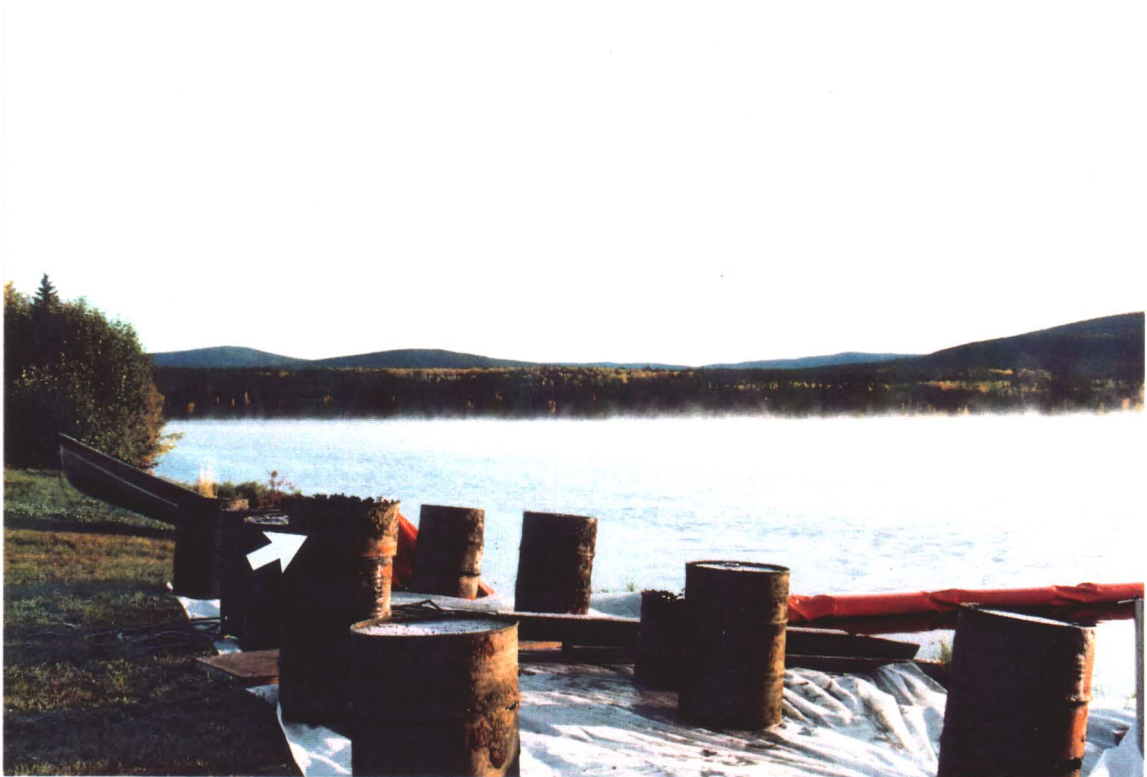
PHOTOGRAPH NO. 4: Recovered barrels at the Initial Attack Base. Note plastic ground sheet and half corroded barrel (arrow).

A ground sheet of polyethylene plastic was laid down upland of the spill boom where the barrels were brought ashore and temporarily stored, see Photograph No. 4. The polyethylene sheets were placed so that any leakage from the barrels would drain down to a single point where it could be captured.

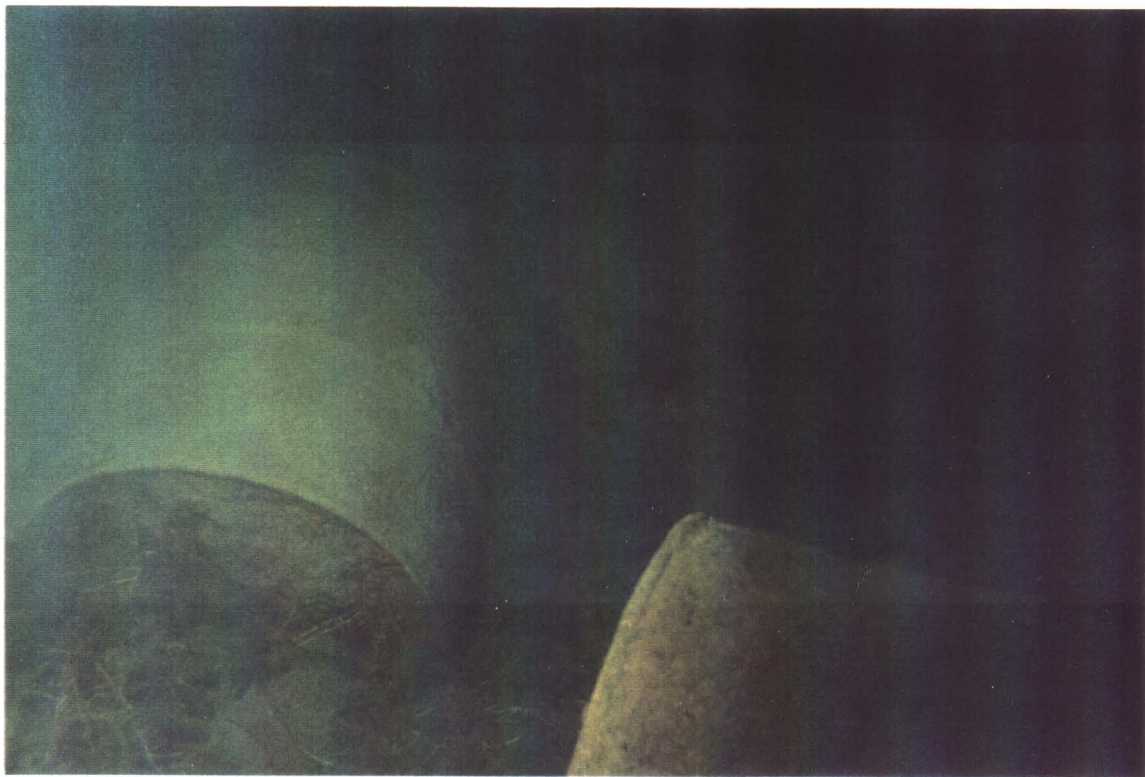
A dive survey of the barrels was conducted to determine their condition, see Photograph No. 5. Those barrels that were severely corroded and did not appear to contain any significant amounts of contaminants were recovered first. By recovering the most heavily damaged barrels first, clues as to the actual contents of the barrels could be gathered with the lowest risk of a contaminant release.

PHOTOGRAPH NO. 5: Unrecovered barrels at the Initial Attack Base site.

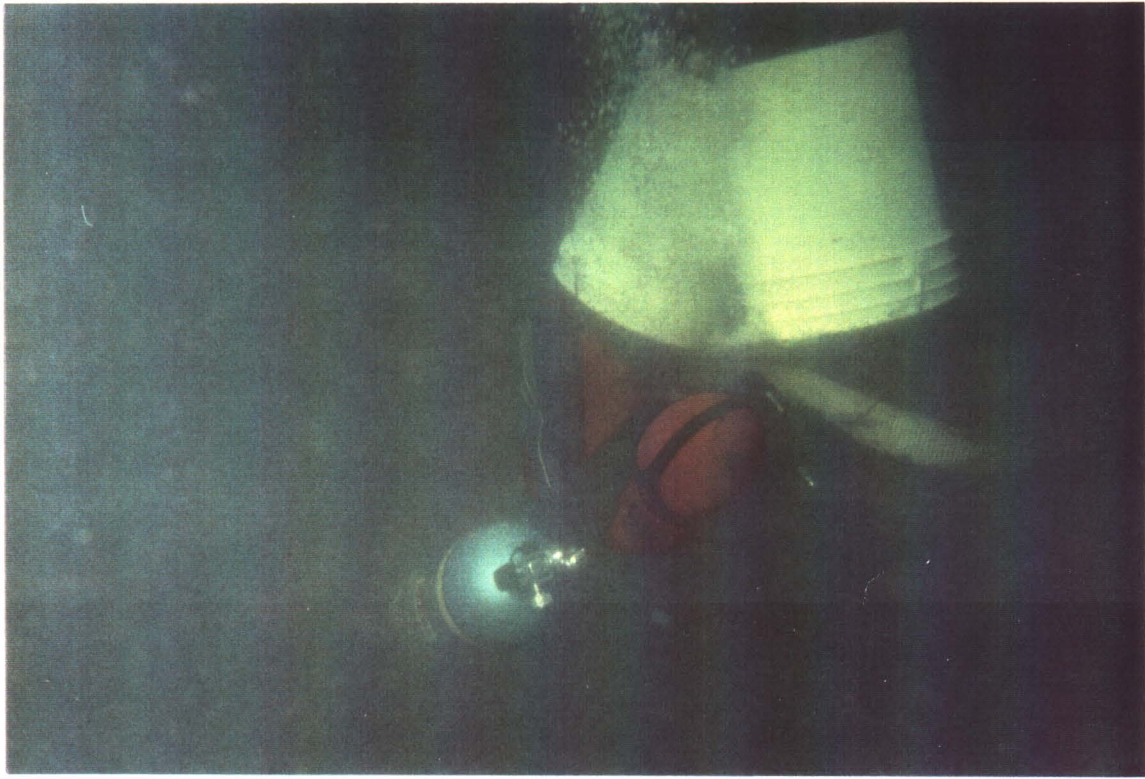
PHOTOGRAPH NO. 7: Barrel suspended in the water column being inspected by diver for leaks and pre-transport integrity.

Two 22 litre buckets, attached to a lifting strap, were used to raise the barrels off the bottom in an upright position, see Photograph No. 6. While suspended in the water column the barrels were inspected for leakage and structural integrity, see Photograph No. 7. The barrels were then floated through the water column to inside the spill boom where the lift buckets were disconnected, see Photograph Nos. 8, 9 and 10.

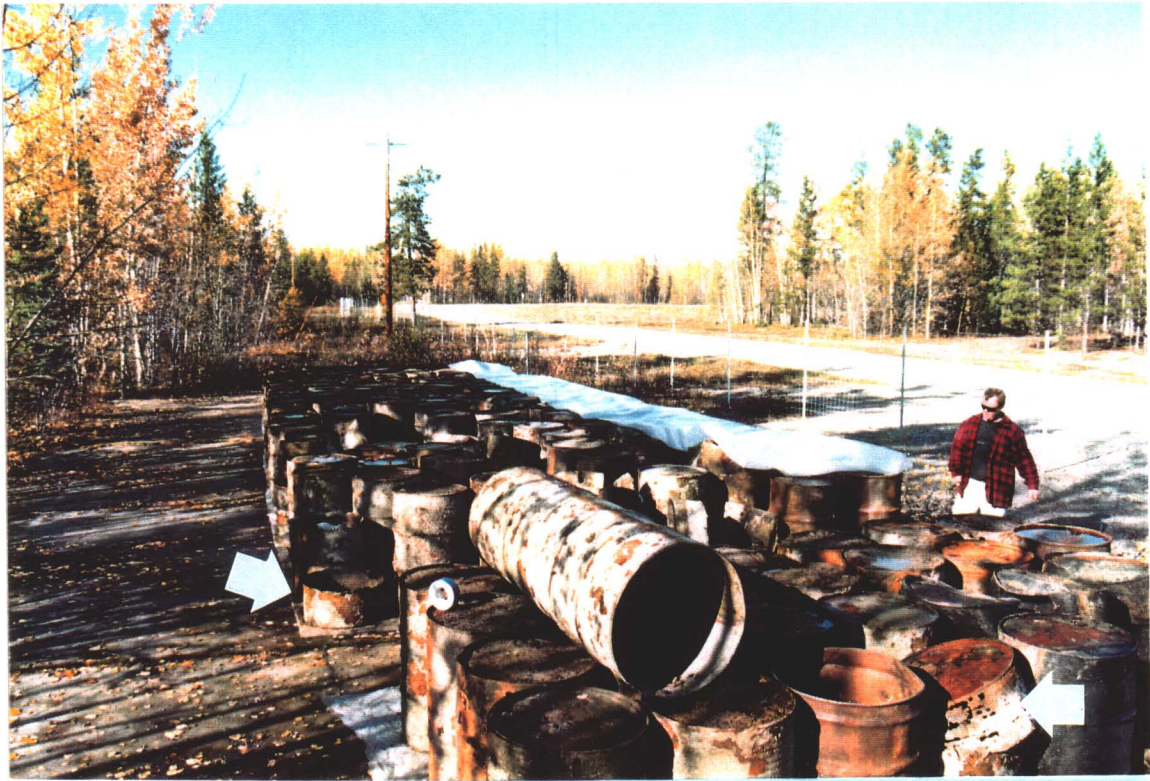
PHOTOGRAPH NO. 13: Plastic sheet being laid over top of stacked barrels. Note poor condition of some of the barrels (arrows).

A concrete pad at the DIAND site was chosen as a suitable storage area as it would form a physical barrier between the barrels and the underlying soil. In addition, a plastic sheet was laid over the concrete pad prior to storage of the barrels in order to ensure that leaked contaminants did not pass through any cracks in the concrete and into the ground, see Photograph No. 12. In order to prevent rain creating a leachate from the barrels, plastic sheets were laid over top of the stored barrels, see Photograph Nos. 13 and 14.

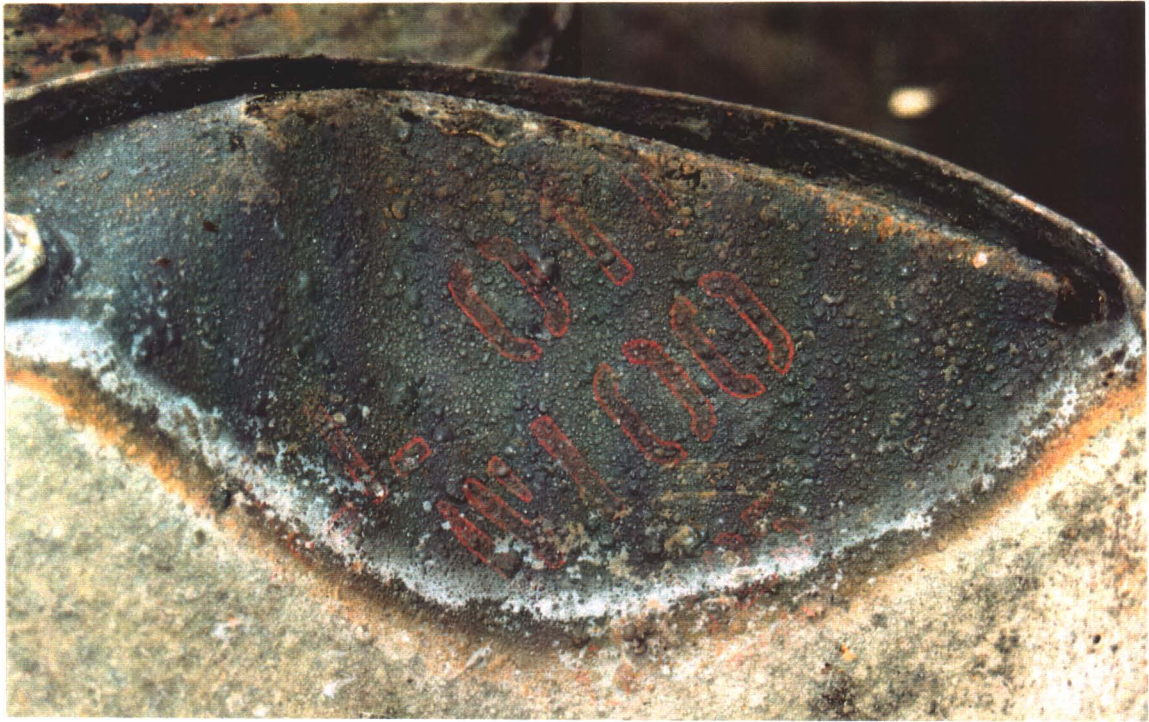
PHOTOGRAPH NO. 15: Markings on one of the barrels recovered from the Initial Attack Base indicating that the barrel once contained 100 weight oil.

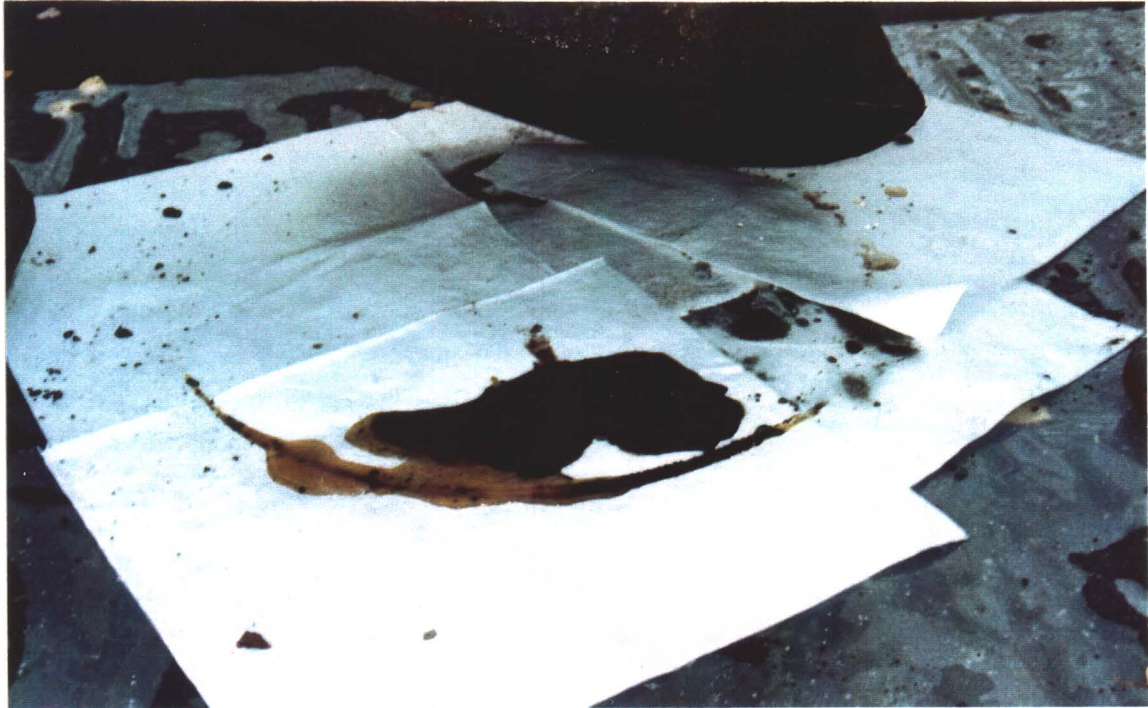
PHOTOGRAPH NO. 16: Oil residue from the barrel identified in Photograph No. 15. Spilled contaminants were recovered using oil absorbing pads and transported along with the barrels to the DIAND storage site.

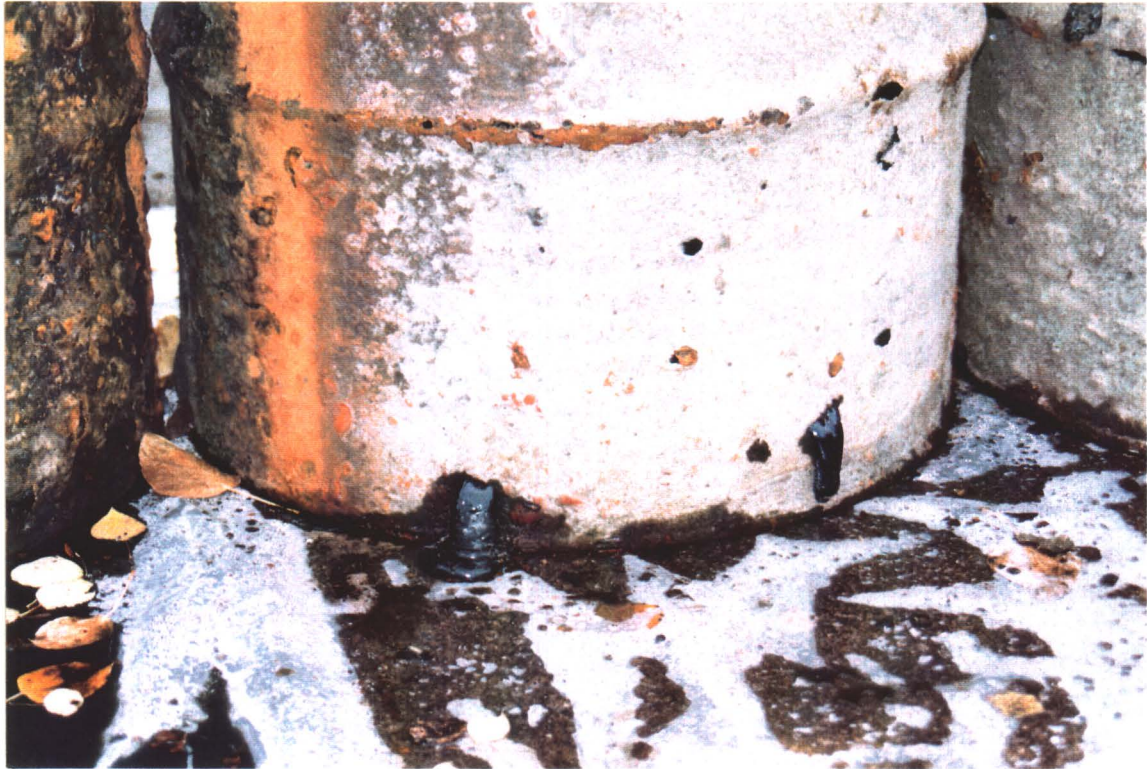
The condition of the barrels ranged from being corroded in half to having a few holes (2 mm in diameter). Typically, the holes were located at random over the barrel surfaces that were not buried in the lake bottom. However, in some cases the holes were concentrated on the ribs of the barrels.

The most common contaminant identified was a tar-like substance located in the bottom or adhering to the sides of some barrels. The amount of contaminant in any one barrel appeared to be less than one litre. One barrel was recovered that contained a small amount of 100 weight oil, see Photograph Nos. 15 and 16. One other barrel appeared to contain a small amount of diesel fuel. In both of these cases there was little residue left in the barrels and any spilled material was successfully collected using absorbent pads.

PHOTOGRAPH NO. 17: Black shiny tar-like residue typical of most barrels recovered at the Initial Attack Base. Note higher levels of corrosion damage on the raised rib of the barrel.
