# **An Environmental Study of the Aishihik Airstrip Yukon Territory**

**Prepared by the  
Environmental Sciences Group**

**Royal Roads Military College  
Victoria, British Columbia**

**© Indian and Northern Affairs Canada, Whitehorse, February 1995**

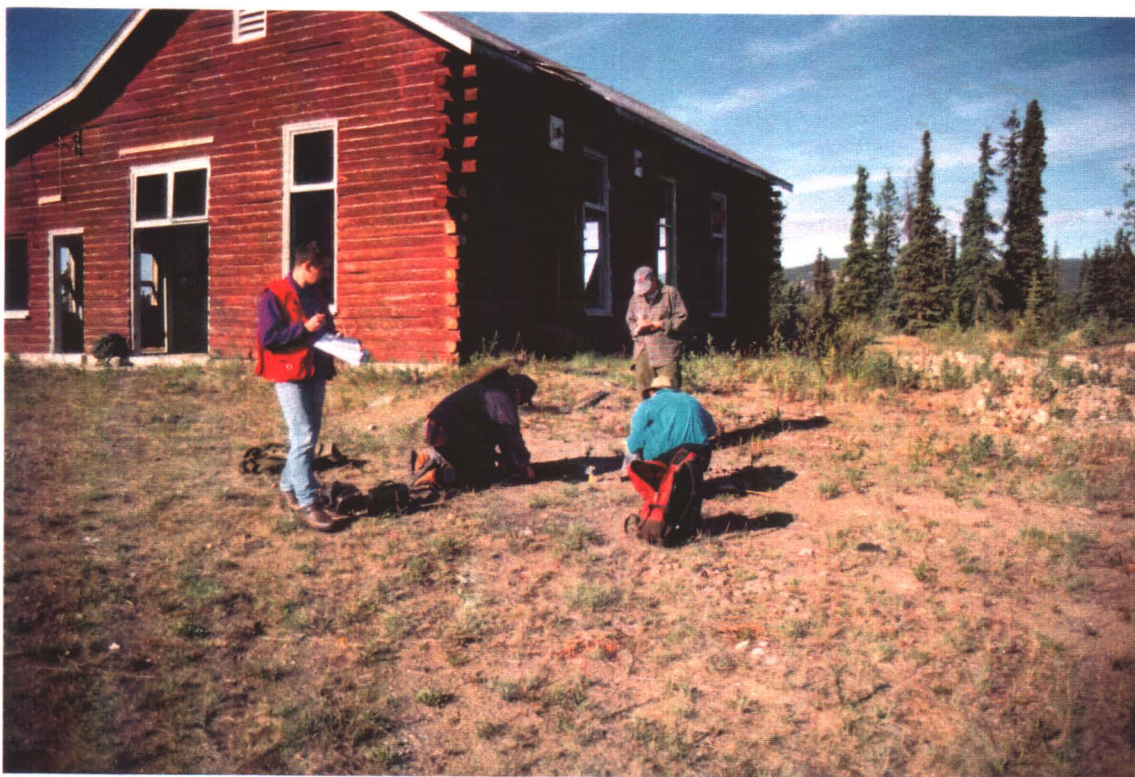
The powerhouse is structurally intact but the doors and windows are missing (Photograph V-3). This building had been used as a canteen during a First Nations convention but at the time of the ESG visit was not in use. The main generator room had a concrete floor (Photograph V-4); the generators had been removed and dumped in a depression about 200 m to the north. There were two more small rooms in the powerhouse on the southwest and southeast corners of the building. The floor was littered with wooden debris and ceiling cladding, and two radiators still remained on the north wall.

**Photograph V-3: View from the northwest side of the powerhouse.**

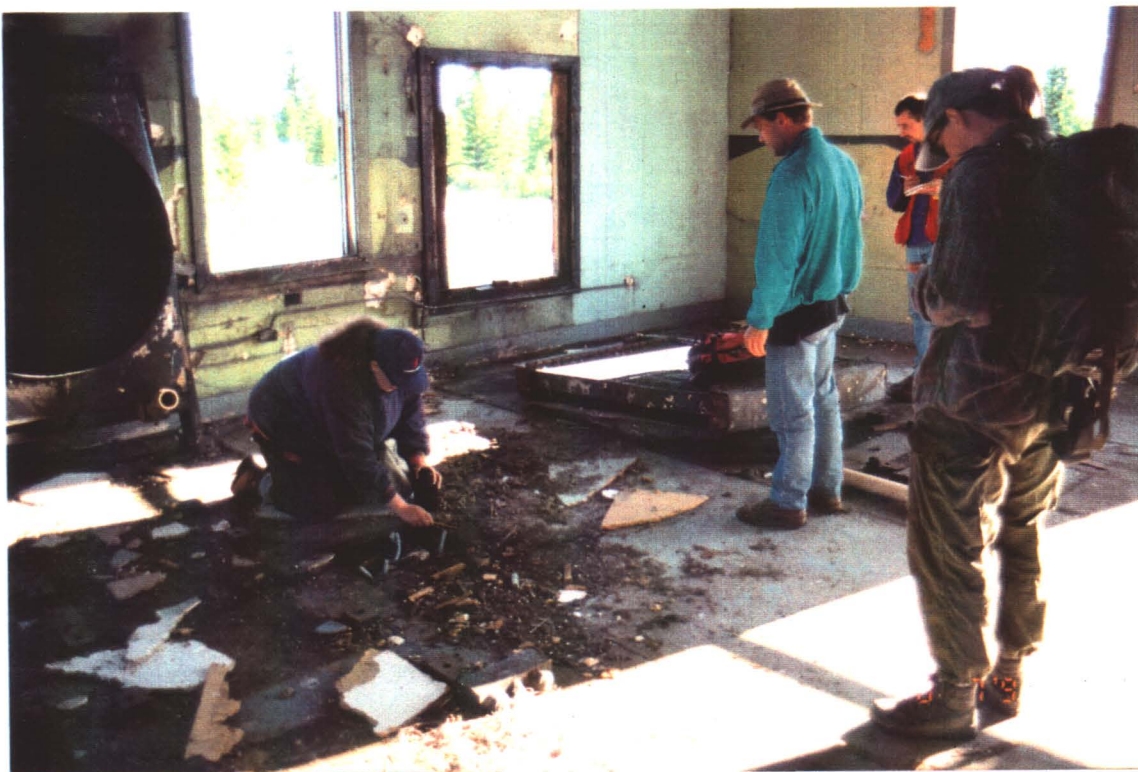
**Photograph V-5: A sample was obtained from the floor of the powerhouse (AA100).**

- Remove all loose paint on the walls;
- sweep and vacuum the floor and place all material in a suitable container for PCB waste;
- coat the floor with a PCB decontamination agent (Sanisolv) and allow to stand for at least 30 minutes;
- sweep the floor again and place residue in a suitable container for PCB waste;
- wipe all surfaces with an oil absorbant material and again place this in a container suitable for PCB waste; and,
- repeat the solvent wash three times.

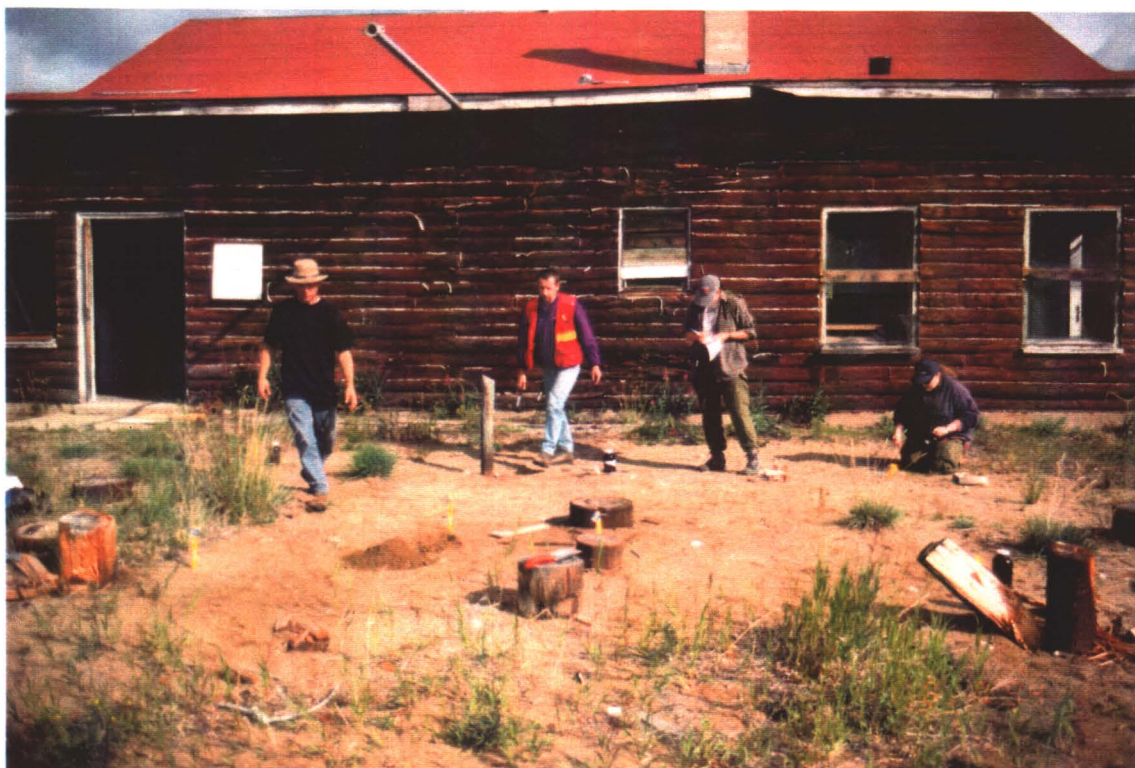
**Photograph V-6: The pole stumps are all that remains of the transformer rack that contained four transformers.**

A transformer rack was originally present on the south side of the powerhouse. All that remained were several pole stumps that would have been the support for the rack. The area underneath the rack was sandy and devoid of vegetation. Eleven soil samples were obtained from this area, seven from the region directly around the poles and four in drainage from this area (see Map V-5). The PCB results are illustrated in Figure V-1 (the PCB concentrations in ppb are given in parentheses).

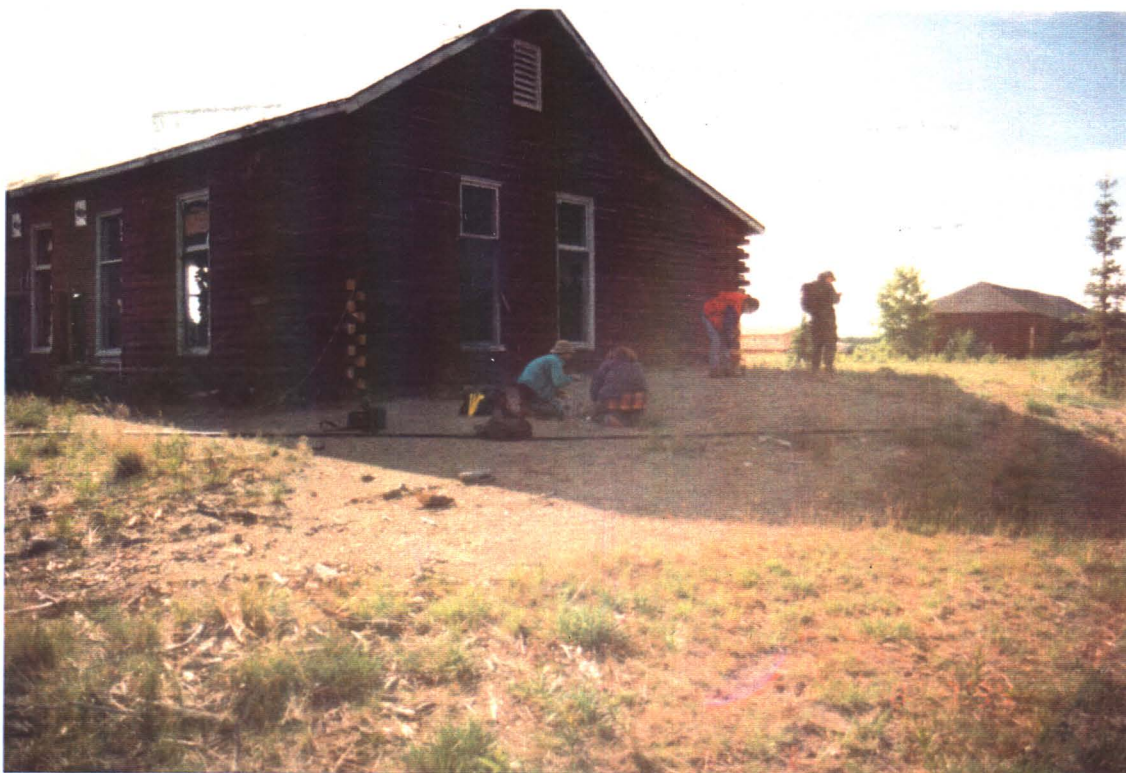
**Photograph V-7: Underground fuel tank on the west side of the powerhouse.**

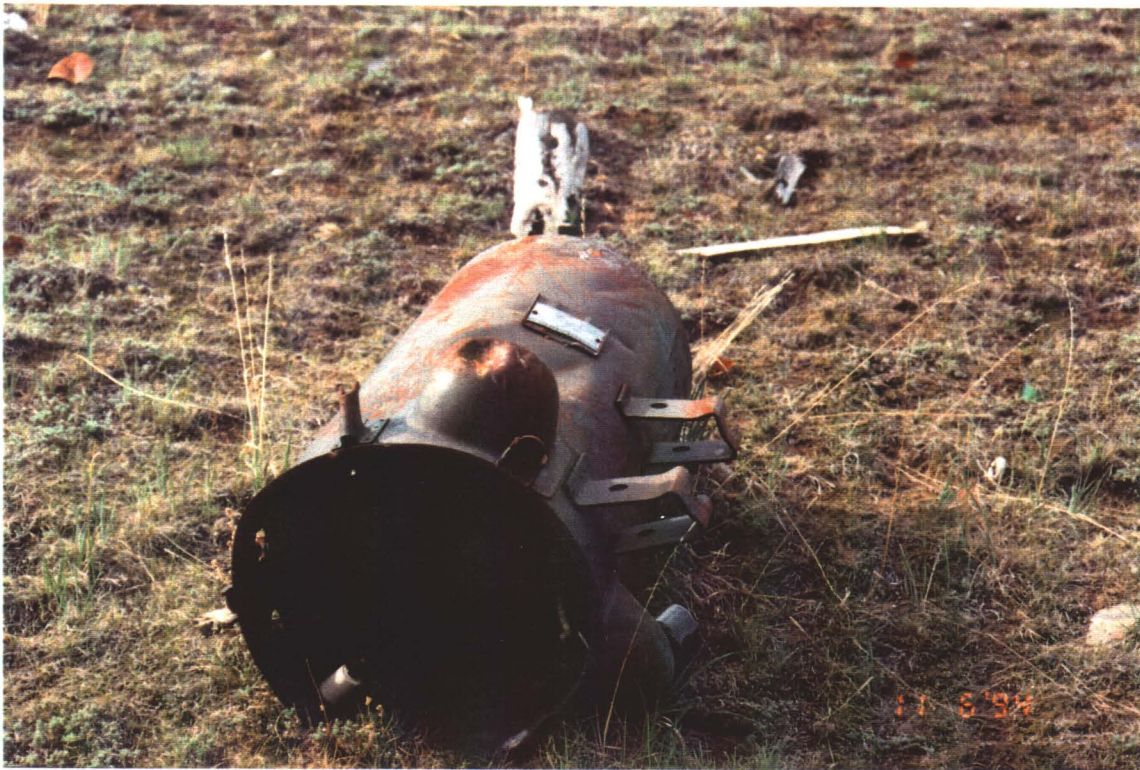
**Photograph V-9: Close up view of the transformer in Dump Site 1. This transformer had an oil capacity of 12.5 gallons.**

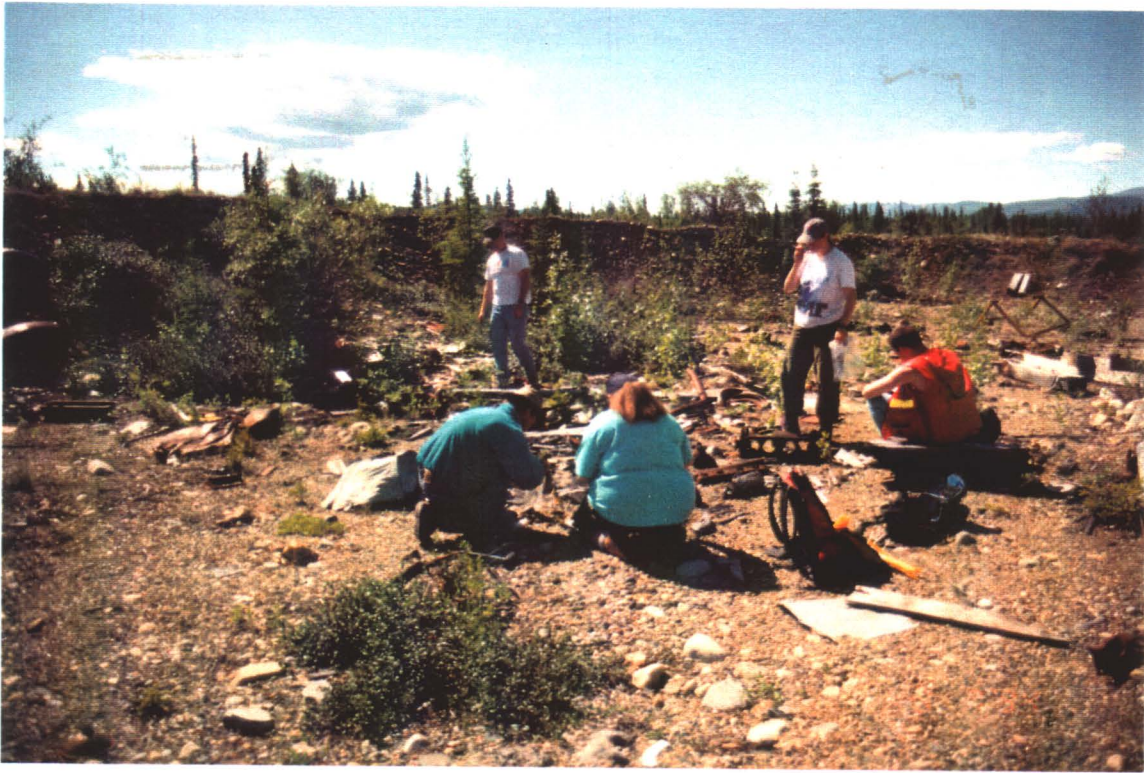
Three soil samples including one analytical duplicate, taken from Dump Site 3, were analyzed for PCBs and inorganic elements; PCBs were not detected in any of the samples. Levels of inorganic elements were comparable to levels in background samples with the exception of lead in sample AA142. This sample was collected next to some broken lead batteries and not surprisingly contained 513 ppm lead, exceeding both the CCME R/P criteria and DCC Tier II. A root and shoot sample of *Salix richardsonii* was also taken at this location. Levels of lead were significantly elevated from background levels, both in the shoots and the roots. The lead concentration in the shoots was 234 ppm whilst in the roots it was 67 ppm. The levels of lead in the soil and the plants indicate that some source control is necessary.

**Photograph V-11: Dump Site 3 contained two large piles of broken batteries (Sample AA142).**

The stained soil at the garage marked by AA116 should be removed and placed in the landfill on site. The same treatment should be applied to the soil underneath the broken battery at AA142.

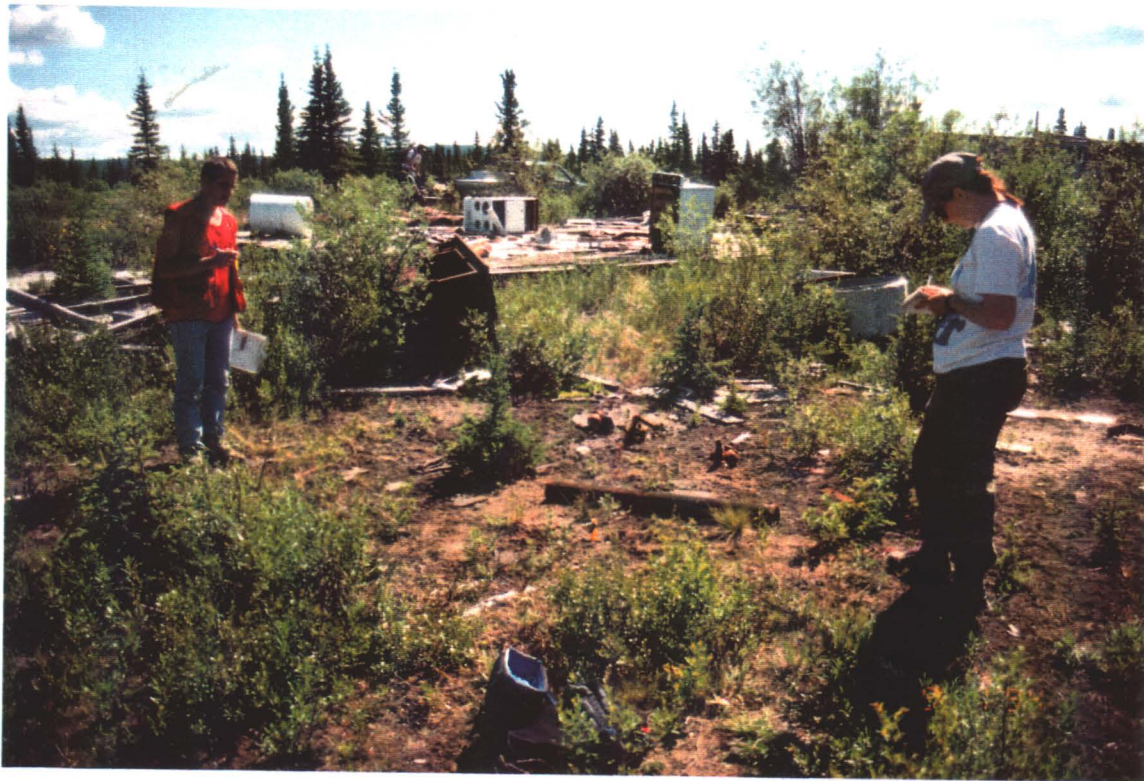
The main road forks approximately 250 m south of the garage. Just beyond this fork is the foundation of a burned building (Photograph V-12). Several kitchen fixtures are present in the vicinity along with many partially full tar barrels, some of which have leaked tar onto the ground. Three soil and one plant sample were taken in the vicinity of the building. A sample was also taken of the tar.

**Photograph V-12: Remains of a burned building on the south side of the site.**

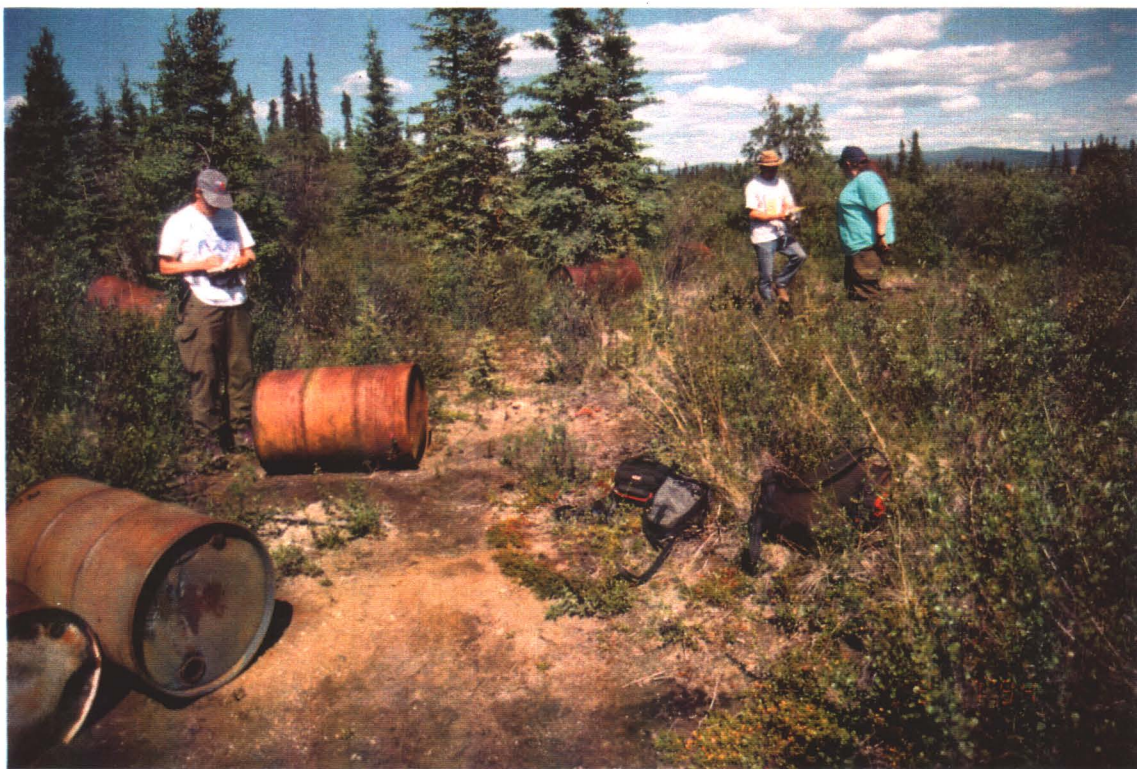
Approximately 250 m southwest of the burned building is a barrel dump. This area contains about 150 barrels, only ten of which contain any fluid (mainly water). Several stained areas are associated with leaking drums in this area (Photograph V-13). Two soil samples were collected in stained areas next to the barrels and one soil and plant sample was obtained in a low wet area that would concentrate drainage from the barrel dump. Four barrels containing fluid were opened and a sample obtained from each.

**Photograph V-13: The barrel dump on the south side of the site contained approximately 150 barrels, mostly hidden in the trees.**

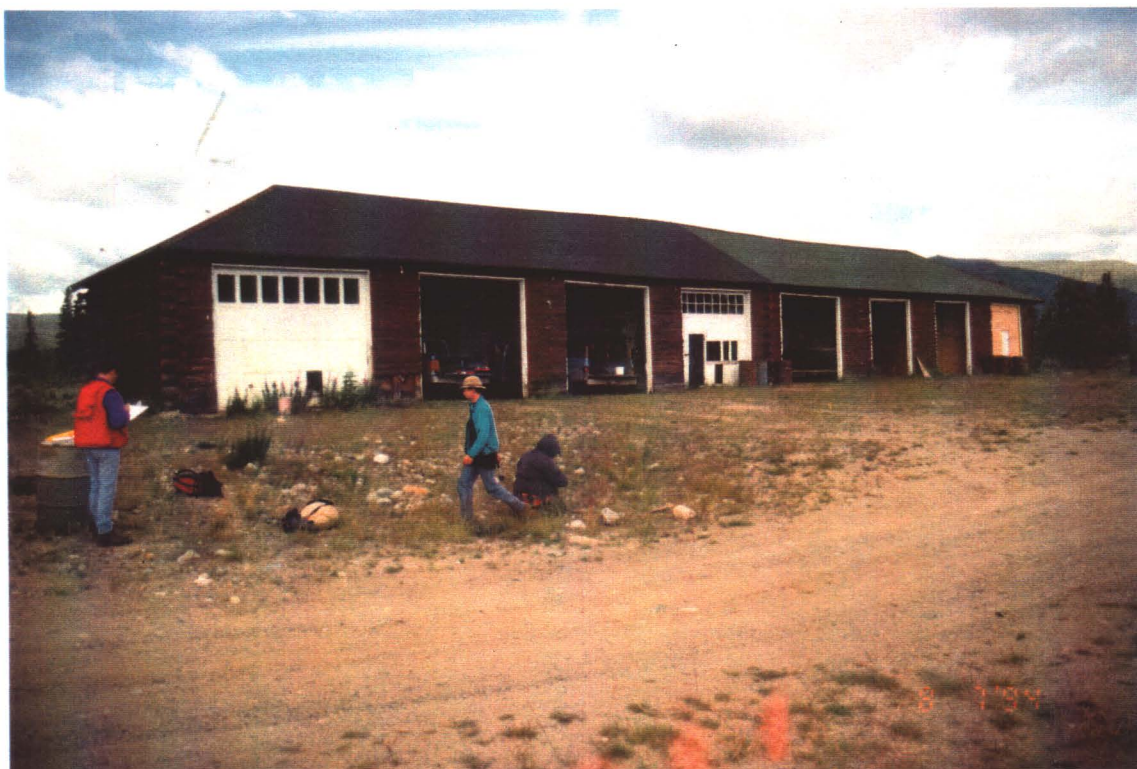
Three soil samples, taken in stained areas around the garage, were analyzed for inorganic elements and two soil samples were analyzed for PCBs. Levels of lead were elevated in all three samples and in one case (AA116) were comparable (200 ppm) with the CCME R/P or DCC II criteria.

**Photograph V-14: The garage was used by local people for vehicle repair and boat/general storage.**

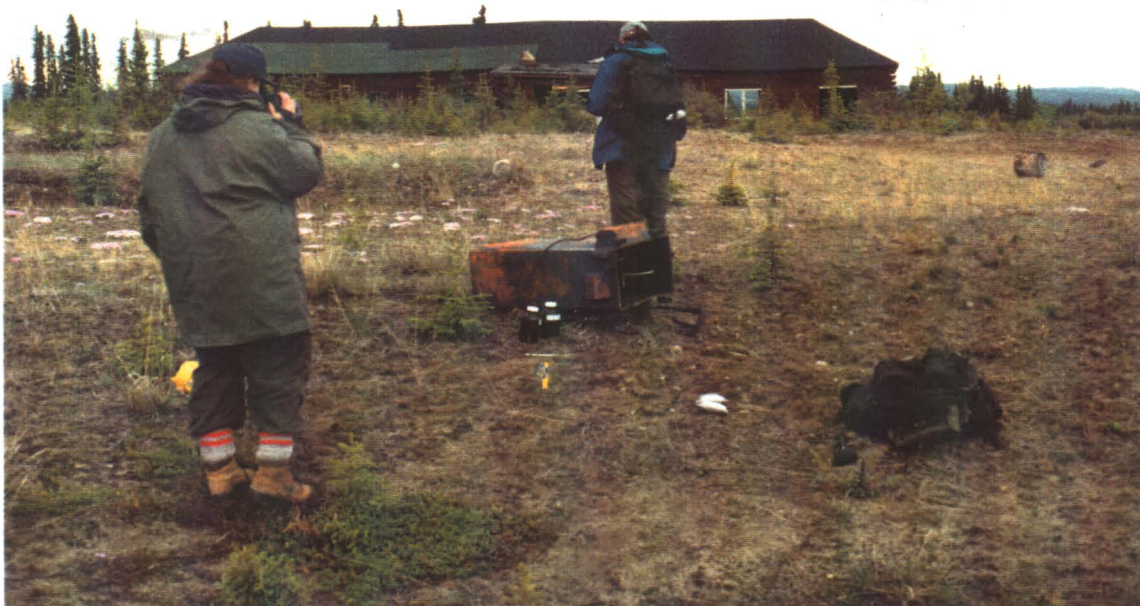
**Photograph V-15: A transformer casing found approximately 70 m southwest of the garage (AA018/019).**

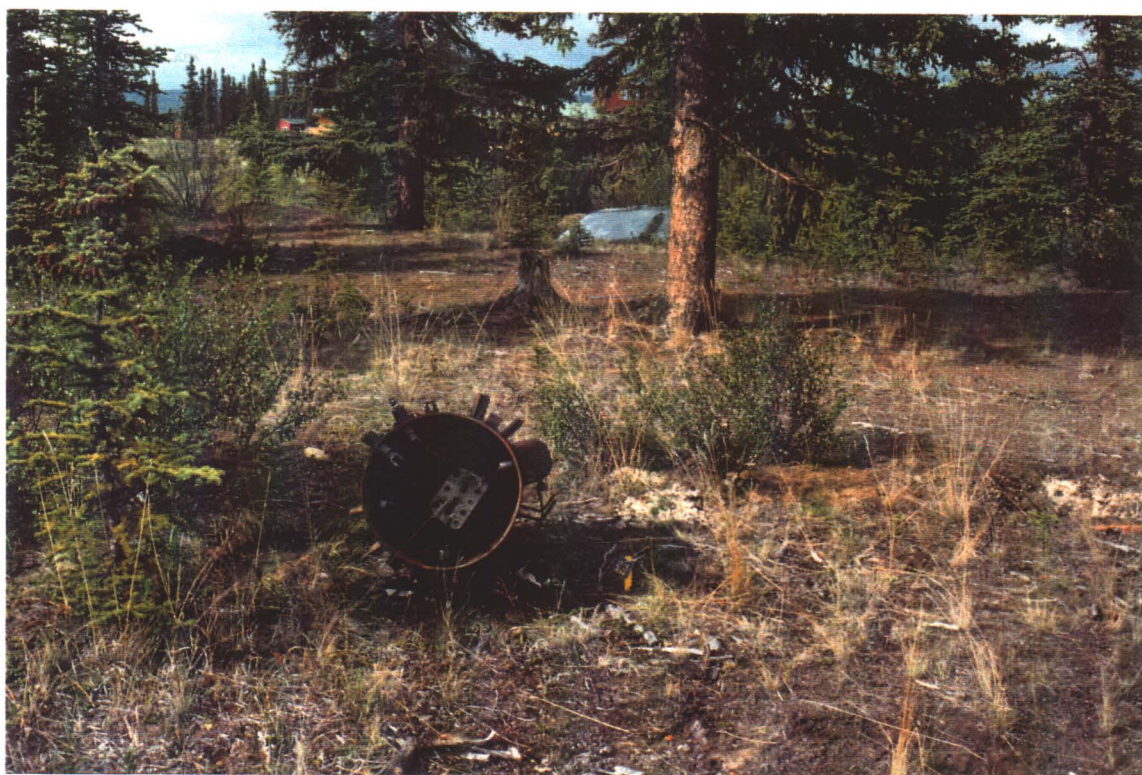
**Photograph V-20: Soil sample AA026 was taken next to this transformer casing to the south of the airways building.**

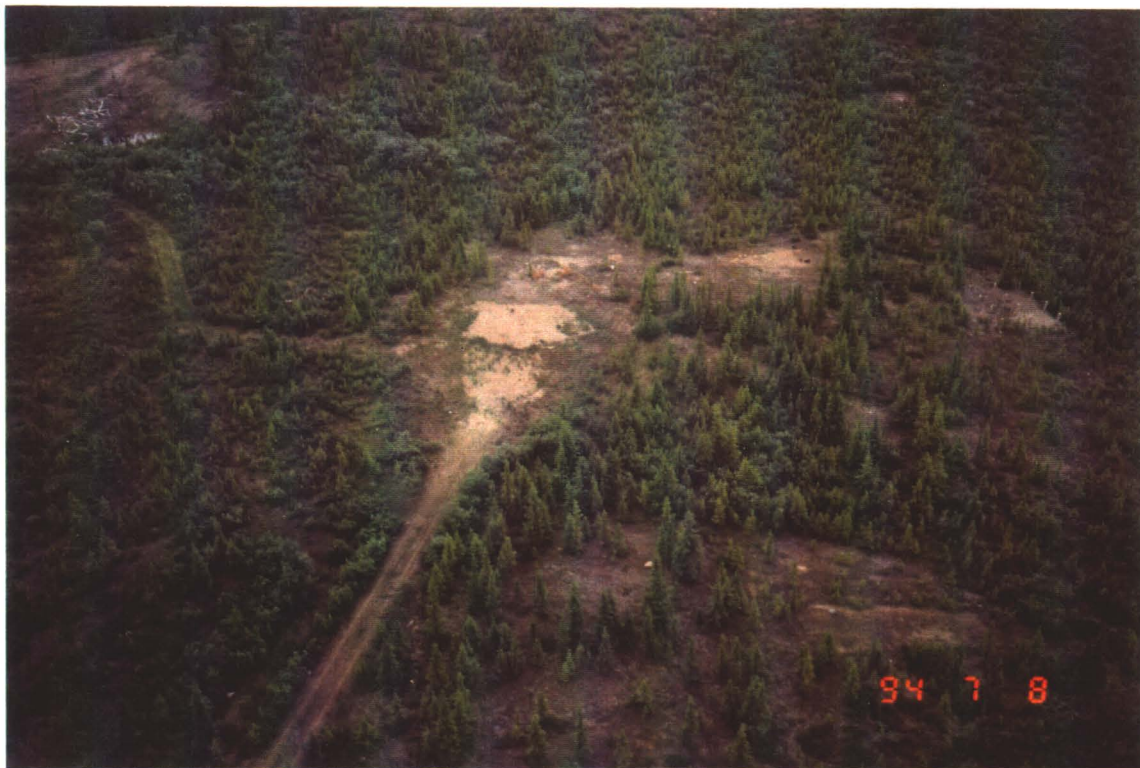
**Photograph V-22:** The upper beacon site, located about 8 km from the airstrip. Note wooden and metallic debris in upper left corner.

Two soil samples, taken from the upper beacon site, were analyzed for PCBs and one soil sample for inorganic elements. Levels of PCBs were low (maximum concentration 5.8 ppb) and the concentrations of inorganic elements were comparable to background levels with the exception of lead (23 ppm) at AA 140, which was slightly elevated. Two samples of vegetation were analyzed for PCBs and inorganic elements. The concentrations of inorganic elements were comparable to background levels and PCBs were not detected.

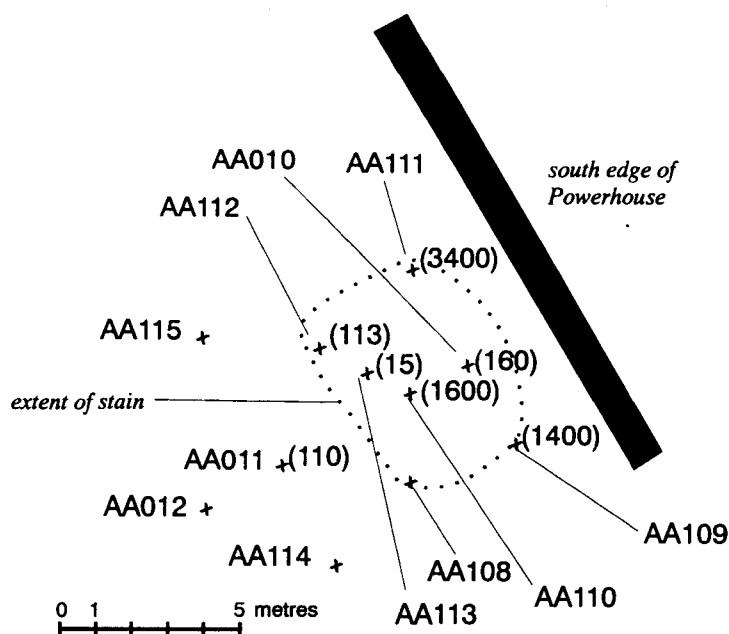
**Figure V-1: Sample Locations and PCB Concentration at Former Site of Transformers on South Side of Powerhouse**

The PCB concentration is greatest towards the northern end of the stained area. There exists the possibility that greater concentrations of PCBs may be found closer to the building. That would be the case if the PCBs were not originating from the transformer rack but from seepage from the building. This is not unlikely given the PCB levels found on the floor of the building, and could be ascertained using field test kits during cleanup. This is discussed further in Section E of this chapter. Three of the samples (AA111, AA110 and AA109) contain PCB concentrations greater than DCC Tier I. Sample AA113, taken at a depth of 35 cm, contained a low concentration of PCBs, indicating little or no vertical migration is occurring. PCB concentrations of 110 ppb at AA011, which was in the direct drainage path from the stained area, indicates that horizontal migration may be occurring. A vegetation sample was obtained at AA011 and analyzed for PCBs. The sample was divided into roots and shoots; the roots contained 25 ppb PCBs and the shoots contained 8.0 ppb. Both were significantly elevated over the background level. The concentration of PCBs in the roots and shoots of this sample also provides evidence that PCB migration may be occurring. **The soil and vegetation samples away from the stained area both indicate the necessity for source control.**

Inorganic element results for this area were all comparable to background with the exception of elevated lead (118 ppm) in soil sample AA110. This level was still below the CCME R/P criteria (500 ppm) and the DCC Tier I (200 ppm).
