## **WATERLOO BARRIER™ SYSTEM**

### **SHEET PILE & SEALANT INSTALLATION REPORT**

**VENUS MINE SITE  
TAILINGS POND  
KM 86 - KLONDIKE HIGHWAY, YUKON TERRITORY  
D.P.W. PROJECT # 626483**

**OCTOBER 16th, 1995**

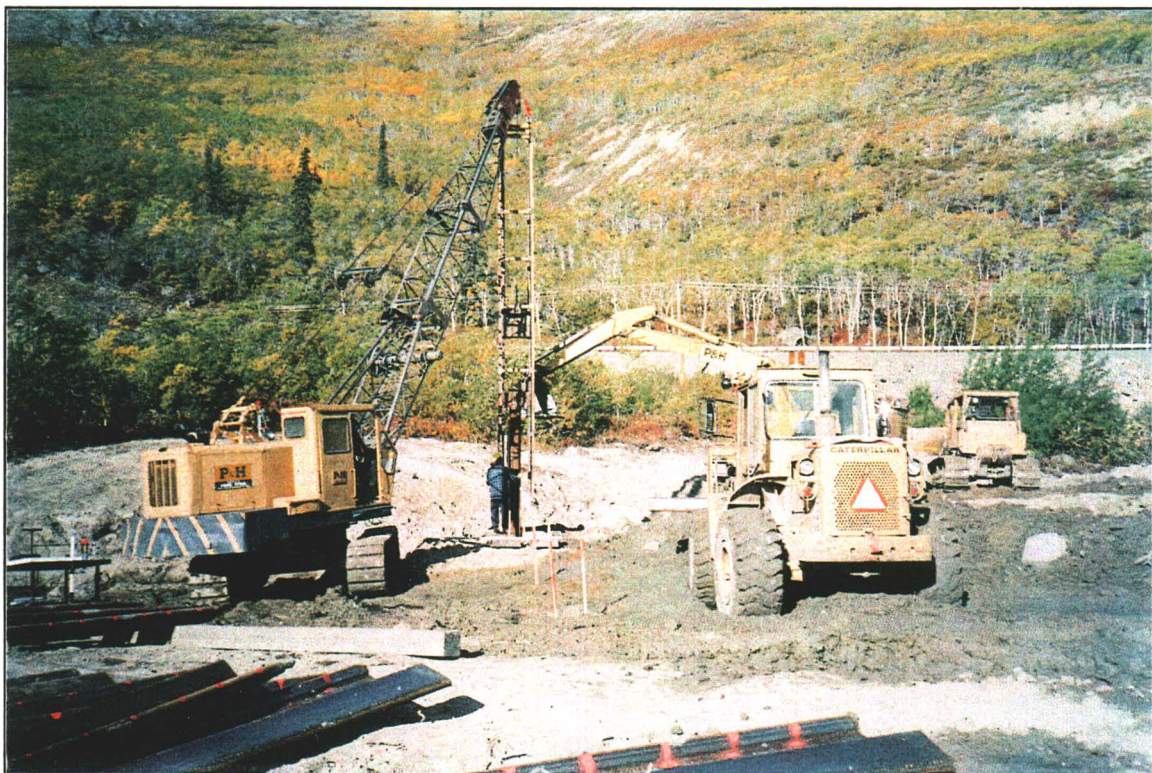
**Photo 1: Pile Driving Equipment**

Photo 1 shows the pile driving in progress.

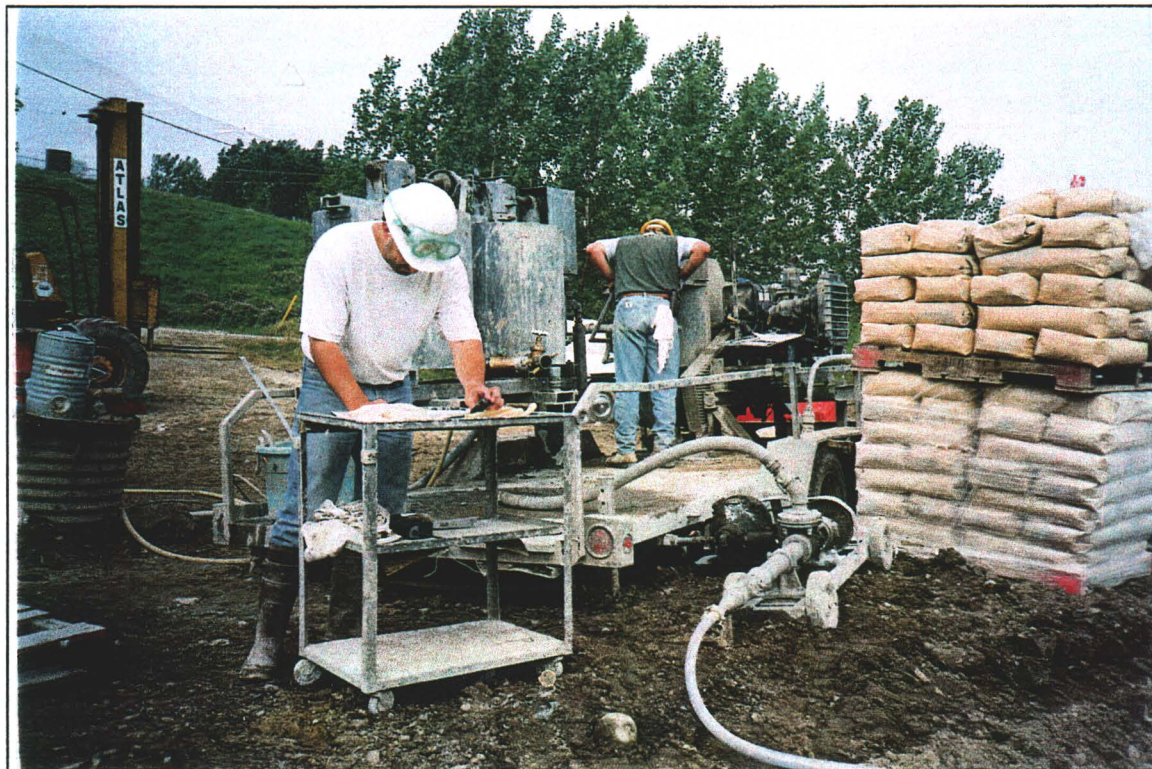
Photo 2: Typical Grouting Equipment

Photo 2 shows the grouting equipment required for this project.

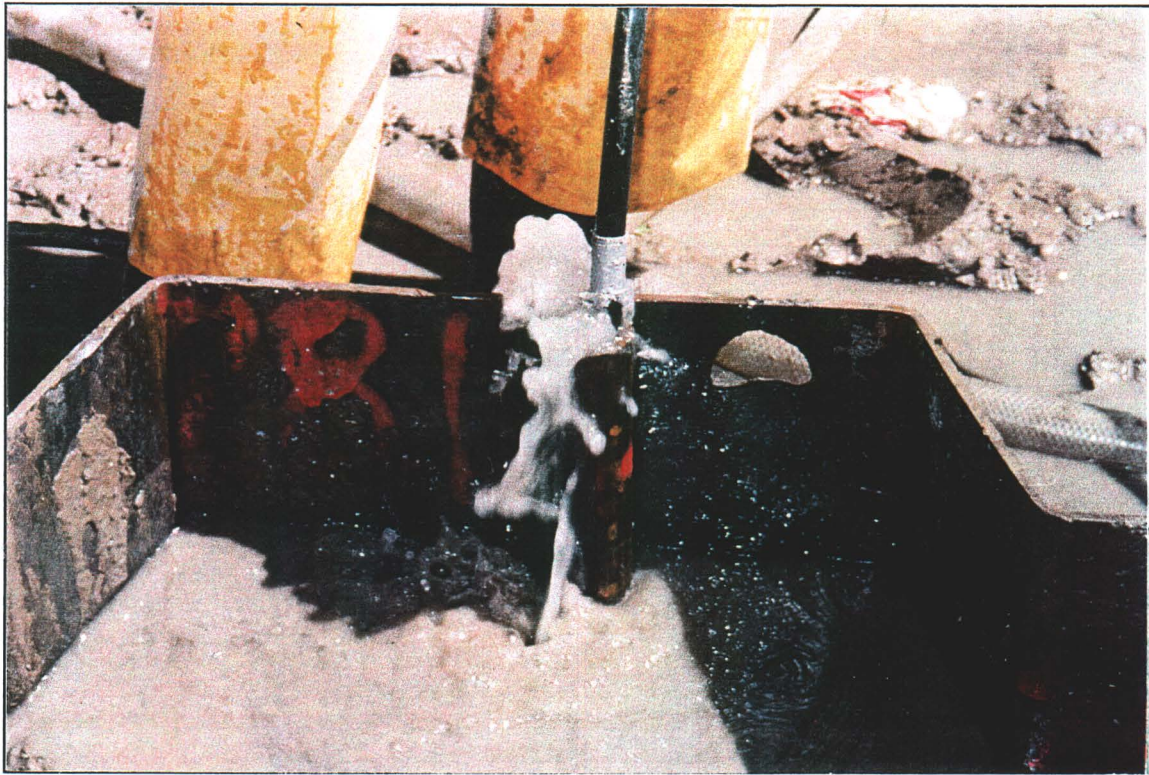
**Photo 4: Typical Joint Flushing**

- 1) **JOINT FLUSHING** - A high pressure water pump, water tank and rigid hose was used to remove any loose material from the sealable cavities. Flushing was conducted until the return water became clear (Photo 4). The flushing procedure was continued until a sufficient number of joints (20) were cleaned to allow for the installation of sealant.

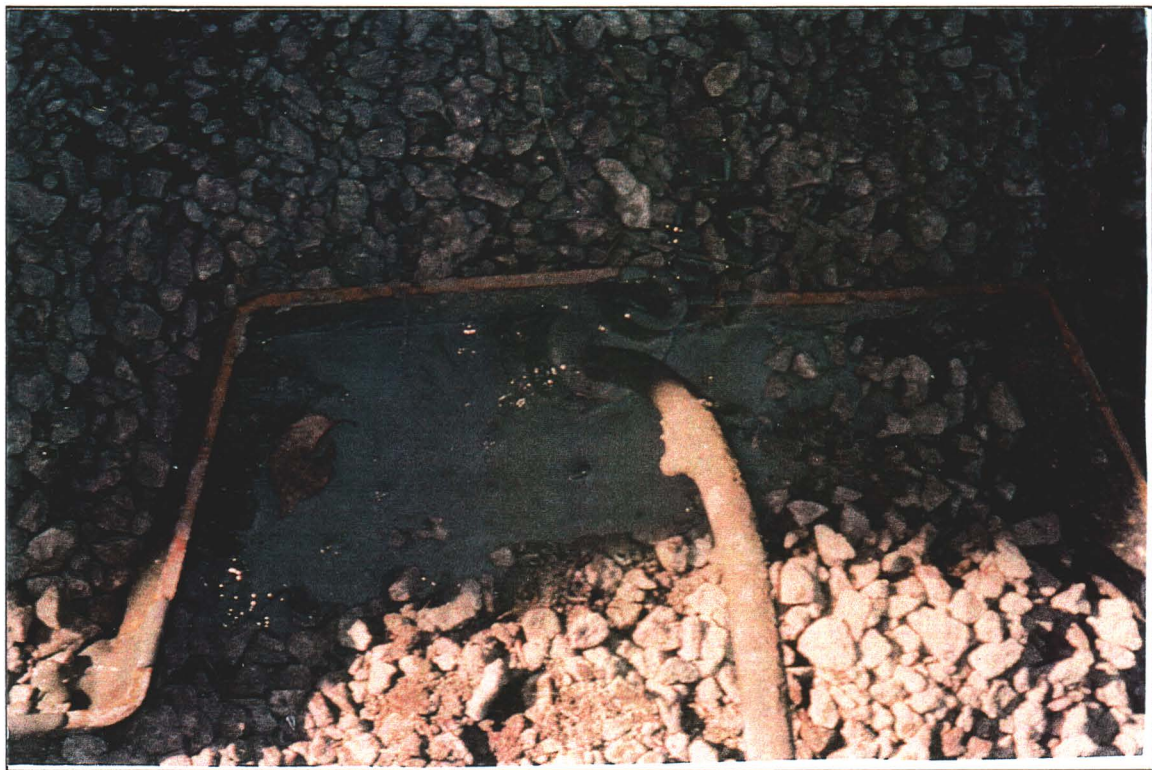
**Photo 5: Sealant Injection**

- 3) **SEALANT INJECTION** - The grout line was inserted to the base of the clean joint and the sealant was tremied into the cavity.
- 4) **GROUT LINE WITHDRAWAL** - Once sealant was observed to be flowing out the top of the sealable cavity (Photo 5), the injection line was slowly withdrawn.
