Preliminary Environmental Investigation

~~BC 96~~ **Site 30 - North of Burwash Landing**

~~HS 49~~ **Site 39 - Kathleen River Crossing**

~~HJ 11~~ **Site 44 - Marshall Creek Road**

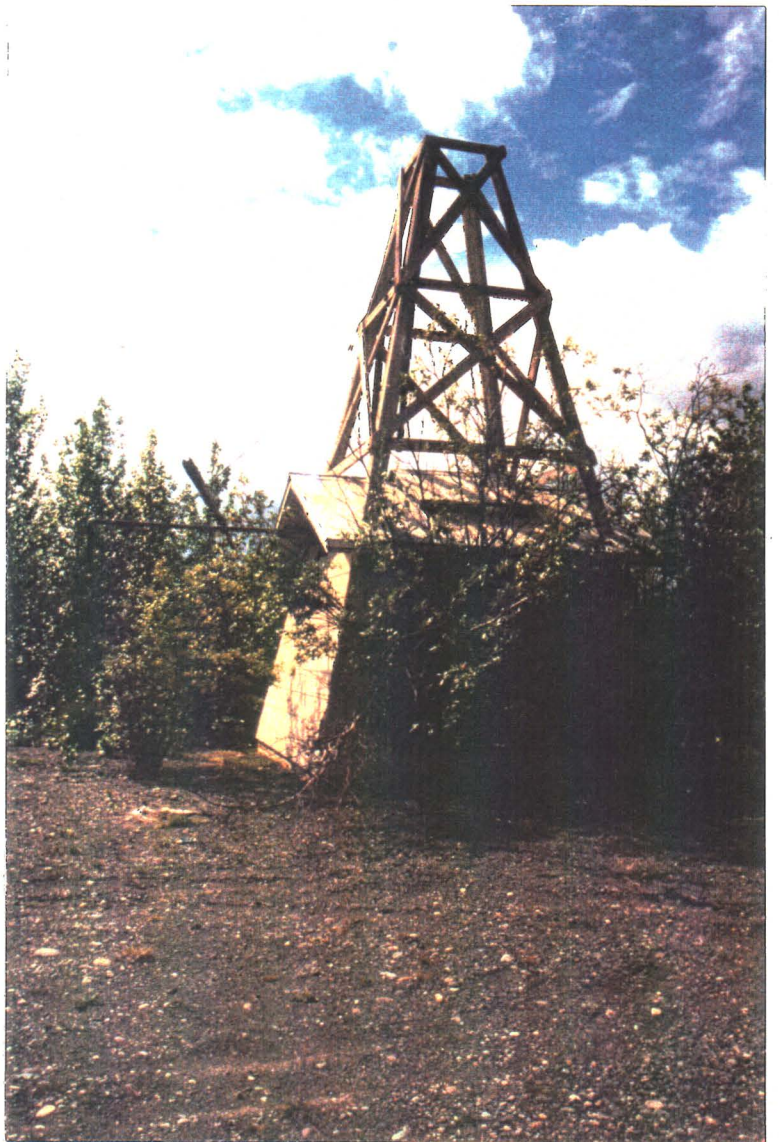
Photograph 30-P1: South facing view of pumphouse. Gravel access road is in the foreground.

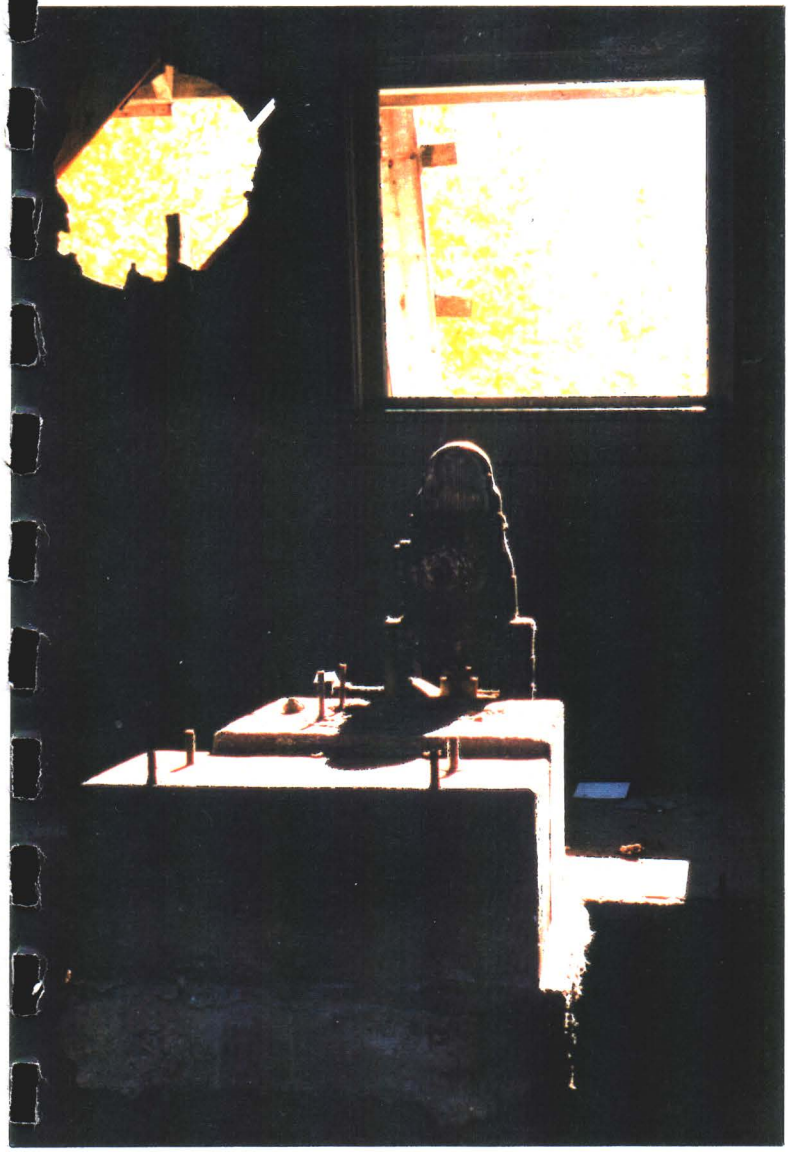
Photograph 30-P2: Interior shot of pumphouse showing non-working wellhead gear.

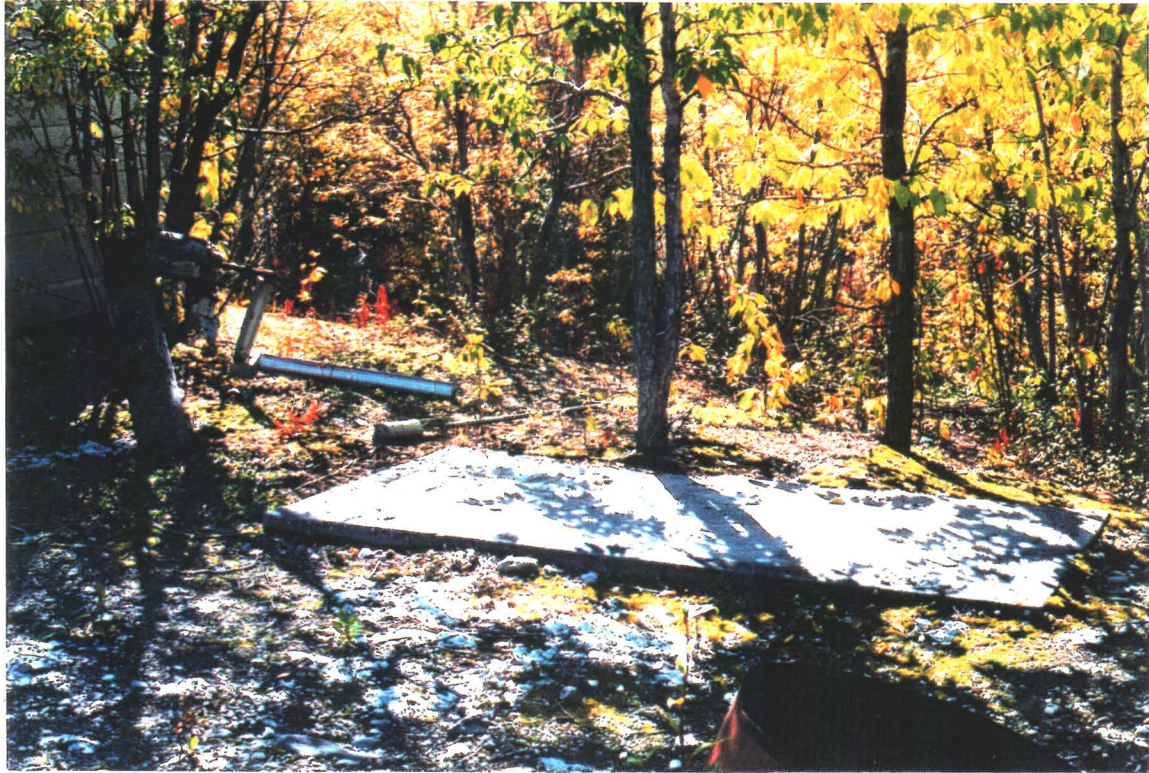
Photograph 30-P3: Small concrete pad to the east of the pumphouse. The left side of this pad was sample site 30-S24.

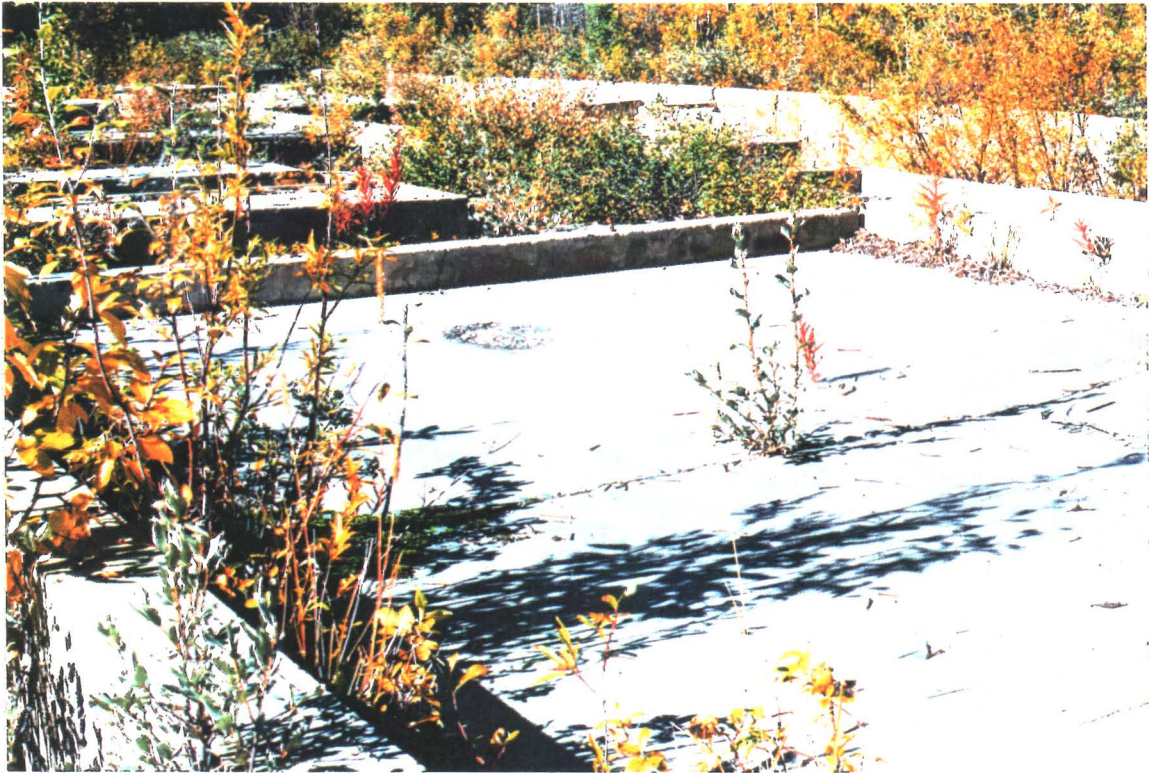
Photograph 30-P4: View of the concrete foundation facing northwest.

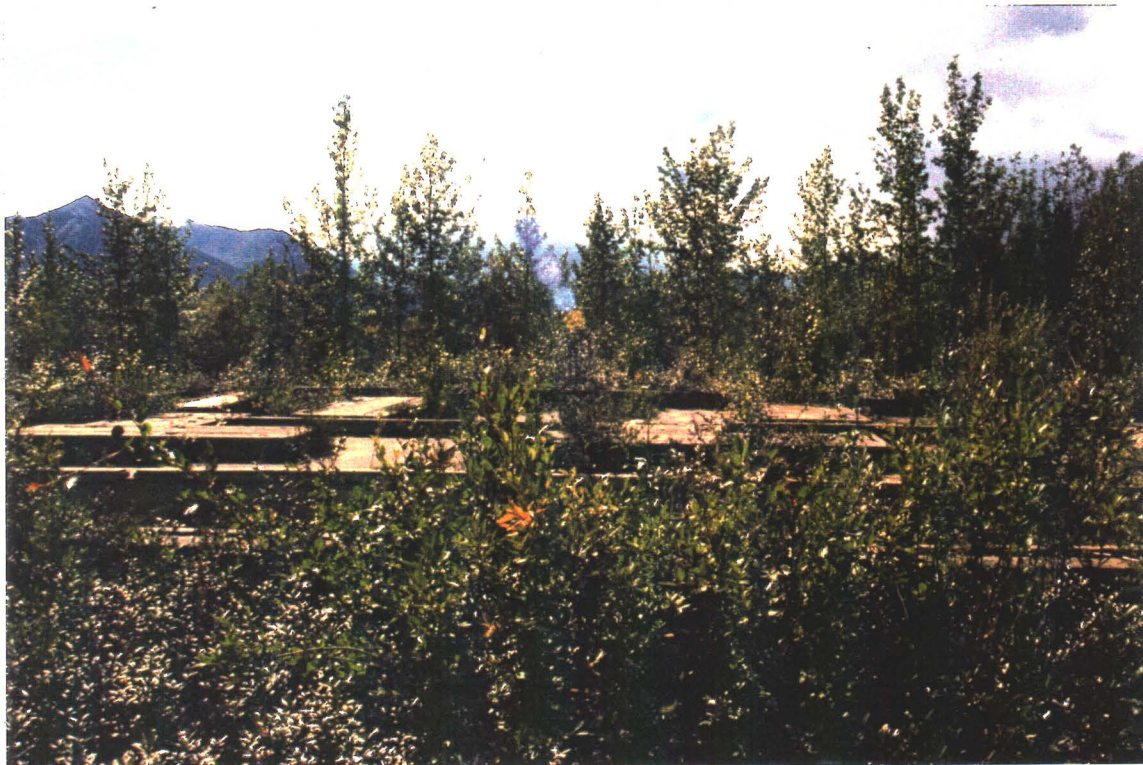
Photograph 30-P5: View of the concrete foundation facing south.

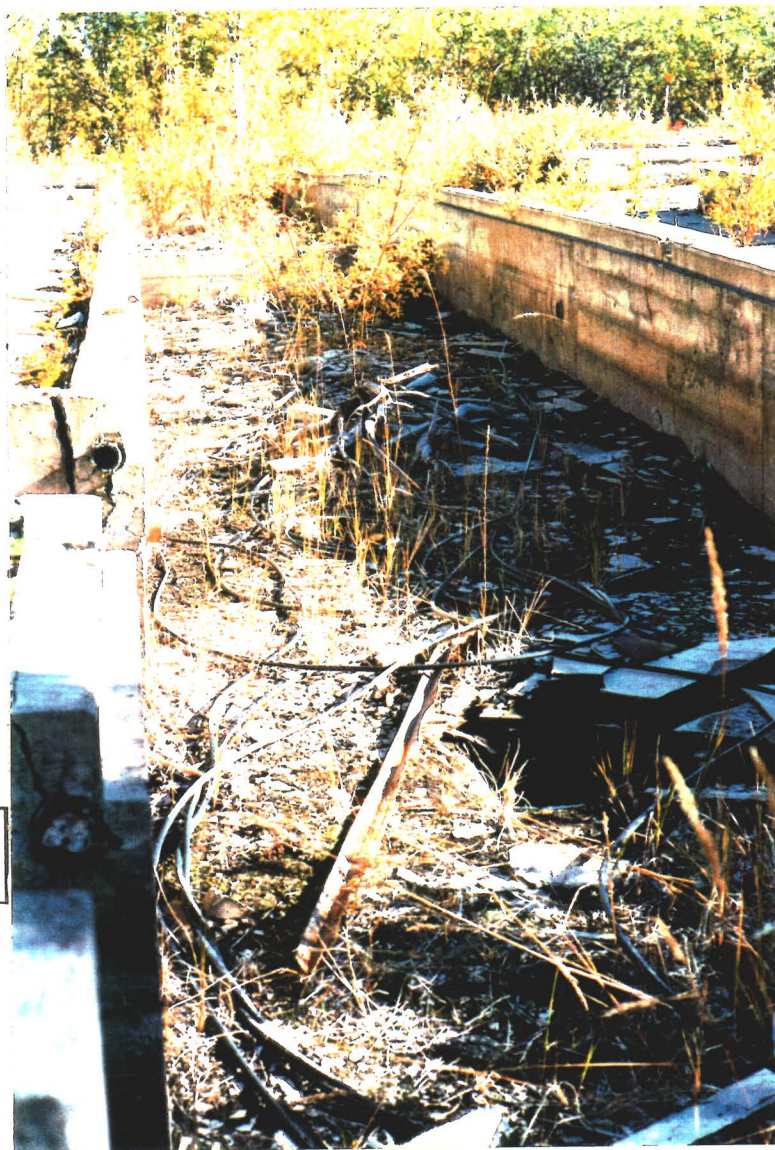
Photograph 30-P6: Channel on the north side of the concrete foundation. Note small pit in the right foreground.

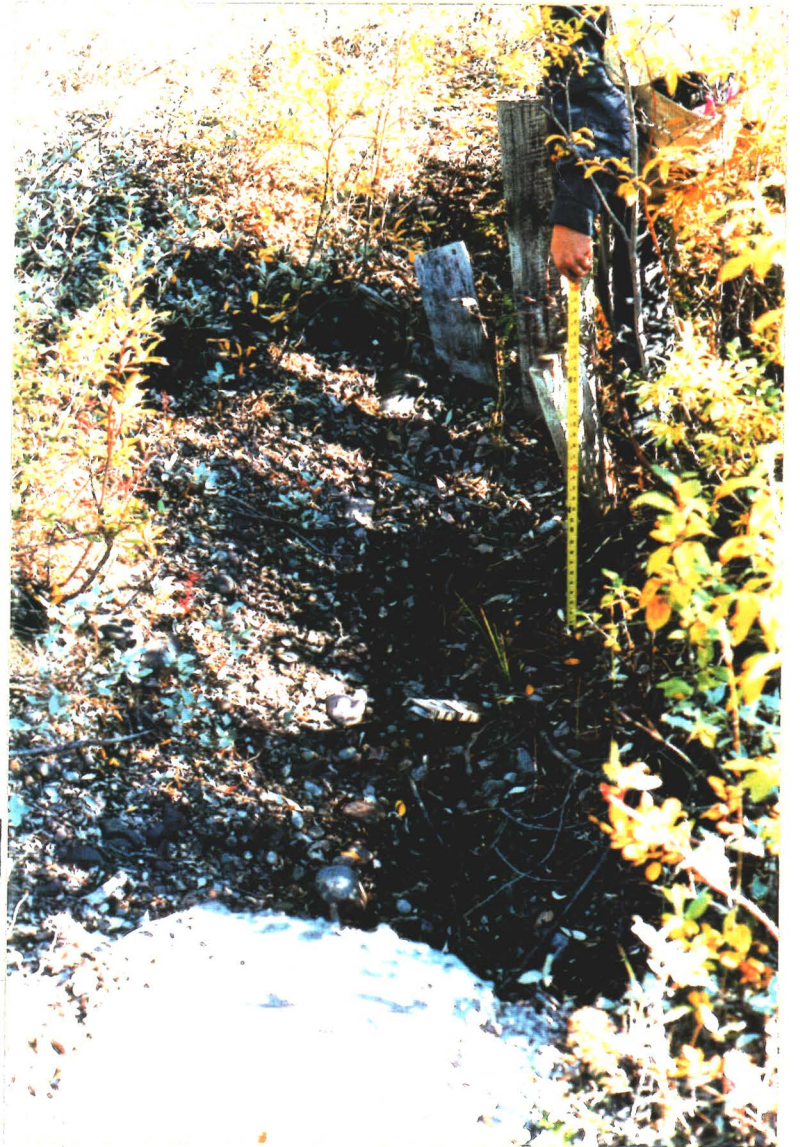
Photograph 30-P8: Depression on the outside of the northwest corner of the concrete foundation.

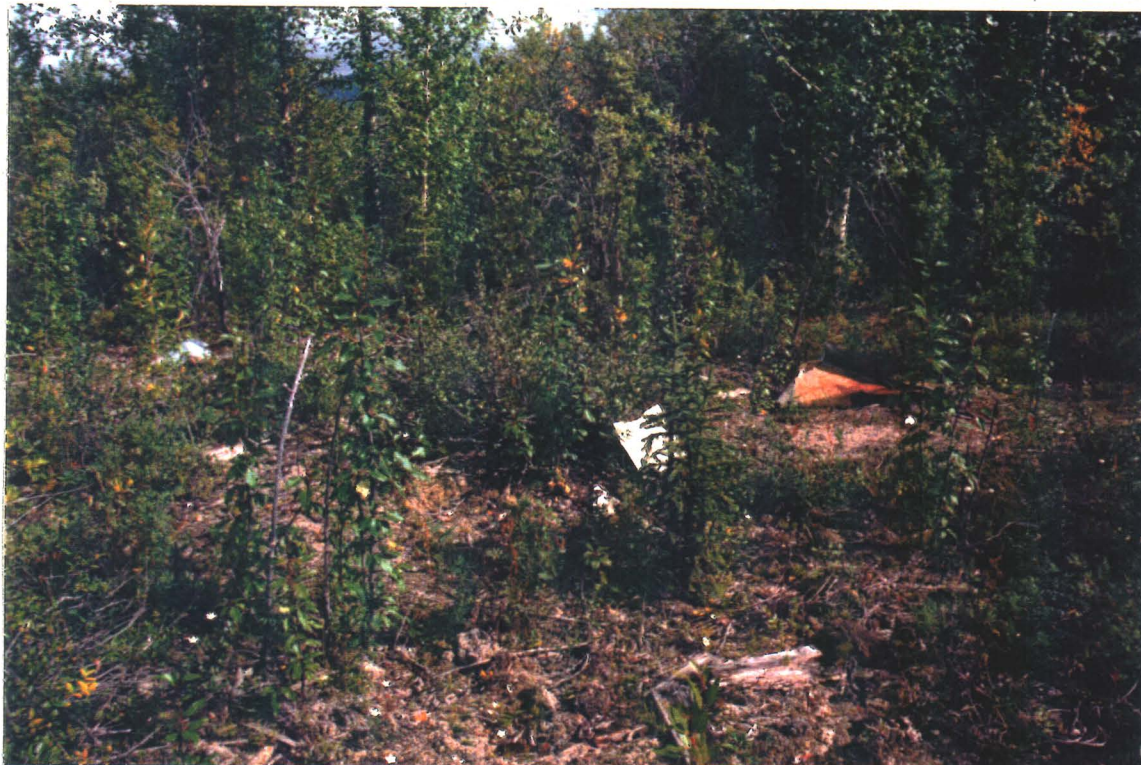
Between the concrete foundation and the Alaska highway, there is thick bush with clearings interspersed. In some of these clearings and within the bush there are scattered small cans and glass, pieces of 4" metal pipe and jumbled concrete blocks (Photographs 30-P9 and 30-P10).

Photograph 30-P9: Clearing in poplars 30 metres west of the pumphouse. View is north facing and shows typical surface debris.

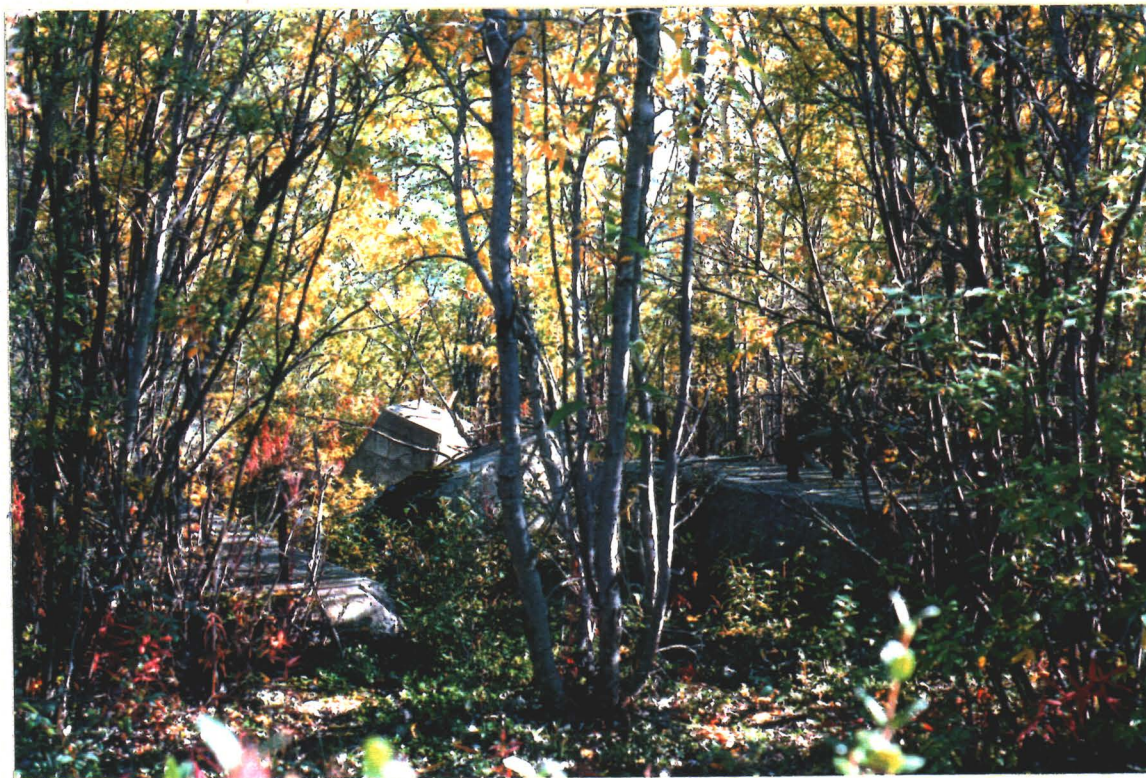
Photograph 30-P10: Bearberry growth between jumbled concrete blocks. Sample site 30-S13.

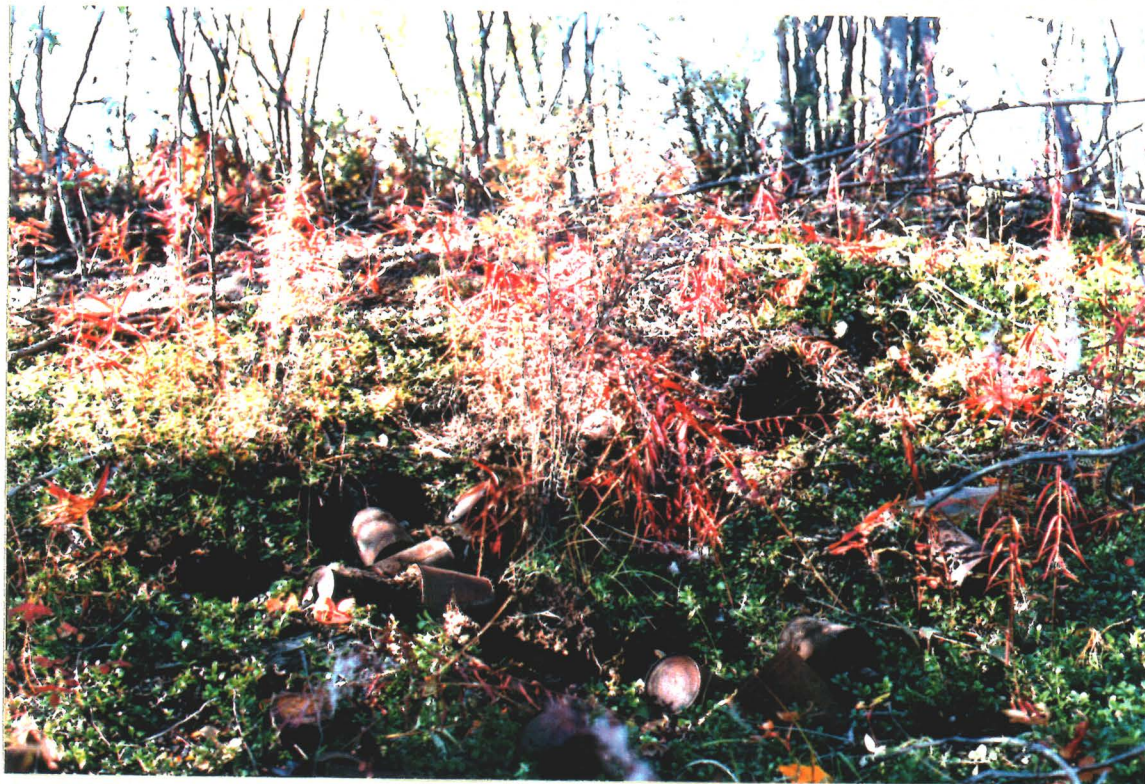
Photograph 30-P11: View of sample site 30-S15. Note typical surface debris.

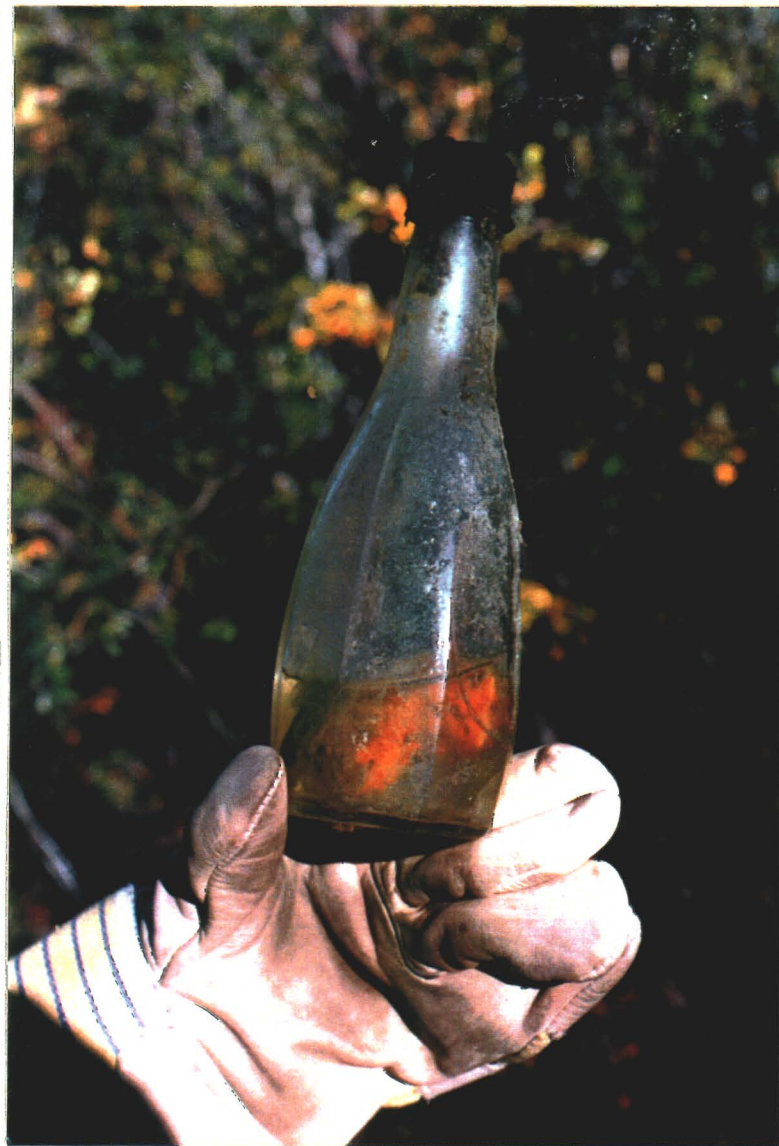
Photograph 30-P12: Unbroken bottle found near sample site 30-S15.

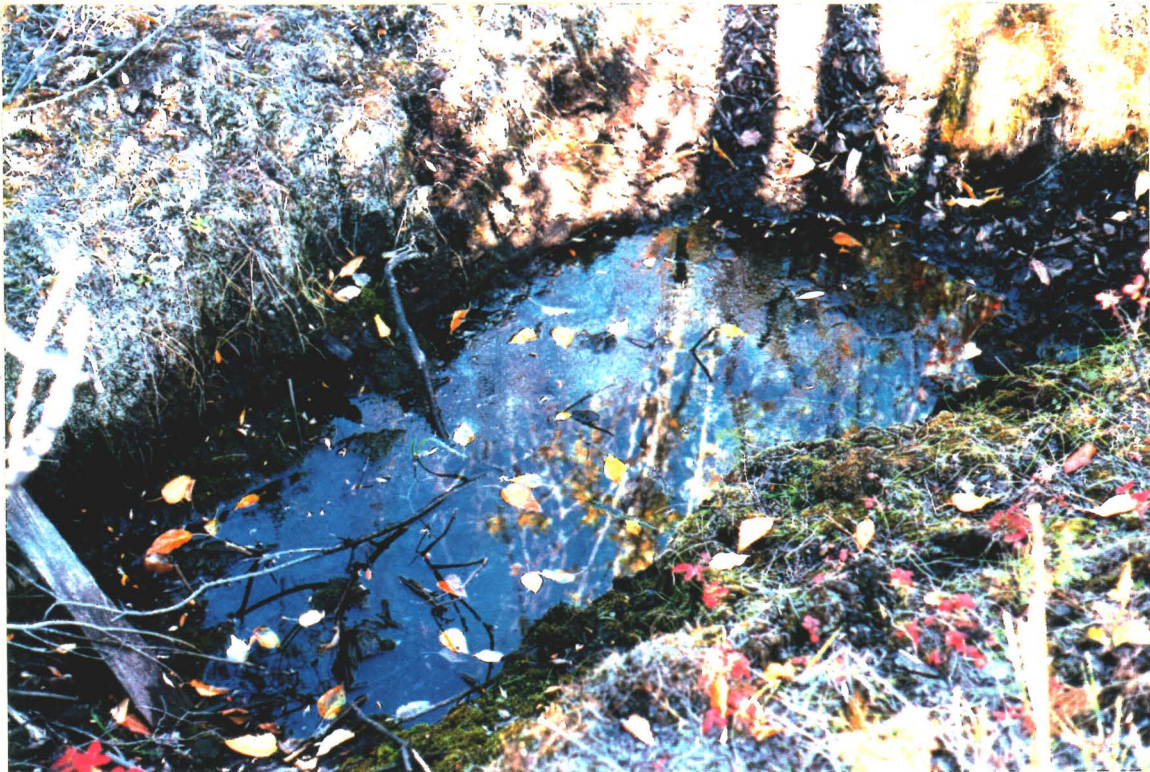
Photograph 30-P14: View of water filled pit which had a foul organic smell. Sample site 30-W1 and 30-S23.

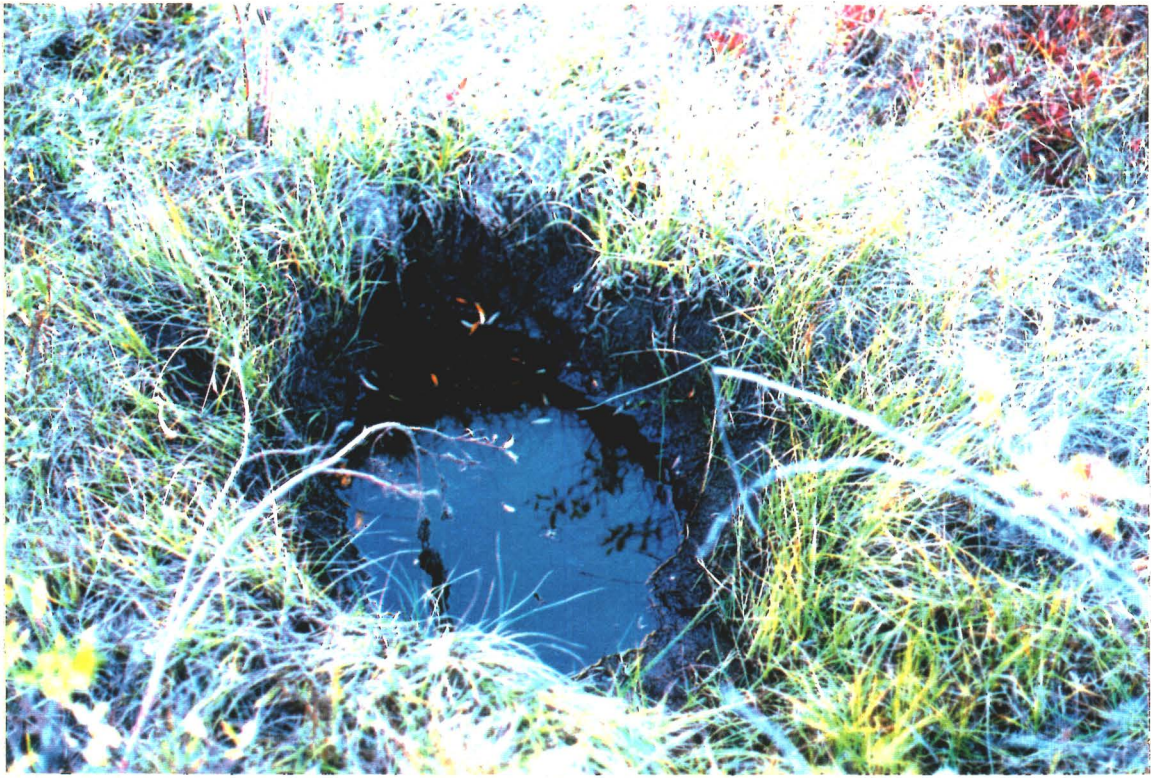
Photograph 30-P15: View of water filled pit with strong hydrocarbon smell. Sample site 30-W2 and 30-S17.

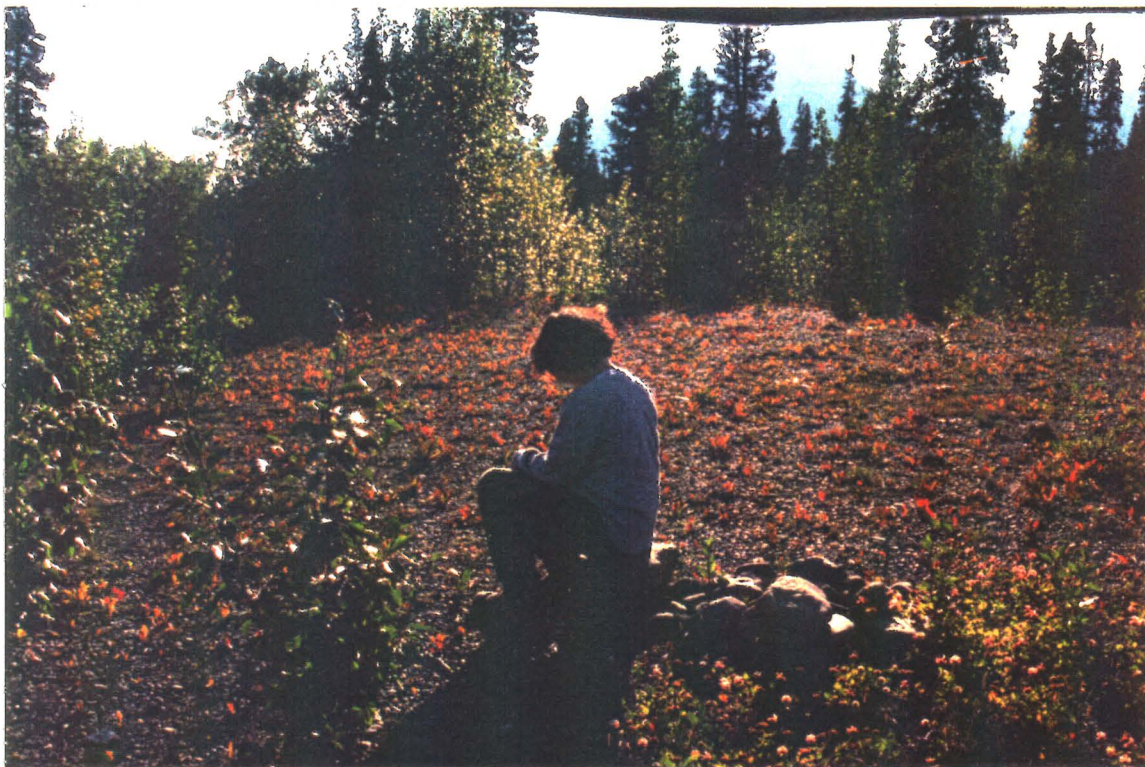
Photograph 39-P2: View of mound plateau looking west.

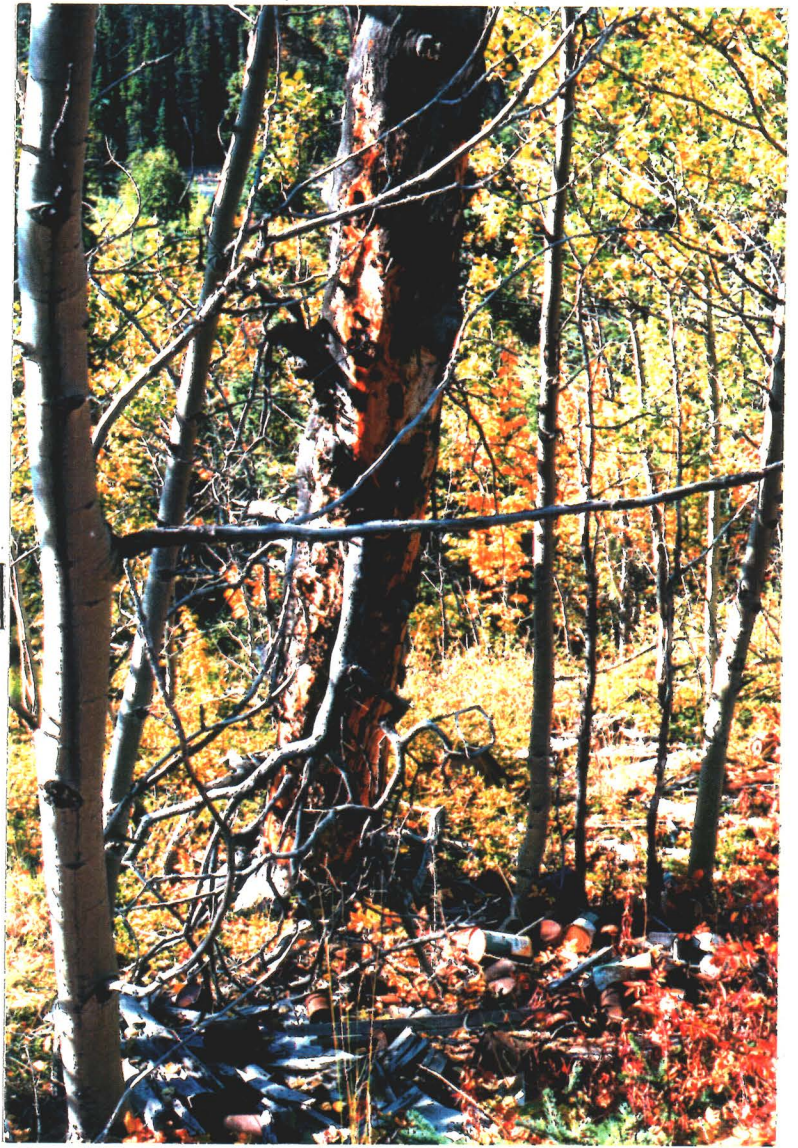
Photograph 39-P3: Garbage debris found on surface east of 39-TP4. This view is to the south.

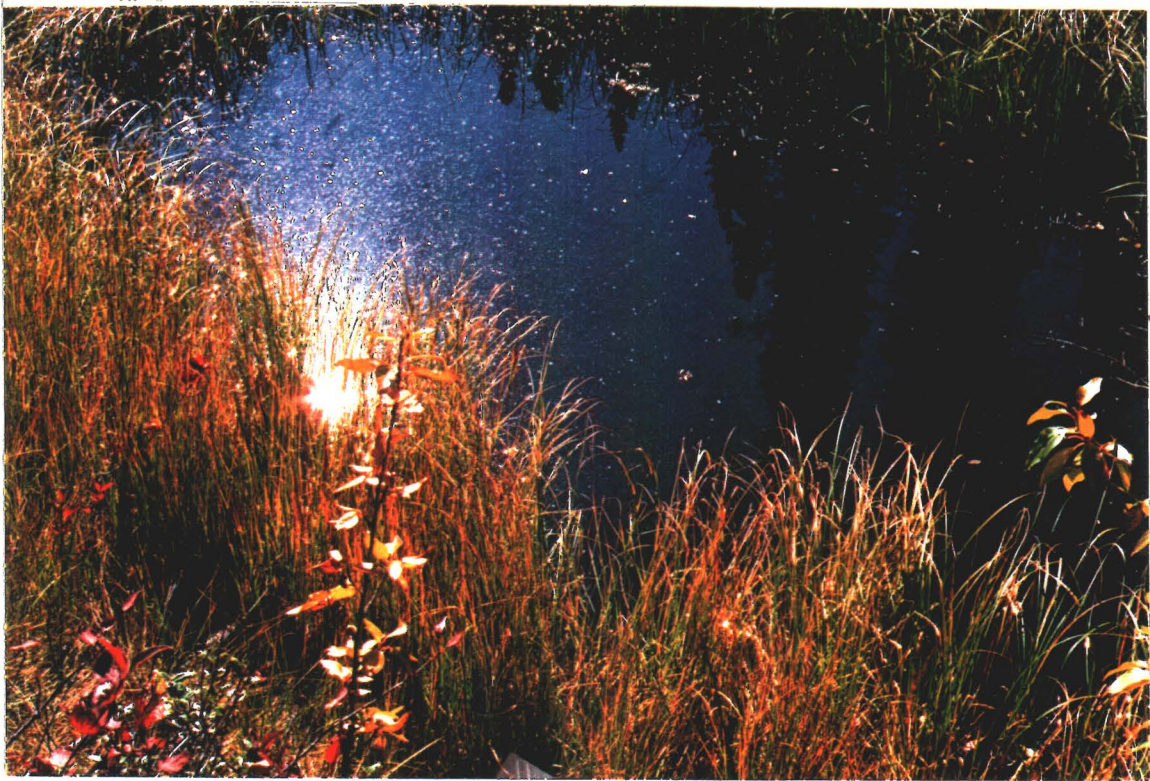
Photograph 39-P4: East pond with 39-S7 in the foreground.

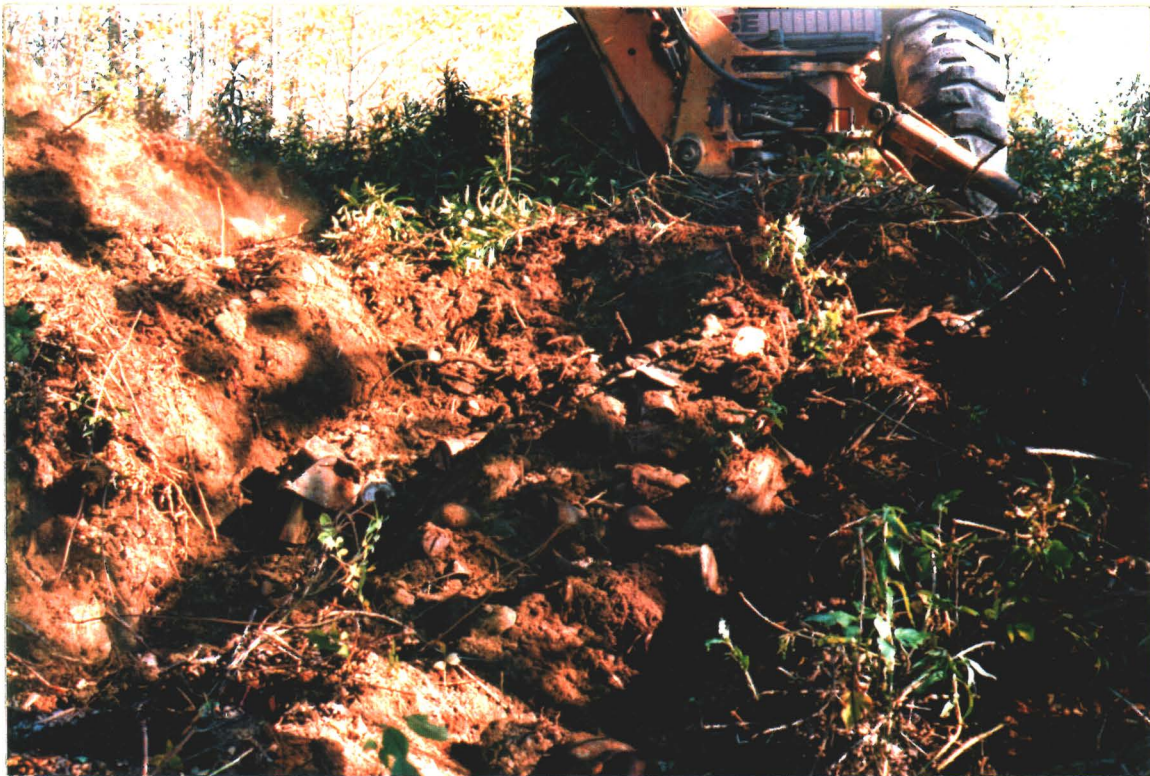
Photograph 39-P6: Excavation of 39-TP3 looking north. Garbage debris was found in 39-TP3.

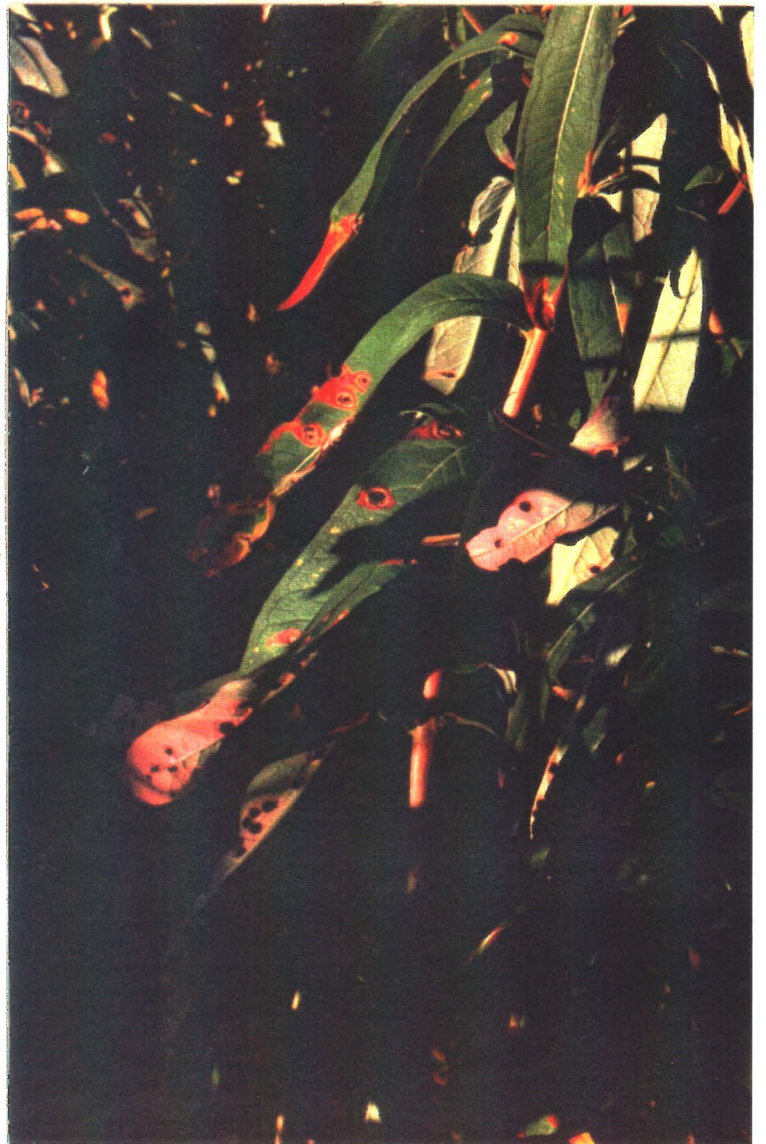
Photograph 39-P8: Stressed fireweed near 39-TP2

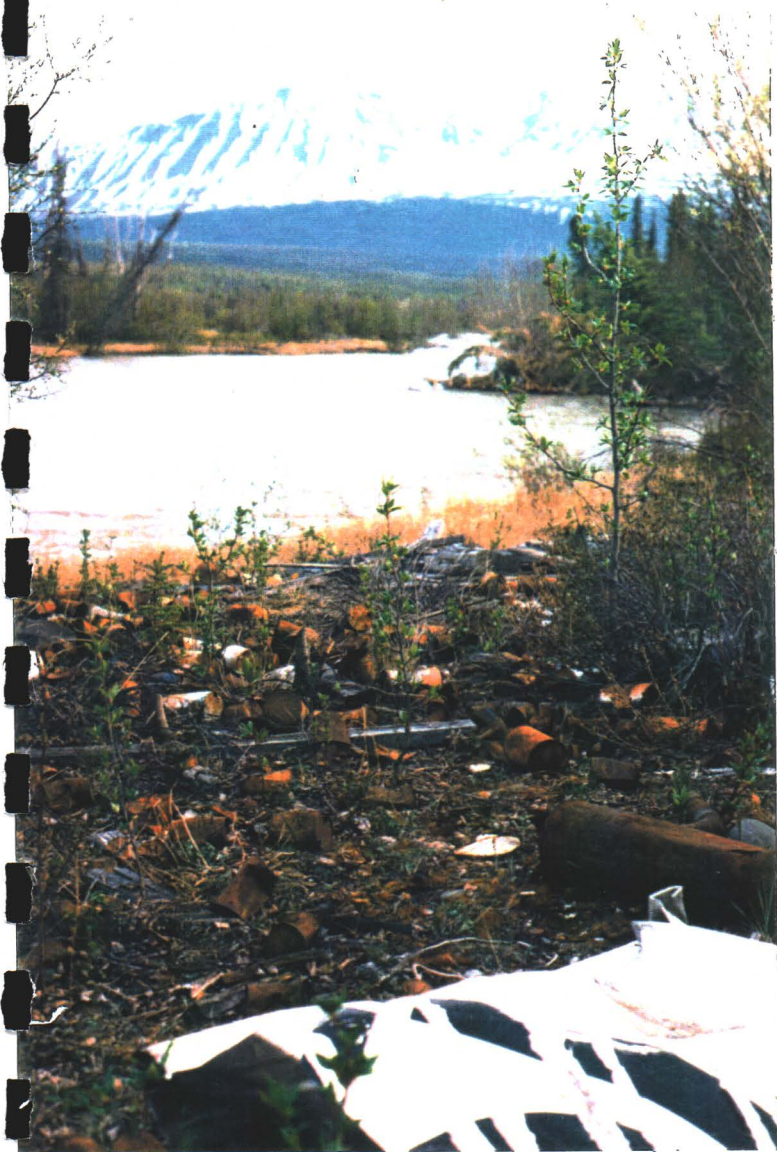
Photograph 44-P3: View of surface debris near 44-TP1.

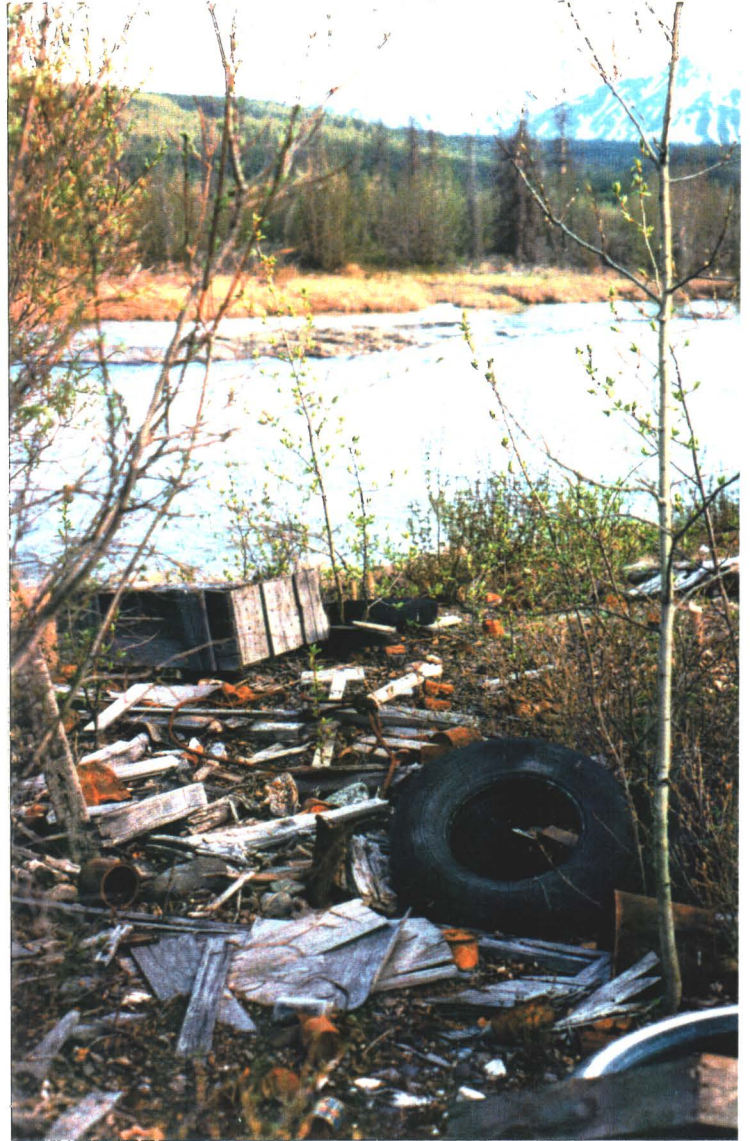
Photograph 44-P4: View of surface debris near 44-TP2.

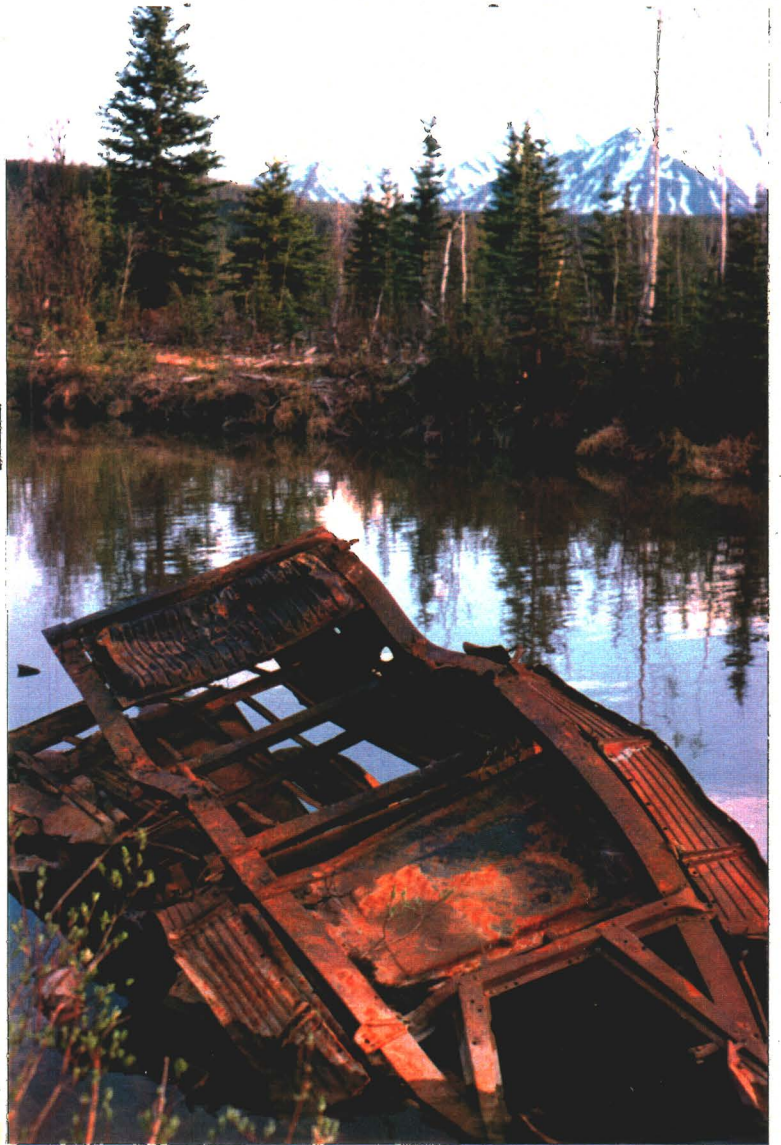
Photograph 44-P6: East facing view of vehicle wreck in the marsh area. This is 10 metres north of the survey reference point.

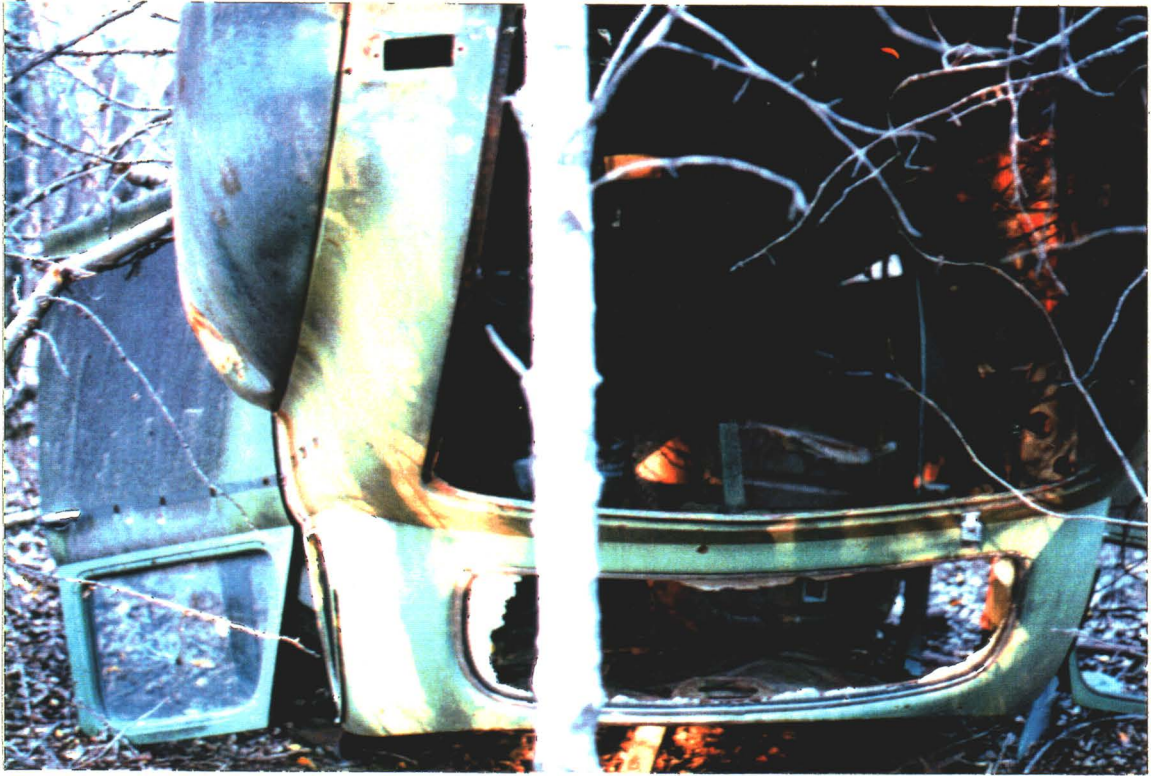
Photograph 44-P7: Vehicle wreck near 44-S16.

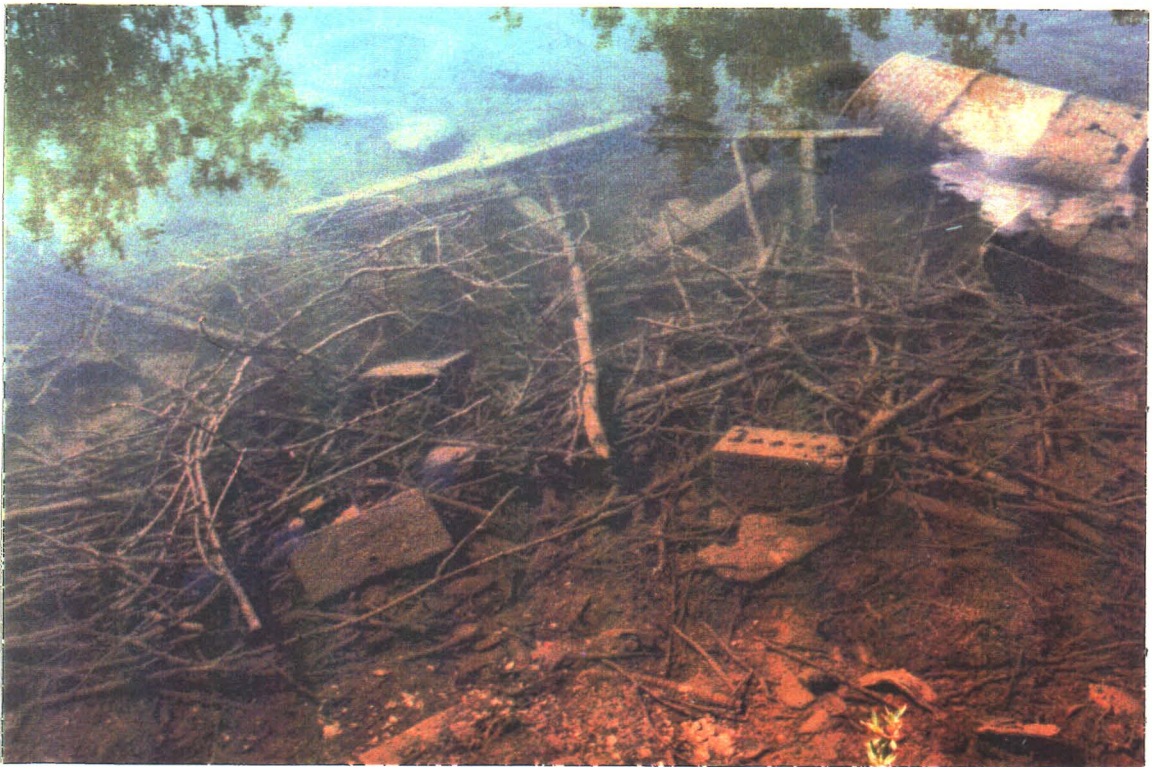
Photograph 44-P8: Batteries and large metal drums submerged on east side of the west pond.

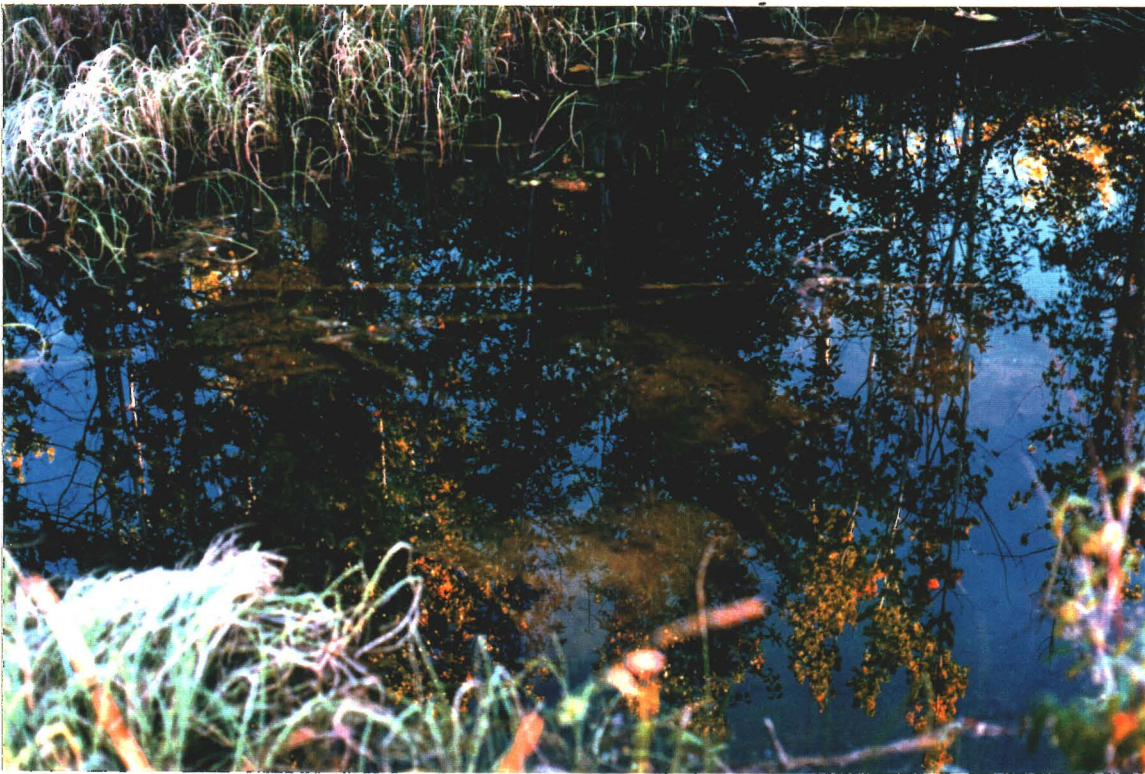
Photograph 44-P9: Submerged large metal drums at north end of east pond.

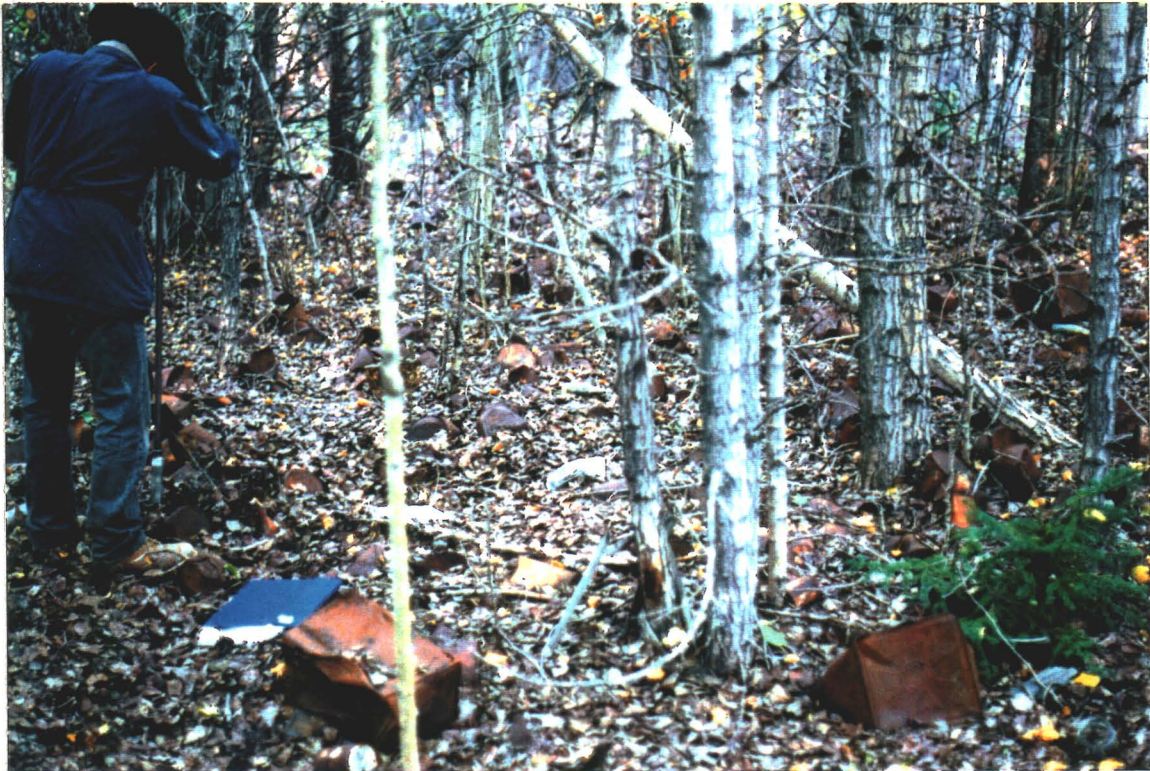
North of the young poplar area, bounded by the access track to the west and the marsh to the east, is an area dominated by old growth poplars. The western portion of this area has experienced severe blowdown and is difficult to walk through. Surface garbage is scattered in a 100 metre strip 50 metres deep, paralleling the marsh to the east. The majority of this garbage is cans, broken glass and small pieces of metal but there is one vehicle body (Photograph 44-P7), some metal office fixtures, numerous tires and empty 20 gallon barrels (Photograph 44-P14 and

Photograph 44-P14: View of surface debris in old growth poplars. 44-S14 is on the left.

44-P15). There are small (2 metre diameter, 0.5 metres high) clay mounds in this area, clear of any underbrush and having garbage and debris in and around them.
