Preliminary Environmental Investigation

~~BC 96~~ **Site 30 - North of Burwash Landing**

~~HS 49~~ **Site 39 - Kathleen River Crossing**

~~HJ 11~~ **Site 44 - Marshall Creek Road**

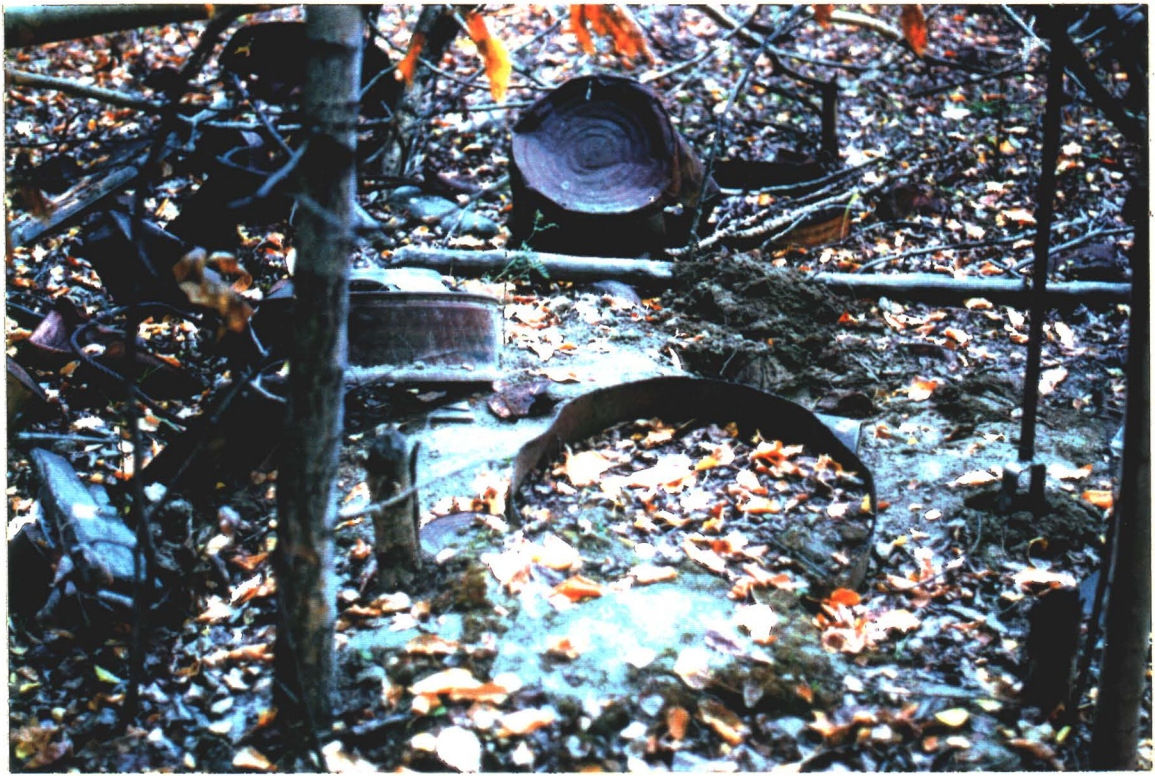
Photograph 44-P15: View of surface debris in old growth poplars. 44-S15 is on the right.

44-P15). There are small (2 metre diameter, 0.5 metres high) clay mounds in this area, clear of any underbrush and having garbage and debris in and around them.
