**Phase I & II Environmental
Site Assessment**

**Former Military Site
Donjek River
Mile Post 1130 Alaska Highway
(DIAND Site 31)**

**Arctic Environmental Strategy - Action on Waste
Indian and Northern Affairs Canada
Whitehorse, Yukon**

November 1996

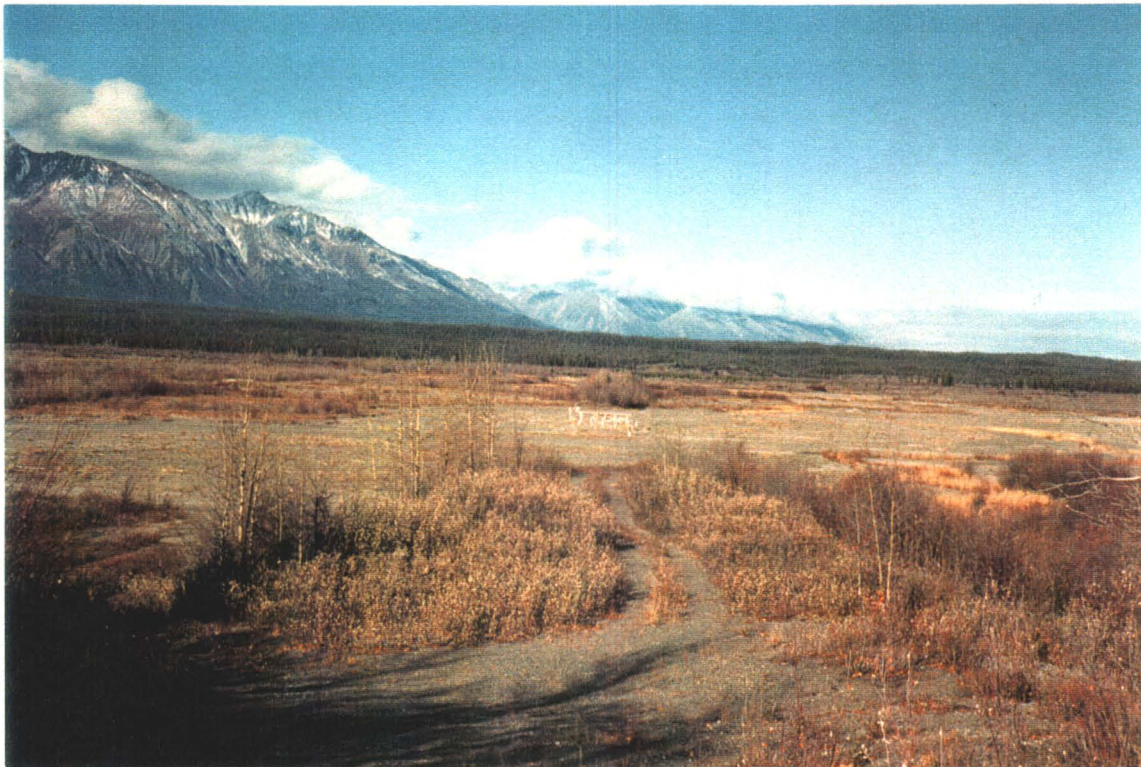
Photograph 2

Road from uplands portion of the subject site to the Donjek River valley, looking west. Former dump area was located immediately north of the road, in the right corner of the photograph. September 1996.

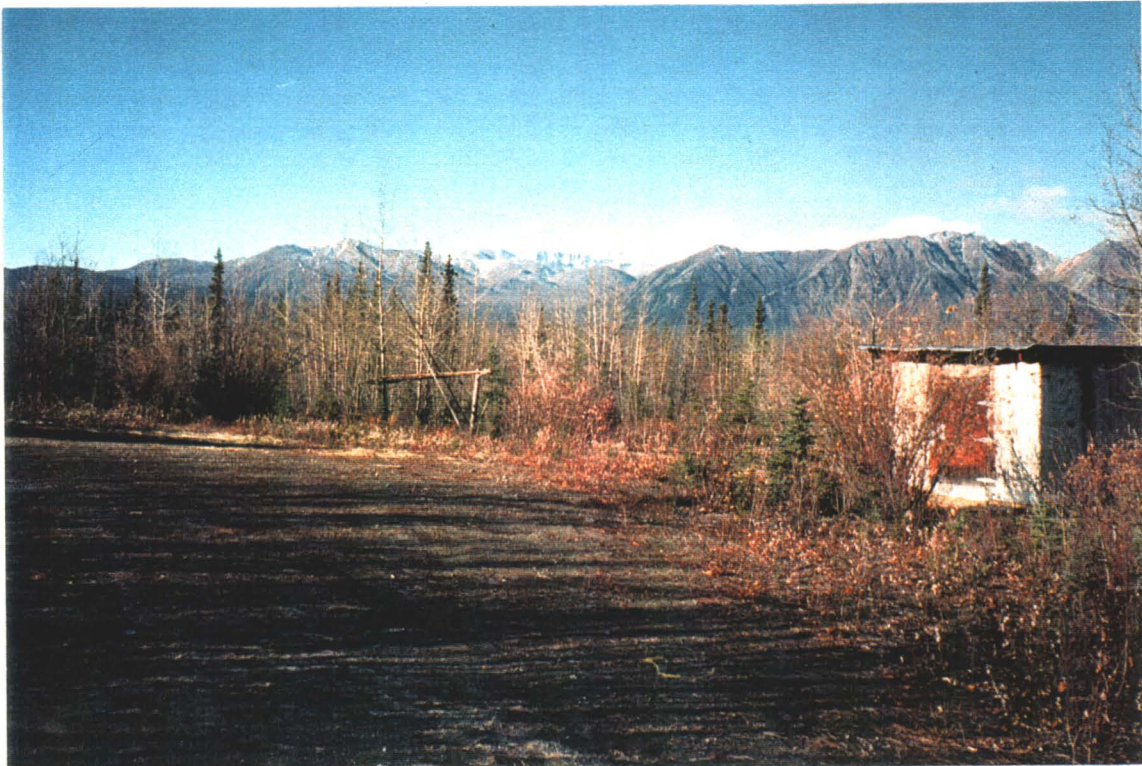
Photograph 3. Road and shed beside oil change pit on subject site. September 1996.

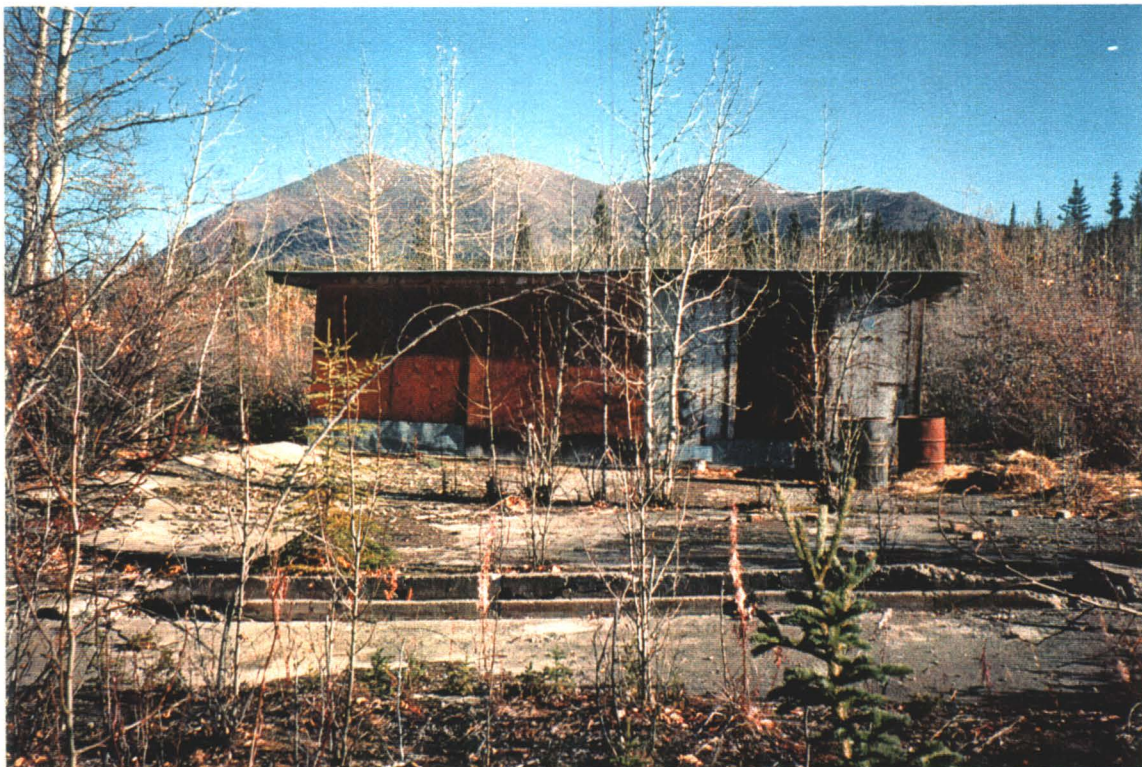
Photograph 4. Oil change pit and shed on subject site. September 1996.

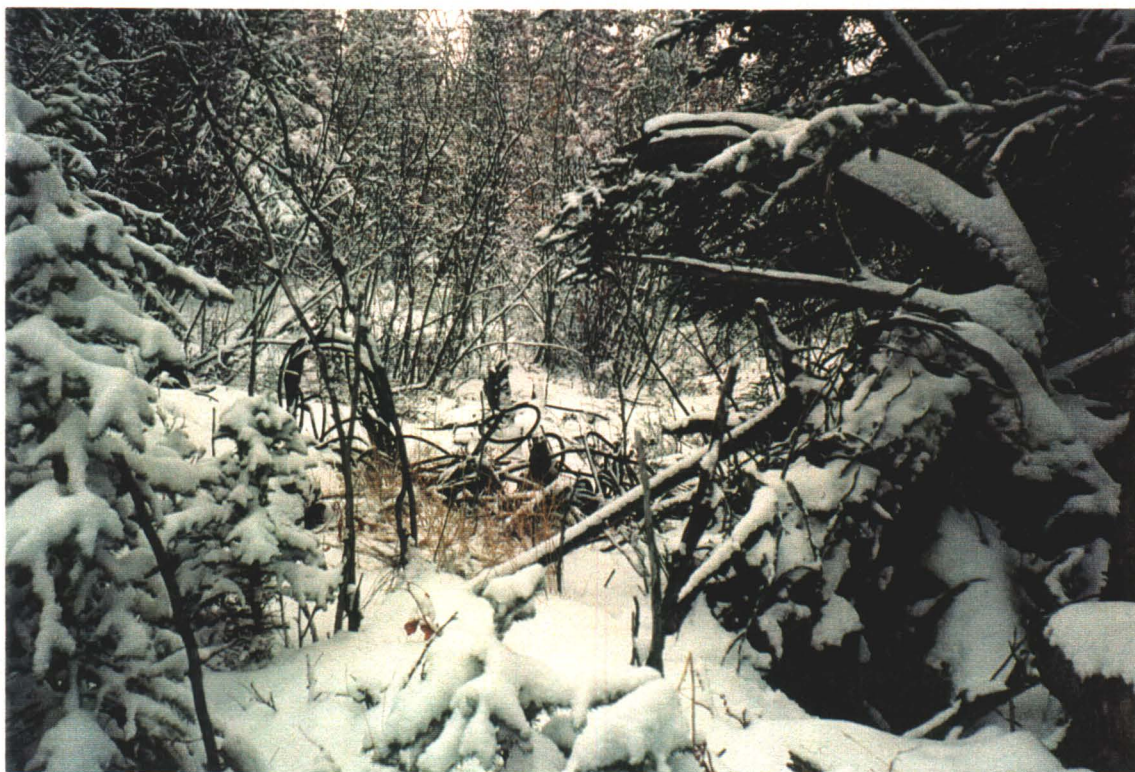
Metal and wood debris, including pieces of barrels, pails, vehicle parts, and building foundations were scattered throughout the site (Photographs 5 and 6). Vegetation was observed growing through much of the debris (Photograph 7).

Photograph 5. Metal debris on surface of subject site. October 1996.

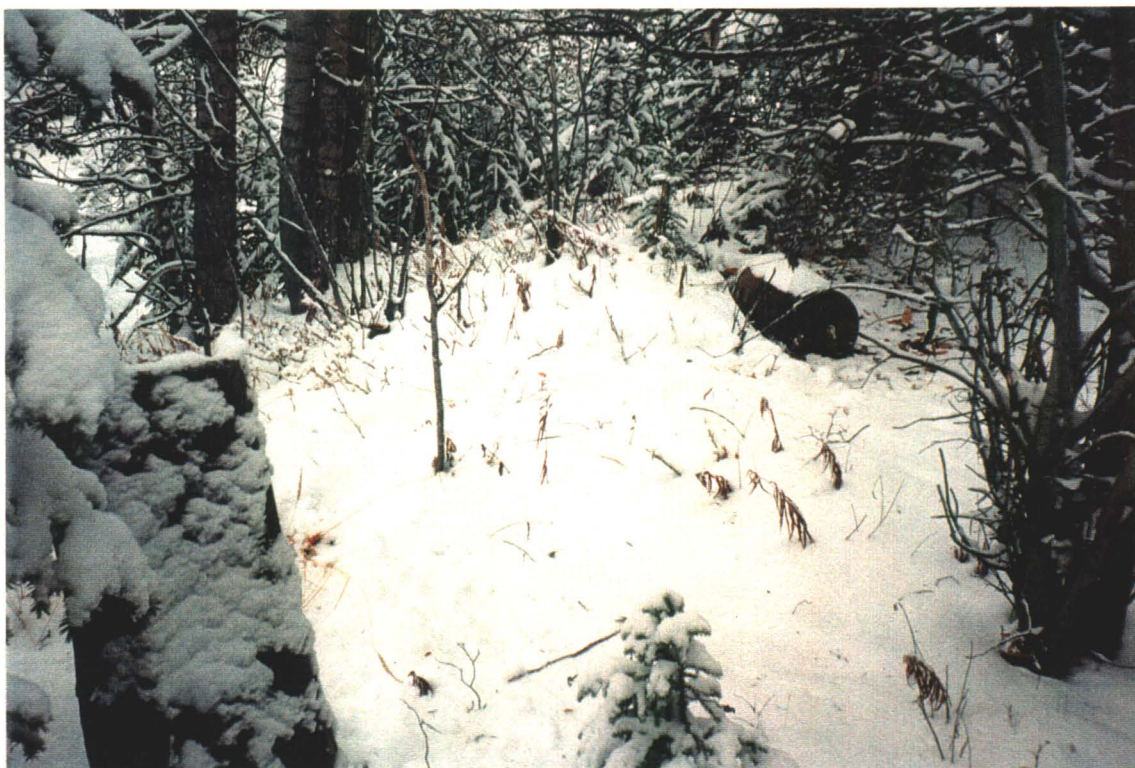
Photograph 6. Discarded barrel on subject site. October 1996.

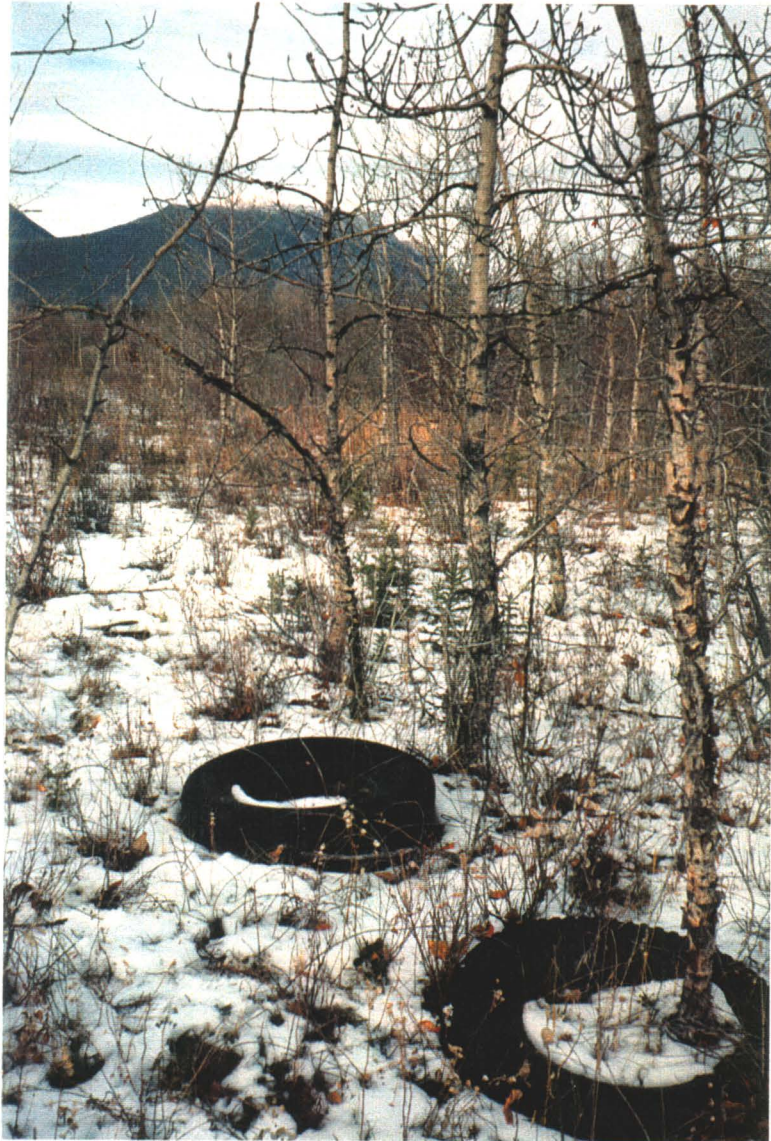
Photograph 7. Vegetation growing through postwar debris on river valley portion of the subject site. October 1996.

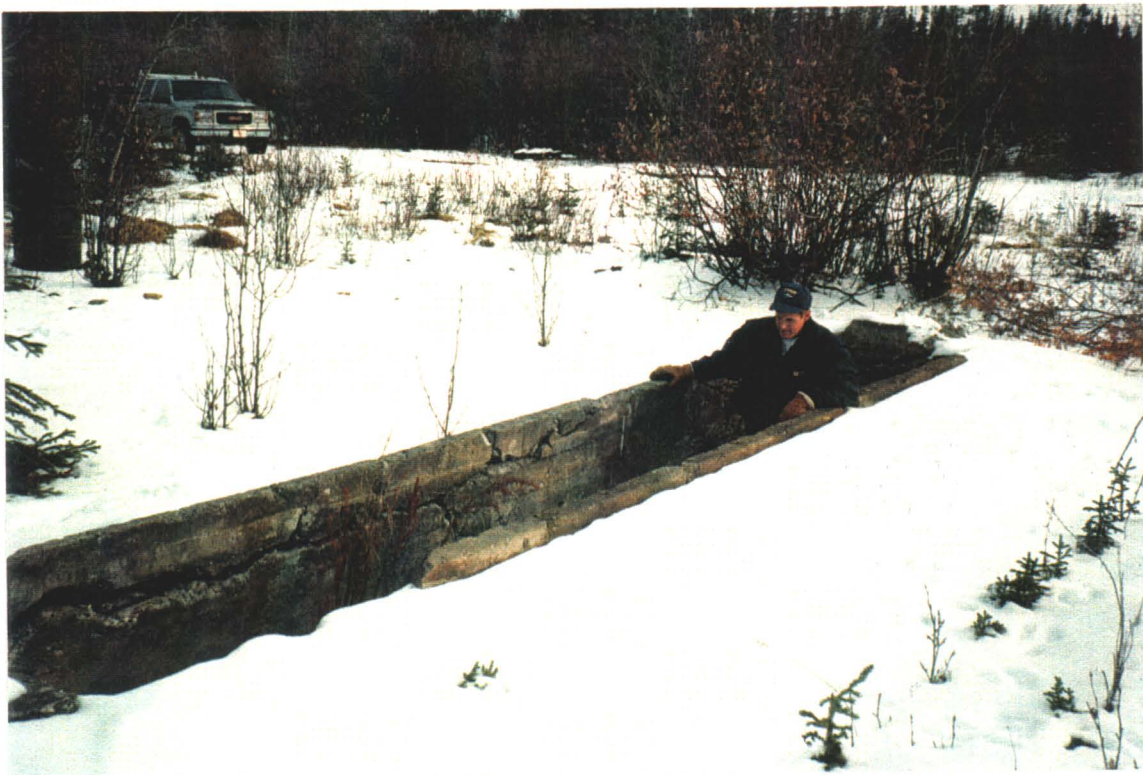
Several concrete structures were present on the site. These included an oil change pit, of approximately 1 1/2 metres in depth (Photograph 8). The walls of the pit were largely intact, however, several large cracks were present in the concrete (Photograph 9). A concrete slab, which appeared to have been the foundations of a building, was located close to the outfitter's cabin on the site (Photograph 10).

Photograph 8. Oil change pit on subject site. October 1996.

Other contaminants of concern found at this site included hydrocarbons within the former oil change pit and the organo-chloride pesticides DDD, DDE and DDT. The hydrocarbons represent a moderate to low risk since concentrations were fairly low, and they were believed to be localized within the concrete pit, where there is limited vegetative growth. However, the organo-chlorides may represent a significantly higher risk due to their classification as persistent

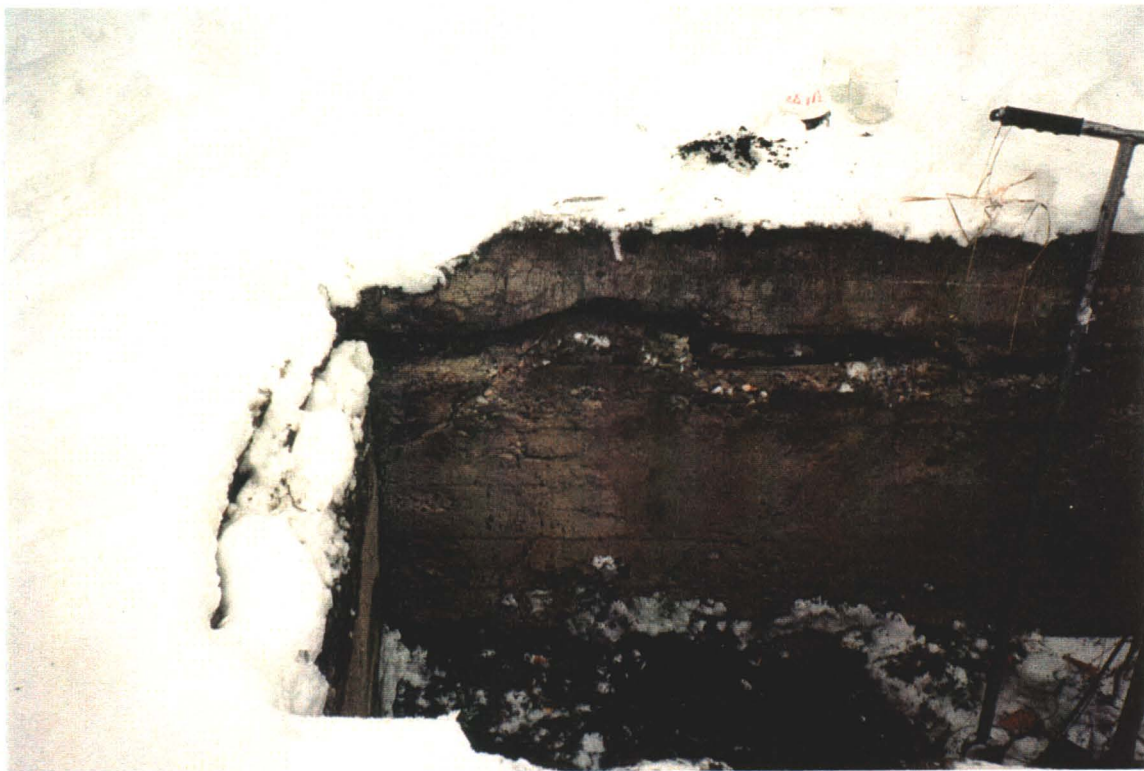
Photograph 9. Interior of oil change pit on subject site. October 1996.

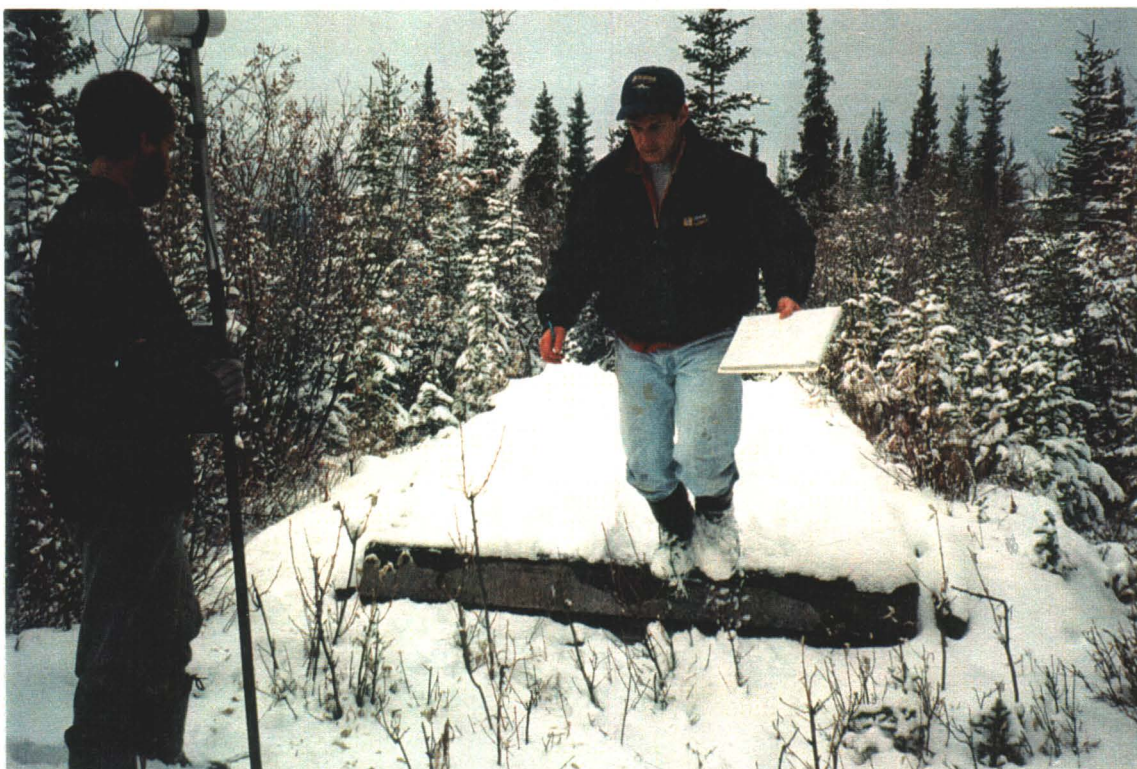
Photograph 10. Concrete foundation near outfitter's cabin on subject site. October 1996.

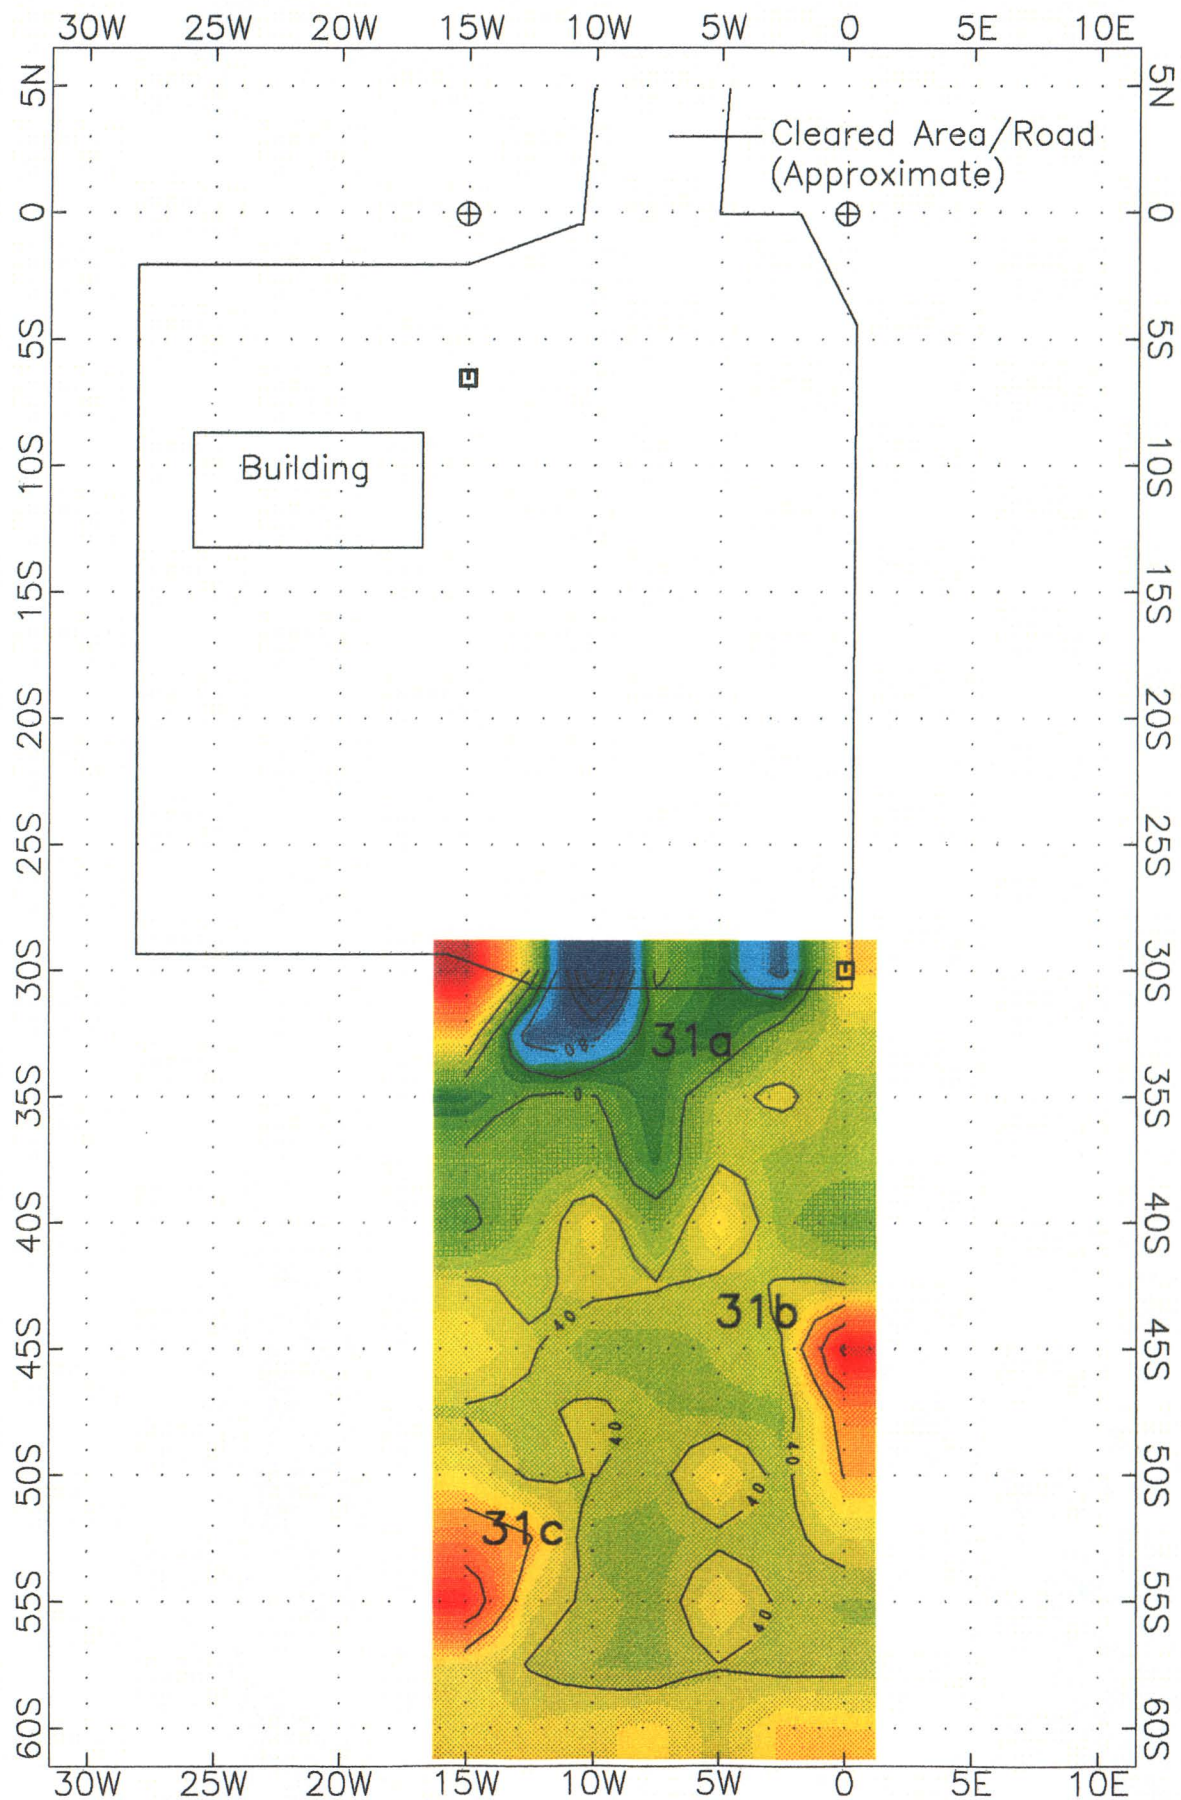
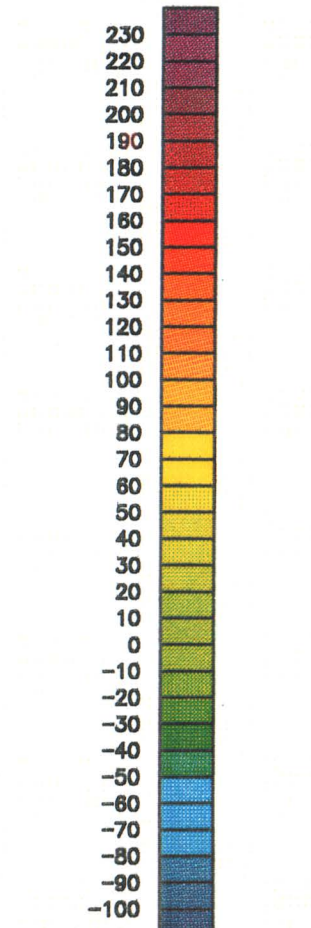
Magnetic Anomaly 31b - of relatively small lateral extent and of low to moderate magnitude

Magnetic Anomaly 31c - of relatively small lateral extent and of low to moderate magnitude

The climate and age of the site would suggest that any buried drums would have been subject to deterioration. **Leachate monitoring would provide information on potential migration from areas of buried metal with less damage to the ground surface than excavation of the metal would entail.** Further geophysical work, to identify all major areas of metal burial should be conducted prior to planning the location of any monitoring wells.
