Phase I & II Environmental Site Assessment

**Former Military Site
Koidern River - Long's Creek
Mile Post 1155 Alaska Highway
(DIAND Site 32)**

**Arctic Environmental Strategy - Action on Waste
Indian and Northern Affairs Canada
Whitehorse, Yukon**

November 1996

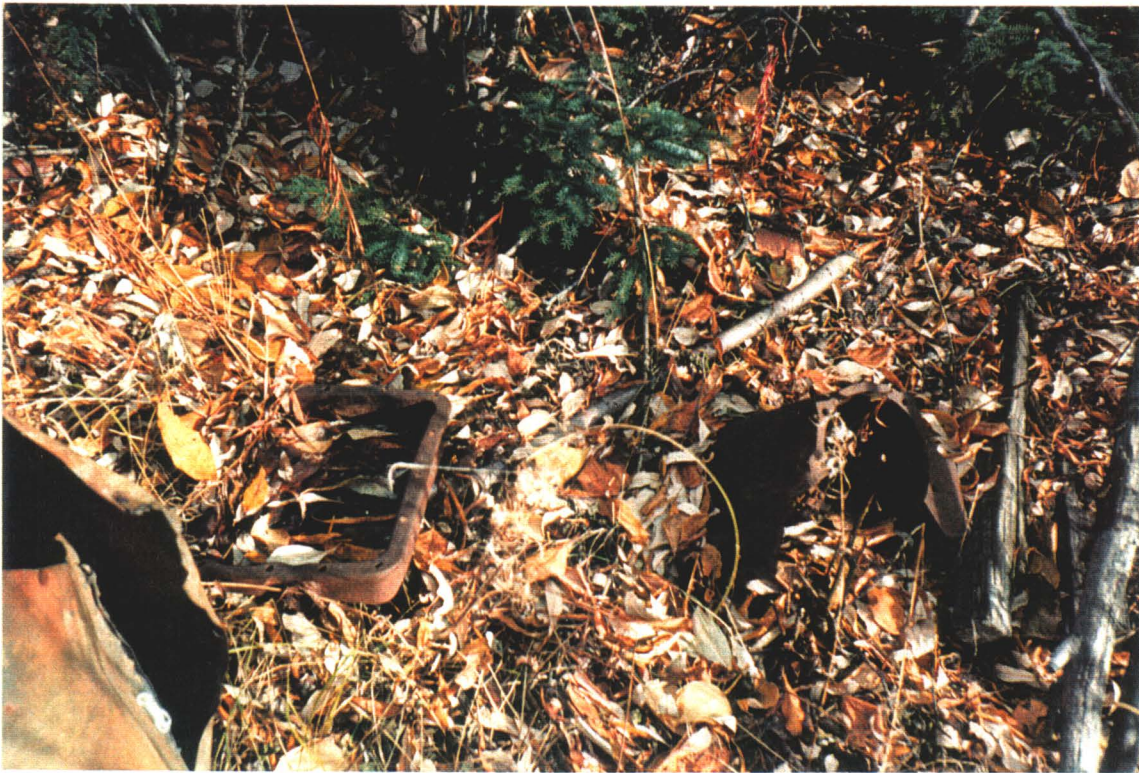
Photograph 2. Discarded vehicle parts on the ground surface at the subject site. September 1996.

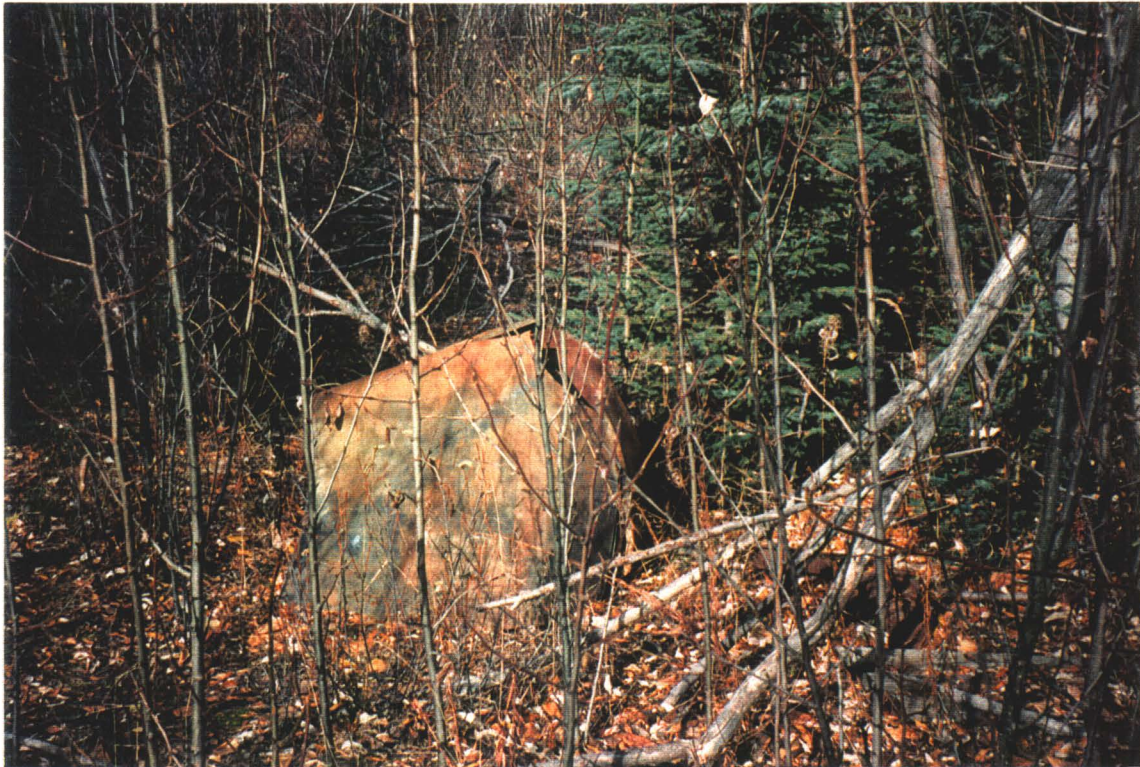
Photograph 3. Metal debris at surface on subject site. September 1996.

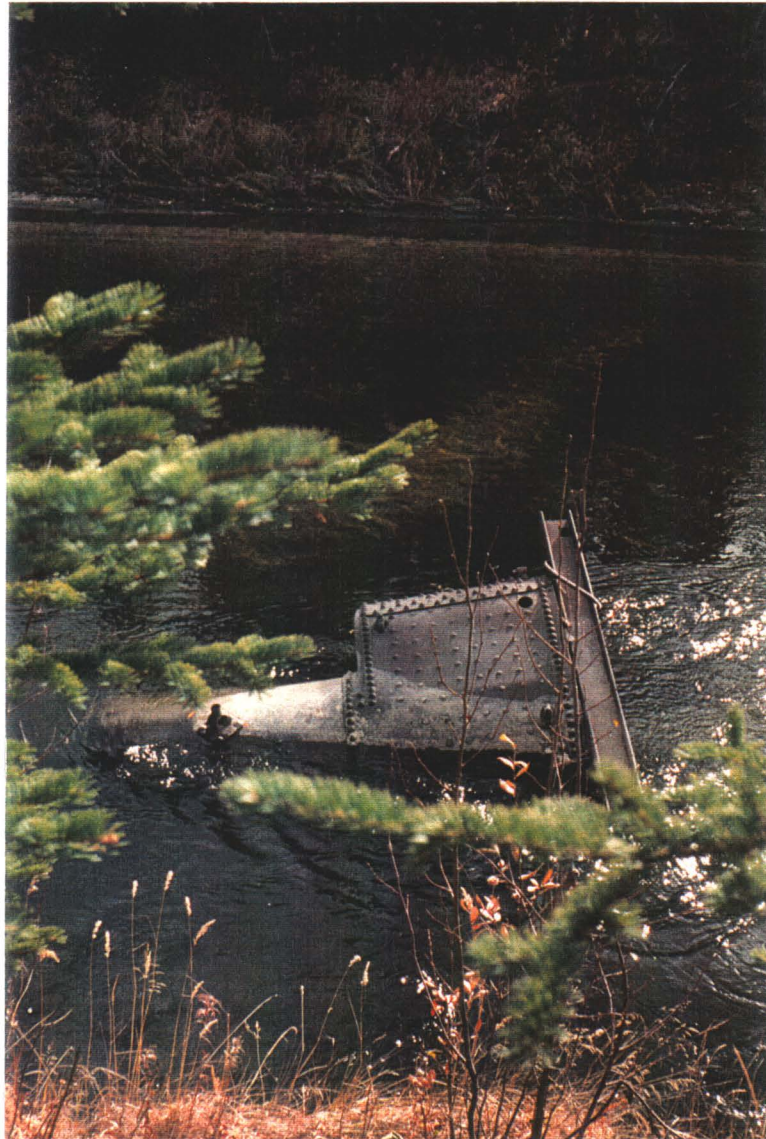
Photograph 4. Abandoned equipment in the Koidern River, adjacent to the subject site. September 1996.

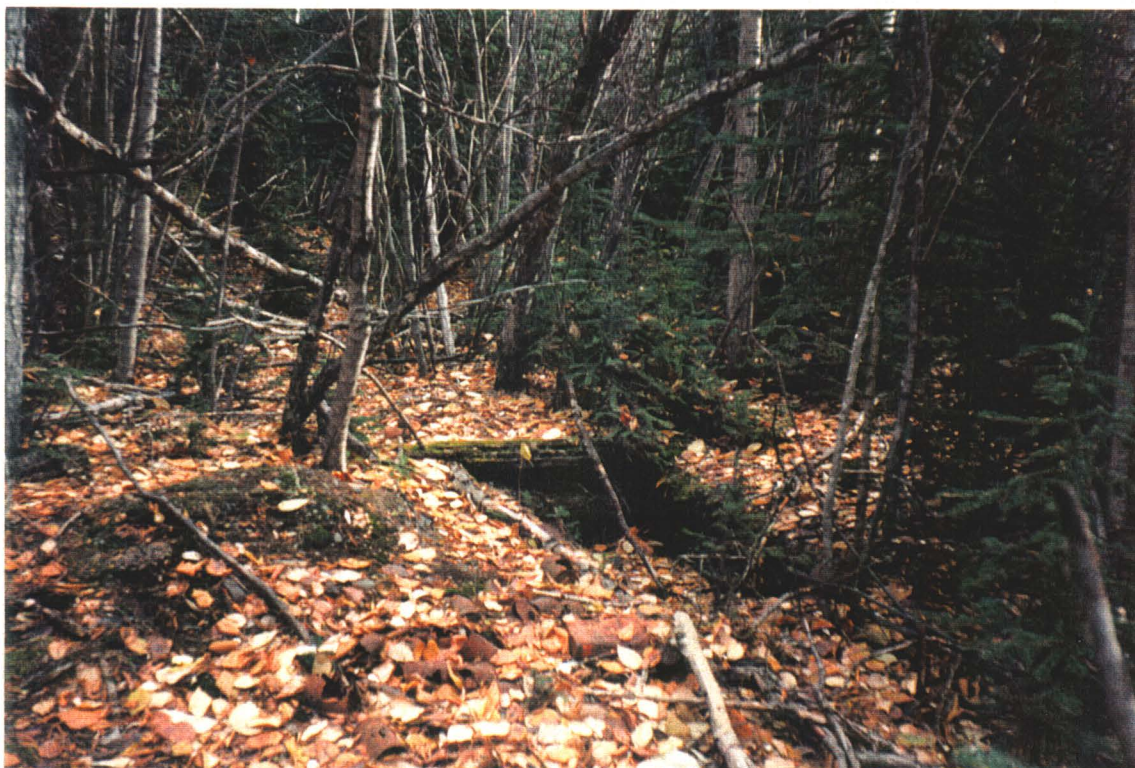
Photograph 5. Former building foundation on subject site.
September 1996.

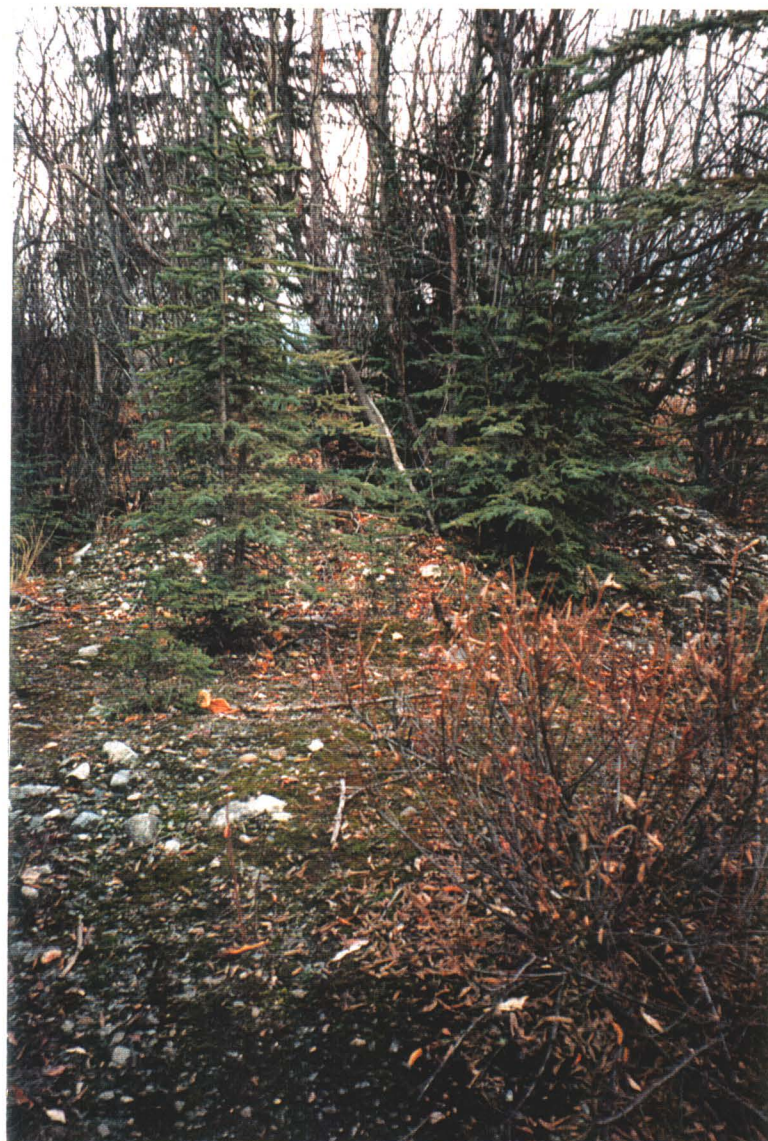
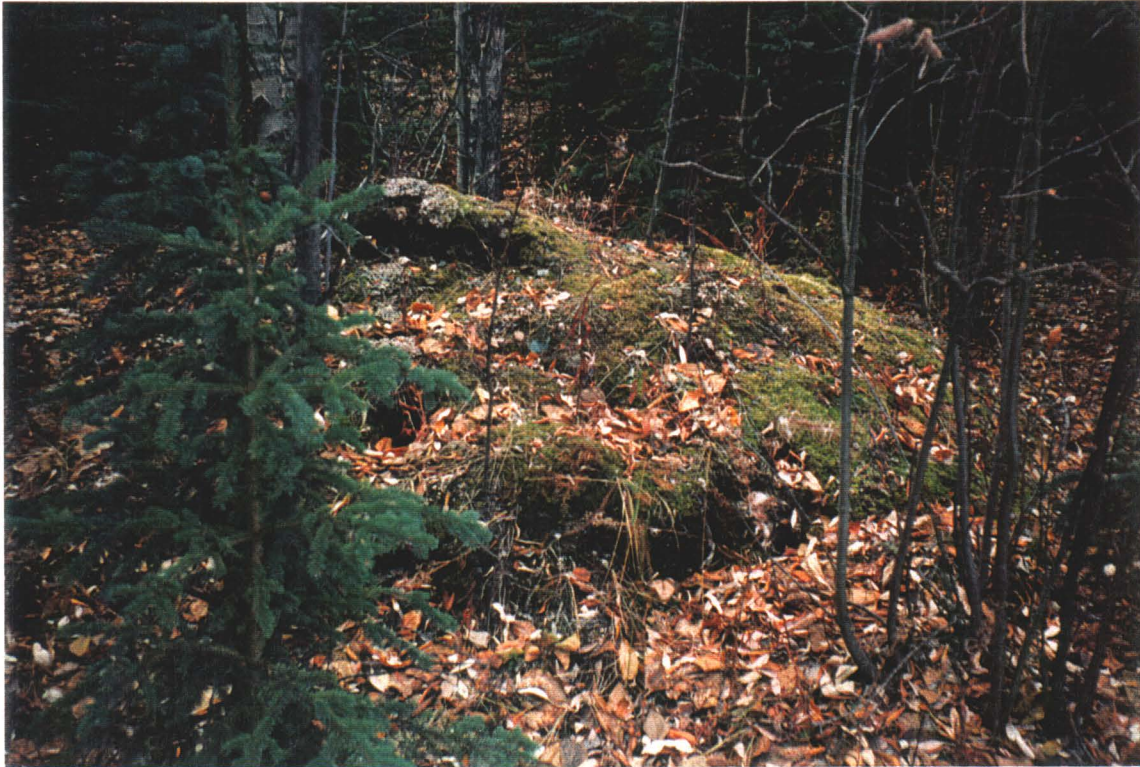
Mounds of one to two metres elevation were present throughout the southern portion of the site (Photographs 6 and 7). Some of these mounds were attributed to human activities, due to the protrusion of metal and wooden debris from within them. Visual inspection could not determine whether other mounds on the site were related to human activities or were the result of frost heaving. A one-metre high mound was also noted in the clearing on the north side of the site (Photograph 8). In order to determine their possible origin, some of the mounds were investigated using geophysical methods.

Photograph 6. Mound on subject site. September 1996.

Photograph 7. Mound on subject site. September 1996.

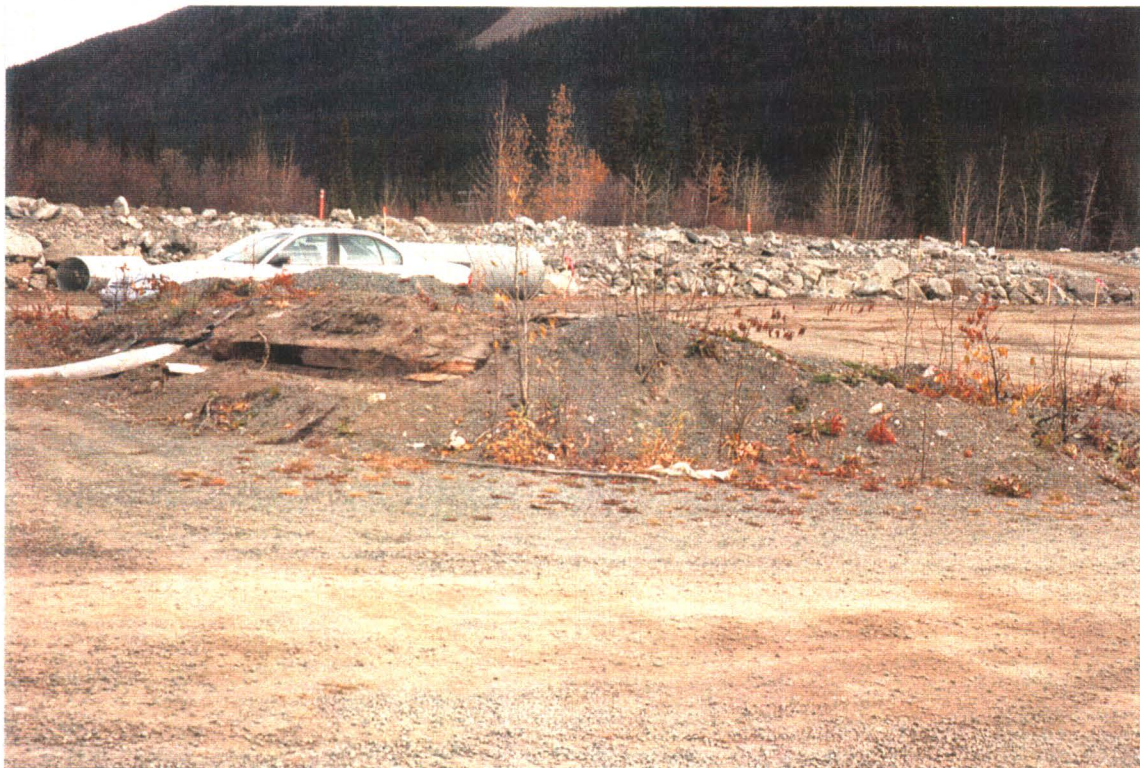
Photograph 8. Mound at centre of equipment yard on subject site. September 1996.

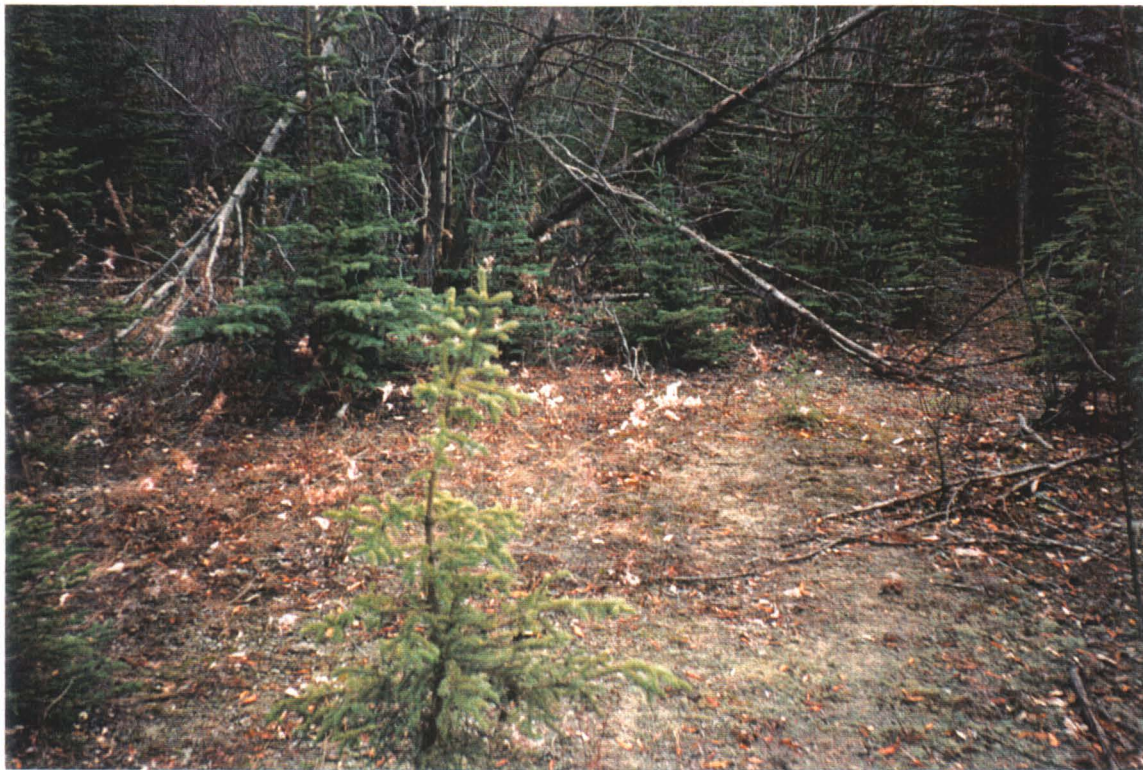
Photograph 9. Poorly vegetated area on the subject site. September 1996.

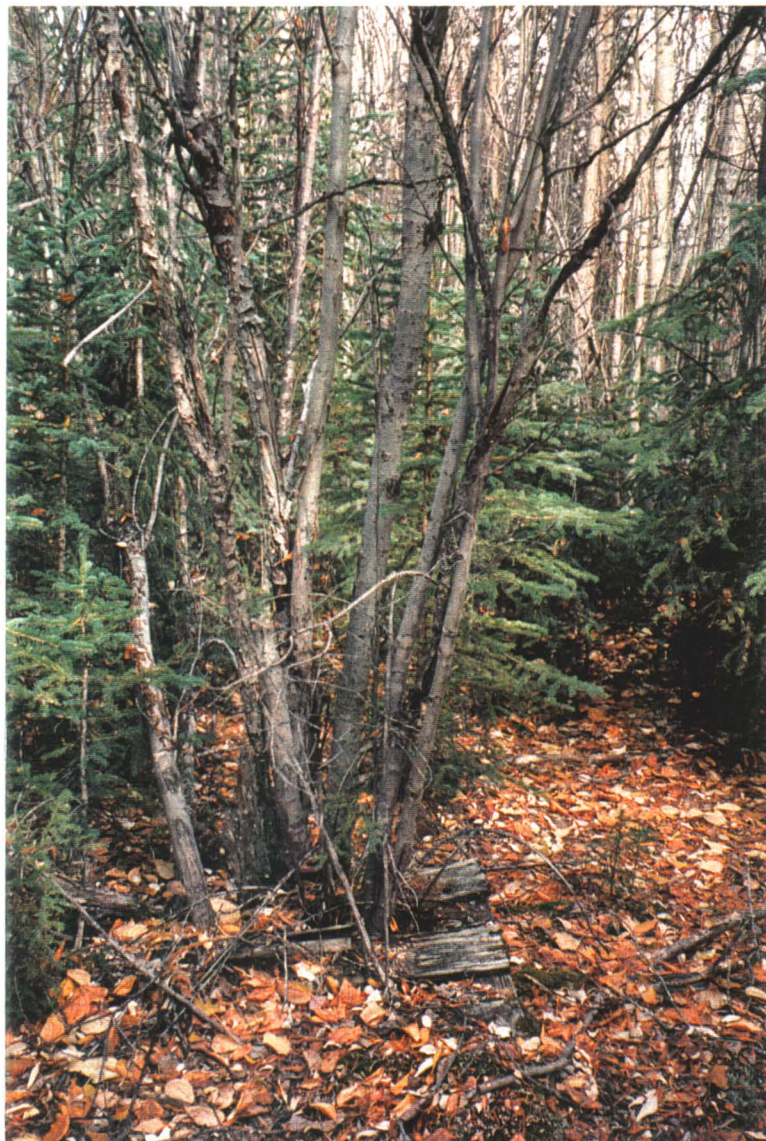
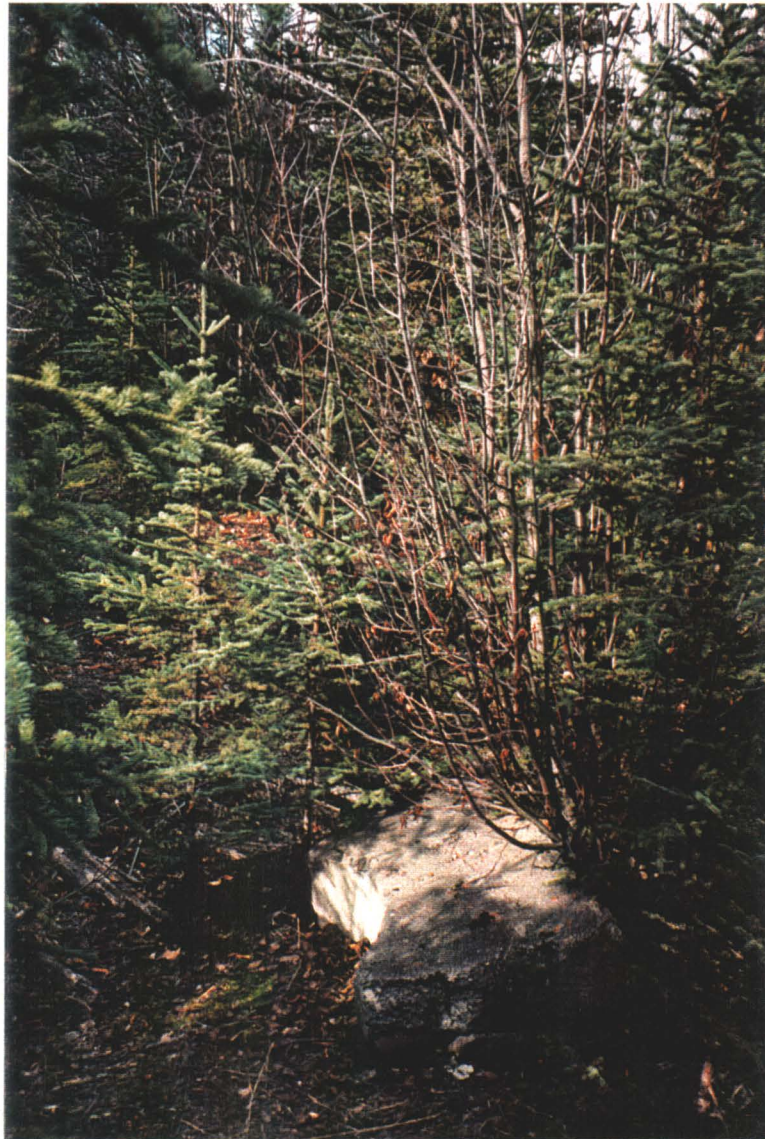
Photograph 10. Vegetation growing through former building site.
September 1996.

Photograph 11. Vegetation growing through former building site.
September 1996.

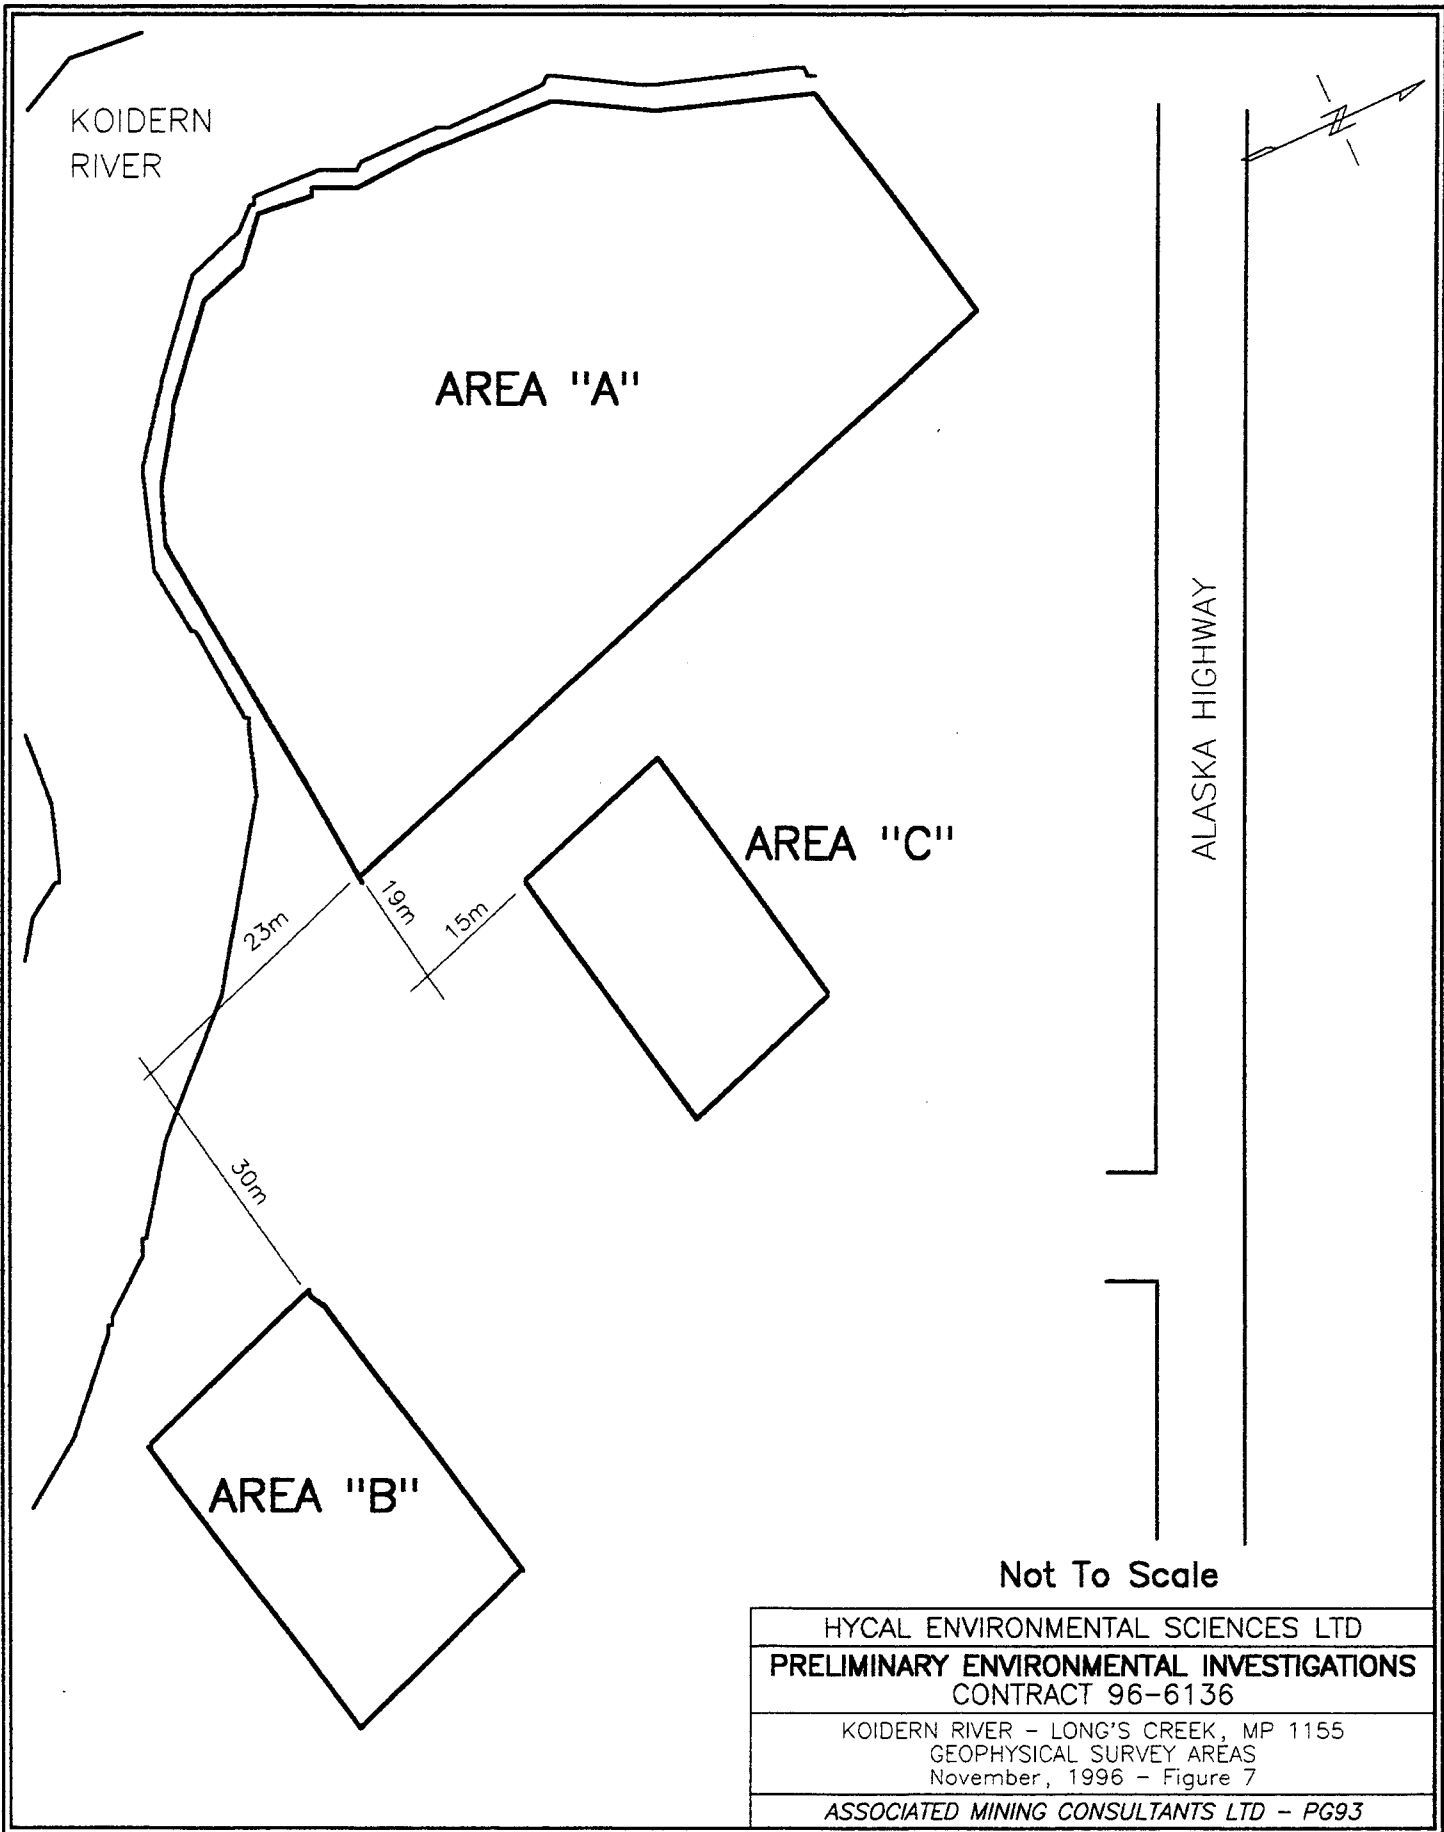
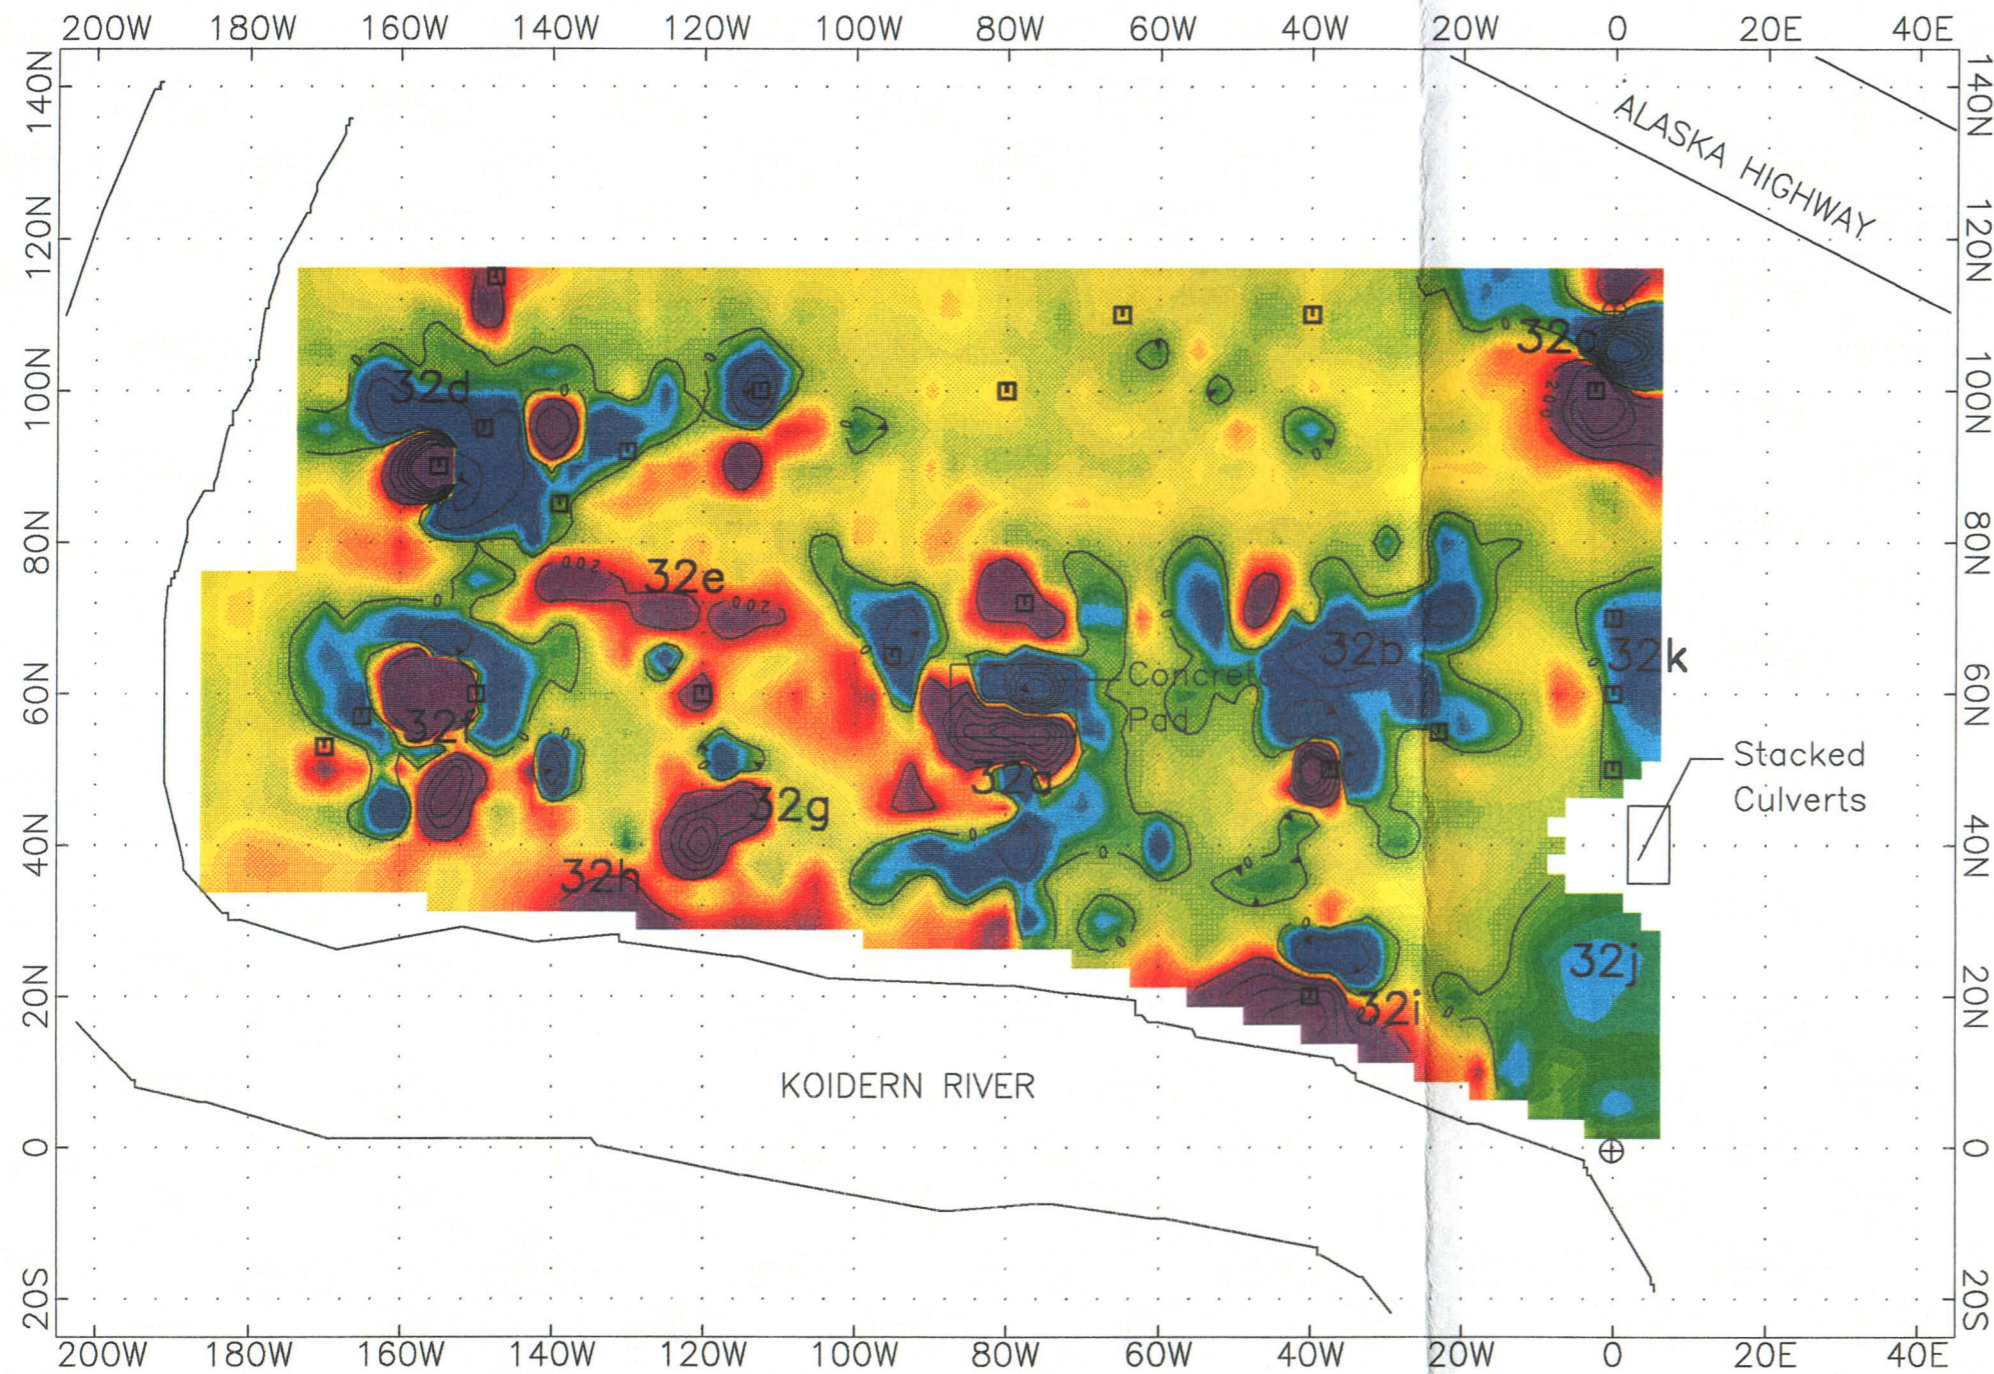
HYCAL ENVIRONMENTAL SCIENCES LTD
PRELIMINARY ENVIRONMENTAL INVESTIGATIONS CONTRACT 96-6136
KOIDERN RIVER - LONG'S CREEK, MP 1155 TOTAL FIELD MAGNETOMETER SURVEY - AREA 'A' November, 1996 - Figure 8
ASSOCIATED MINING CONSULTANTS LTD - PG93

Collected at 5 metre by 5 metre sample intervals, the measured magnetic response over Area "A" is presented in Figure 8. The region of anomalous magnetic response was relatively extensive within the surveyed area. Identified anomalies were as follows:

- 32g Relatively large magnetic anomalies. No evidence of surficial metal in the immediate vicinities, suggesting the presence of buried metal.
- 32h Relatively large magnetic anomalies. No evidence of surficial metal in the immediate vicinities, suggesting the presence of buried metal.

- 32i Surficial metal was evident. The magnitude of the anomaly suggests the existence of additional metal buried at depth.

The climate and age of the site would suggest that any buried drums would have been subject to deterioration. **Leachate monitoring would provide information on potential migration from areas of buried metal with less damage to the ground surface than excavation of the metal would entail.** Further geophysical work, to identify all major areas of metal burial should be conducted prior to planning the location of any monitoring wells.

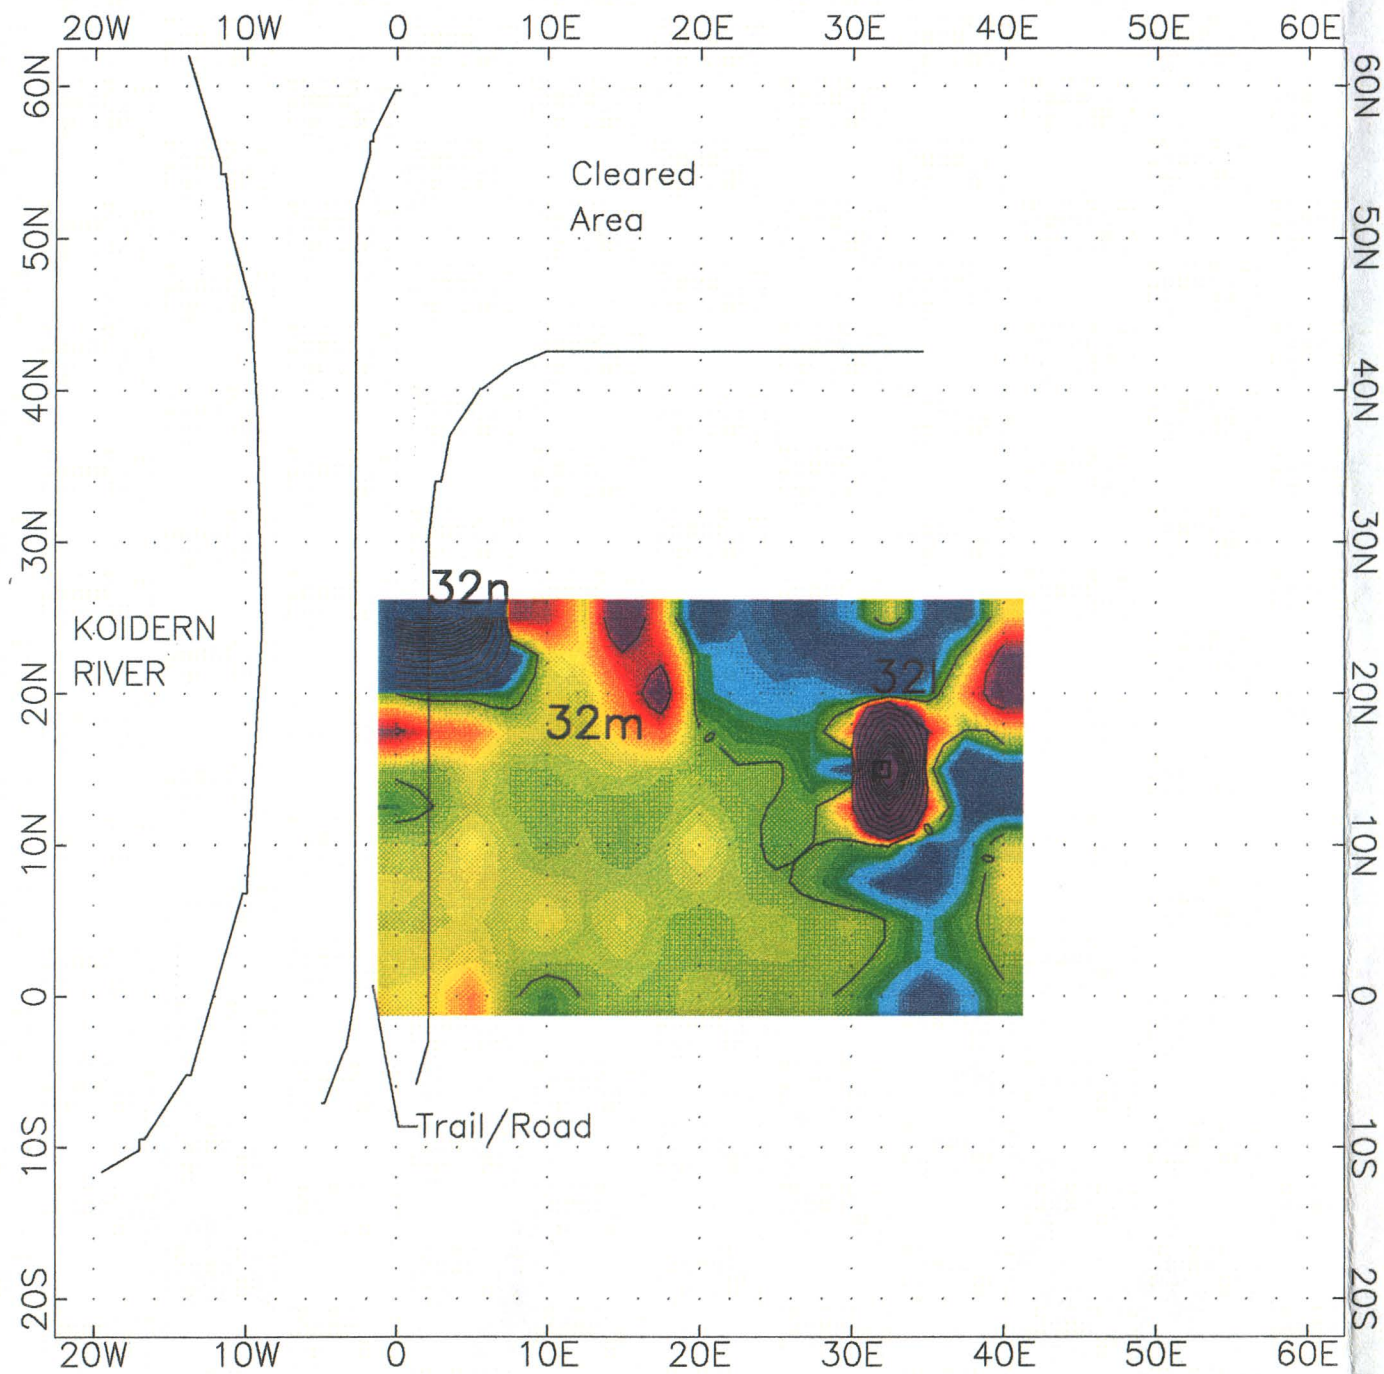
HYCAL ENVIRONMENTAL SCIENCES LTD	
PRELIMINARY ENVIRONMENTAL INVESTIGATIONS	
CONTRACT 96-6136	
KOIDERN RIVER - LONG'S CREEK, MP 1155	
TOTAT FIELD MAGNETOMETER SURVEY - AREA 'B'	
November, 1996 - Figure 9	
ASSOCIATED MINING CONSULTANTS LTD - PG93

Area "B", positioned to the southeast of Area "A", encompassed numerous mounds of partially buried metallic objects, including a vehicle. Relatively dense vegetation and, to a lesser extent, variable topography, resulted in the use of a magnetometer.

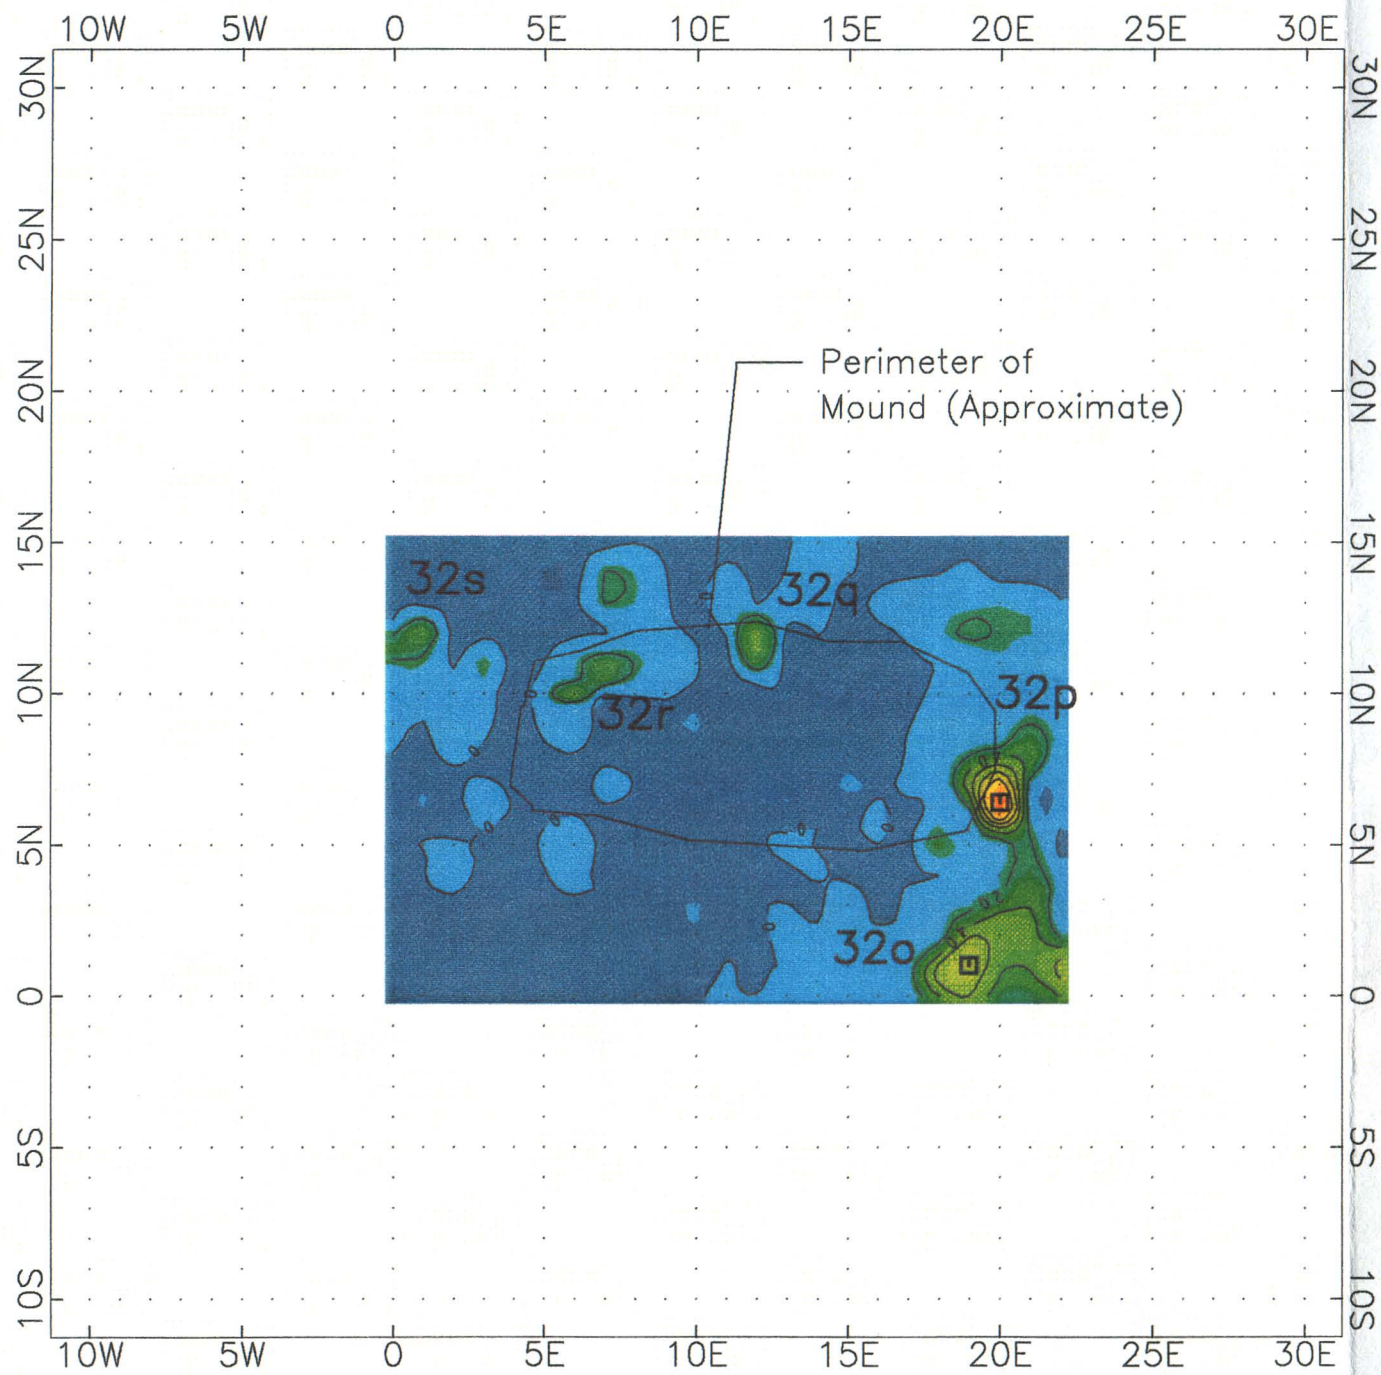
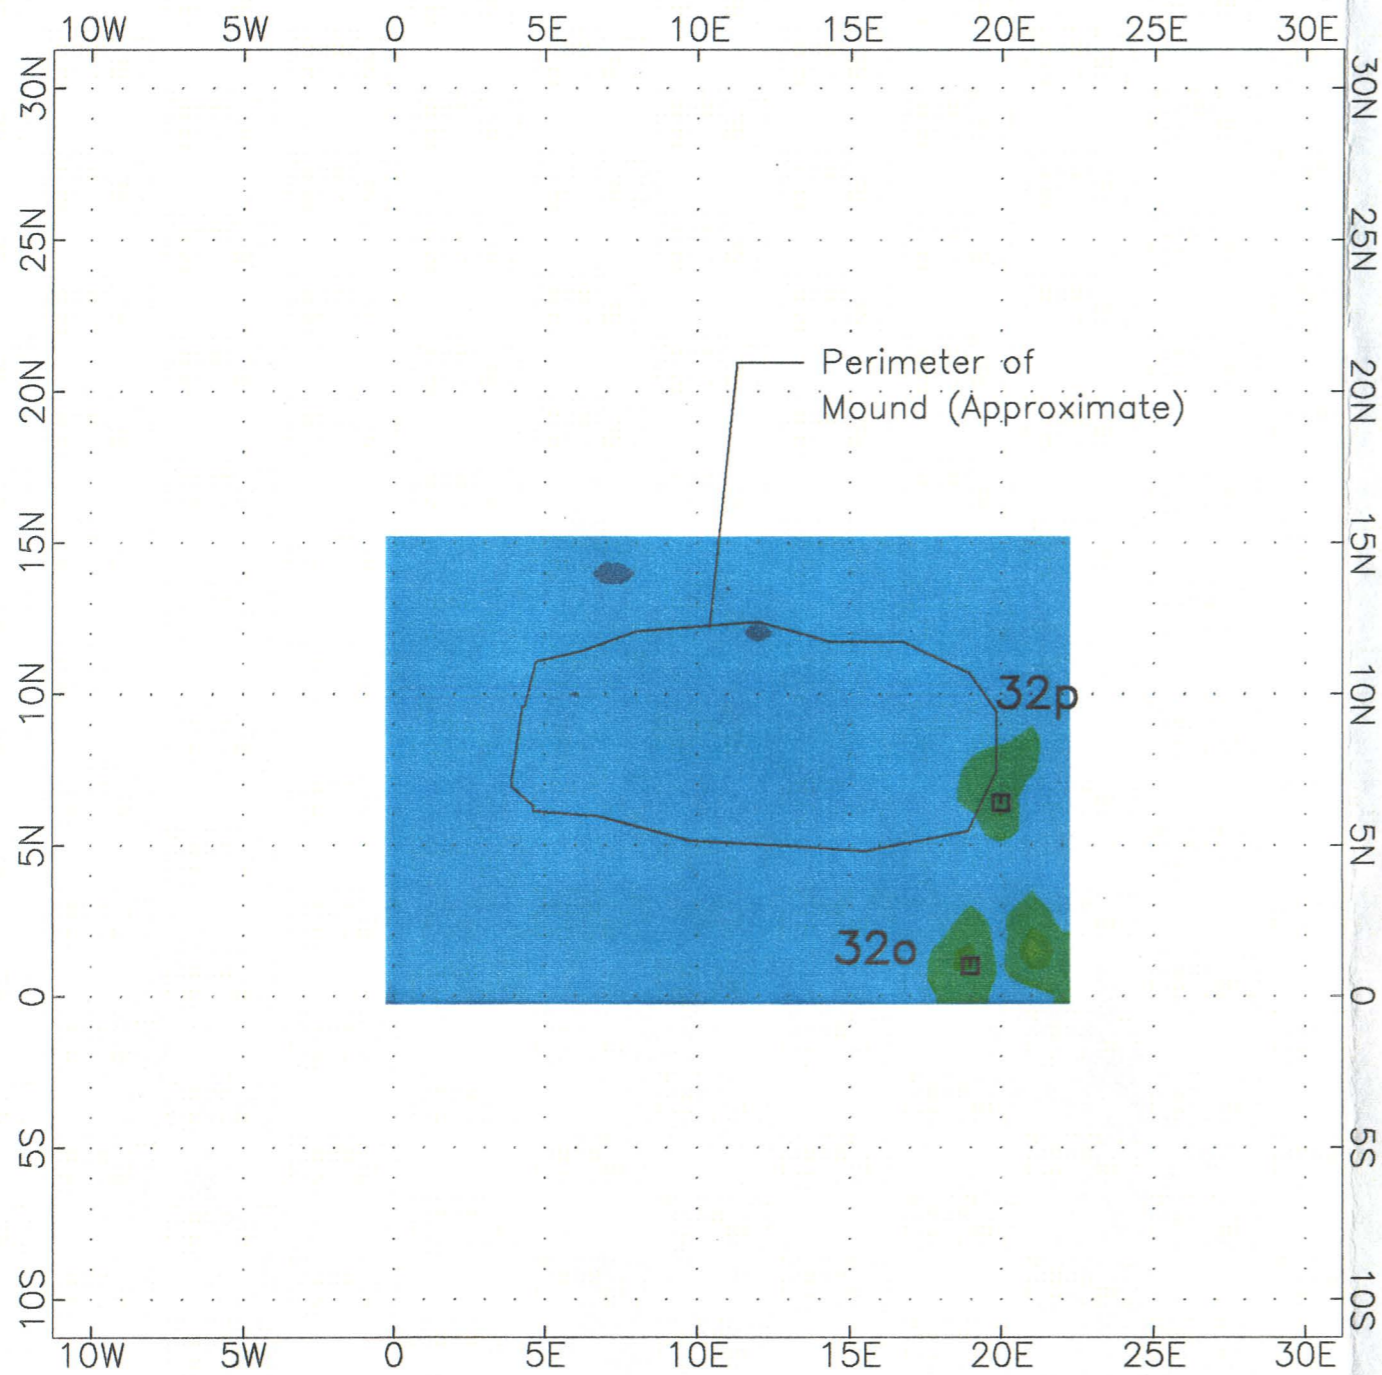
HYCAL ENVIRONMENTAL SCIENCES LTD	
PRELIMINARY ENVIRONMENTAL INVESTIGATIONS	
CONTRACT 96-6136	
KOIDERN RIVER - LONG'S CREEK, MP 1155	
EM61 SURVEY - Channel 2 - AREA 'C'	
November, 1996 - Figure 10	
ASSOCIATED MINING CONSULTANTS LTD - PG-93

EM61 data were acquired at 0.2 metre intervals along survey lines spaced 1 metre apart in Area "C". Results of the EM61 Channel 2 survey identified five distinct areas of anomalous electromagnetic response (Figures 10 and 11).

- 32o Anomalies 32o and 32p are coincident with surficial metals visible at the site,
- 32q, 32r and 32s indicate the presence of relatively small metallic objects. Review of the EM61 Differential Channel and survey reveals that the corresponding anomalies are significantly smaller, or non-existent, suggesting that the metal contributing to the anomalous Channel 2 response is buried within one metre of the ground surface.

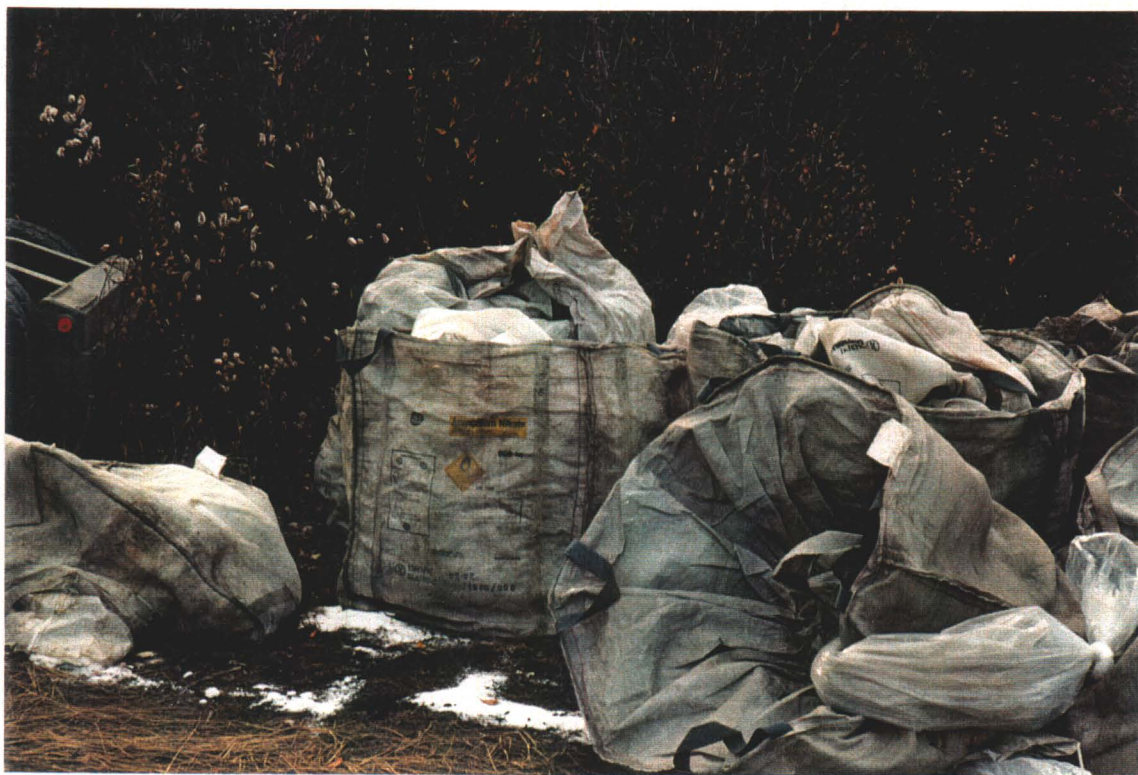
- spills of ammonium nitrate, which were observed in the northern portion of the site, where current road building materials are stored, may adversely affect that area and preclude proper vegetative regrowth. **Spilled ammonium nitrate should be removed from the site. Environmental practices being used during the construction should be reviewed and upgraded to ensure that further materials are not spilled.**

Photograph 12. Ammonium nitrate leaking from sacks in the highway construction materials storage area on the subject site. September 1996.

Spills of ammonium nitrate, which were observed in the northern portion of the site, where current road building materials are stored, may adversely affect that area and preclude proper vegetative regrowth. **Spilled ammonium nitrate should be removed from the site. Environmental practices being used**

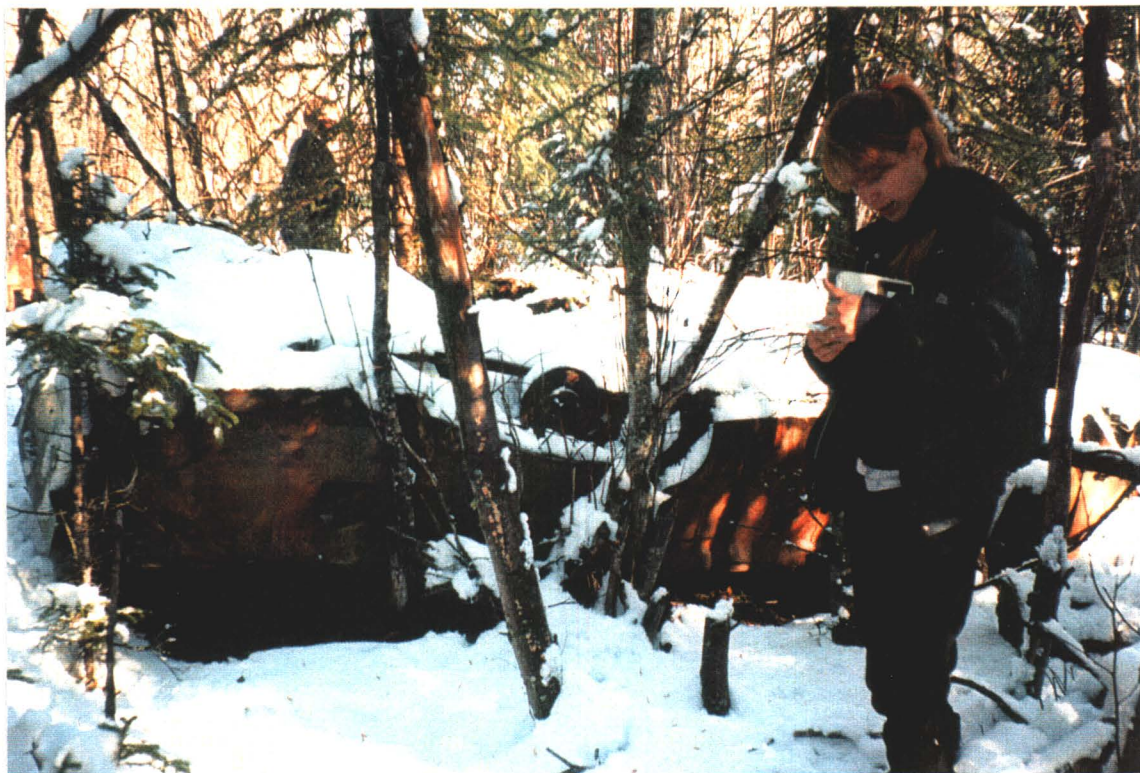
Some areas of the site appear to have been used for unauthorized dumping of waste materials postdating the military occupation. A 1960s vintage vehicle hulk was observed in the central portion of the site (Photograph 13) and a small amount of postwar material, including a desk, bottles, cans, and a used battery were also observed on the site.

Photograph 13. Derelict 1960s vehicle on the subject site. October 1996.
