Phase I & II Environmental Site Assessment

**Former Military Site
Koidern River - Long's Creek
Mile Post 1155 Alaska Highway
(DIAND Site 32)**

**Arctic Environmental Strategy - Action on Waste
Indian and Northern Affairs Canada
Whitehorse, Yukon**

November 1996

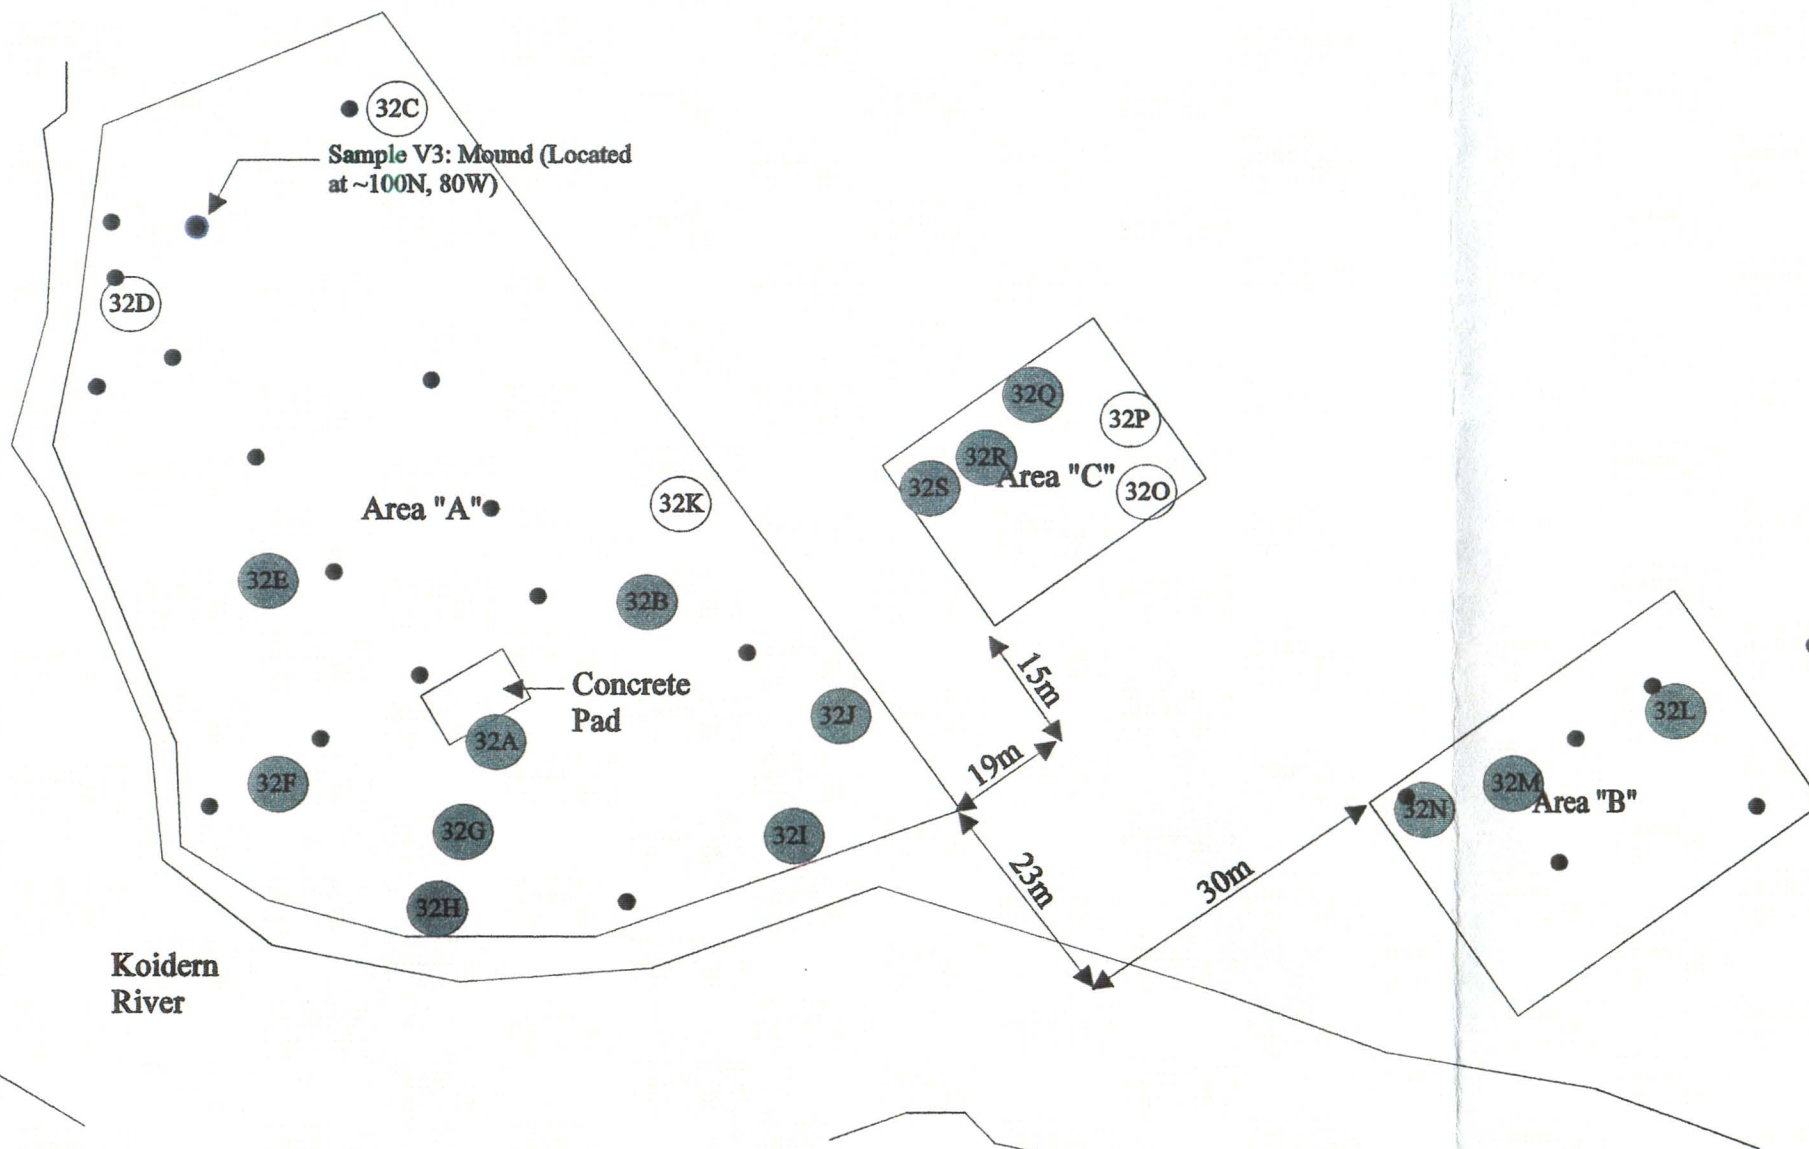
Magnetometer Results	
Anomaly	Description
Area "A":	
32a	attributed exclusively to rebar within an existing concrete pad, however, the magnetic anomaly extending to the southeast is likely the result of buried metal
32b	laterally extensive magnetic anomaly attributed to buried metal, no metal visible at surface
32c	located at northern corner of the survey area, due exclusively to surface metal
32d	large anomaly centered around surface metals which include a vehicle, additional surface metal evident around the perimeter of the mapped magnetic anomaly
32e	although metal is evident at surface along the southeastern extent of the anomaly, the northern extent is likely a result of buried metal
32f	a relatively large anomalous magnetic response in the immediate vicinity of surficial metals, the magnitude and lateral extent suggest additional buried metal in the region
32g & 32h	relatively large magnetic anomalies, no evidence of surface metal in the immediate vicinity, suggesting the presence of buried metal

32i	anomalous response due to surficial metal, the magnitude of the anomaly suggests the existence of additional metal buried at depth
32j	relatively weak negative magnetic response extending to the southeast region of the survey area indicative of buried metal in the immediate vicinity
32k	anomalous magnetic response attributed exclusively to surficial metal (culverts)
Area "B":	
32l	anomaly attributed exclusively to a partially buried vehicle
32m & 32n	positive and negative magnetic anomalies 32m and 32n, respectively, are likely a result of buried metal occurring in the northwest corner of the study area
