**Phase I & II Environmental
Site Assessment**

**Former Military Site
Koidern - White River
Mile Post 1164 - 1167 Alaska Highway
(DIAND Site 33)**

**Arctic Environmental Strategy - Action on Waste
Indian and Northern Affairs Canada
Whitehorse, Yukon**

November 1996

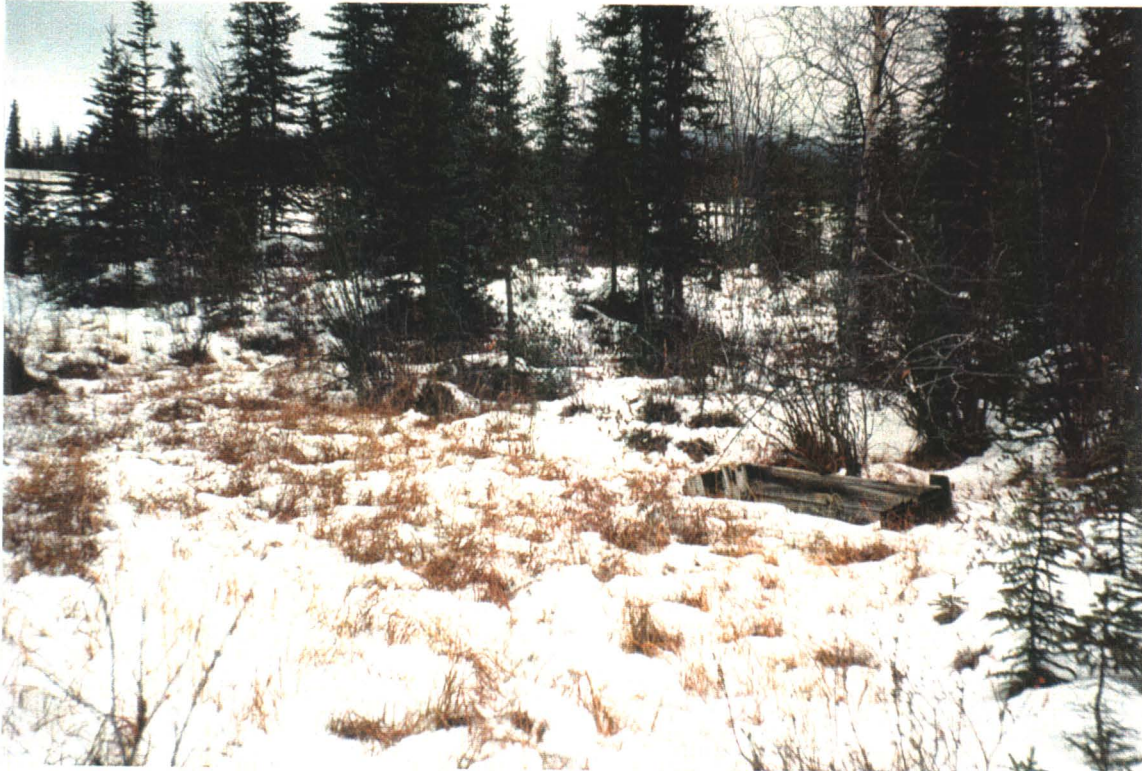
- analysis of a soil sample from the northern edge of the Koidern River Lodge Site indicated the presence of barium, cadmium, chromium, cobalt, mercury, silver, tin, vanadium, and zinc in excess of CCME Assessment Criteria. Arsenic, copper, lead, nickel and selenium were found at levels exceeding CCME Residential / Parkland Remediation Criteria. The hydrocarbon level of the sample was found to be above the Alberta Tier 1 criterium for hydrocarbons.

Photograph 3. Wooden debris on the northern edge of the Koidern River Lodge site in the area of Sample S1). October 1996.

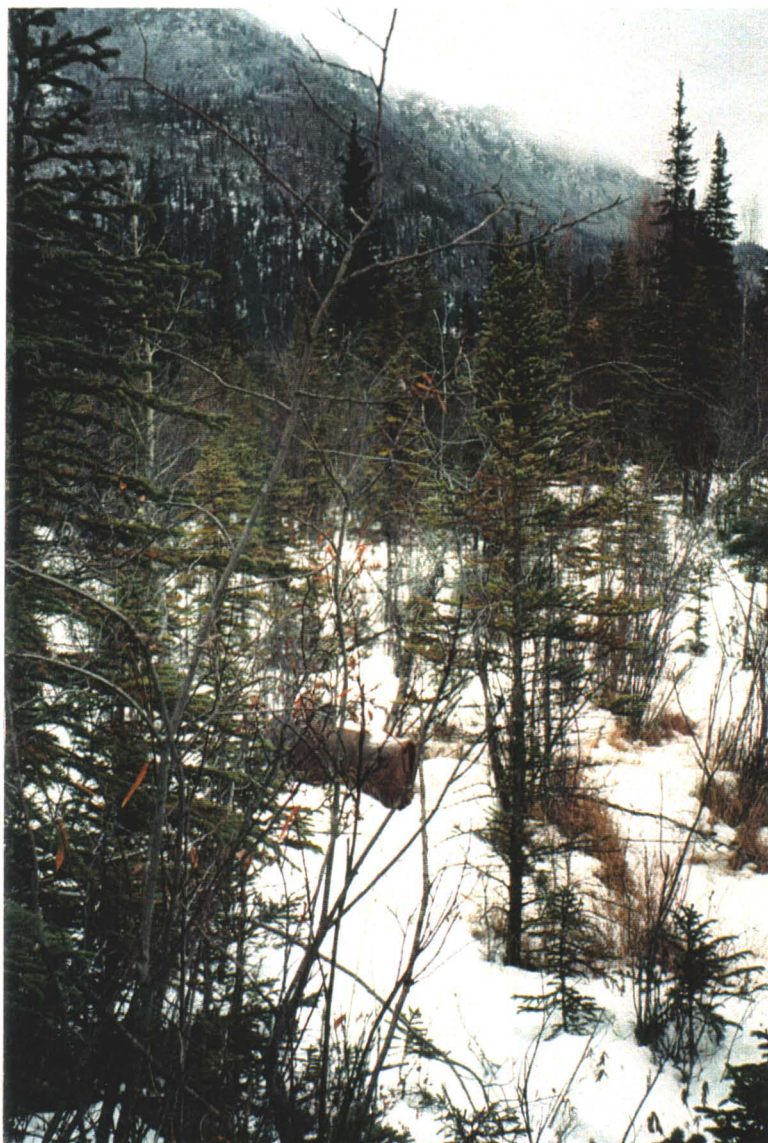
Photograph 4. Discarded barrel on Koidern River Lodge site.
October 1996.

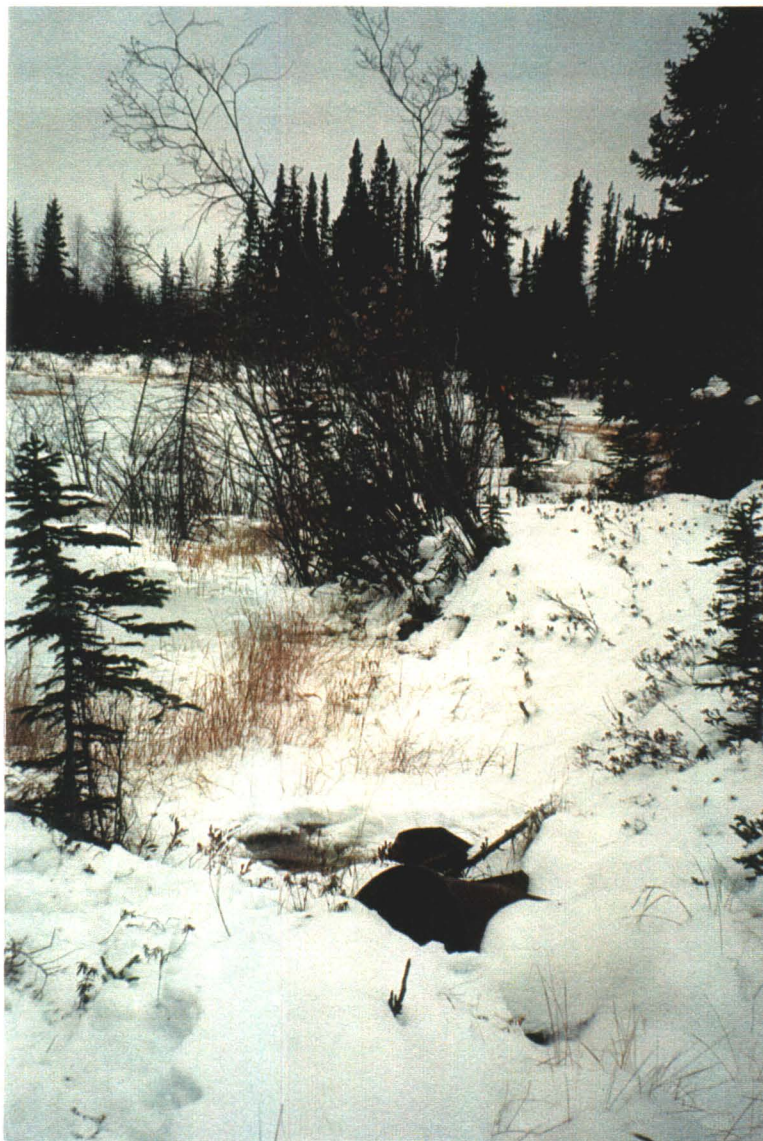
Photograph 5. Discarded barrel and 'jerry can' at the southeastern edge of the Koidern River Lodge site. October 1996.

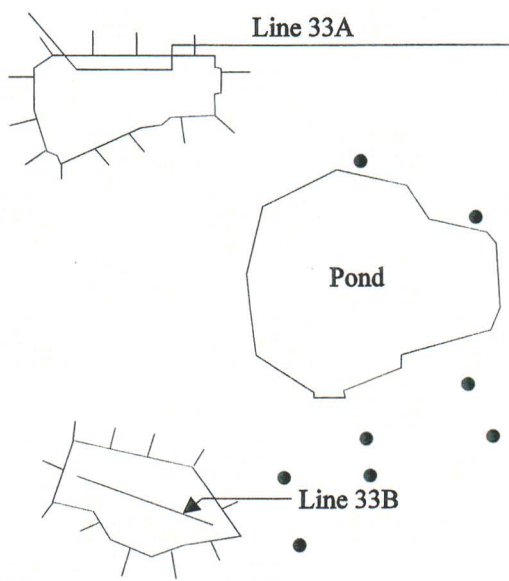
Yukon Environmental Strategy - Action on Waste DIAND		
Phase I & II ESA		
Former Military Site - Mile Post 1164, Koidern River Lodge DIAND Site 33		
Summary of Geophysical and Soil Investigations		
Figure 9	November, 1996	Not to Scale

Magnetometer Results	
Line 33A	no significant quantity of metal is indicated in the immediate vicinity
Line 33B	slight variations in magnetic intensity are attributed to metal observed on the ground surface

← Sample S1: Scrap Pile on Edge of Trees

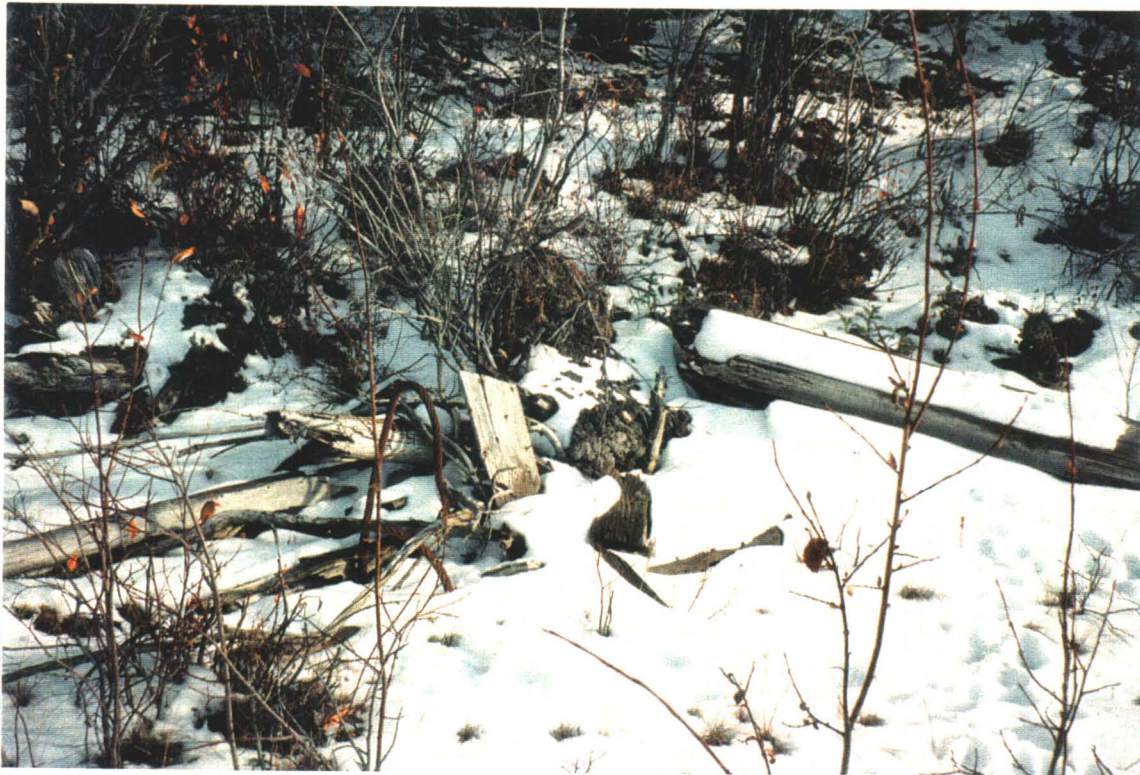
Photograph 10. Wood and Metal Debris at Canol Pump Station G,
MP 1166. October 1996.

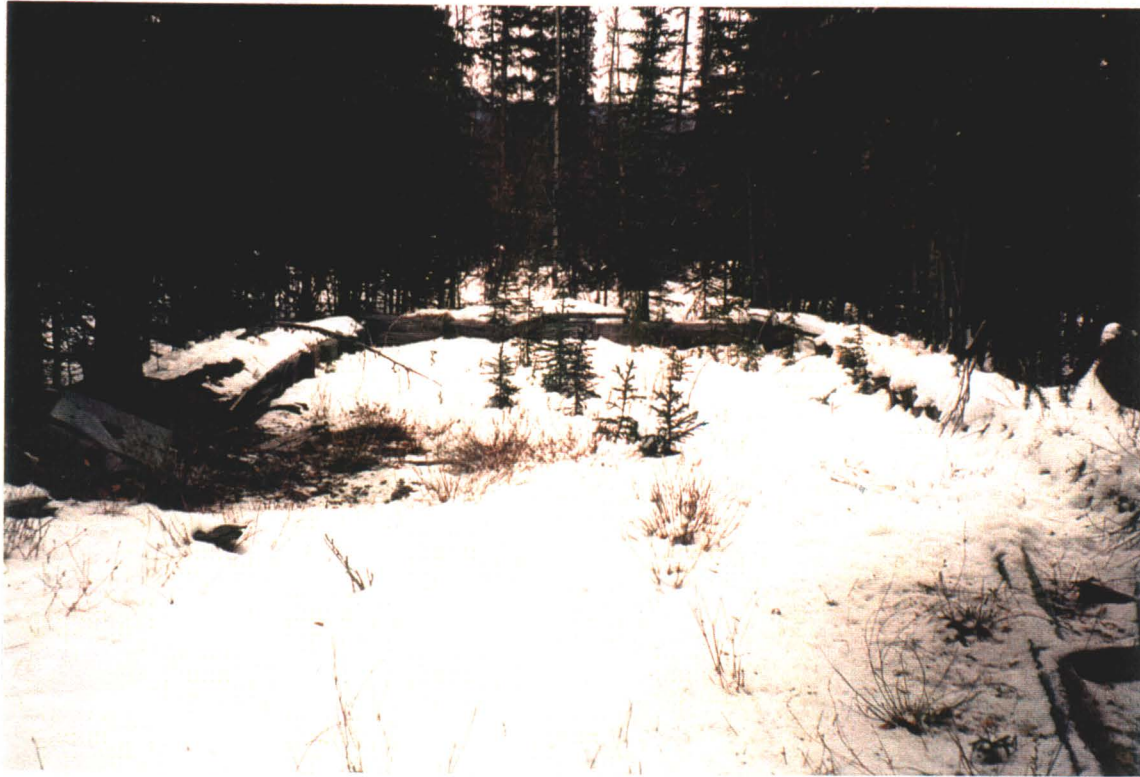
Photograph 11. Remnant Building Foundations at Canol Pump Station G, MP 1166. October 1996.

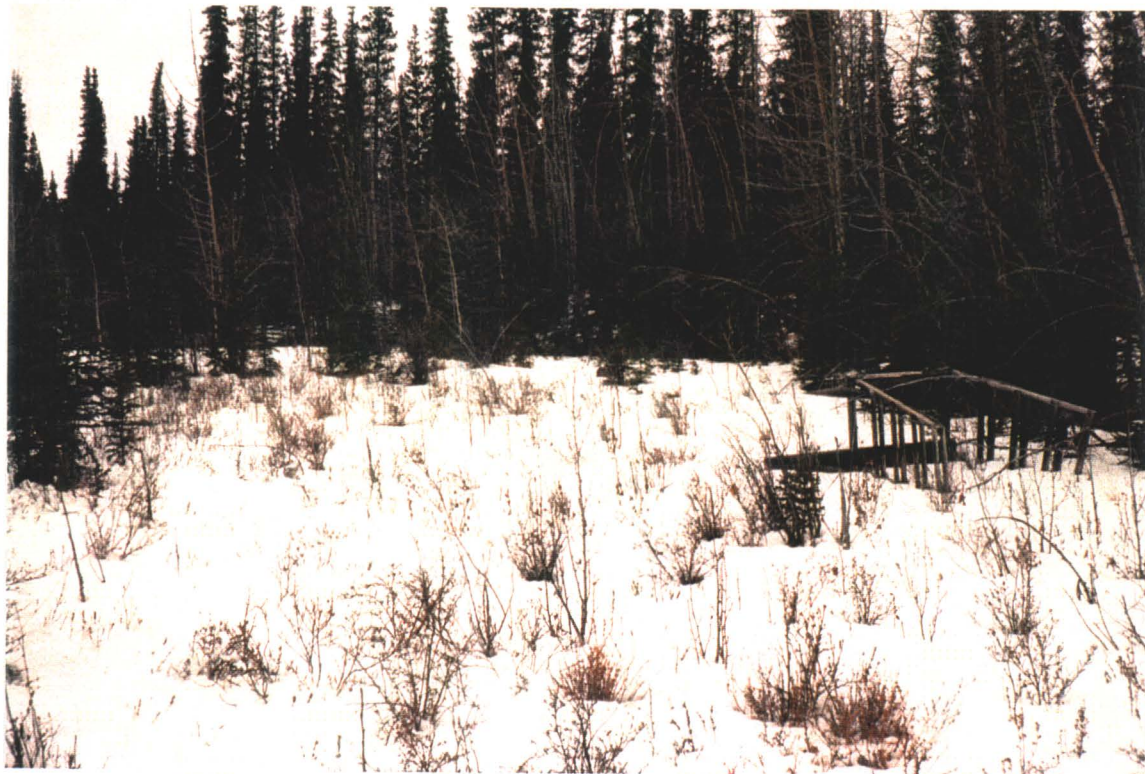
Photograph 12. Former Building Site, Canol Pump Station G, MP 1166. October 1996.

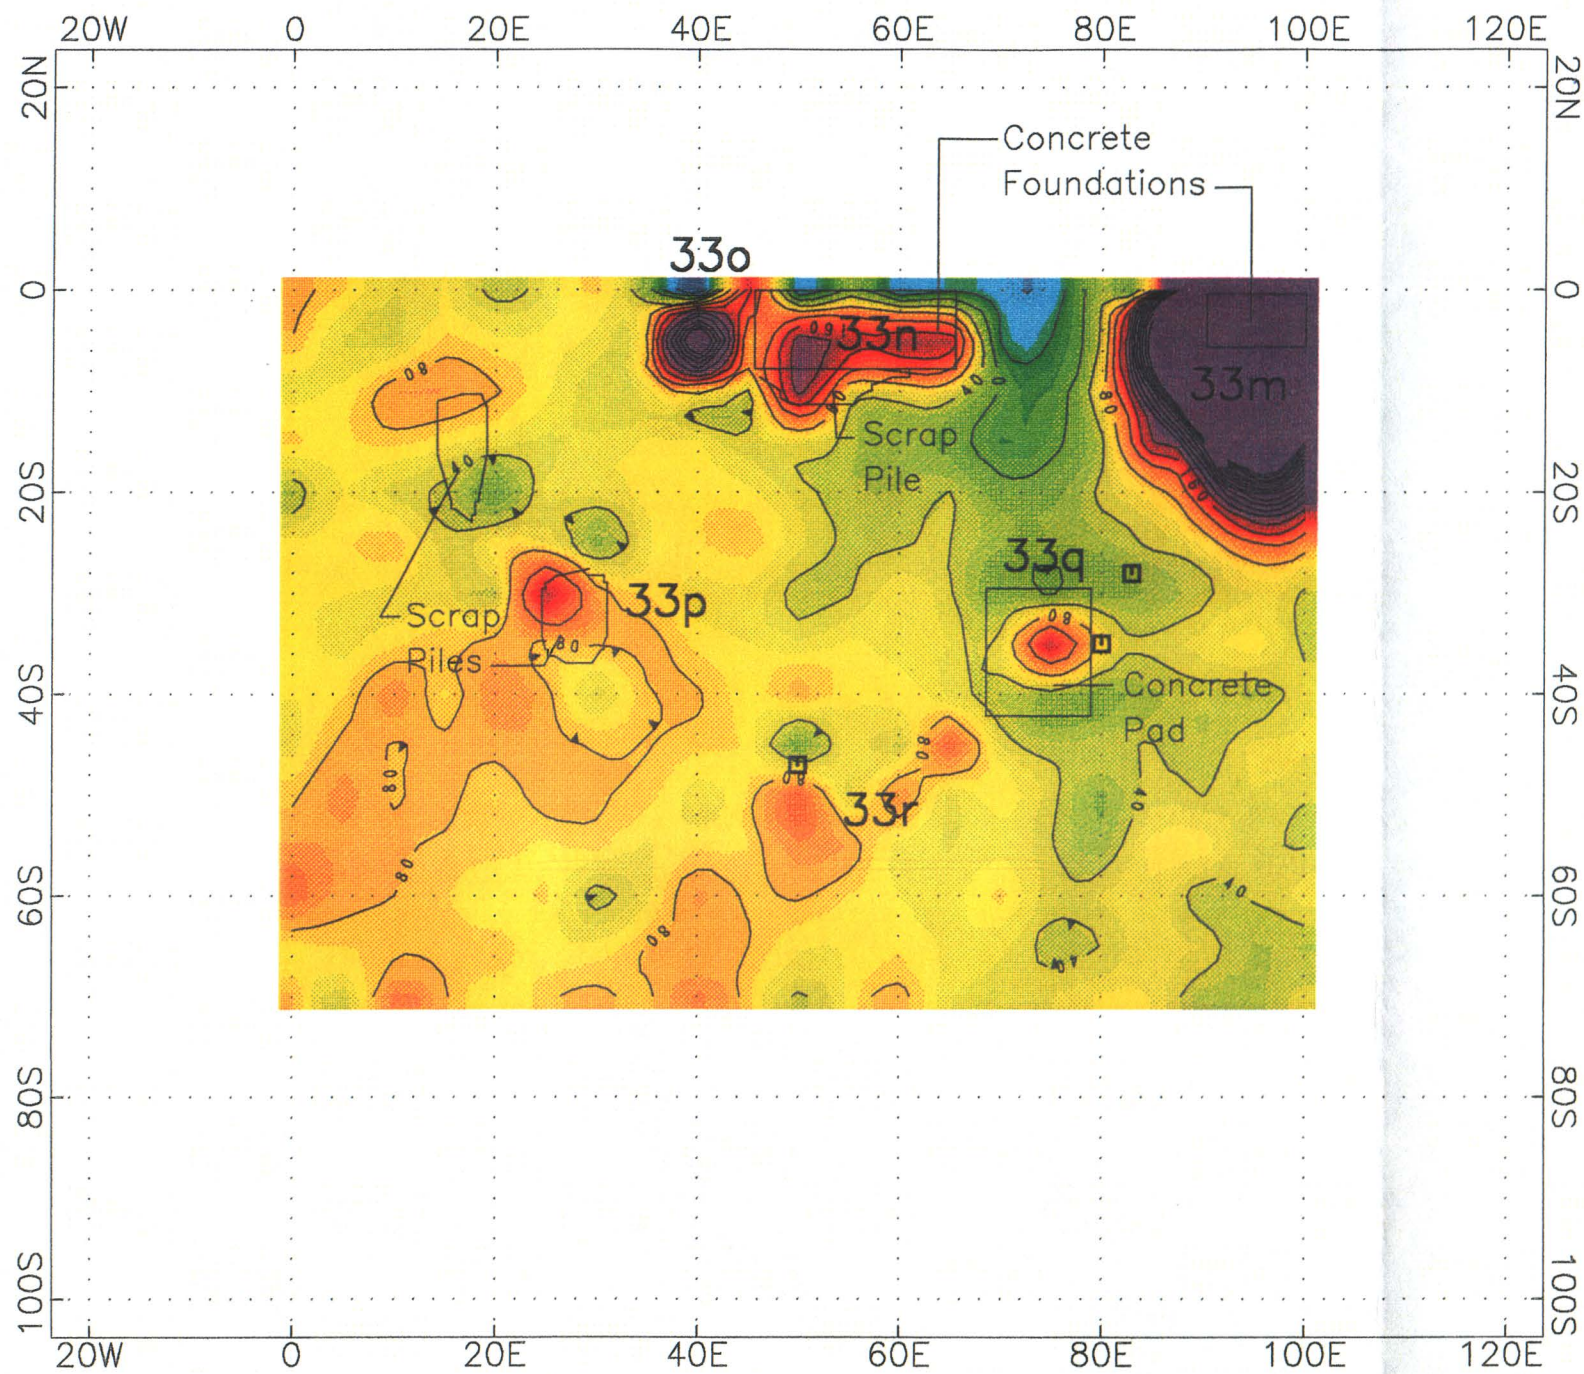
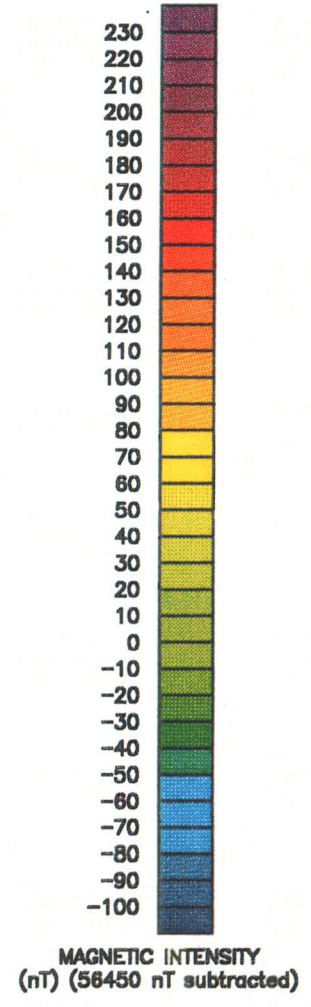
HYCAL ENVIRONMENTAL SCIENCES LTD
 PRELIMINARY ENVIRONMENTAL INVESTIGATIONS
 CONTRACT 96-6136
 CANOL PUMP STATION G, MP 1166
 TOTAL FIELD MAGNETOMETER SURVEY - AREA 'C'
 November, 1996 - Figure 15
 ASSOCIATED MINING CONSULTANTS LTD - PG93

location of the foundations of pre-existing buildings. Only small quantities of buried metal are, therefore, indicated.

Magnetometer Results	
Anomaly	Description
Area "C":	
33m, 33n & 33o	anomalies are the response to remaining pump station infrastructure
33p	coincident with existing scrap pile, evidence that buried metal extends west in this region
33q	anomalous response attributed to pipe on ground surface
Line 33G	slight variations correspond with the location of the foundations of pre-existing buildings

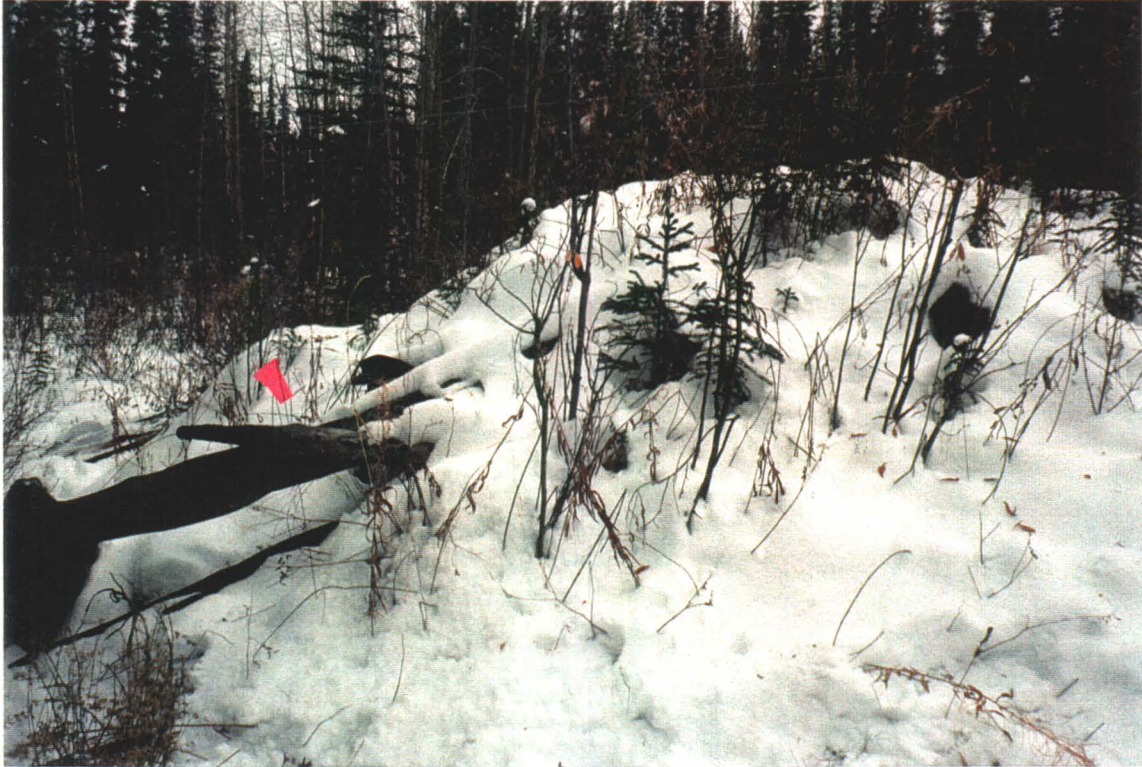
Photograph 15. Debris Mound at Bear Flats - White River Lodge Site, MP 1166. October 1996.

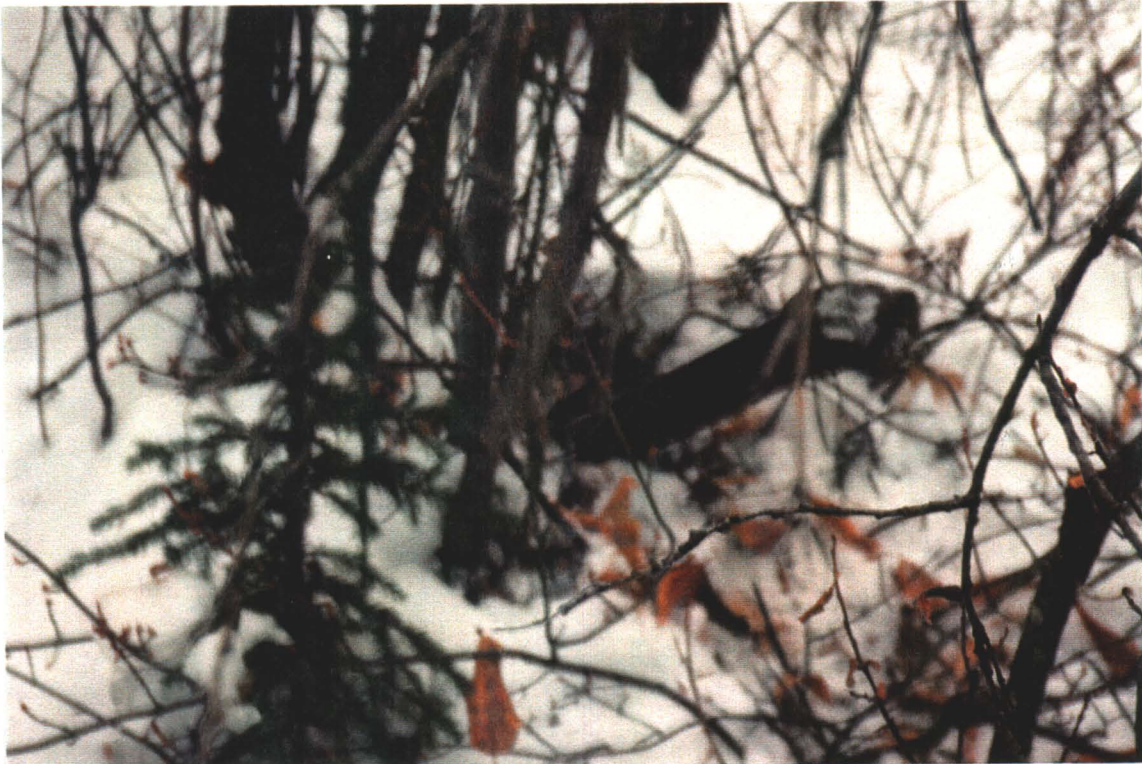
Photograph 16. Possible Tank Outlet, Bear Flats - White River Lodge Site, MP 1166. October 1996.

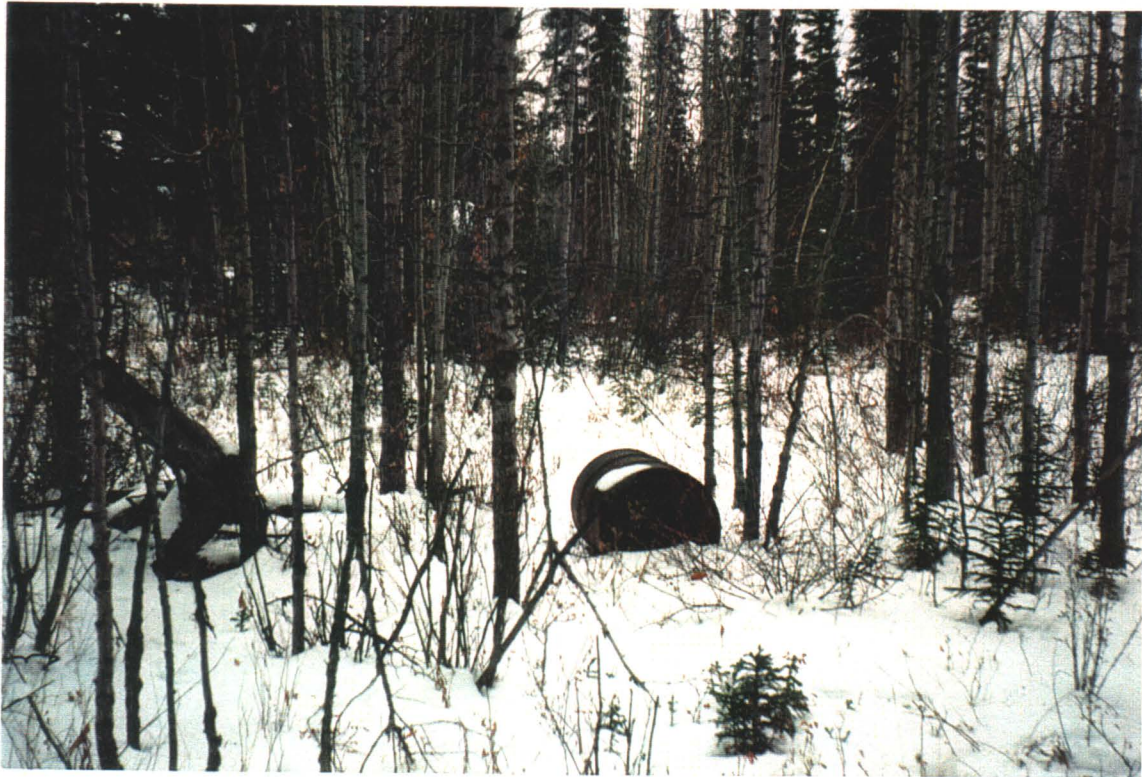
Photograph 17. Discarded Barrel, Bear Flats - White River Lodge Site, MP 1166. October 1996.

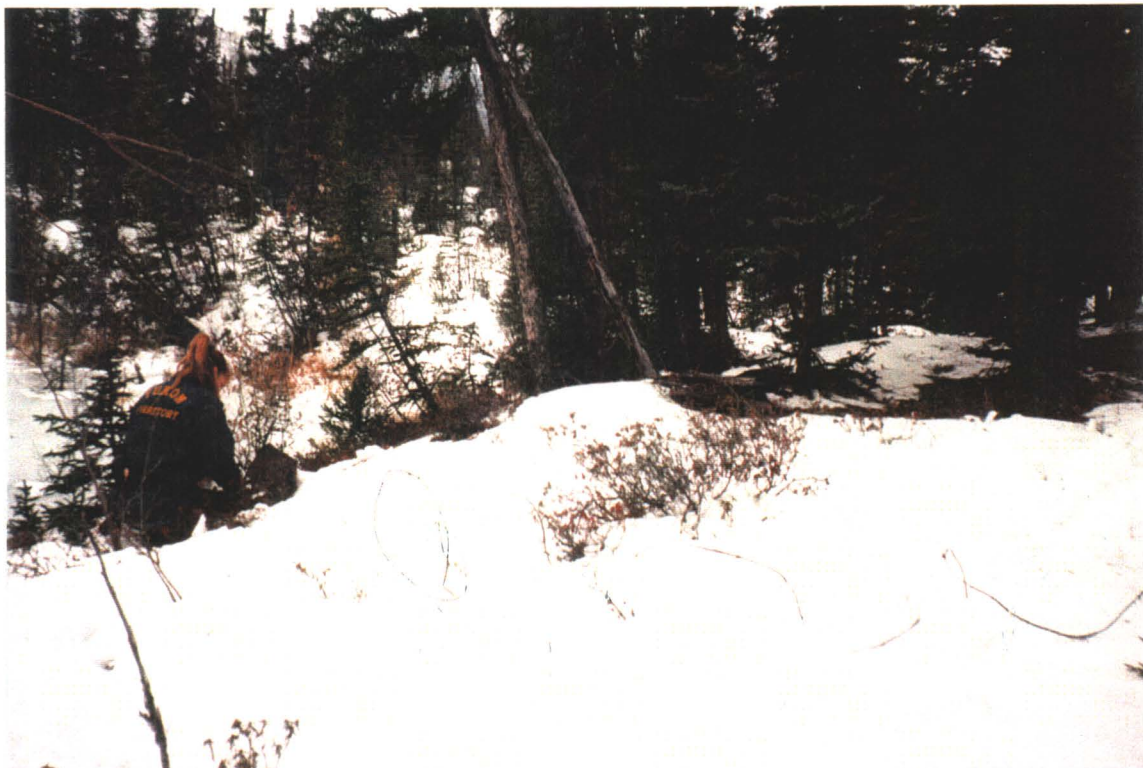
Photograph 18. Barbed Wire Fencing On Top of Mound, Bear Flats - White River Lodge Site, MP 1166. October 1996.

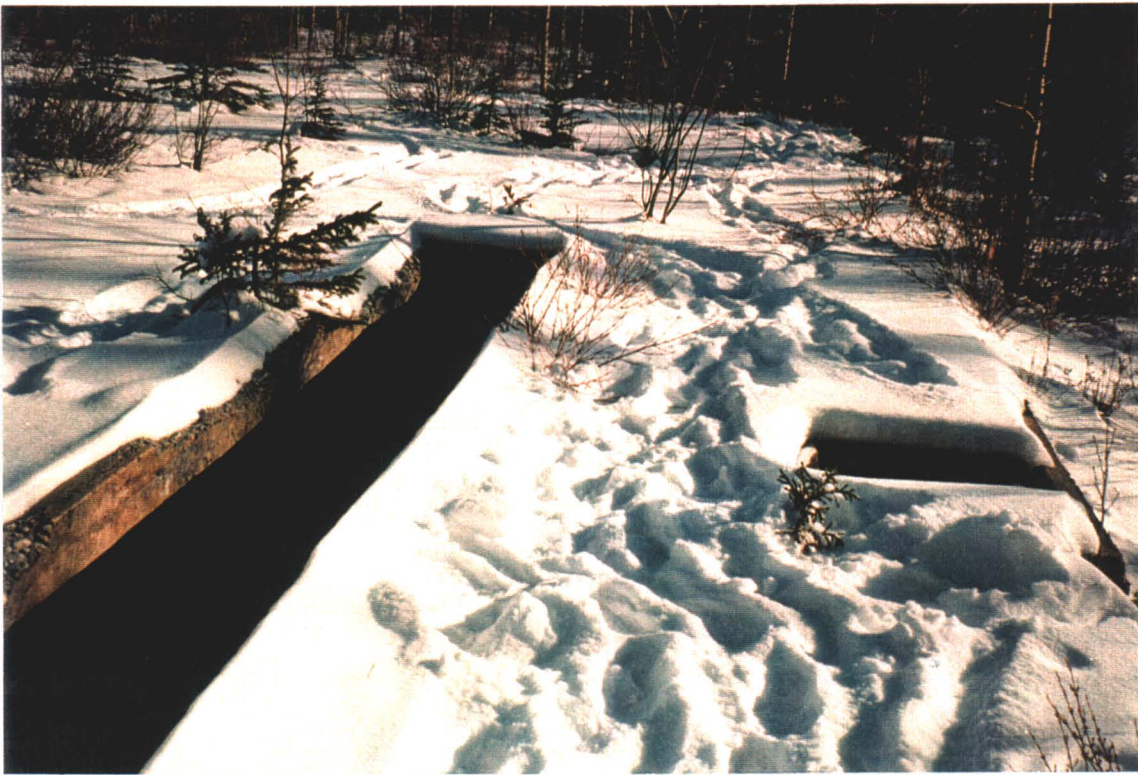
a soil sample from one of the two oil change pits at the Bear Flats - White River Lodge Site was found to contain barium, cadmium, chromium, cobalt, mercury, tin and vanadium in excess of CCME Assessment Criteria, but below CCME Remediation Criteria. The levels of arsenic, copper, lead, nickel, selenium and zinc in this sample were above CCME Remediation criteria. Hydrocarbons in this sample exceeded the Alberta Tier 1 Criterium for hydrocarbons. No PCBs were detected in the sample.

Photograph 19. Oil Change Pit and Sump, Bear Flats - White River Lodge, MP 1167.5. October 1996.

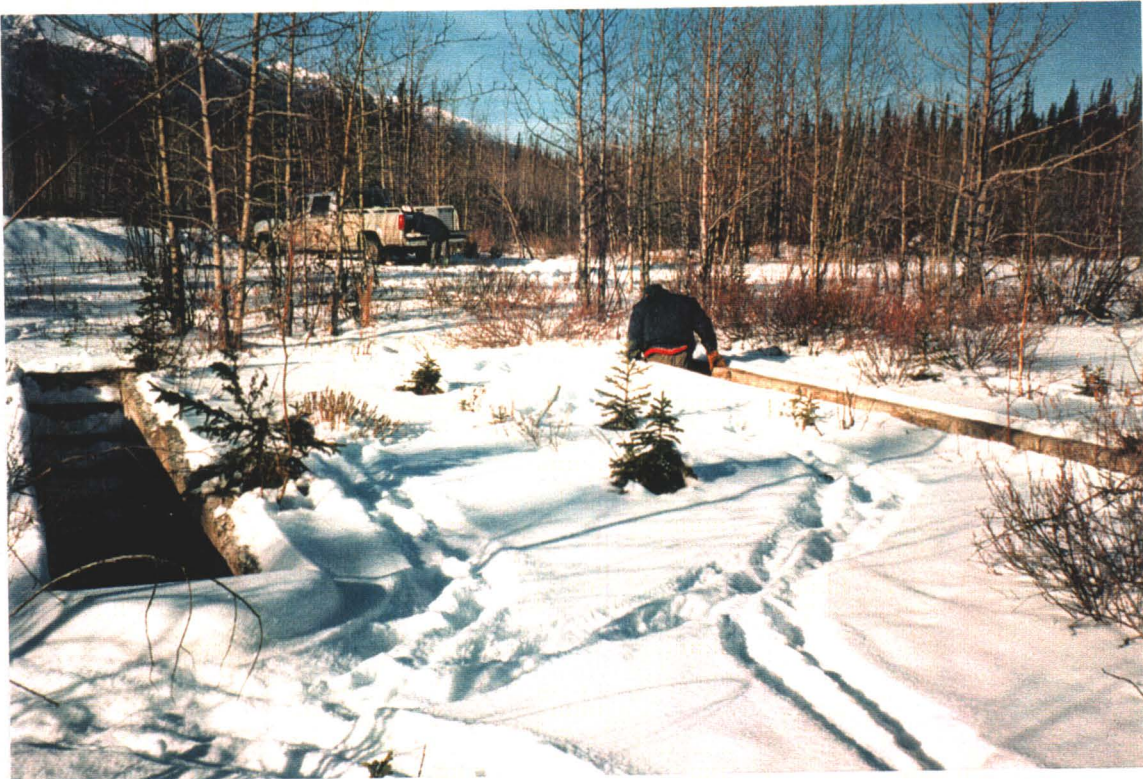
Photograph 20. Oil Change Pits, Bear Flats - White River Lodge, MP 1167.5. October 1996.

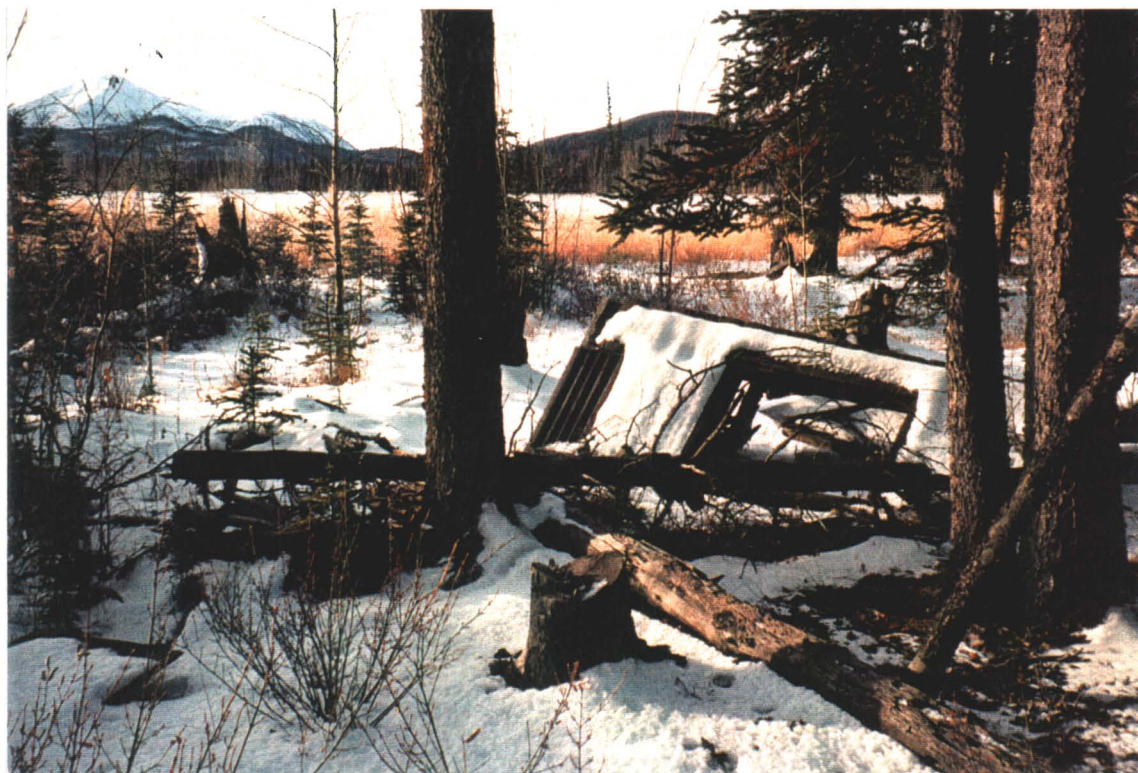
Photograph 21. Building Debris on Northern Side of the Alaska Highway, Bear Flats - White River Site. October 1996.

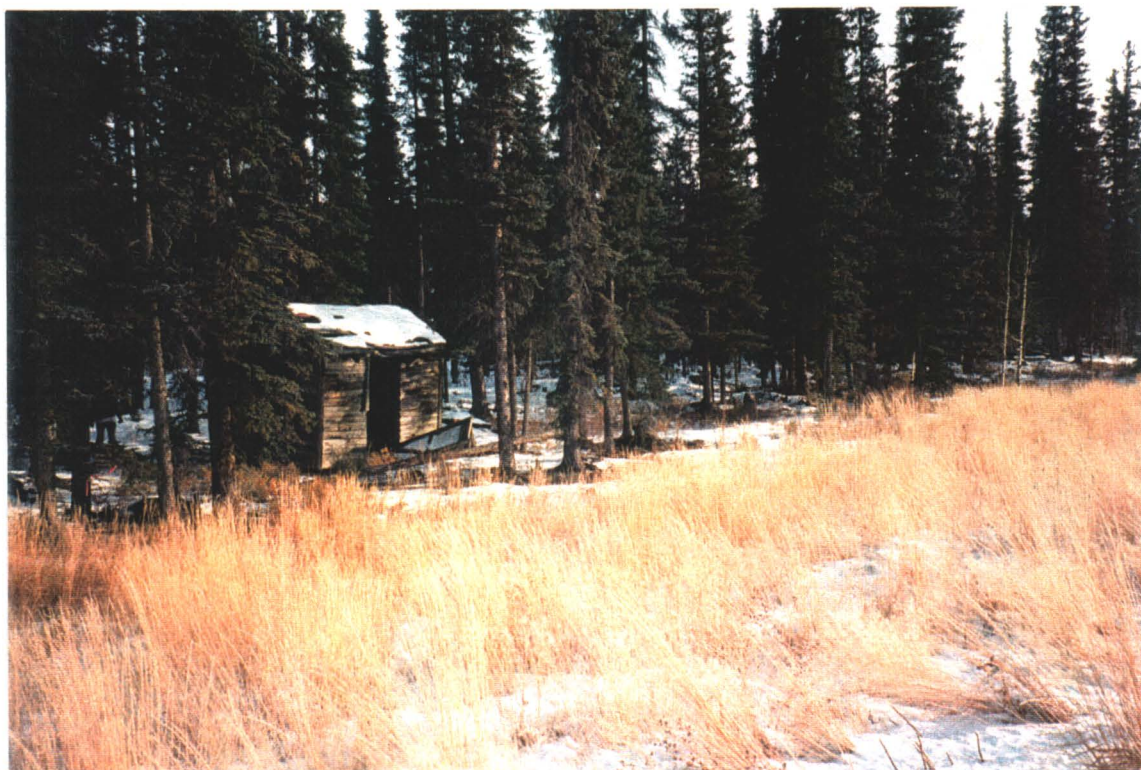
Photograph 22. Abandoned Building on Northern Side of the Alaska Highway, Bear Flats - White River Site. October 1996.

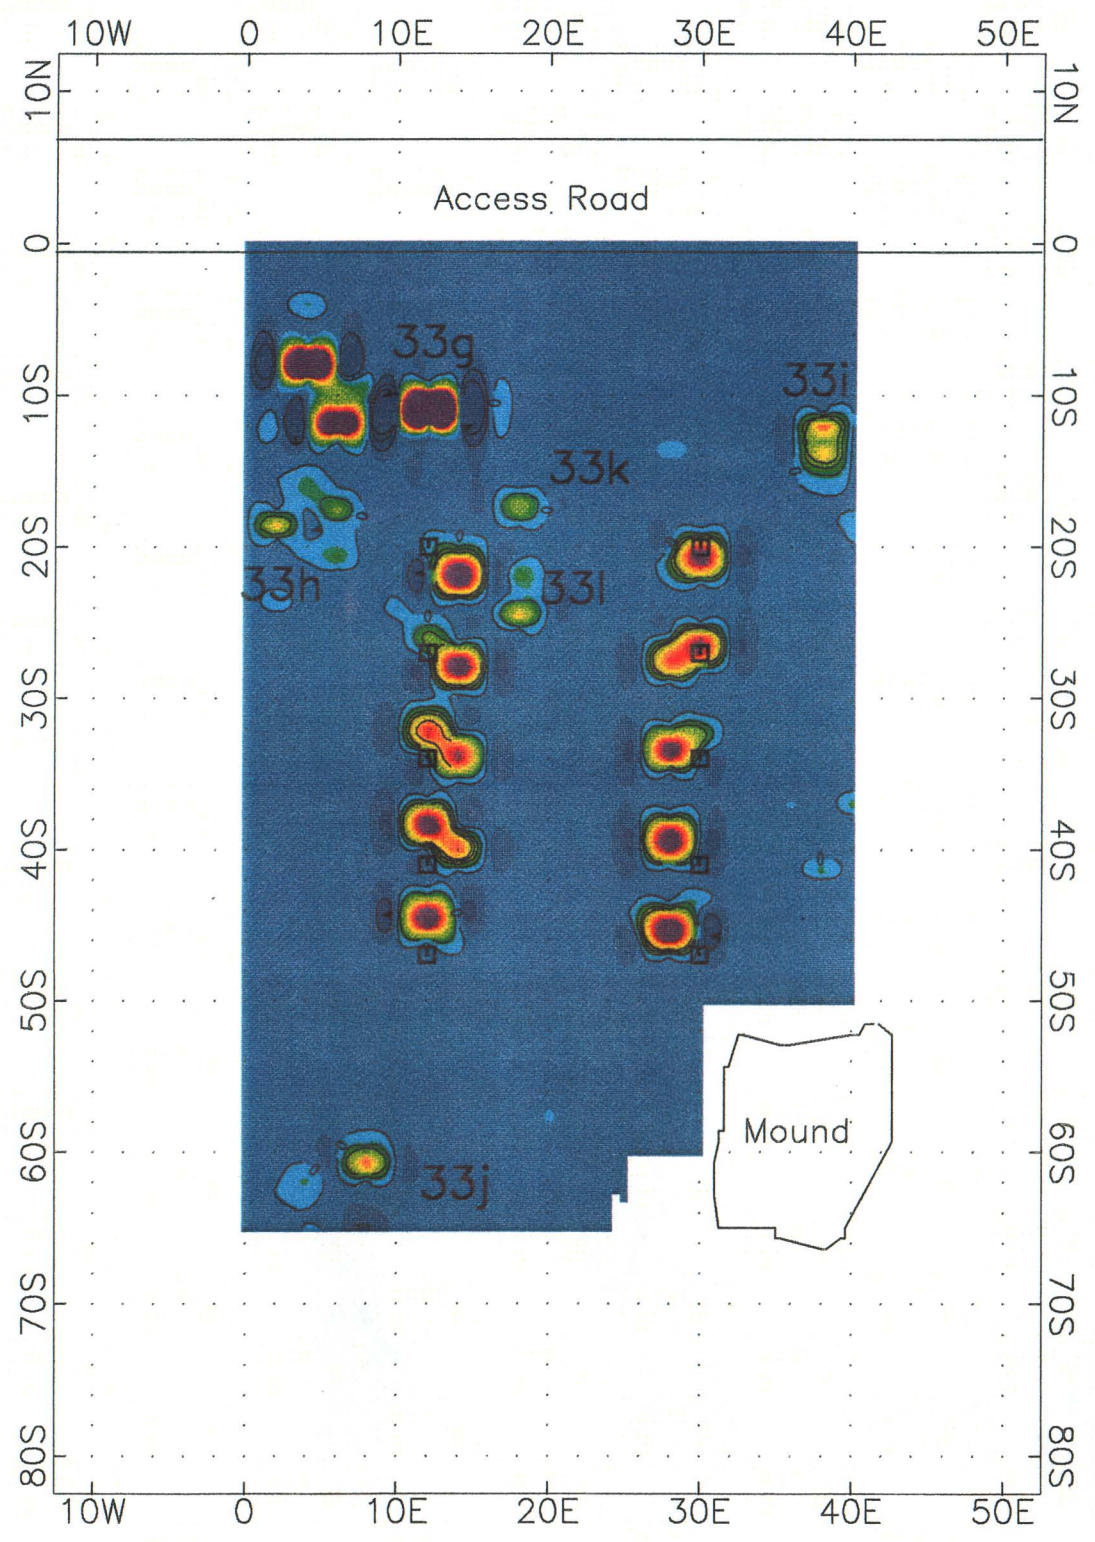
HYCAL ENVIRONMENTAL SCIENCES LTD
 PRELIMINARY ENVIRONMENTAL INVESTIGATIONS
 CONTRACT 96-6136
 BEAR FLATS - WHITE RIVER, MP1167
 EM61 SURVEY - Channel 2 - AREA 'B'
 November, 1996 - Figure 23
 ASSOCIATED MINING CONSULTANTS LTD - PG93

EM61 Survey Results	
Area "B"	Anomaly 33g is attributed to surface metal. Anomalies 33h - 33l are attributed to shallow, buried metal. Other anomalies were consistent with metal panels mounted at ground surface.
