**Phase I & II Environmental
Site Assessment**

**Former Military Site
Snag - Enger Lakes
Mile Post 1189 Alaska Highway
(DIAND Site 36)**

**Arctic Environmental Strategy - Action on Waste
Indian and Northern Affairs Canada
Whitehorse, Yukon**

November 1996

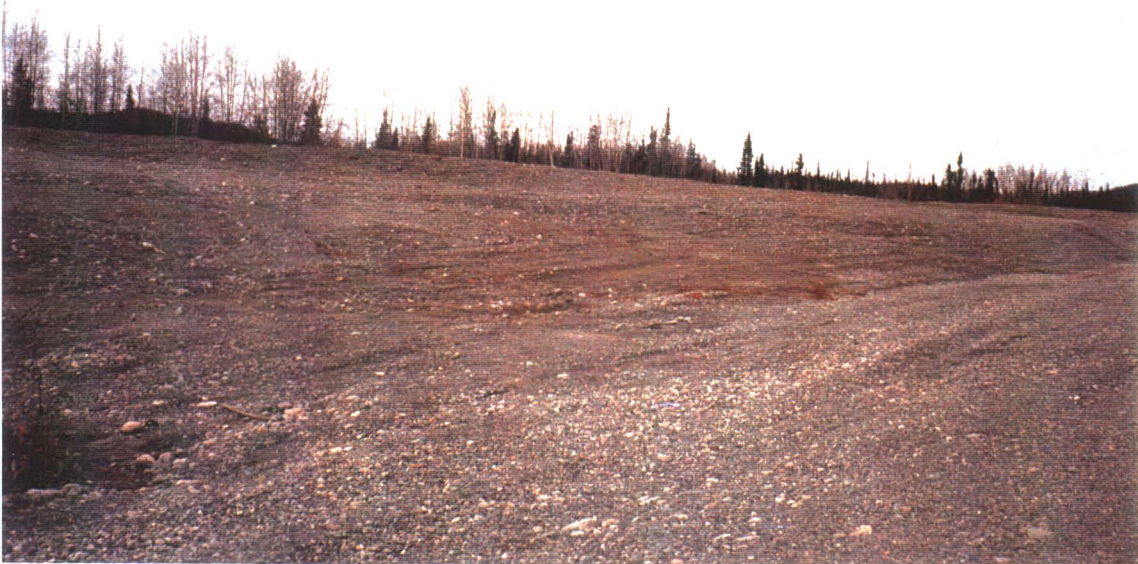
Photograph 1. View of subject site, looking westward. September 1996.
(Cover Page)

It was discovered that the clearing at MP 1189 had been covered by at least 3 metres of fill material. The area was flat and there were no surface indications of what might lie below the fill (Photograph 1). The depth of the fill precluded geophysical investigation for shallow buried metal. It also precluded the usefulness of soil sampling to indicate the presence of soil contamination associated with former dumping activities.

Given the depth of fill overlying the site, further investigation of the site would be limited and somewhat problematic. Installation of leachate monitoring wells might be used to determine whether there is any leachate associated with previous activities at the site.

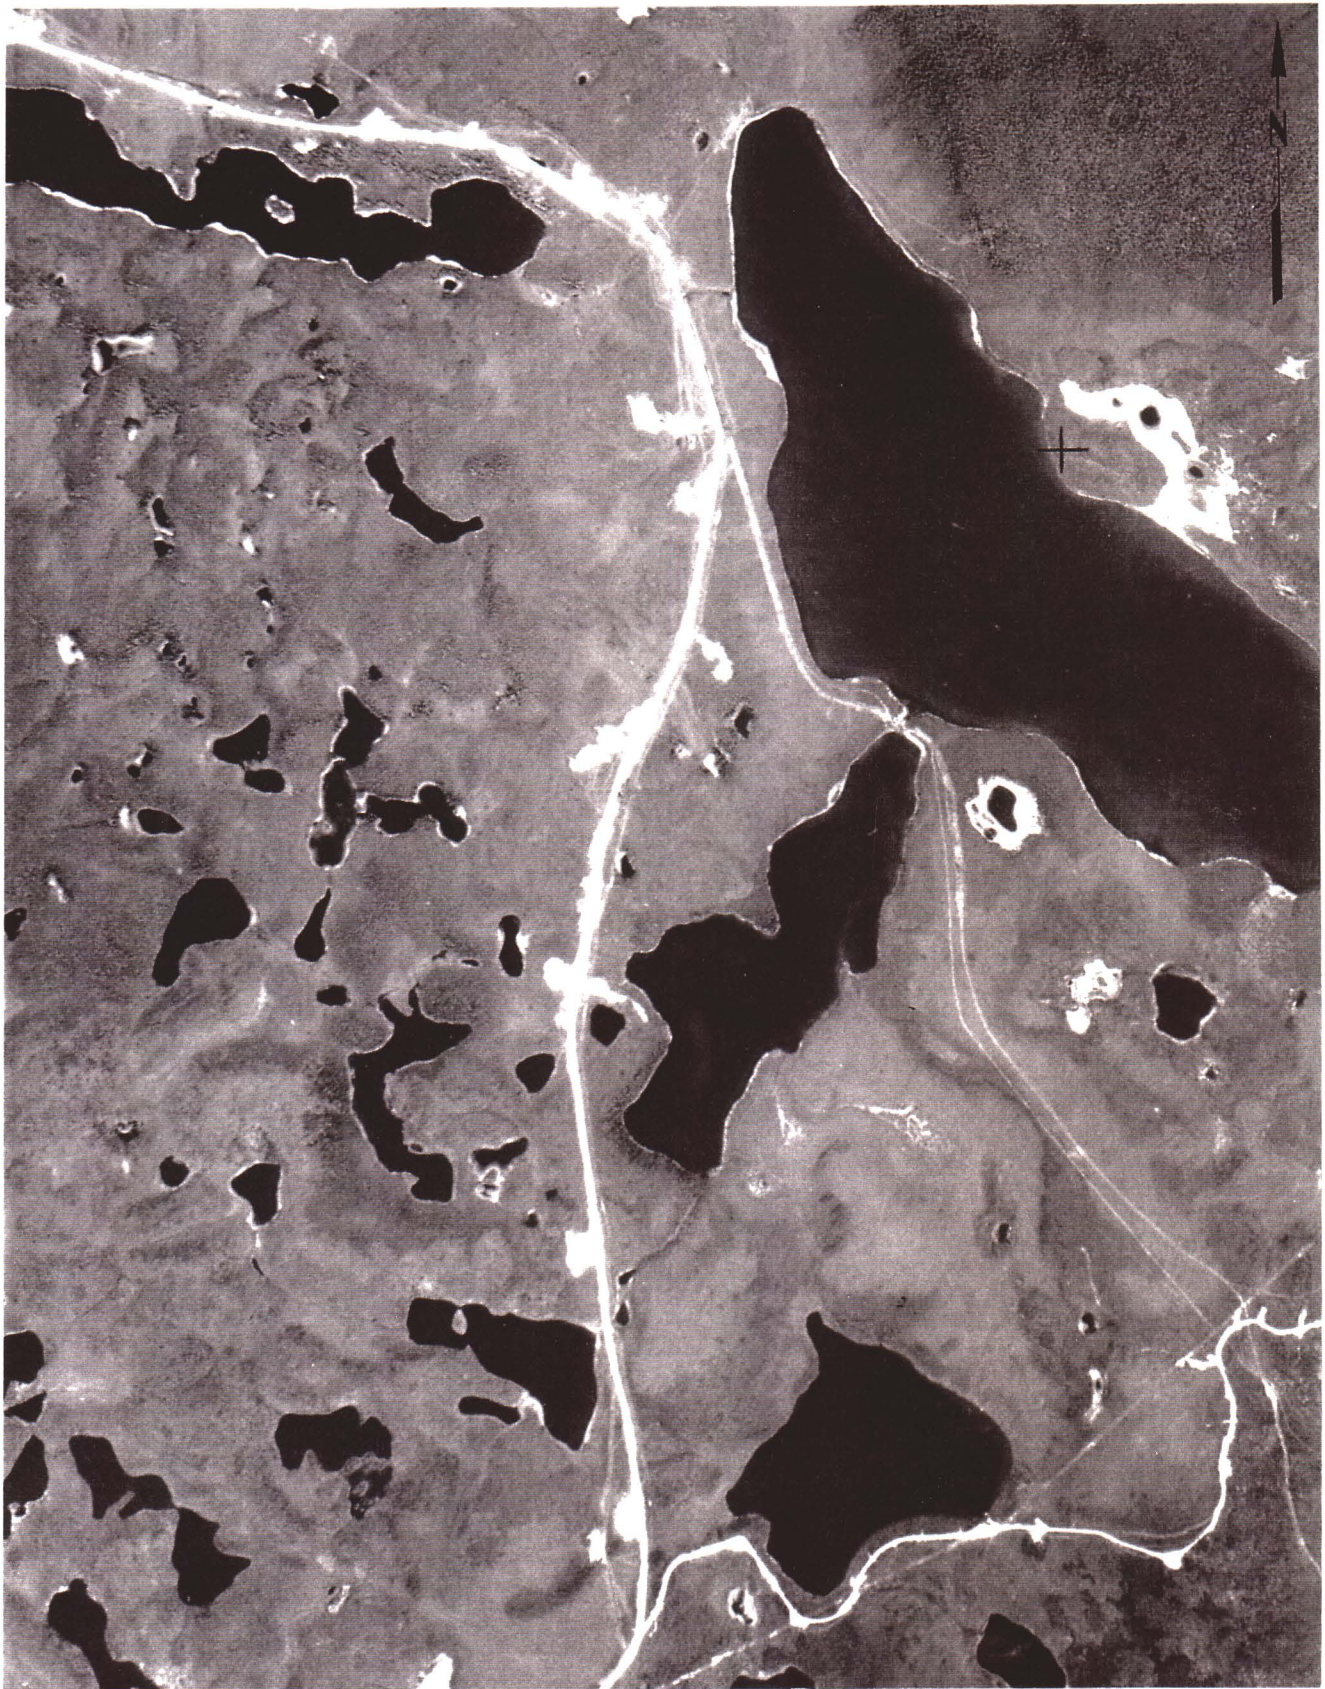
Figure 3. Aerial Photograph of Subject Site, 1948. (115 K 40 A 11452-147)

A review of aerial photographs of the area revealed a clearing in the area of MP 1189 in 1948 (Figure 3). This suggests that the subject site may have been in some sort of use (for dumping or other activities) at this time.
