REPORT NO.: 8054-20

**PRELIMINARY ENVIRONMENTAL
INVESTIGATIONS AT VARIOUS SITES
THROUGHOUT THE YUKON
SITES #3, 4, 5, and 6
Contract 96-6134-1**

Submitted to:
INDIAN and NORTHERN AFFAIRS CANADA
ARCTIC ENVIRONMENTAL STRATEGY
ACTION ON WASTE PROGRAM

NOVEMBER, 1996

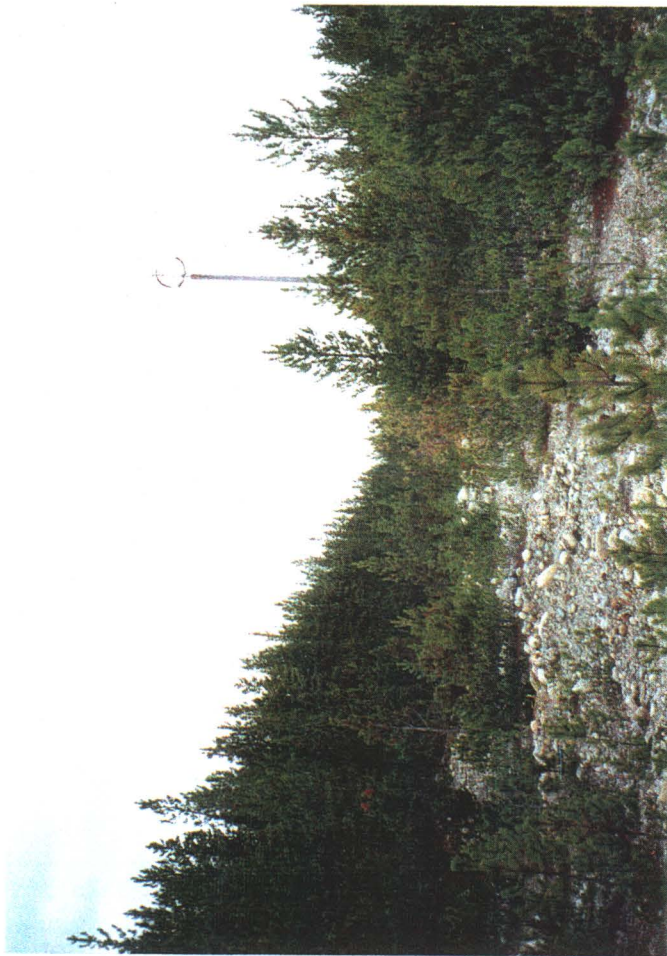
PHOTO 4

As seen on Figure 4, this area is located on the west edge and approximately 920 m north of the southern limit of the airstrip. This is the site of the old windsock and former cabin identified from historical searches. The site conditions in this area at the time of the investigation are best represented by Figure 6 and Photo 4.

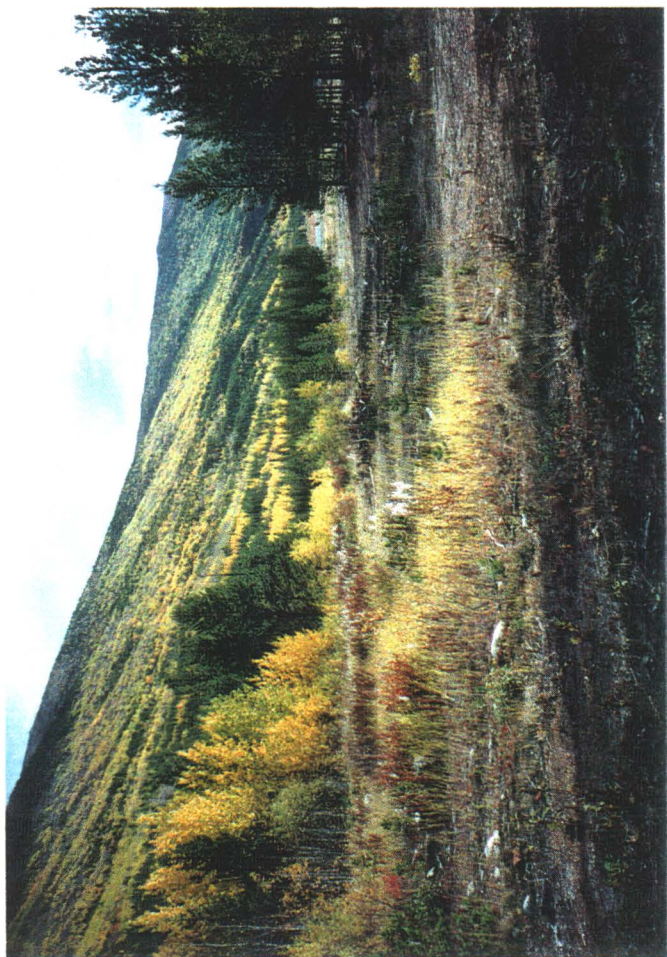
PHOTO 1

The location of the Rancheria Dump in relation to the Rancheria Lodge and Restaurant is depicted on Figure 2. The site conditions during the reconnaissance trip and the subsequent test pitting programs essentially reflect those detailed on Figure 3 and on Photo 1.

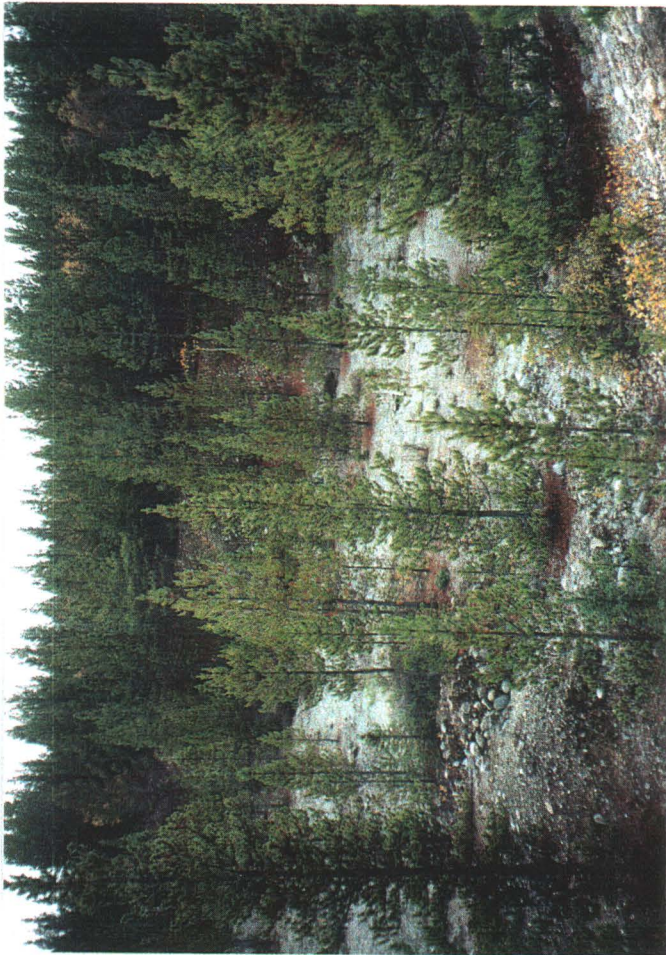
PHOTO 9

As depicted on Figure 4, this area is located on the west side of the access road approximately 60 metres south of the southern edge of the airstrip. The subject site was located relative to existing survey posts as identified on the overall plan of area P4 shown on Figure 8. The site conditions at the time of the investigation essentially reflect the details on the site sketch enclosed as Figure 8 and the picture presented as Photo 9 in Figure 12.

The area occurs within a depression which has most likely derived from gravel borrow activities in the past. This was intimated from the clearing noted on the air photo of 1948 and the obvious characteristics of a gravel pit such as an access road and near-vertical pit wall with little to no vegetative growth. The area of the pit floor was flat and sparsely vegetated with semi-mature pine trees.

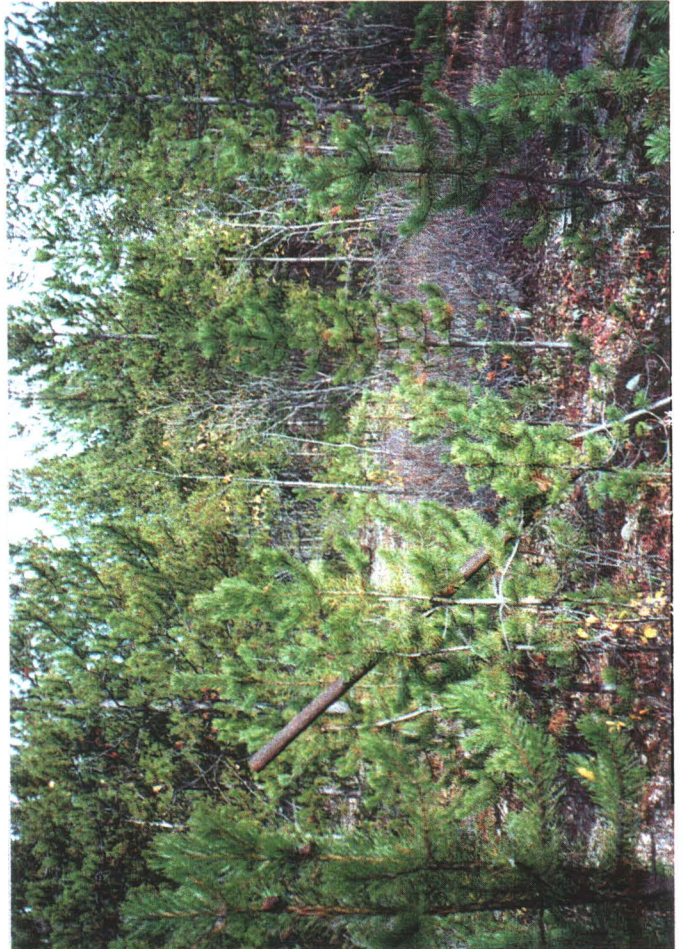
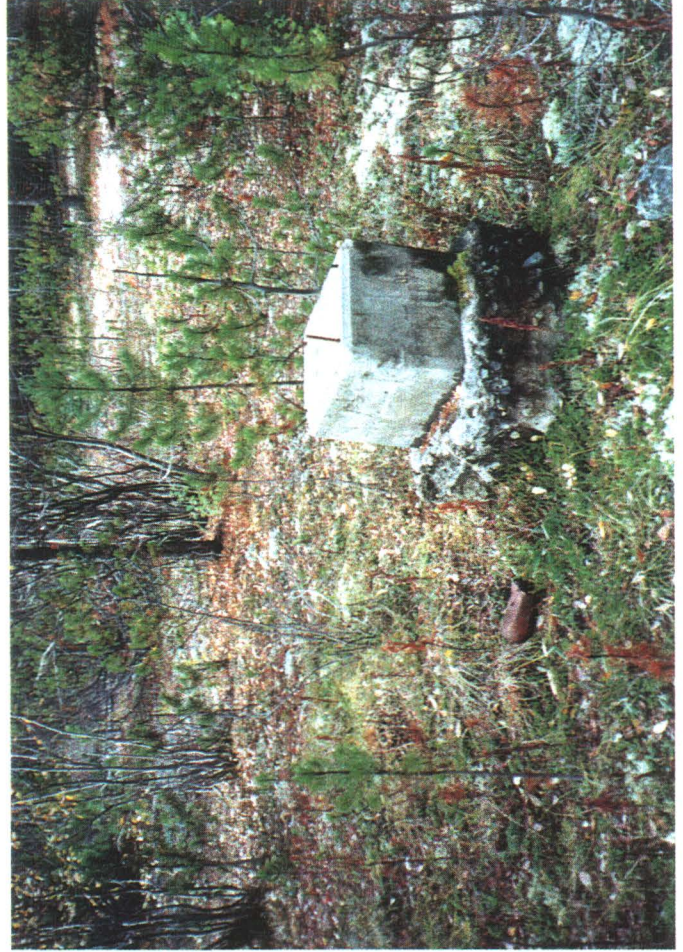
Sub-area P3 refers to the area surrounding the beacon tower and the former powerhouse located on the west side and approximately 1140 metres north of the south edge of the airstrip. The test area and general site conditions are depicted on Figure 7 and on Photos 11 and 12.

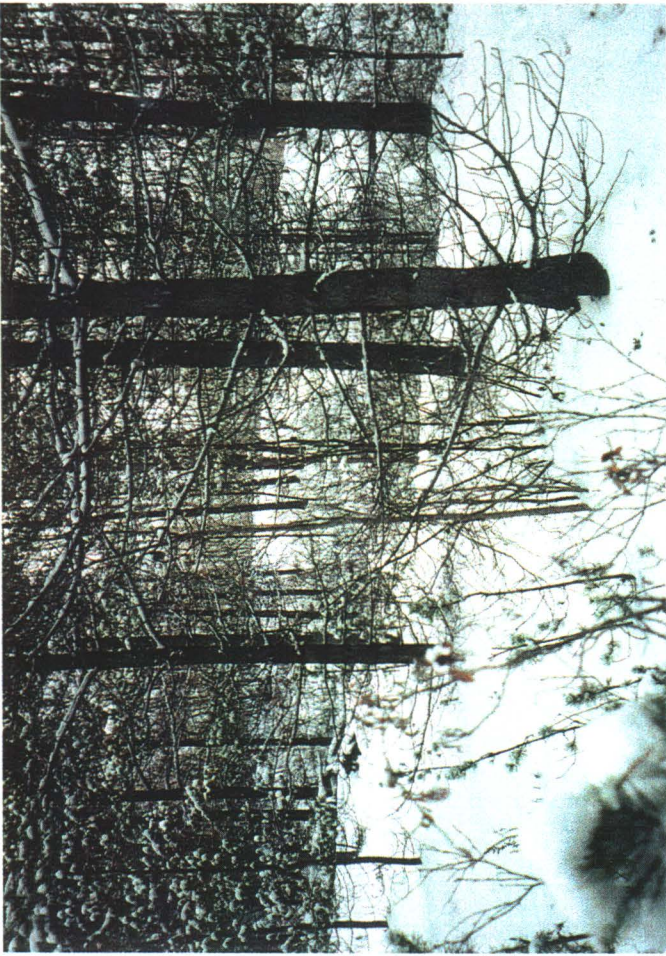
PHOTO 14

13	-Site #5, Camp 10.5 E -looking west from Alaska Hwy at clearing where former Camp 10.5 E was situated; note young grass vegetation recently seeded
14	-Site #5, Camp 10.5E, Sub-area C3 -looking south-east at depression where TP#C3-b was excavated
15	-Site #5, Camp 10.5E, Sub area C3 -looking south-west at small clearing where old tires located
16	-Site #6, Swift River Crossing -looking west at area of clearing adjacent to Swift River and Alaska Hwy
