**PRELIMINARY INVESTIGATIONS AT
THREE SITES IN YUKON
(SITES BC102, HJ044, MA026)**

**Prepared for:
DEPARTMENT OF INDIAN AFFAIRS
AND NORTHERN DEVELOPMENT**

**Prepared by:
GARTNER LEE LIMITED**

January 1997

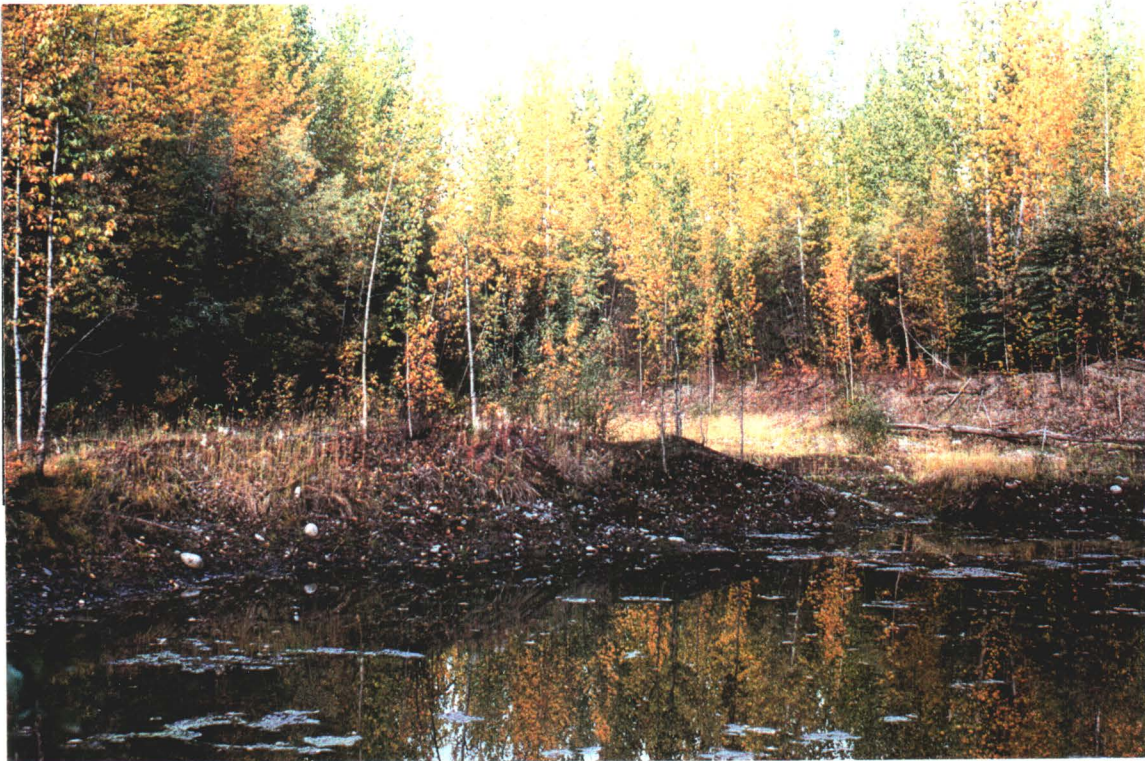
PHOTOGRAPH 3

The site is heavily overgrown with vegetation consisting of aspen, willow and alder, with only two cleared areas remaining as evidence of past site activities. Two, water-filled borrow pits are located in one of the cleared areas (Photographs 3 and 4). The second clearing is located at the terminus of the access road near the creek (Photograph 5).

The borrow pits are located to the north of the access road, near the centre of the site. They were excavated by road construction crews and the material was used on the Alaska Highway (N. Wortley, pers. comm.).

West side of borrow pit area.

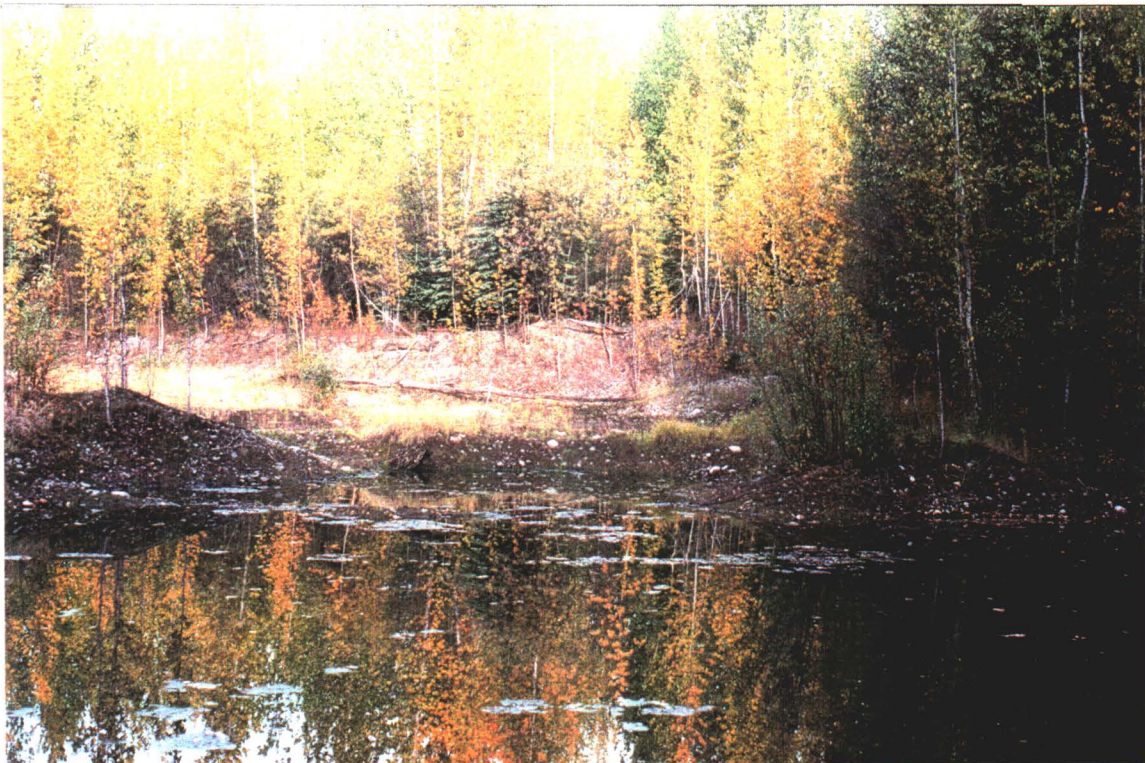
PHOTOGRAPH 4

East side of borrow pit area.

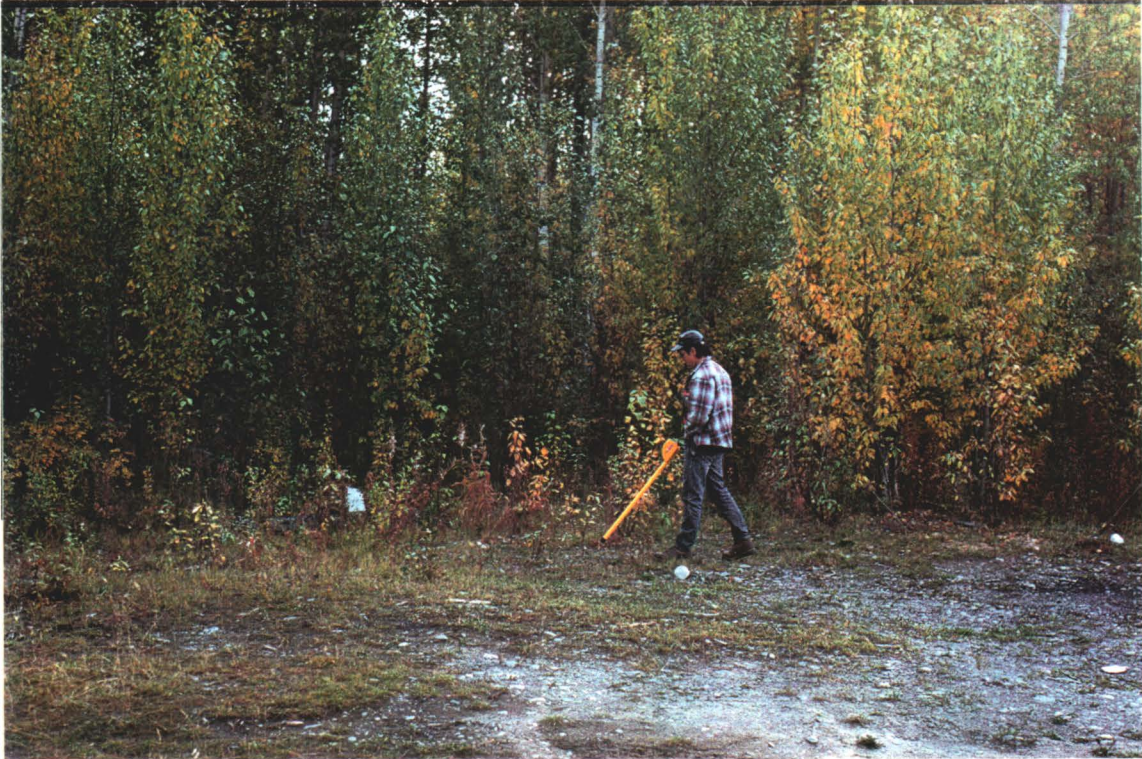
PHOTOGRAPH 5

The second clearing is believed to be the area identified on the site map provided by AES as that which contained the refuse. There were no signs of any garbage as previous recommendations in the 1976 site report suggested that the refuse be removed to the Beaver Creek landfill. This appears to have been carried out and was confirmed with the local Resource Management Officer (RMO), Mr. Neale Wortley. Further discussions with Mr. Wortley resulted in the identification of two other potential sites near Long's Creek and behind the White River Inn. The site at Long's Creek apparently has several buried drums whose contents are unknown, and the site behind the White River Inn reportedly was the location of a large oil pipeline spill.

Investigating former refuse area with metal detector.

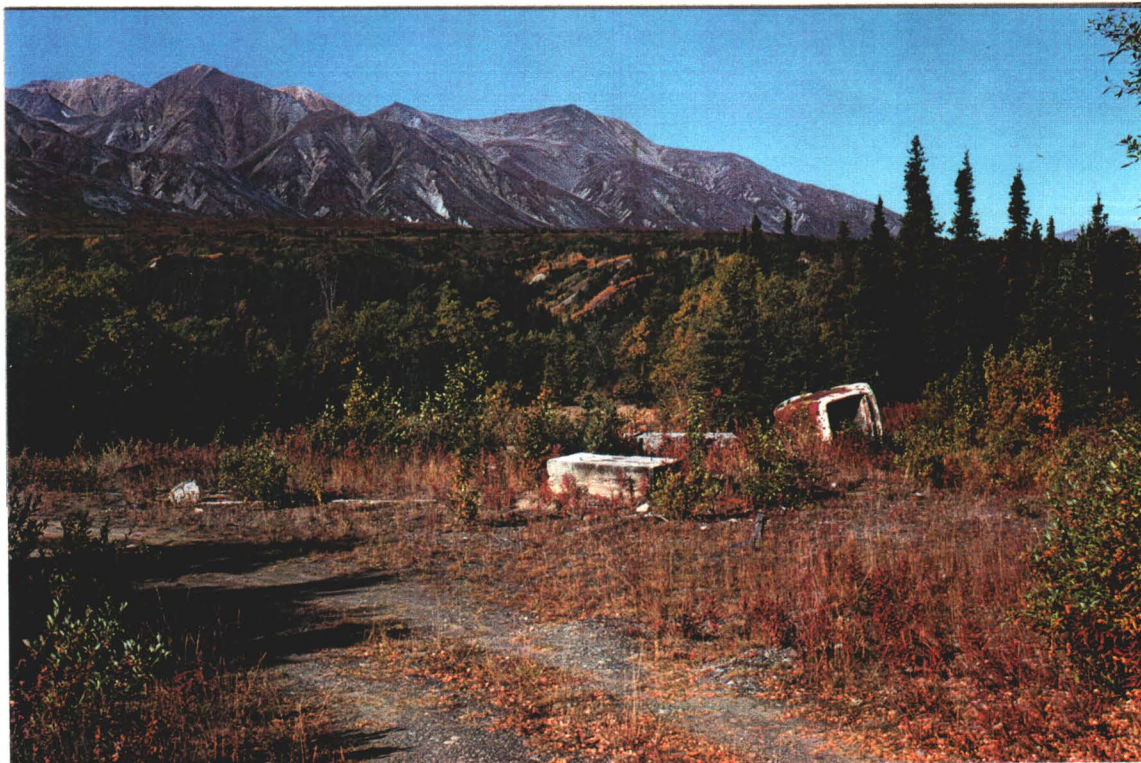
PHOTOGRAPH 8

The site looking west. Remnants of old foundation are located in centre of photograph.

The site is mostly clear of vegetation and has a sand and gravel surface (Photographs 8 and 9). Many small piles of debris (metal, wood, concrete, tires) are scattered about the site with two areas of debris also pushed over the banks of the slopes (Photographs 10 and 11). A single vehicle hulk is located within the cleared area as is the burnt remnants of a building (Photograph 12).

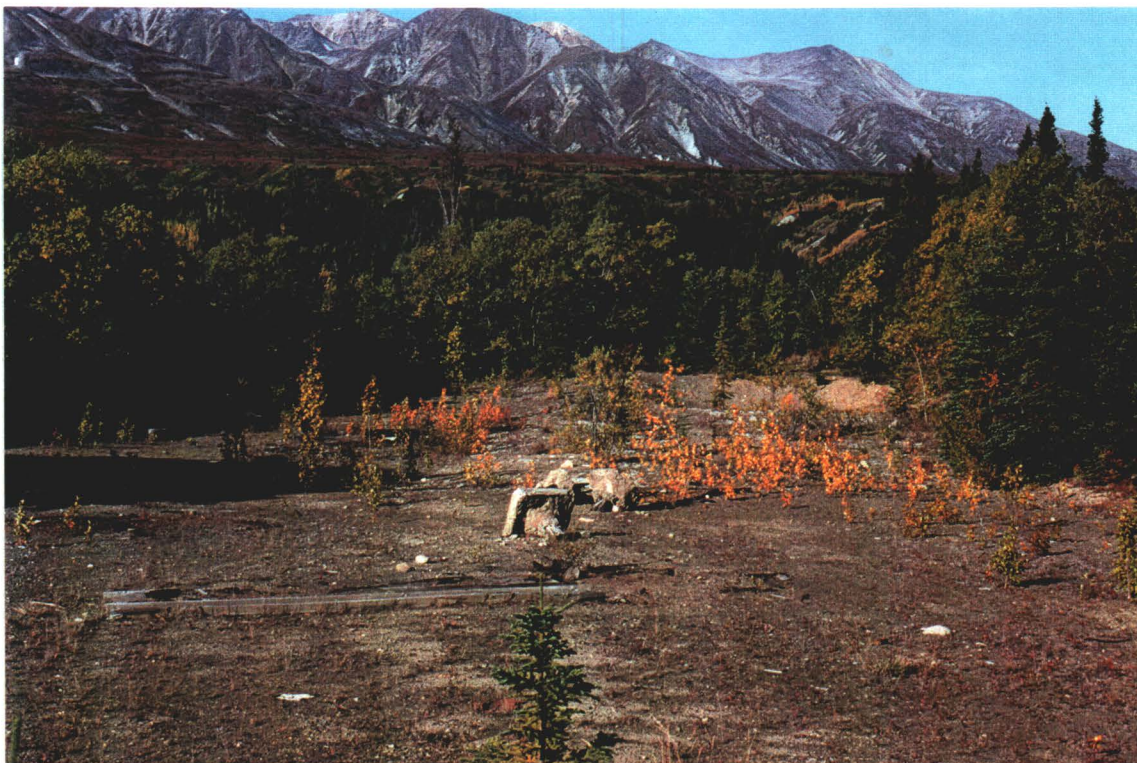
PHOTOGRAPH 9

Looking west downslope. Note pit near right centre of photograph.

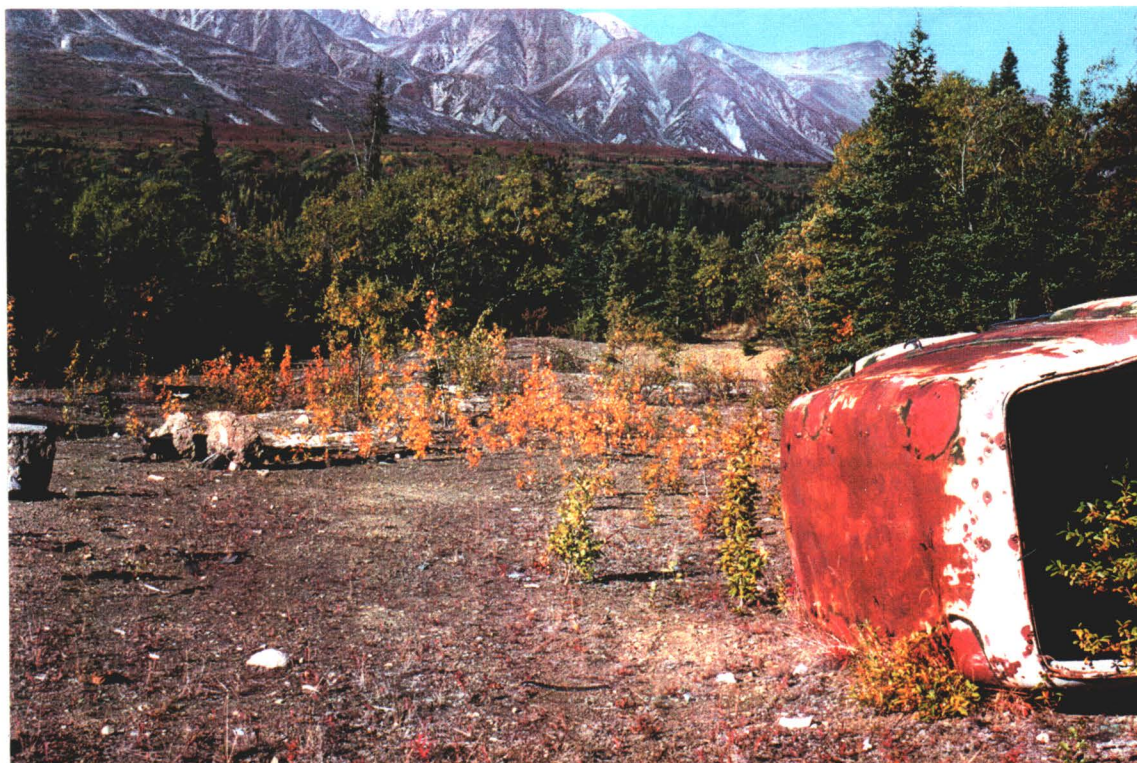
PHOTOGRAPH 10

Old vehicle hulk and concrete and wood debris. Looking west.

- a) No further environmental investigation of this site is warranted.
- b) The remaining debris should be removed or buried on site; however, burial should be initiated only after the possibility of disturbing human remains on the site is duly considered.
- c) During site clean-up, the small oil stained area should be scarified using the heavy equipment.

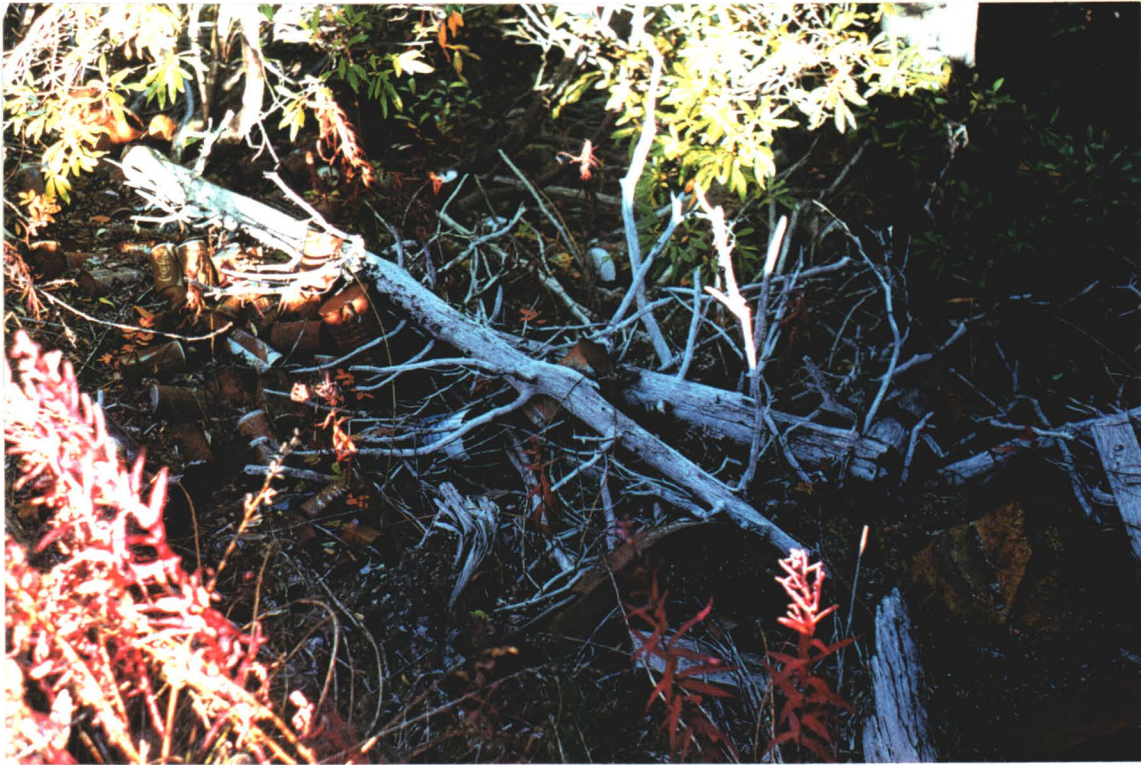
PHOTOGRAPH 11

Metal debris and cans pushed over bank along north edge of site.

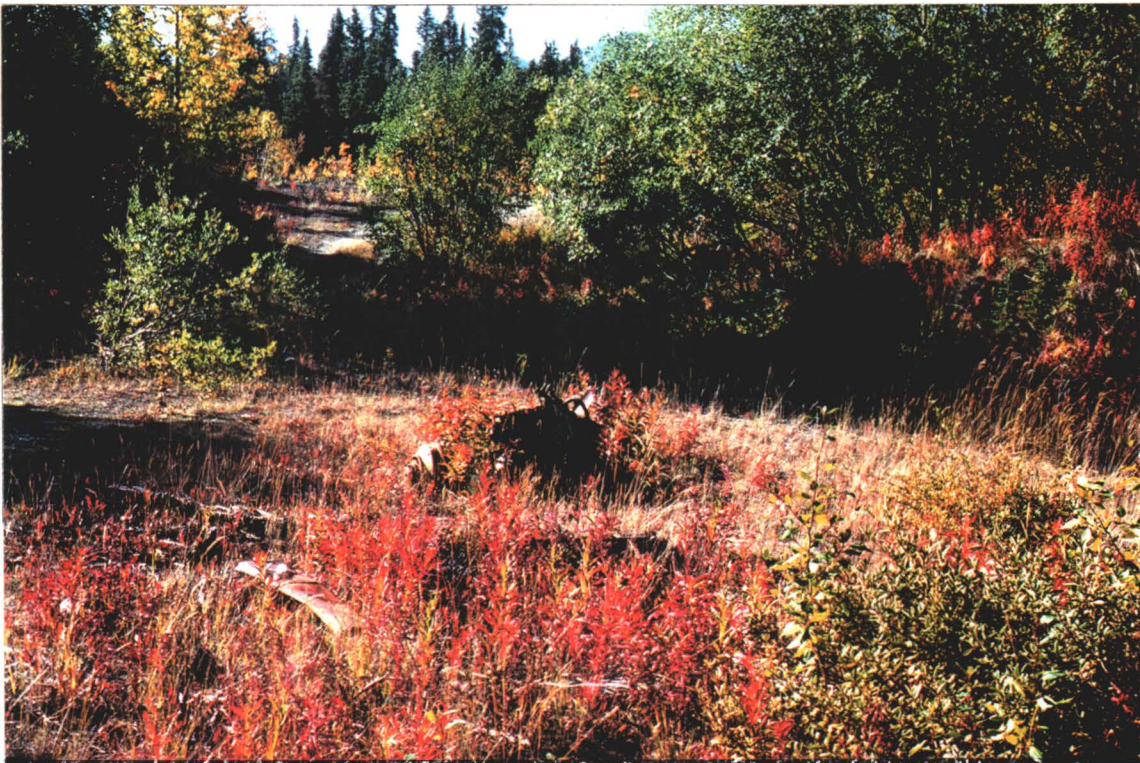
PHOTOGRAPH 12

Brush covered foundation in foreground. Note old engine in centre of photograph. Looking south.

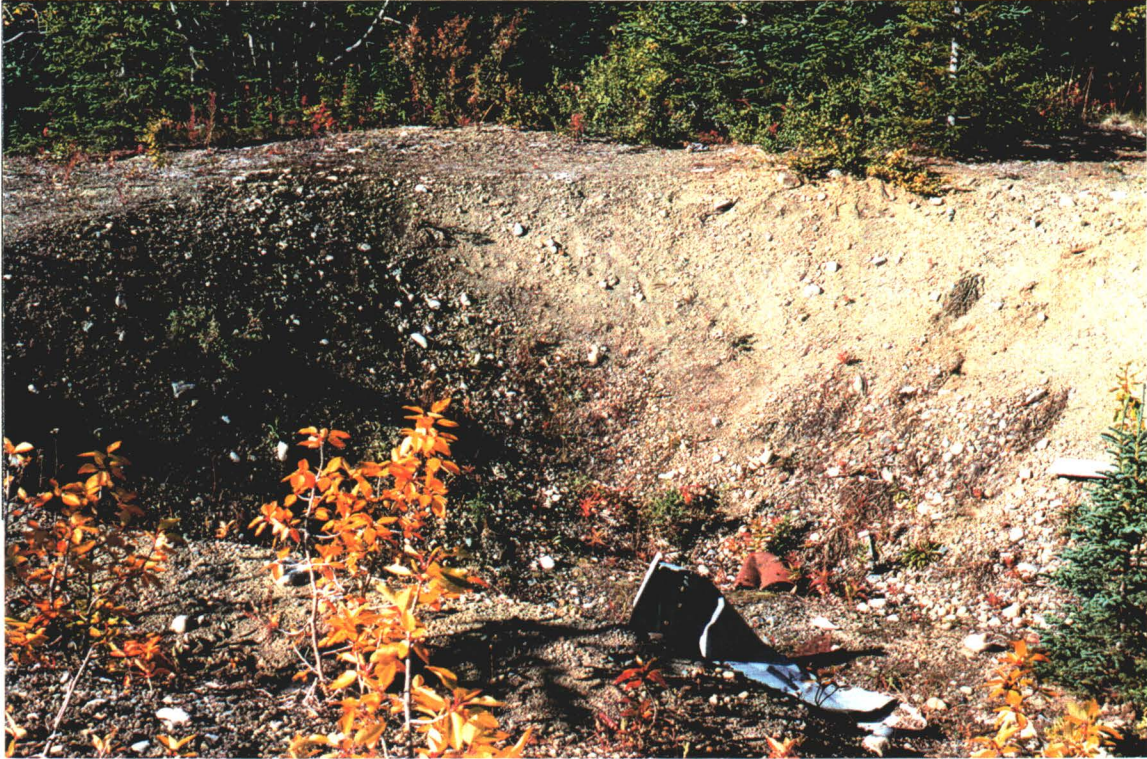
PHOTOGRAPH 13

Close-up view of pit near northwest corner of site.

A 7 m x 8 m pit containing a small amount of metal debris is located in the northwest corner of the site (Photographs 13 and 14). The origin of this pit is unknown but its isolation from the main building would suggest that it is not the site of the service station's underground storage tanks (USTs).

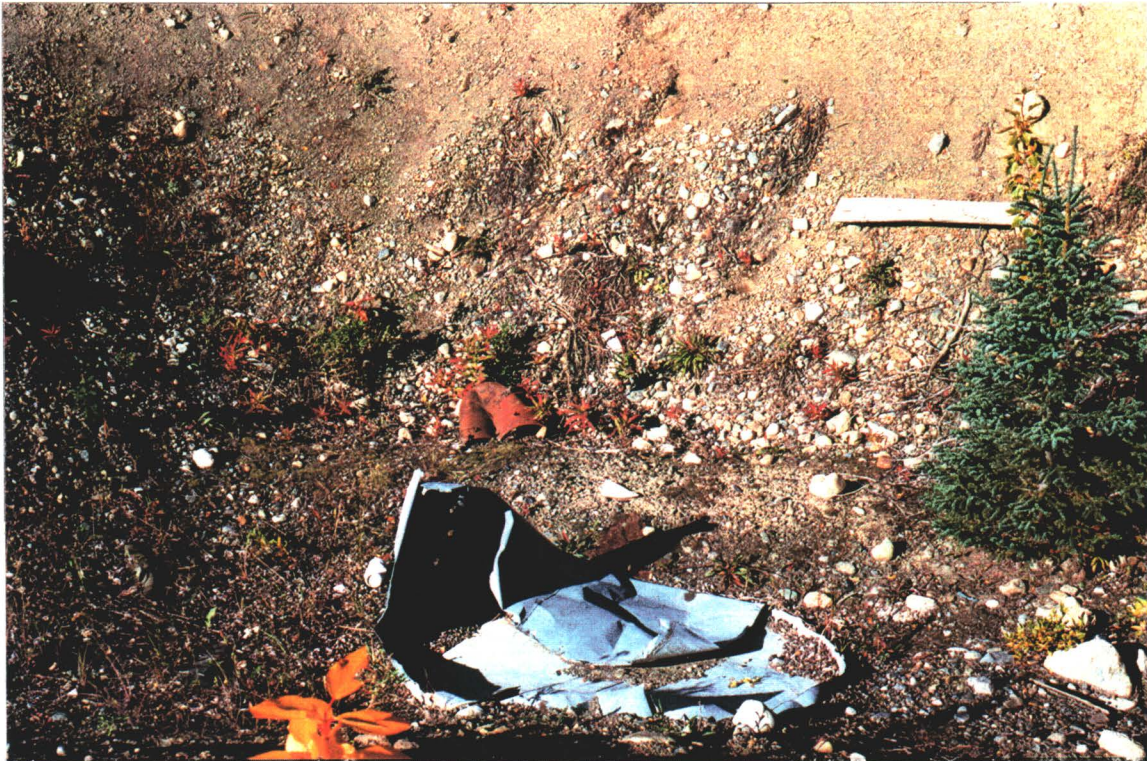
PHOTOGRAPH 14

Metal debris in base of pit. Note gravelly soils.

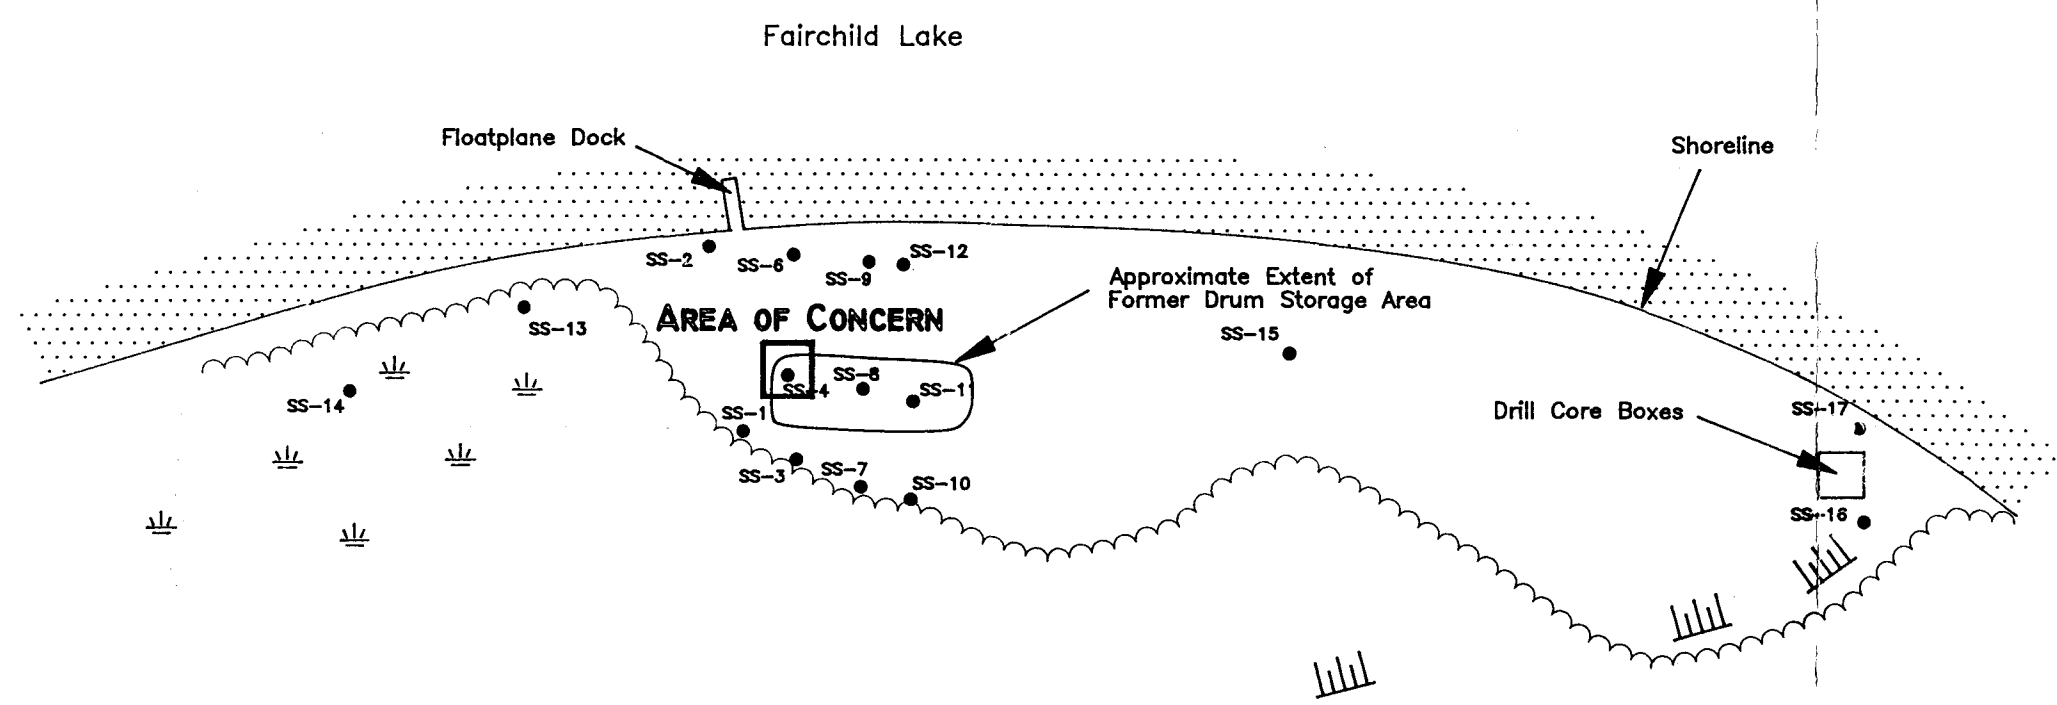
SKETCH MAP FAIRCHILD LAKE

At the north end of the site, there is a large stack of wooden drill core boxes, complete with core samples (Photographs 19 and 20), and a few small areas of wooden debris. Near the south end of the site, where the fuel drums had been located, there was an area devoid of vegetation with ground water at surface (Photographs 21 and 22). Within the unvegetated area, evidence of leaked fuel was observed as a hydrocarbon sheen on the ground water and a noticeable odour emanating from the soils (Photographs 22, 23 and 24). This area of impacted soils and ground water appeared to be limited to the area shown on the Site Plan (Figure 7) as "Area of Concern".

The results from the field screening of the soil samples indicates that a small area of residual contamination from spilled or leaked fuels exists on the site. This area is highlighted on the Site Plan. The organic vapour concentrations do not indicate that gross contamination of the shallow soils has occurred, and the absence of vegetation in the impacted area is likely attributable to the length of time that drums were stored in this area and the short rehabilitation time which has passed since their removal in 1994.

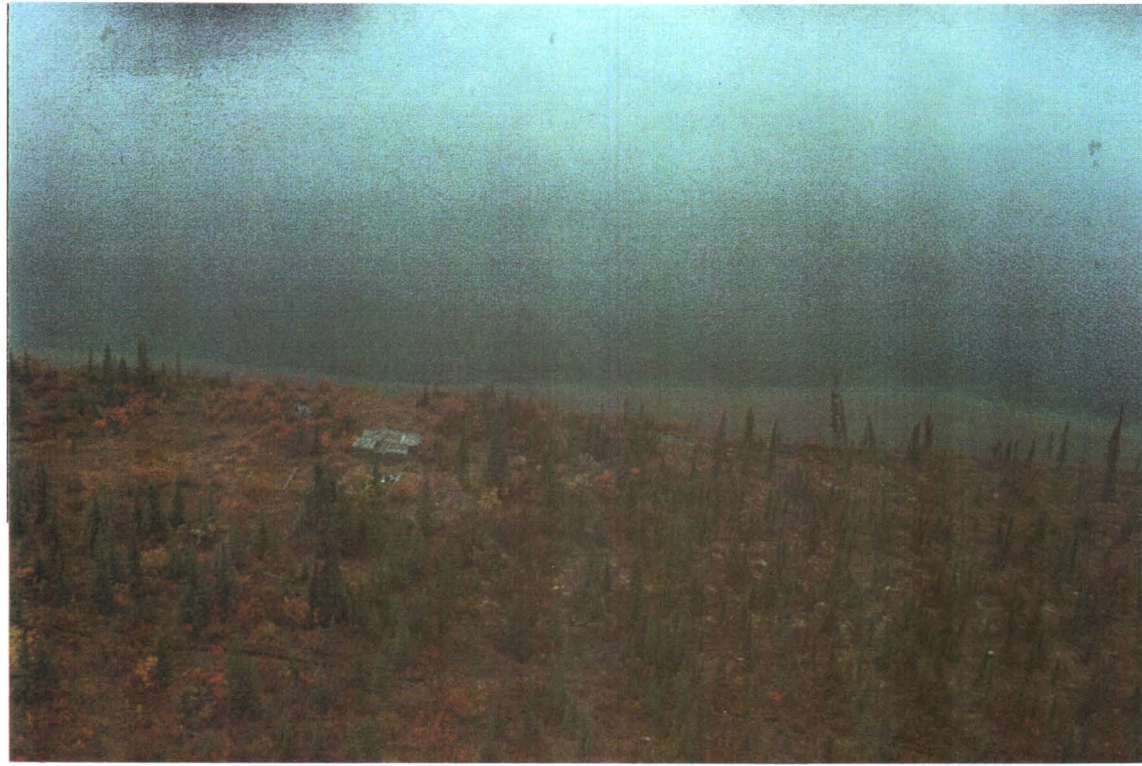
PHOTOGRAPH 19

Aerial view of drill core boxes located at northend of site. Looking west.

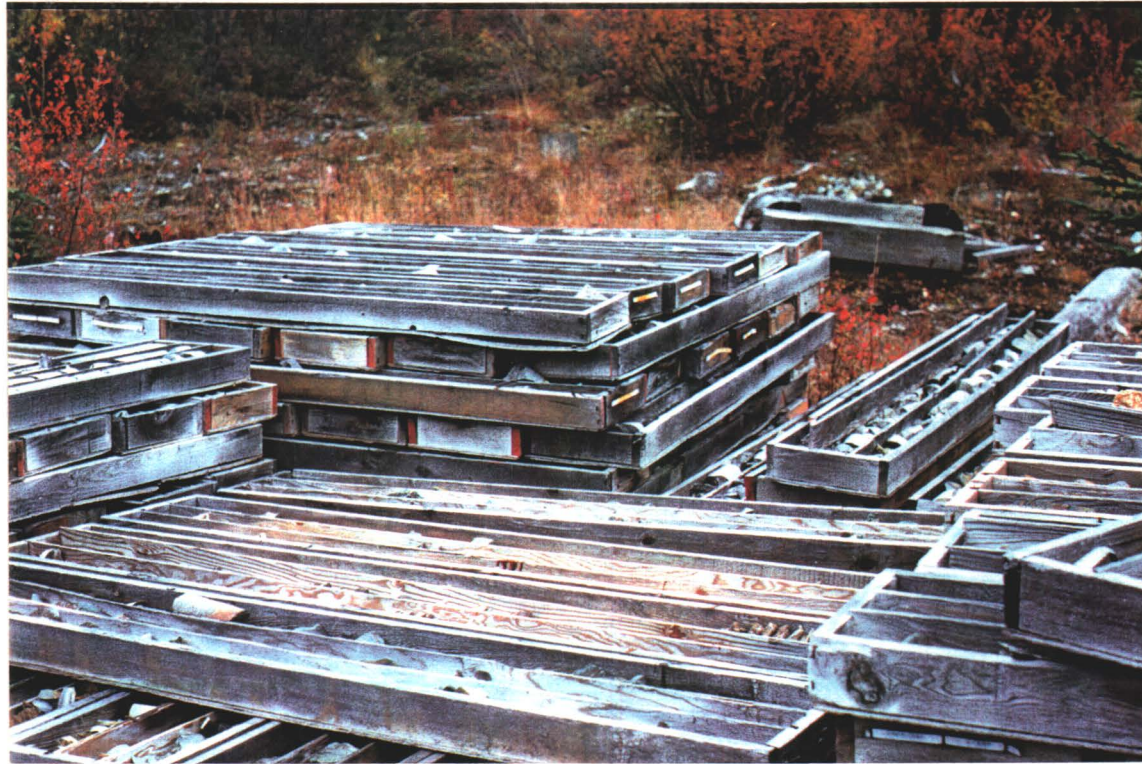
PHOTOGRAPH 20

Close-up of drill core boxes at north end of site

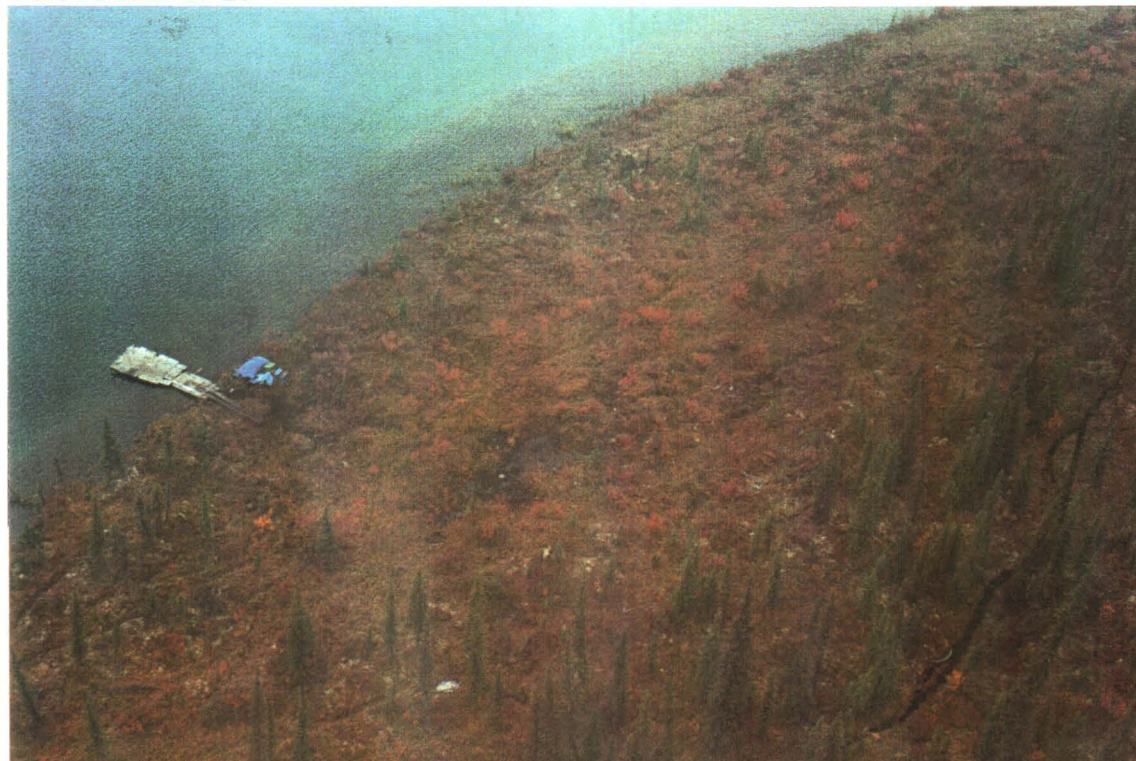
PHOTOGRAPH 21

Aerial view over affected area of site. Note lack of vegetation in area at centre of photograph.

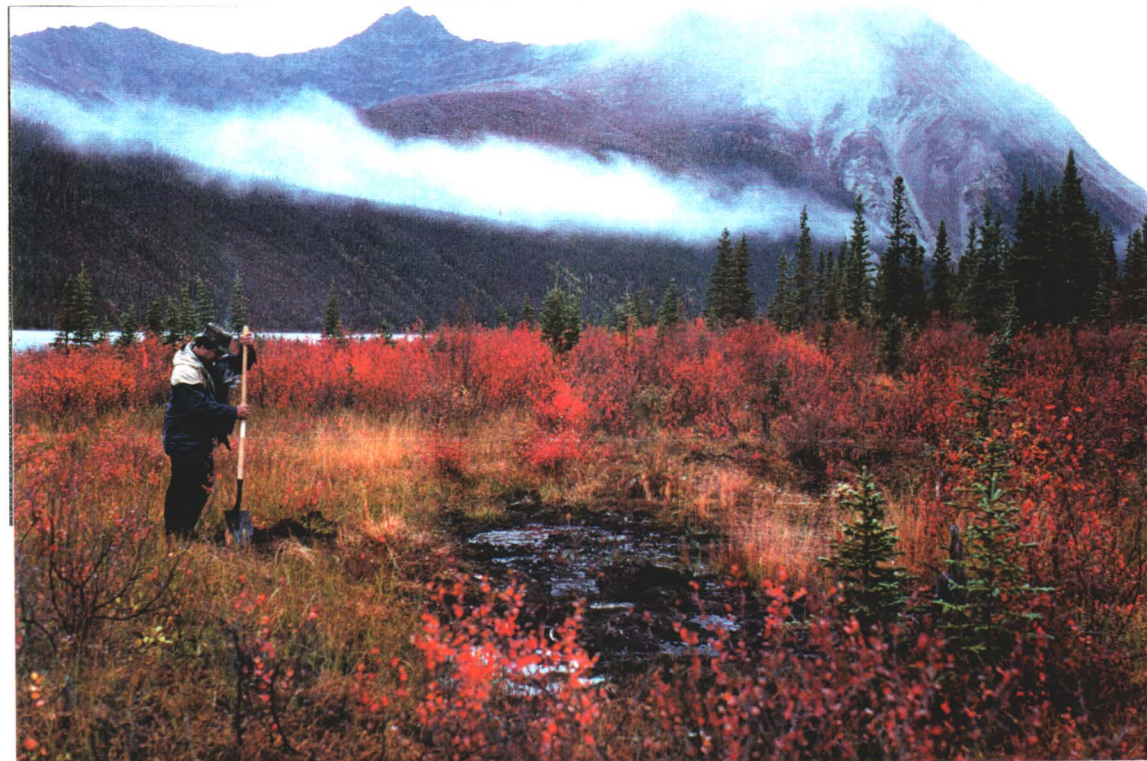
PHOTOGRAPH 22

Close-up of affected area with soil sample being collected by First Nations student.

The analytical results of soil sample FL SS-4 show concentrations of LEPH and HEPH to exceed B.C. Park Land criteria. The analytical results also support the trend observed in the field screening that the shallow soil contamination appears to be confined to a limited area and that significant migration towards the lake has not occurred.

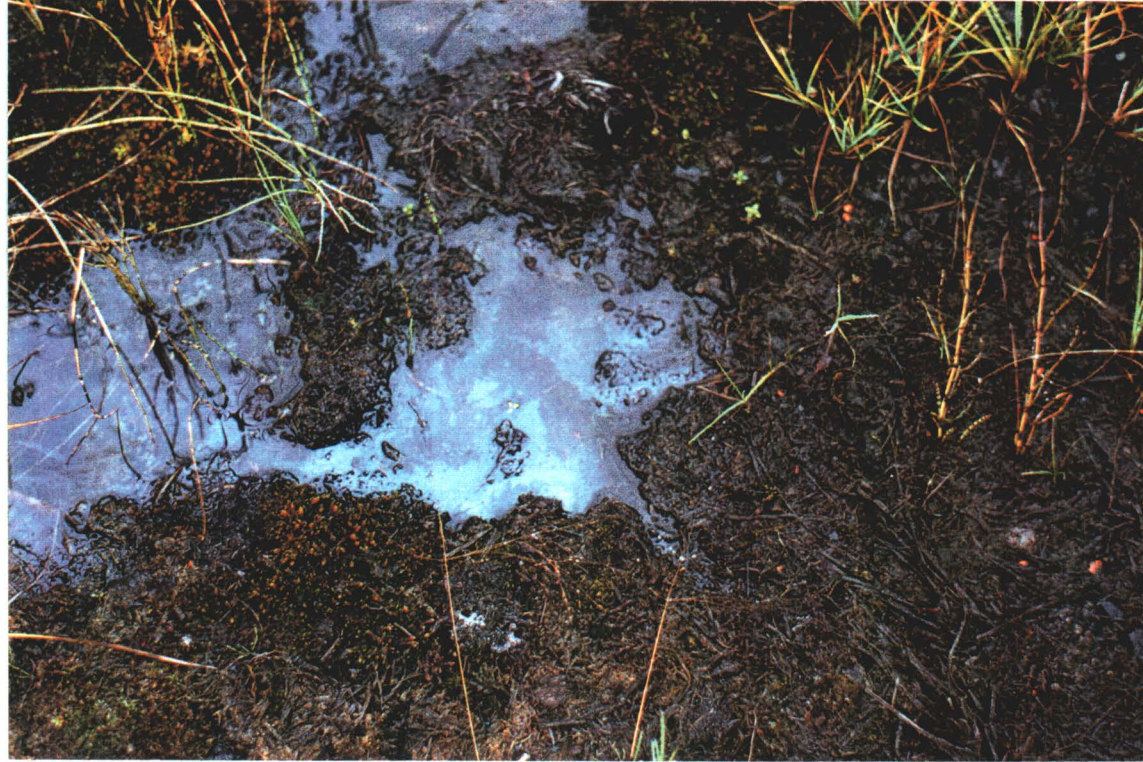
PHOTOGRAPH 23

Close-up of hydrocarbon sheen on ground water at surface.
