**ENVIRONMENTAL SITE REMEDIATION  
HJ011-MARSHALL CREEK ROAD  
HAINES JUNCTION, YUKON**

REPORT NO.: 8054-24

**PROJECT:** Environmental Site Remediation

**LOCATION:** HJ011, km 5.2, Marshall Creek Road  
Haines Junction, Yukon

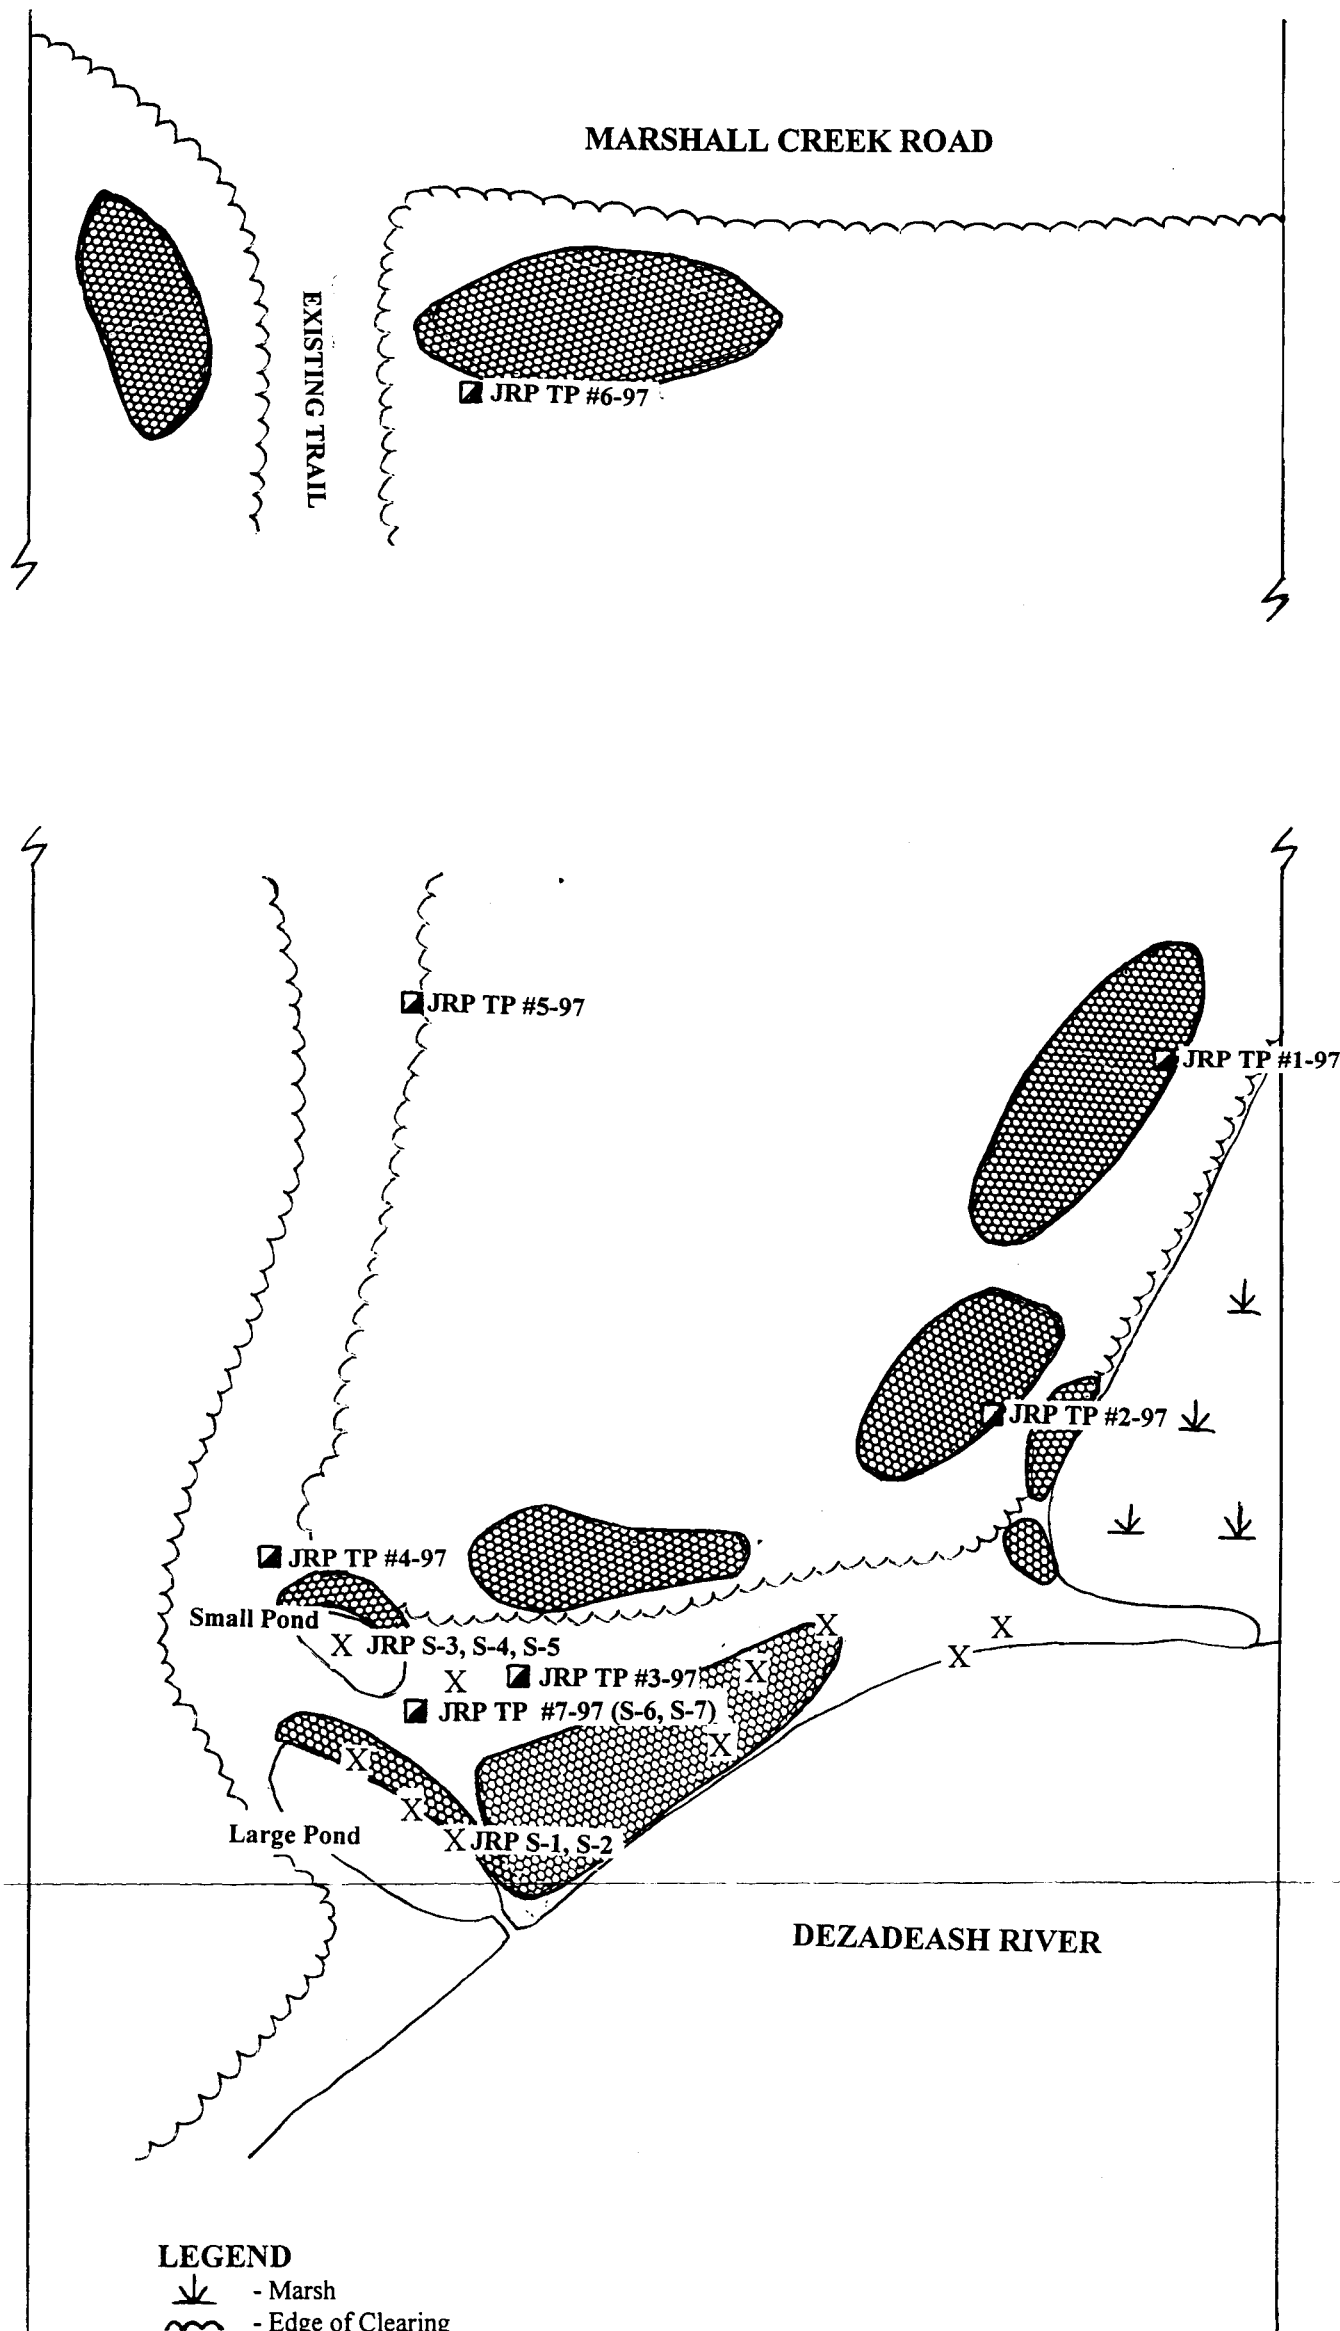
<b>J. R. Paine &amp; Associates Ltd.</b> <small>CONSULTING AND TESTING ENGINEERS</small>	
<b>FIGURE 2-</b> Remediation Operations, Test-pit & Sample Locations	
Dwn. By TD	Date 09/06/97
Scale As Shown	Plate No. 1-2

The areas where the surficial hand clean-up operations were carried out are depicted in the Site Sketch shown in Figure 2. In general, clean-up operations were successful in removing all surficial debris originally identified at the site. However, it became apparent during the removal program that a larger quantity of vehicles/debris was present at the site than previously determined. The debris was located along the periphery of the large pond and the Dezadeash River underneath the surficial vehicles/debris, supporting the theory that waste materials were bulldozed into the existing ponds and nearby Dezadeash River

Upon completion of the removal program, a single test-pit (T.P.# 7-97) was excavated in the location shown in Figure 2 in an attempt to determine if the contaminated material encountered in the small pond may be migrating towards the river (samples # 6 & 7) . No contaminated material was encountered. The test-pit soil profile for T.P.# 7-97 is shown in the test-pit logs presented in Appendix A.

Locations of the equipment clean-up operations are depicted in the Site Sketch shown in Figure 2.

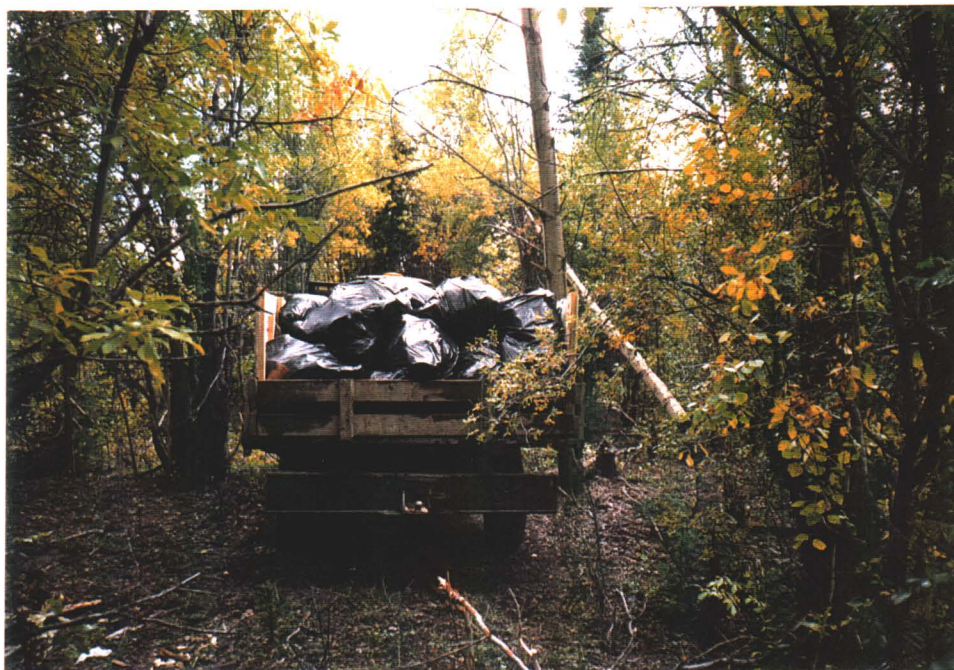
**Photo # 1-** Typical haul load during hand clean-up operations.

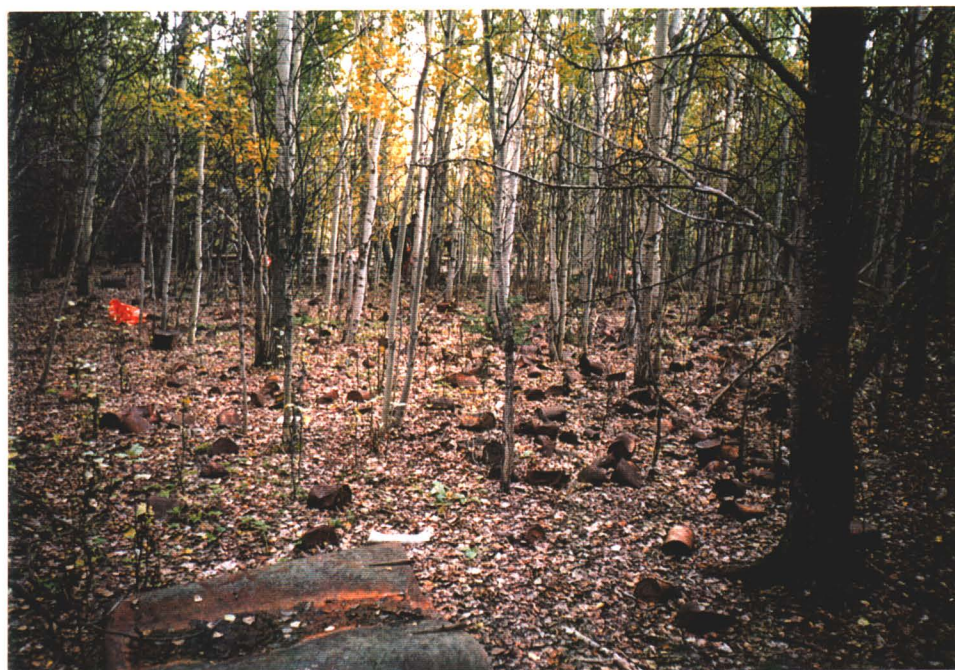
**Photo # 2 -** Site conditions near T.P.# 1-97 prior to hand clean-up operations.

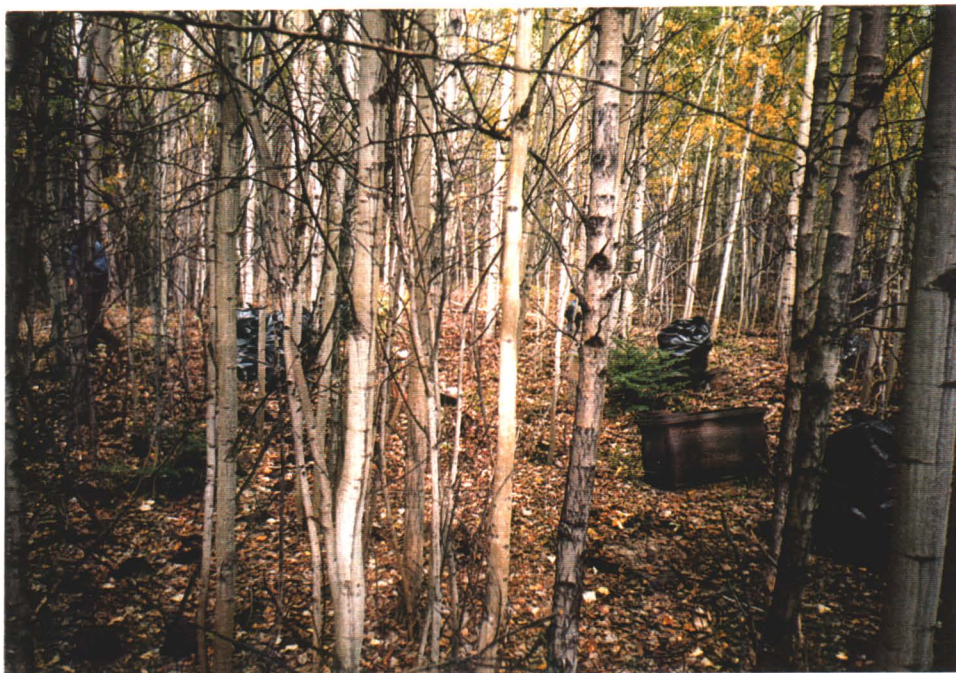
**Photo # 3** - Site conditions near T.P.# 1-97 near completion of clean-up operations

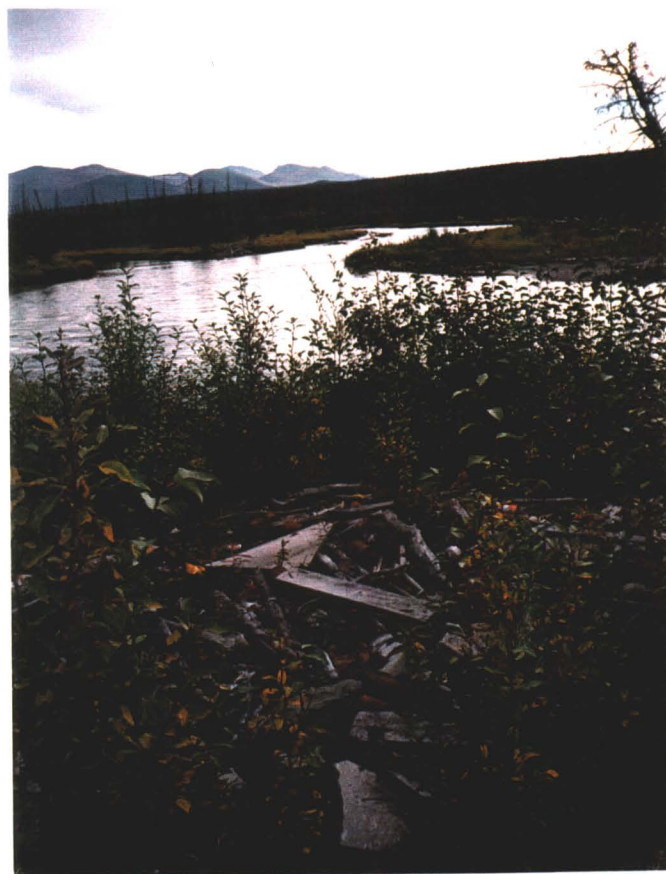
**Photo # 4** - Site conditions near the Dezadeash River prior to hand clean-up operations.

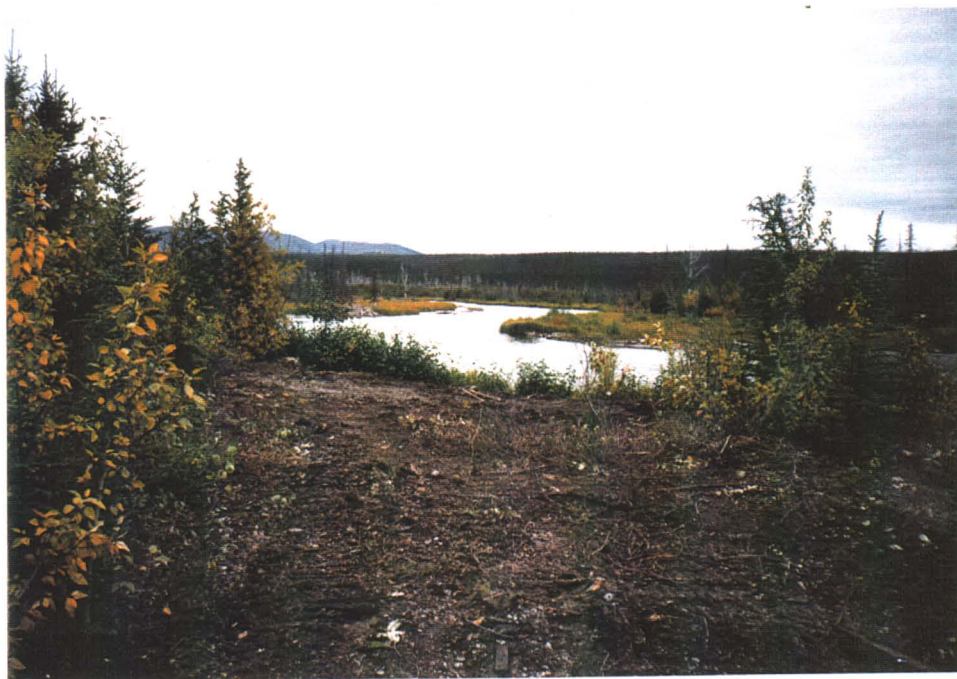
**Photo # 5-** Site conditions near the Dezadeash River upon completion of hand clean-up operations.

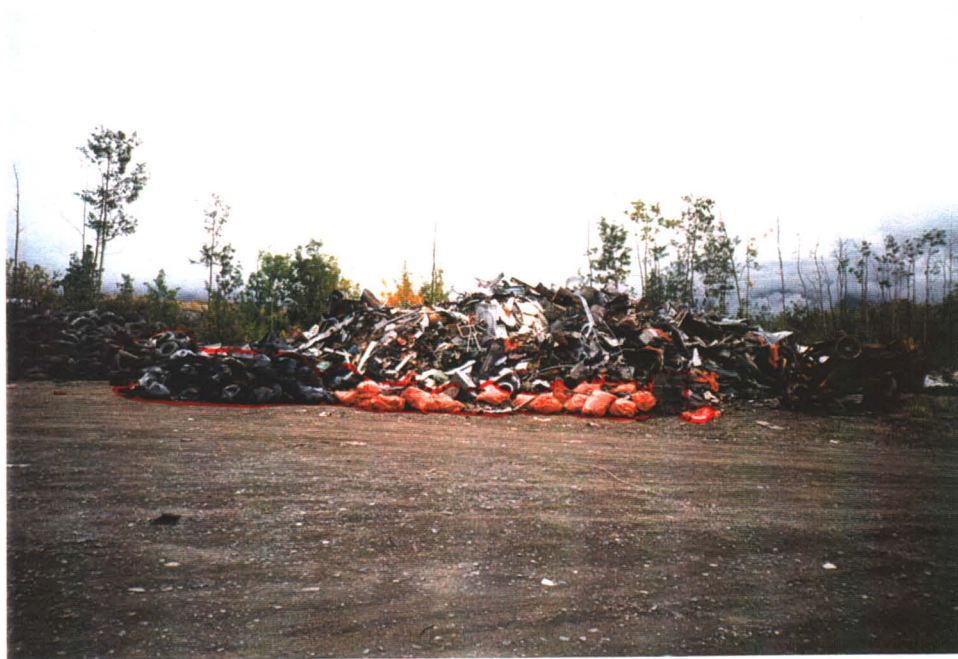
**Photo # 6 -** Surficial debris removed near completion of hand clean-up operations. Photo taken at Haines Junction landfill.

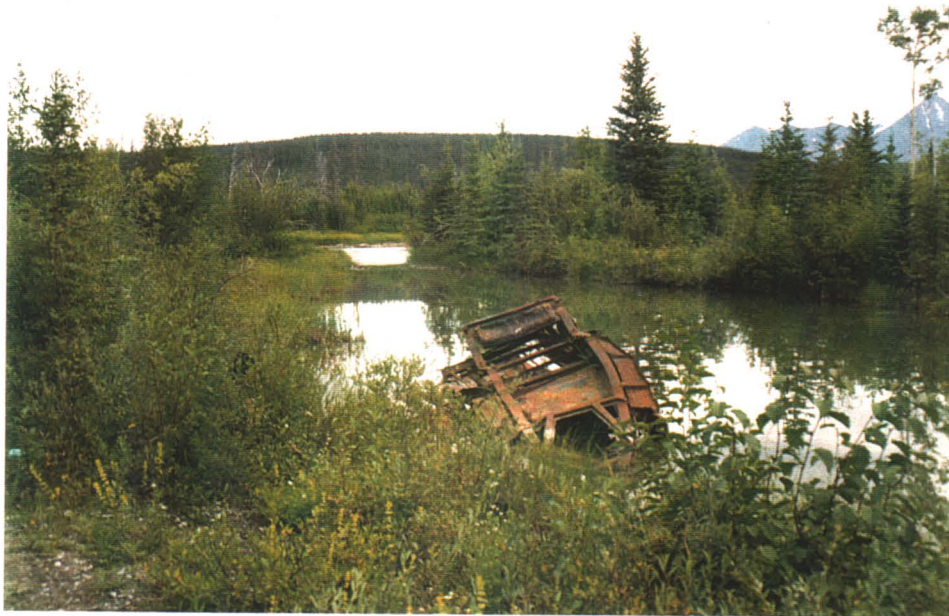
**Photo # 7-** Site conditions in the large pond prior to clean-up operations.

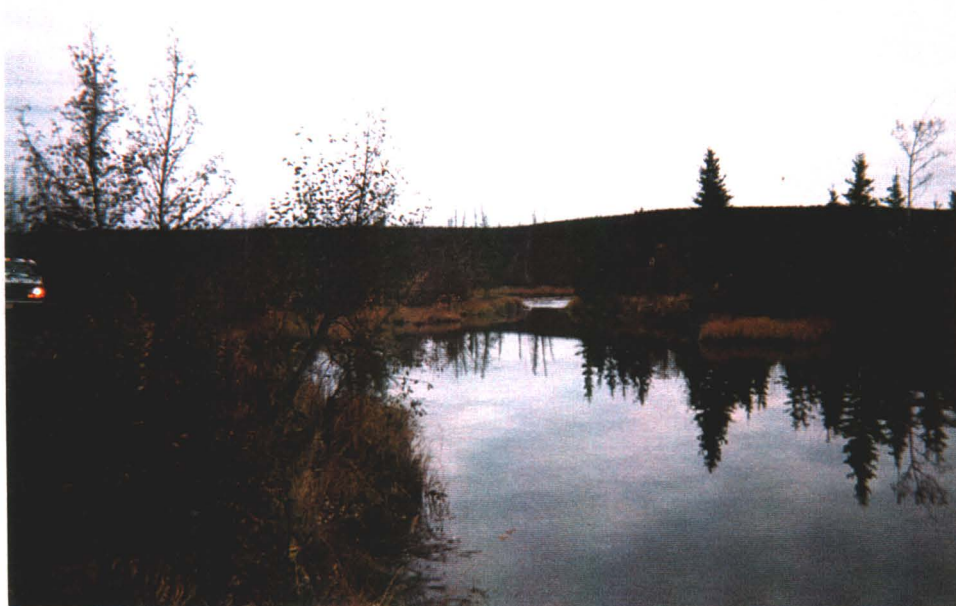
**Photo # 8 -** Site conditions in the large pond upon completion of clean-up operations.

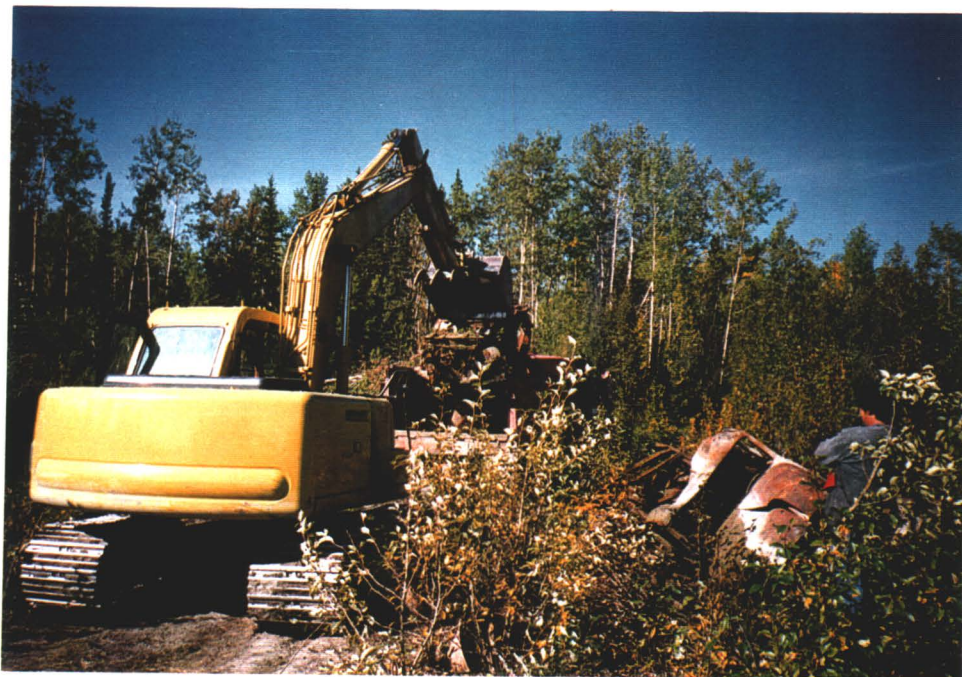
**Photo # 9** - Removal of debris during heavy equipment clean-up operations.

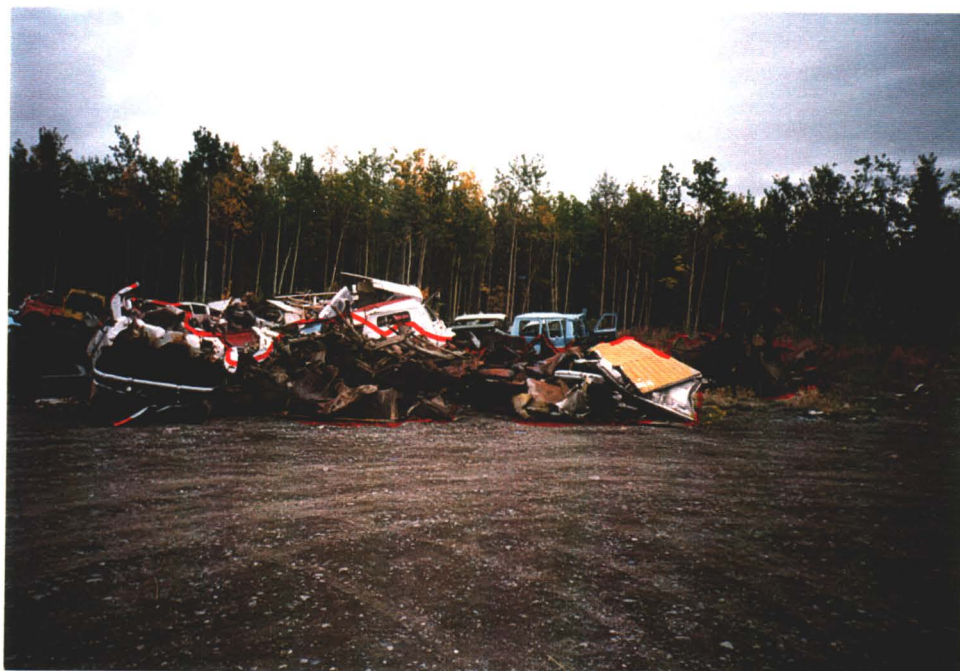
The equipment clean-up operation utilized a claw equipped tracked backhoe (Caterpillar 215 equivalent ) in conjunction with an end-dump dump truck on September 4<sup>th</sup> and 5<sup>th</sup> . Operations generally consisted of utilizing the backhoe claw in conjunction with chains to remove old vehicle bodies, metallic drums and similar oversized debris (please see photos # 7-9). This debris was subsequently placed in the dump truck and hauled to the Haines Junction municipal landfill. Approximately ten truck loads were hauled to the landfill during the clean-up operations (please see photos # 10 & 11).

**Photo # 10** - A portion of surficial debris removed near completion of heavy equipment clean-up operations.  
Photo taken at Haines Junction landfill.

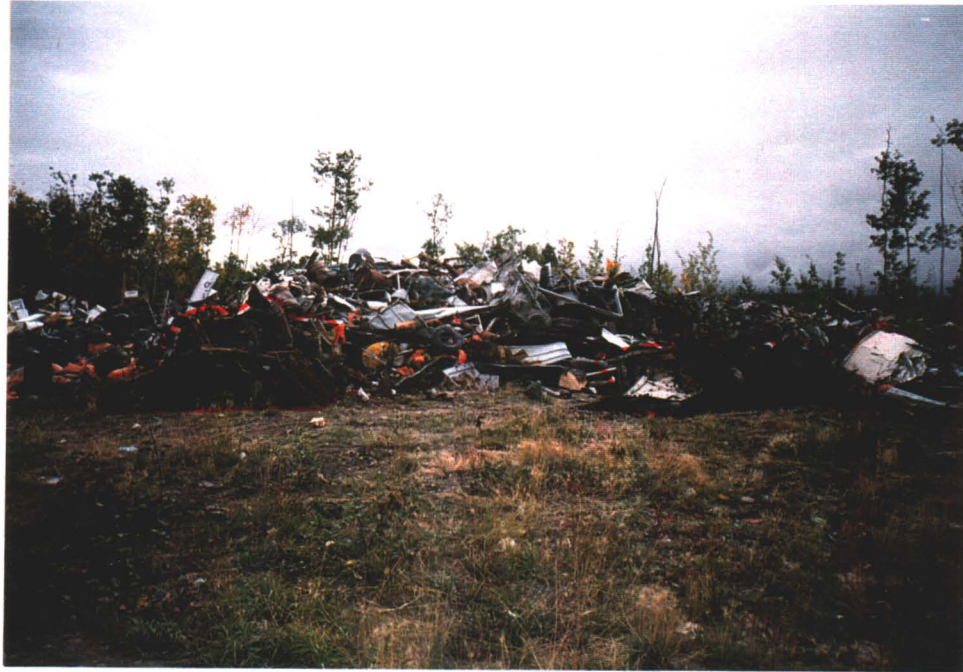
**Photo # 11-** A portion of surficial debris removed near completion of heavy equipment clean-up operations.  
Photo taken at Haines Junction landfill.

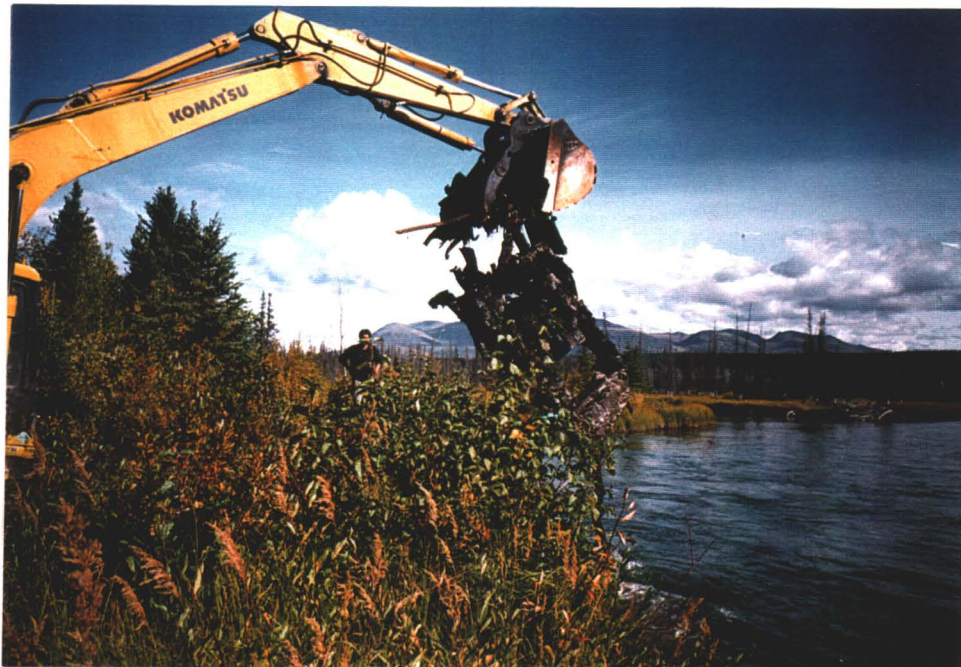
Overall, all accessible vehicle bodies were removed from the site. Three vehicles were however left in densely forested areas due to their relative inaccessibility. It was determined that these vehicles represented only a small contaminant liability and that excessive destruction of forest would be necessary to facilitate their removal. As such, these vehicles were left in-situ. As mentioned above, it became apparent during the removal program that a larger number of vehicles/debris was present at the site than previously determined. This debris was located along the periphery of the large pond and the Dezadeash River underneath the surficial vehicles/debris, supporting the theory that waste materials were bulldozed into the existing ponds and nearby Dezadeash River (please see photos # 12 & 13). As such, in accordance with our scope of work, it was

**Photo # 12 -** Site conditions near the Dezadeash River during heavy equipment clean-up operations.

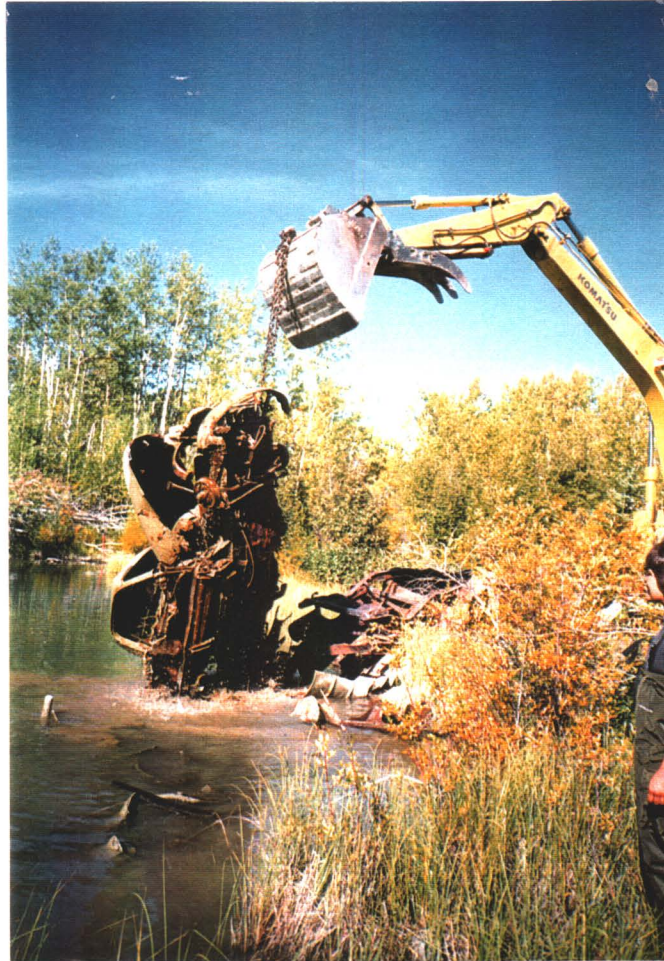
**Photo # 13** - Site conditions near the large pond during heavy equipment clean-up operations.
