# Environmental Investigation

**Destruction Bay Pumping Station**

**HJ031**

Re: **Environmental Investigation - Destruction Bay, Site HJ031**

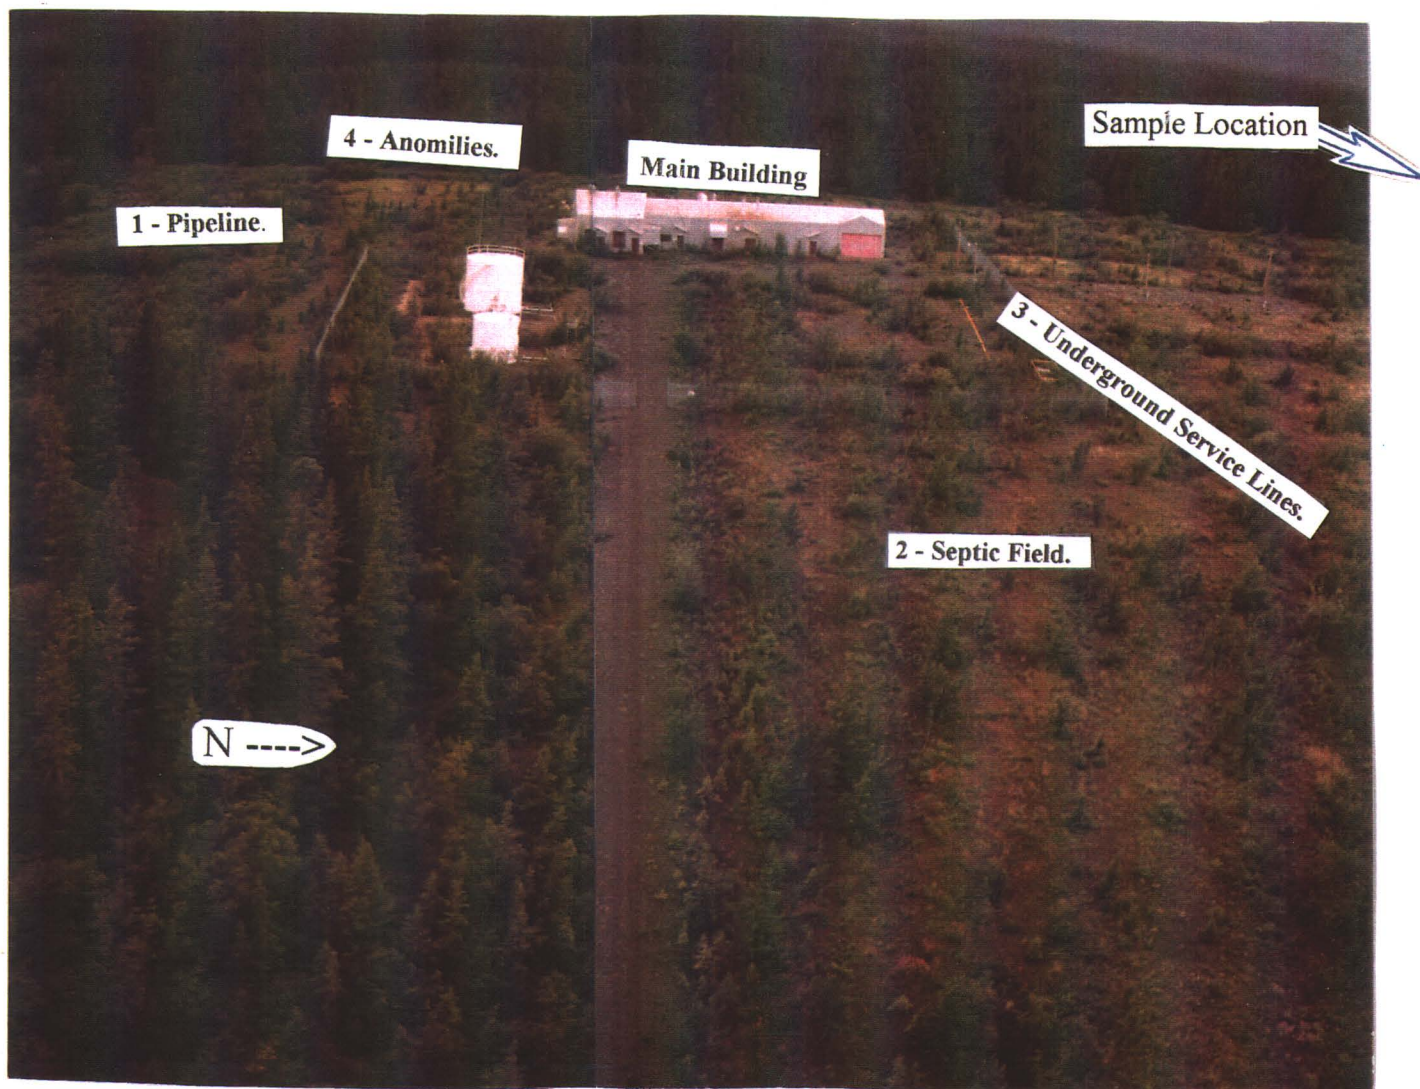
**Photo 1. Site Layout - Main Building**

Sample Location N.W. of main building. (See Photo 2)

1 - Underground Pipeline.

2 - Septic Field situated W.E.

3 - Underground Service lines to maintenance garages.

4 - Anomilies detected in initial area of excavation.

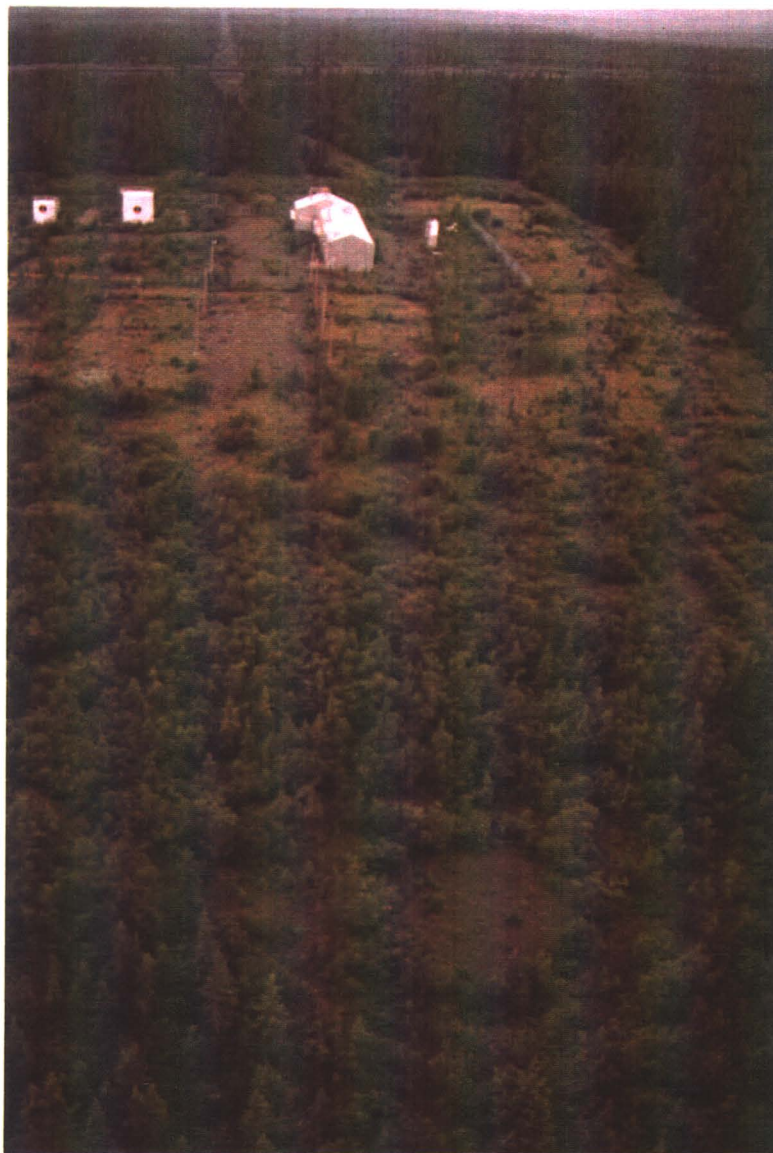
Located in the Northwest corner of the property is a circular area 11 x11 meters void of vegetation. A 1.5 meter deep hole was excavated in which strong hydrocarbon odours were emitted. A layer of pea gravel covered the contamination. A soil sample was obtained from excavated soil. The soil was analysed for PCBs, TEHs and phenoxy acid herbicides. All soil analysis meet Yukon Regulations for Contaminated Sites, 1996. Results are located in Appendix C

**Photo 2. Sample Location** - Situated approx. - 190 m NW of main building.  
- 30 m East of pipeline treeline.  
Area approx. 11 m diameter.

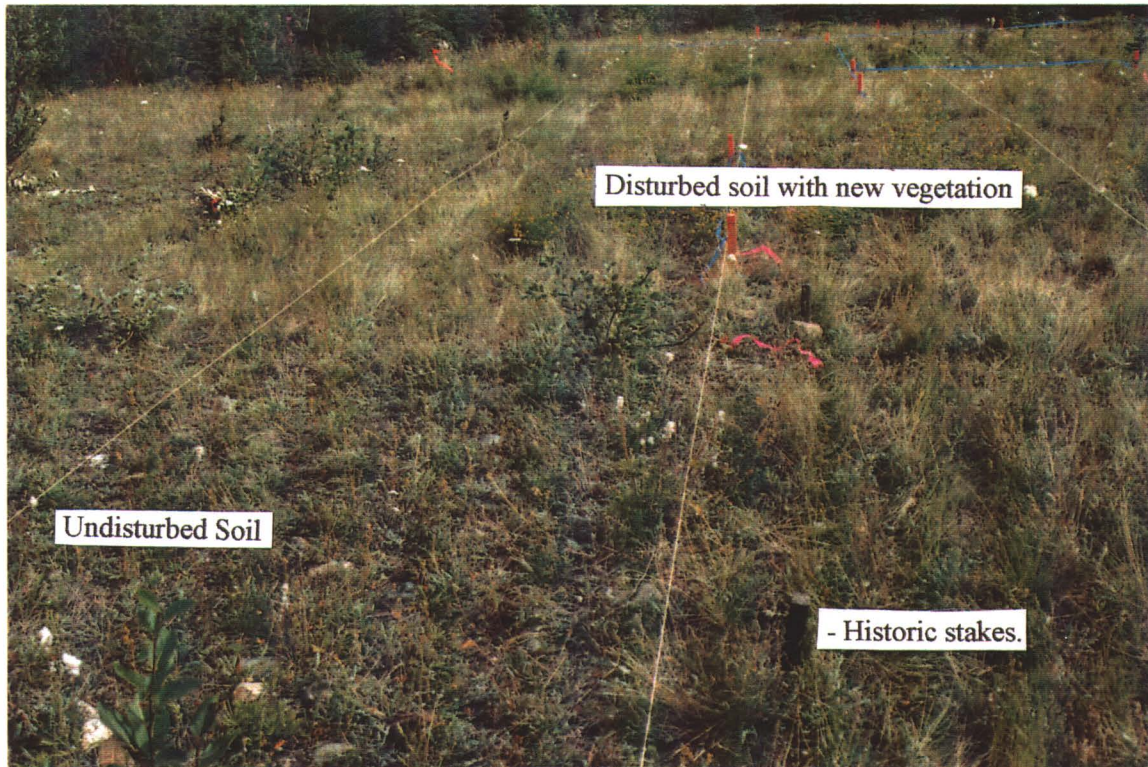
**Photo 1.** Burial Trench Indication - *South-west corner of compound.*  
- Historic stakes.  
- Disturbed surface soil with new vegetation  
- Undisturbed surface soil

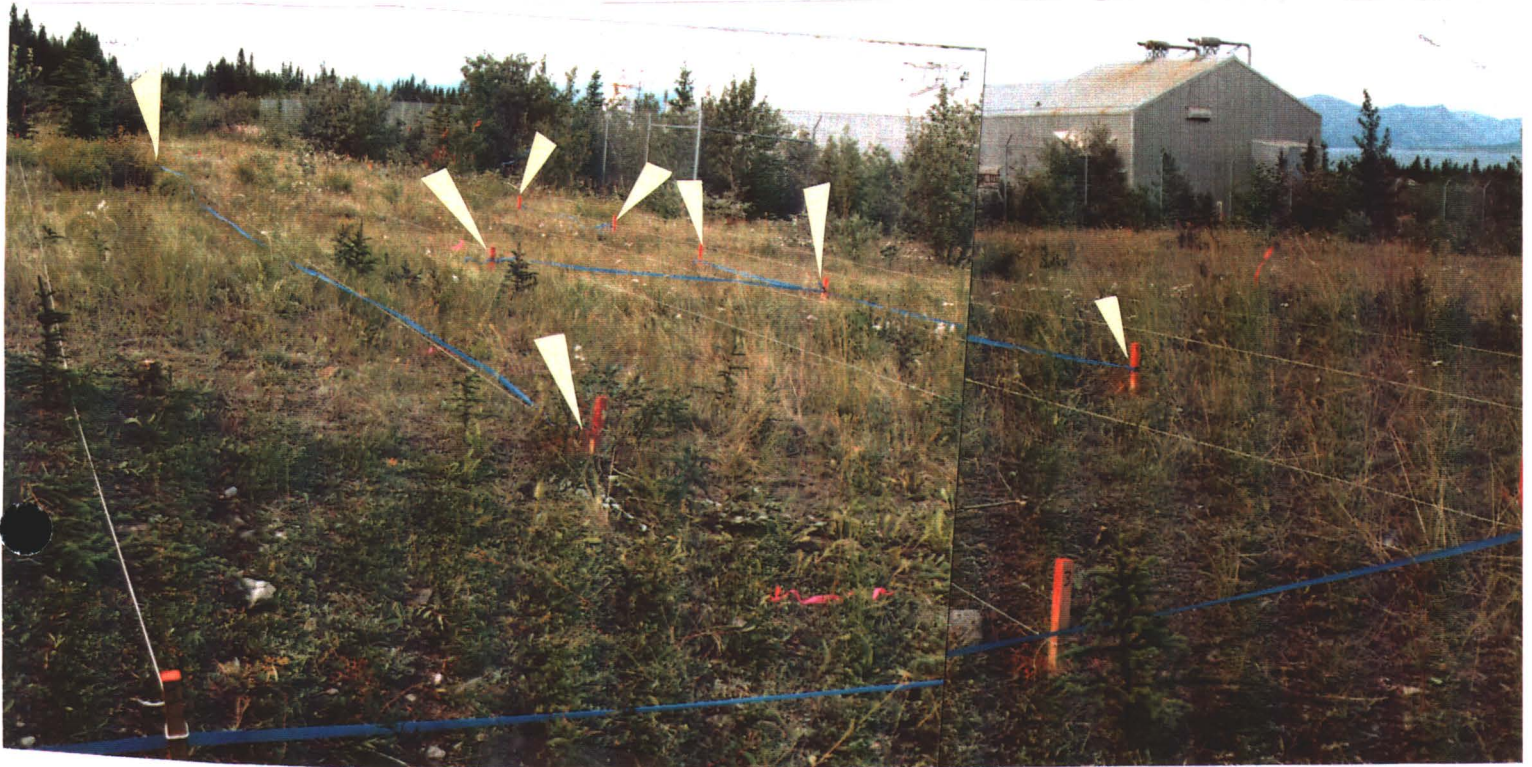
The subsurface penetrating radar was completed using an EM 61 Electro Magnetic Indicator. The initial suspected bury trench was thoroughly scanned for anomalies using one meter grid intervals. Several areas indicated the presence of metal object resembling barrels; these areas were painted and flagged. Anomalies were situated approximately in the middle of the excavation foot print. Approximately 15 similar anomalies were identified within the staked area, four to five feet below the ground surface. (See Appendix: B - Photo 2)

**Photo 2. Anomaly Locations** - Blue tape and orange stakes inside grid, indicates the locations of metal anomalies.  
- No buried drums were located in this area.

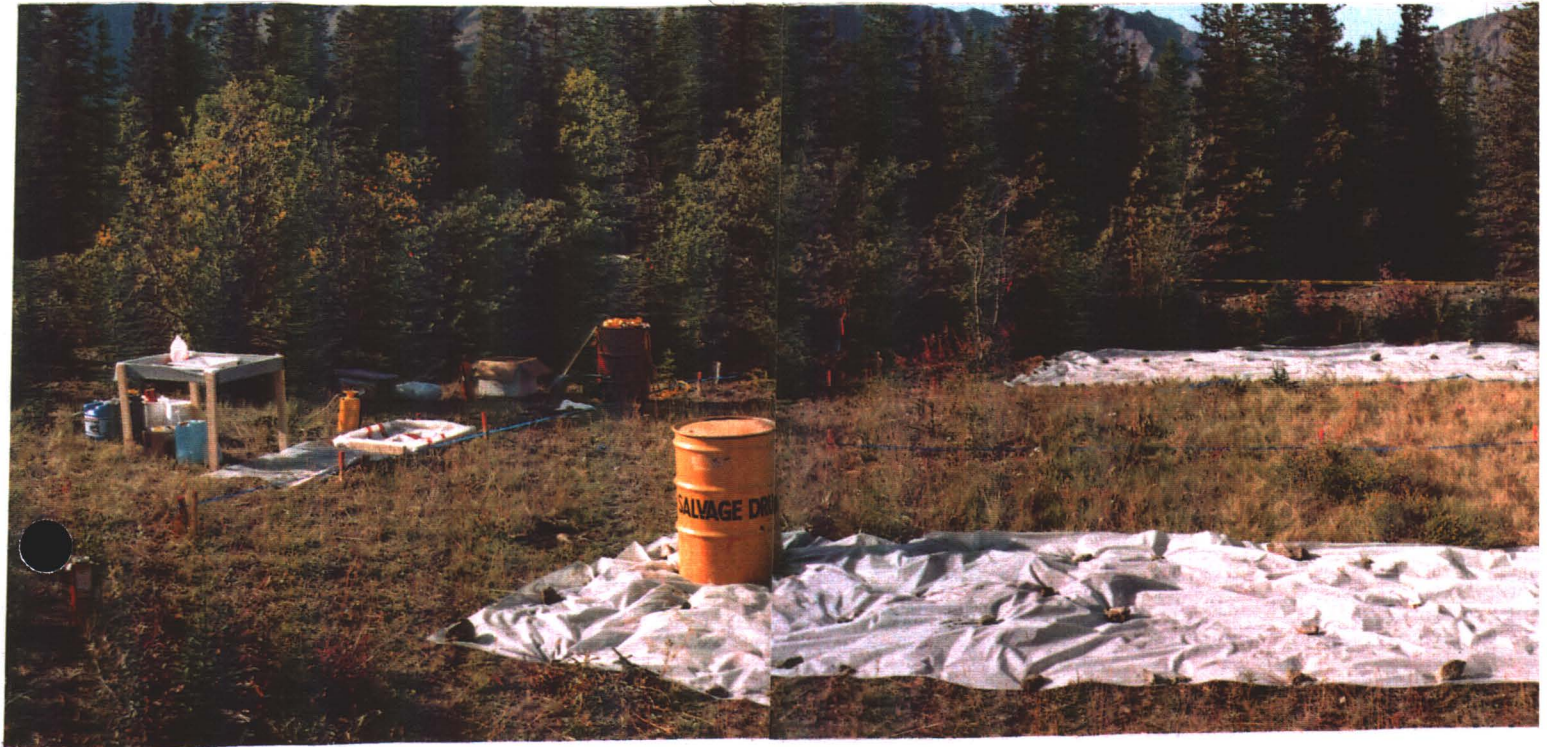
**Photo 3. Hazmat Set-up** - Containing; two overpacks, lined decontamination centre, poly sheeting to contain excavated soil, two barrels and pump to remove any free product, protective clothing and respirators, fire protection devices, drum hoist, and a photoionization detector.

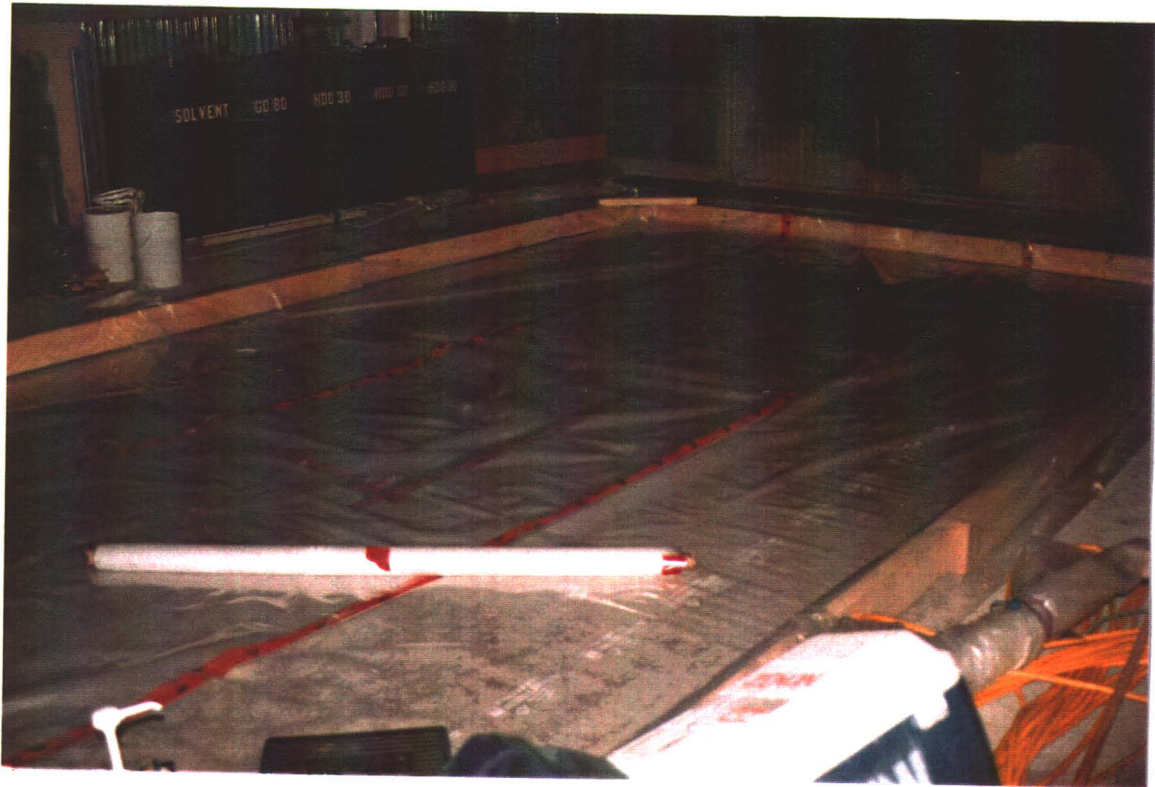
**Photo 4. Hazmat Containment Cell** - *Located inside the main building.*  
- 10 m x 17 m x 0.2 m poly lined containment cell.  
- containment cell was not used.

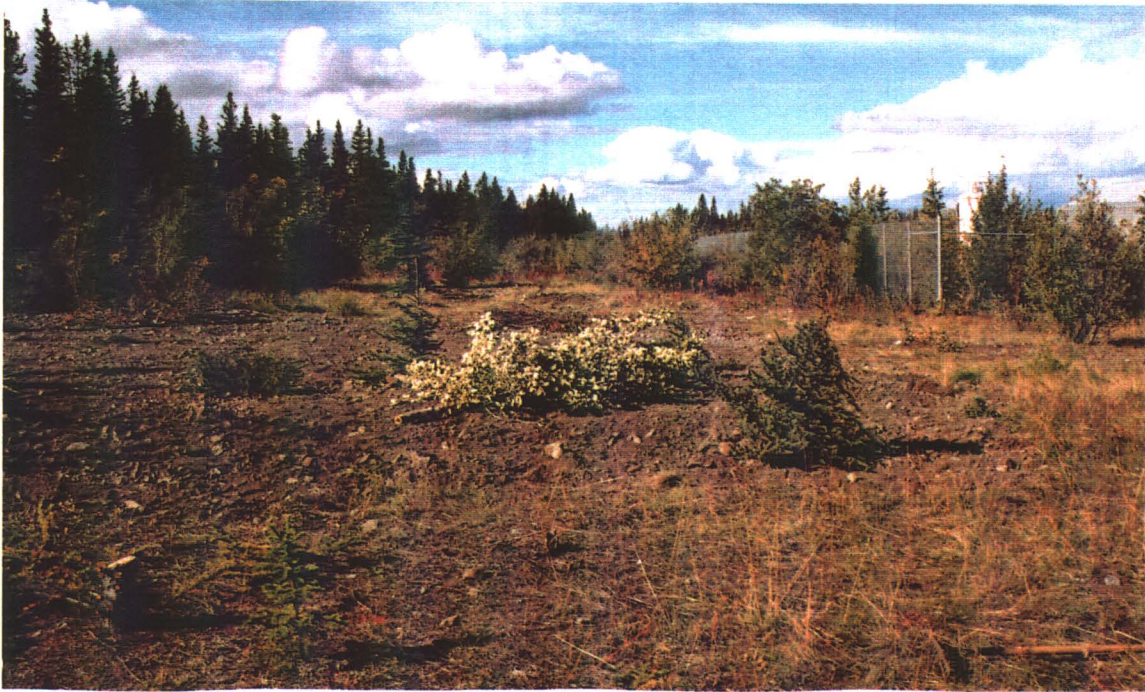
**Photo 5. Excavation #1 - Southwest of main building.**  
No buried drums were located in this area.

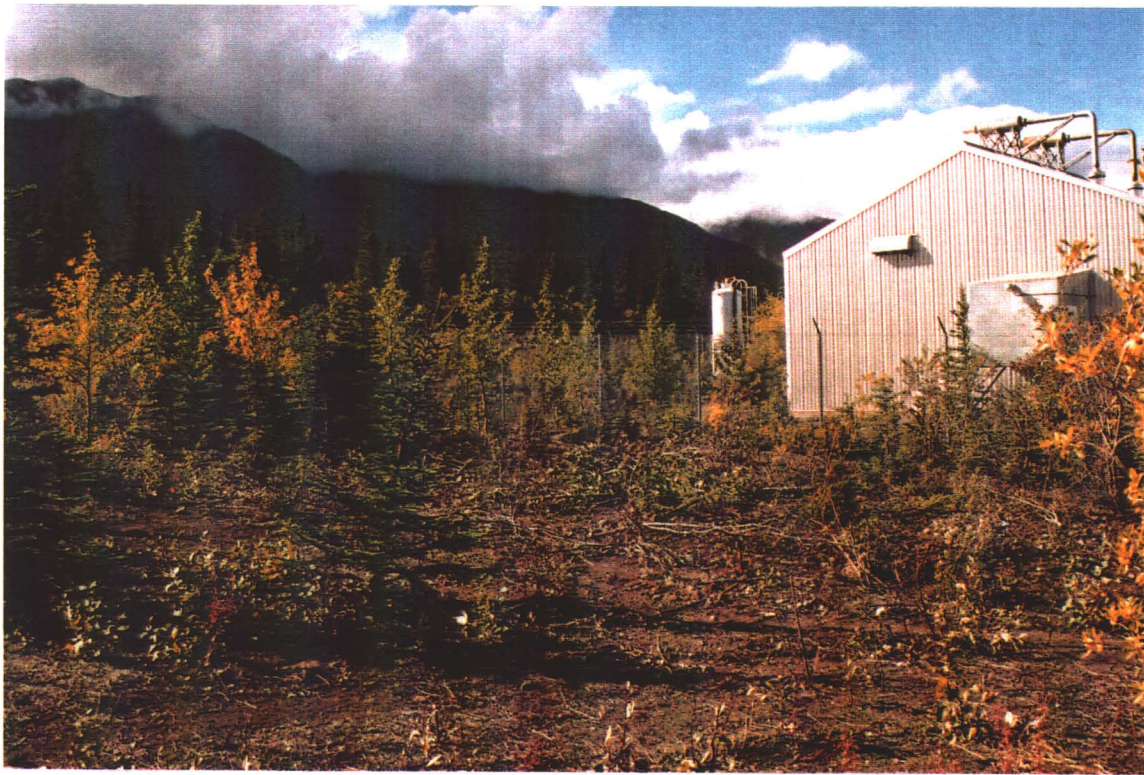
**Photo 6 Excavation # 2 - South of the main building**  
No buried drums were buried in this location.

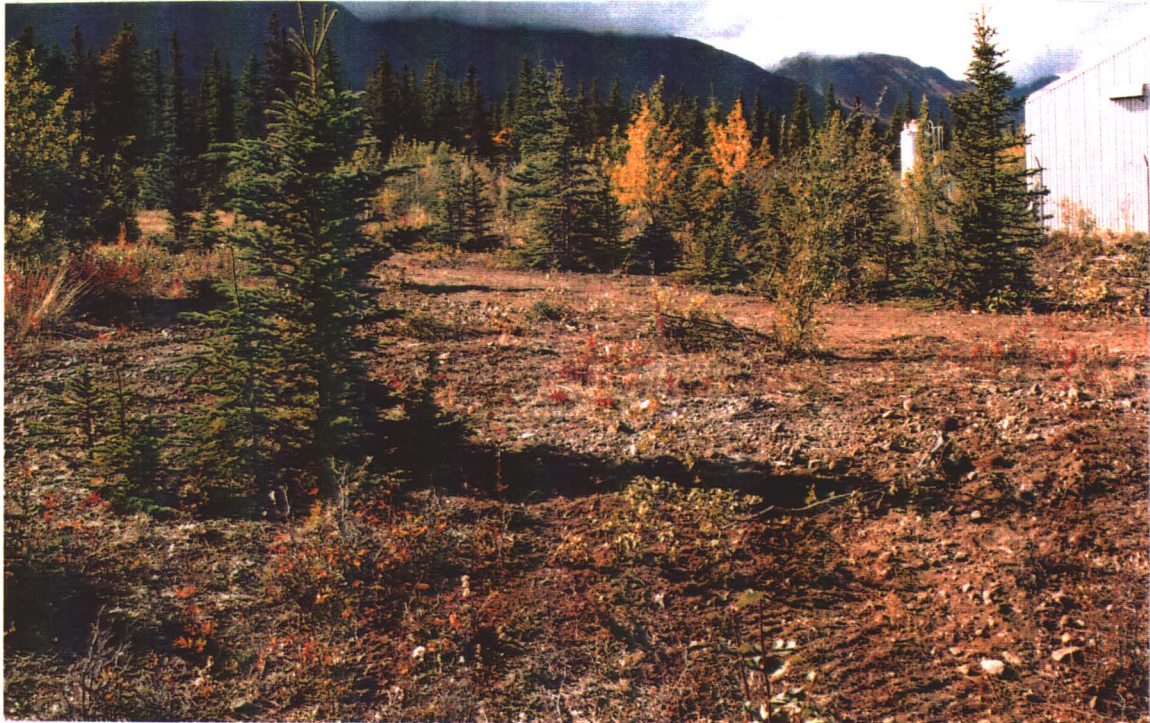
**Photo 7** Excavation #3 - Further south of the main building.  
No buried drums were located in this area.

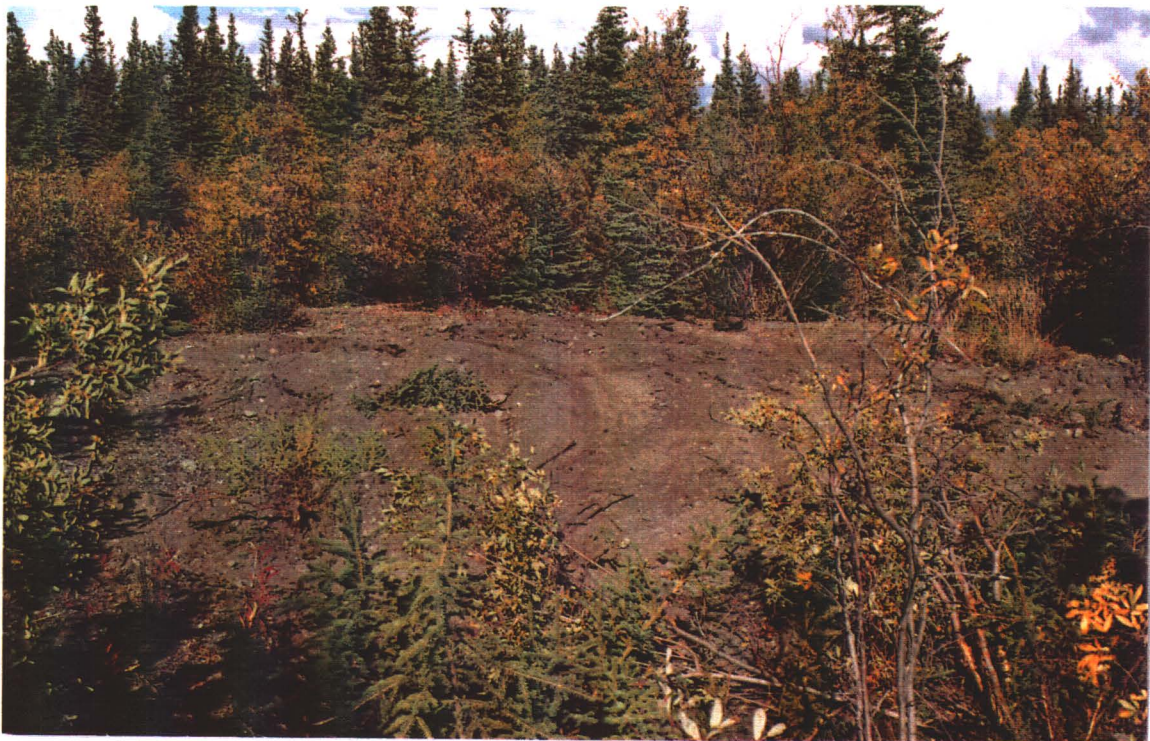
**Light/Heavy Petroleum Hydrocarbons - (LEPHs)** soil concentrations were recorded at 14, 15, and 56 ug/g; Yukon Contaminated sites Regulations, 1996, Schedule 1 Generic Numerical Soil standards pg. 30, states a 1000 ug/g soil concentration limit for LEPHs. **(HEPHs)** soil concentrations were recorded at 41 ug/g; Yukon Contaminated Sites Regulations, 1996, Schedule 1 Generic Numerical Soil Standards pg. 30, states a 1000 ug/g soil concentration limit for HEPHs on park land.

**Photo 8** Final Excavation #7 - Northwest corner of property.  
No buried drums were located in this area.  
Soil staining was evident. ( See Analytical Results)

Groundtrax (Yukon) Inc., *Environmental Systems* recommends to maintain awareness that hydrocarbon contamination is evident on-site at concentrations of at least 56 ug/g.

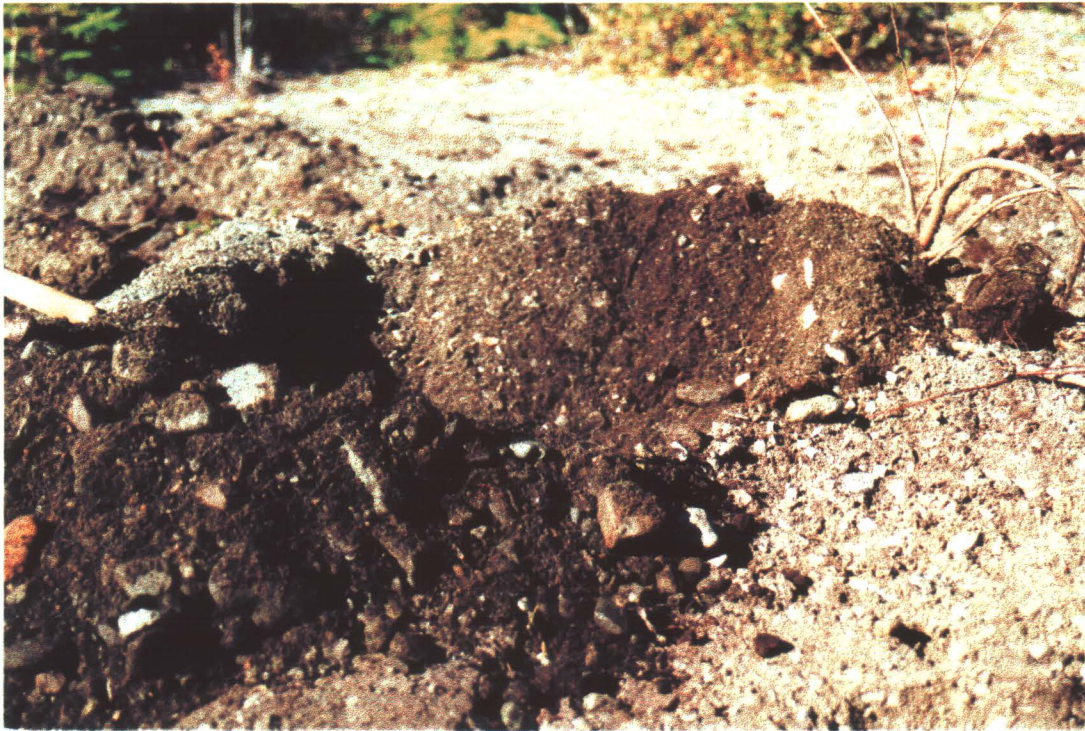
**Photo 9. Contaminated Soil** - *Located in the Northwest Corner of the property.*  
- Quantity unknown,  
- Containing hydrocarbons.
