PRELIMINARY ENVIRONMENTAL INVESTIGATIONS
of
EXISTING WASTE SITES
in the
YUKON TERRITORIES

SITE 19 - CRACKER CREEK HJ-33
SITE 20 - CANYON CREEK HJ-34
SITE 42 - HAYES CREEK NORANDA CAMP -CA 35

INDIAN AND NORTHERN AFFAIRS CANADA

FINAL REPORT

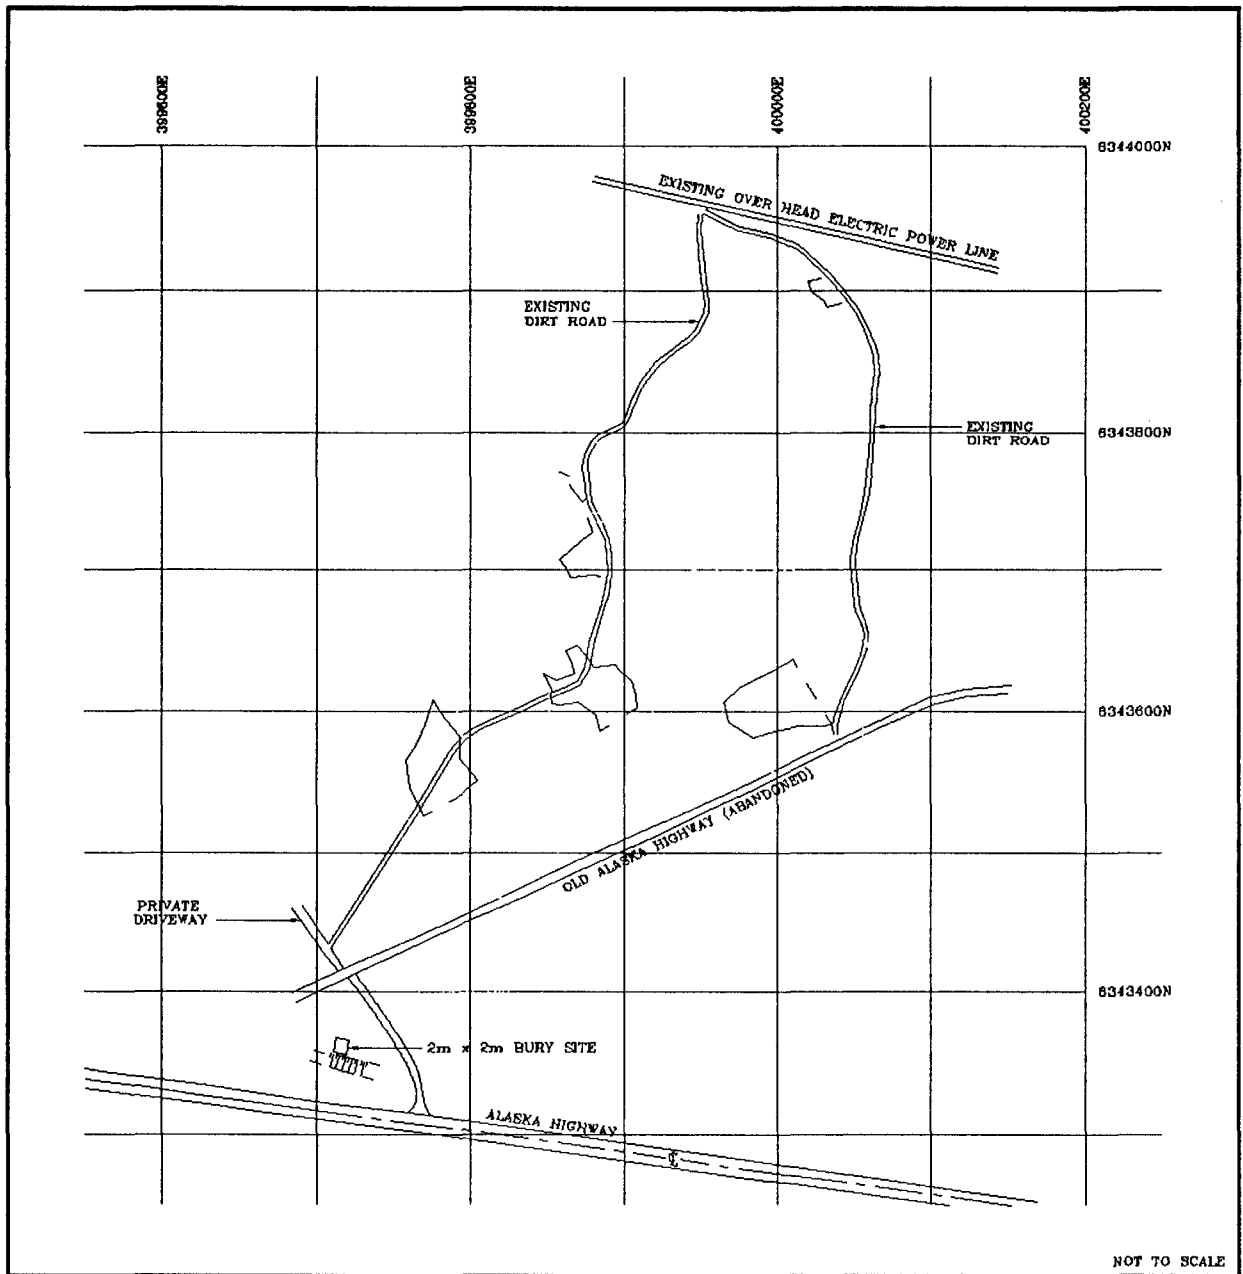
Figure 11: General site plan for Site 19 - Cracker Creek showing locations of sub-sites 19A through 19I

The detailed site plan of Cracker Creek is provided in Figure 11 (drawing 705-103). This site is scattered across an area estimated to be approximately 28 ha., although only about 9 ha of this area were surveyed in detail as part of the 9 sub-sites that were identified. The smallest sub-site is 19A which is shown in Plate 1. This site consisted of metal debris, primarily tins and cans, and had been partially excavated. MDA was unable to learn who, when or why this excavation was undertaken either from the local landowners or from the INAC office. The small area of this site and the visible contents led us to conclude that there was little possibility for contaminants to exist at this site and no further investigation was undertaken.

Sub-sites 19B, C, E, F and G were areas where extensive clearing had occurred and the presence of surface debris suggested possible burial. These sites had been identified in the earlier investigations of these sites (see section 3.1.1) and are clearly visible as cleared areas in the 1948 and 1964 aerial photographs. Although considerable regeneration of natural vegetation has occurred at these sites, the cleared areas are still quite visible on the ground as evidenced by the sharp transitions in vegetation shown in Plate 2. In these fill areas, various earth and root mounds still remain with metal debris protruding as illustrated in Plate 3. In some cases, especially 19E and F, the natural grass remains sparse as illustrated in Plate 4 and the shrubs and trees have failed to regenerate. Due to the presence of buried material at sites 19B,C,E,F and G, these sub-sites were geophysically surveyed with the EM31. These results and their interpretation will be discussed below.

Several sub-sites warrant special mention here. Site 19D was a rectangular area with obviously younger vegetation than the contiguous land. This sub-site was surveyed extensively but without any evidence of metallic debris present (see below for results) and thus it has been assumed that while this area was cleared, the native soils were not disturbed by stripping and burial and natural regeneration of the vegetation is occurring. Sub-site 19G was a cleared area but there was no evidence of burial of metal debris based upon the results of a randomized geophysical survey and thus this site was not investigated further. Sub-site 19H, is aesthetically the worst part of the entire site as illustrated in Plate 5. This surficial debris consists mainly of old food tins and other metal debris, crates, broken china and glass. Only a very minor portion of this debris is recent.

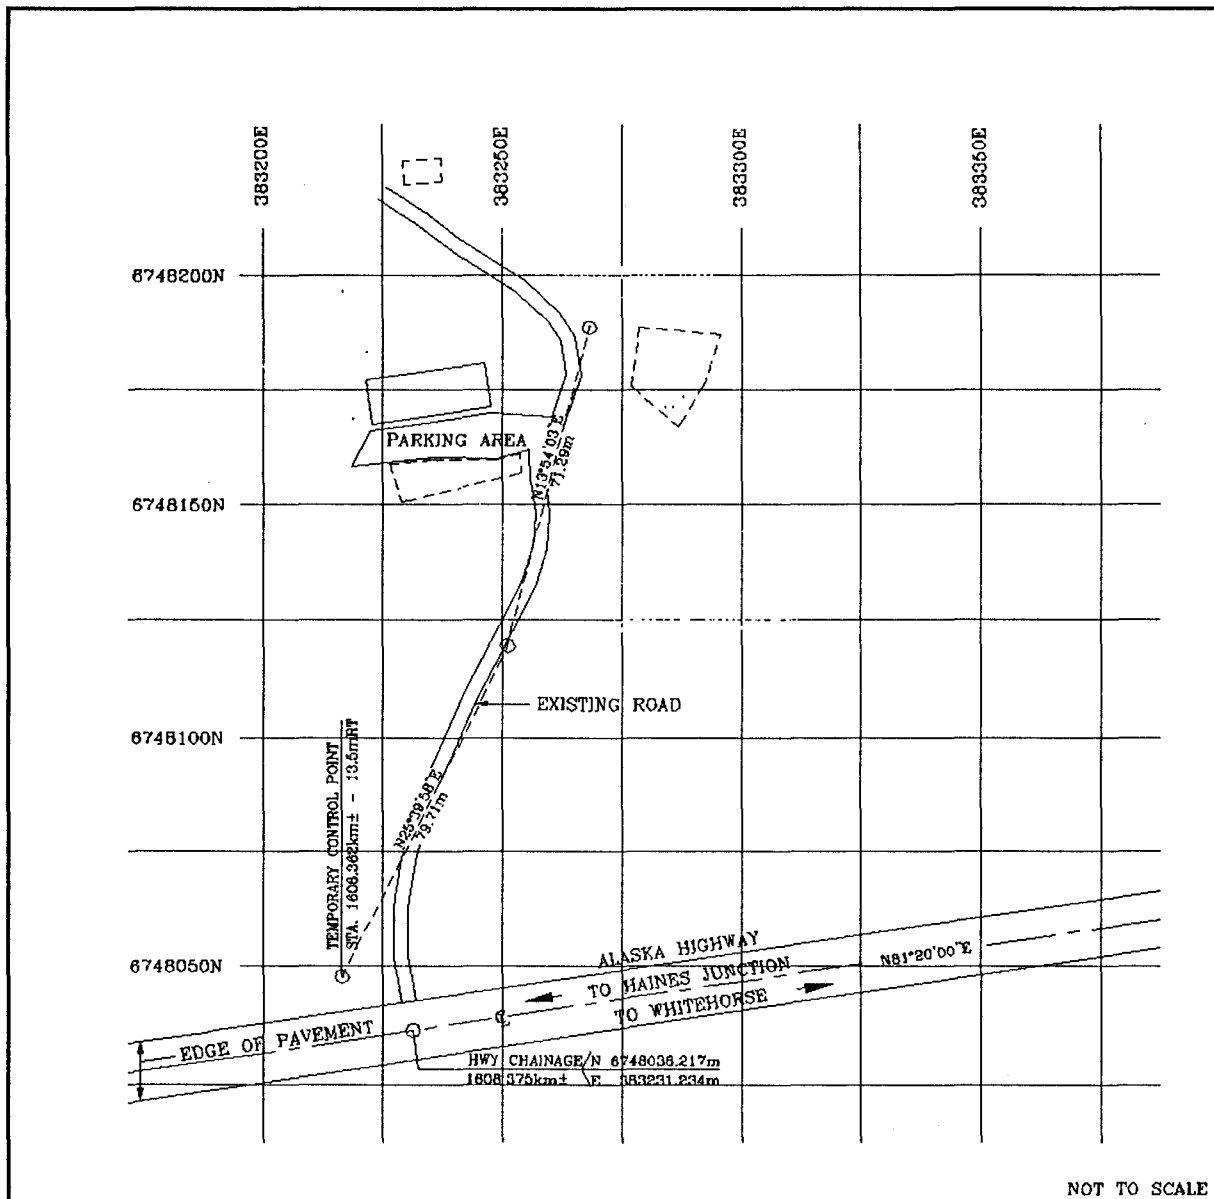
Figure 12: Detailed site plan for sub-site 20A - CANOL Pumping Station C at Canyon Creek site

This site has been divided into 5 subsites as illustrated in Figure 3. Sub-site 20A is the CANOL Pumping Station C site. As illustrated in Figure 12 (drawing # 705-109) this entire site is large covering at least 1.25 ha; but with three smaller debris sites exclusive of the concrete foundation remains of the pumping station (see Plates 8 and 9 {sub-site 20A, photos 1 and 2}), looking west and east respectively). One debris site is immediately to the south of the pumping station and consists of timber, wood and asphalt shingles. Another similar, but smaller site is located to the north of the pumping station. The main burial site is located to the east of the pumping station and there is only limited evidence of surface debris here in the gravelly soil. This site has been subjected previously to some excavation, evidently for inspection purposes, and this has exposed some of the burial

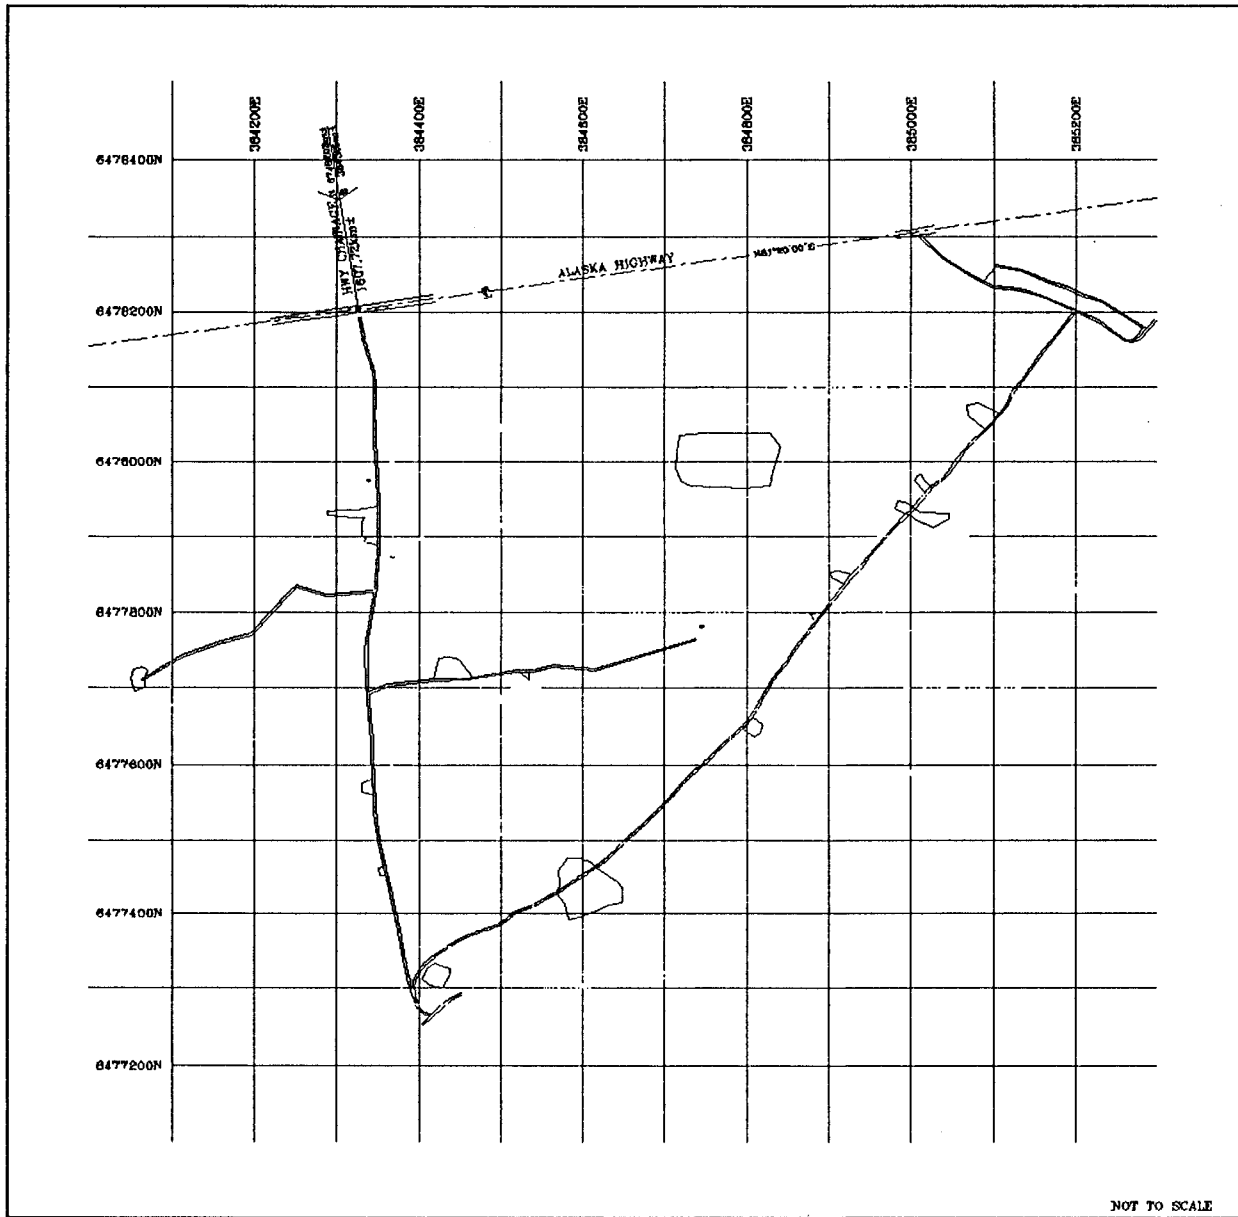
Figure 13: Detailed site plan for sub-site 20B on the southwest corner of Site 20 - Canyon Creek west

Figure 13 (drawing 705-111) outlines the large area of 17 discrete waste disposal and debris sites comprising sub-site 20B. Also shown here as sub-site 20B-18 is the large clearing identified on the airphotos as noted in section 3.1.2 but not investigated due to the fact that we were not aware of this site until observing it on the air photos following the on-site investigations. It was not obvious on the ground as there is no access trail evident. This entire sub-site covers approximately 80 ha of land but the actual area of the debris sites are, fortunately, much smaller. The site is generally treed except in the vicinity of the debris sites which were either natural clearings or the vegetation had been removed or destroyed. This is best illustrated in Plates 10 and 11 (sub-site 20B, photos 1 and 2) which show the clearings surrounded by healthy coniferous forests. Some of the sites show evidence of burning (see Plate 12 {20B3}) which may be the reason for the lack of vegetation still in the central parts of these debris sites. Possibly, the fires destroyed the natural vegetation cover and removed the organic matter from the sandy soil, thus greatly increasing the time for plant regeneration (see Plate 13 {20B4}).

All of the 17 sub-sites were investigated either with a metal detector (sites 20B-1, 3, 4, 6, 7, 8, 9, 10, 12, 13, 14, 16 and 17) or with the EM31 (sites 20B-2, 5, 11 and 15). As well, numerous shallow pits were dug at these sites to confirm the presence or absence of buried debris. While the majority of these sites had the appearance of just being a convenient spot to dump a load of wood and other debris, several of them had the appearance of being an area where the natural vegetation had been cleared and debris had been buried. This is especially noticeable along the trail running south from the Alaska Highway at chainage 1607.914 km, as there had been extensive clearing along both sides of this trail. The trees and stumps had been pushed into windrows along both sides of the trail as is clearly seen in the 1948 air photos.

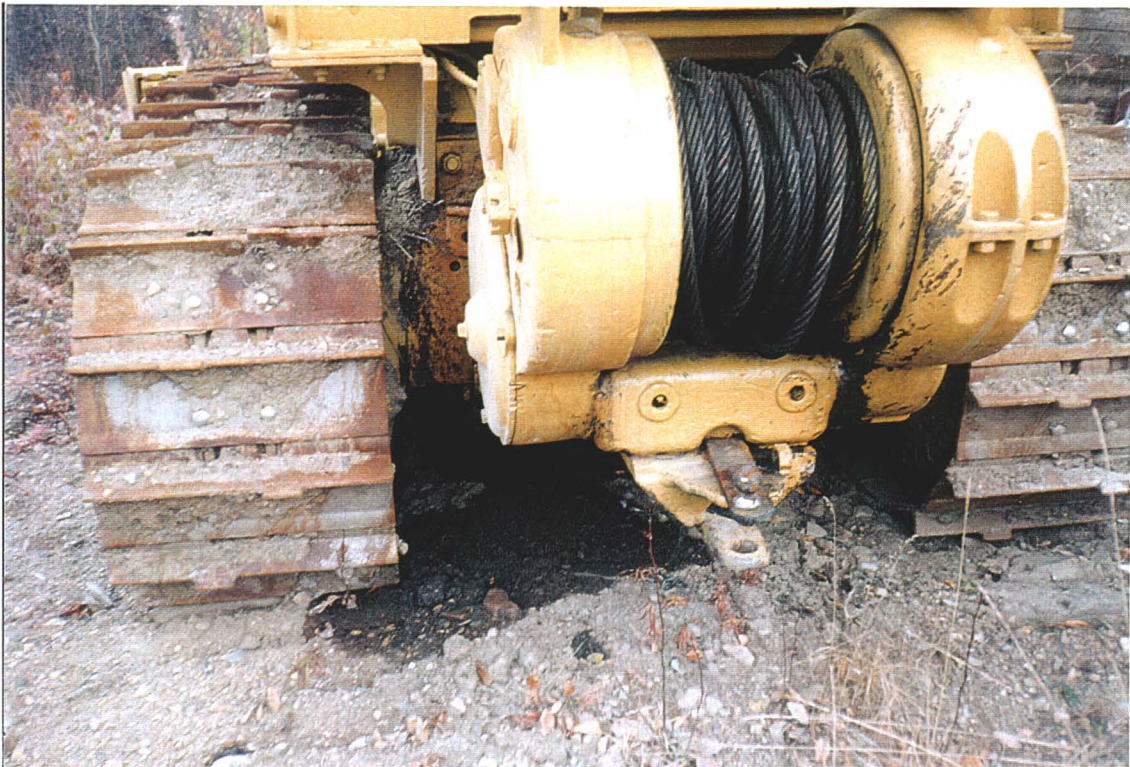
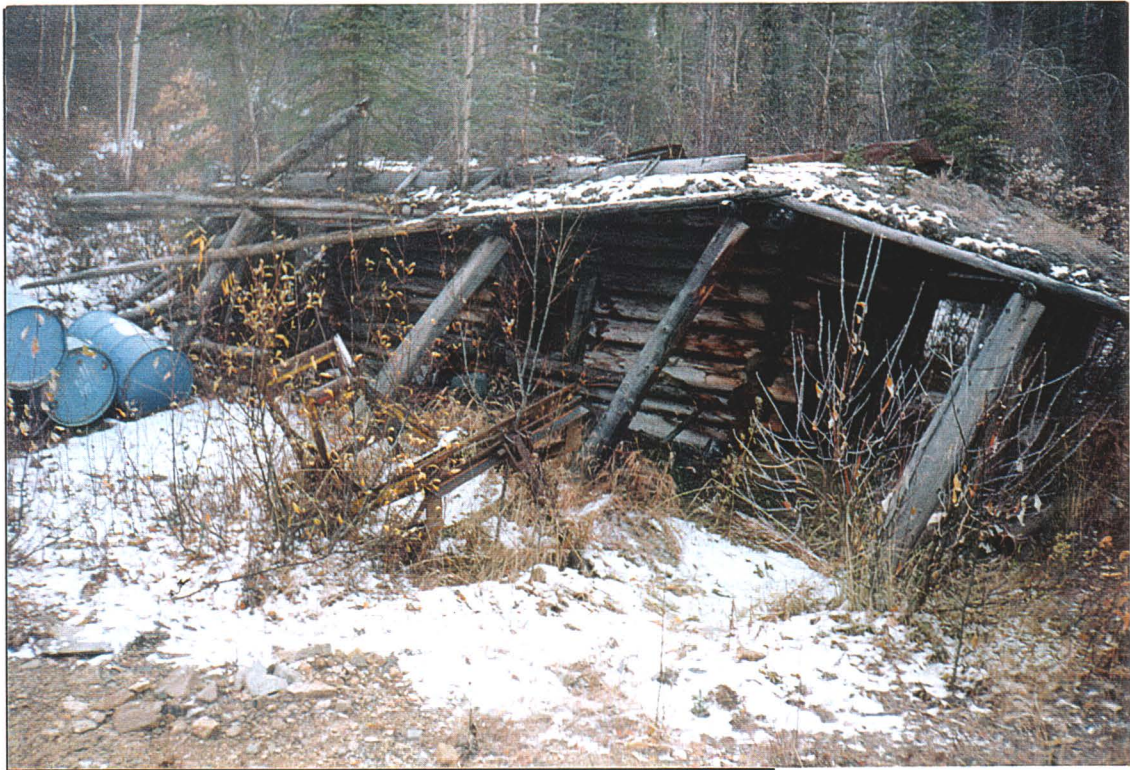
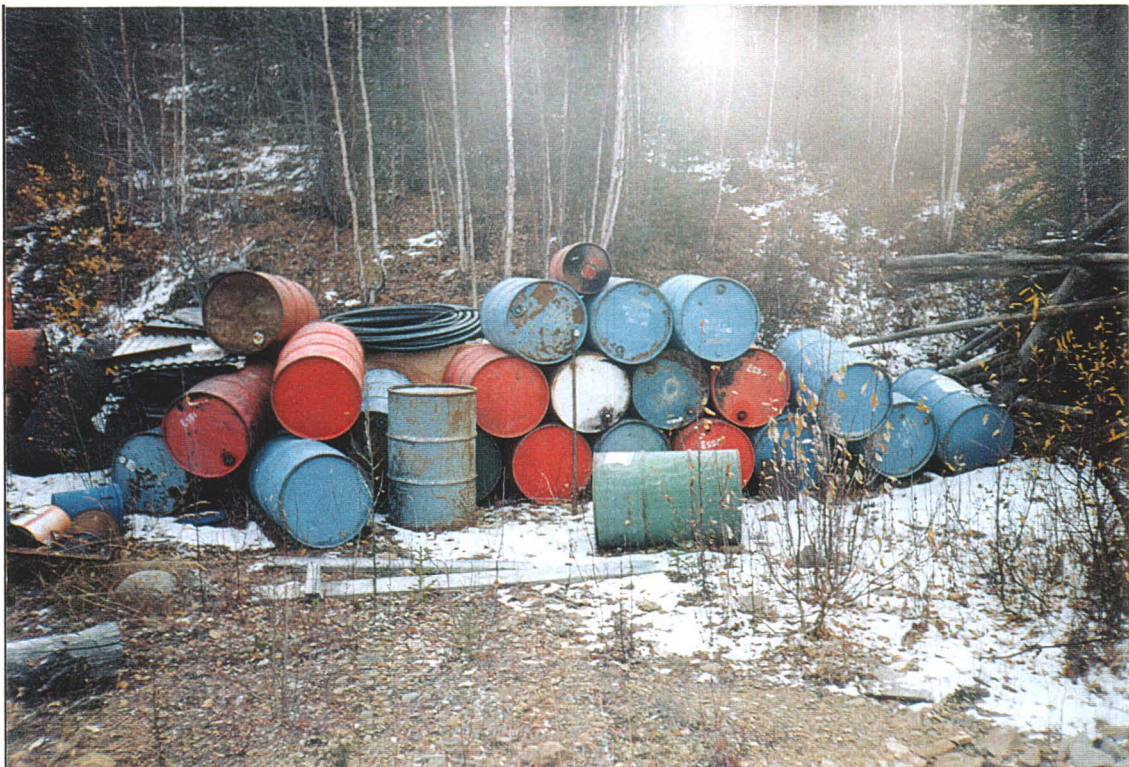
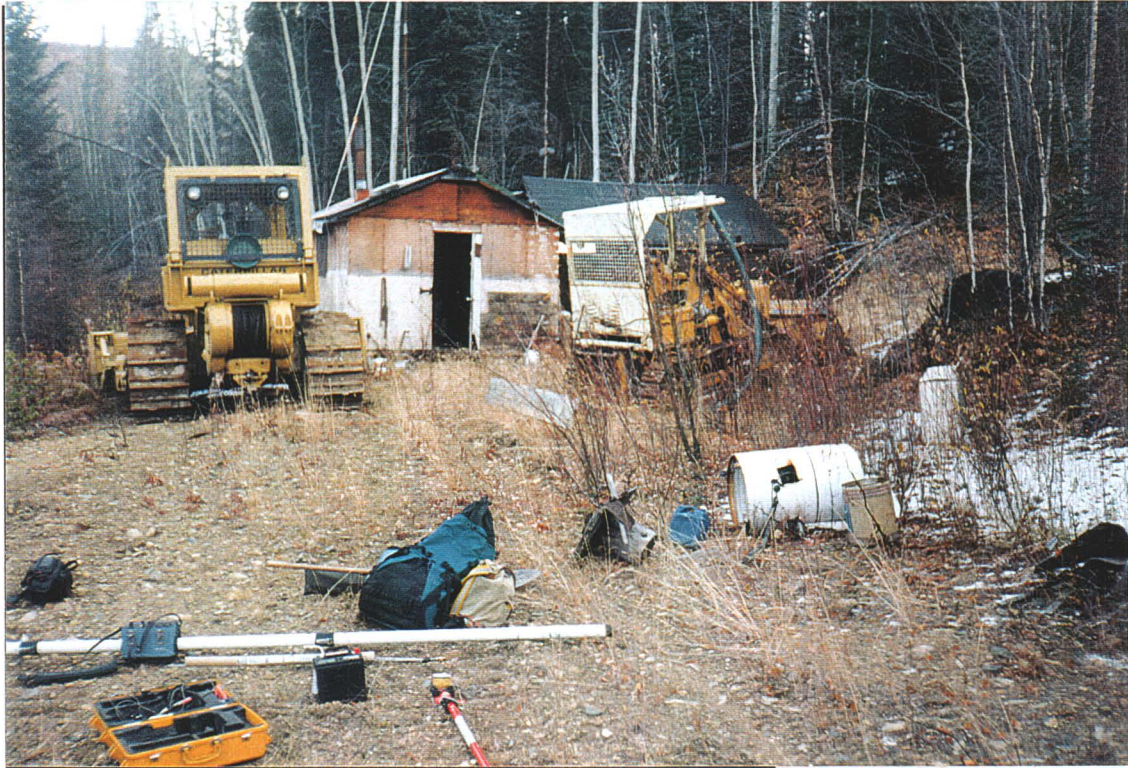
(See plates 14 through 17)

- diesel fuel barrels (empty)
 - 14 blue - Chevron H. Diesel, Aug. 84, May 85
 - 17 red - Esso (Imperial Oil)
 - 1 small red (no label)
 - 1 green - Isopropyl Alcohol
- old log cabin
