**1997 Environmental Investigations along the
Canol Road**

Prepared For:
Ross River Dena Council

Prepared By:
Gartner Lee Limited

May, 1998

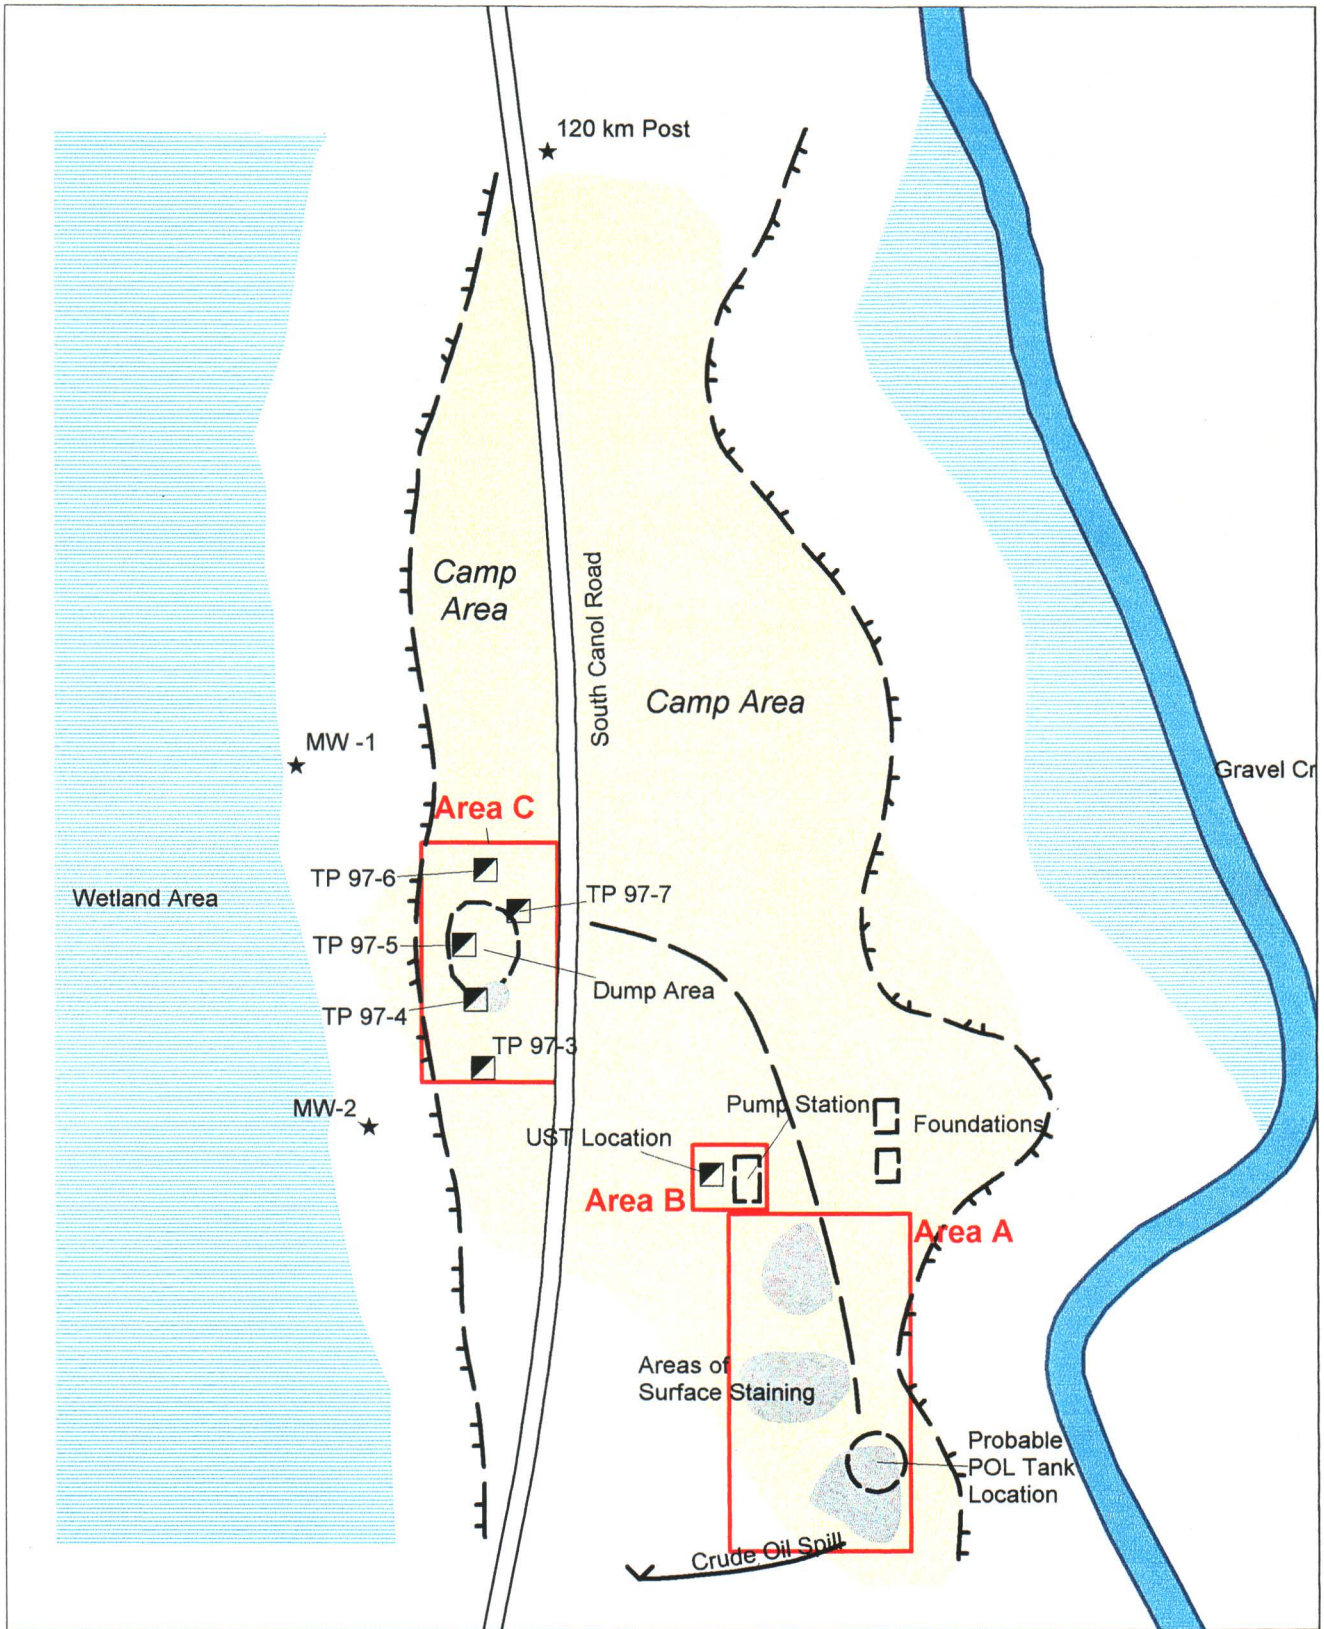
1. soils in excess of 2 m in depth around the POL tank site (Area A in Figure 4) have been impacted by petroleum hydrocarbons at concentrations which exceed the Parkland and Industrial criteria;
2. an Underground Storage Tank (UST) is located adjacent to the pump station foundation (Area B in Figure 4) and the soils beneath the tank have been impacted by petroleum hydrocarbons at concentrations which exceed Special Waste criteria;

The dump site area has been defined as shown in Figure 4 with an extent of approximately 25 x 20 m.
Debris has been encountered in test pitting up to 1.5 m below the surface. The dumps site was found to
contain drums of grease and motor oil (Phillip sample ID 97031496). These drums represent potential
sources of contamination since they contain free hydrocarbon product. Soil samples from the dump site

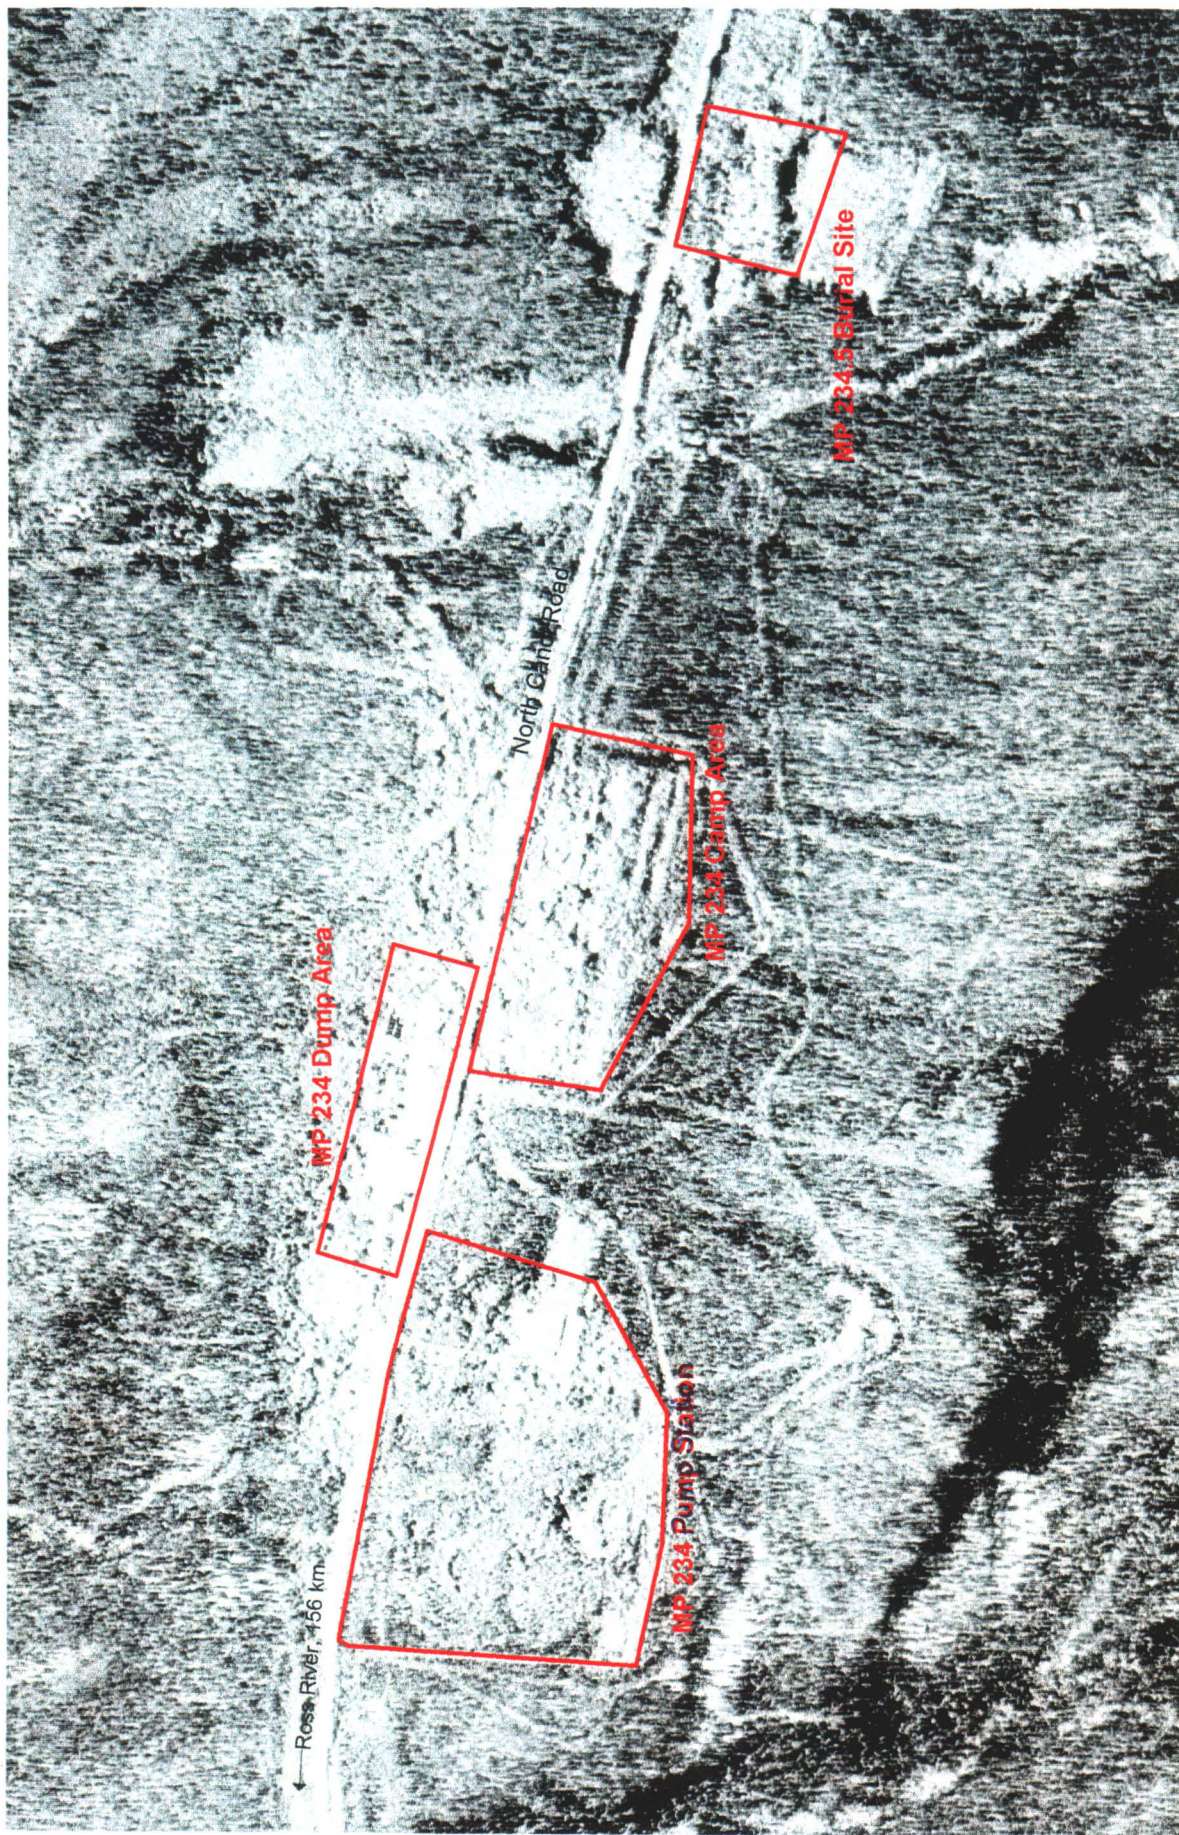
Figure No.
11

Three groundwater samples were collected from the monitor wells installed down gradient of the dump site (MW-1, MW-2 & MW-3 on Figure 11). Groundwater samples were analyzed for hydrocarbons. The complete analytical results are presented in Table 4.6.2 and Appendix B.

Of the three samples, only MW-1 detected hydrocarbons. Although there are no regulated guidelines for hydrocarbon concentrations in groundwater, the light extractable hydrocarbon concentrations encountered in MW-1 (0.9 mg/L) were quite high

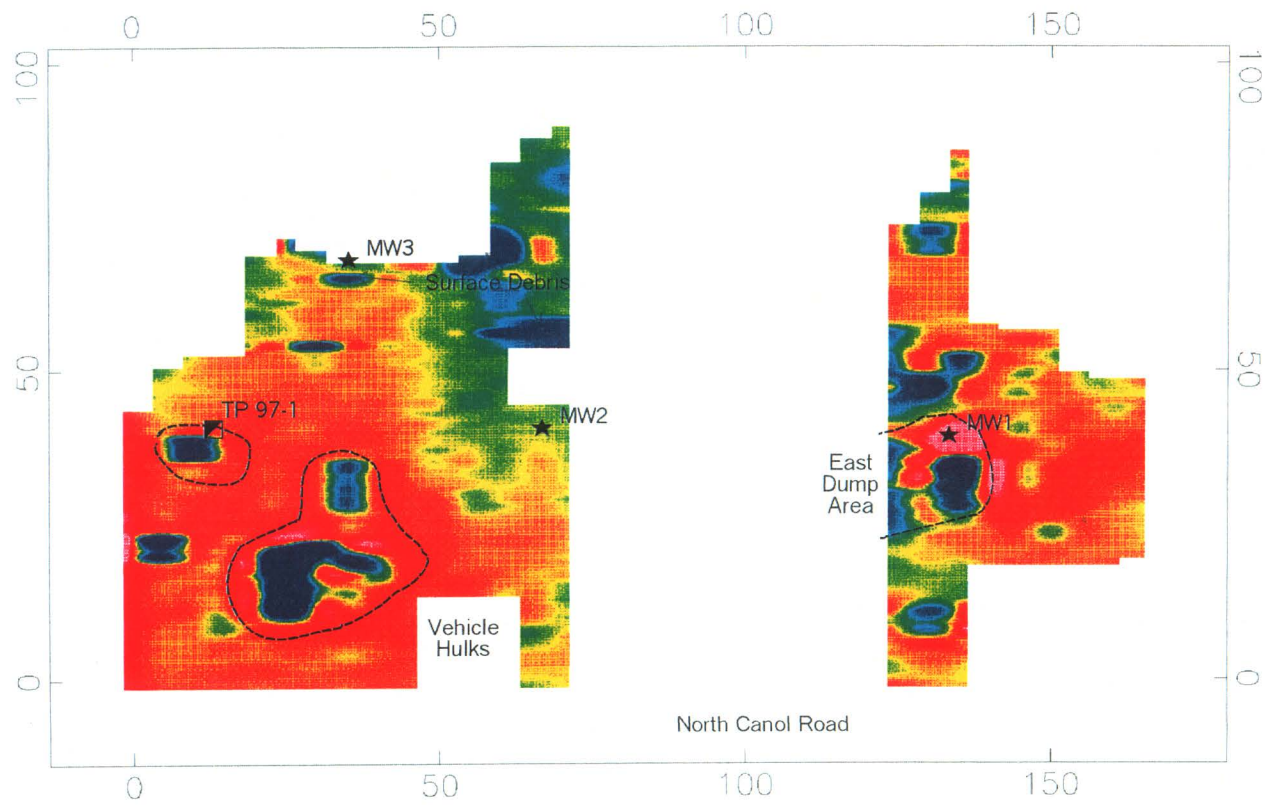
Mile Post 234
Terrain Conductivity (mS/m)
DRAFT MAP

A second area to the east of the original burial had been found during excavation of MW-1. The geophysical survey has indicated an eastern extent to the buried material, but due to time constraints, the westerly limits of the dump area are yet to be determined. Soil sampling in this eastern dump area should be conducted to determine if soil contamination is associated with the burial of the metallic debris encountered.

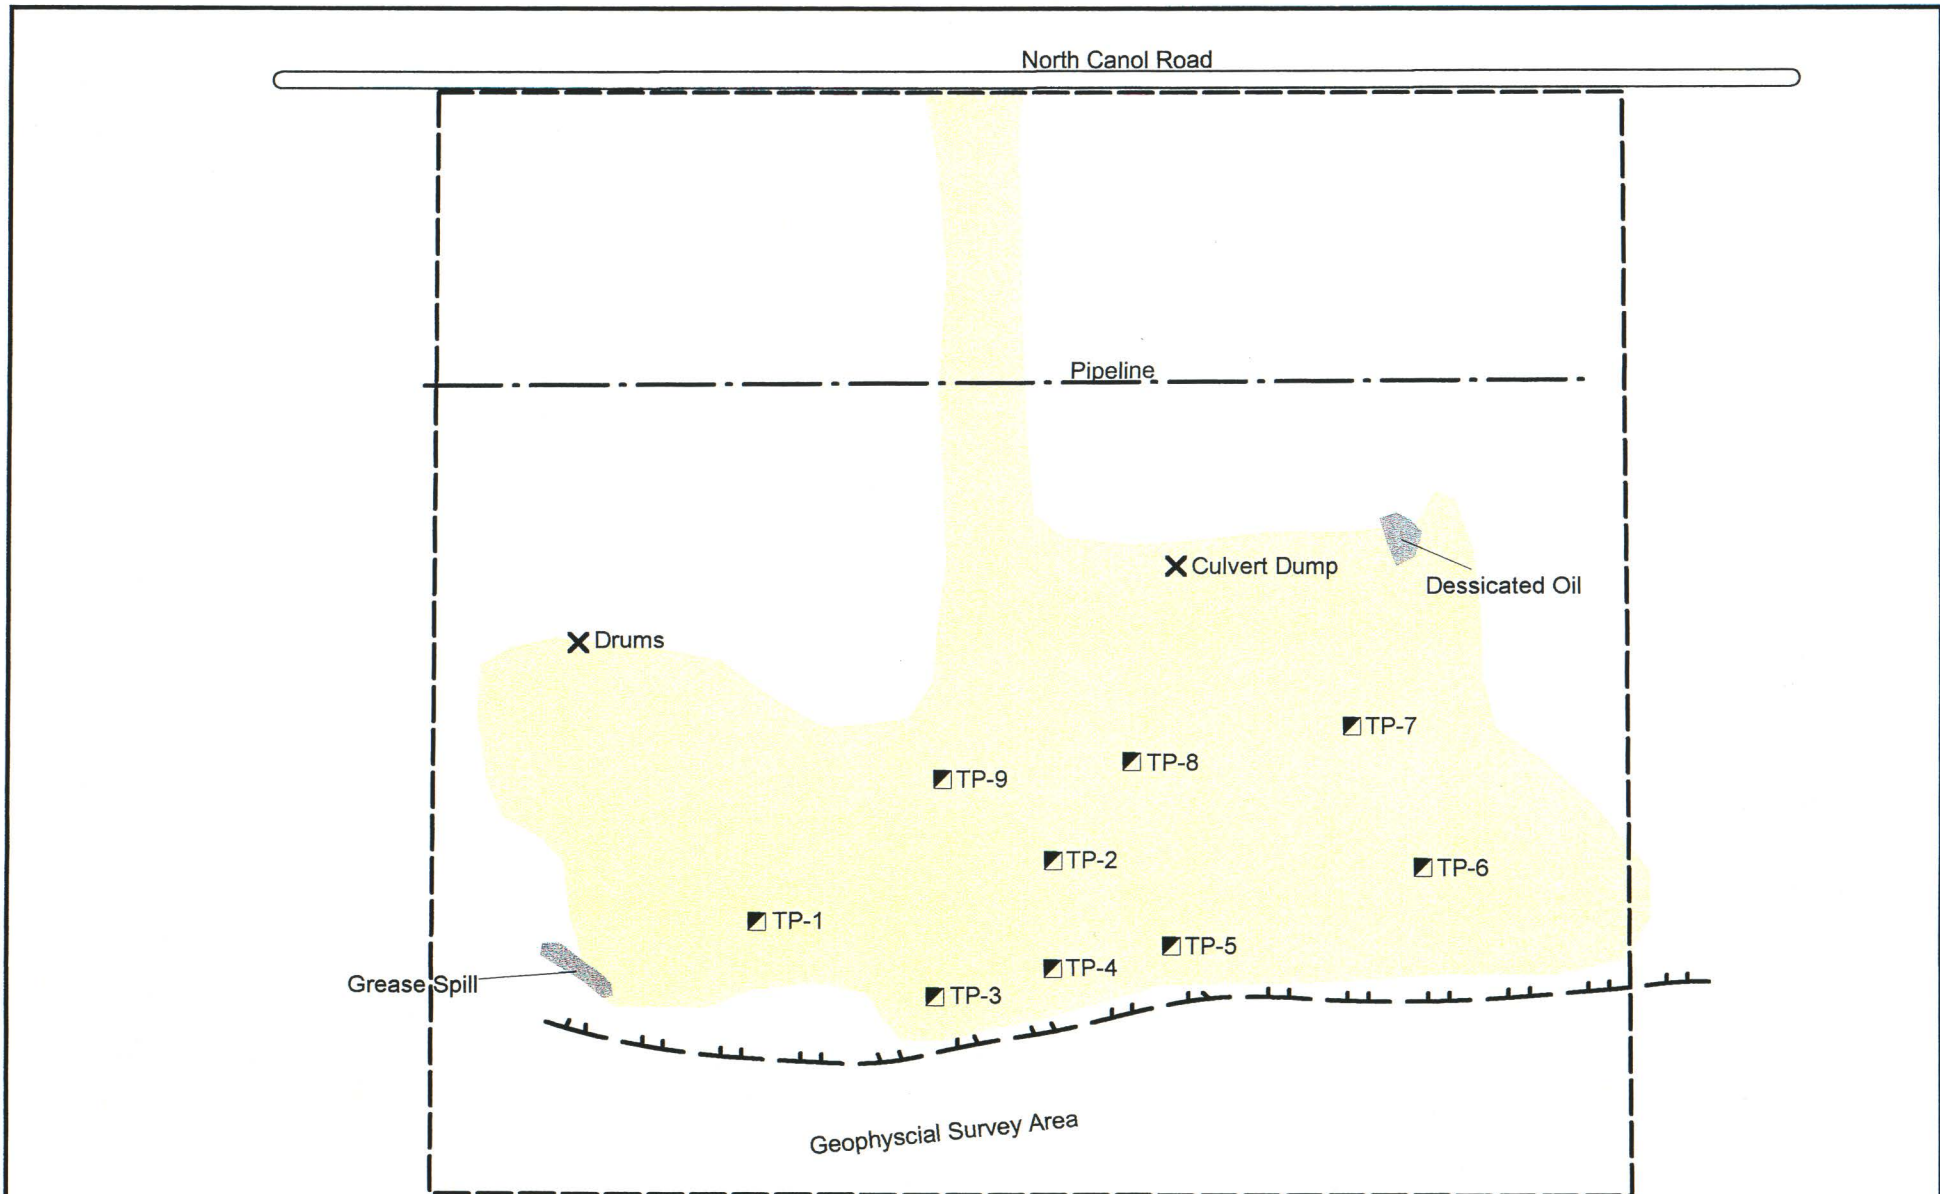
Less than one kilometre east of site MP 234, a second debris burial site was located south of the North Canol road (Figure 11 and 12). This site has been called MP 234.5 and was located by Ross River residents. The site consists of a clearing approximately 30 south of the road. Pieces of culvert are piled on the northeast side of the clearing, and dried grease, desiccated oil and crushed drums are found sporadically over the area. Details of this area are shown in Figure 20.

A series of nine test pits were excavated in this clearing to investigate the buried waste. Soil samples were collected from all test pits and analyzed for hydrocarbon content. The location of the test pits are shown on Figure 20. Significant amounts of metallic debris were encountered in test pits TP 97-4 and TP 97-9. This debris consisted mostly of vehicle parts and miscellaneous metal.
