**PRELIMINARY ENVIRONMENTAL INVESTIGATIONS
AT SITES 1(WL066), 2(WL067), 27(HJ040), AND 29(HJ042)**

FOR
A.E.S. ACTION ON WASTE

BY
LABERGE ENVIRONMENTAL SERVICES

JANUARY, 1997

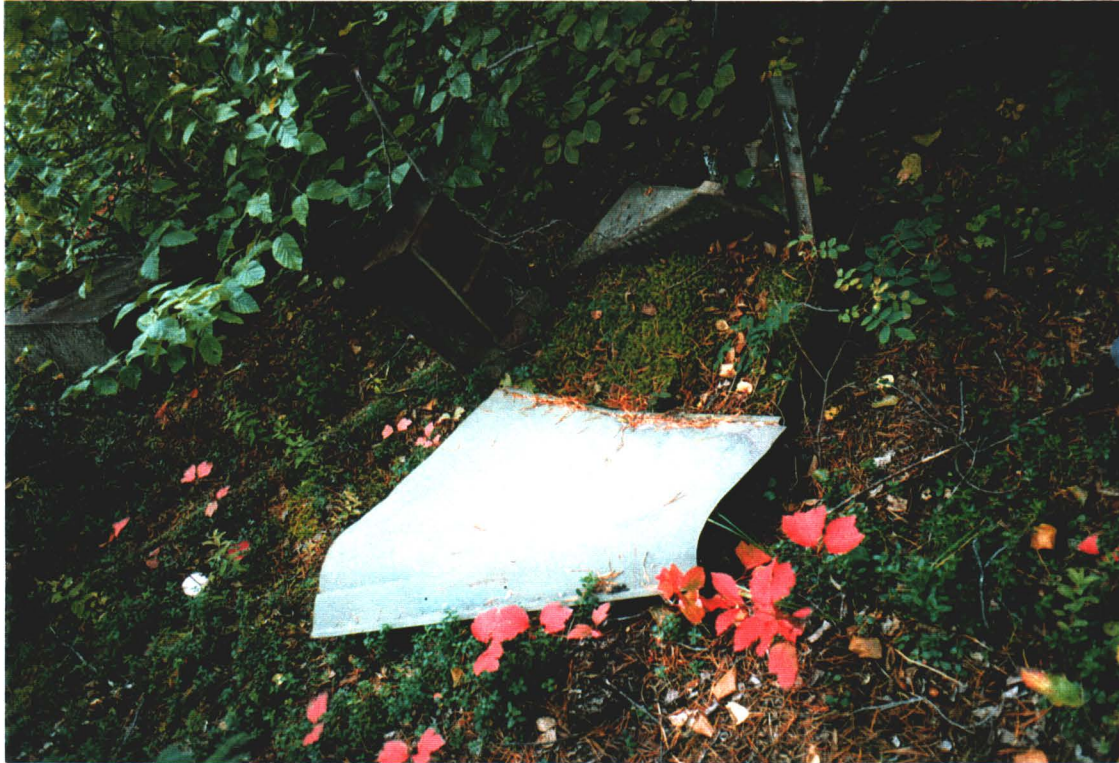
PLATE I1- WWII garbage dump, over embankment along east side of pond.

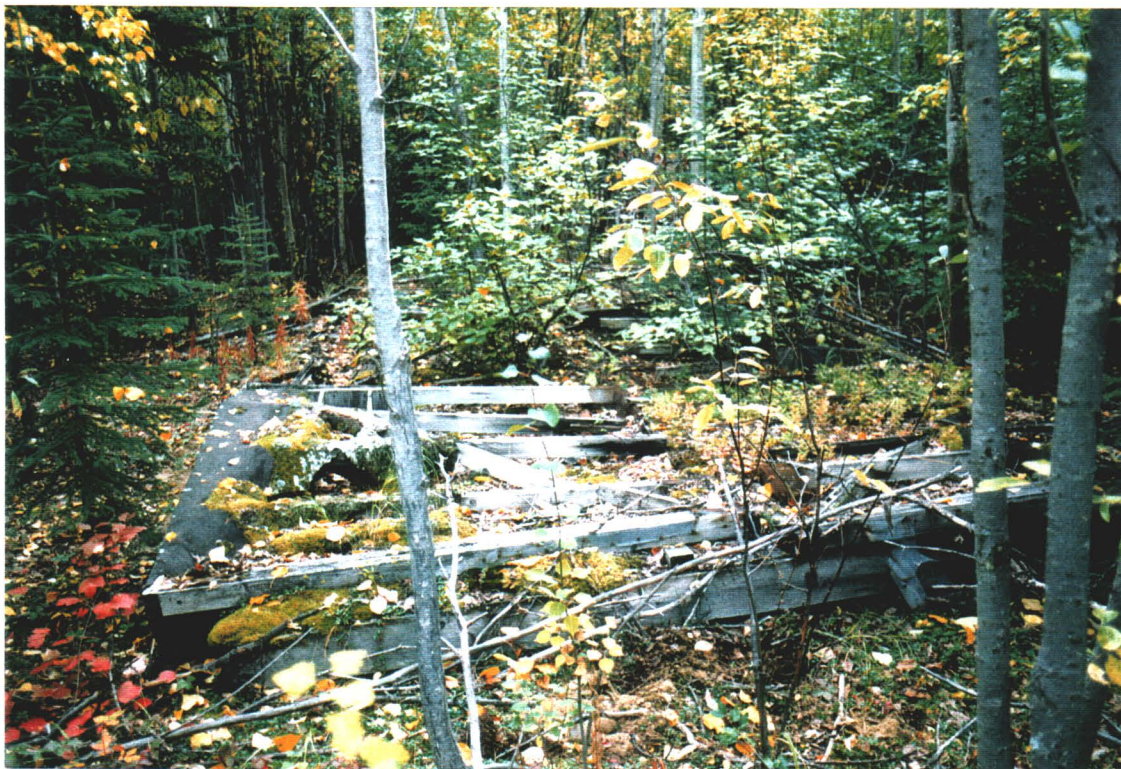
PLATE I2 - One of only two remaining collapsed army construction site buildings.

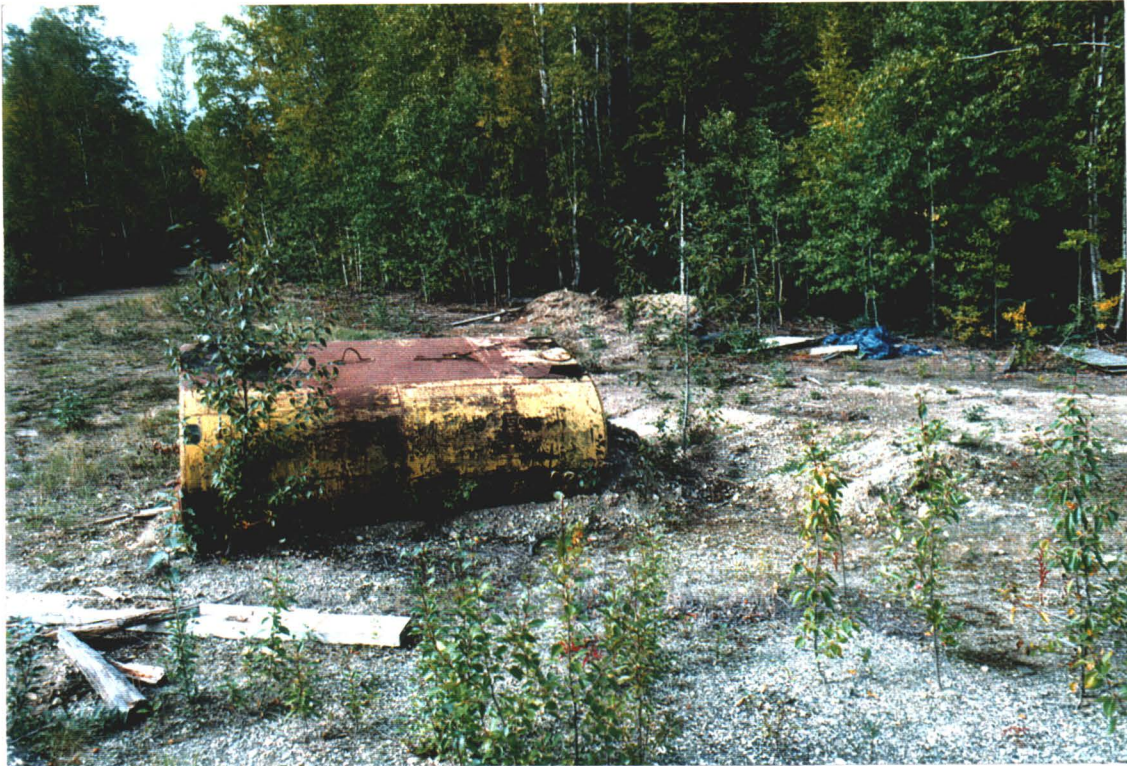
PLATE 13 - Tar tank disposed in clearing south of camp. Typical of junked equipment in the cleared area.

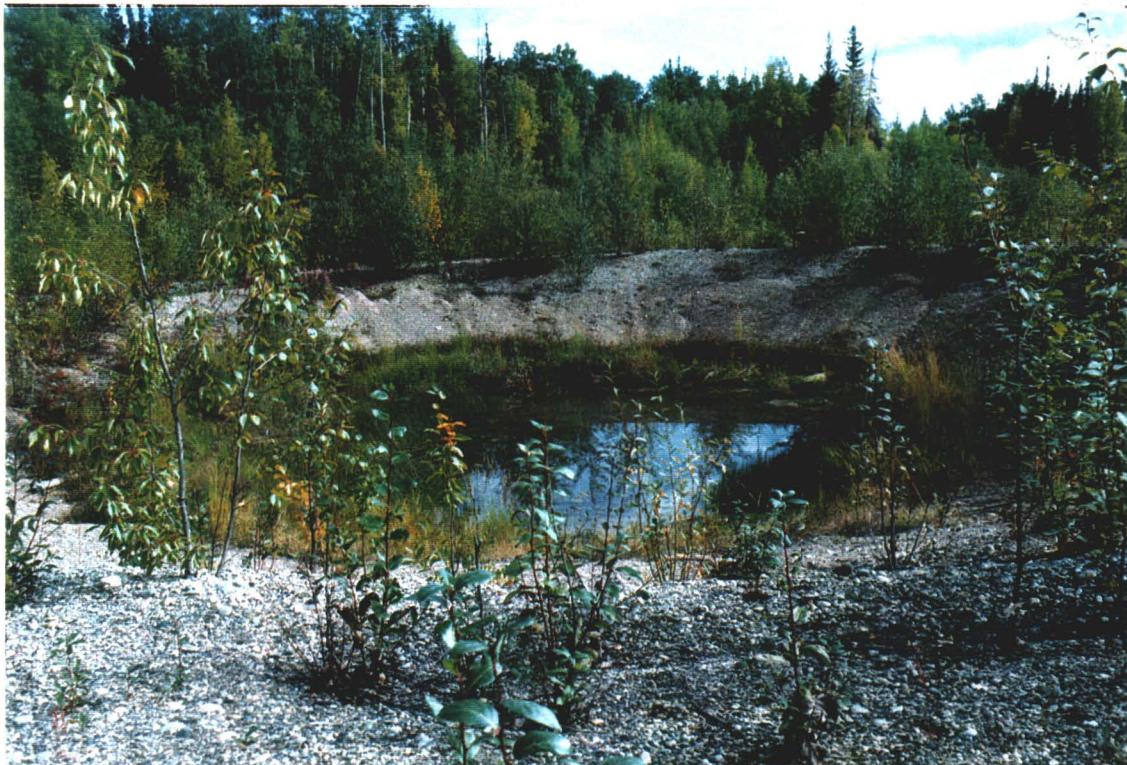
PLATE 14 - Unused sewage disposal pit in clearing south of camp. According to local residents, the pit was never used.

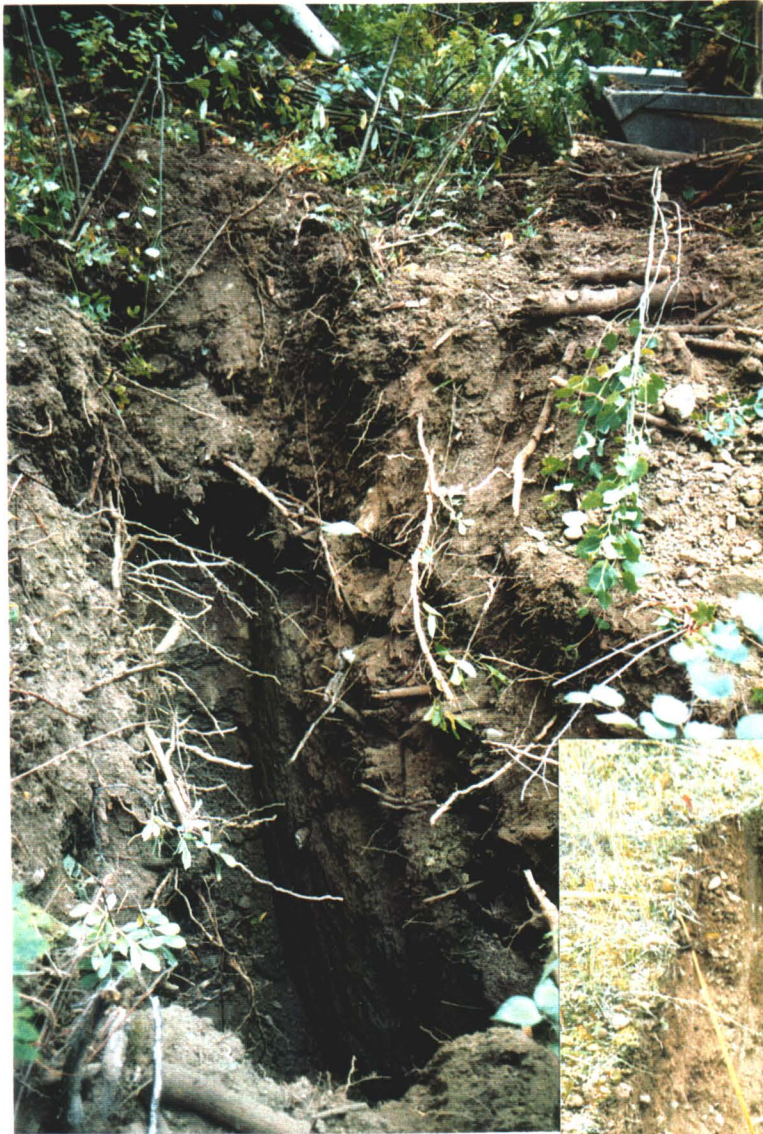
PLATE I5 - Test Pit TPI-7 at north east corner of site between collapsed army buildings.

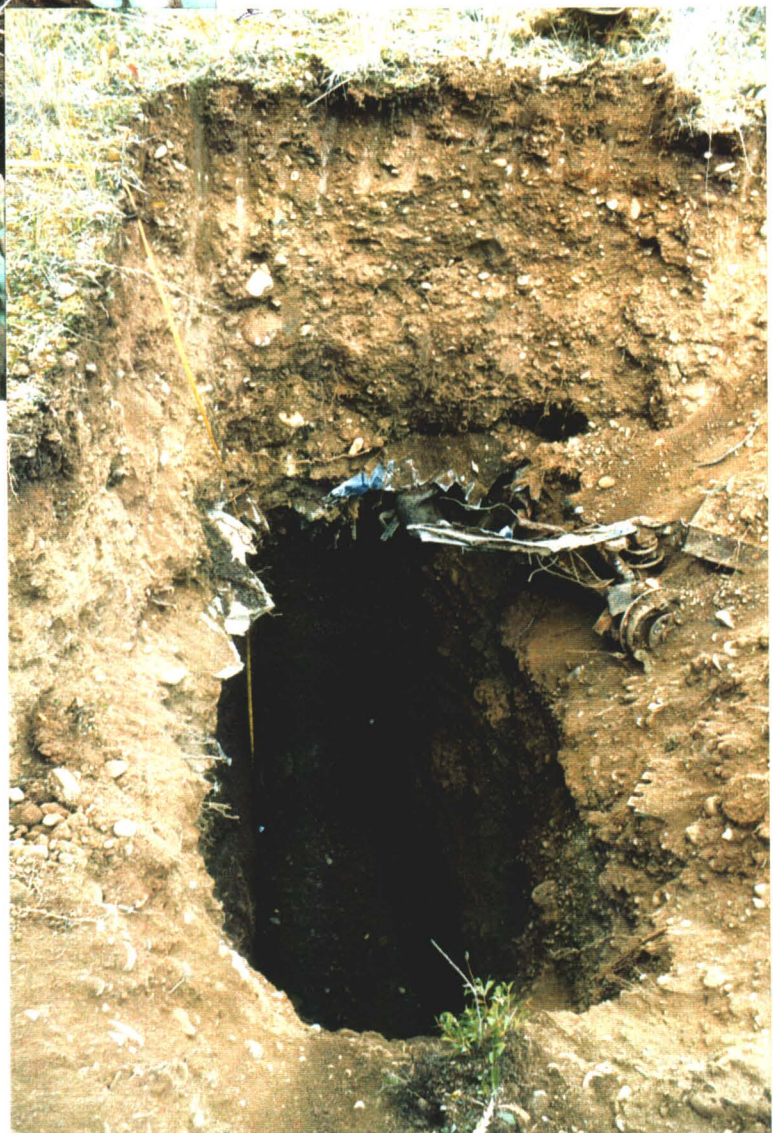
PLATE I6 - Test Pit TPI-1, edge of back filled dump site in clearing south of the camp.

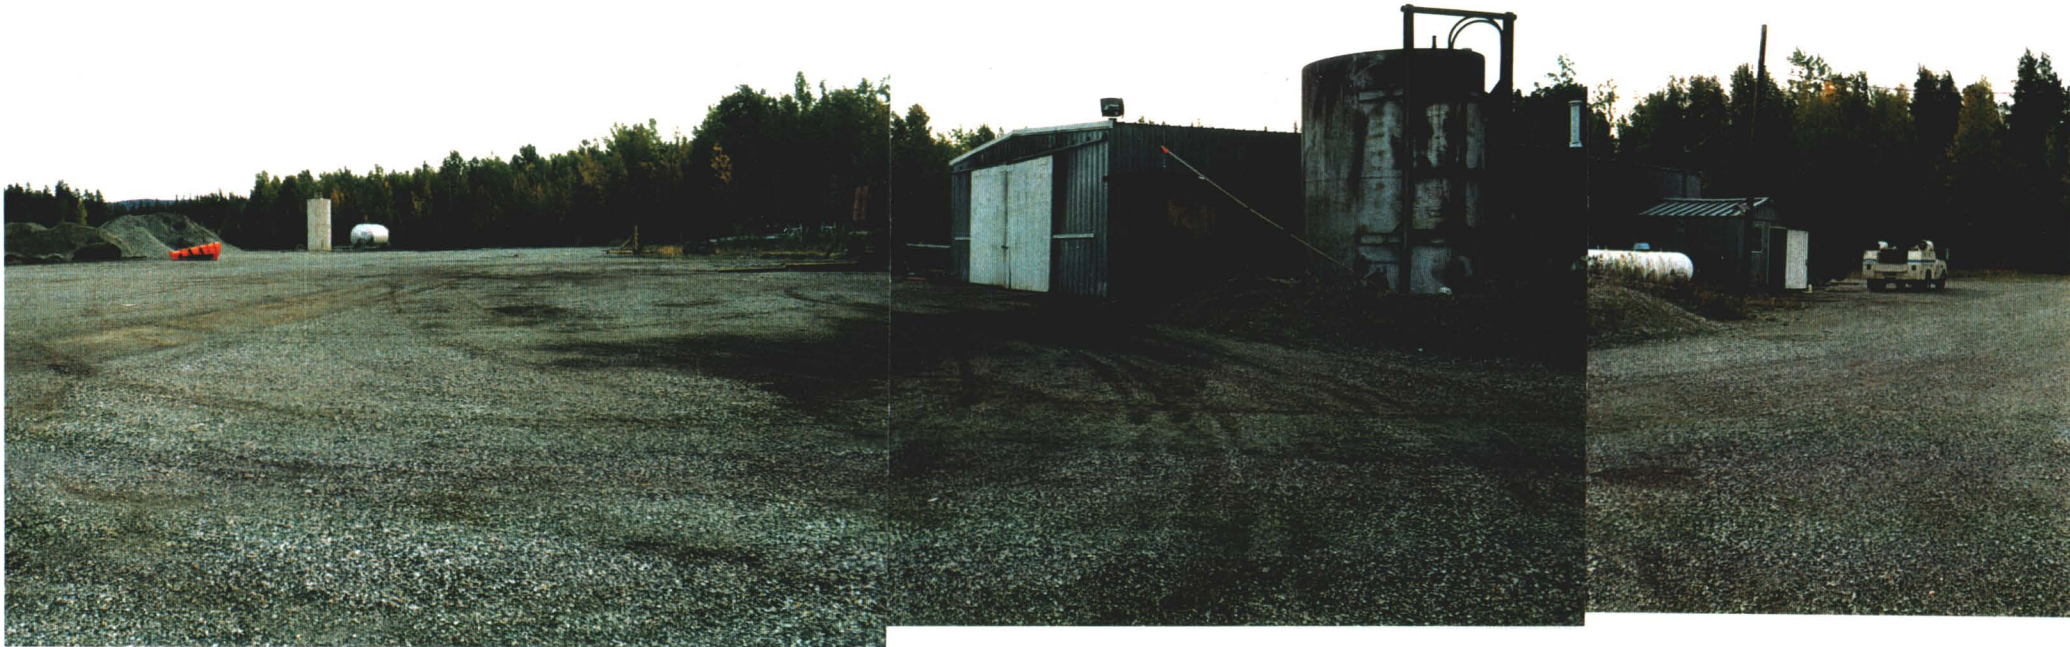
PLATE 17 - Existing clearing at Iron Creek site, currently used for road maintenance under contract to Public Works Canada. The original army road construction camp was located here.

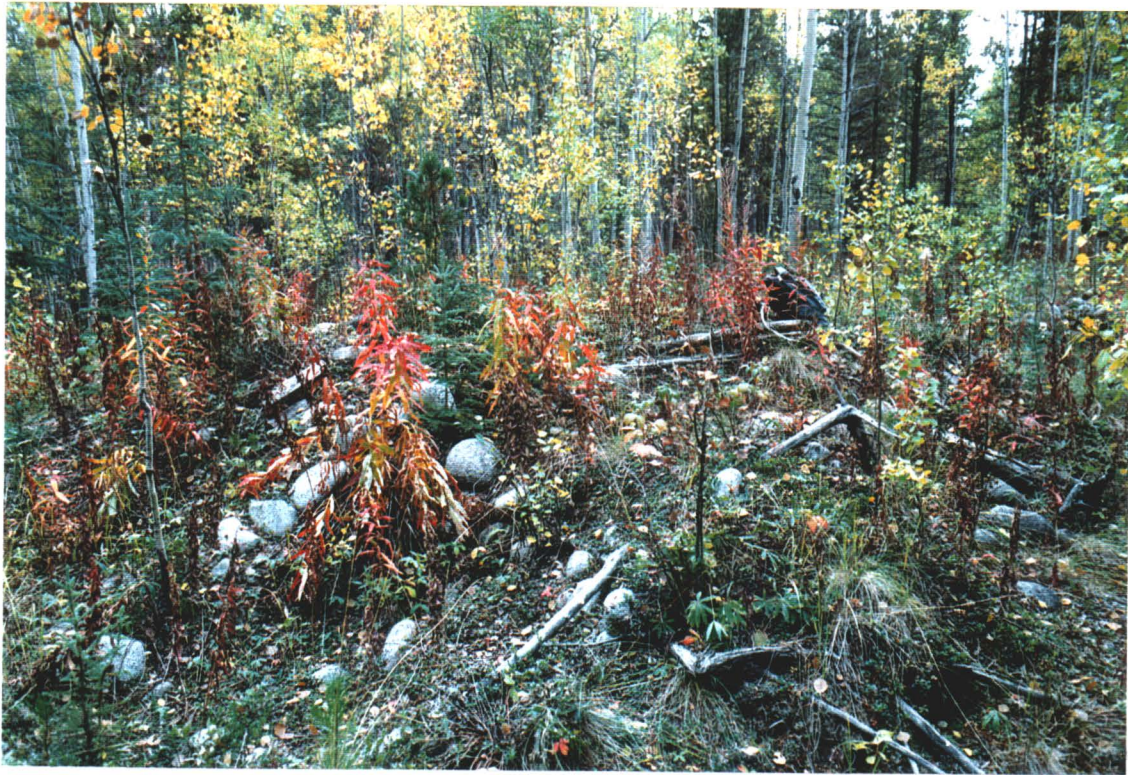
PLATE R1 - Typical of former camp building restoration work.

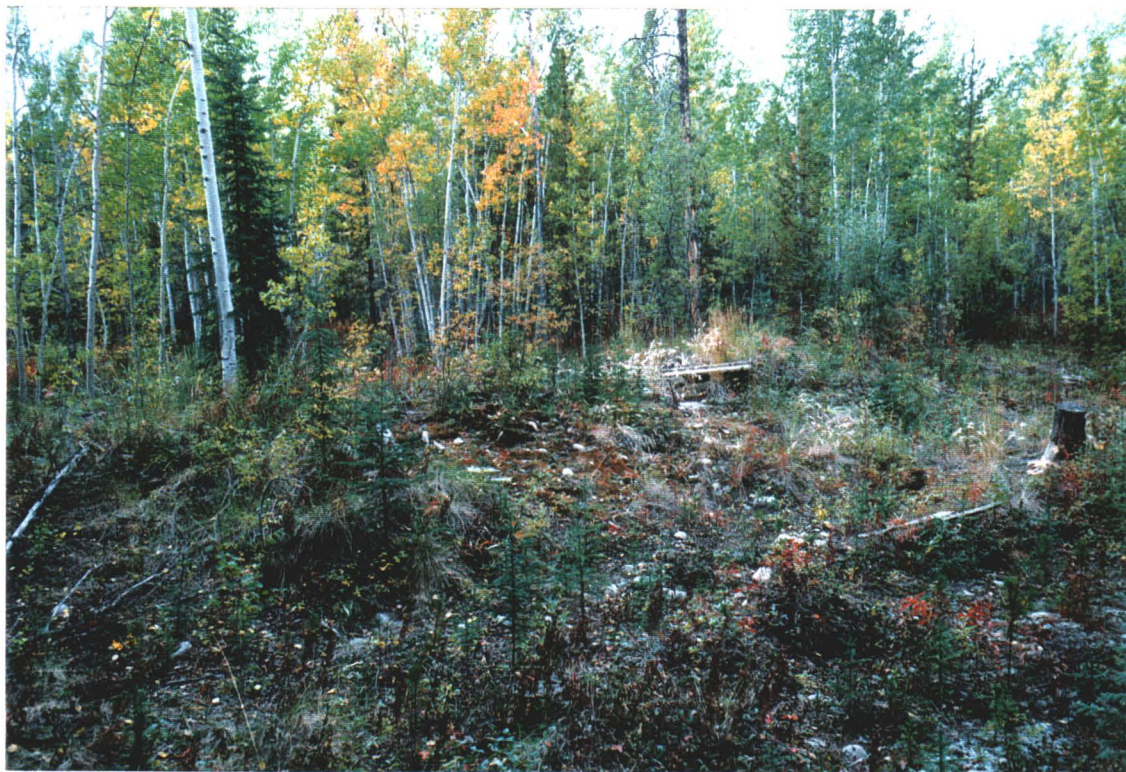
PLATE R2 - Power house site. Hydrocarbons detected in backfill material.

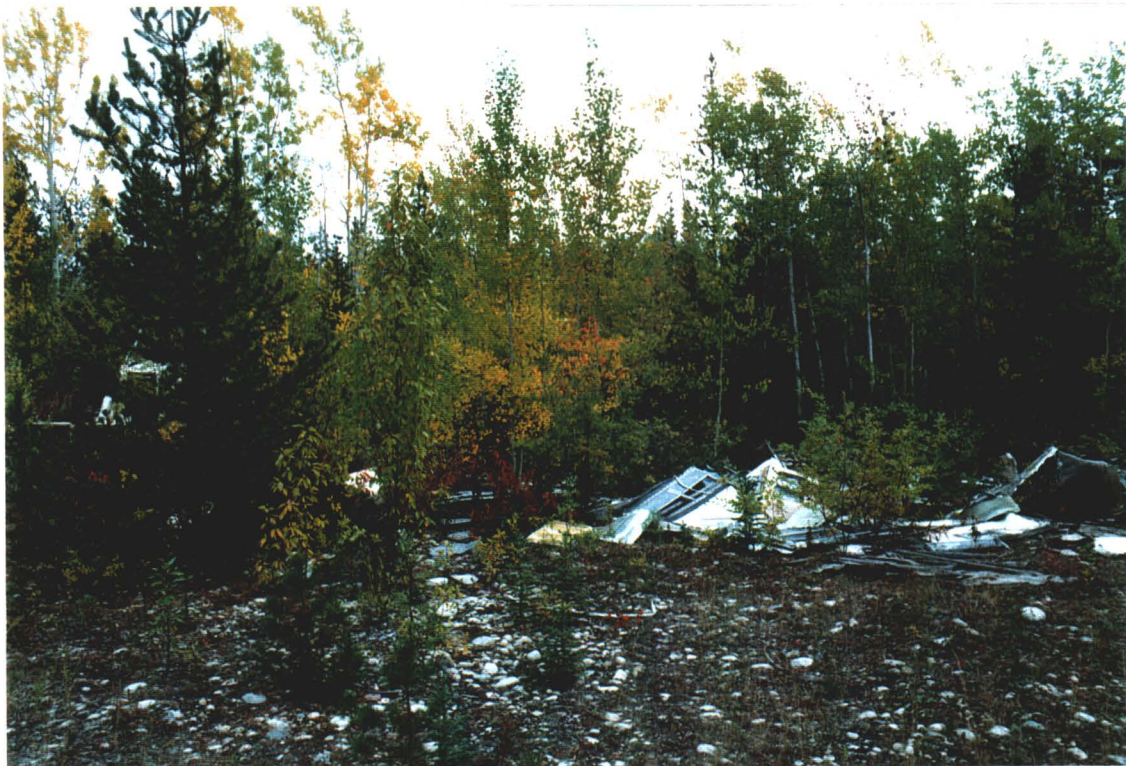
PLATE R3 - Looking east at edge of old army dump.

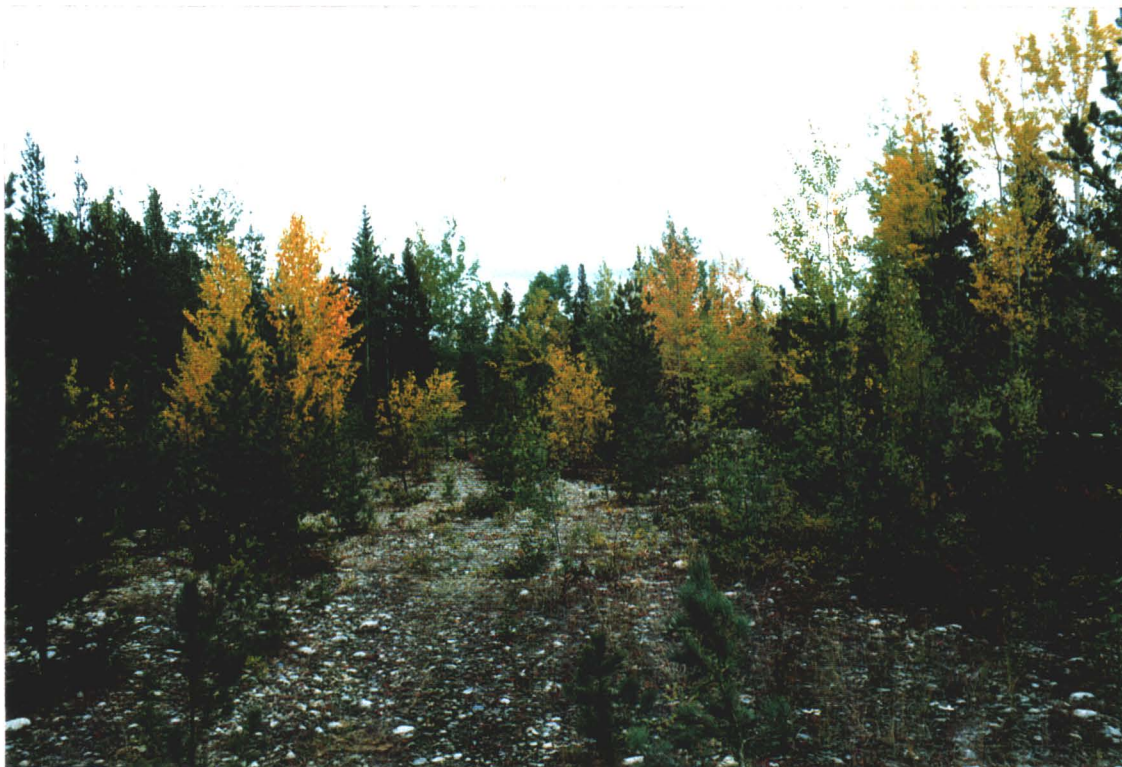
PLATE R4 - End of access to old army dump, edge of dump on right.

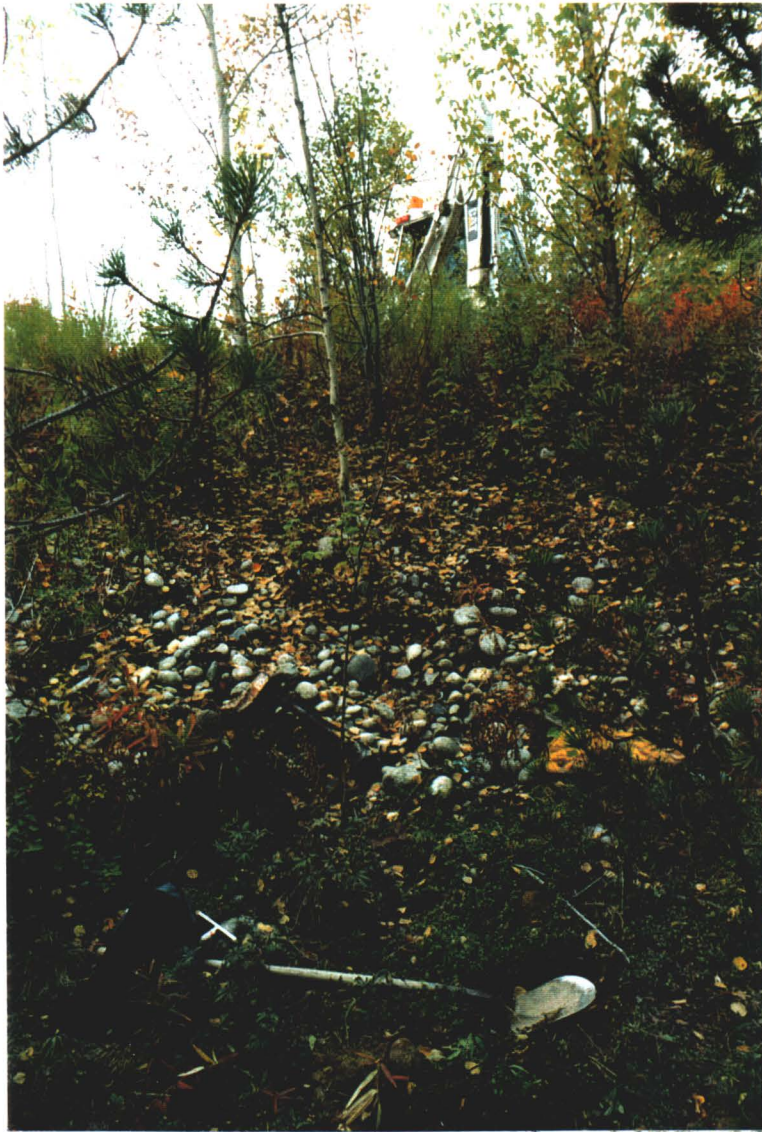
PLATE R5 - Toe of old army dump. Test pit R - 2 on crest above.

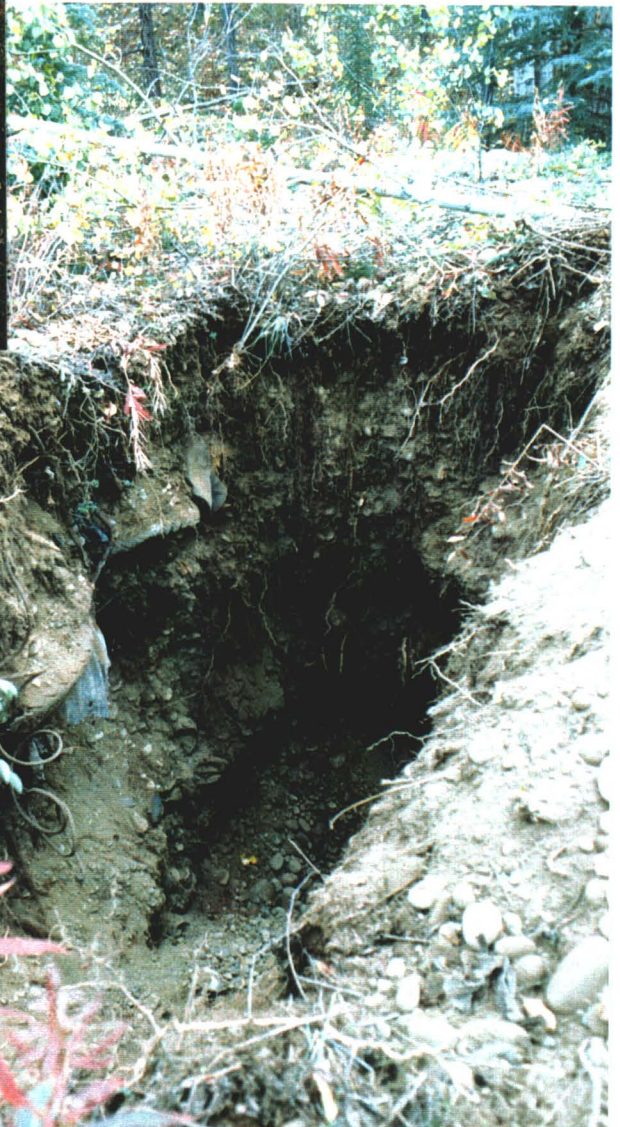
PLATE R6 - Test Pit R - 2, crest of old army dump.

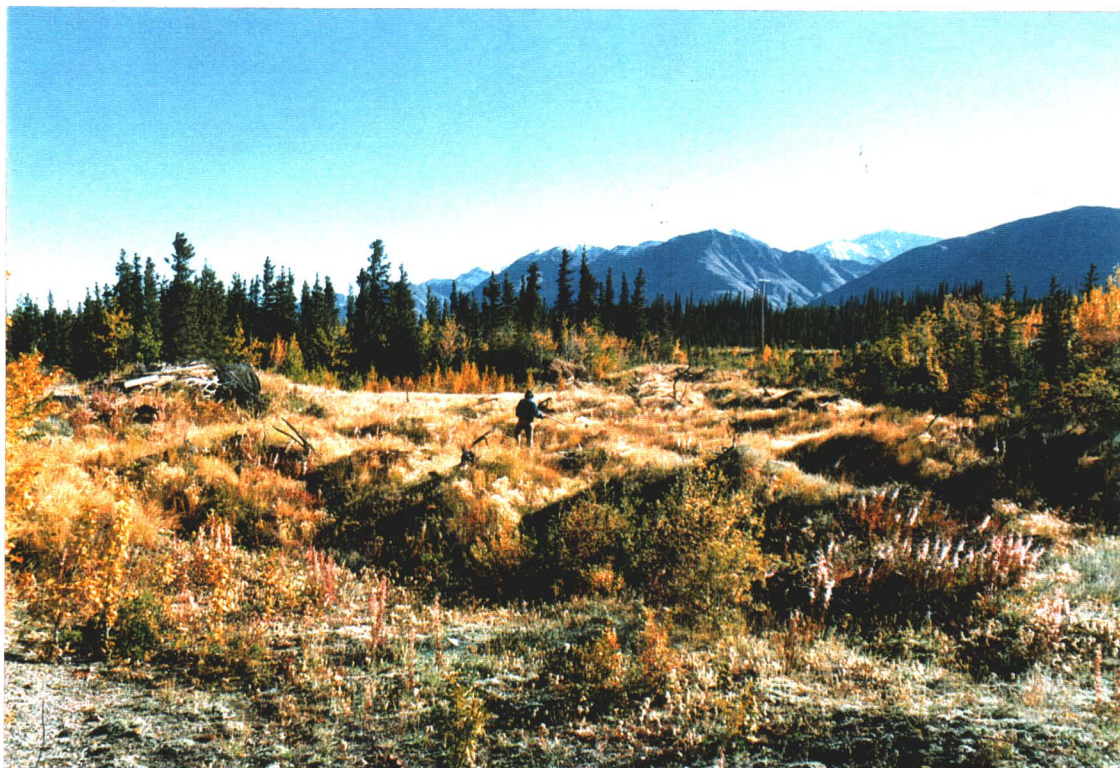
PLATE B1 - Looking south across buried dump from access road.

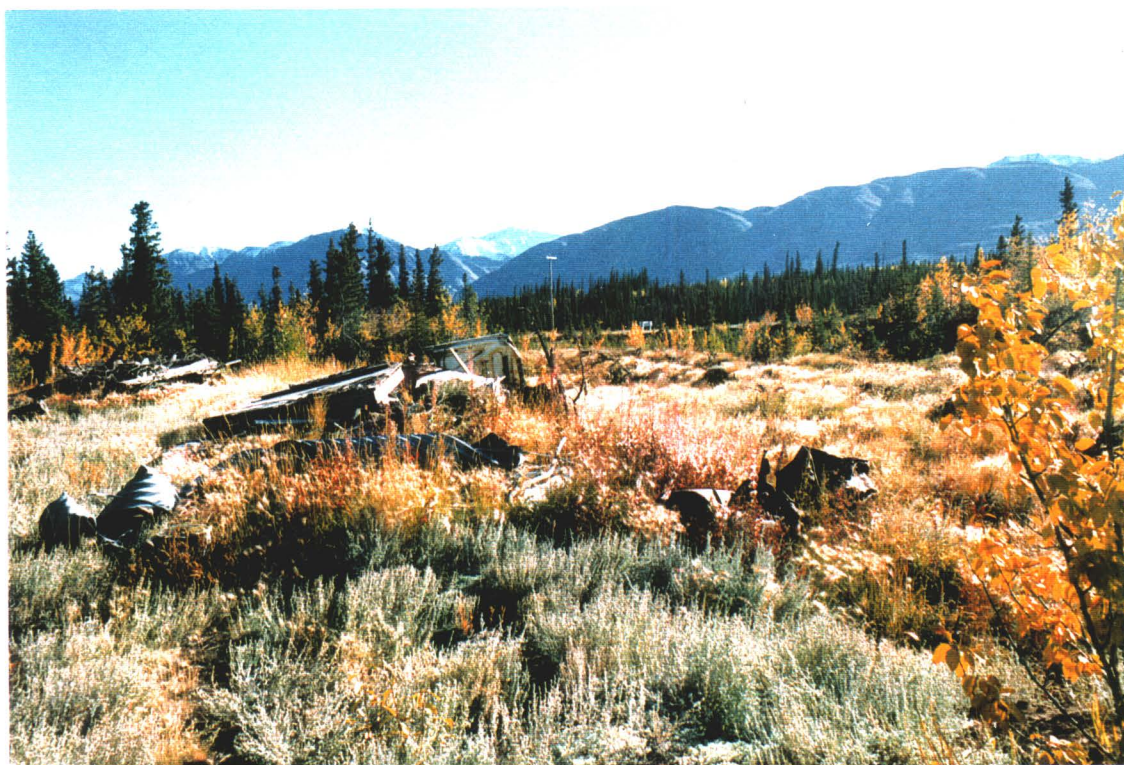
PLATE B2 - Looking south along edge of old dump at remaining metal waste.

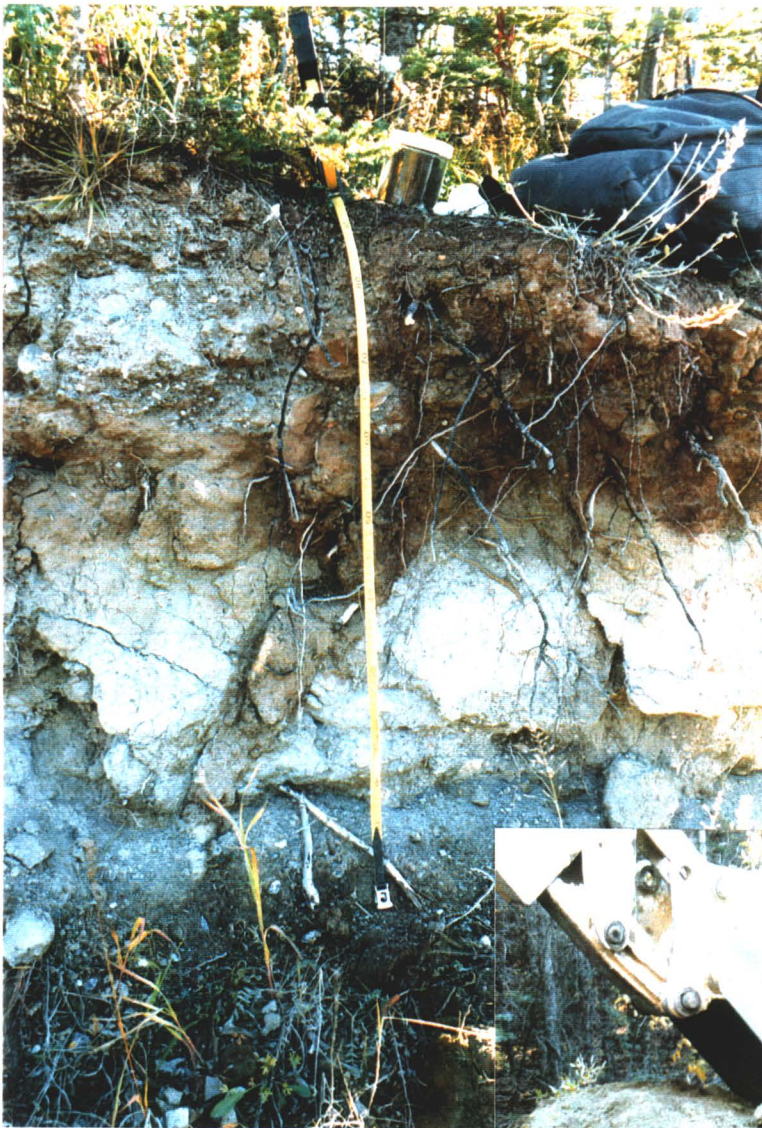
PLATE B3 - Exposed cut bank at south end of old dump.

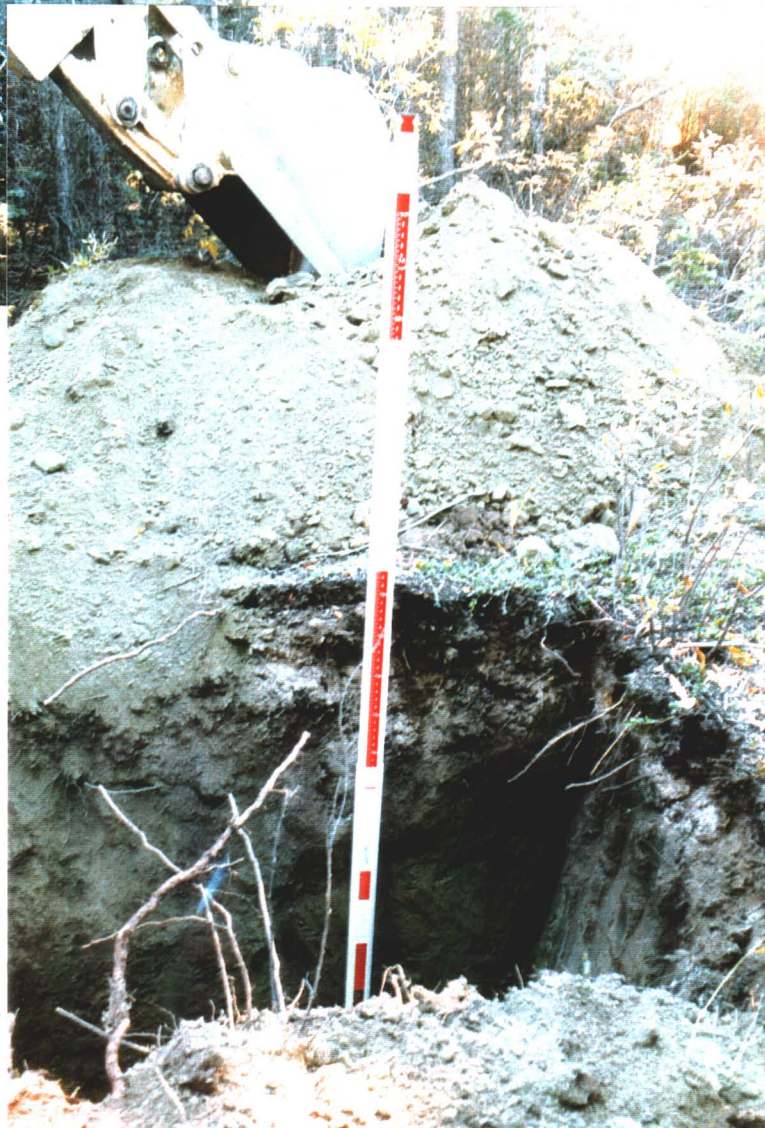
PLATE B4 - Test Pit B - 1 at the southern edge of the old dump.

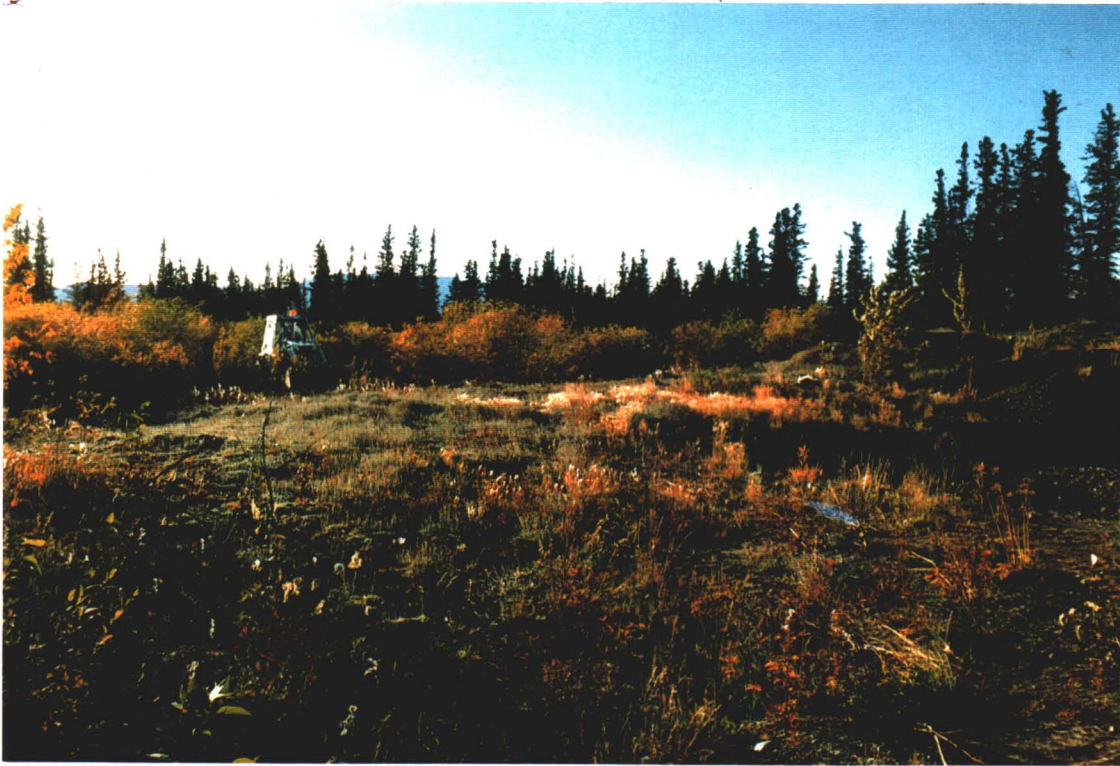
PLATE B5 - Test pit B-5 in cleared area across the access road directly north of the old dump.

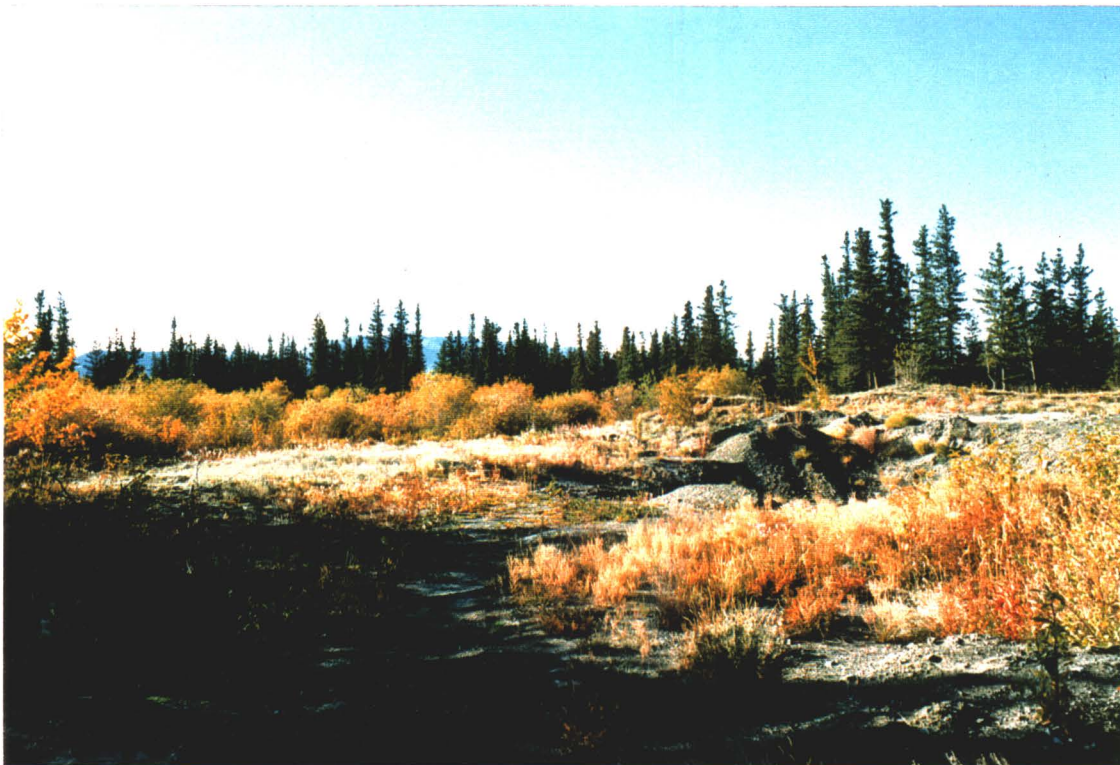
PLATE B6 - Casual borrow pit, former location of old Pan American Construction building, across the access road directly north of the old dump.

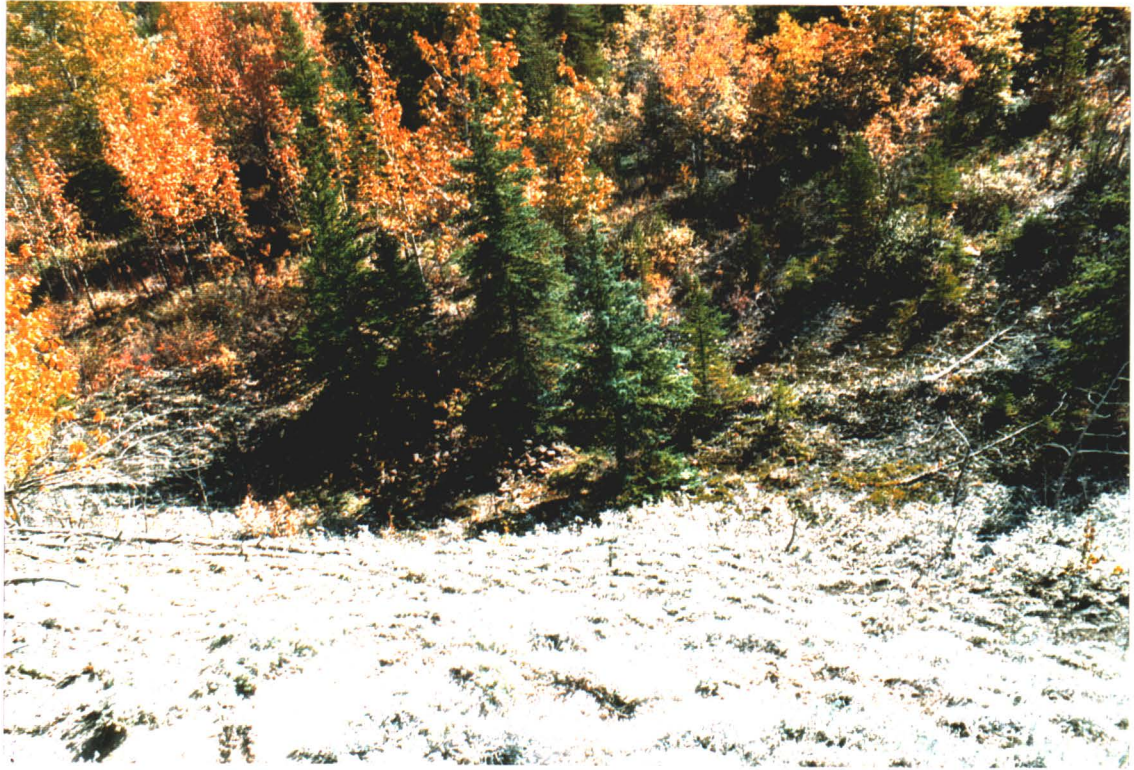
PLATE S1 - Looking down on casual garbage dating to road construction.

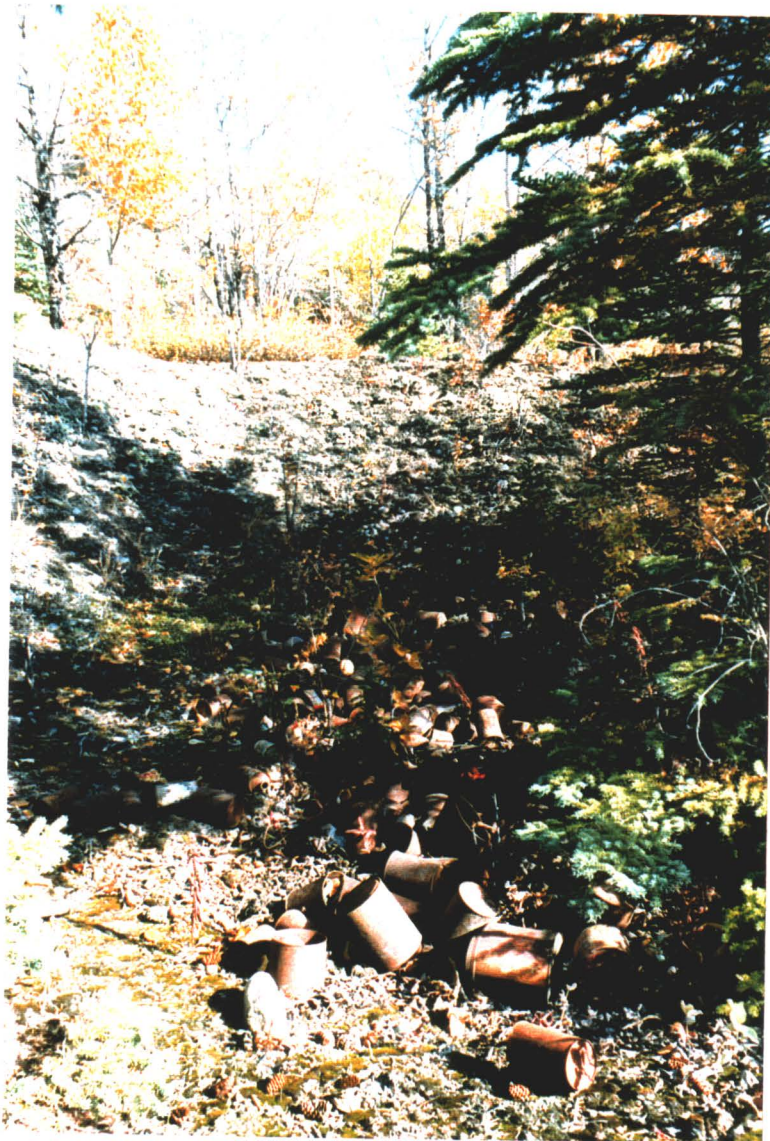
PLATE S2 - Typical of old construction era dumps along road embankment.

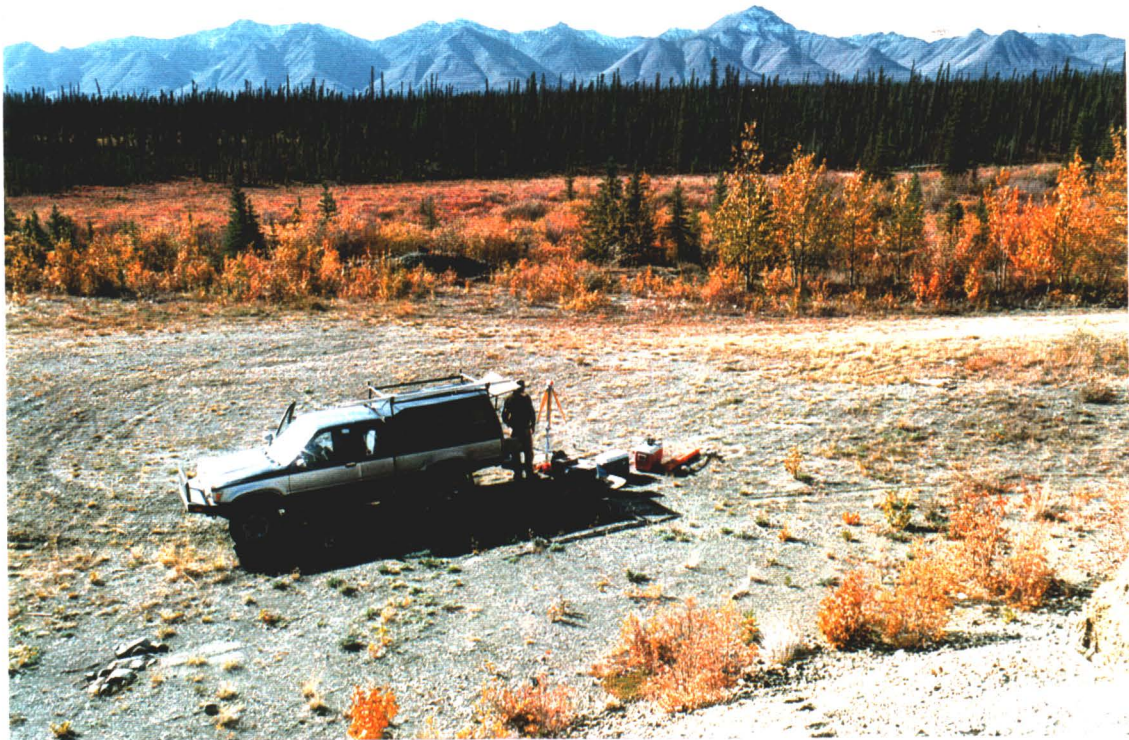
PLATE S3 - Looking south across clearing, old buried dump is at edge of clearing, creek just beyond.

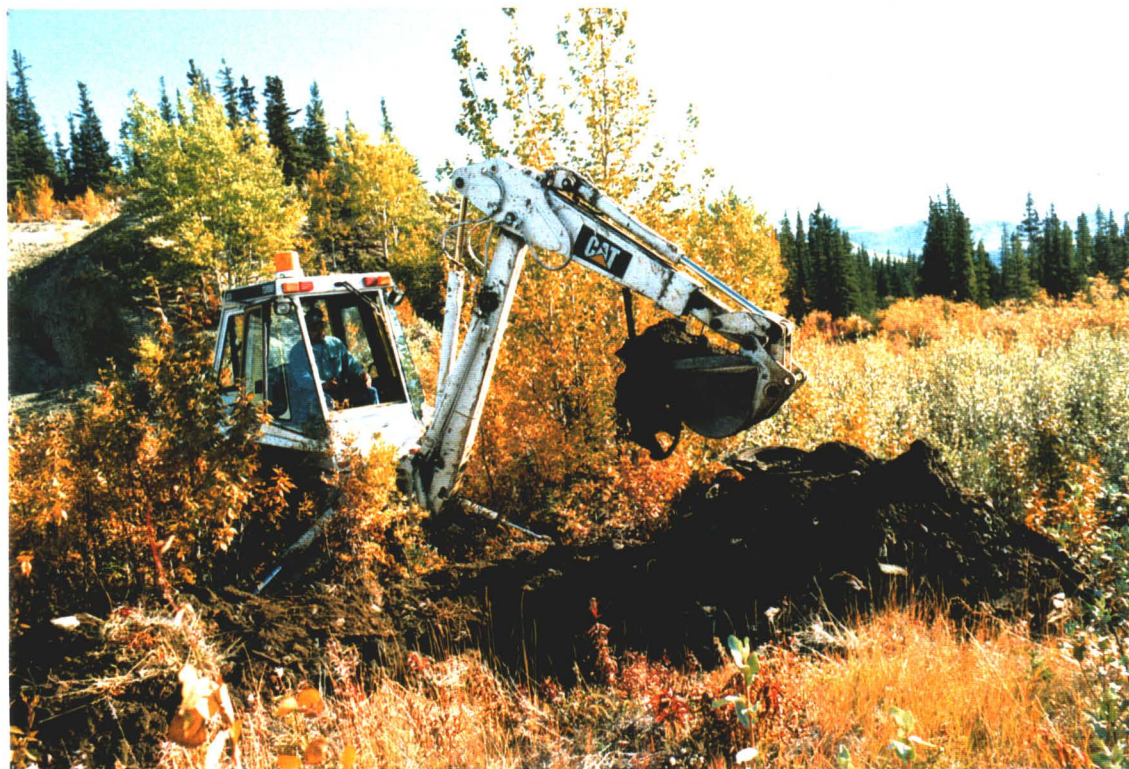
PLATE S4 - Test pit S-2 at southeast extent of buried dump.

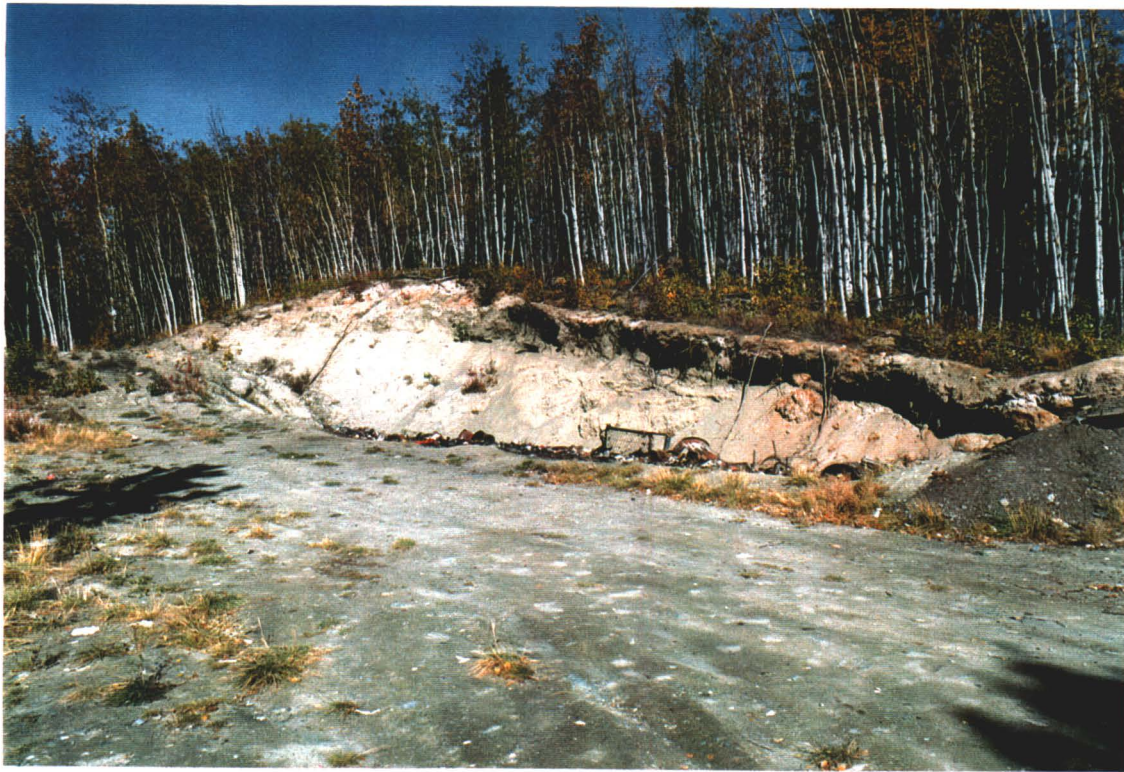
PLATE S5- Garbage dump currently in use.

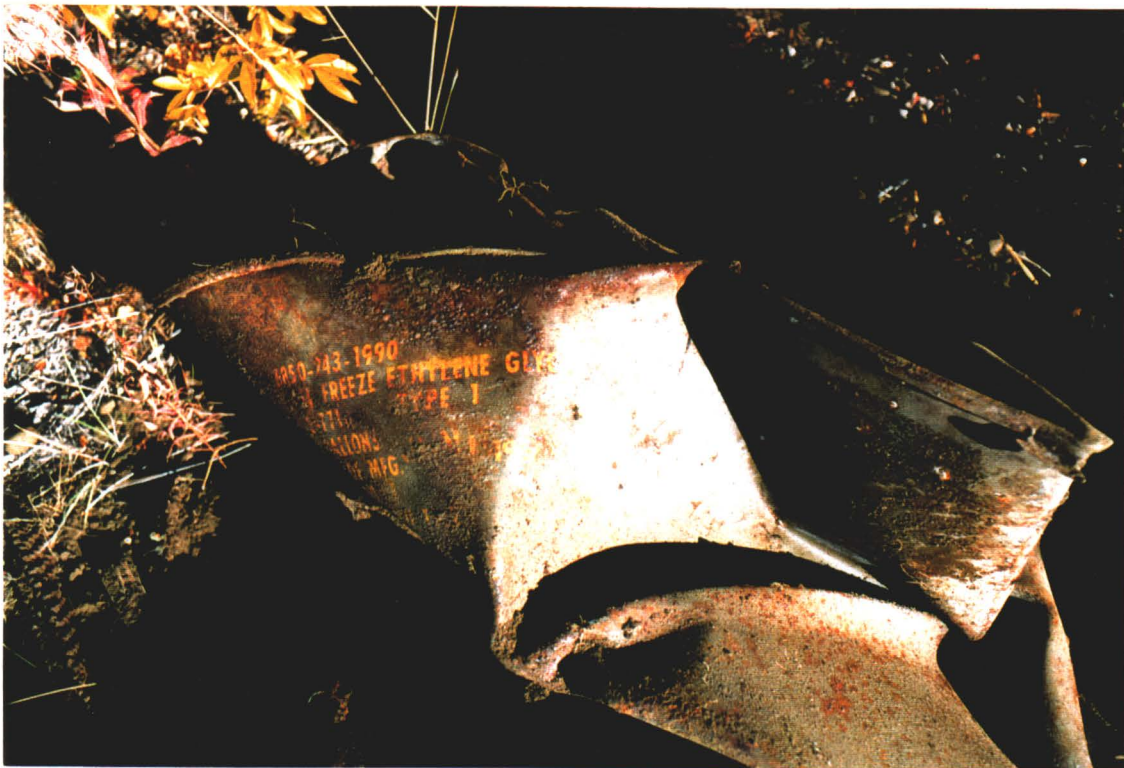
PLATE S6 - U.S. Military container dated 1957, near surface in TPS-2.
