**Inventory of Equipment, Machinery,
Major Fixtures and Hazardous Materials
at the ~~Donjek~~ Pumping Station,
Yukon Territories.**

**Prepared for
Indian and Northern Affairs Canada**

August, 1998

**Prepared by
Arctic Environmental Services Ltd., and KO KEN General Contractors**

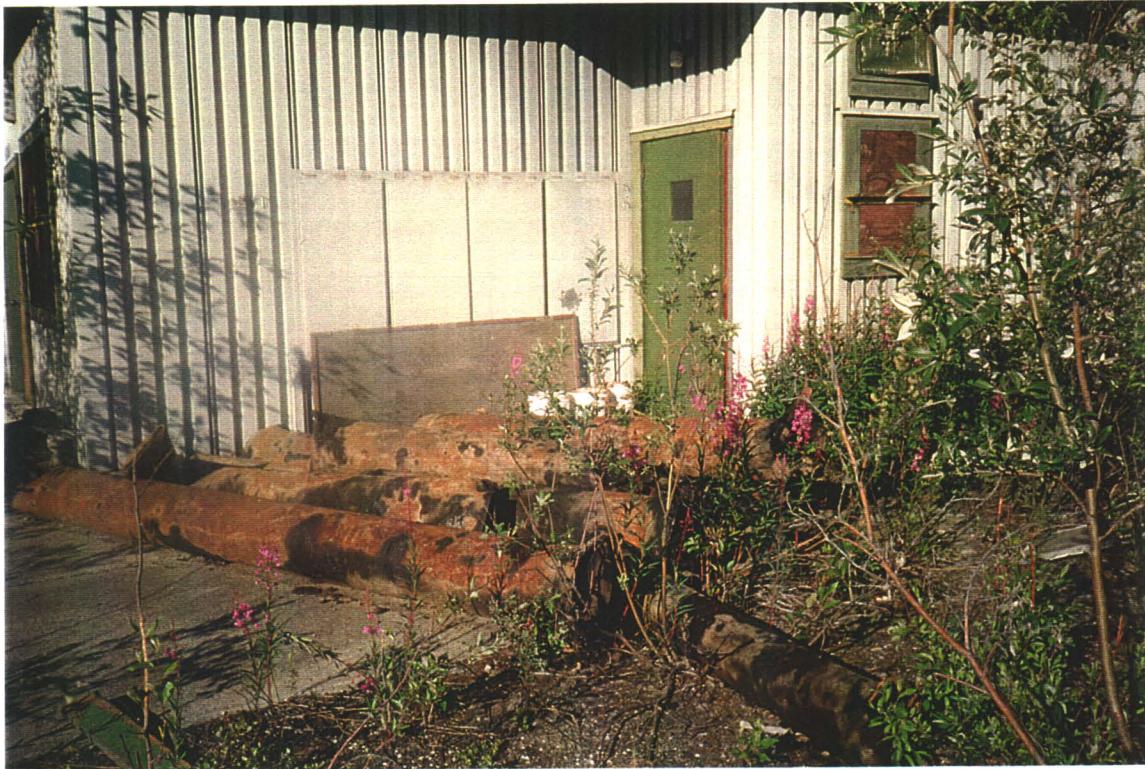
Main Building. Sections of old pipeline stored here.
Contain accumulated hydrocarbon/wax deposit.

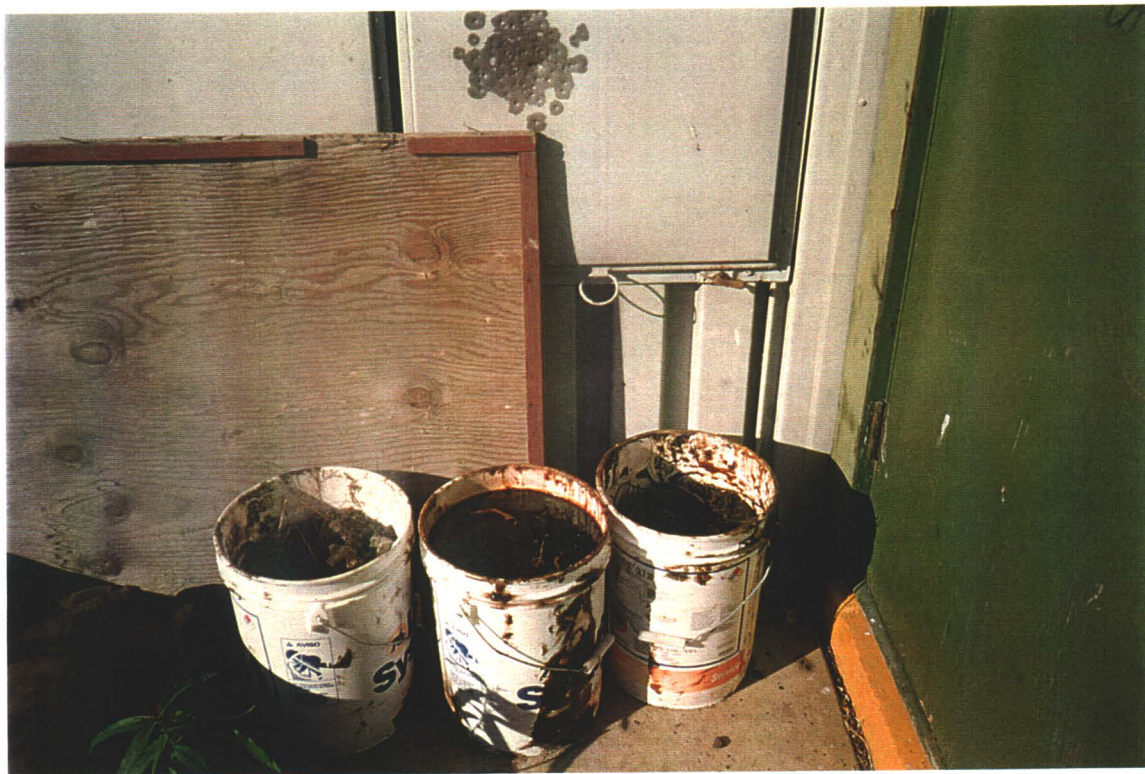
Main Building. Pails of hydrocarbon contaminated
soil associated with stored sections of pipeline.

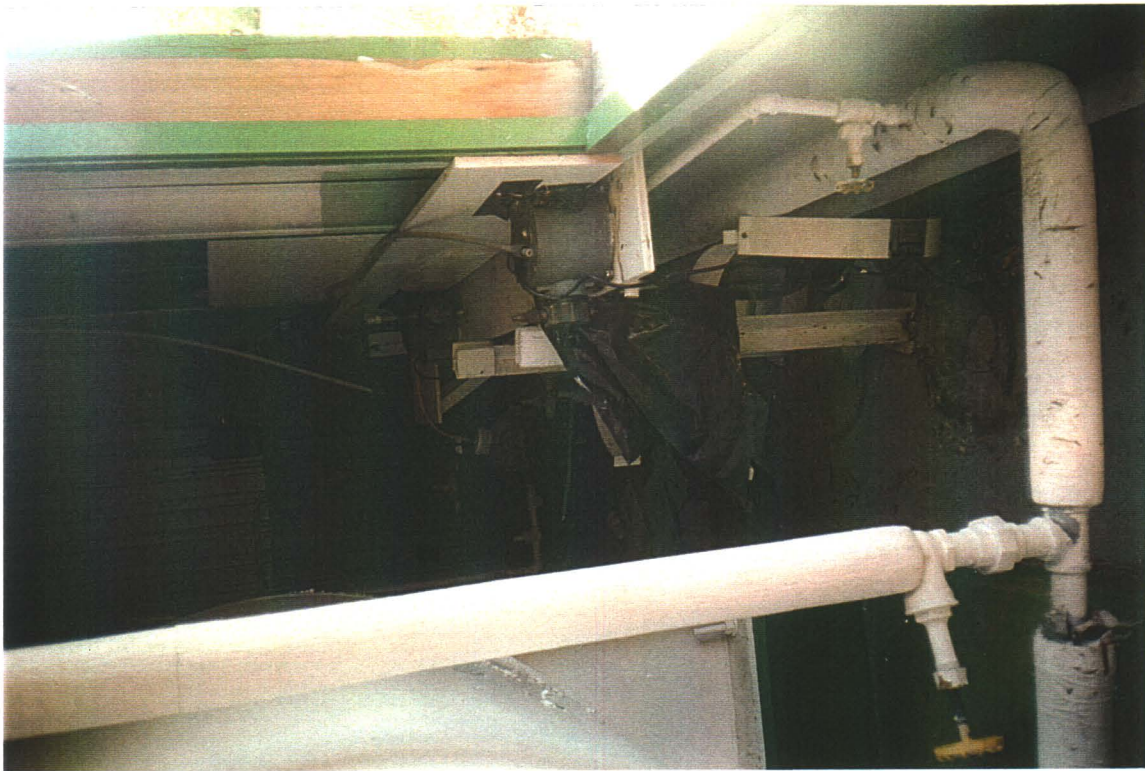
Main Building. Water Storage Room. This room houses a drained water tank and various flow metering devices and pressure system. Asbestos is present in the pipe insulation knuckle connections

- Asbestos removal procedures applied by a qualified asbestos contractor must be undertaken to ensure that other equipment and building components are not contaminated by asbestos fibres during removal.

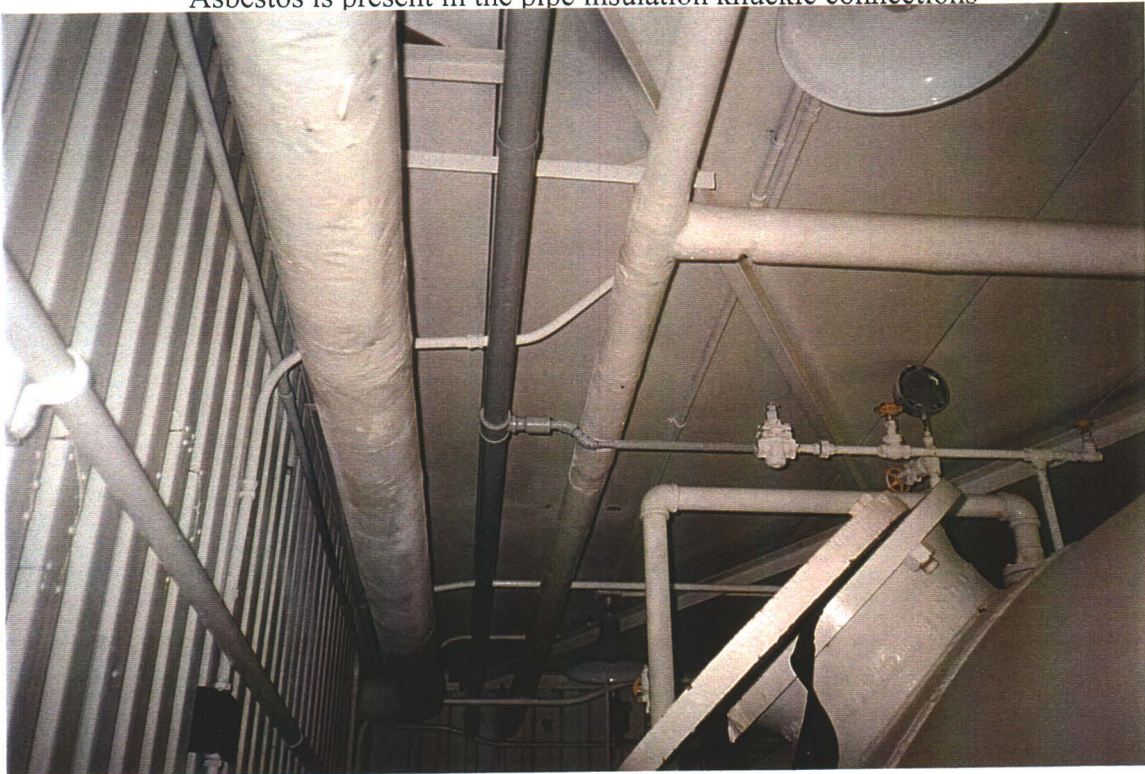
Main Building. Water Storage Room. Ceiling pipes above tank. Lead paint is present throughout.

- The presence of lead paint has been confirmed throughout the Station on floor/wall paint and on equipment housed within. Lead removal procedures applied by a qualified contractor must be undertaken to ensure that other equipment and building components are not contaminated by lead dust during removal. The most feasible option is to remove loose paint chips and dispose of this material as hazardous waste. Paint that is currently in good shape can be encapsulated with acceptable paint or by wallboard.

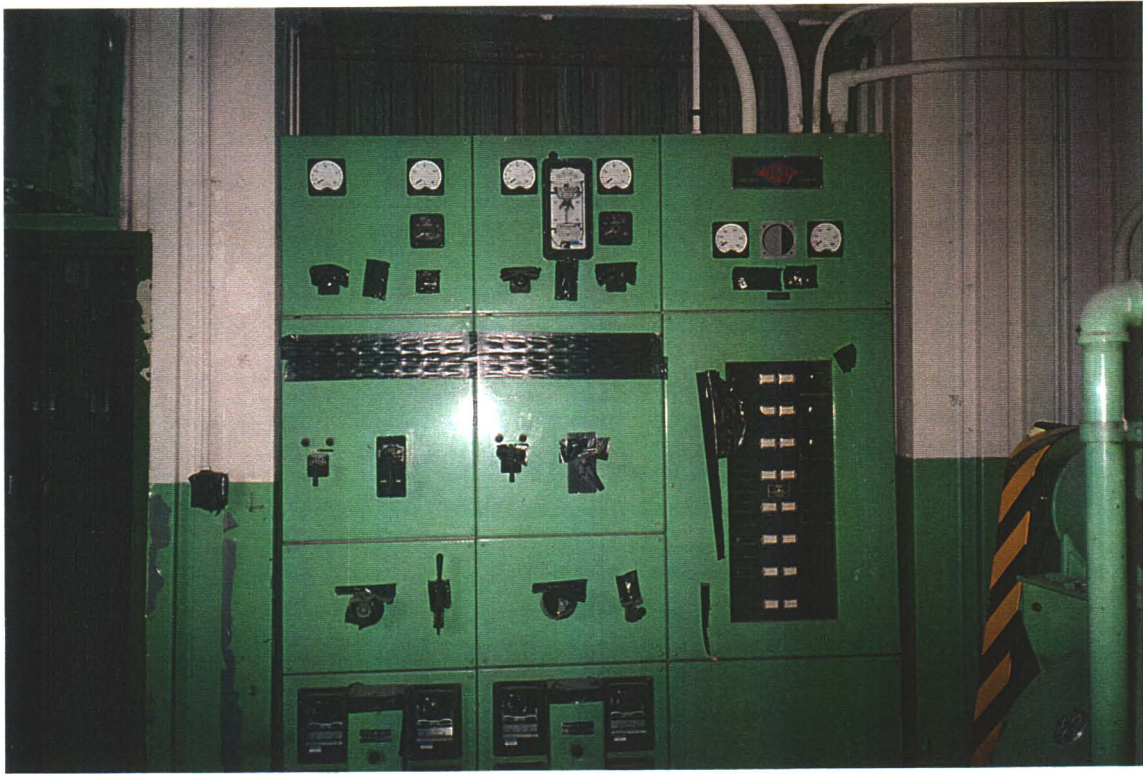
Main Building. Generator Room. Control panel, possibly containing mercury switches. Green paint is high in lead content.

- Lead paint on engines, steel piping, etc. can be safely removed from the Main Building without concern during removal of these items. Whoever accepts these removed items must be warned of the lead paint concern.

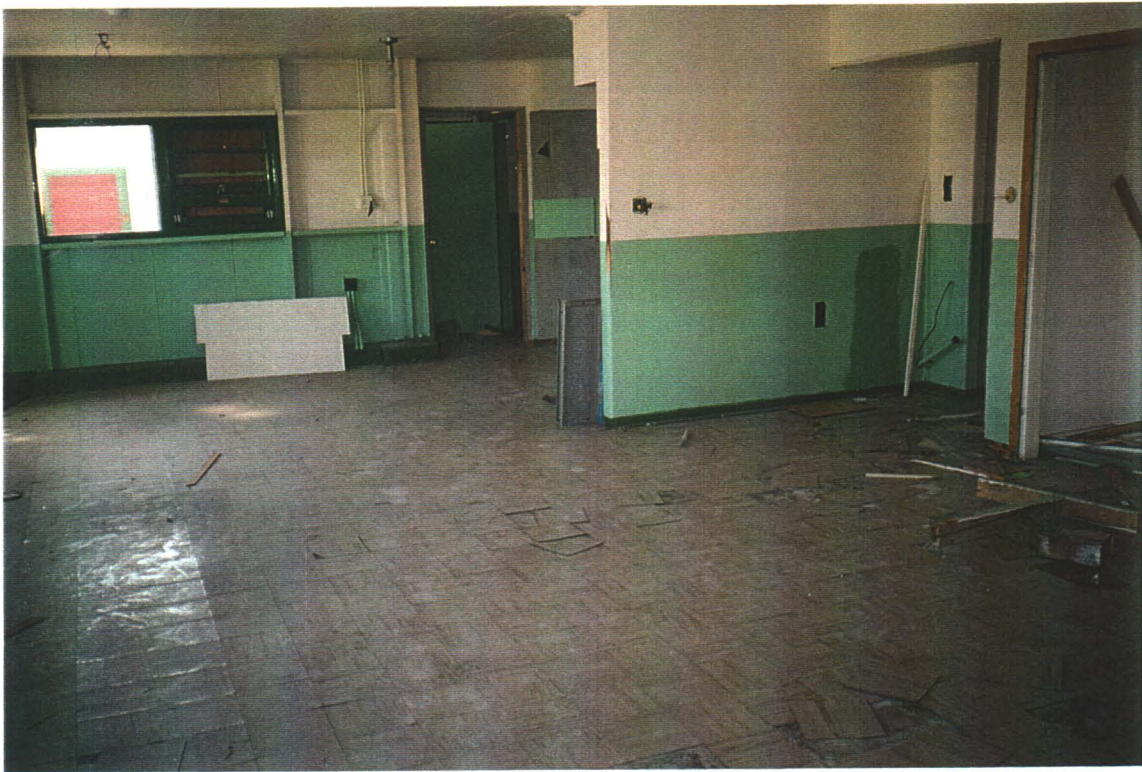
Main Building, Office Room. Note asbestos floor tiles and lead paint on walls. Interior walls are asbestos wallboard.

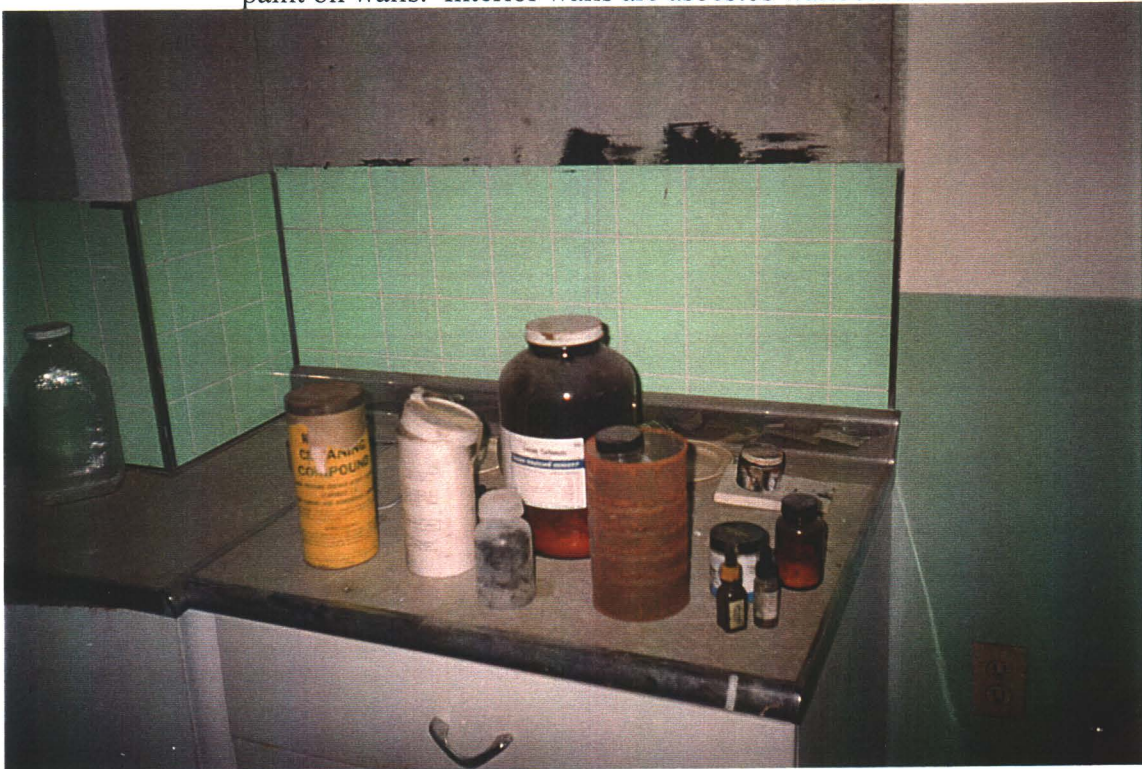
Main Building, Office Room. Kitchen area, with collection of non-hazardous chemicals. Drop ceiling is asbestos free. Piping above has asbestos content, at least in knuckles.

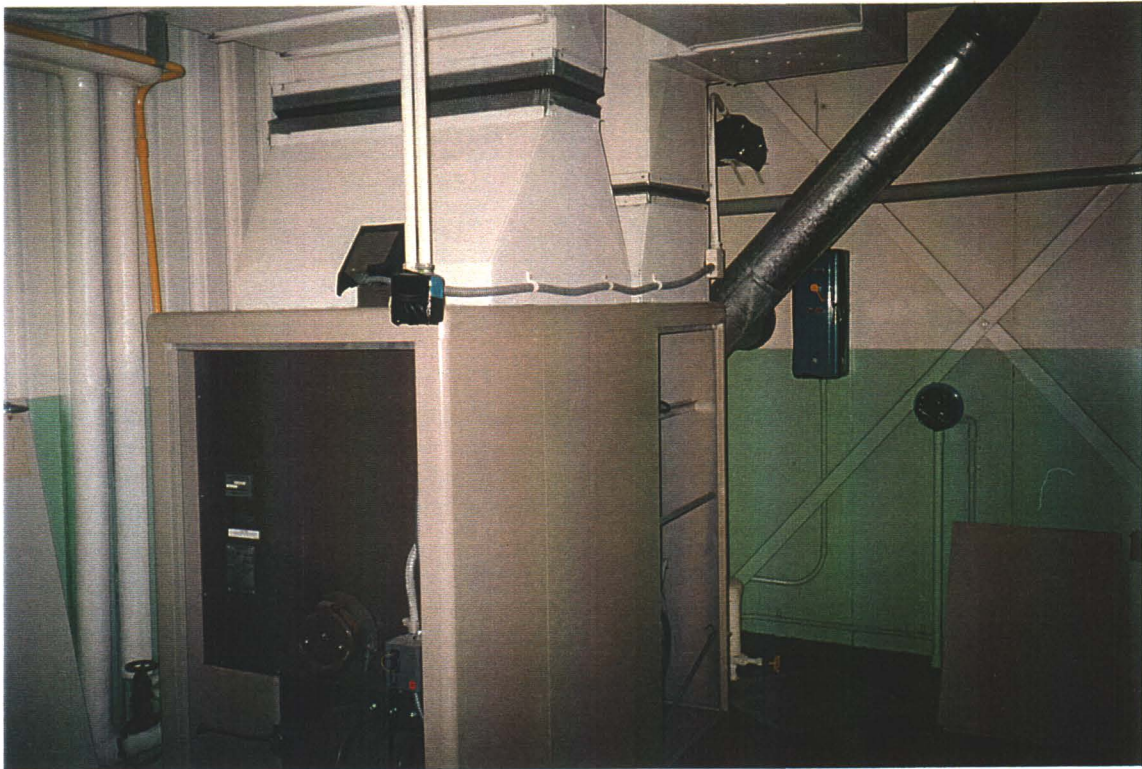
Main Building, Office Room furnace area. Interior walls are asbestos, as are pipe joints. Mercury switches in electrical circuitry.

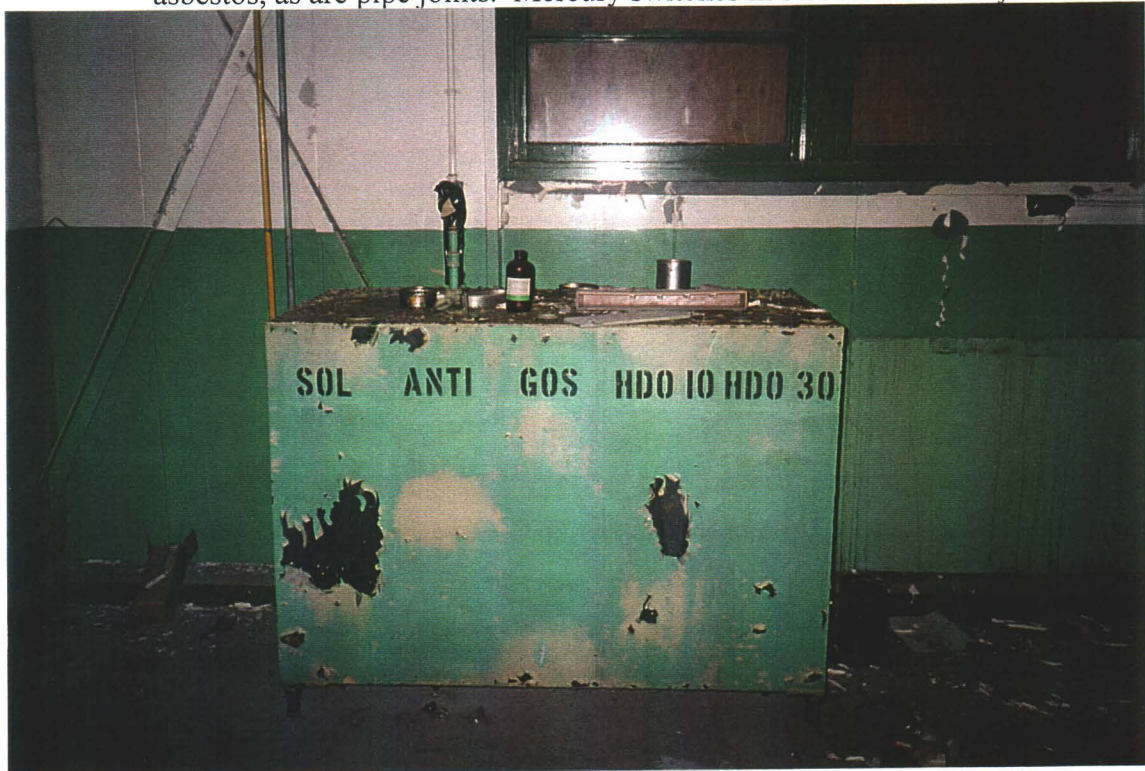
Main Building, Shop. Service fluid storage tank, intact with no leaks.

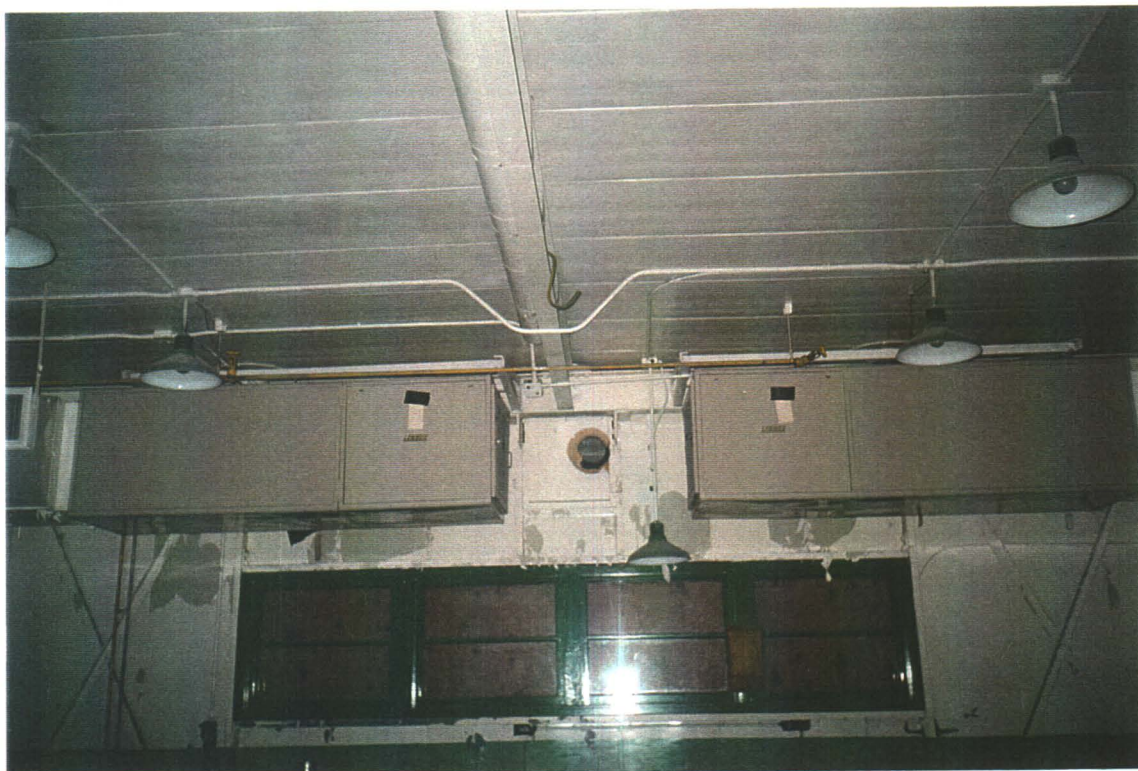
Main Building, Shop. Overhead heat exchanger.
Note lead paint peeling from metal walls on building interior.

- There is lead paint on the floors and walls of each structure. Loose paint chips should be removed and disposed of as hazardous waste by a qualified contractor before the buildings are reused for any purpose.

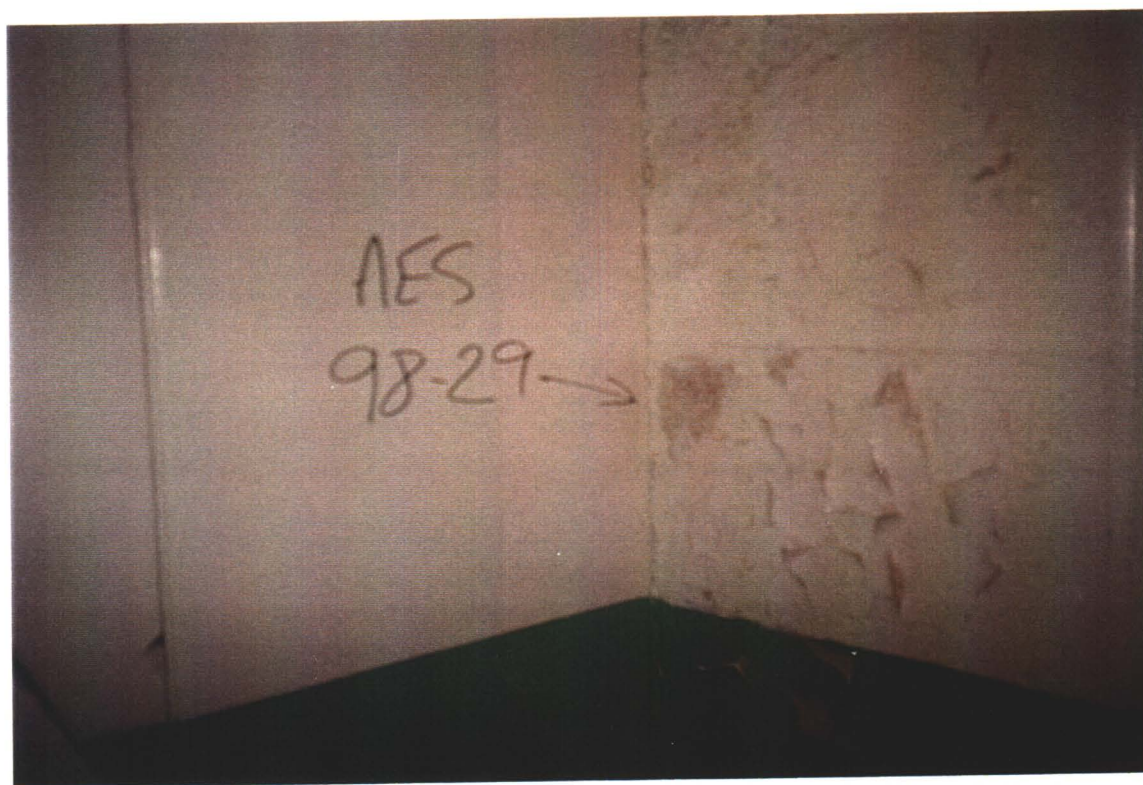
Main Building, Shop. Asbestos-filler in I-beams. Friable asbestos.

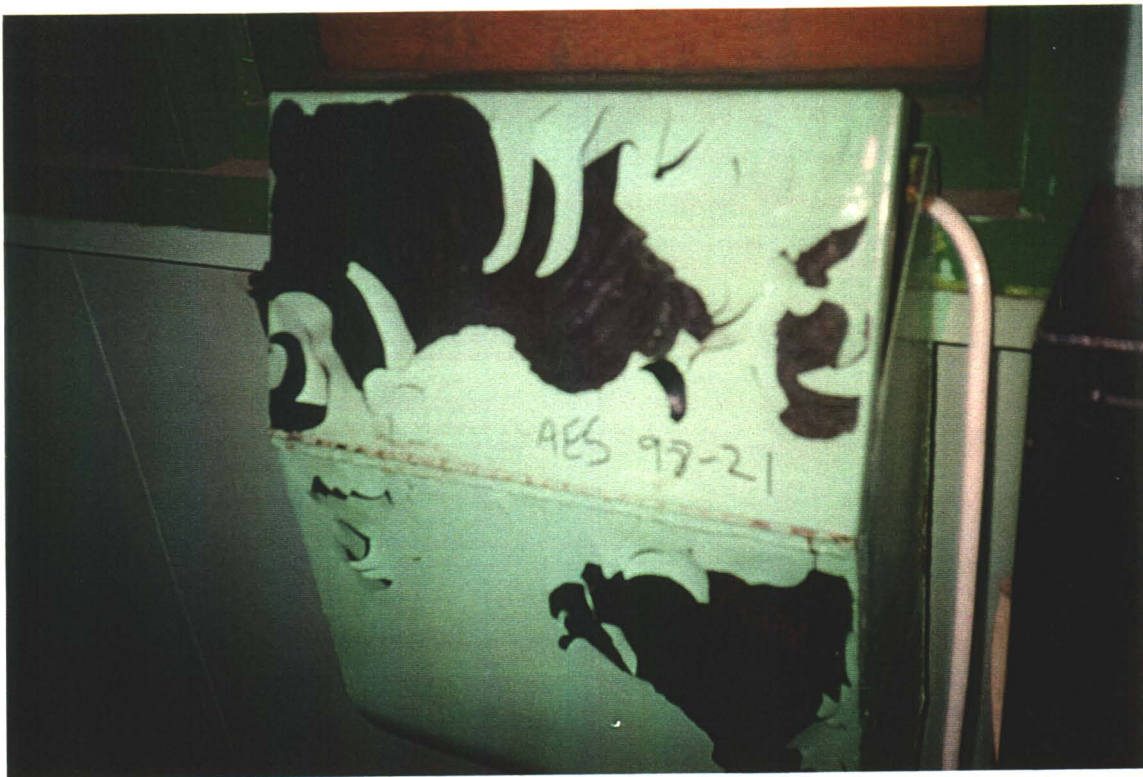
Compressor Building. Flaking green lead-based paint common to all equipment components.

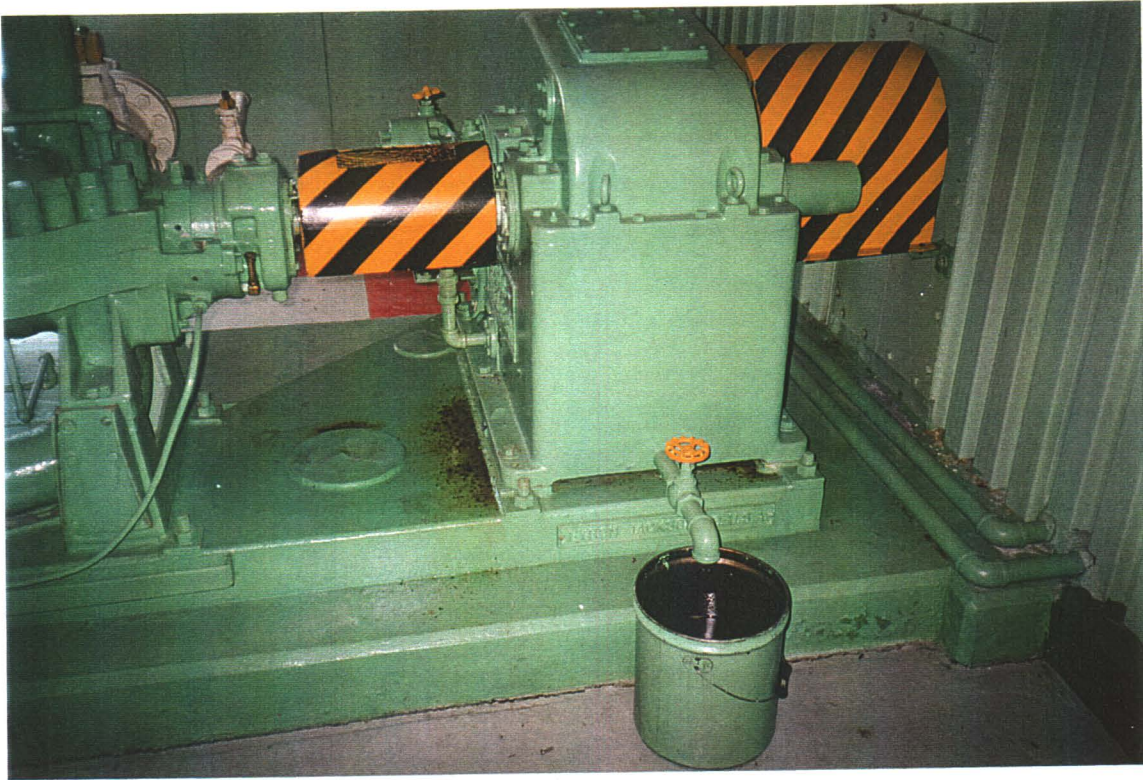
Compressor Building. Pump unit. Note fluid drained from mothballed unit.

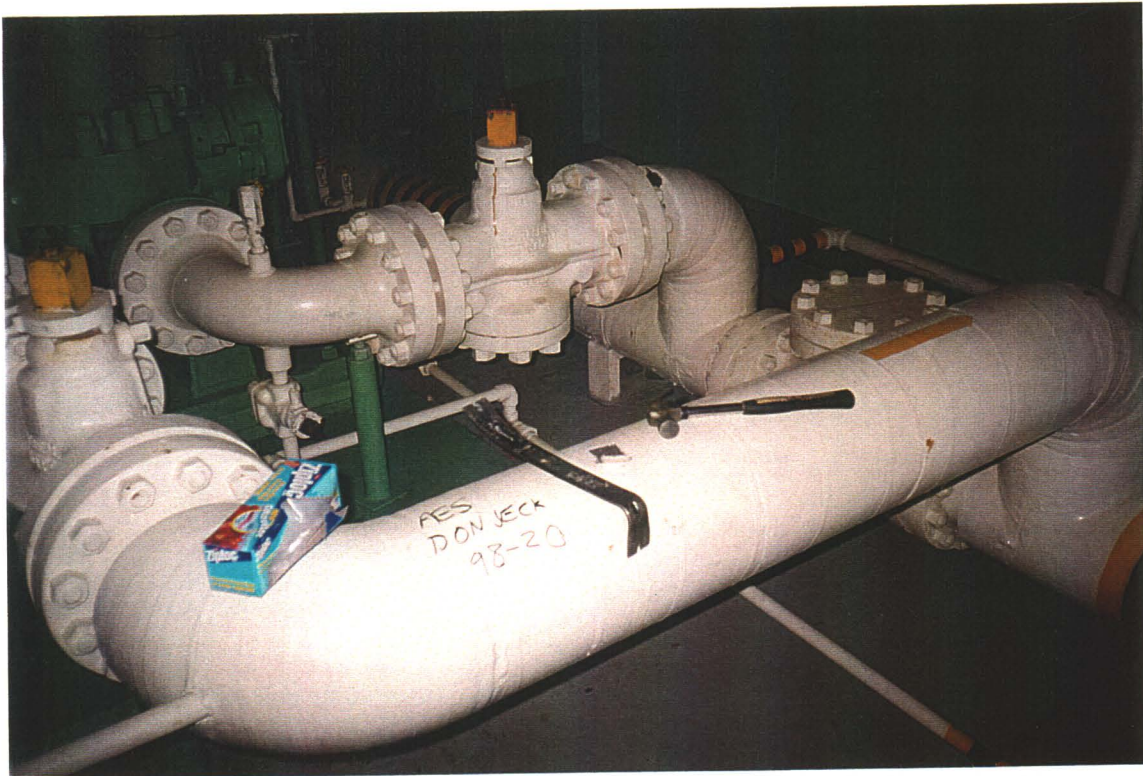
Compressor Building. Piping section.
Both green and white paint tested positive for lead content.

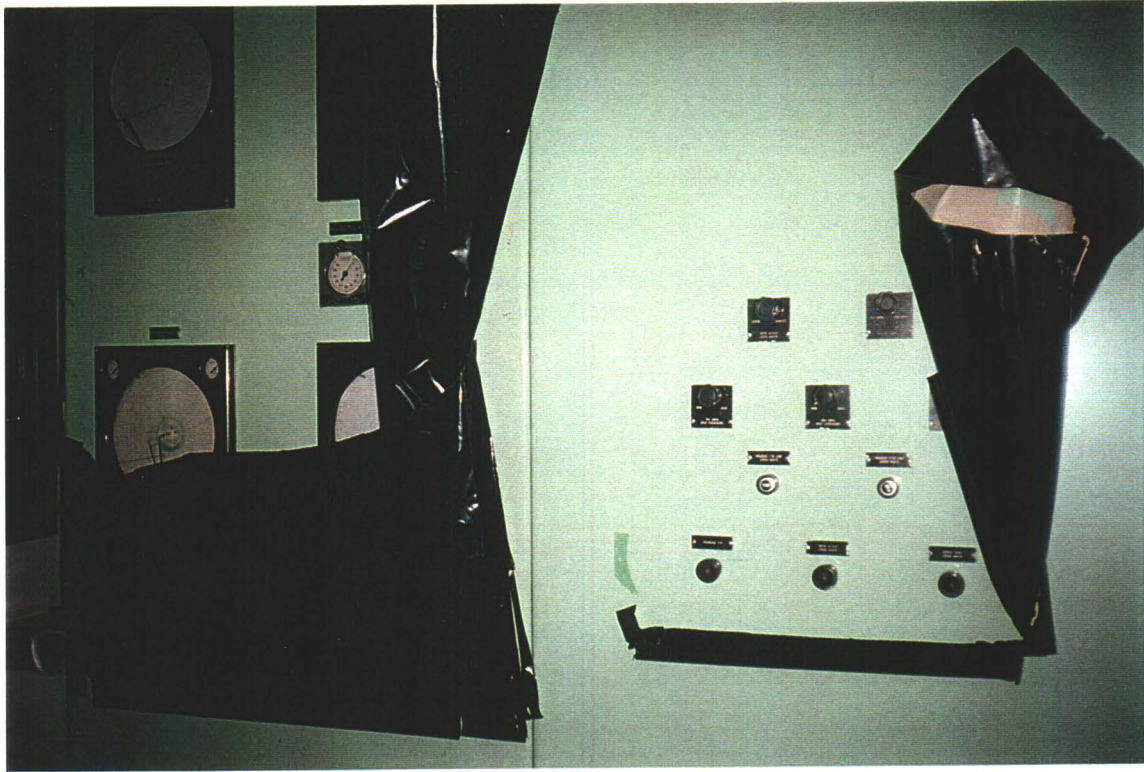
Compressor Building. Control panel, may contain mercury switches.

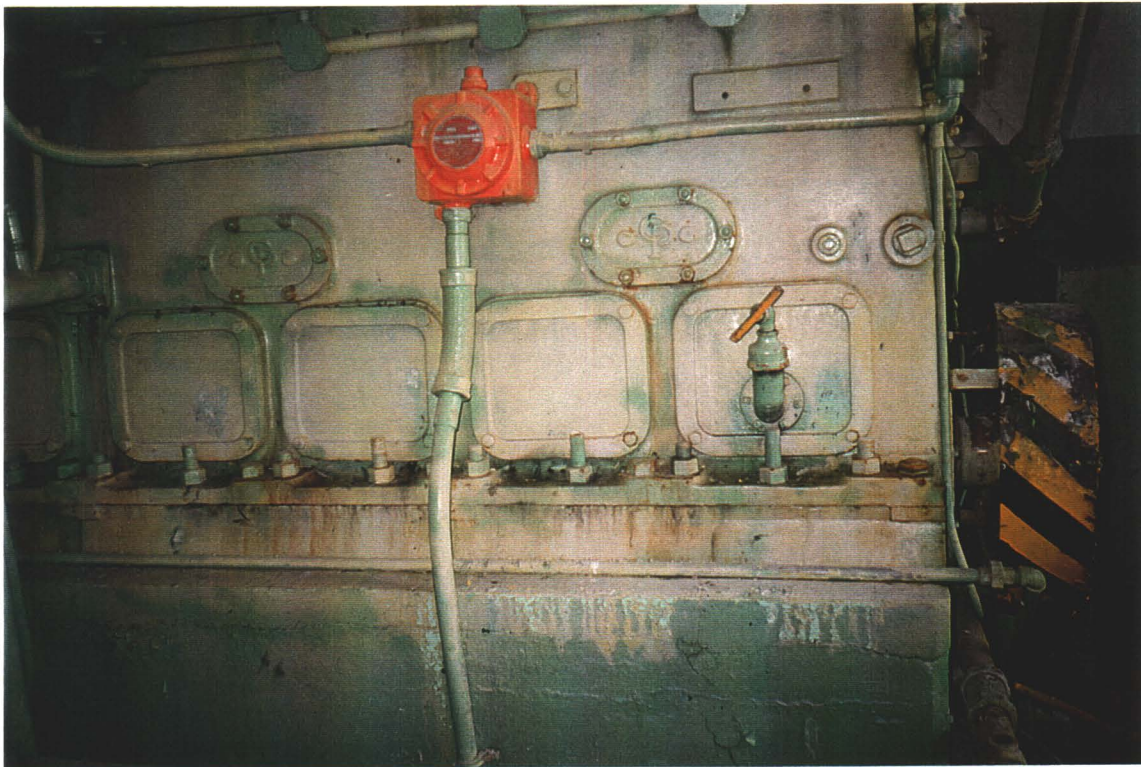
Compressor Building. Engine Room. One of two engine units to power compression pumps. Engine completely mothballed, including drained of antifreeze.

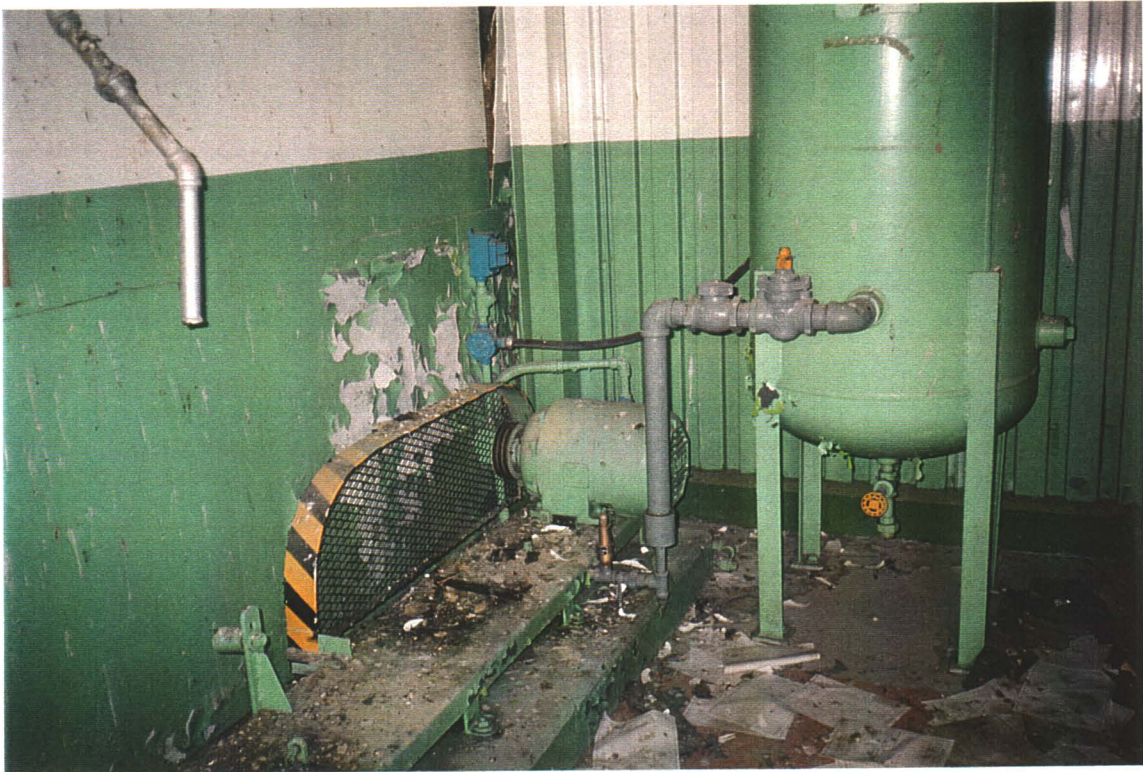
Compressor Building, Engine Room.
Small compressor unit gone, but 3 phase motor and pressure tank remain.

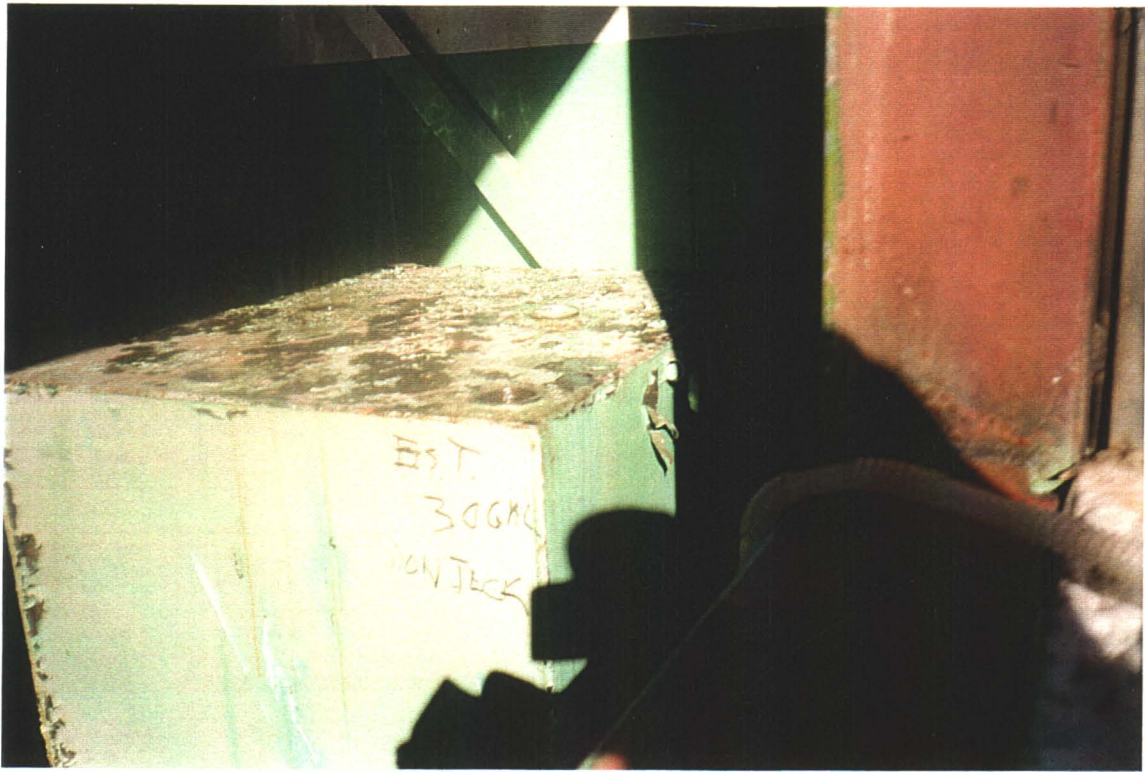
Compressor Building, Engine Room.
Maintenance fluid storage unit. Approximately 30 gallons of fluid remain.

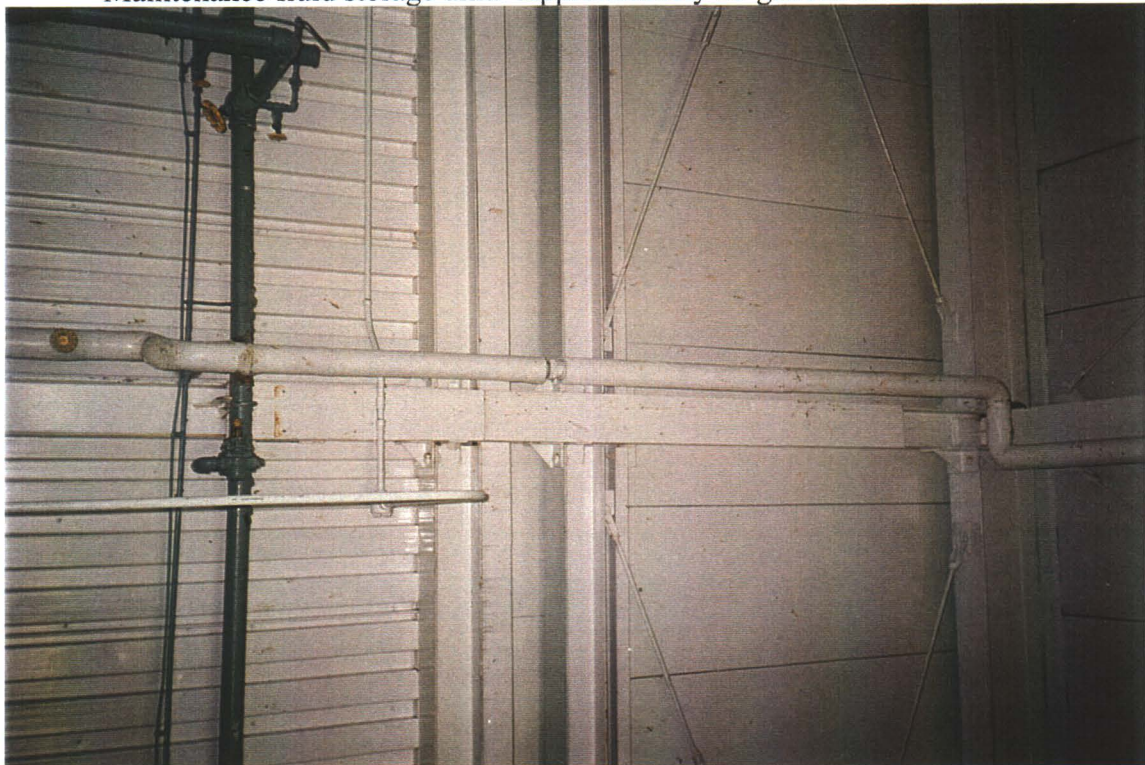
Compressor Building, Engine Room.
Ceiling piping, containing asbestos in knuckles.

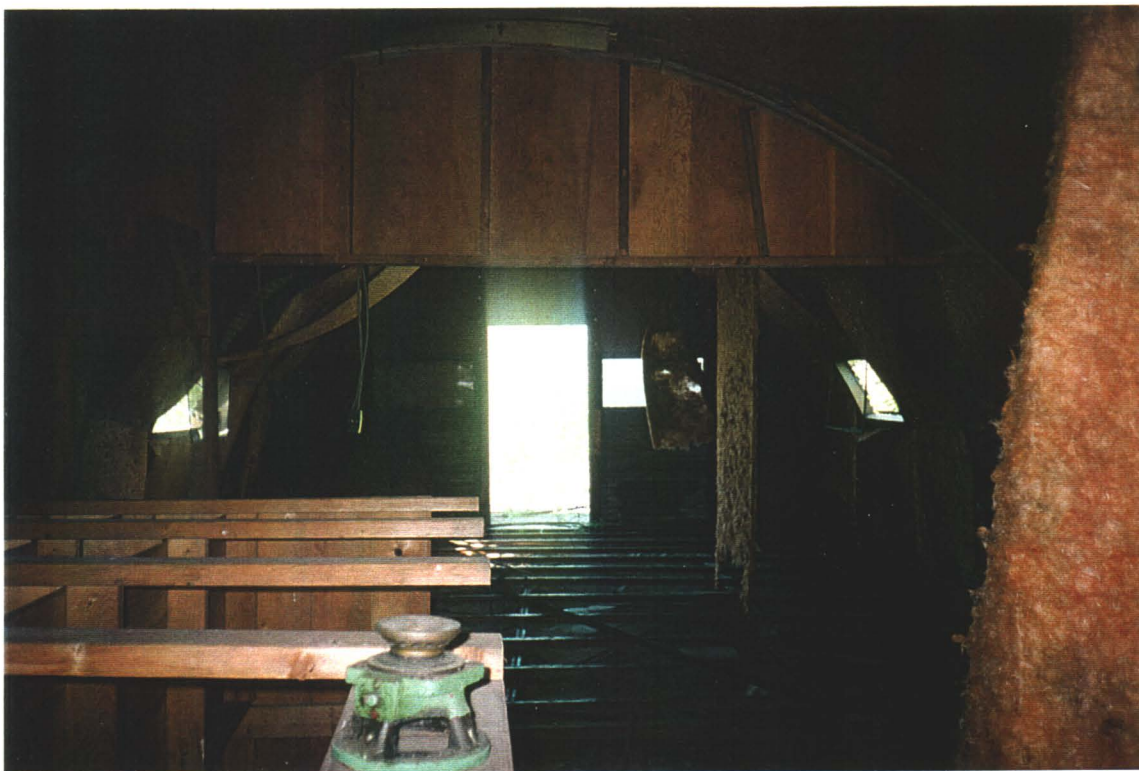
Interior of Quanset. Extensive vandalism. No asbestos.

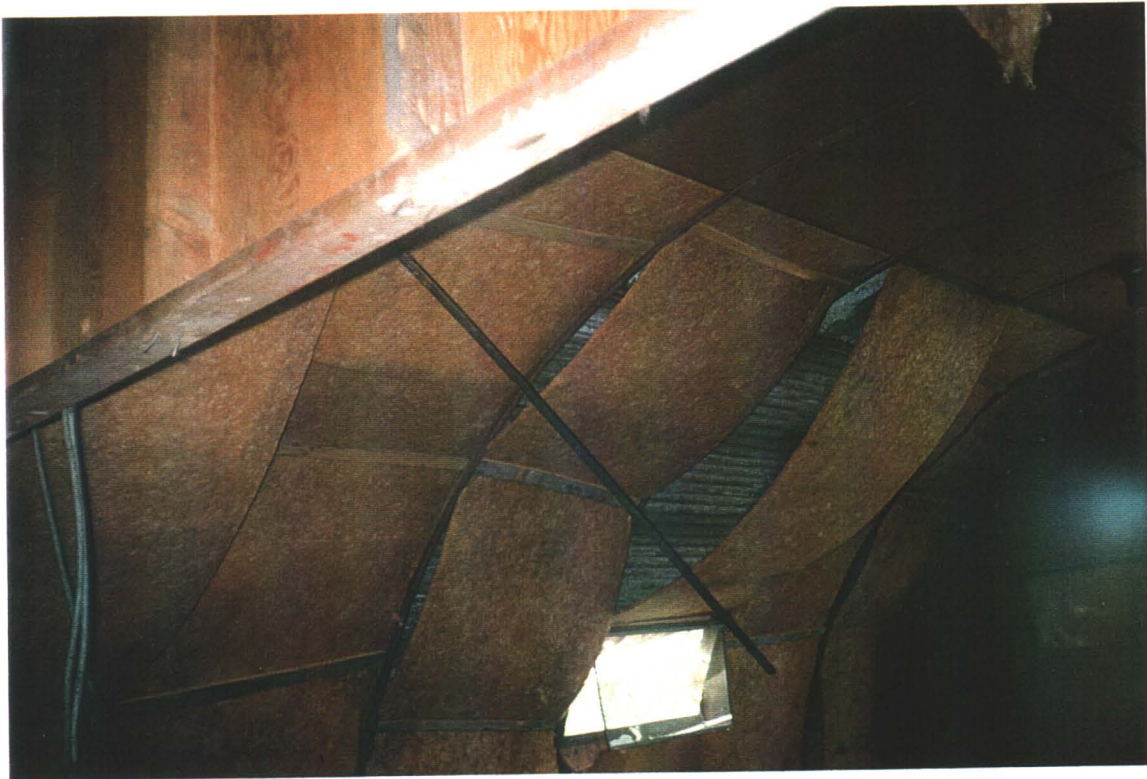
Interior of Quanset. Loose fibreglass insulation.

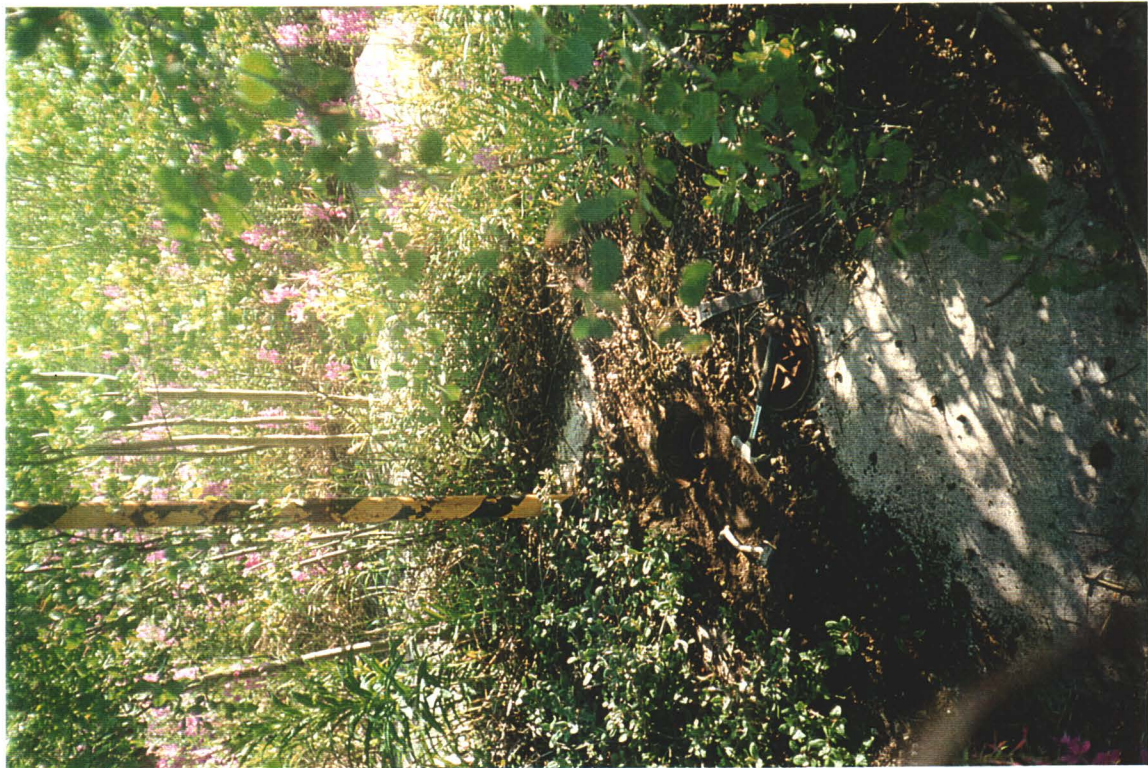
Concrete underground storage tank(s) for vehicle fuel.

- One concrete underground storage tank remains on site and should be properly disposed of.
- There are no lights within any of the structures, and general entry should continue to be restricted until this is changed. A qualified electrician should thoroughly examine the electrical system before power is restored.

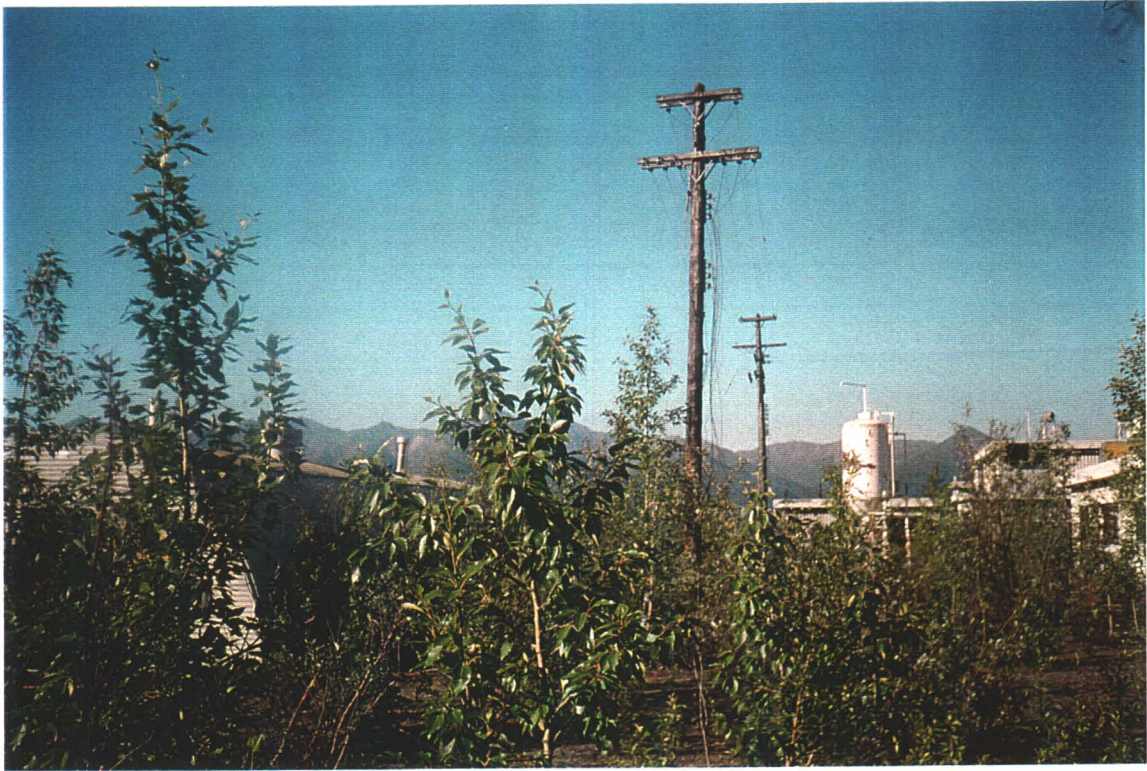
Typical power pole array, both frames. Power disconnected.
No pole-mount transformers.

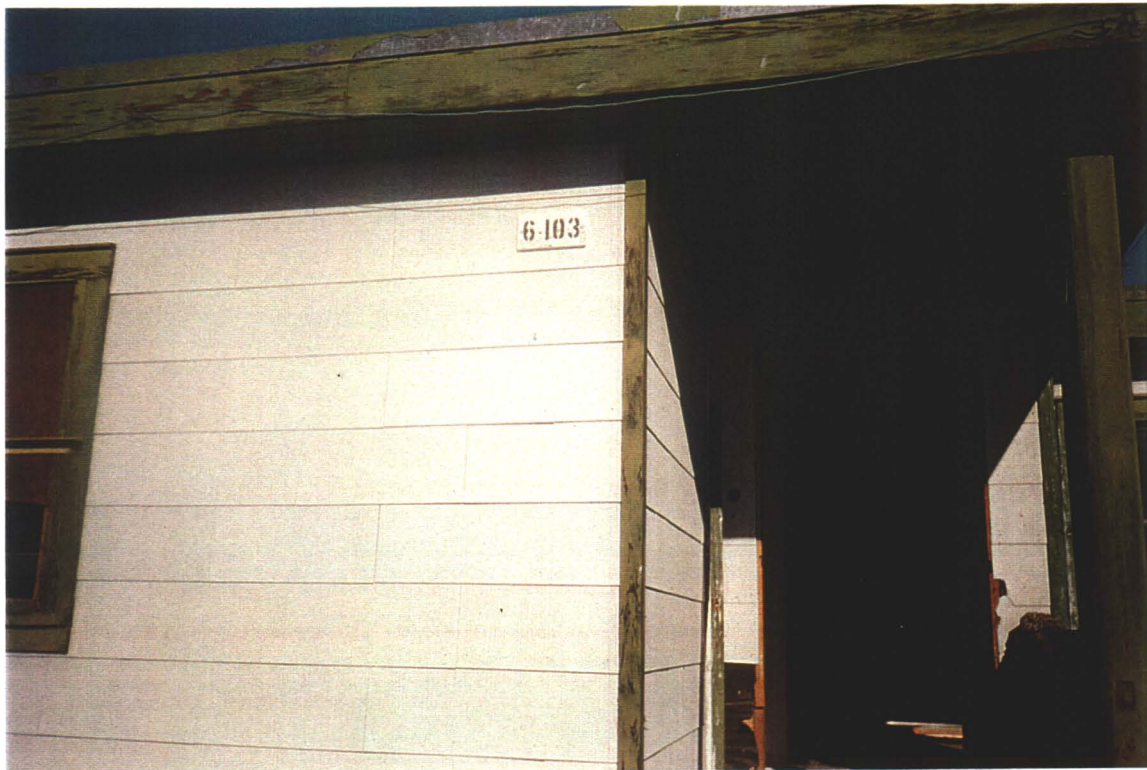
Single Residence. Note white asbestos cladding.

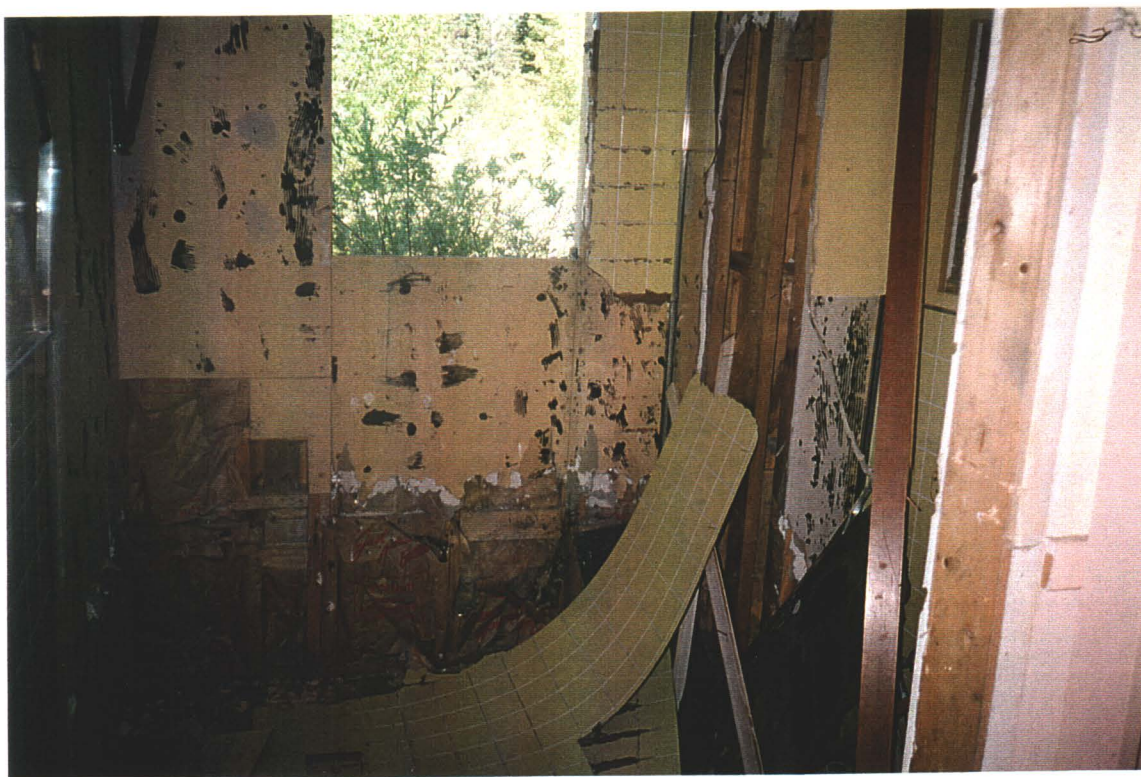
Single Residence. Note extensive vandalism.
