**Inventory of Equipment, Machinery,
Major Fixtures and Hazardous Materials
at the ~~Donjek~~ Pumping Station,
Yukon Territories.**

**Prepared for
Indian and Northern Affairs Canada**

August, 1998

**Prepared by
Arctic Environmental Services Ltd., and KO KEN General Contractors**

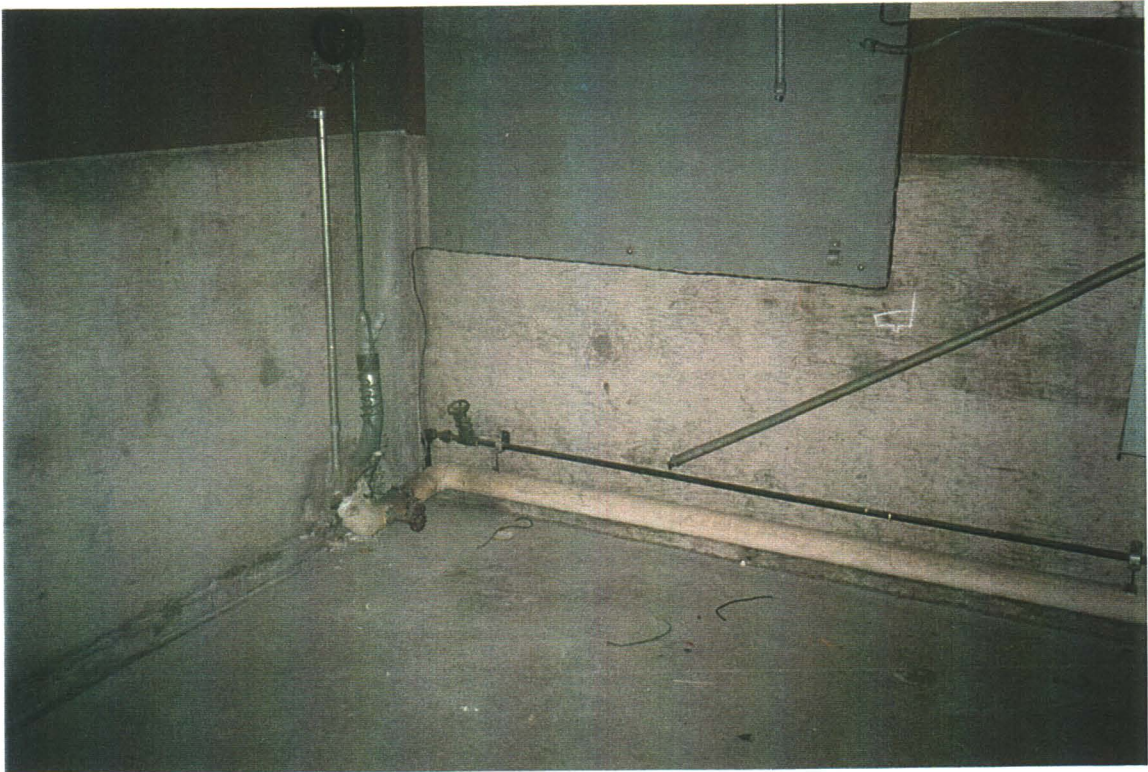
Single Residence. Detail of basement piping. Asbestos knuckles present.

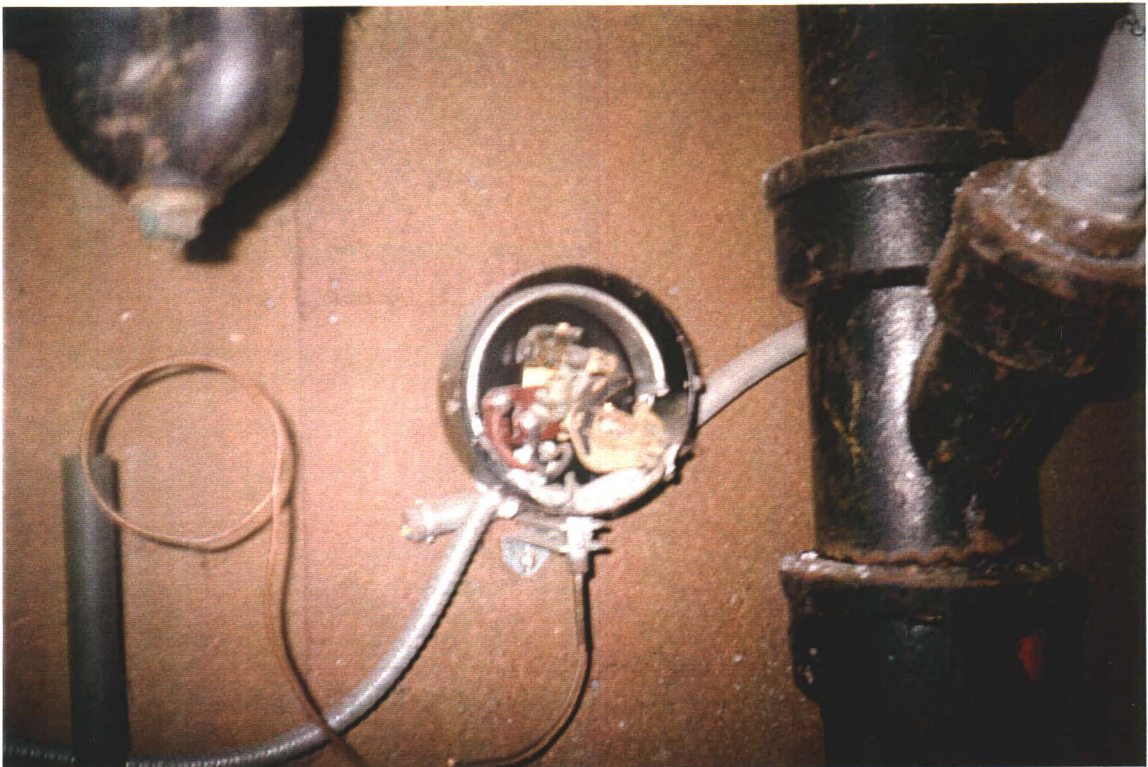
Single Residence, basement. Note mercury-containing electrical control switch.

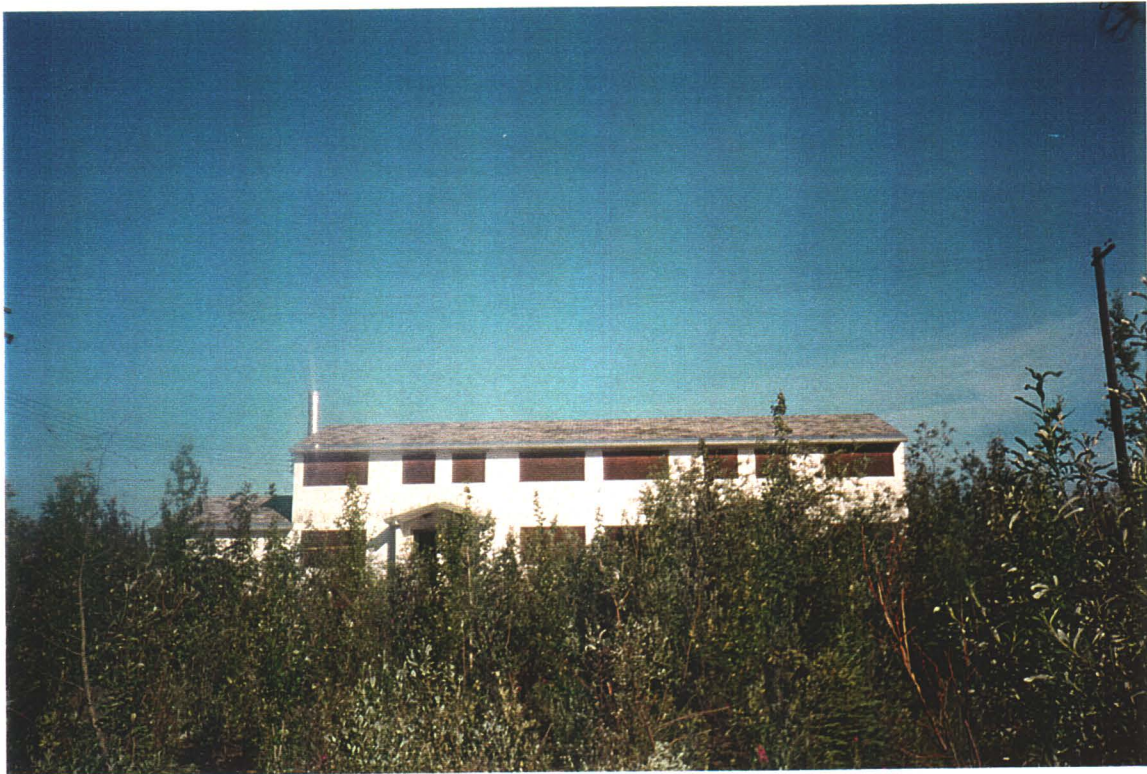
Multi-family Dwelling, exterior. Wooden siding, coated with lead-based paint.

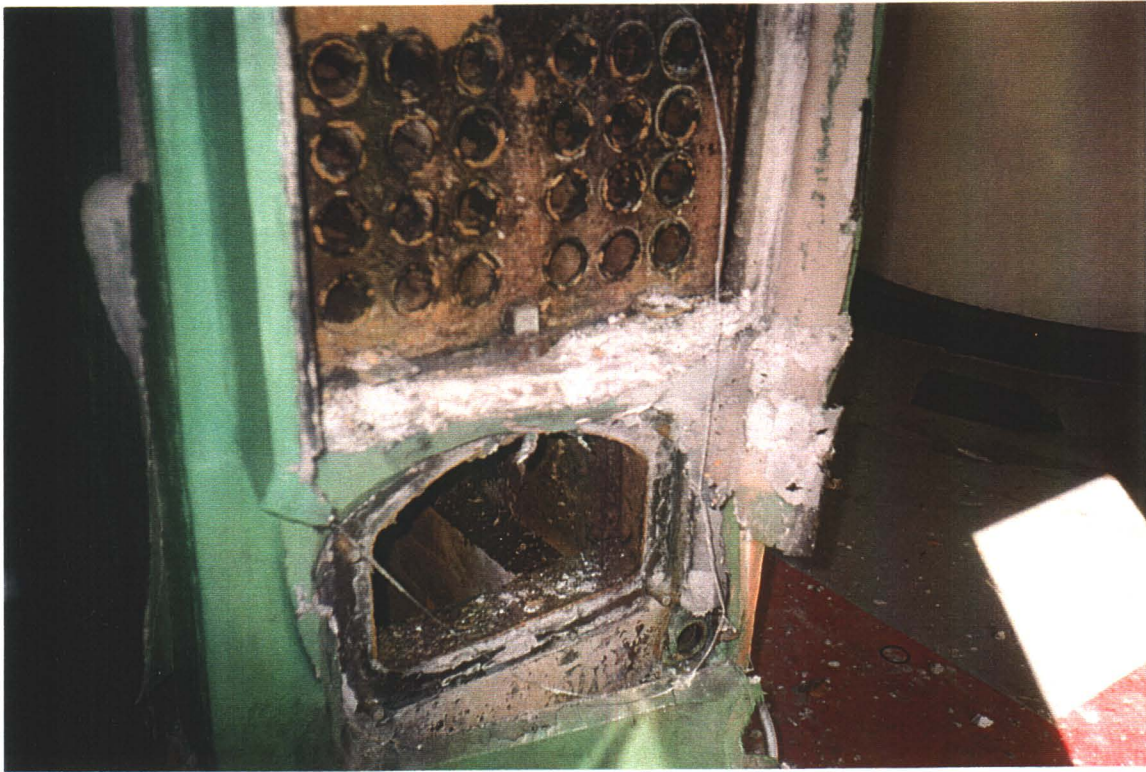
Multi-family Dwelling, Boiler Room. Boiler and tanks present. Friable asbestos present in abundance due to vandalism. Very hazardous conditions.

- Asbestos removal procedures applied by a qualified asbestos contractor must be undertaken to ensure that other equipment and building components are not contaminated by asbestos fibres during removal.

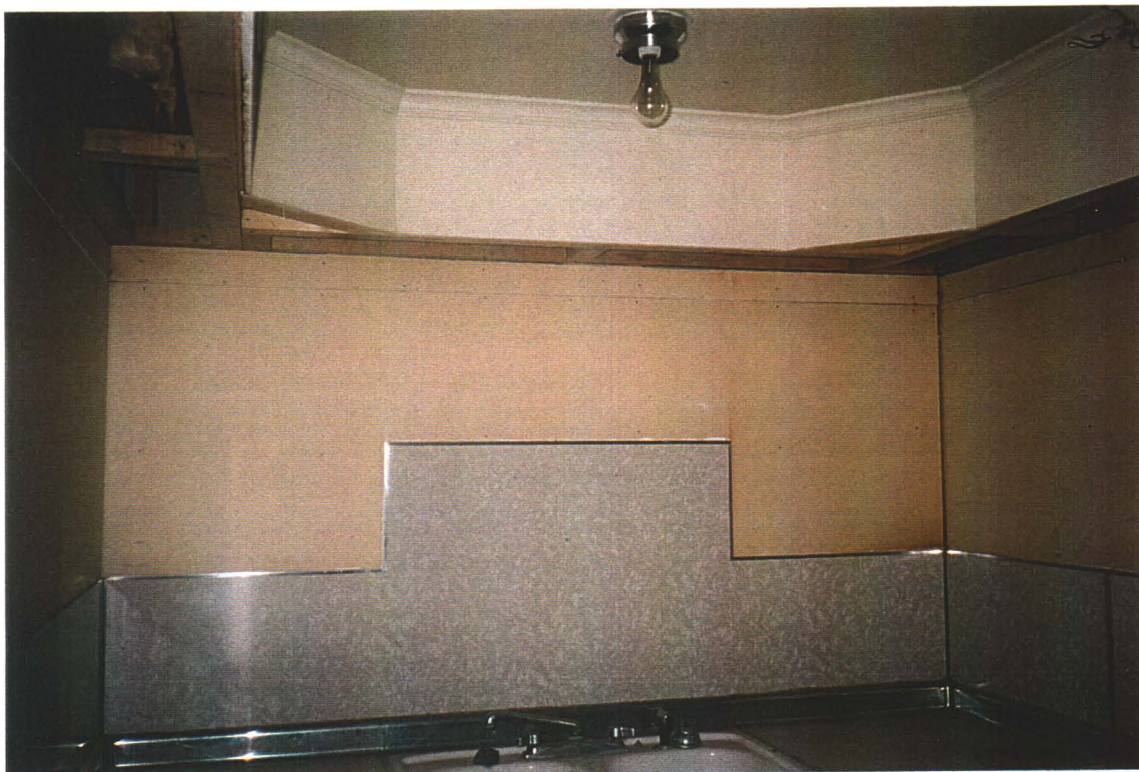
Multi-family Dwelling, interior kitchen. No asbestos present, except for knuckles in heating system pipes, which are inside walls.

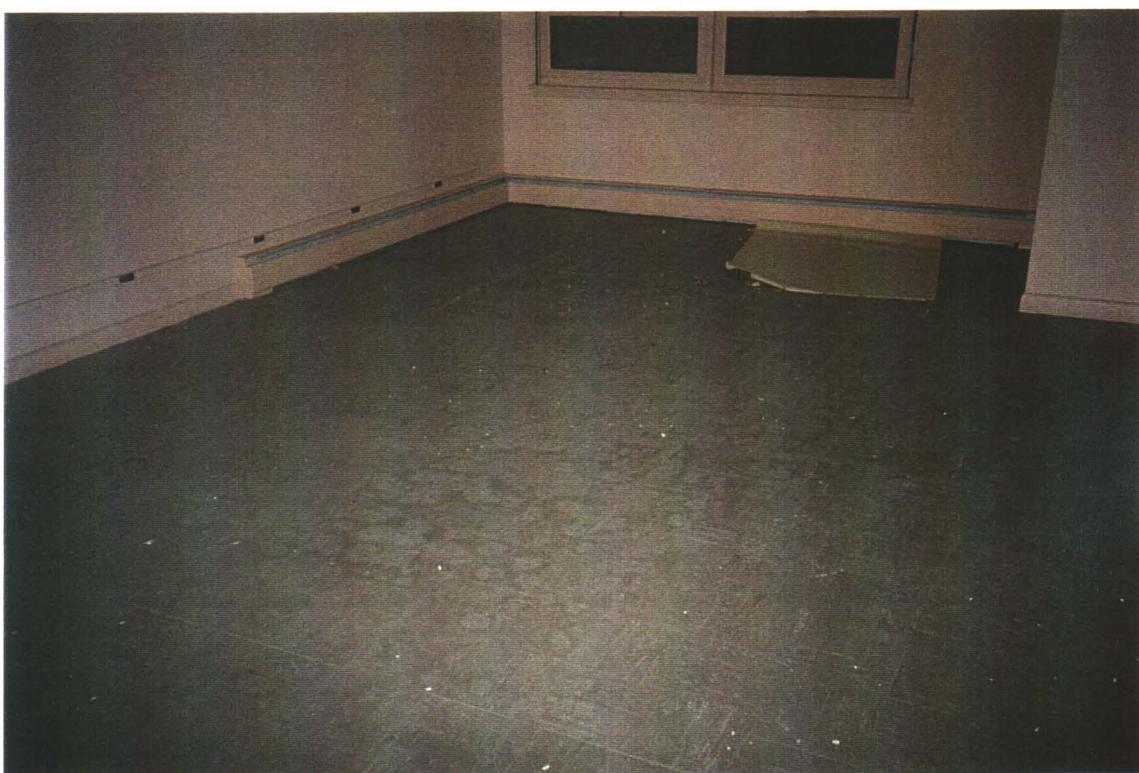
Multi-family Dwelling, living room. Note asbestos floor tiles.

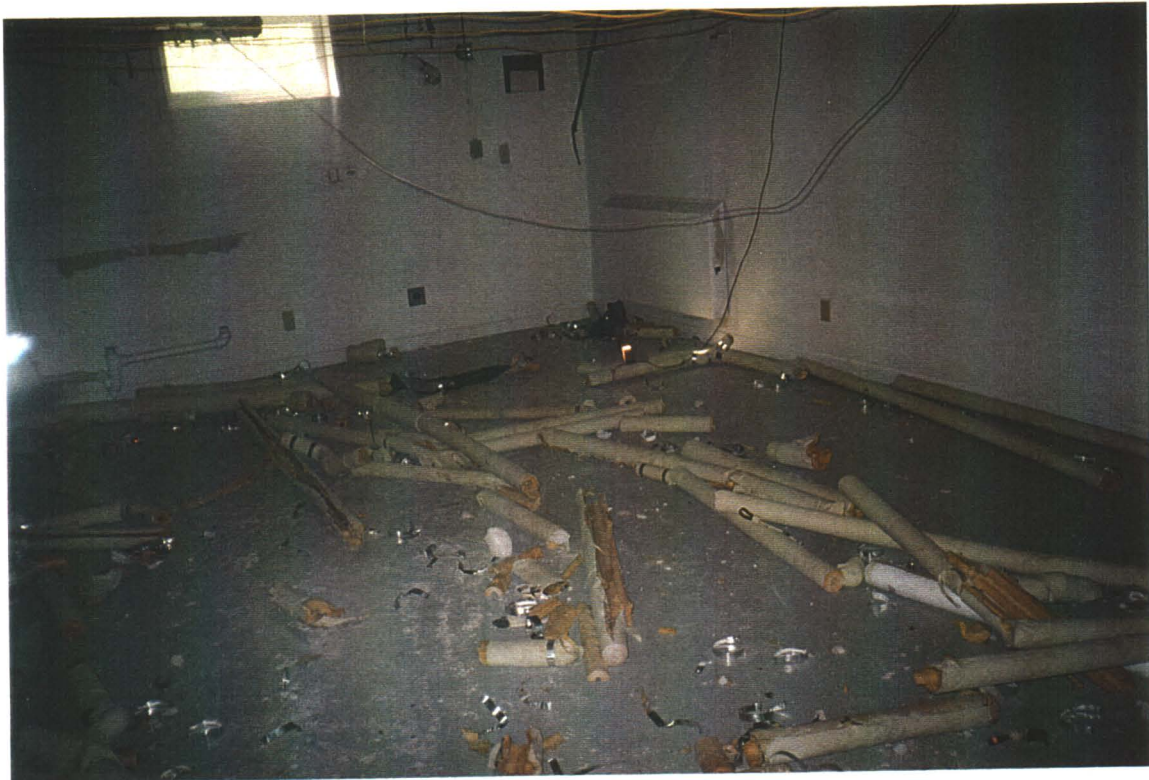
Multi-family Dwelling, basement. Note extensive vandalism, including exposure of asbestos containing materials (knuckles only) in pipe insulation. This has created hazardous conditions throughout the building, as asbestos fibres move with the airflow.
