**Inventory of Equipment, Machinery,
Major Fixtures and Hazardous Materials
at the Beaver Creek Pumping Station,
Yukon Territories.**

**Prepared for
Indian and Northern Affairs Canada**

July, 1998

**Prepared by
Arctic Environmental Services Ltd., and KO KEN General Contractors**

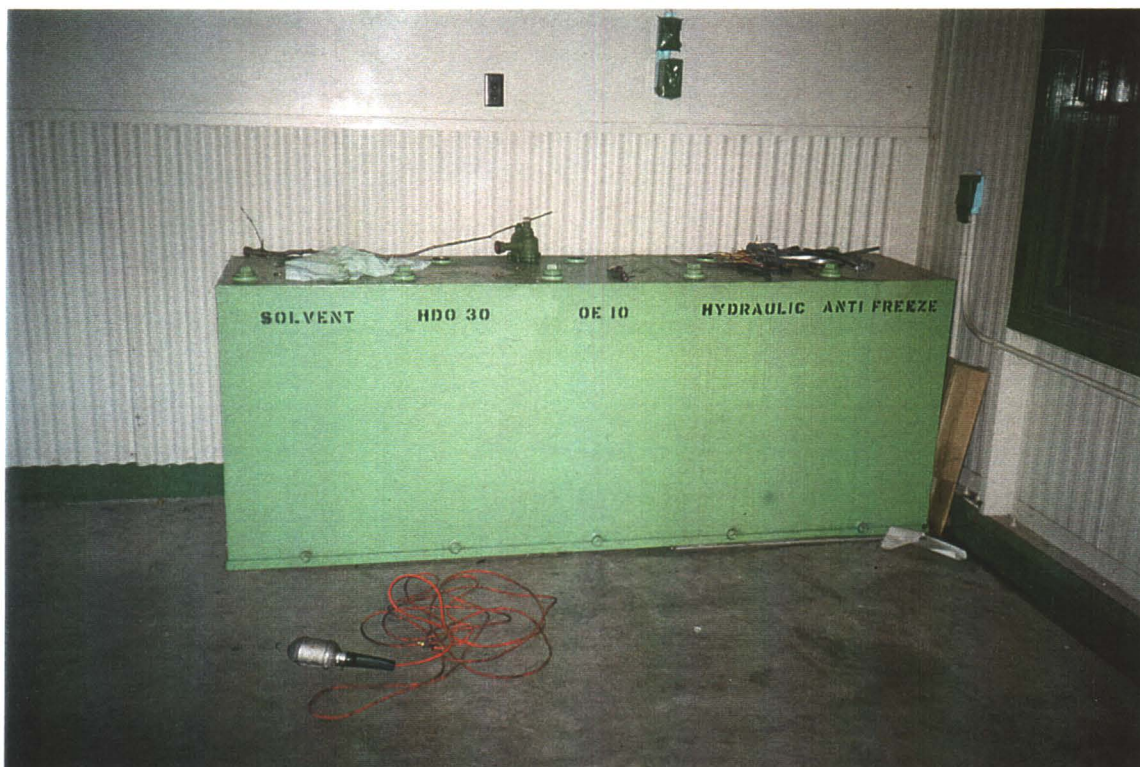
Mechanical Room/Shop. Maintenance fluid storage tank.
(Note: there are about four inches of product in each separate compartment)

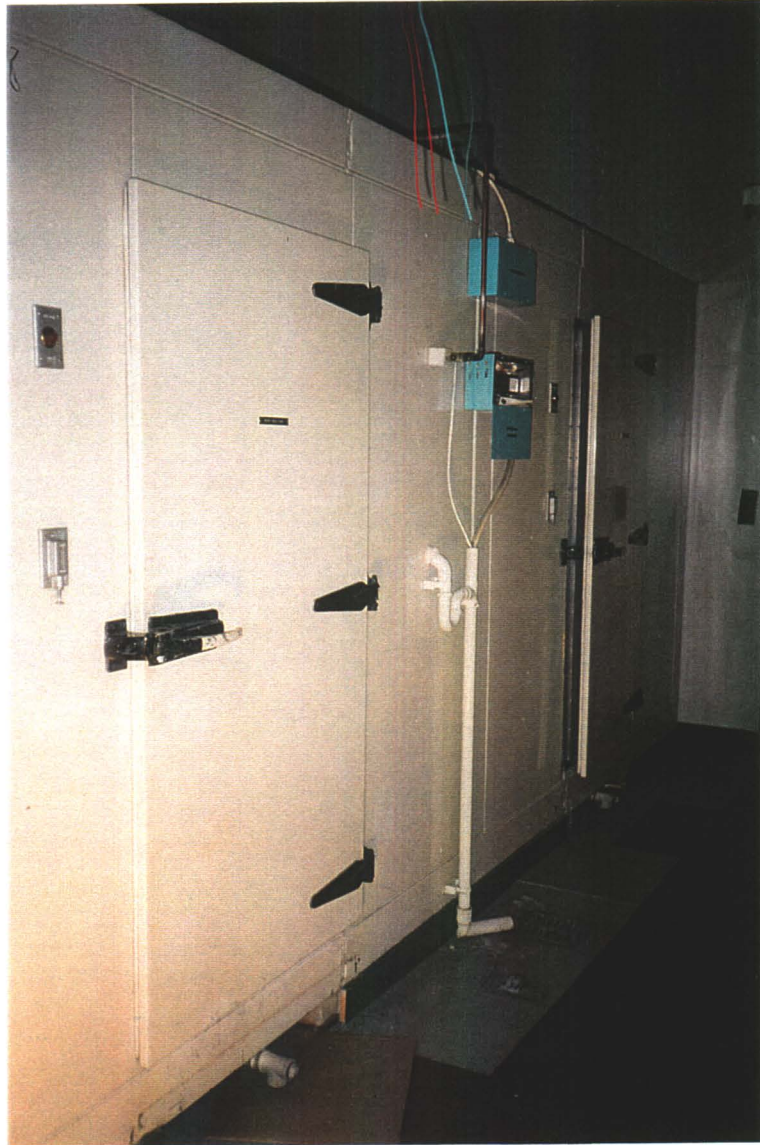
Store Room. Side by side walk-in cooler and freezer units. These units are complete, and are likely charged with coolant

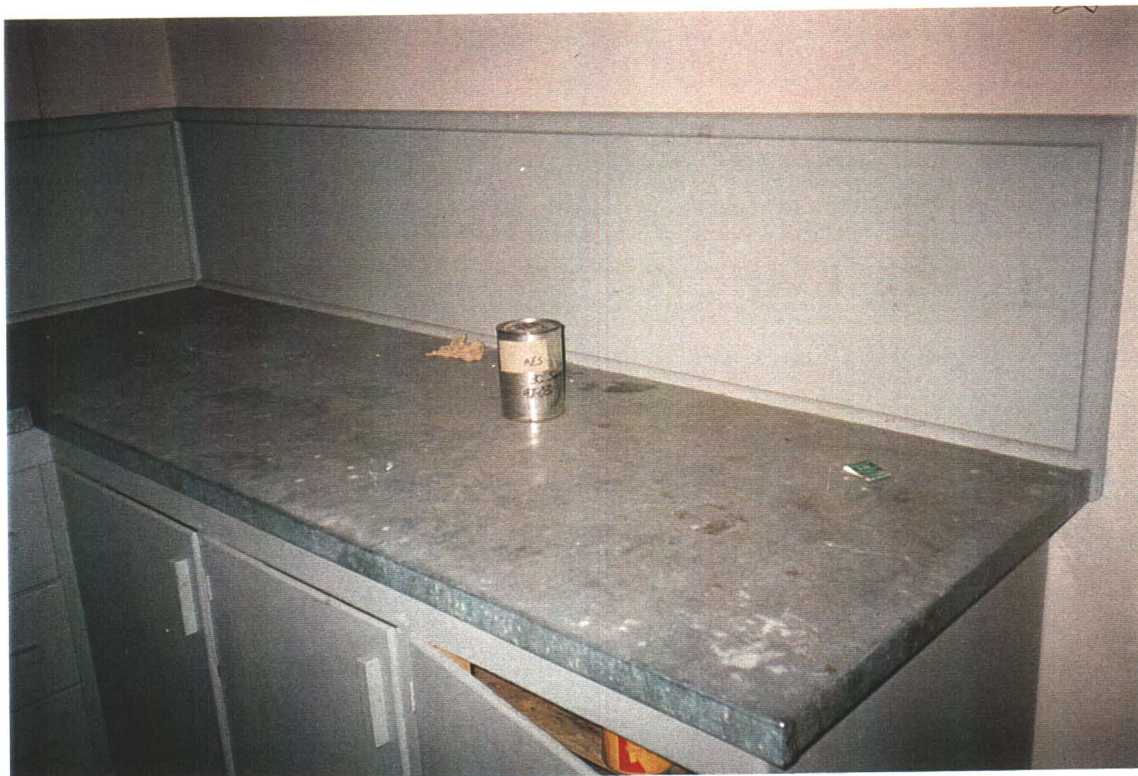
Store Room. Cabinet storage area.
(Un-labeled can of black powder identified as Decolourizing Carbon)

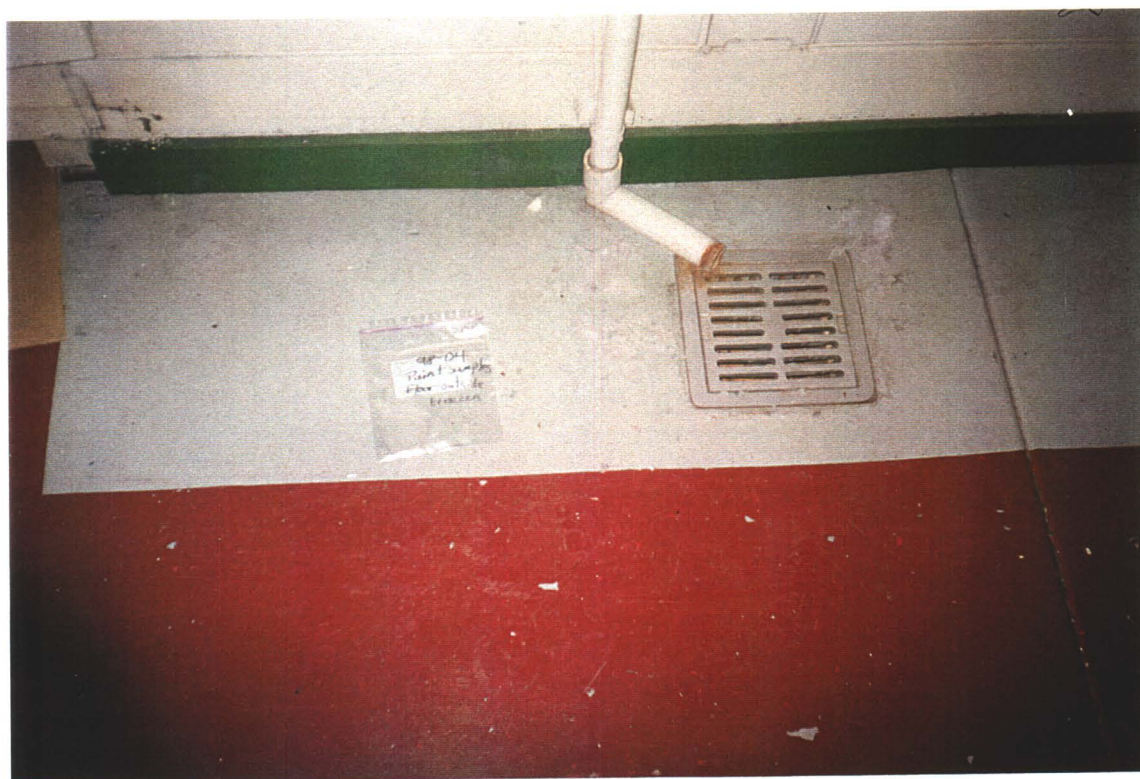
Mercury	Beads of mercury in switch gear	Guages, control room	1 guage	Current low risk. High risk if released
PCB's	N/A	N/A		N/A
Lead Based Paint	Sample 98-04 4560 mg/kg	Paint chip on floor adjacent to freezer		Moderate
	Sample 98-05 2610 mg/kg	Water tank		Current low risk. Low risk if disturbed.
	Sample 98-09 2850 mg/kg	Floor paint under Boiler unit 1		Current low risk. Low risk if disturbed.
	Sample 98-13 7030 mg/kg	Green metal paint on engine components, engine room		Current low risk. High risk if disturbed.
	Sample 98-14 5830 mg/kg	Wall paint in office/control room		Current low risk. High risk if disturbed.
Solvents		Fluid maintenance tank, mechanical room.	Less than 2 gallons	Low
Pressure Vessels		Boiler room Compressor room	No product	Nil
Random Chemicals (small quantities in containers)	Medicine chest Paint	Office/Control Room Mechanical Room/Shop	Less than 1 litre	Low

Store Room. Paint sample taken from floor in front of lockers.
(Identified as lead-based paint)

- There is lead paint on the floors and walls of each structure. Loose paint chips should be removed and disposed of as hazardous waste by a qualified contractor before the buildings are reused for any purpose.

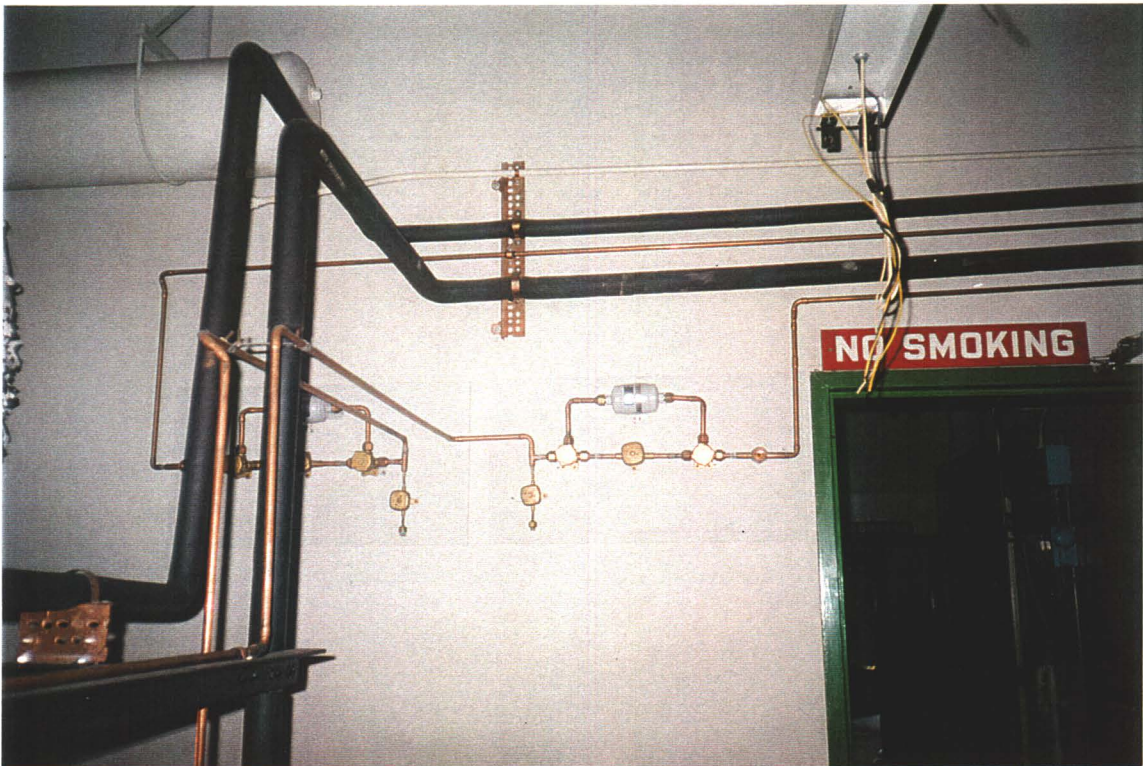
Boiler Room. Wall-mount coolant piping devices for cold storage lockers
(These lines are likely charged)

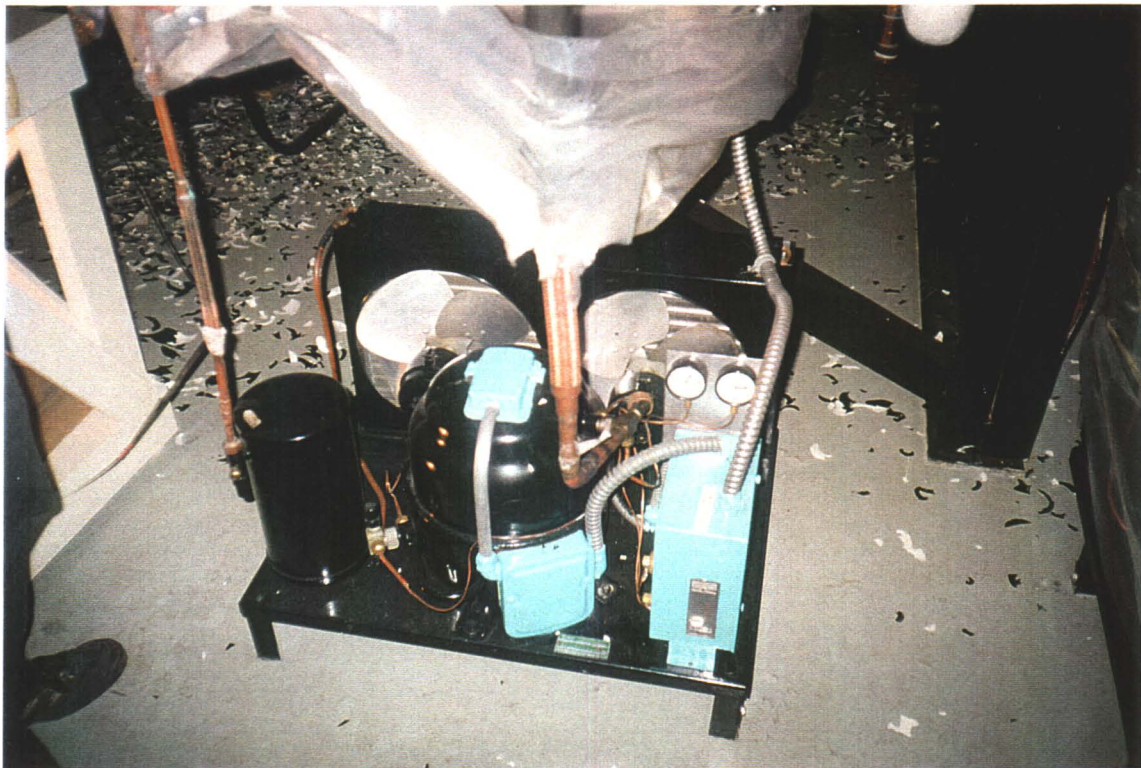
Boiler Room. One of two floor mount coolant compressor units for walk-in coolers
(These units are likely charged with coolant)

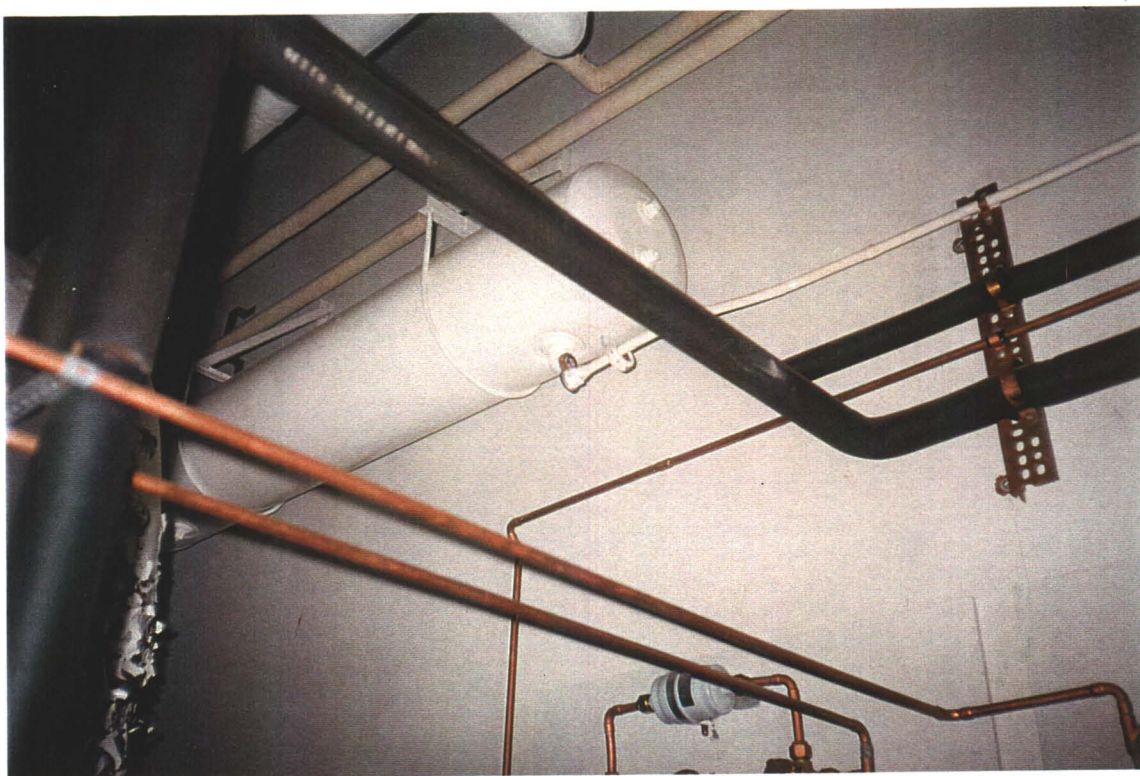
Boiler Room. Compressed air tank, wall mount.
(Note that discharge lines are disconnected and drained)

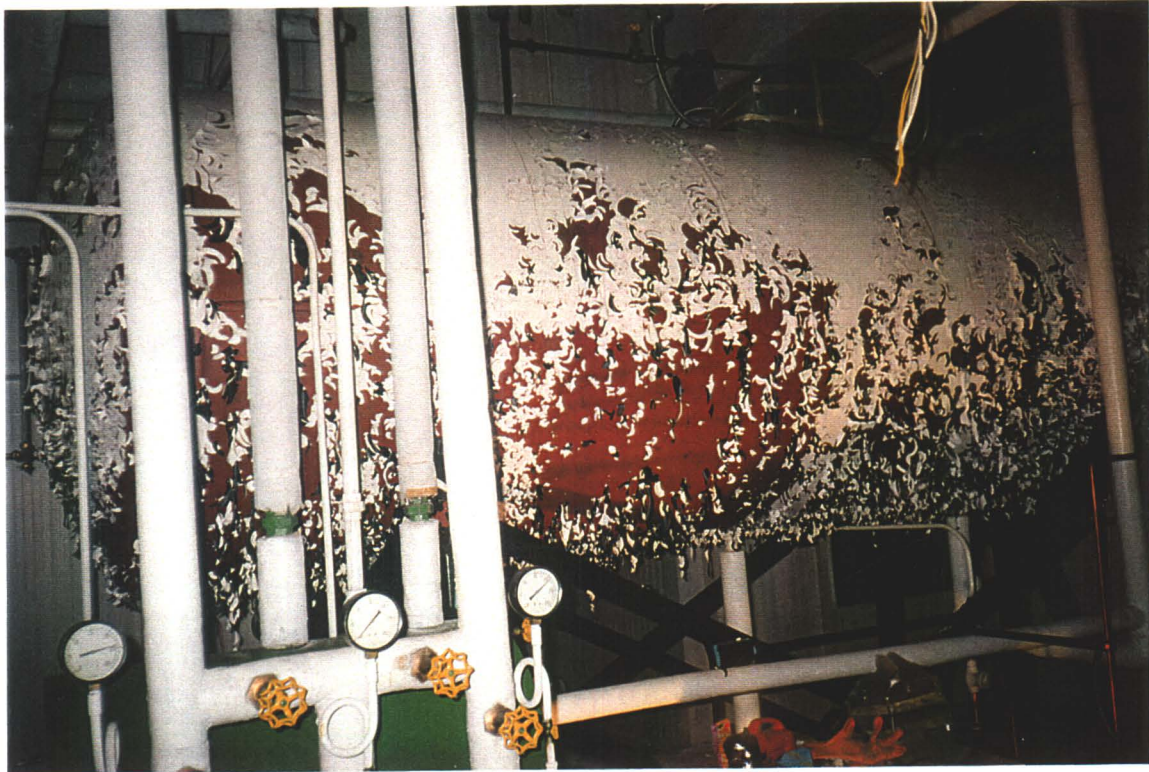
Boiler Room. Water storage tank, completely drained.
(note: lead based paint is flaking off)

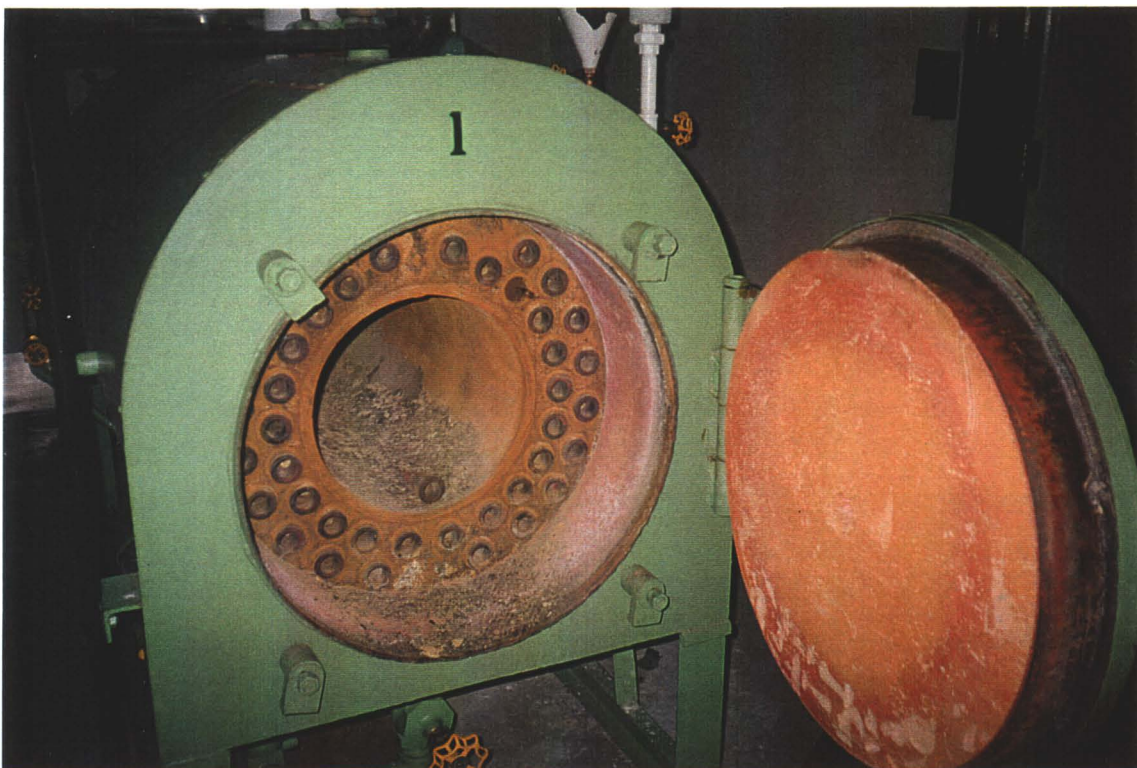
Boiler Room. Entry door, boiler # 1.
(note: asbestos gasket on door)

- Asbestos has been confirmed on pipe joints, exhaust stacks, boiler main steam lines, gaskets, transite pipe. All asbestos should be removed before any equipment is taken from the Station or modifications to the heating system are made.

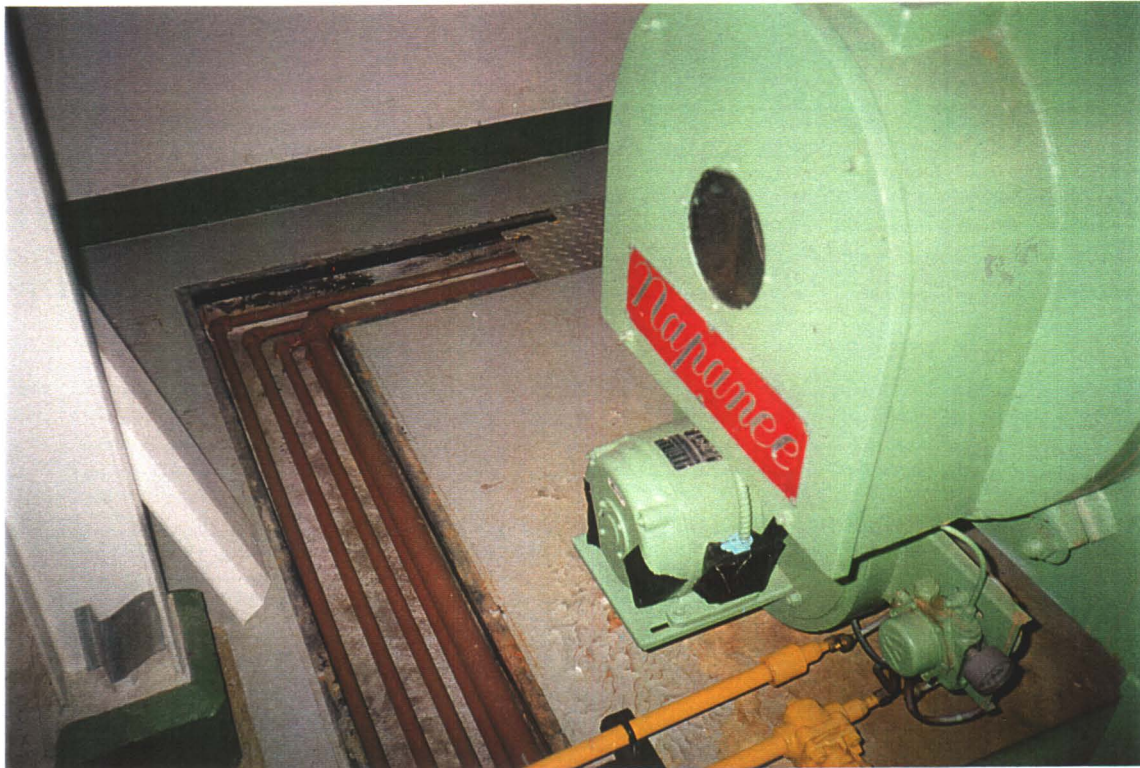
Boiler Room. Back end of boiler #2
(note: all water/glycol lines are disconnected and drained)

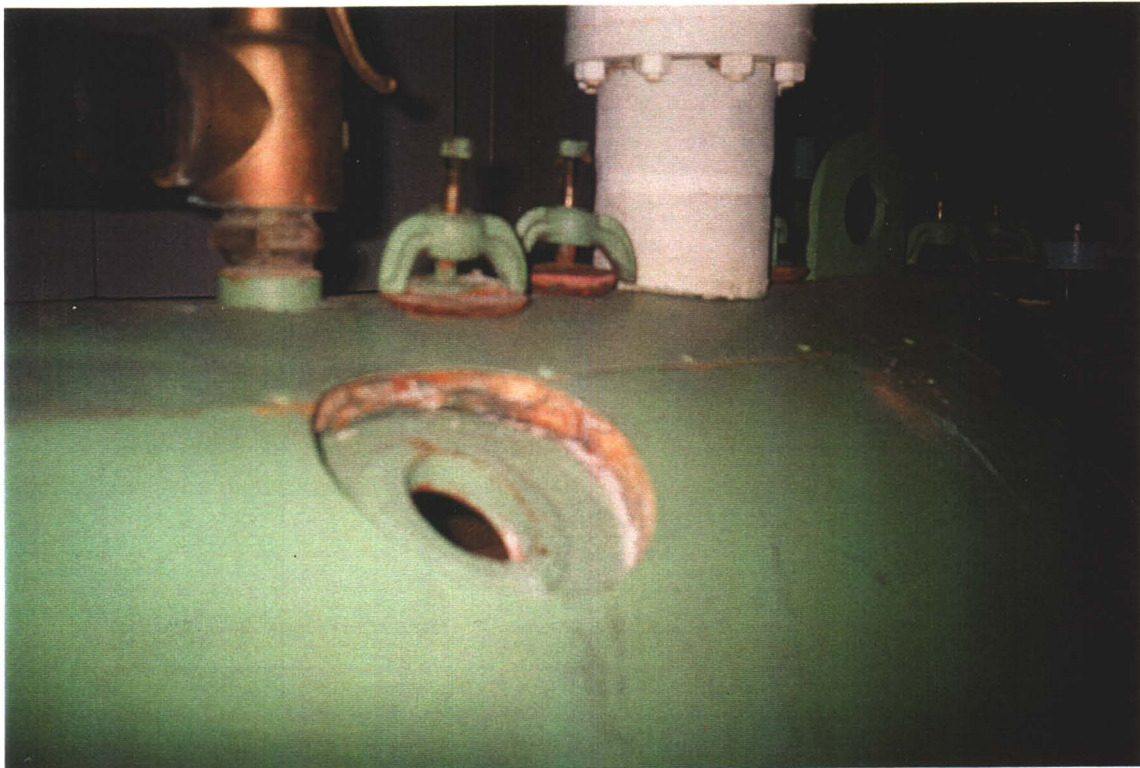
Boiler Room. Top of boiler #1.
(note: yellow-coloured boiler insulation confirmed to be man-made fibre, not asbestos)

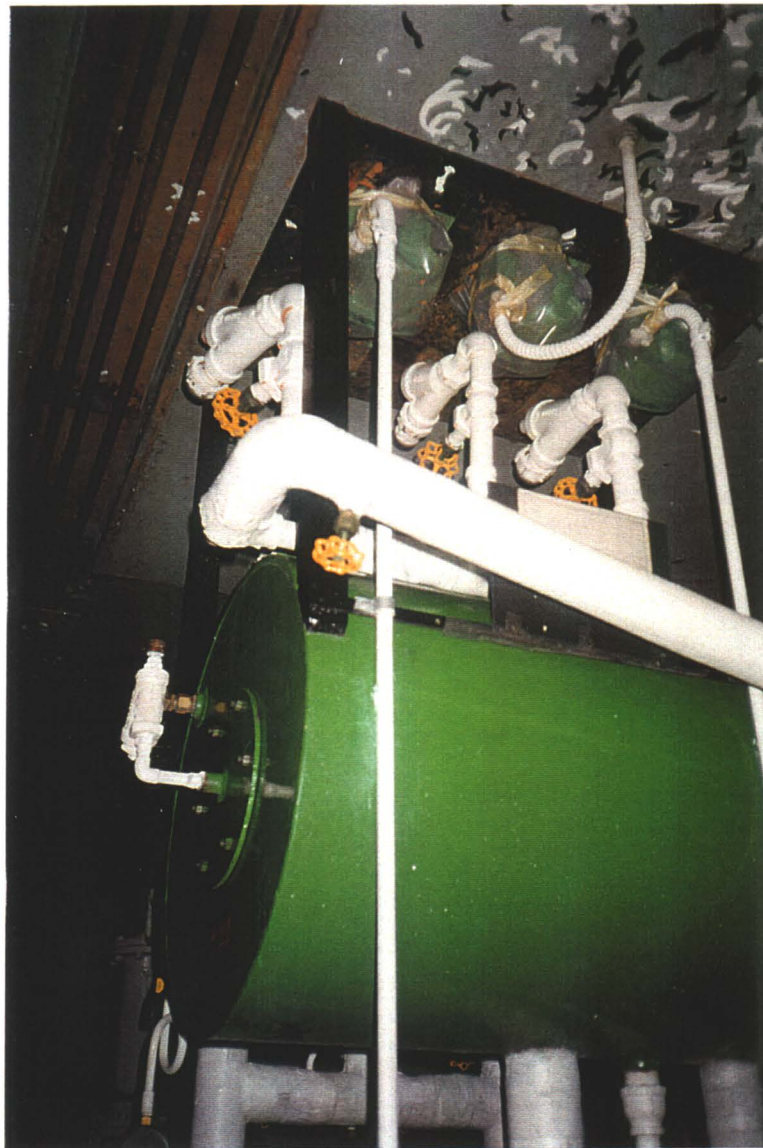
Boiler Room. Pressure vessel for hot water.
(note: asbestos knuckles, and pumps have been disconnected to drain lines)

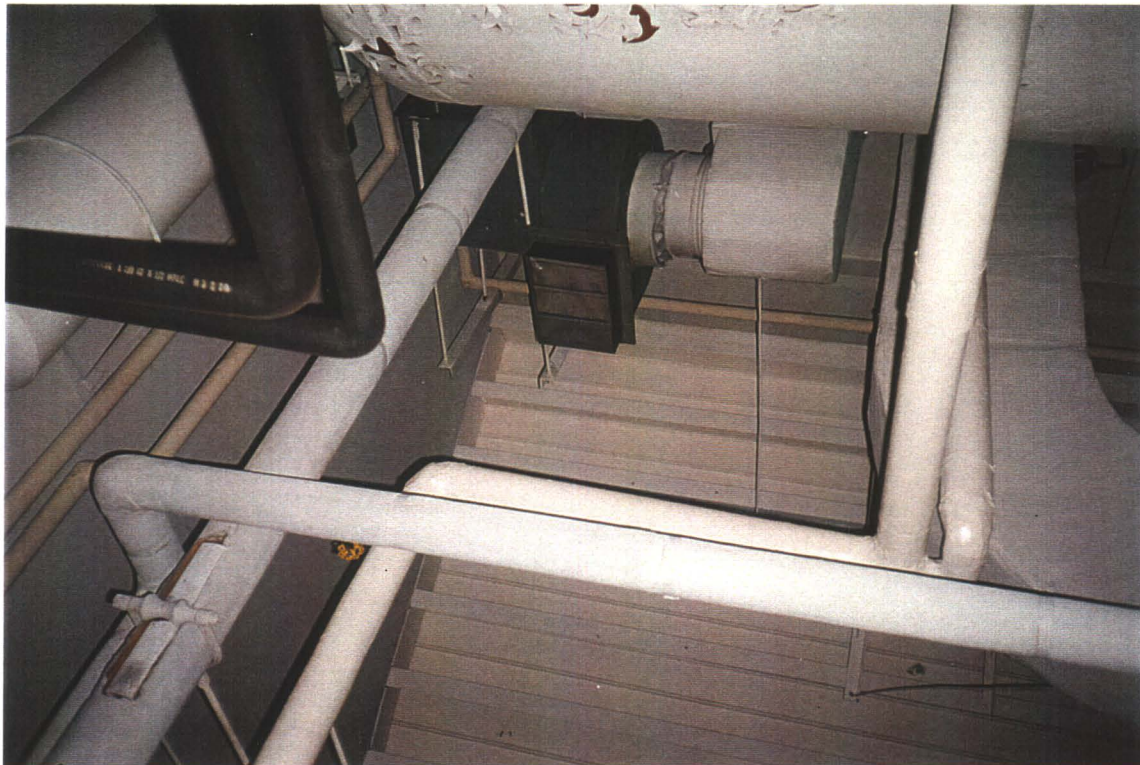
Boiler Room. Outside air intake unit above water storage tank.
(Note: insulated pipe has asbestos knuckles)

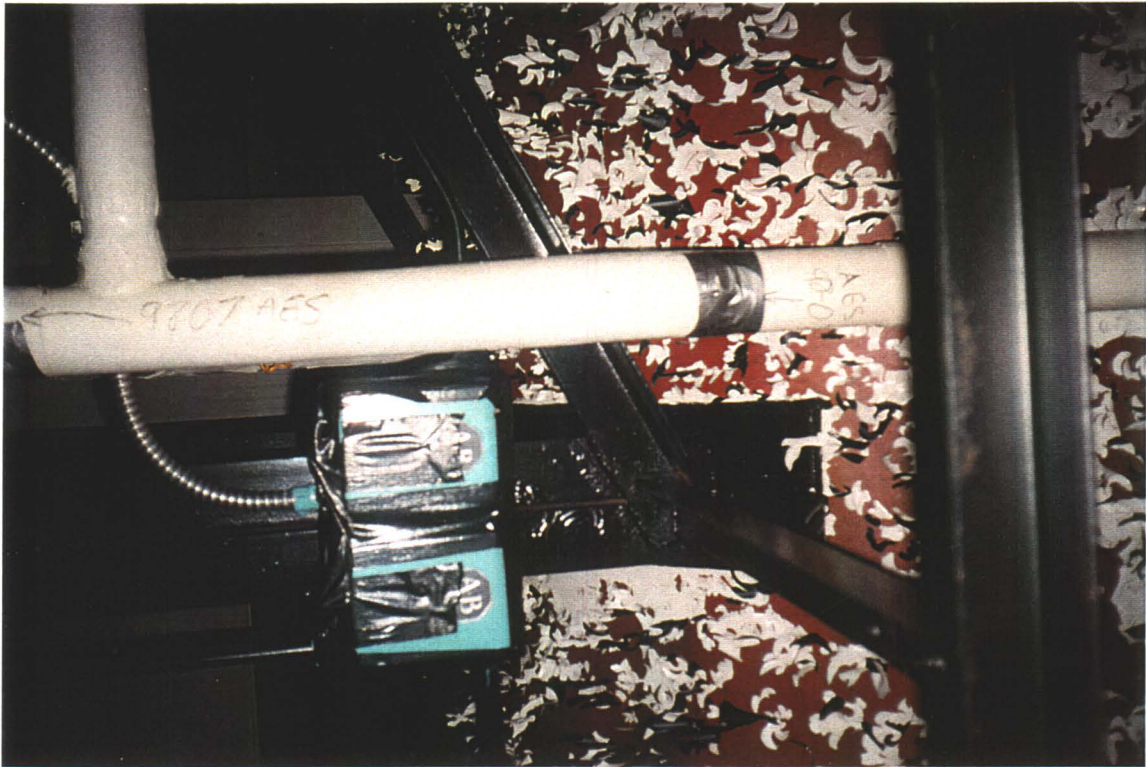
Boiler Room. Confirmed asbestos locations on insulated pipe joints.

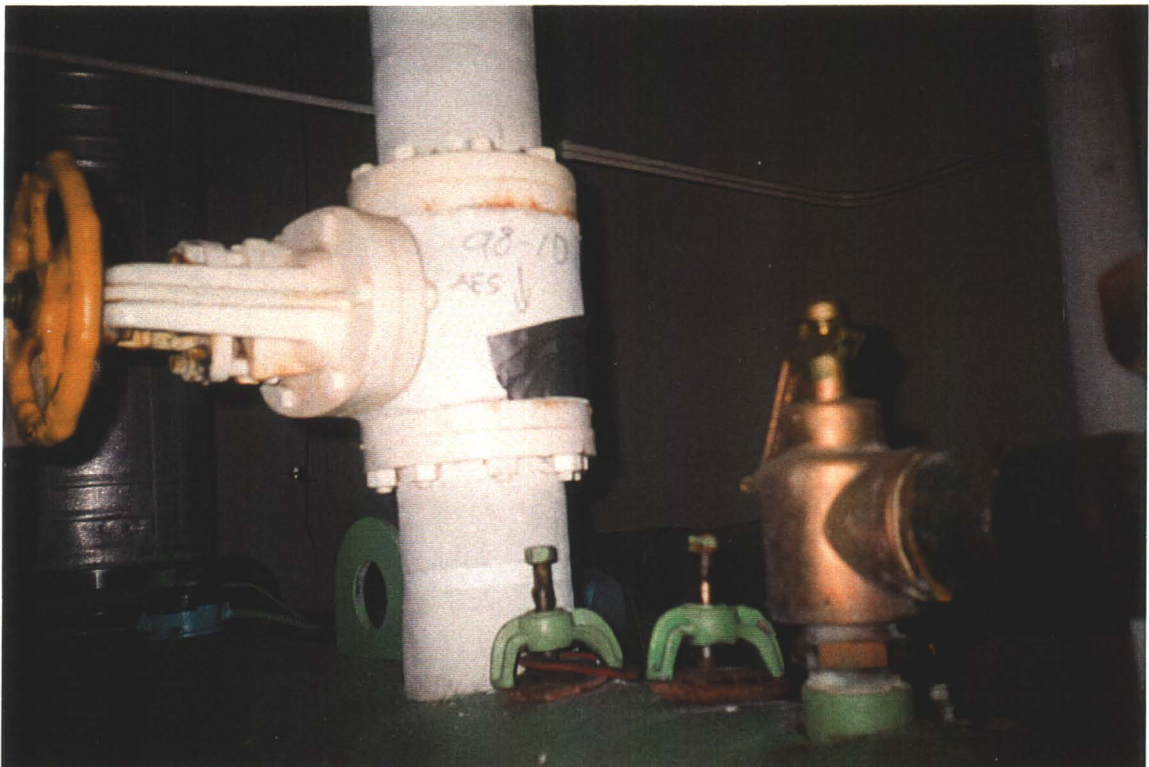
Boiler Room. Confirmed asbestos on main steam line joint.

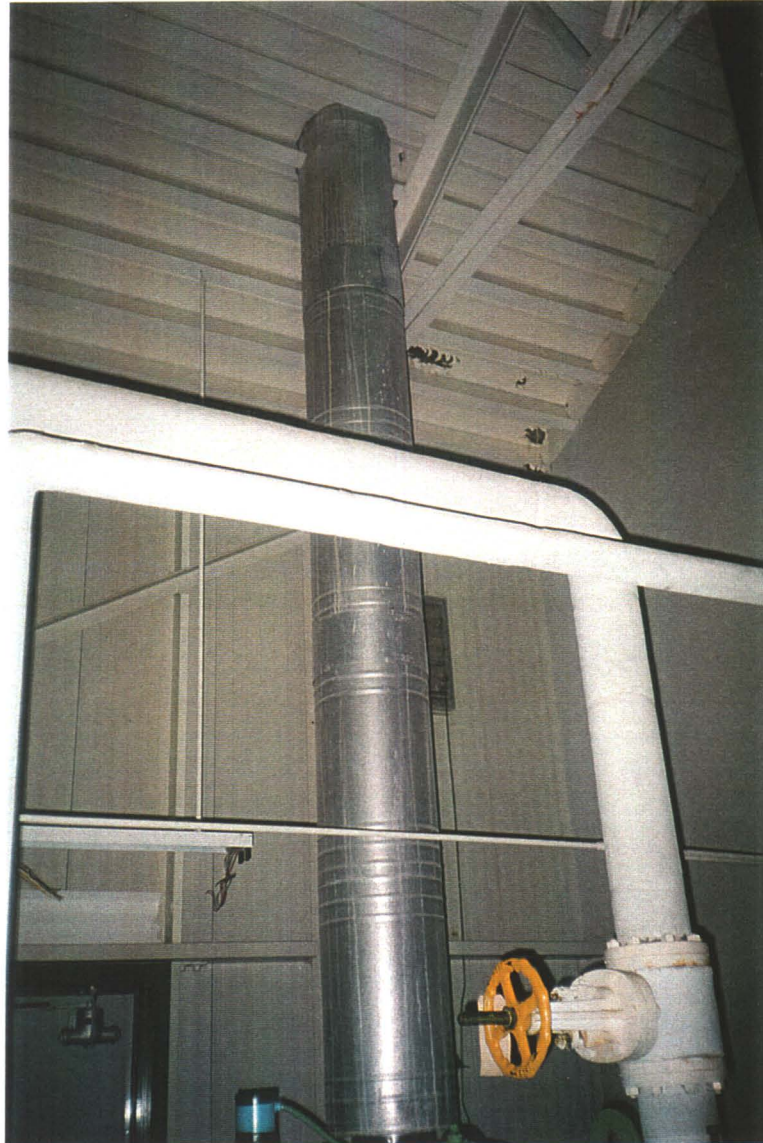
Boiler Room. Boiler Stack and main steam lines.
(Note: each contains asbestos)

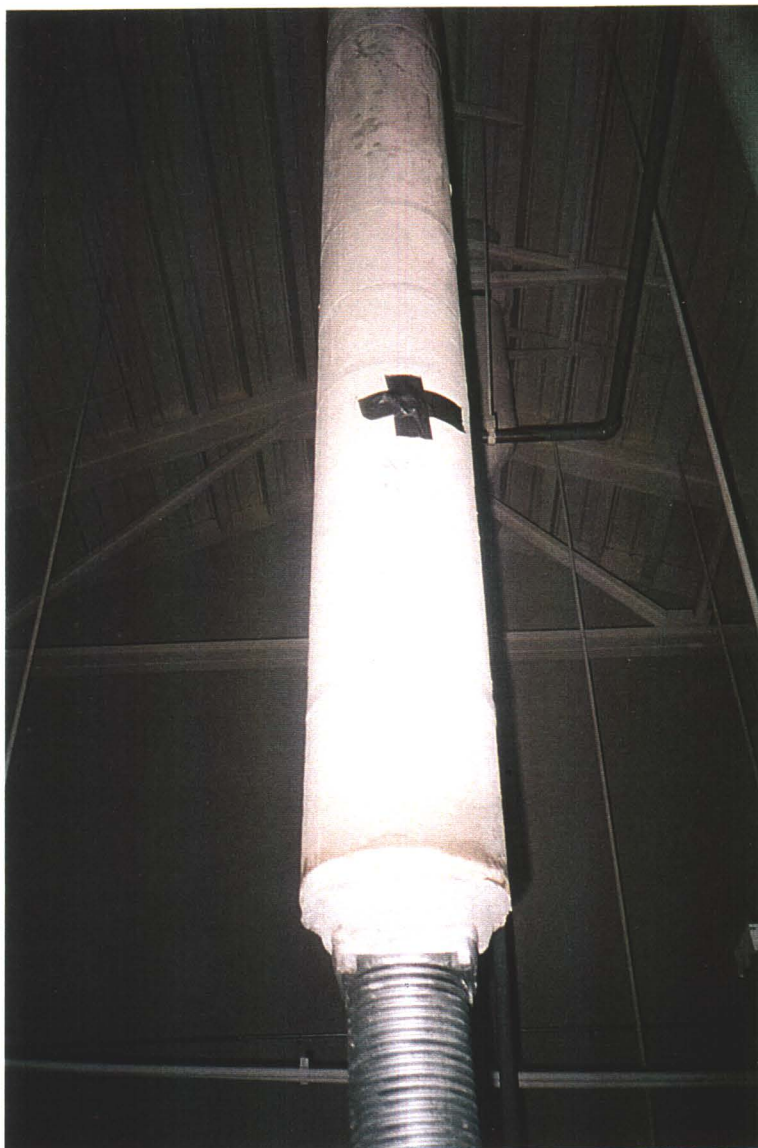
Generator Room. Generator stacks confirmed to contain friable asbestos (sample 98-12).

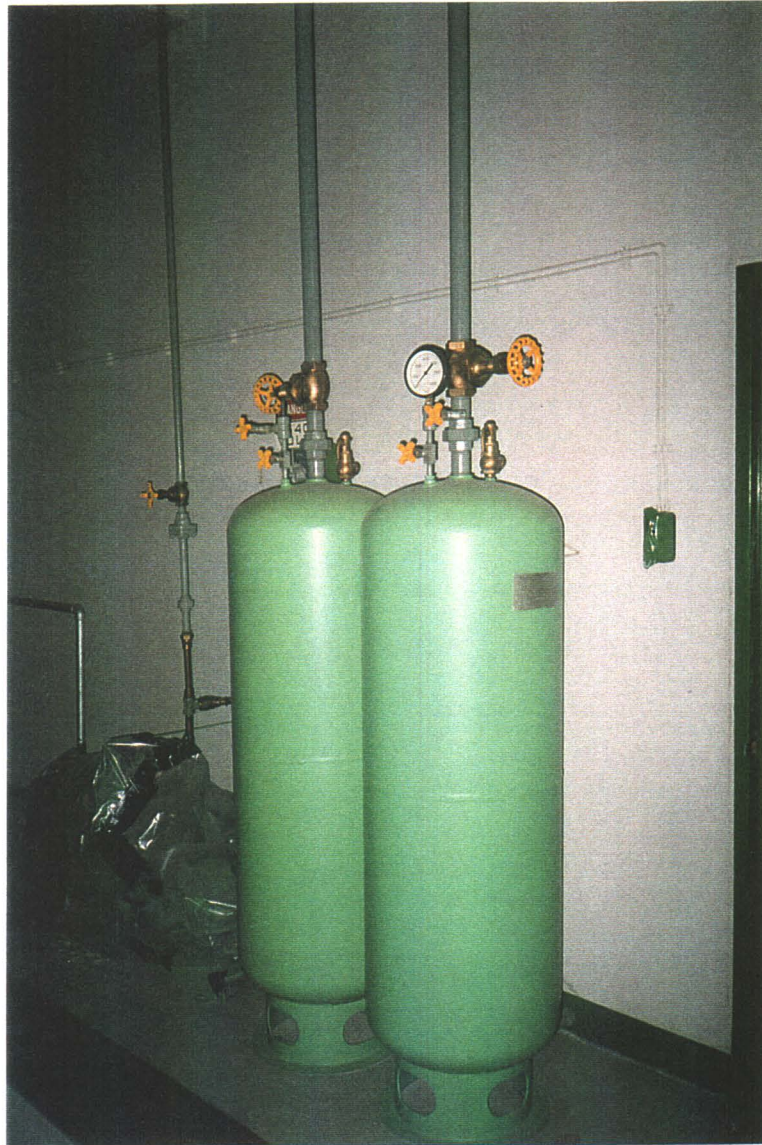
Generator Room. Compressed gas vertical storage tanks, currently drained.

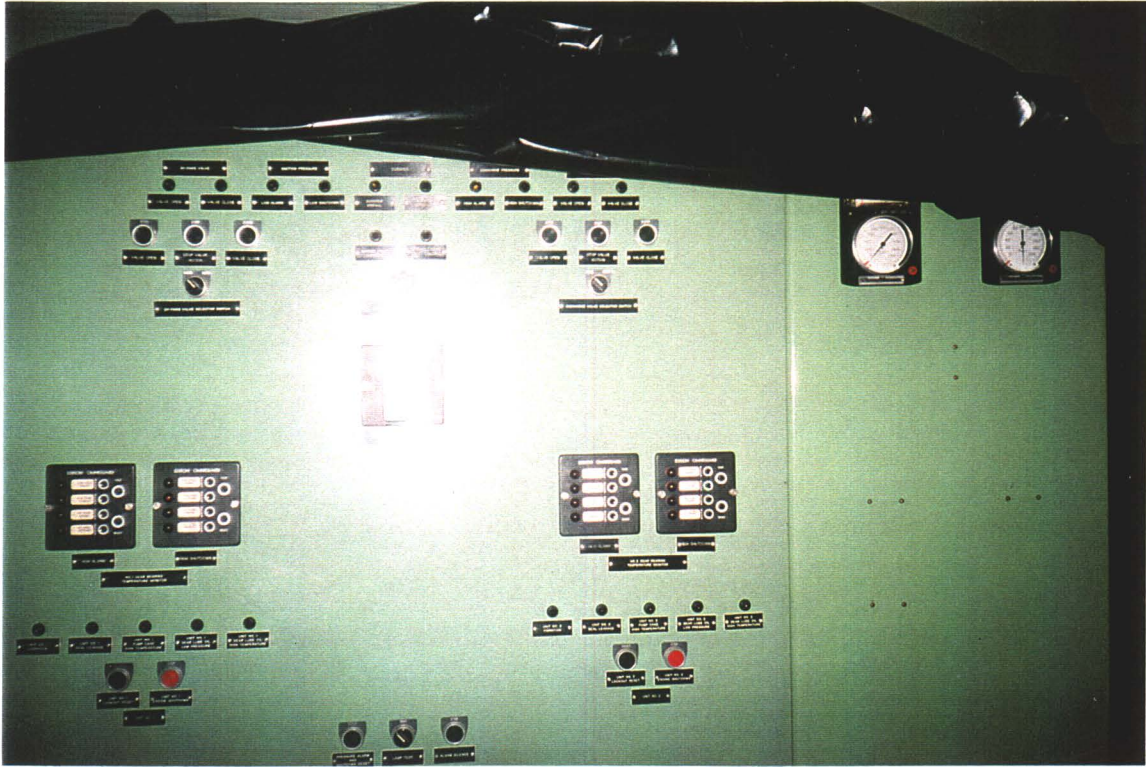
Office Room. Control Panel.
(note: contains at least one mercury activated switch)

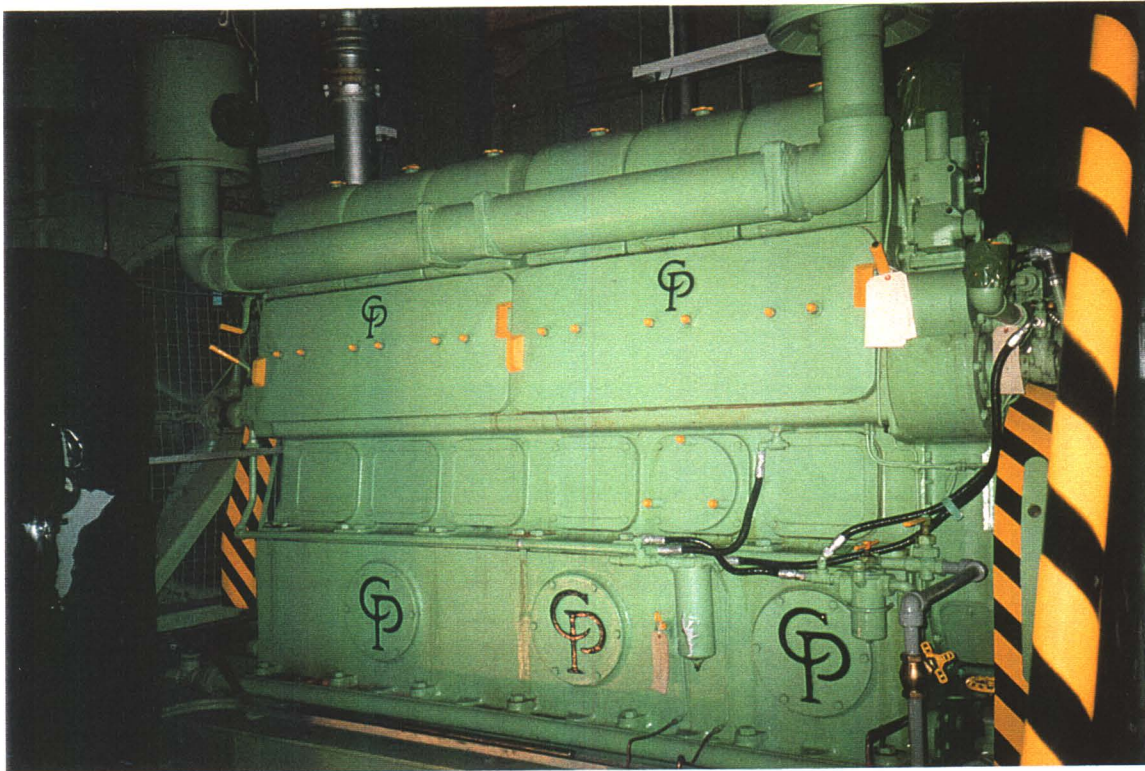
Engine Room. Diesel engine units to power compressors in adjoining Compressor Room. Both units are skid mounted. Exhaust systems are asbestos free, and each unit is equipped with engine jacket water coolers which have asbestos gasket connections to the engines.

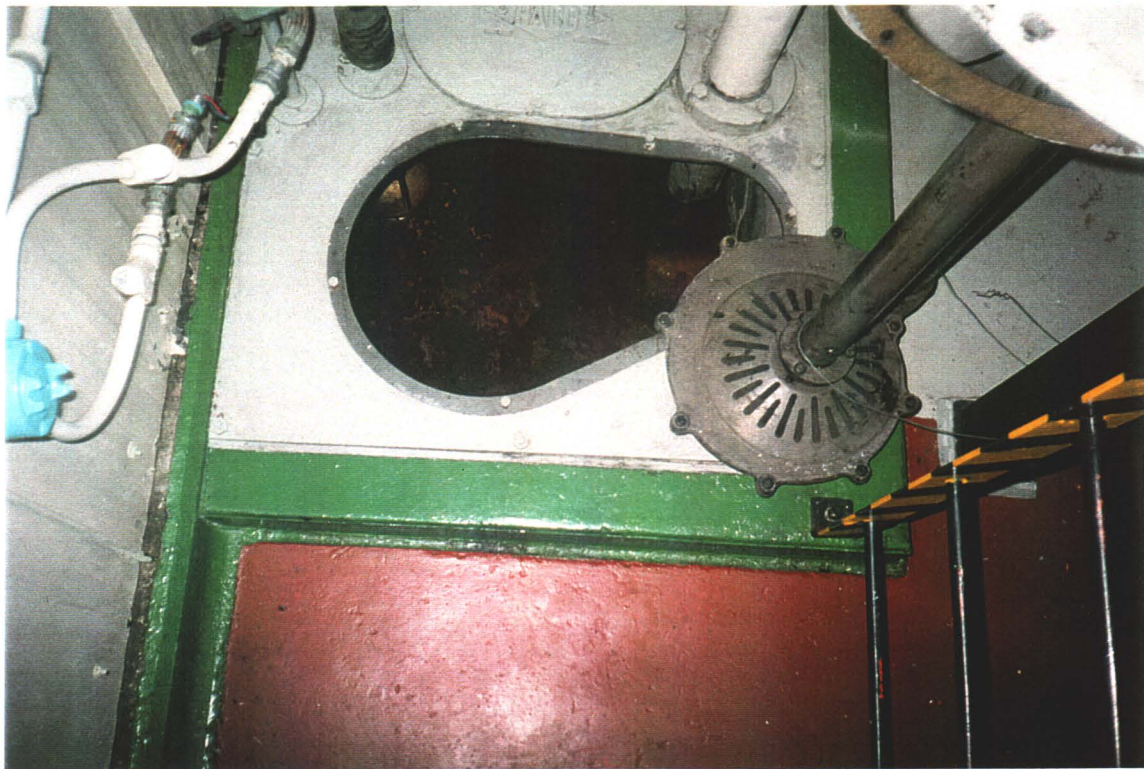
Compressor Room. Sump and stored electric sump pump. Sump contains antifreeze.

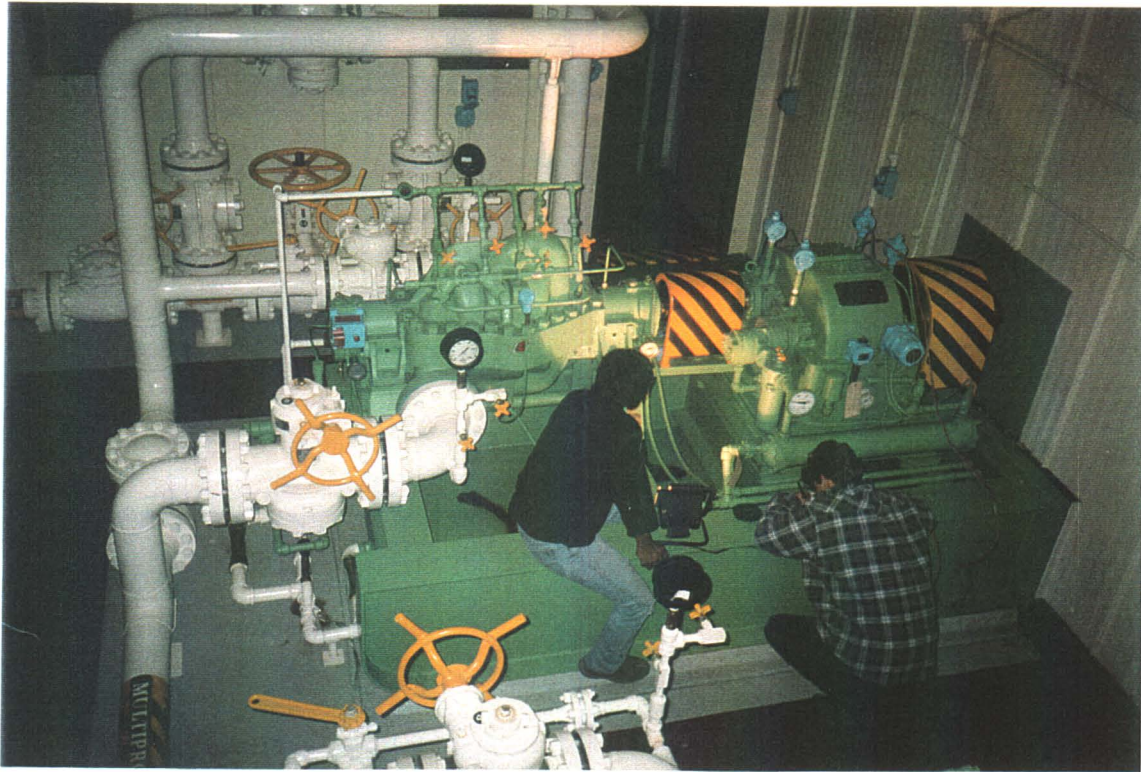
Compressor Room. Two compressor units, both drained and filled (for storage) with P-9 light oil.
(note: all lead-based paint in this room)

- Lead paint on engines, steel piping, etc. can be safely be removed from the Main Building without concern during removal of these items. Whoever accepts these removed items must be warned of the lead paint concern.

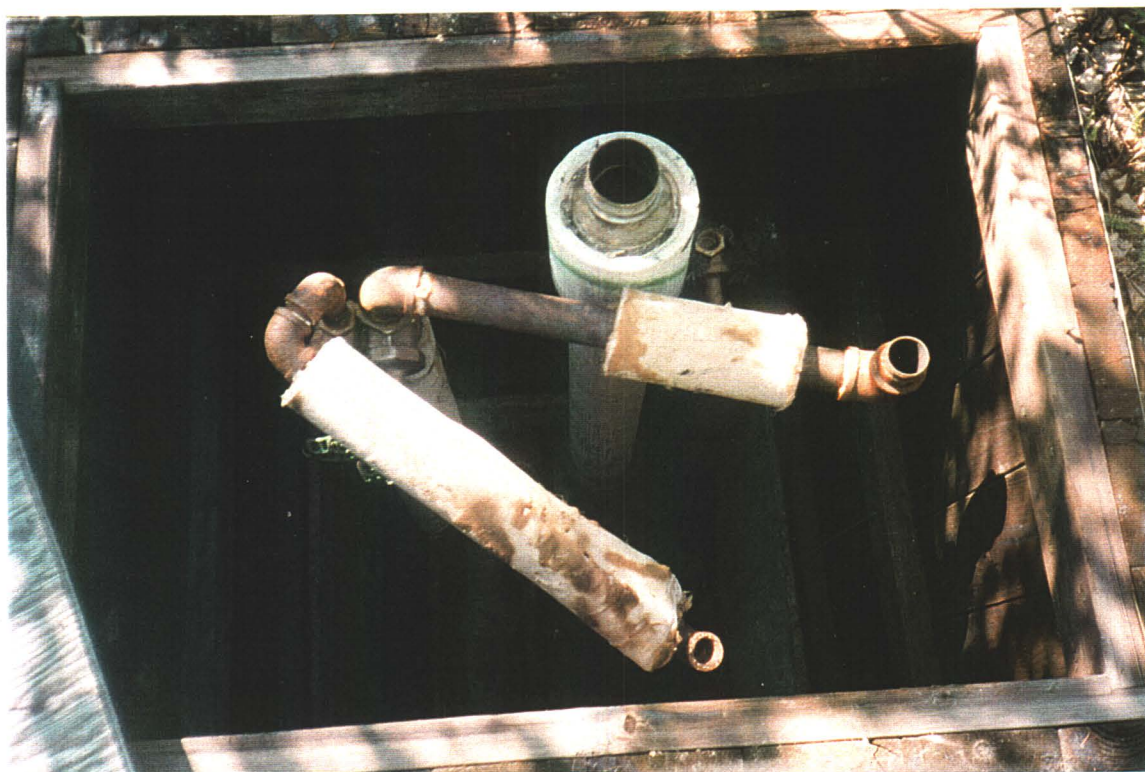
Typical services pit at each trailer stall (one of six).
(Note: transite asbestos pipe sewer connection)

- The six utility pits which formerly serviced trailer housing units. These pits have wooden covers but should be removed or filled in.
- Two underground storage tanks remain on site and should be removed and properly disposed of.

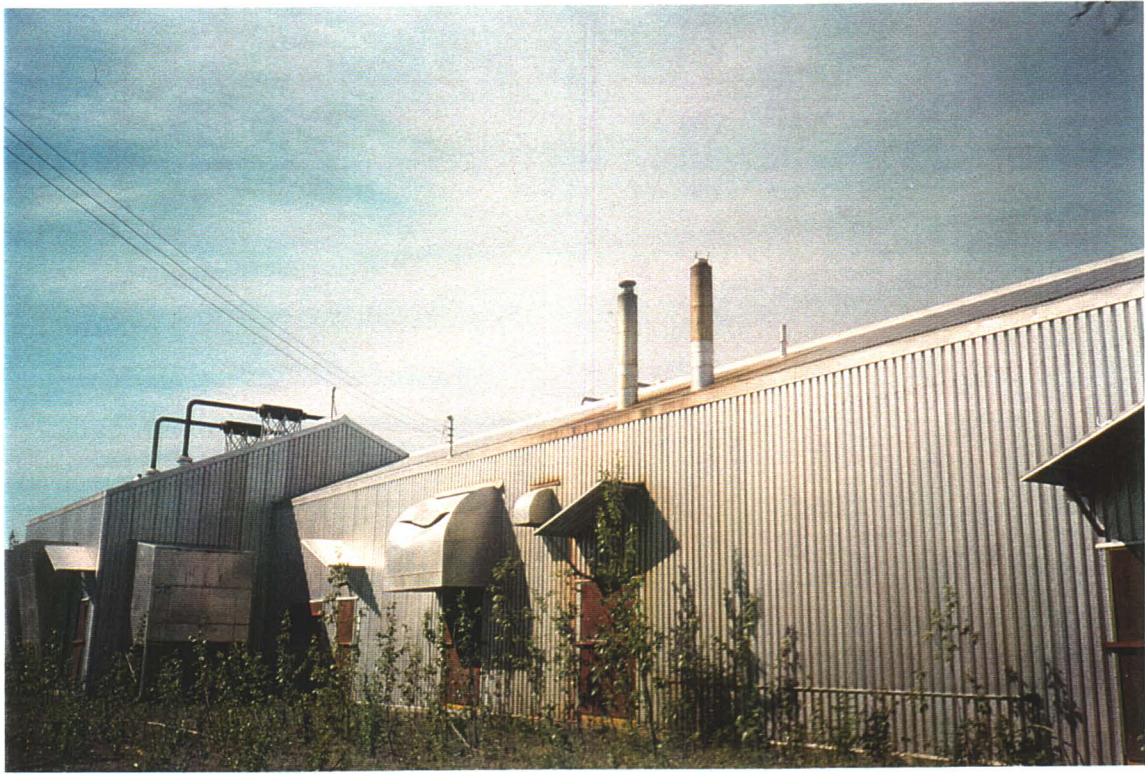
Back of main building. Note stainless steel ventilation structures, and asbestos-filled Generator Room stacks.

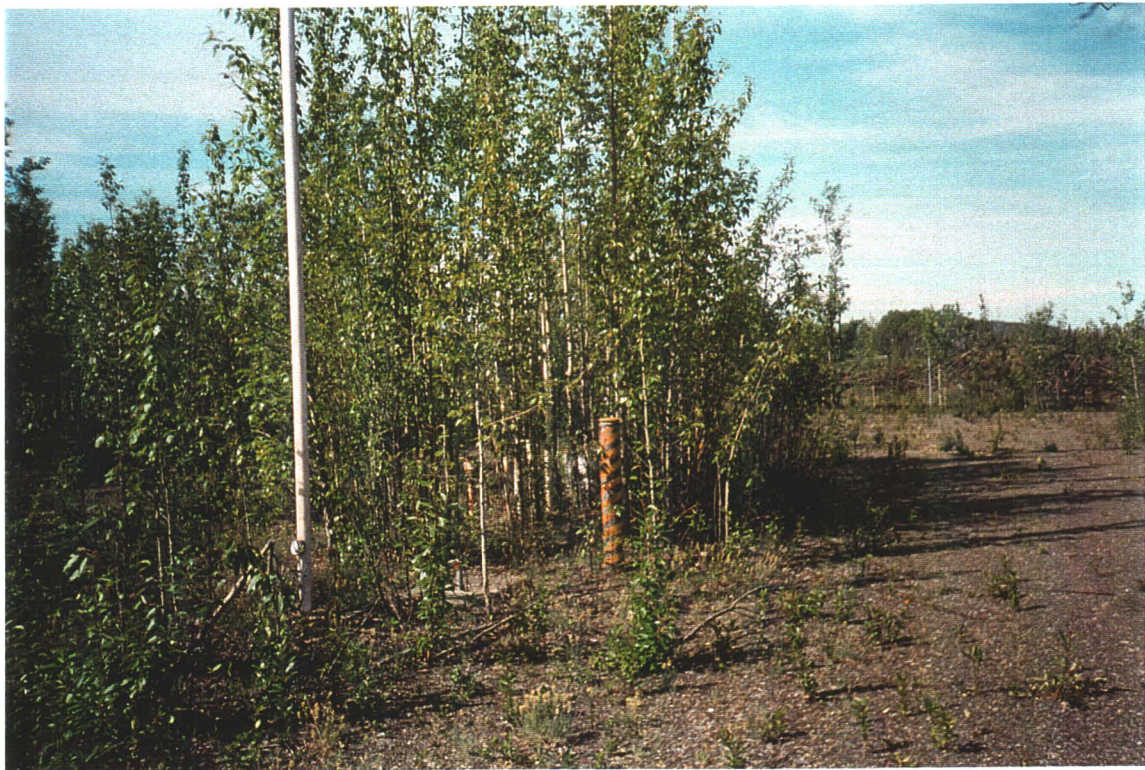
Location of two underground storage tanks and former pump island.
