**Inventory of Equipment, Machinery,
Major Fixtures and Hazardous Materials
at the Beaver Creek Pumping Station,
Yukon Territories.**

**Prepared for
Indian and Northern Affairs Canada**

July, 1998

**Prepared by
Arctic Environmental Services Ltd., and KO KEN General Contractors**

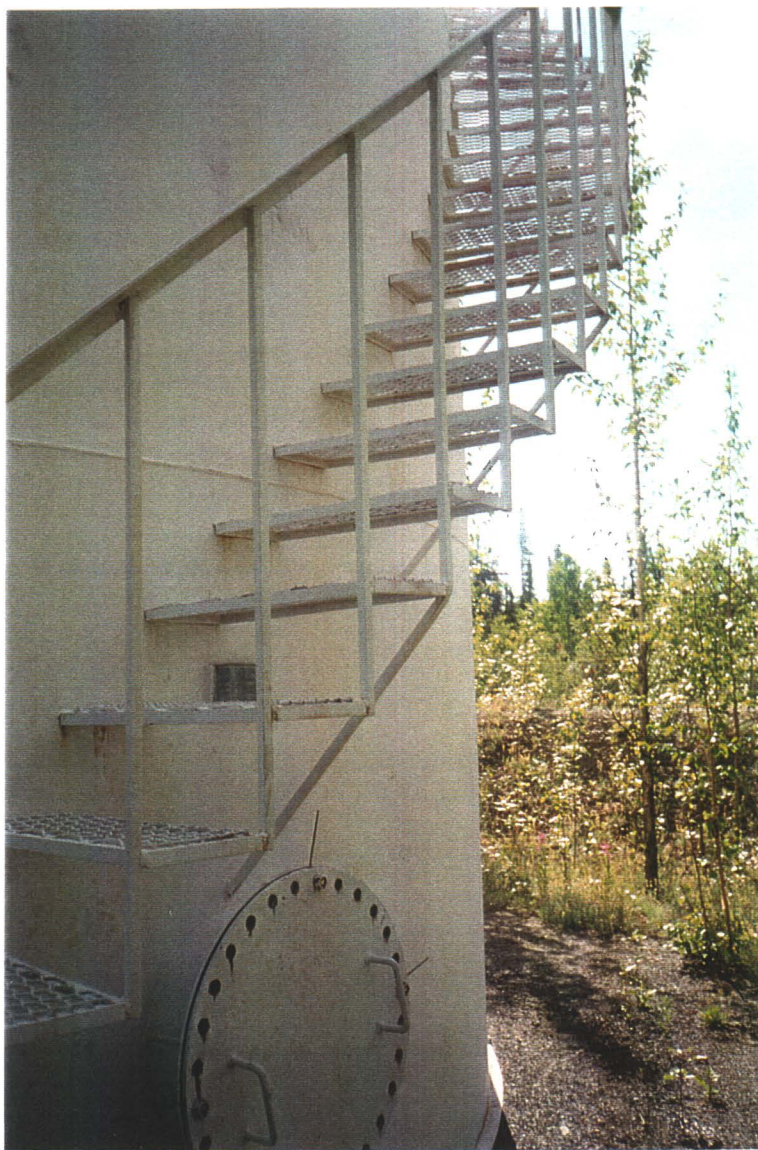
Main product tank, 1440 barrel capacity. Man-way loosely bolted, indicating entry following product removal.
