**INDIAN AND NORTHERN AFFAIRS CANADA
ABANDONED CLINTON CREEK
ASBESTOS MINE
1998 SITE RECONNAISSANCE**

APRIL, 1999

**PREPARED BY
UMA ENGINEERING LTD.
ENGINEERS AND PLANNERS
1479 BUFFALO PLACE
WINNIPEG, MANITOBA
R3T 1L7**

Reference: Abandoned Clinton Creek Asbestos Mine – 1998 Site Reconnaissance

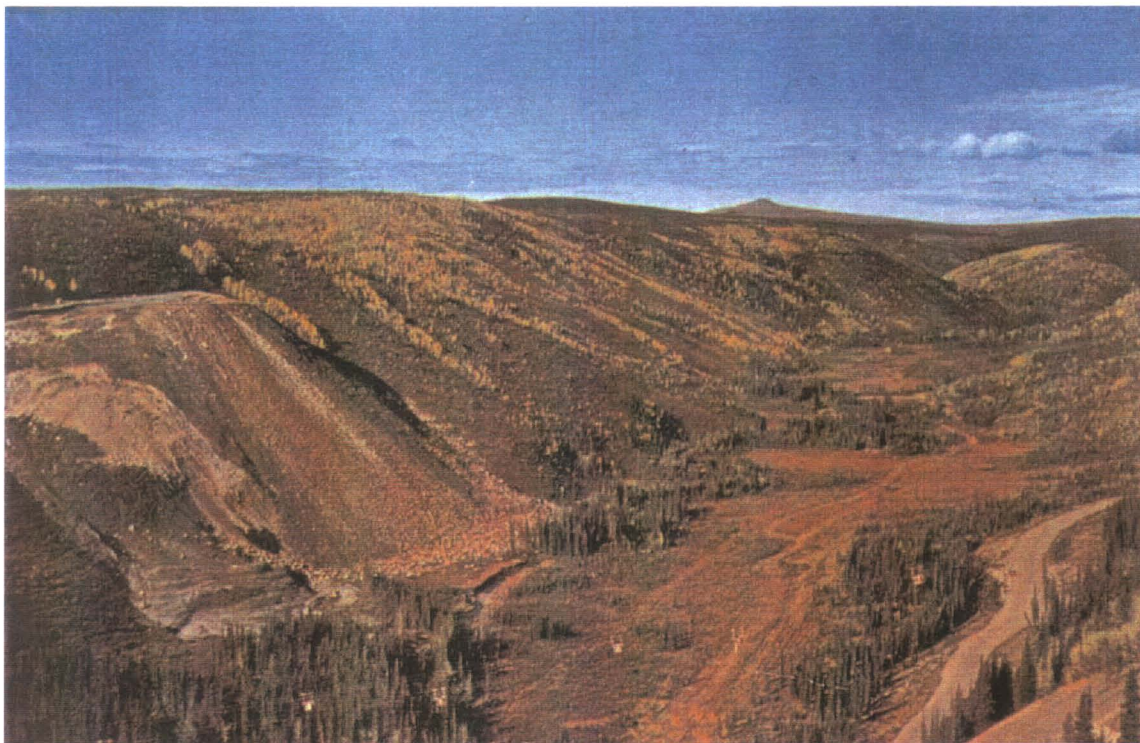
The waste rock from Porcupine Pit was initially placed along the south valley slope west of the mine as shown on Photo CC-01, probably taken around 1970 (Geo-Engineering, December, 1986). It is apparent that the waste rock was unstable at this early stage as evidenced by visible slumping of the east section of waste rock. This early photograph, looking upstream, also illustrates Clinton Creek along its original alignment in the center of the valley (now Hudgeon Lake).

Photo CC-01: Clinton Creek Waste Rock Dump (Circa 1970)

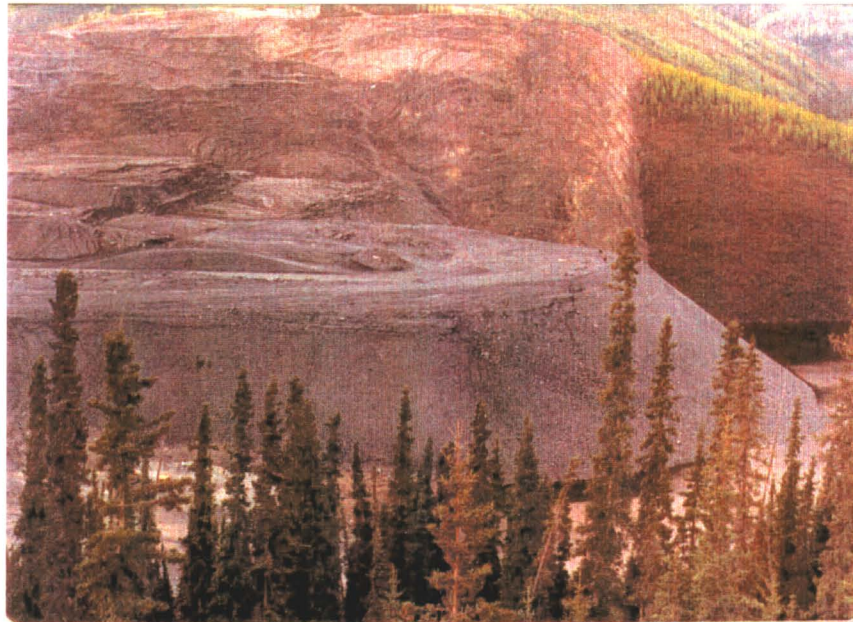
Between 1970 and 1975, a considerable volume of waste rock was dumped across the valley as shown on Photo CC-03 taken in May, 1975. The resulting valley blockage impounded water from the Clinton Creek watershed creating Hudgeon Lake.

Photo CC-03: West end of Waste Rock Dump (May, 1975)

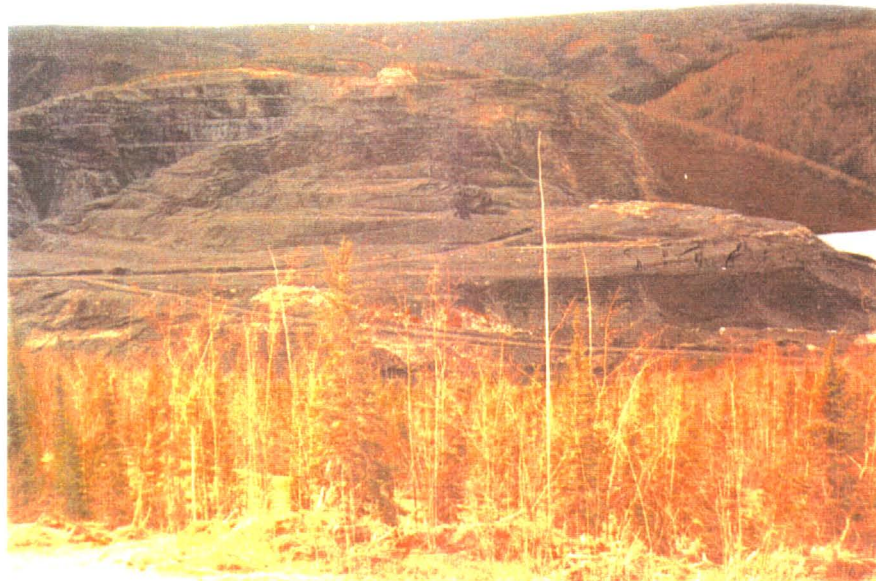
Significant lateral spreading of the rock fill, in particular at the west end of the dump towards Hudgeon Lake, occurred as a consequence of the continued placement of waste rock. Photo 1, taken in about May 1976 (Golder Associates, April 1977), shows tension cracks along the crest of waste rock adjacent to Hudgeon Lake. By 1985, the west end of the waste rock dump had slumped considerably towards, and into, Hudgeon Lake (Photo 2, Klohn Leonoff, September, 1986).

Photo 1: Tension Cracks at West End of Waste Rock Dump (1976)

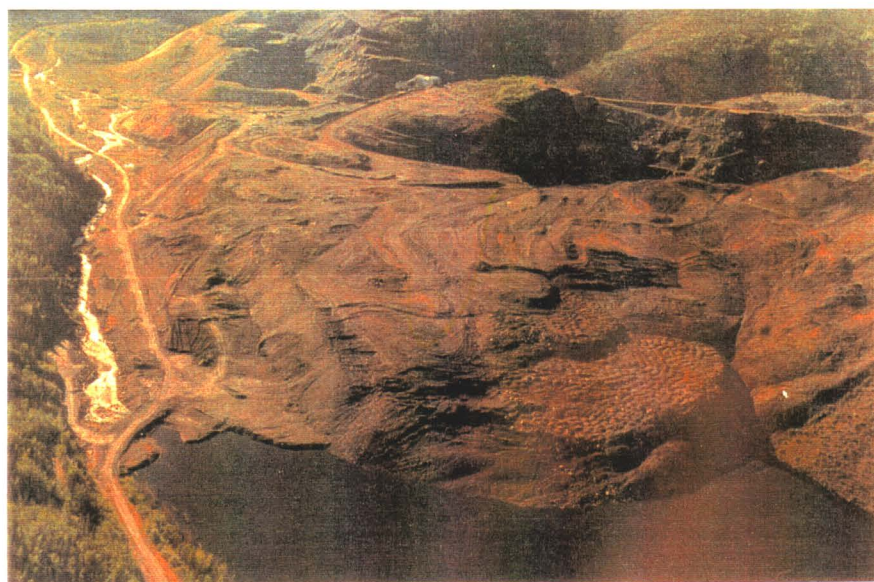
Photo 2: View South at Waste Rock Dump (1985)

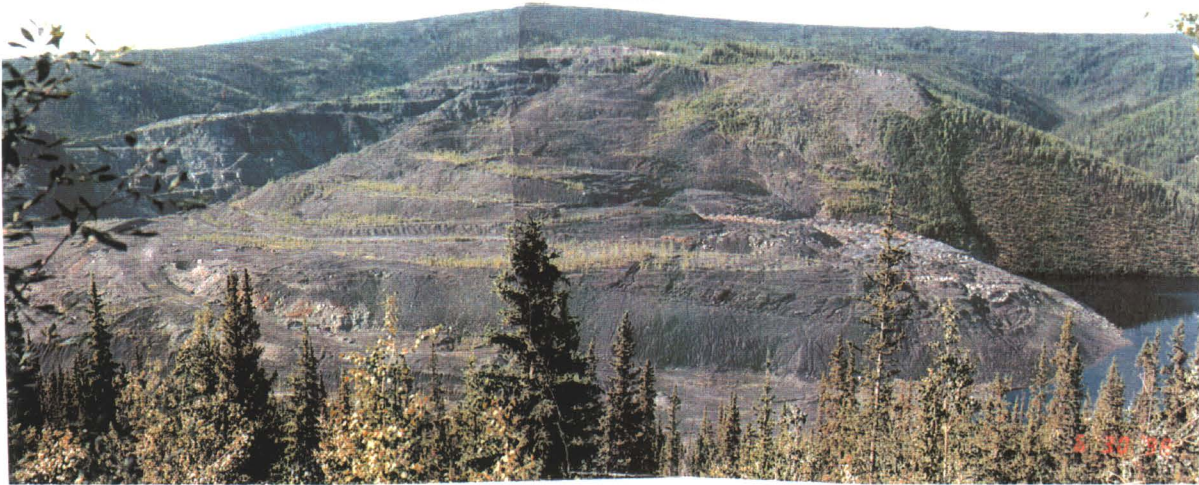
Based on observational records, active movement of the waste rock dump has continued since mine closure in 1978, although the magnitude of this movement has not been quantified since that time. Prior to mine closure, surveys of movement monitoring targets were conducted to assess the rate and magnitude (vertical and horizontal) of waste rock movement. With the exception of several targets along the south bank of the creek channel, most of the monitoring points are intact. Targets located during our reconnaissance are indicated on Drawing 02. Visible movements of the waste rock pile were reported in Geo-Engineering's July, 1998 report (Photo 17). Examination of the area near the center of Photo 17 (sparsely covered with young poplar trees) in September revealed that many of the tension cracks associated with slump blocks had been infilled, possibly suggesting reduced slope movement at this end of the dump (UMA Photo 9-3). More recent multiple tension cracks which further confirm on-going lateral movements of the waste rock were observed farther east along the access road during our September, 1998 site reconnaissance (UMA Photo 2-18, Appendix A).

Photo 17: Tension Cracks in Waste Rock Along Sparsely Treed Area (1998)

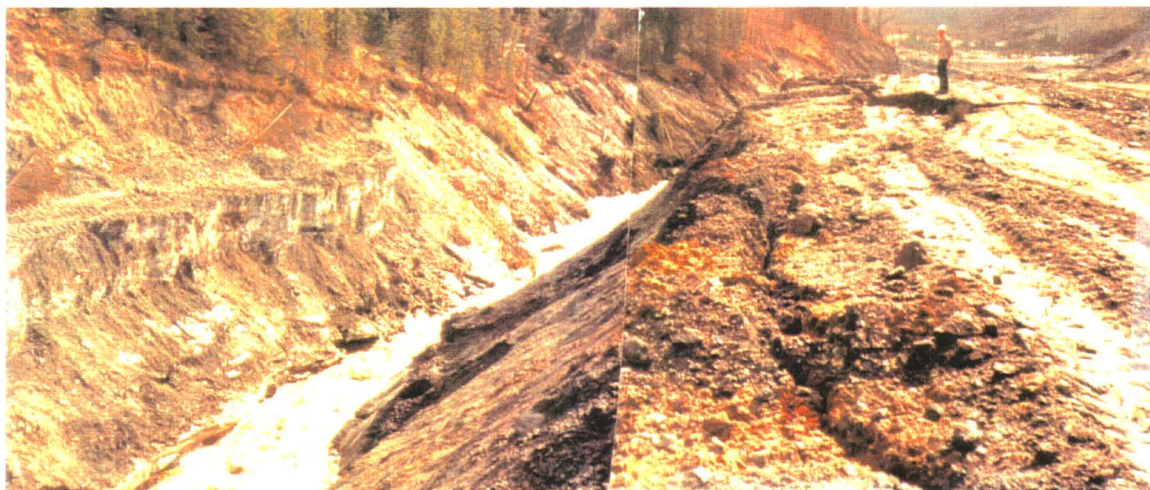
A new access road with a wide shoulder was subsequently constructed through the rock fill along the south side of the creek channel. However, the waste rock was undercut and began slumping soon after it was constructed as shown on Photo 5, (Golder Associates, April 1977). Slumping on the north side of the channel also began to undercut the natural valley slope can also be seen in Photo 5.

Photo 5: Erosion and Slumping of New Access Road on South Side of Creek (1976)

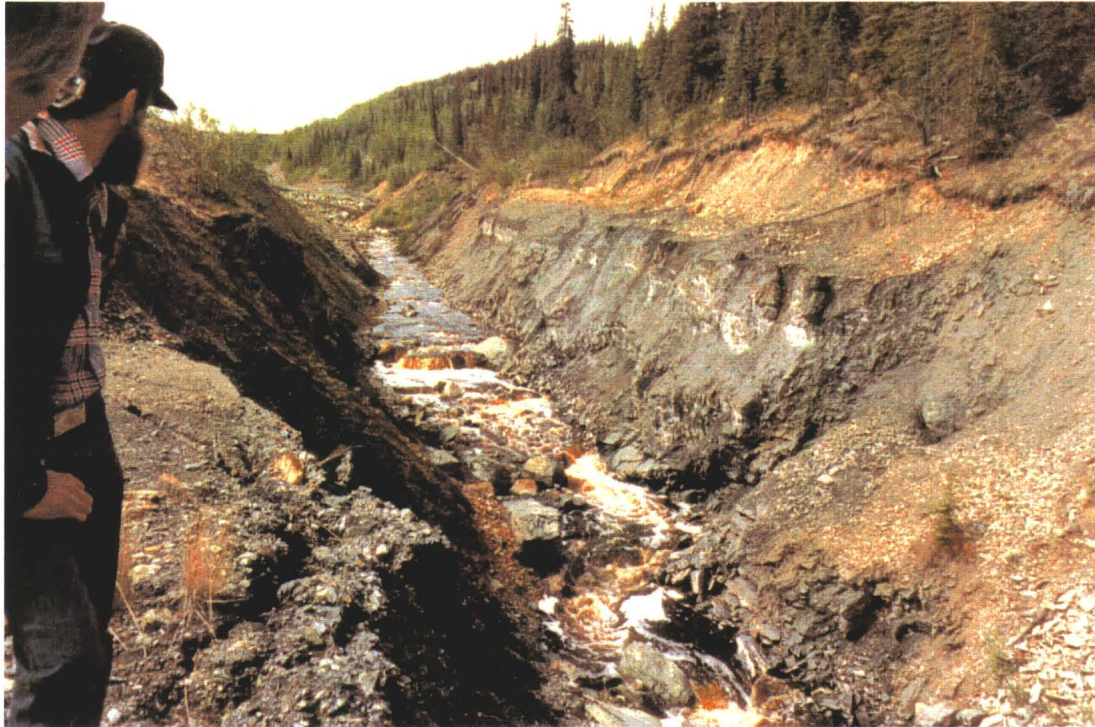
Significant channel erosion and down-cutting is also evident downstream of the weir (Photo 4 Klohn Leonoff, August 1983).

Photo 4: Channel Erosion Downstream of Weirs (1983)

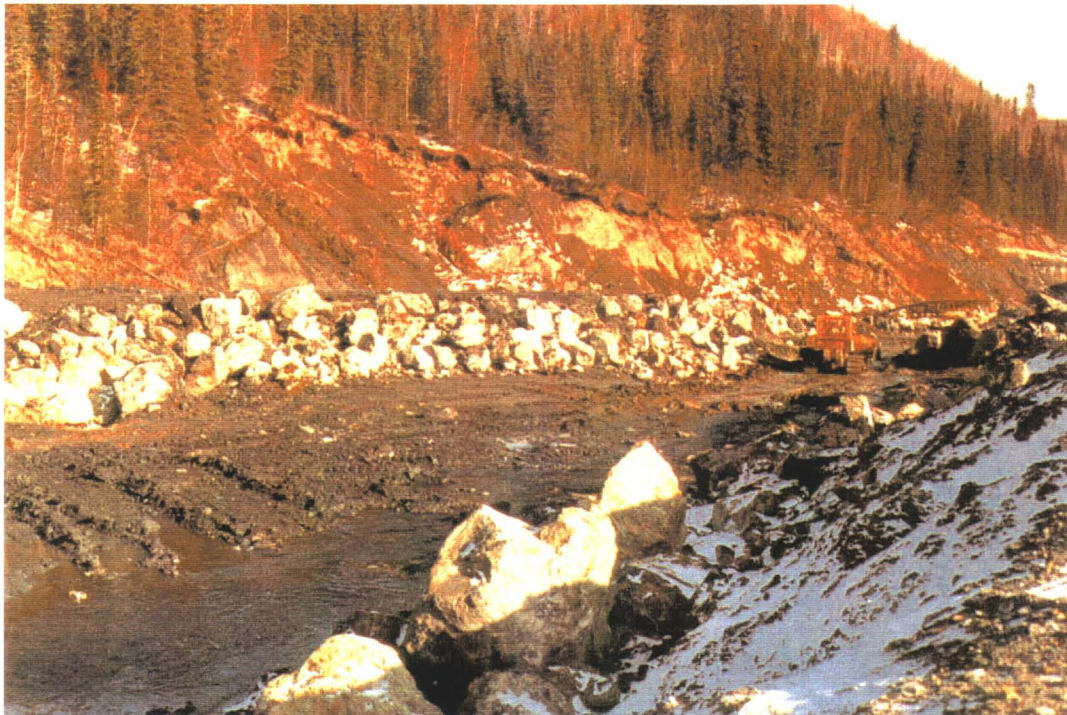
Photo 7: Armouring of North Side of Channel (1983)

Remedial work was again undertaken in the fall of 1983 to reduce channel erosion. Flow was diverted along the south side of the rock weirs while the north side of the channel and the culvert outlets were armoured with rip rap as seen in Photos 7 and 10, respectively (Klohn Leonoff, November 1983). Woven geotextile was placed beneath the rip rap on the north side of the channel (Photo 6 Klohn Leonoff, November 1983).

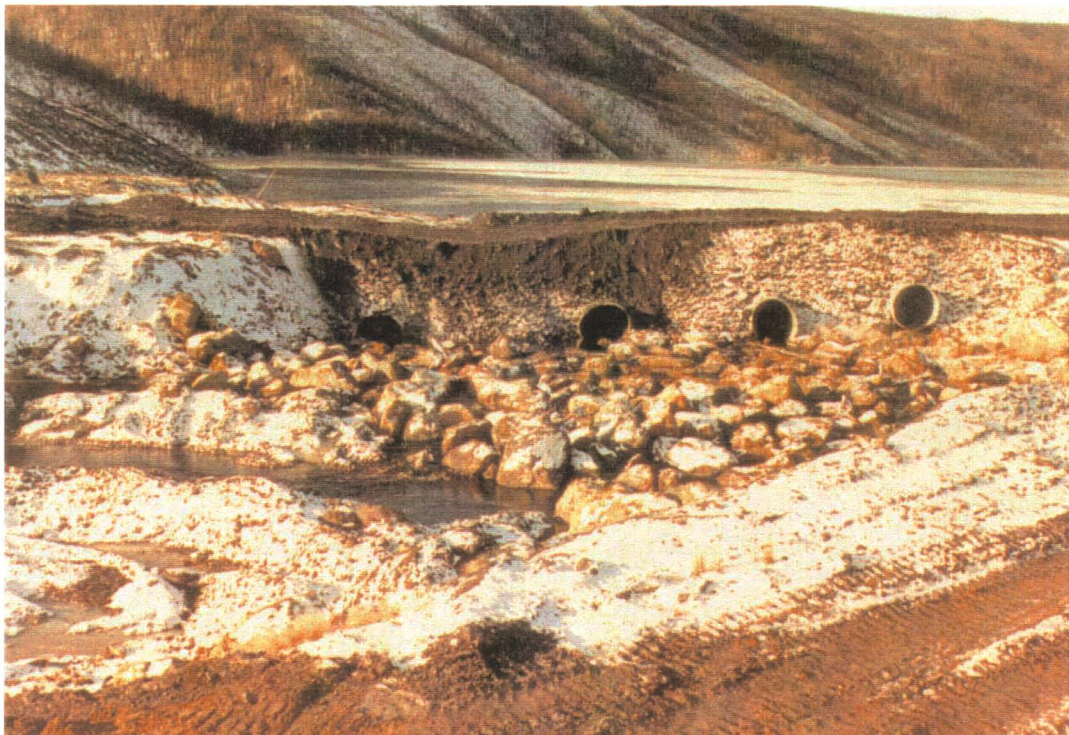
Photo 10: Channel Lining at Culvert Outlets (1983)

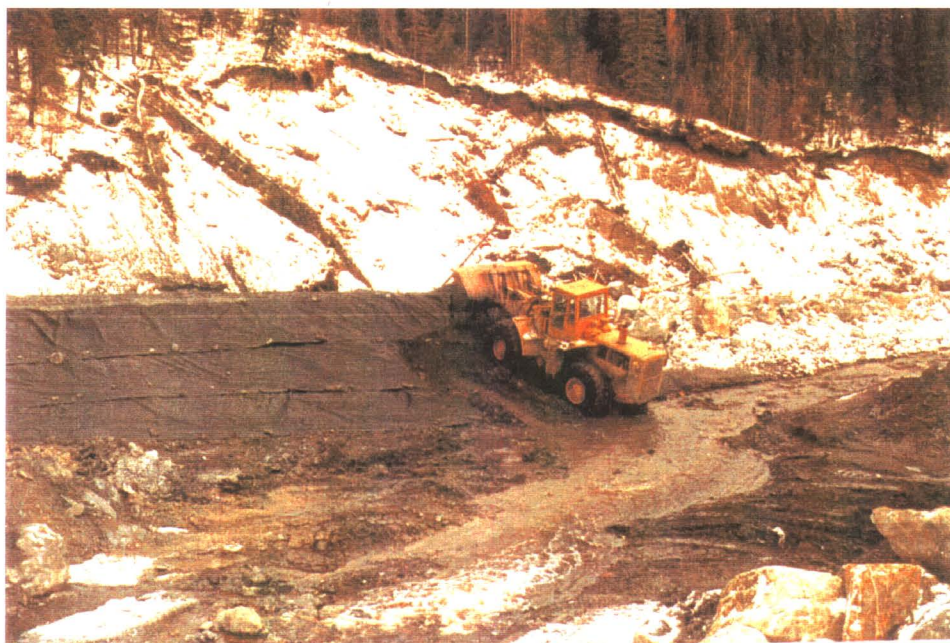
Photo 6: Channel Repairs (1983)

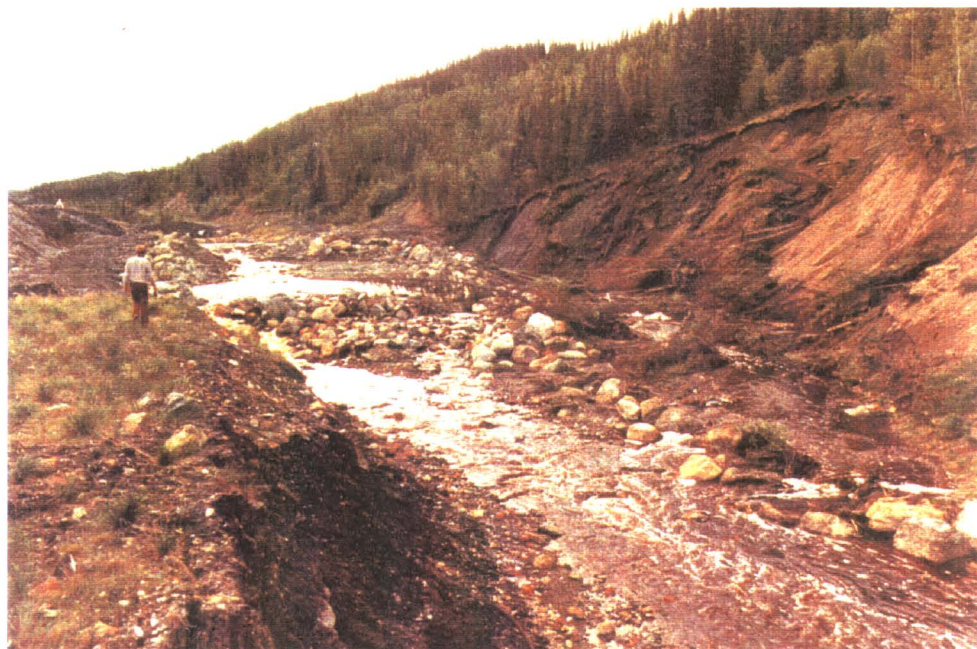
In June 1984, the channel was beginning to by-pass the last downstream rock weir (Photo 2 - Klohn Leonoff, August 1984). Photos 3 and 4, taken in June, 1985 illustrate the minor modifications made to the north side of the channel.

Photo 2: Channel Bypassing Rock Weirs (1984)

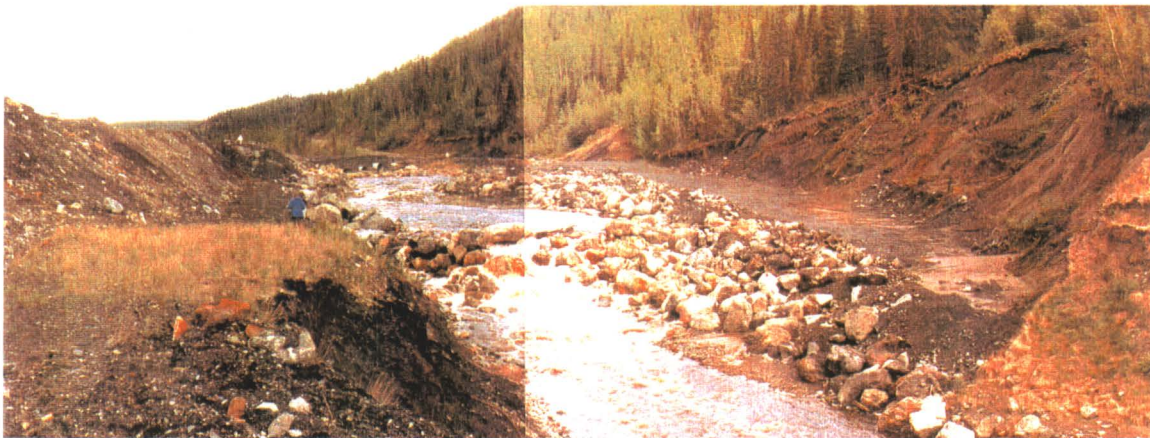
Photos 3 and 4: Channel repairs (1985)

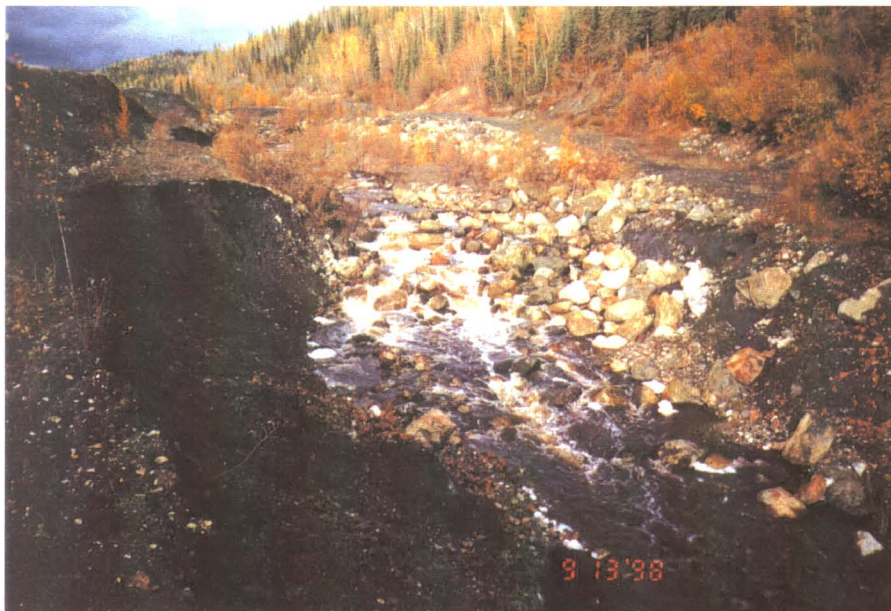
Spring run-off in 1997 destroyed the rock weirs. Since that time, significant channel erosion and incising has occurred downstream of the washed out culverts, apparently down-cutting the channel by up to about 2m (UMA Photo 7-24). Down-cutting of the channel is also apparent farther downstream when Photo 4 (Page 9) is compared with UMA Photo 7-17. At present, numerous slumps and localized slope failures are occurring on either side of the channel as material is eroded (UMA Photos 7-6 and 7-18 and 7-25 in Appendix A). Once material has failed or slumped into the channel, flow is often forced to meander around the debris initiating erosion of the opposite bank.

UMA Photo 7-24: Channel Down-Cutting (1998)

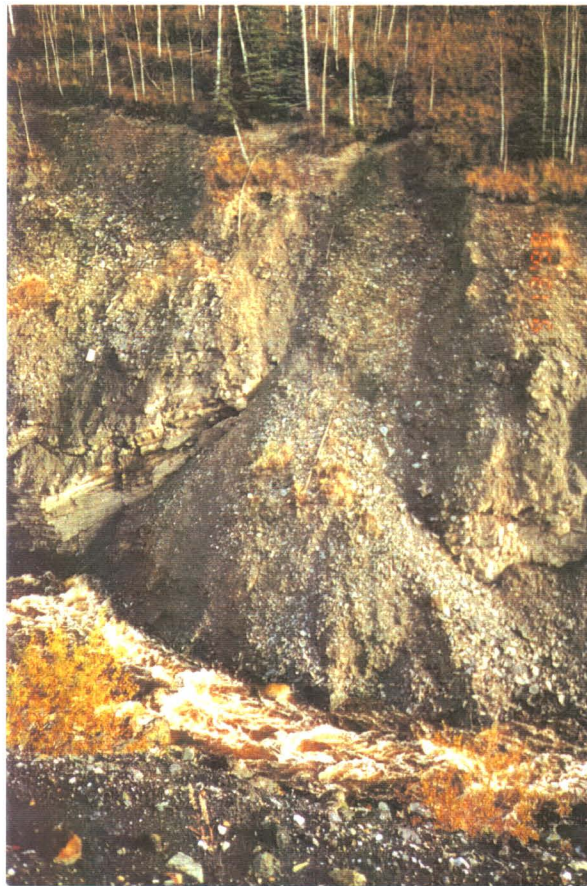
UMA Photo 7-6: Sloughed Till in Channel From Localized Bank Failure (1998)

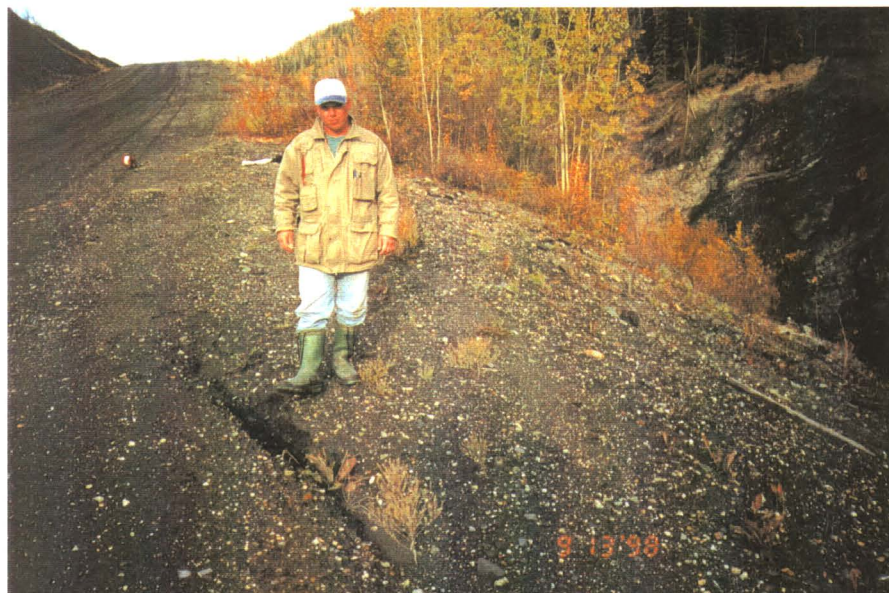
This process has begun to impact the integrity of the access road along the waste rock dump as evidenced by tension cracks along the north shoulder of the access road (UMA Photo 7-14). Slumping has resulted in considerable narrowing of one section of the access road (UMA Photos 2-8 and 7-5 in Appendix A) and it is likely that the access road will become impassible in the near future as this process continues (Drawing 02).

UMA Photo 7-14: Tension Crack Along Access Road (1998)

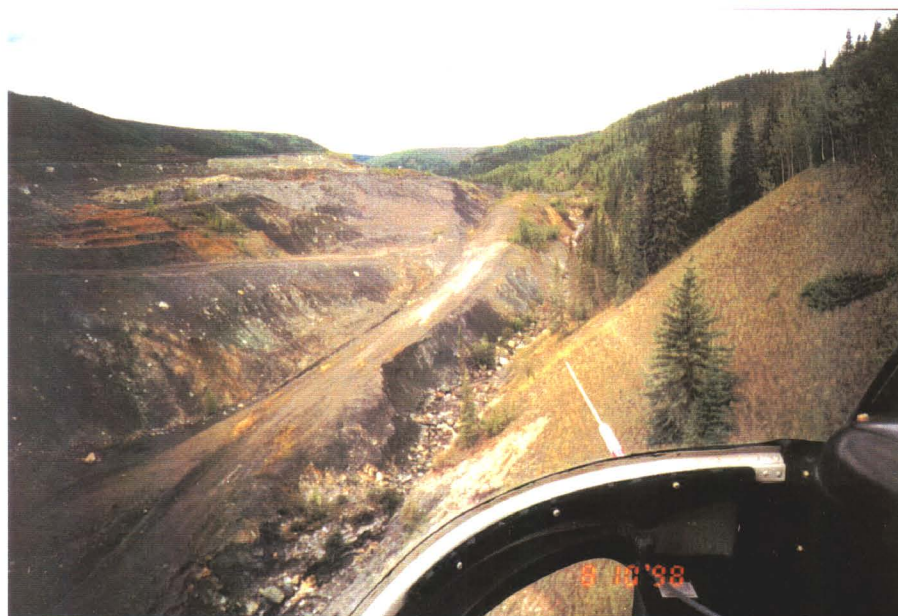
UMA Photo 2-8: Failure Along Access Road Shoulder (1998)

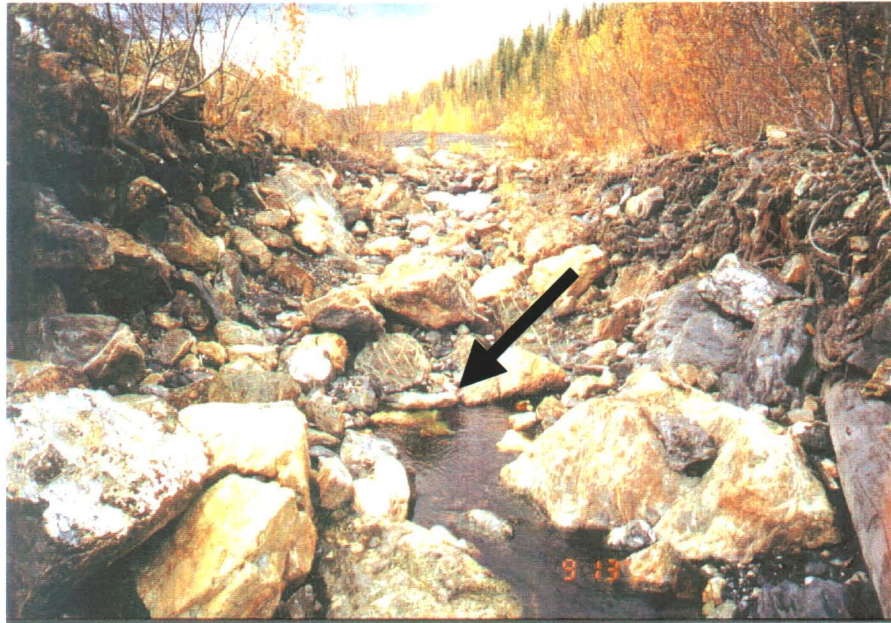
Two springs were observed exiting from the waste rock just downstream of the lake outlet. The first spring exits from what is believed to be the old creek bed, between the island and south bank (Drawing 02 and UMA Photo 8-16). The second spring exits about 2 metres above the creek water level on the south bank (UMA Photo 8-19 and Drawing 02). The water from both springs was clear with no evidence of fines. Brown slime was growing over the rocks at the downstream spring and the water had a noticeable hydrogen sulphide odour. A water sample was collected from the spring by RRU.

UMA Photo 8-16: Spring in Creek channel Remnant (1998)

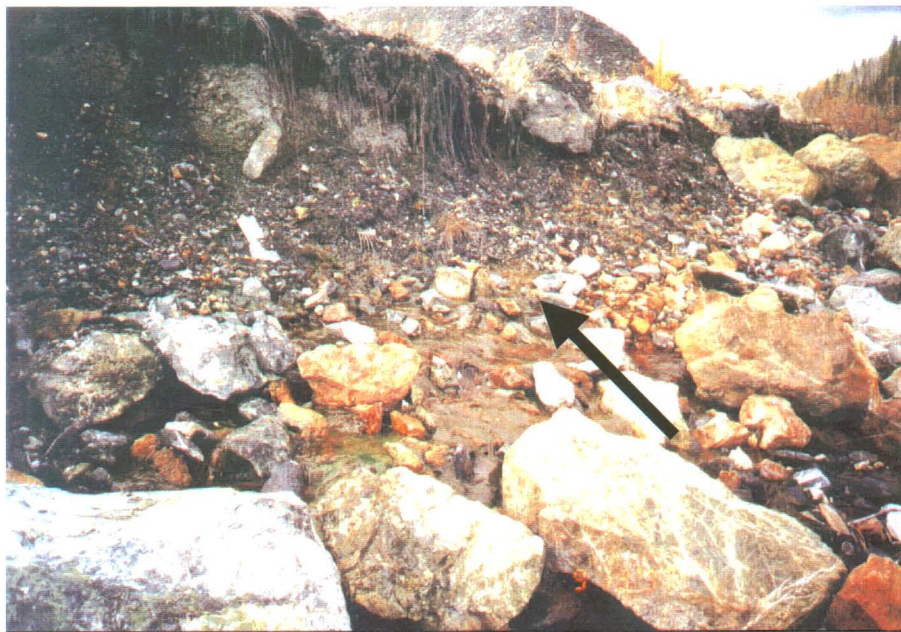
UMA Photo 8-19: Spring on South Bank

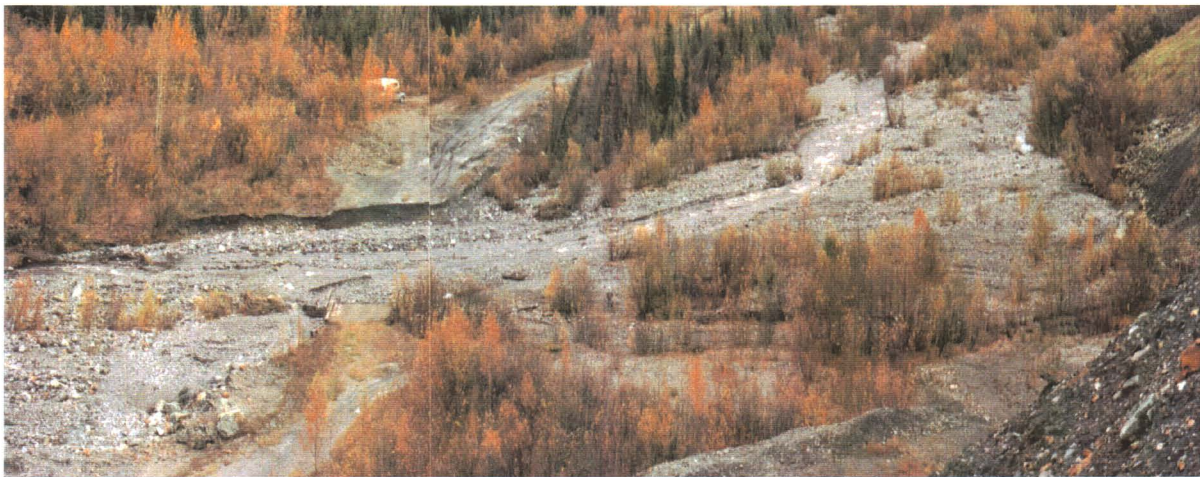
Downstream of the washed out bridge at the east end of the waste rock dump, a single creek channel now meanders through a considerable area of flow debris consisting of gravel to 200mm diameter rock (UMA Photos 13-17 and 13-18, Drawing 02). There appears to be considerably more flow debris downstream of the bridge now (UMA Photo 2-7) as compared with Photo 7 taken in 1986 (Geo-Engineering, November 1986). Several channel remnants and evidence of significantly wider historic channel flow are visible. High water marks in trees in the area are about 600mm above the ground surface, or about 1.5 to 2 metres above the existing creek water elevation. At locations as far as 200 metres downstream of the bridge, trees and brush have trapped flow debris (UMA Photo 11-22 note leaning trees). Beaver dams several hundred metres downstream of the bridge have flooded a large area near the junction of Wolverine and Clinton Creek.

UMA Photo 13-17 and 13-18: Clinton Creek at washed out bridge

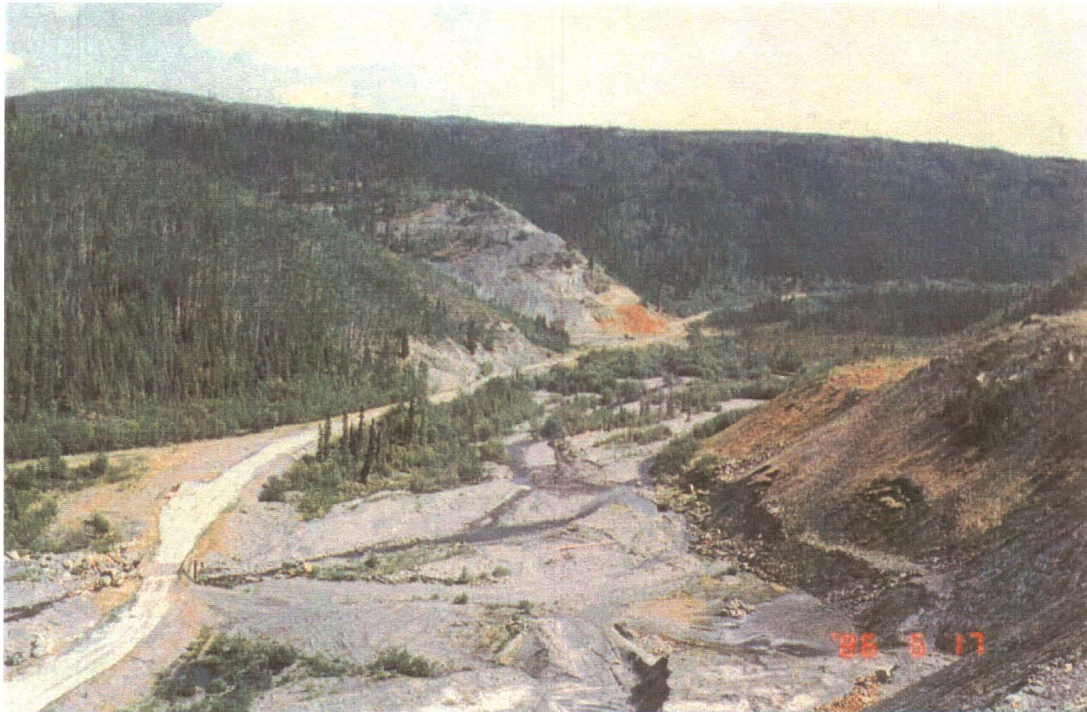
Photo 7: Clinton Creek Bridge Crossing (1986)

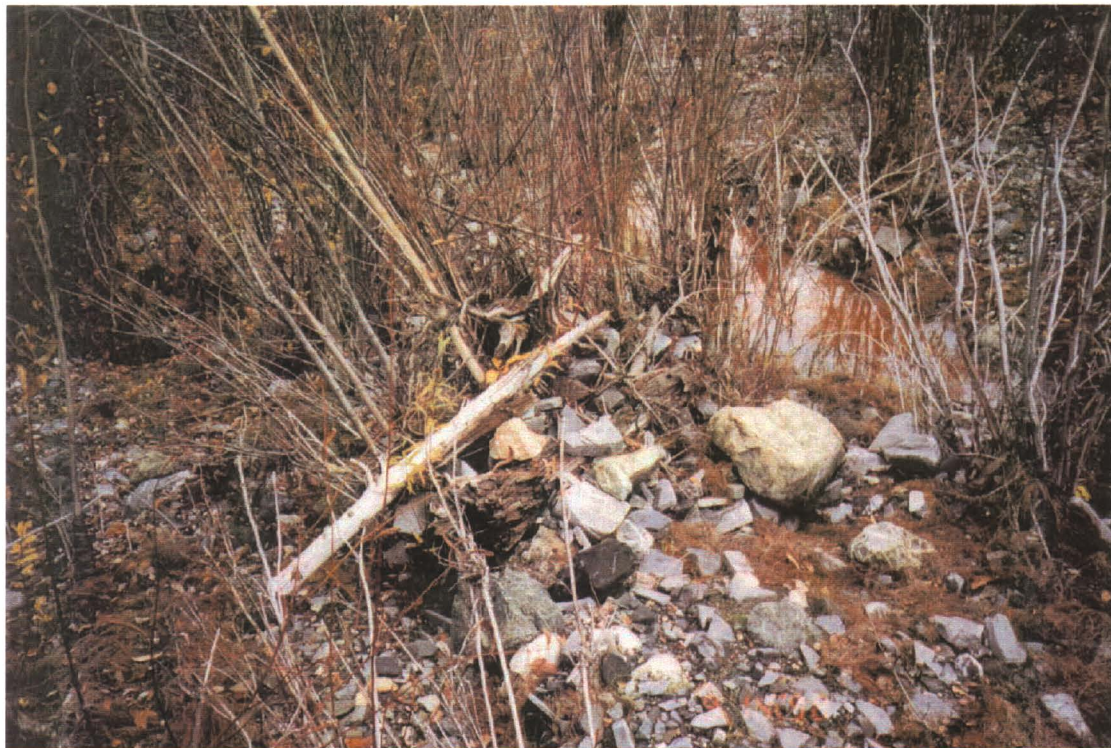
UMA Photo 11-22: Flow Debris in Treed Area

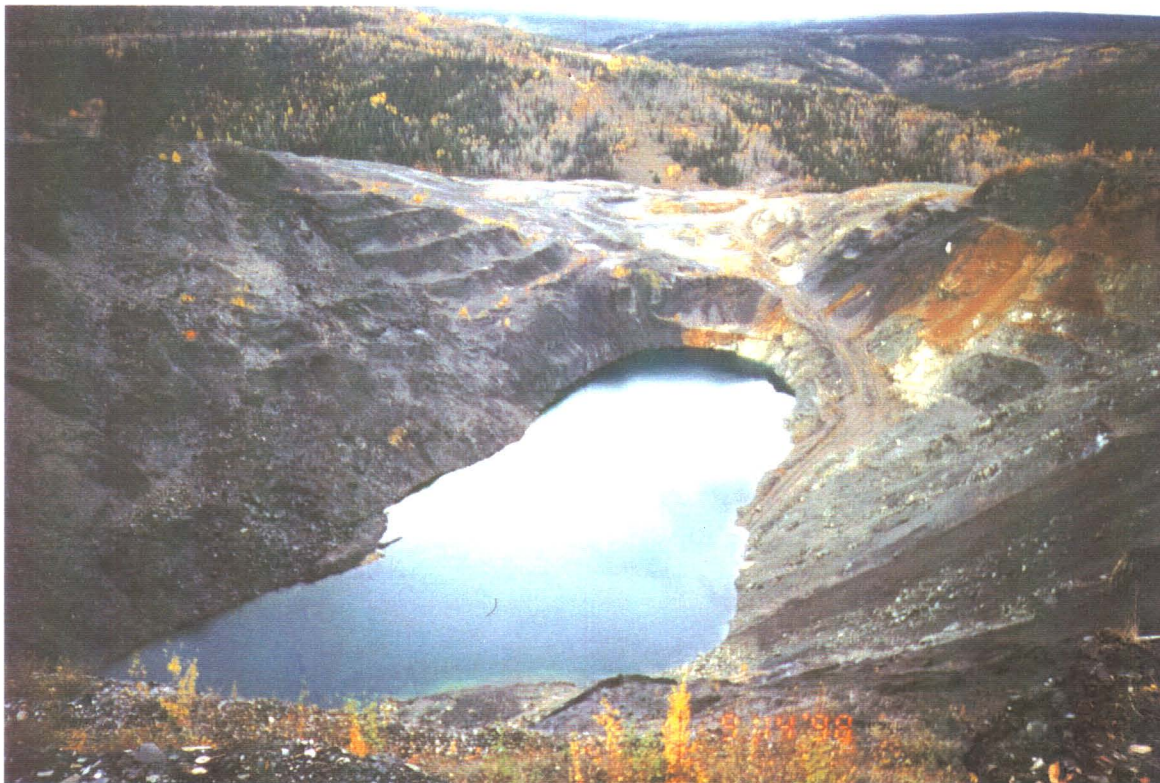
Instabilities of the open pit (Porcupine Pit) sides-slopes have been on-going since closure of the open pit mine. Recent tension cracks were observed during our site reconnaissance, in particular at the crest along the entrance to the mine as shown on UMA Photos 9-10 to 9-12 and along the west edge of the crest where a significant slump block has developed (Drawing 03). Continued sloughing of the over-steepened pit walls is clearly evident and is expected to continue for an indefinite time period (UMA Photo 11-1). Debris could occasionally be heard falling into the water while completing our reconnaissance in the area.

UMA Photo 11-1: View Northeast at Porcupine Pit (1998)

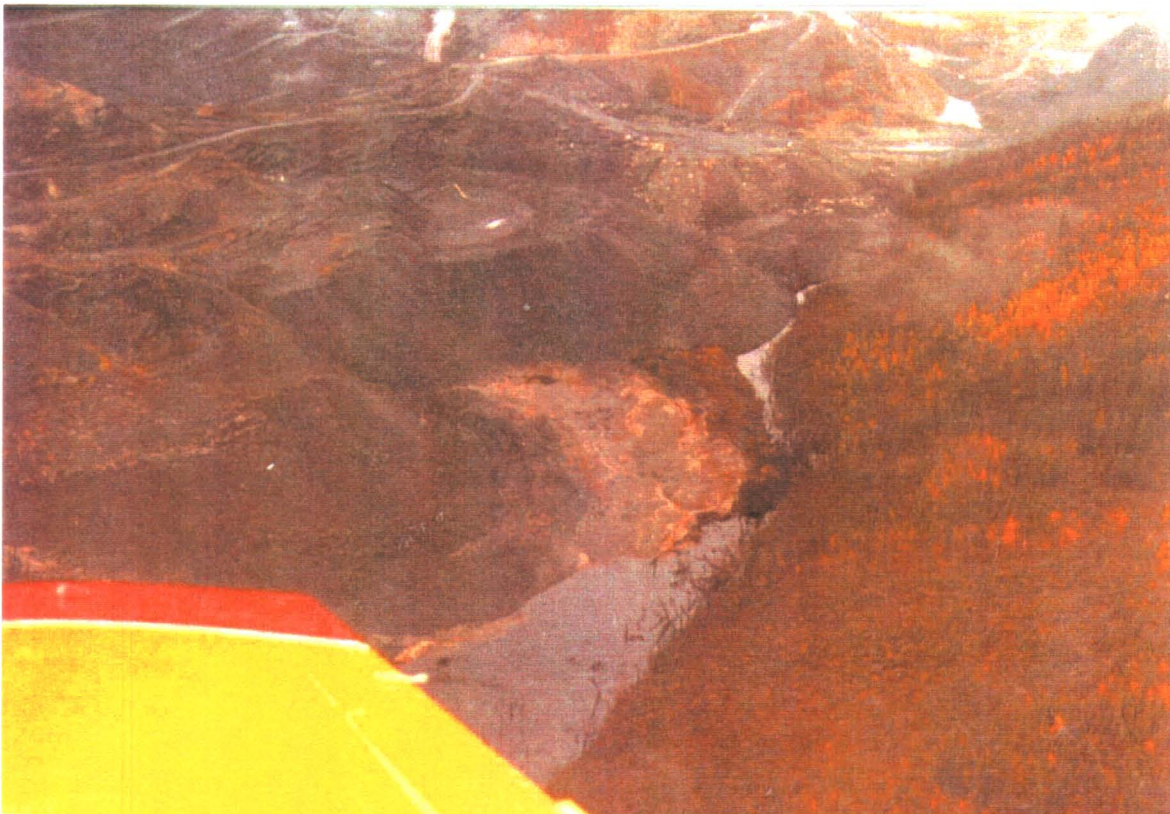
Waste rock was placed across the Porcupine Creek valley slope as shown on Drawing 04 and in Photo 12, one of the earliest aerial photographs of the area taken in 1976 or 1977 (Hardy, 1977). The most northerly section of the dump was placed at least partially up the east valley wall. This area has remained relatively stable. Sections near the centre of the dump which were placed farther away from the east valley toe, however, have experienced slumping creating blockages at two locations, as indicated on Drawing 03.

Photo 12: East Edge of Porcupine Creek Waste Rock Dump (1977)

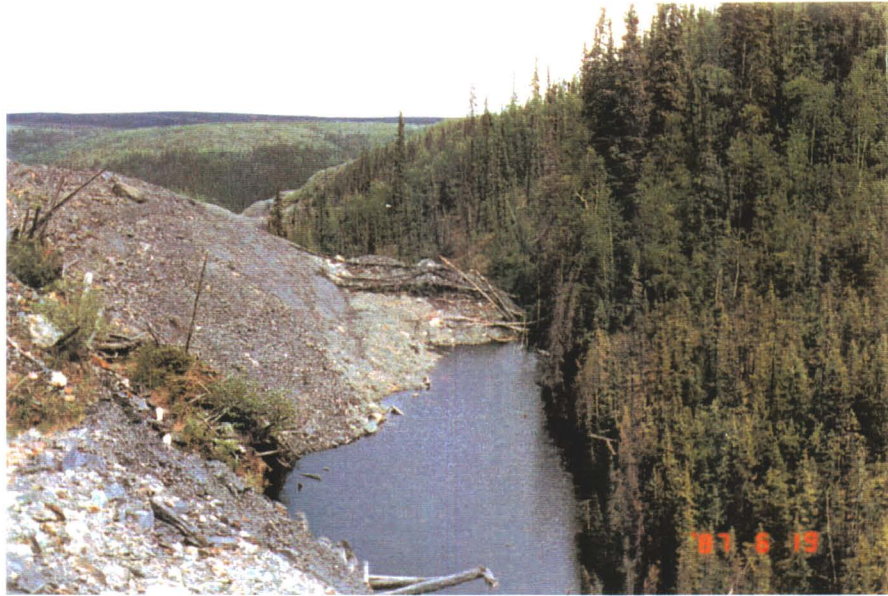
The first blockage (blockage 1) was photographed in 1987 by Geo-Engineering (Photo 8). Subsequent inspections and photos of this blockage and our 1998 site reconnaissance indicate there has been no significant change in the geometry of this blockage (UMA Photos 10-3 & 10-6 in Appendix A).

Photo 8: View Downstream at Blockage 1 (1987)

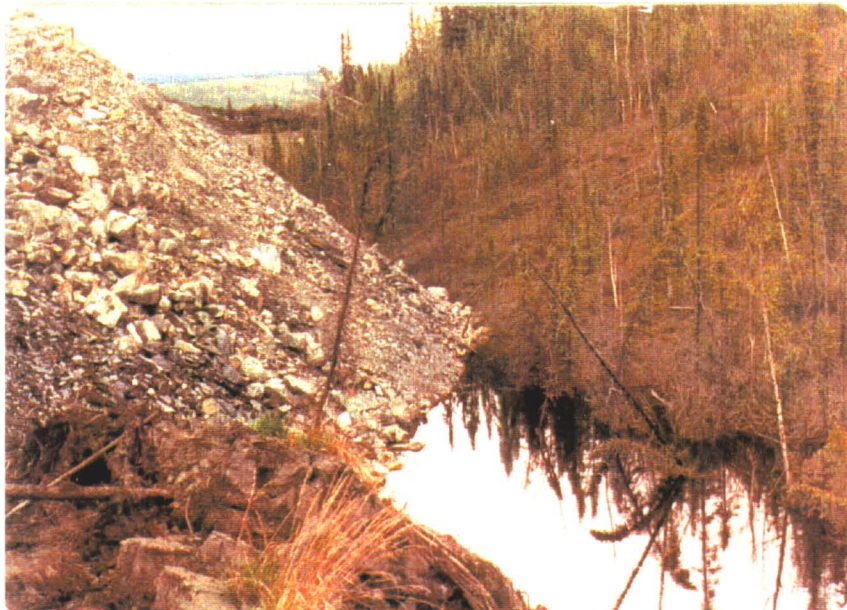
Blockage 2, located upstream of blockage 1, is illustrated in Photo PC-01 taken in 1975. Since 1975, subsequent inspections suggest very little additional movement is occurring (UMA Photo 10-2 in Appendix A). Both blockages probably behave as permeable dams with some water seeping through the waste rock. During high water events however, it is possible the blockages might be overtopped.

Photo PC-01: View Downstream at Blockage 2 (1975)

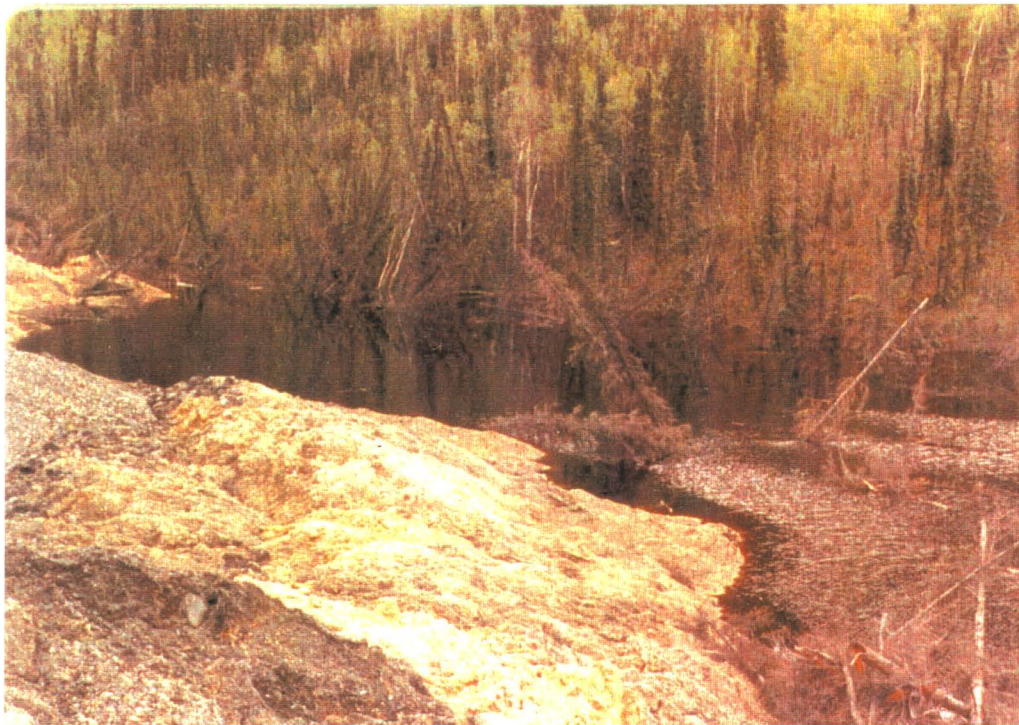
The southern section of the waste rock dump has undergone extensive movement at the toe and crest due to both the volume of waste rock and the method of placement. Dumping probably would have begun at or near the crest of the original valley slope but was only advanced across a portion of the valley. Instabilities of the waste rock pile have heaved the valley floor several metres as shown in Photo PC-03 (May 1975). The heaving (up-thrusting) of the valley floor is the primary reason for the impoundment of water from Porcupine Creek.

Photo PC-03: Till Up-Thrust at Toe of Failed Waste Rock (1975)

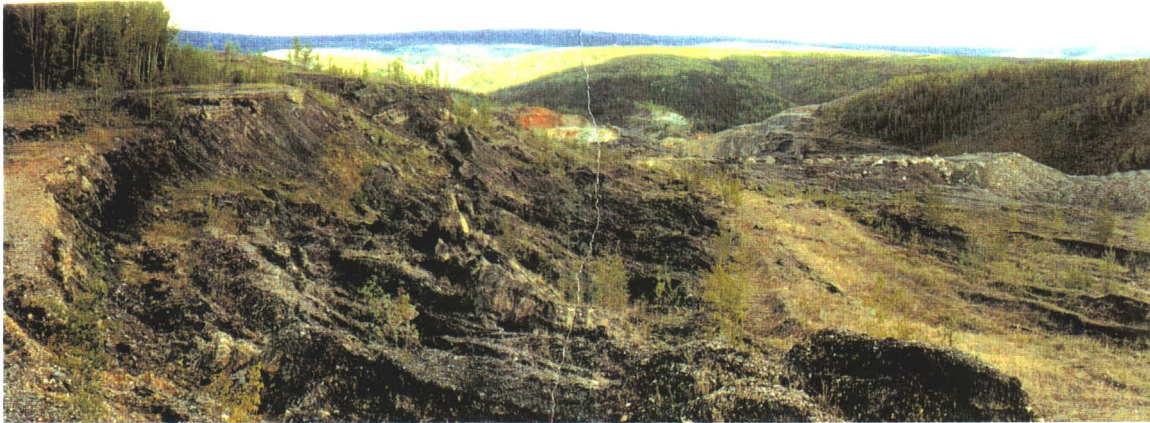
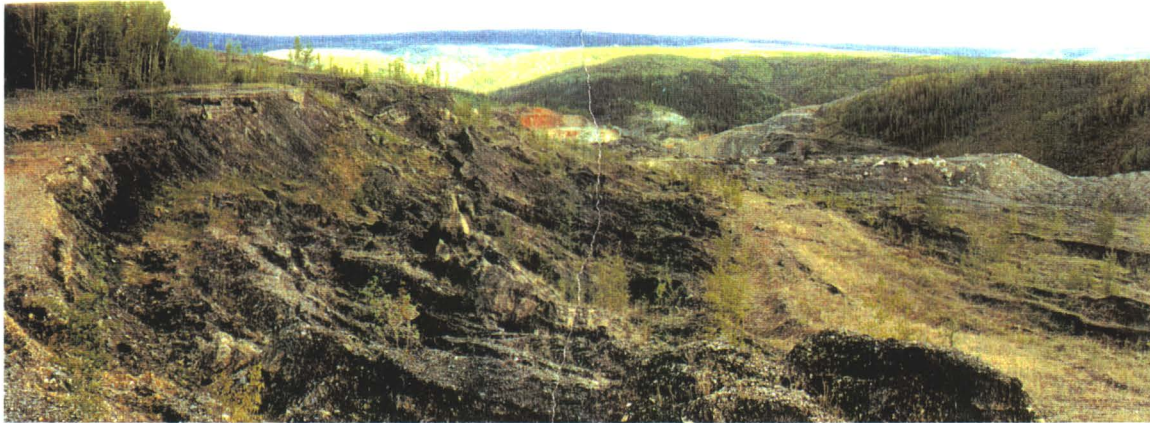
Near the crest of the waste rock dump, movement has resulted in numerous tension cracks and backscarps as shown in Photo 11 (Geo-Engineering, November 1988) and UMA Photos 10-24 to 11-0 in Appendix A. At present, considerable downslope movements are continuing in the upper slope of this section of the waste rock dump as evidenced by recent tension cracks and backscarps. It is anticipated this movement will continue until the waste rock has become geometrically stabilized, a process that could greatly increase the size of the upstream impoundment.

Photo 11: Crest of Unstable Waste Rock (1988)

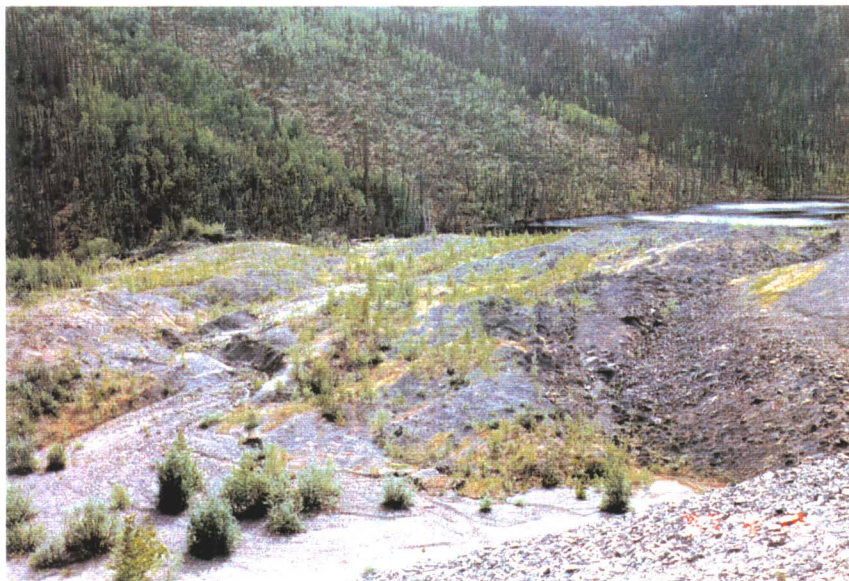
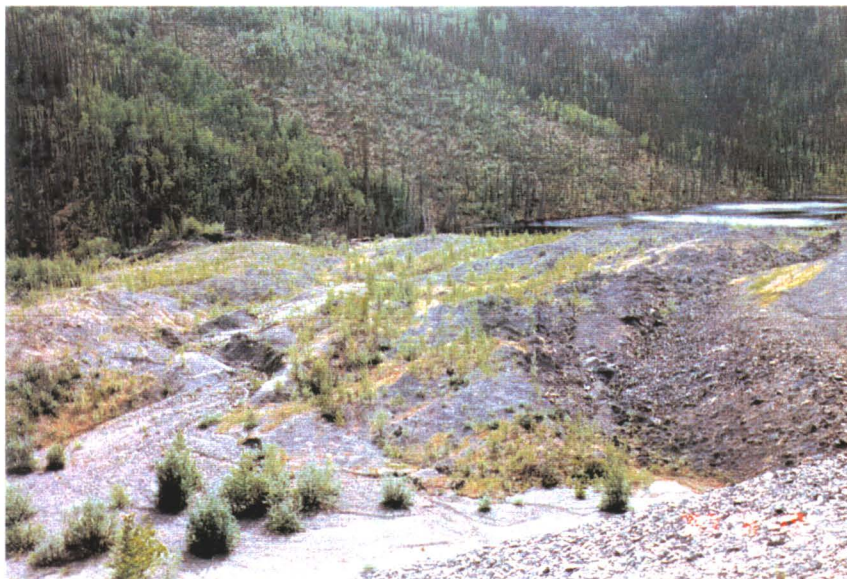
Drainage of the Porcupine Creek watershed through the waste rock dump occurs in two ways. The majority of the water drains through the waste rock pile, entering at a point along the southern limit of the stable waste rock pile (Drawing 03). Water drains from the pond to the waste rock via a drainage channel incised through the slide debris from the unstable southern portion of the waste rock. Evidence of this channel was observed by Geo-Engineering during their July 1987 inspection, although at that time, the channel was dry (Photo 9). During our site reconnaissance, water was entering the waste rock pile through an opening that was estimated to be about 0.3m^2 located at the toe of the waste rock (UMA Photo 10-9 in Appendix A).

Photo 9: Dry Inlet Channel From Pond to Waste Rock Pile (1987)

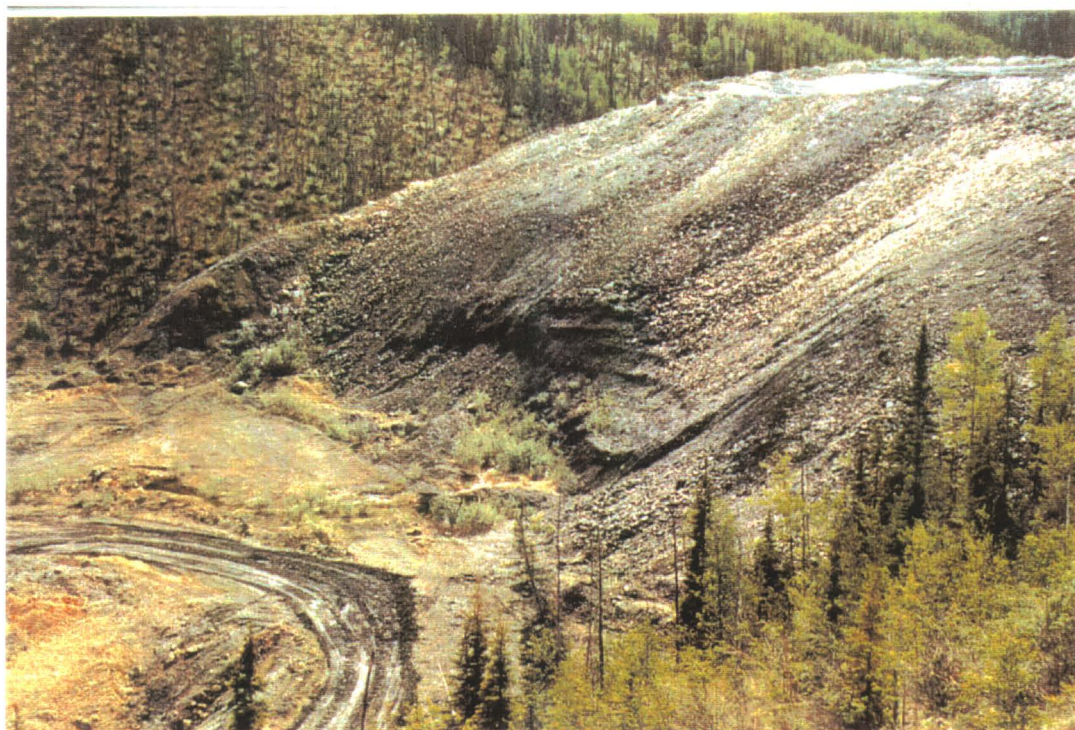
The discharge point is believed to be through the toe of the northern slope of the waste rock dump, or about 550 metres to the north of the inlet (Spring A). At the time of our reconnaissance, discharge at the outlet was estimated to be in the order of 6 to 9 l/s (100 - 150 gpm) approximately 5 m above ground surface. A second outlet point, about 2m above the ground surface, discharges about 1 to 2 l/s (15-20 gpm). Localized slumping is evident where water discharges the core rock slope as seen in Photo 13 (Geo-Engineering, November 1988) and UMA Photo 11-3 (Appendix A). Water is conveyed via a drainage course that has been incised along the south edge of the road (Photo 13).

Photo 13: Outlet and Drainage Ditch on North Waste Rock Slope (1988)
