**INDIAN AND NORTHERN AFFAIRS CANADA
ABANDONED CLINTON CREEK
ASBESTOS MINE
1998 SITE RECONNAISSANCE**

APRIL, 1999

**PREPARED BY
UMA ENGINEERING LTD.
ENGINEERS AND PLANNERS
1479 BUFFALO PLACE
WINNIPEG, MANITOBA
R3T 1L7**

Reference: Abandoned Clinton Creek Asbestos Mine – 1998 Site Reconnaissance

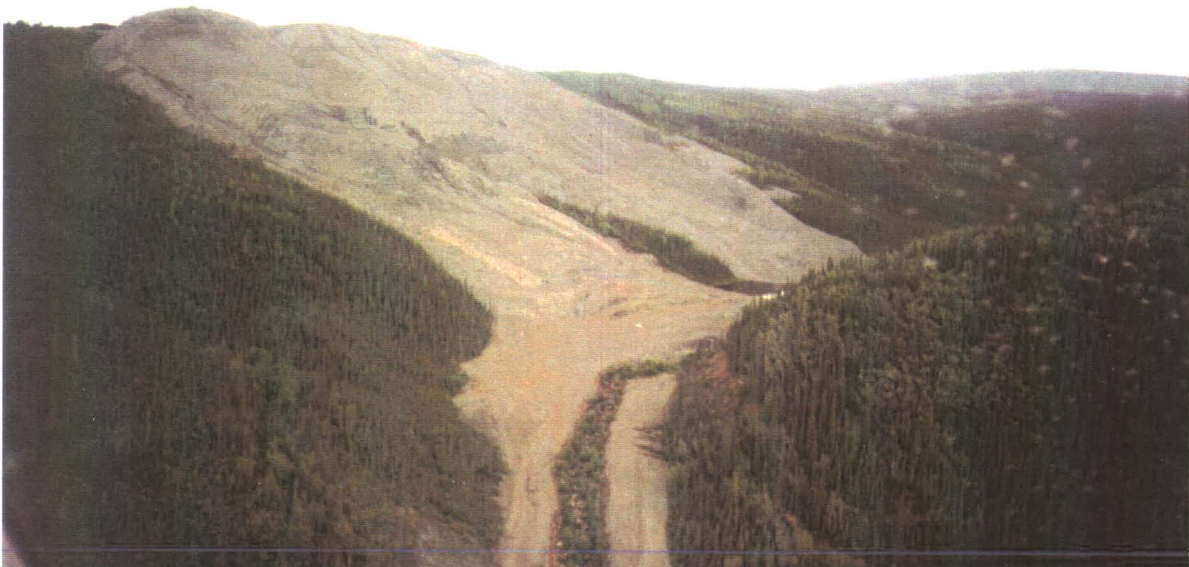
Since the failure of the asbestos tailings pile, the tailings piles have historically been referred to as the south and north lobes (UMA Photo 3-5 and Drawing 04). Each tailings lobe is discussed separately as follows:

UMA Photo 3-5: View North at South and North Tailings Lobes (1998)

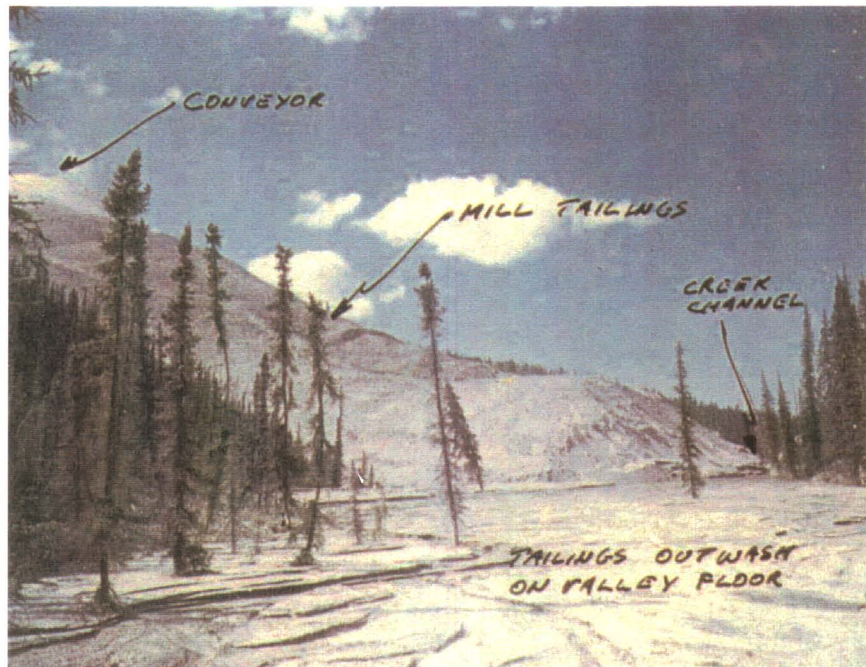
The southerly portion of the tailings pile (south lobe) failed suddenly in early 1974. The tailings moved down the west valley slope and completely blocked the existing creek channel. The blockage was subsequently breached releasing a significant amount of water borne tailings which were deposited downstream of the blockage as shown in Photo 7 (W.B. Bowie, June 1974). Remedial works, including removal of tailings from the channel, were implemented soon after the breach occurred (Photo WC-01, July 1974).

Photo 7: Tailings Deposition After Breach (1974)

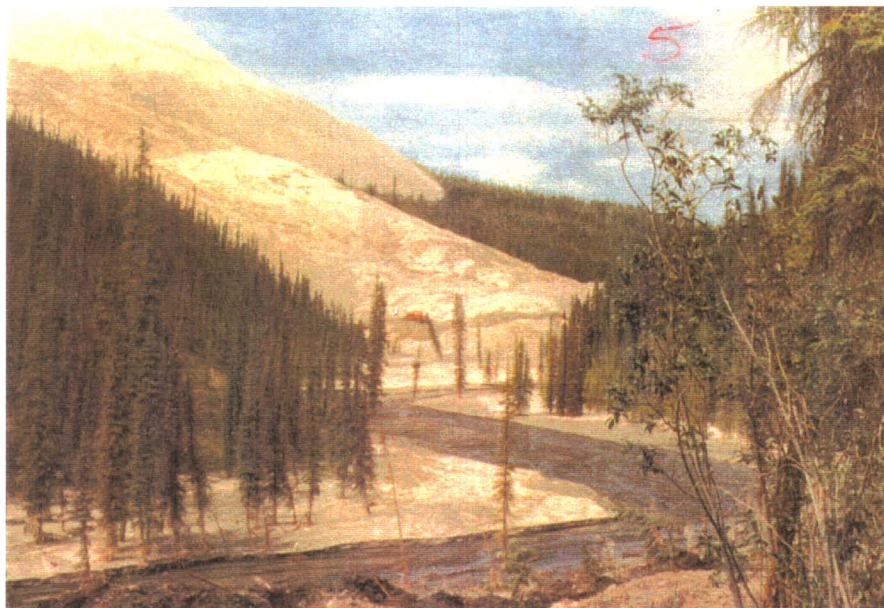
Photo WC-01: Creek Channel Downstream of Breach (1974)

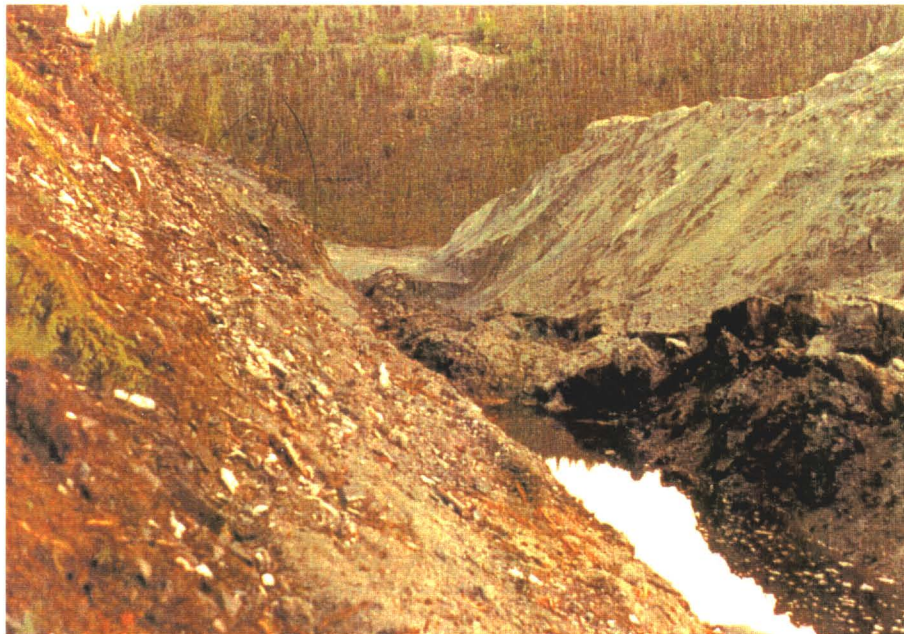
Following the 1974 failure, downslope movement of tailings continued resulting in occasional channel blockage as shown in Photos WC-06 (June 1976).

Photo WC-06: Channel Blockage (1976)

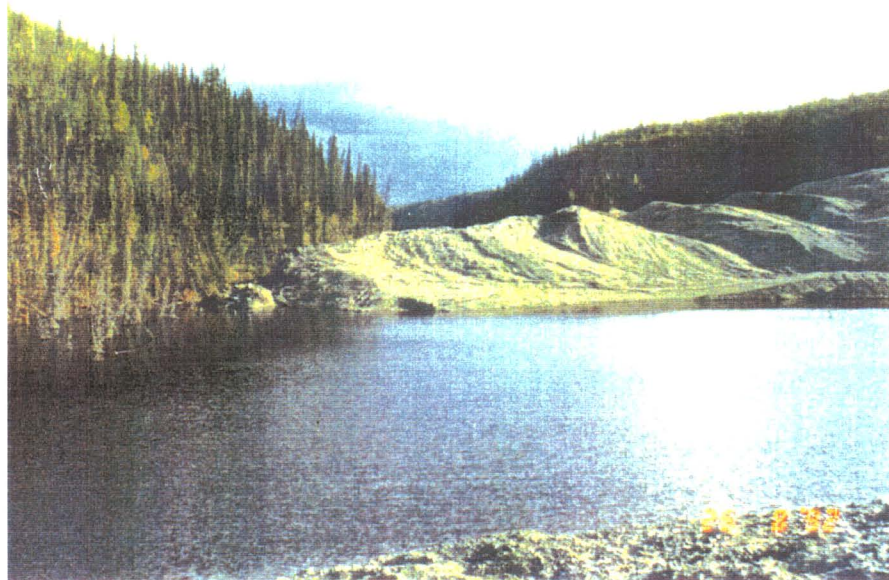
In 1978 a mid-slope portion of the south lobe was regraded (terraced) in an attempt to off-load this area and slow the advancement of the lobe (Drawing 04). The regraded area has since failed and evidence of the terraced slope is visible as inclined benches at the toe (Photo 18 Geo-Engineering, May 1993) and UMA Photos 3-6 and 5-11 in Appendix A.

Photo 18: Impoundment Upstream of South Lobe (1992)

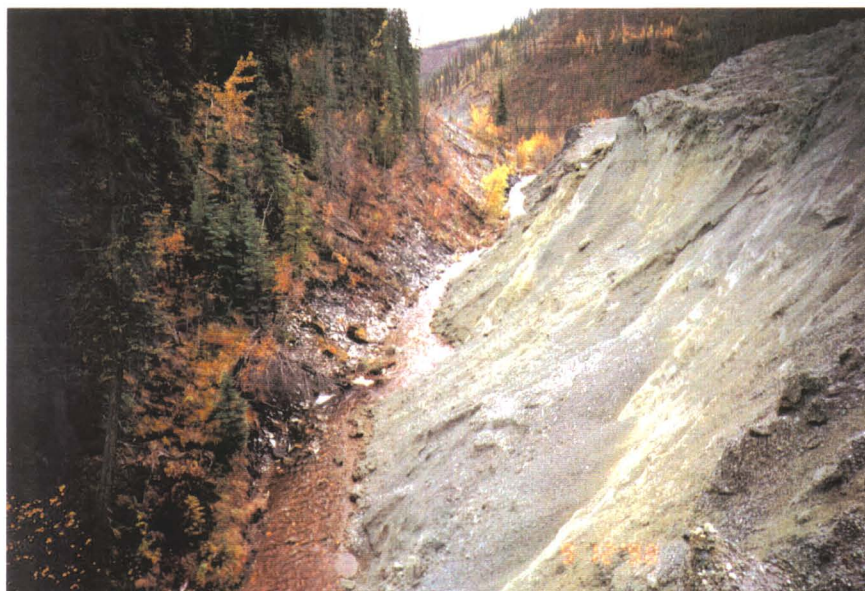
As the tailings continue to move down-slope, they are eroded and transported downstream. A comparison of the position of the leading edge of the tailings in Photo 12 taken in June, 1988 by Geo-Engineering with UMA Photo 5-20 indicates the gradual advancement of tailings into the creek channel.

UMA Photo 5-20: Toe of South Lobe in September (1998)

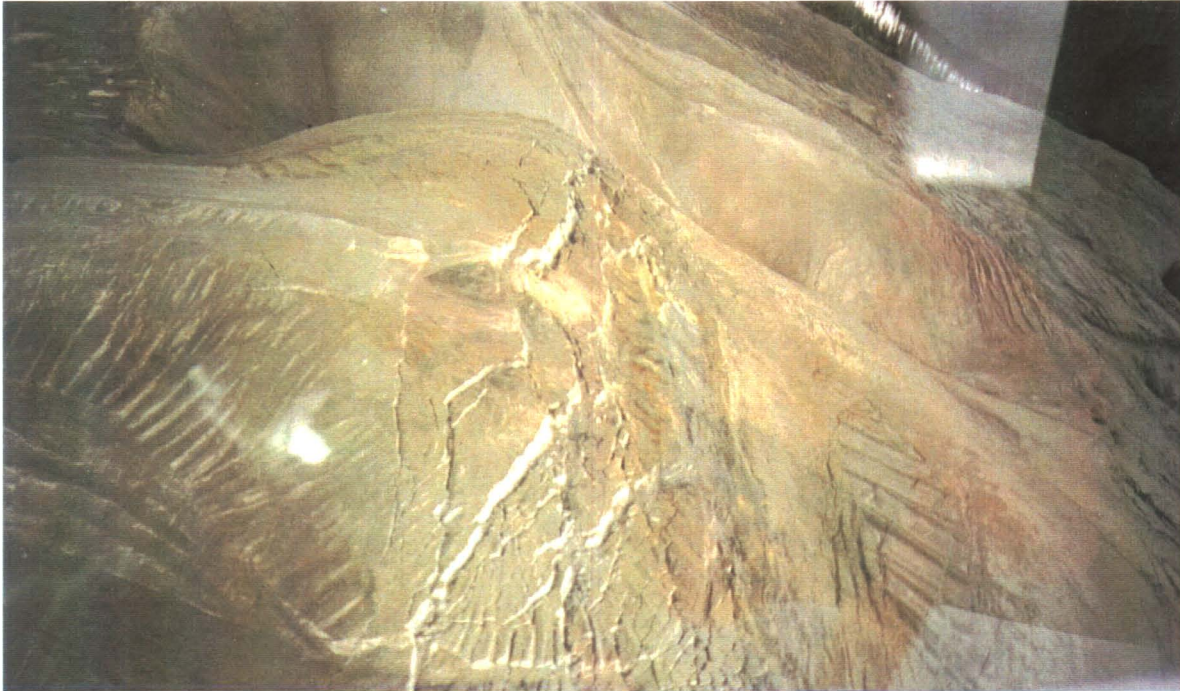
It is clearly evident that the south lobe remains active as evidenced by numerous tension cracks and slump blocks between the crest and toe (UMA Photo 3-13). Although the magnitude of this movement has not been confirmed since mine closure, it is anticipated that sufficient up-slope material exists to continue the advancement of tailings for an indefinite period of time.

UMA Photo 3-13: Tension cracking of Upper Slope (1998)

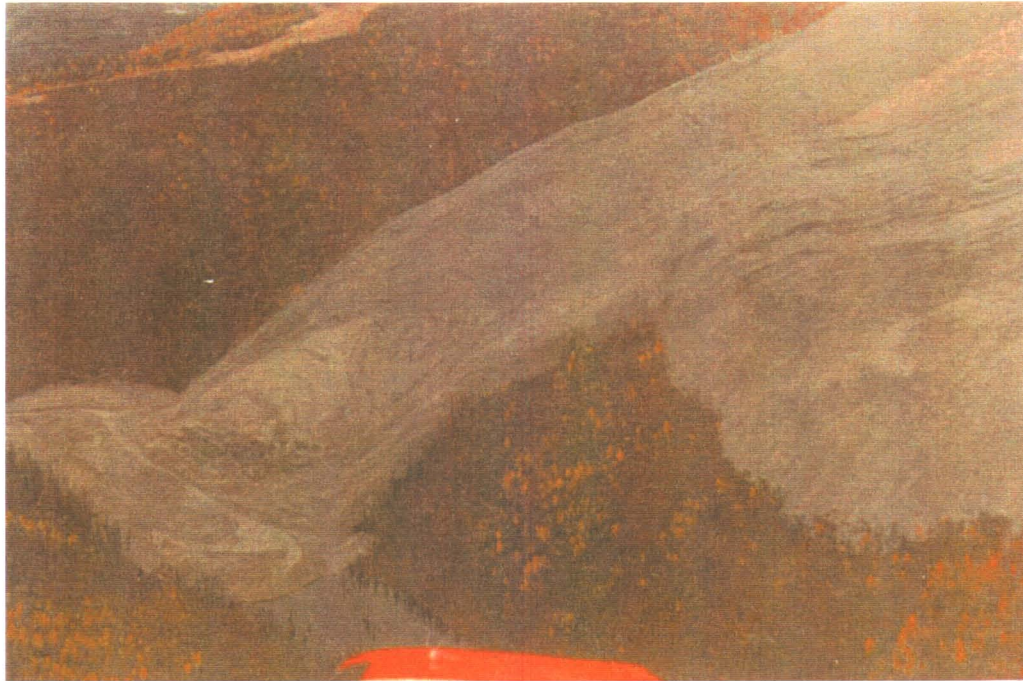
One of first aerial photographs of the unstable north lobe was taken in 1977 (Photo 1, R.M. Hardy and Assoc.). Downslope movement of the north lobe was not as sudden as that which occurred on the south lobe. However, the tailings gradually moved down-slope and within 10 years reached the pond created by the south lobe blockage (Photo 7, Klohn Leonoff, 1984).

Photo 1: Aerial View of Advancing Toe of North Lobe (1977)

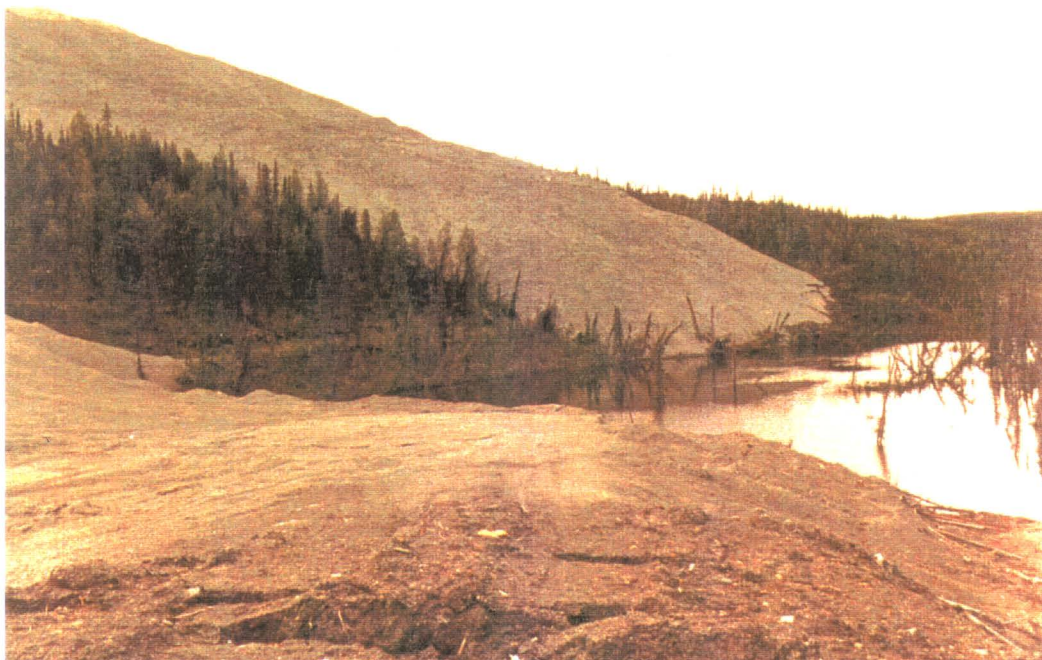
Photo 7: North Lobe at Edge of Pond (1984)

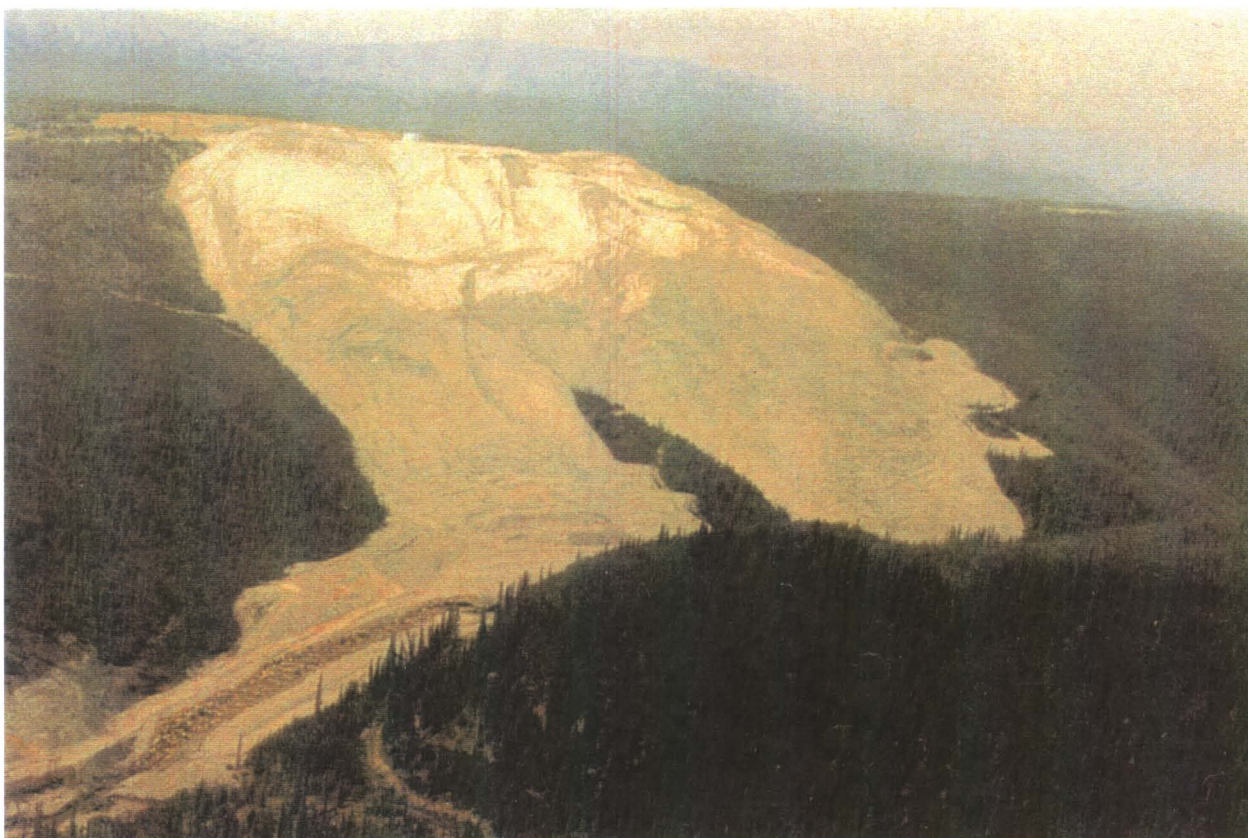
By July, 1986, the north lobe had nearly reached the east valley slope as shown on Photo 8 (Klohn Leonoff, September 1986). The lighter tailings areas in the upper portion of the tailings pile were relatively undisturbed in the photo. The darker areas in the mid and lower portion of the slope are indicative of heavily disturbed material as the north lobe advanced. These observations were verified with monitoring data in Hardy Associates (1978) Ltd.'s 1984 report that indicated upper-monitoring locations moved significantly less than mid and toe monitoring locations.

Photo 8: Failed North Lobe Near Valley Slope (1986)

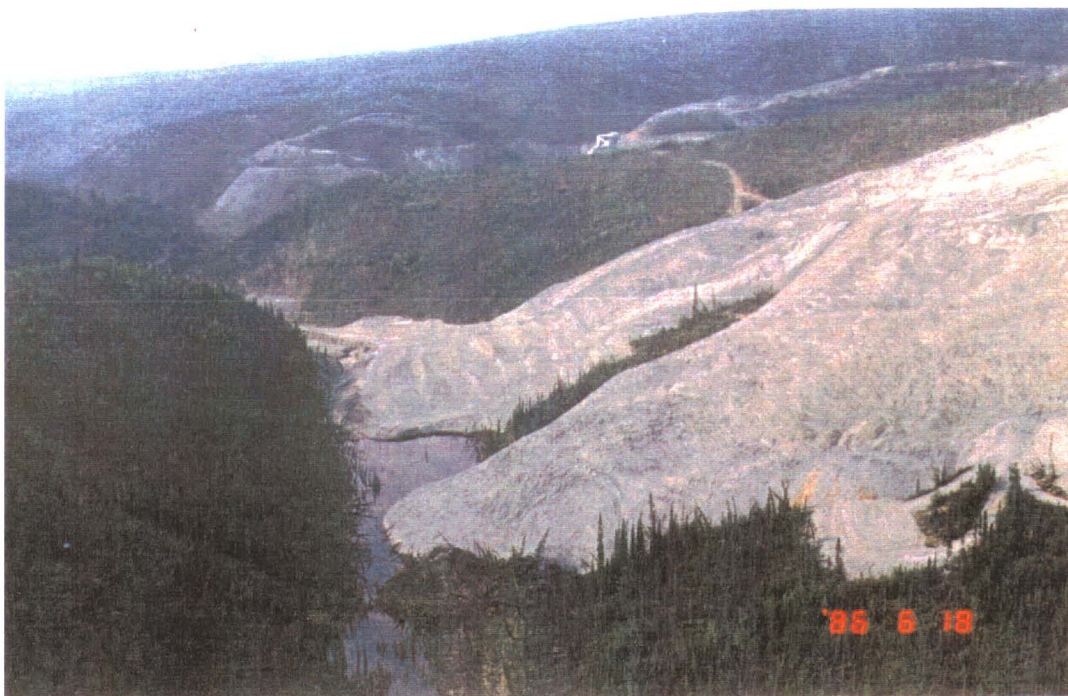
Photo 8: Toe of North Lobe Approaching Valley Slope (1986)

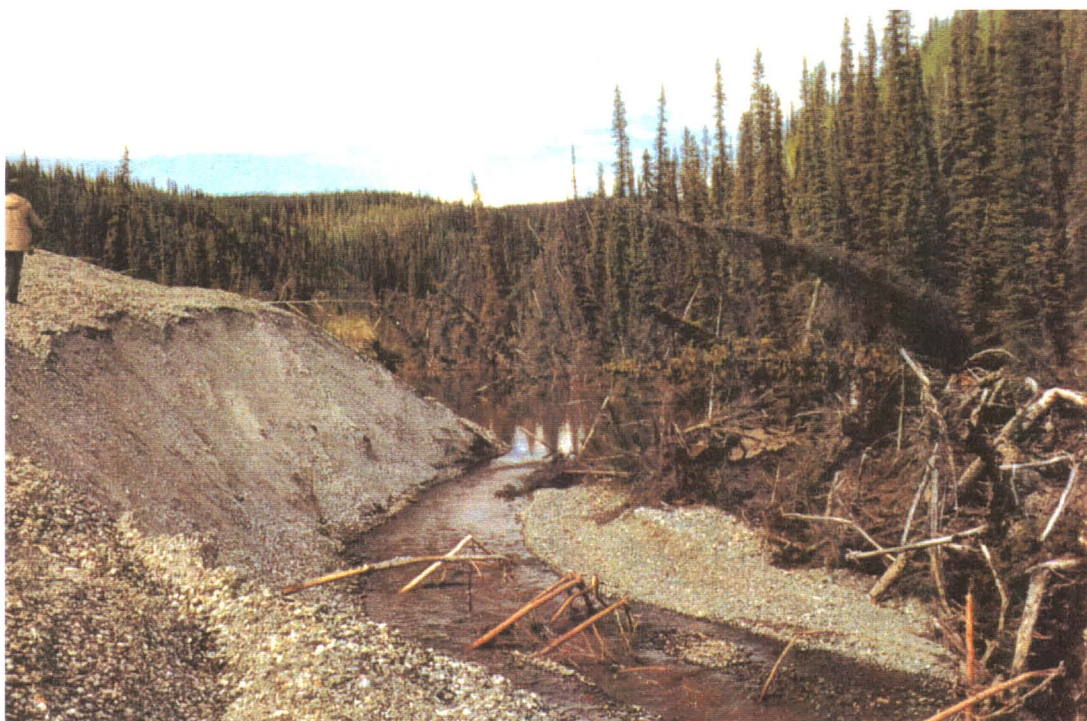
Significant heaving (up-thrusting) of the valley floor also occurred along the north side of the lobe resulting in a narrowing of the upstream section of the channel and the formation of an upstream pond (Photo 8, Geo-Engineering, November 1986). Continued advancement of the north lobe heaved the valley floor directly in the path of the lobe resulting in additional channel constriction as seen in Photo 19 (Geo-Engineering, November 1988) and UMA Photos 1-3, 5-9 in Appendix A.

Photo 19: Erosion of Toe of North Lobe and Heaved Valley Floor (1988)

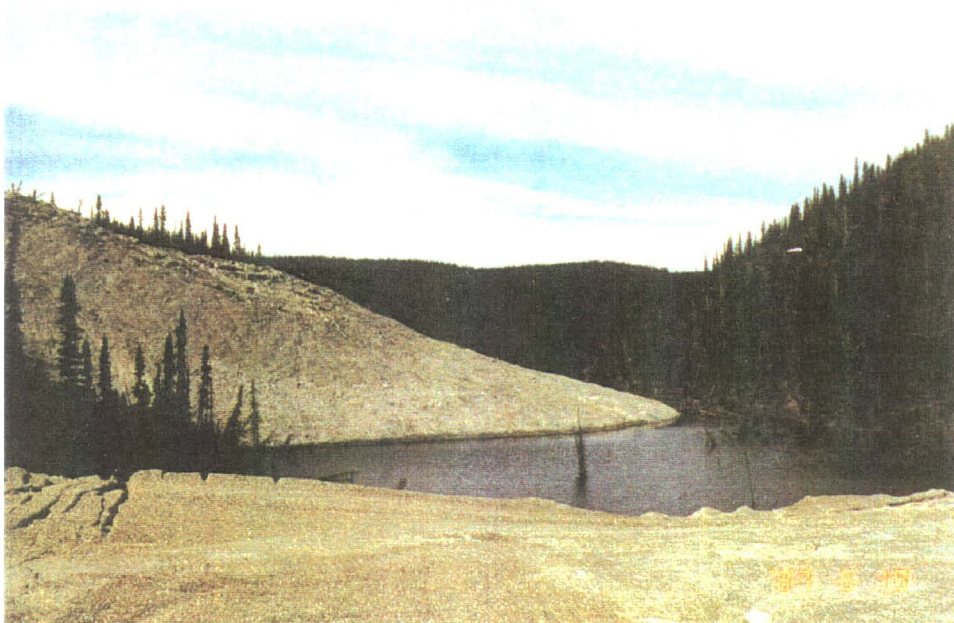
Recent photographs suggest the tailings are advancing faster than they are being eroded as evidenced by mounding near the toe. This can be seen in a comparison of Photo 17 (Geo-Engineering, 1988) with Photo 22 (Geo-Engineering, 1998) and UMA Photo 5-17 (Appendix A), taken 10 years later.

Photo 17: Toe of North Lobe (1988)

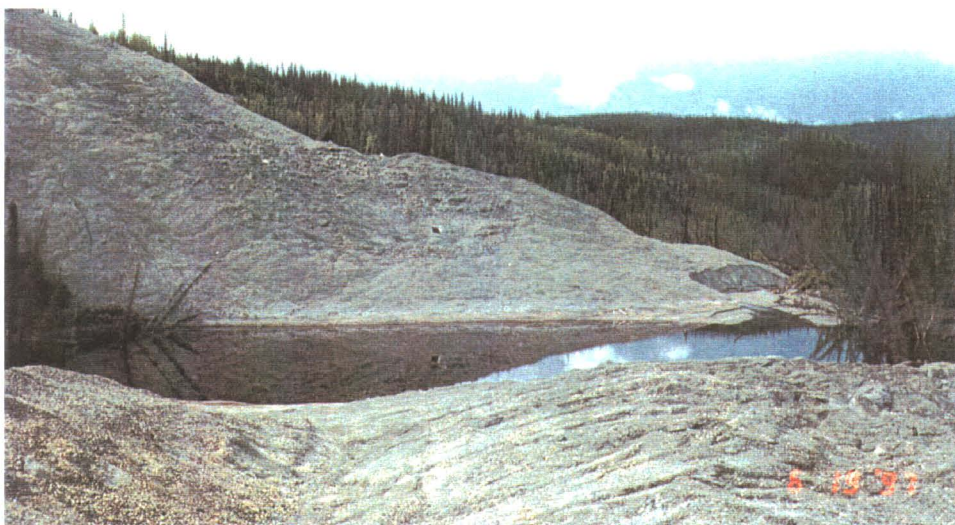
Photo 22: Toe of North Lobe (1998)

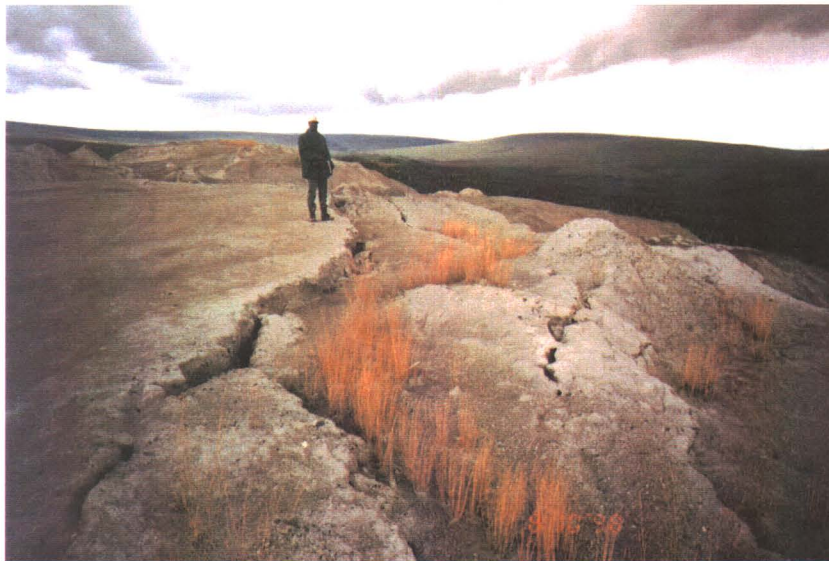
Continued erosion at the toe will undoubtedly trigger retrogressive failures and continued downslope movement. Recent tension cracks were observed in the mid and upper portions of the north lobe in 1998 confirming on-going movement (UMA Photos 1-6 and 1-5, 1-12 and 4-2 in Appendix A). Tension cracks and slumping are evident at and beyond the crest of the slope supporting the observations of continued movements (UMA Photo 1-15).

UMA Photo 1-6: Back Scarps at Crest of North Lobe (1998)

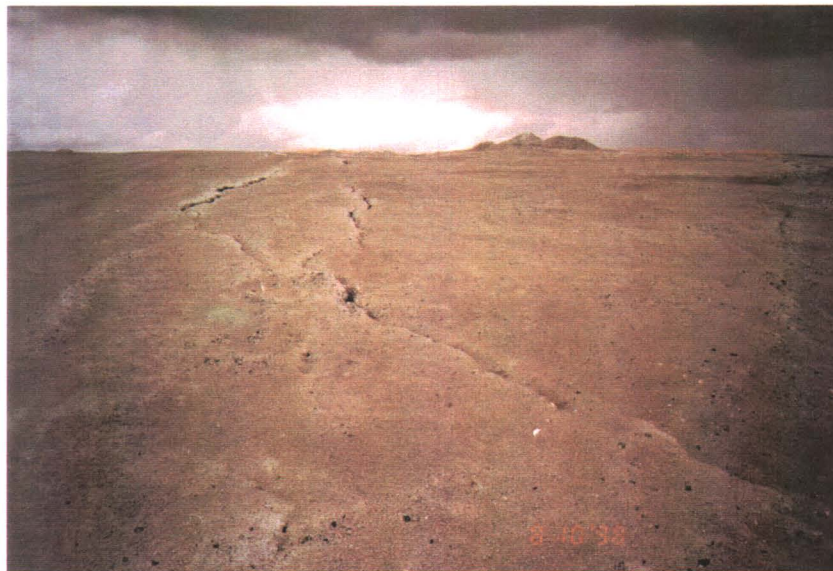
UMA Photo 1-15: Tension Cracks Upslope of North Lobe Crest

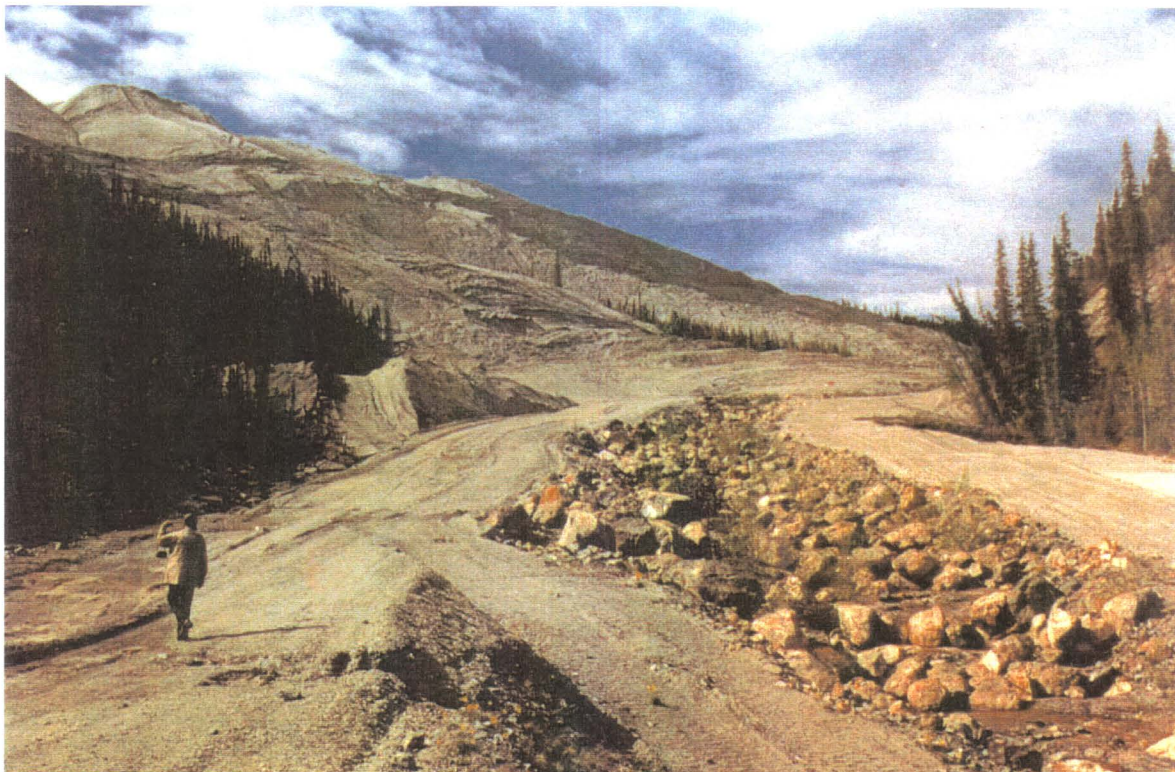
Between 1978 and 1981, channel improvements downstream of the south lobe were undertaken including a series of rock weirs as shown on Drawing 04 and Photos 22 (Geo-Engineering, November 1986) and 12 (Geo-Engineering, November 1988). These channel improvements have remained relatively intact since construction. The secondary channel between the downstream channel improvement and the east valley slope noted in Geo-Engineering's 1986 report was visible, but dry during our September 1998 reconnaissance.

Photo 22: Armouring of Wolverine Creek Channel Downstream of the South Lobe

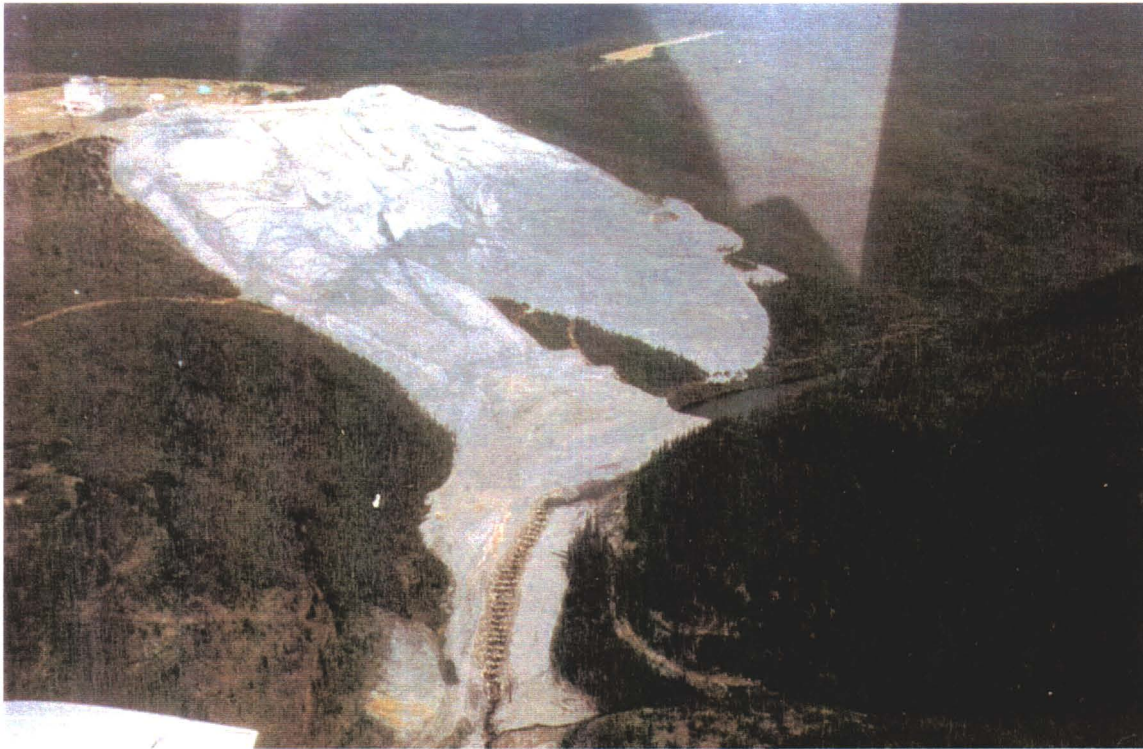
Photo 12: Weirs Downstream of South Lobe (1988)

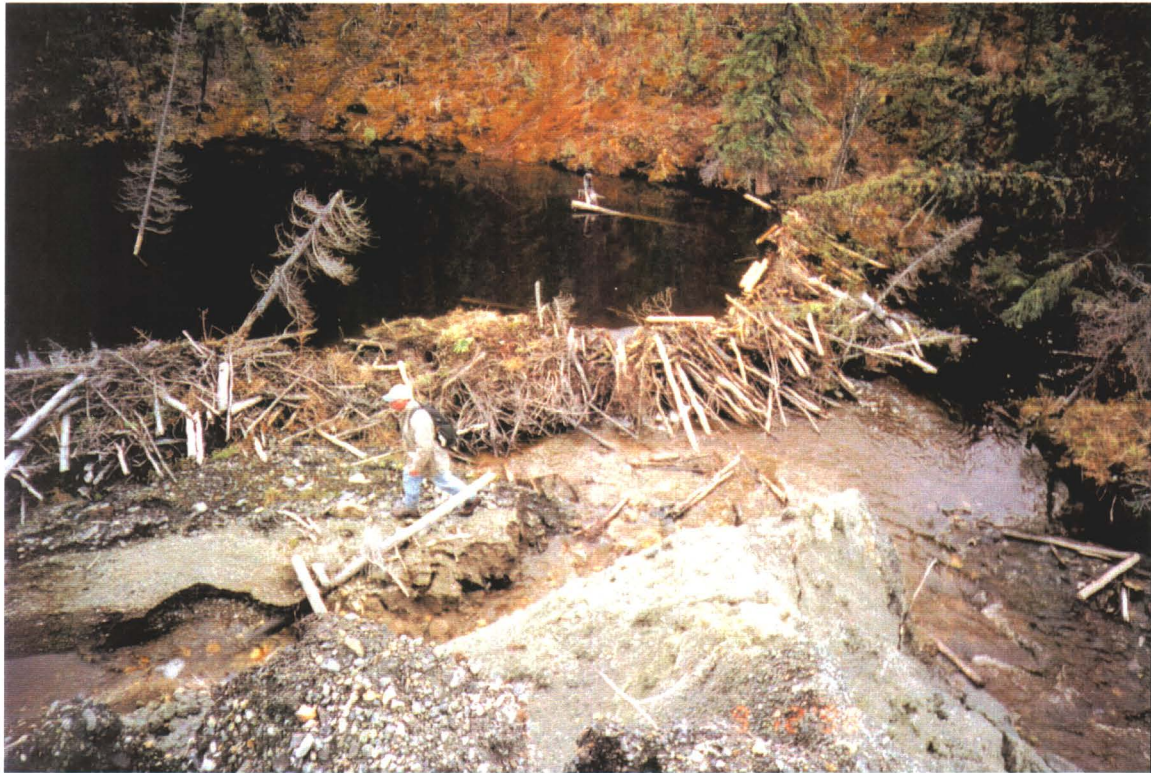
The second beaver dam, located between the upstream end of a small channel island and the toe of the north tailings lobe does not impound a significant amount of water. The third beaver dam is located at the upstream end of the south lobe as shown in UMA Photo 5-18

and is responsible for raising the water in the pond between the two tailings lobes by at least a metre.

UMA Photo 5-18: Beaver Dam 3 (1998)

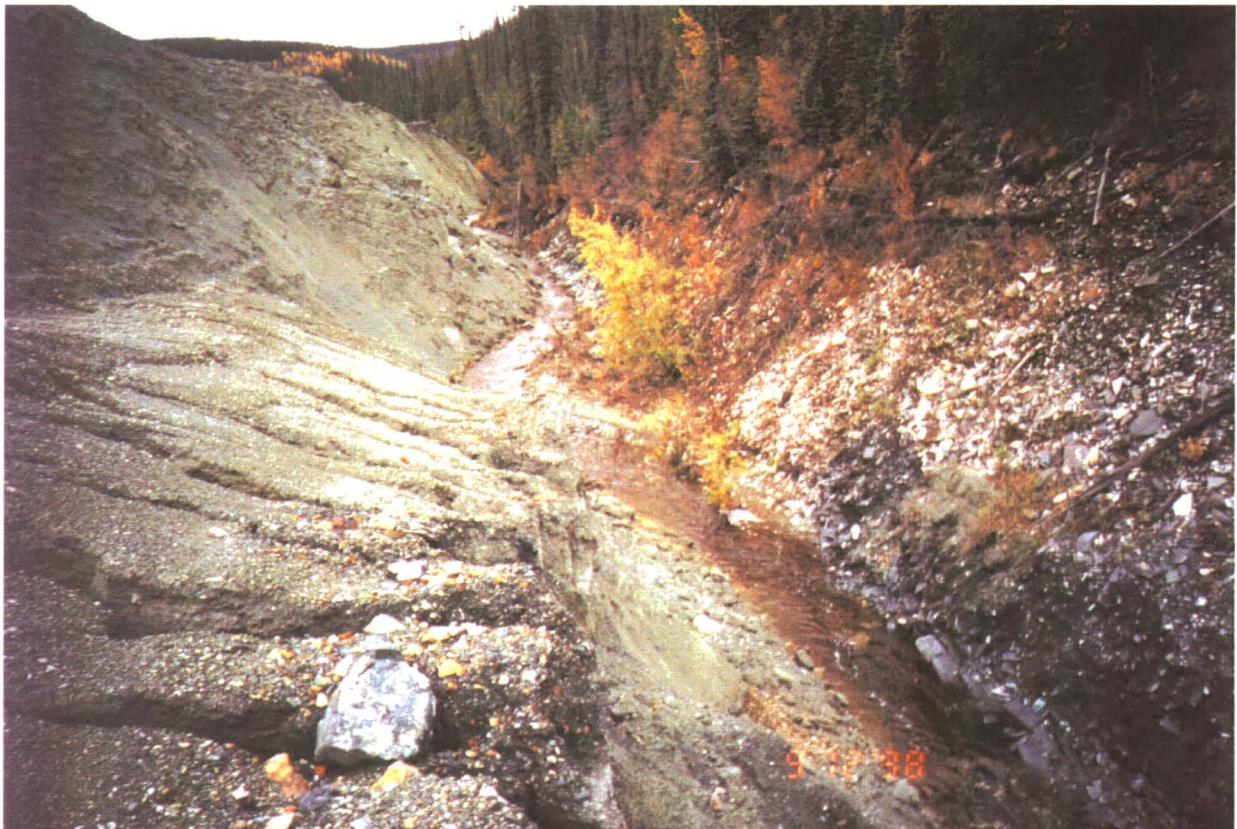
UMA Photo 5-23:

The four beaver dams have significantly reduced channel velocities and erosion of the channel where the tailings piles meet the valley slope. Downstream of beaver dam No. 4 however, velocities increase significantly as the channel narrows and the channel slope steepens. Between the beaver dam and the rock weirs, the channel has down-cut into the underlying weathered argillite bedrock resulting in surficial slumping of the overburden soils (UMA Photos 5-23 and 5-21, 6-1 and 6-2 in Appendix A). Downstream of the south lobe, flow appears to be contained within the original modified channel with no significant erosion or down-cutting observed.

View Upstream of South Lobe Toe and East Valley Slope
