**A Preliminary Environmental Investigation
of Site HJ034 - Canyon Creek**

D. B. Craig, Consulting Engineer
and
W. J. Klassen and Associates Ltd.

February, 1998

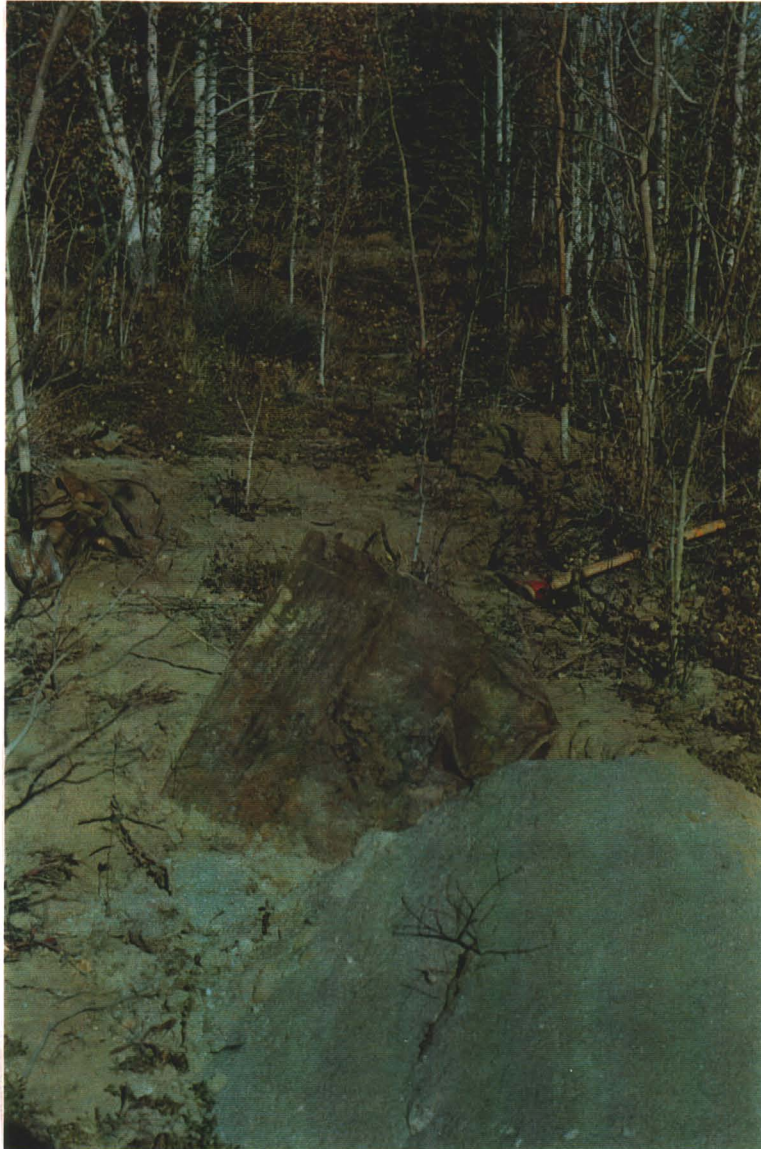
Test Pit Site 1 - A

There was an obvious shallow trench of approximately 100 m. in length and approximately 3 m. in width, trending southwesterly from the Old Alaska Highway. In the test pit dug where the EMI indicated the presence of bulky metallic materials in this shallow trench were found buried truck tires, a wheel hub, a flattened barrel, rusted metal cans of various sizes up to one gallon, 1 quart oil cans, and metal strapping.

Flattened 45 gallon drum found in test pit.

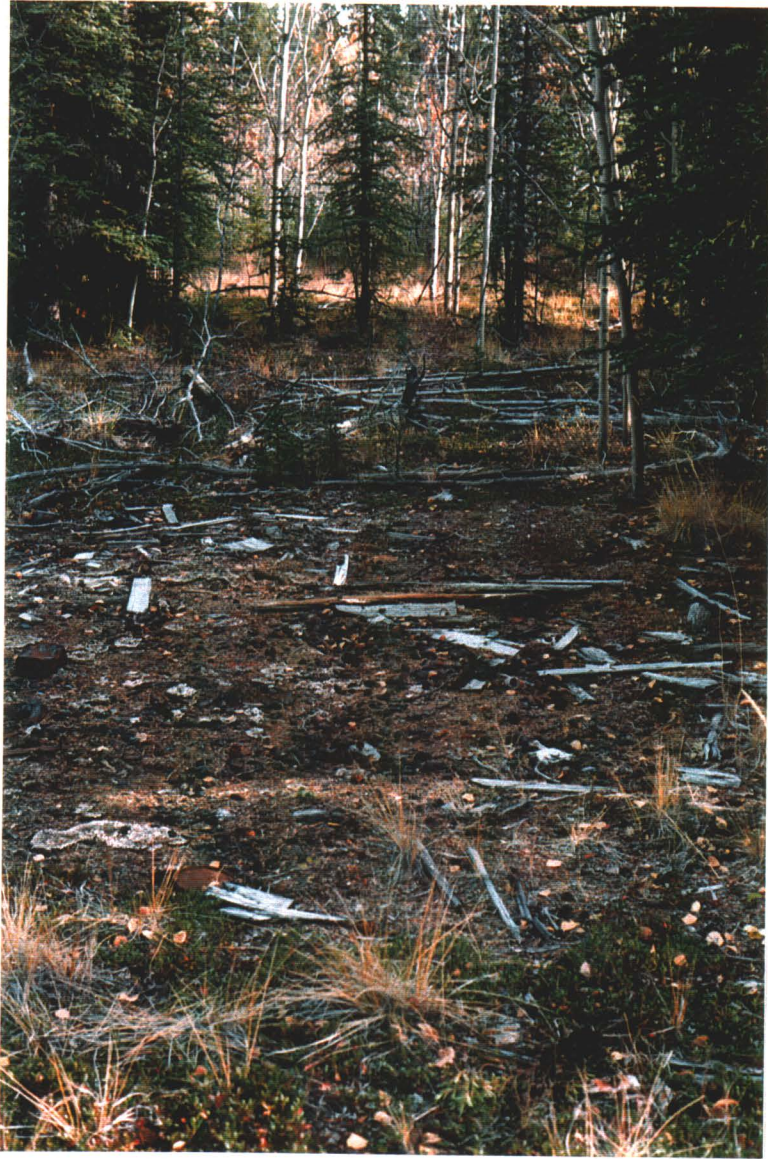
Test Pit Site 2 - A

This site is located on the north side of the Old Alaska Highway, where an area of approximately 100 m by 100 m of the somewhat disturbed ground surface is covered with a variety of scattered debris. It includes: rectangular U.S. military anti-freeze tins, food tins, 45 gallon drums, building material, partially-burned dimensional lumber, bottles, wire, broken crockery, a small quantity (less than .25 cu. m.) scattered asbestos shingles of the kind used for siding, and flattened cans.

The test pit was dug at a point where EMI indicated buried metal materials. Found in the test pit were a crumpled 45 gallon drum and a variety of bottles, cans, wire and other miscellaneous debris.

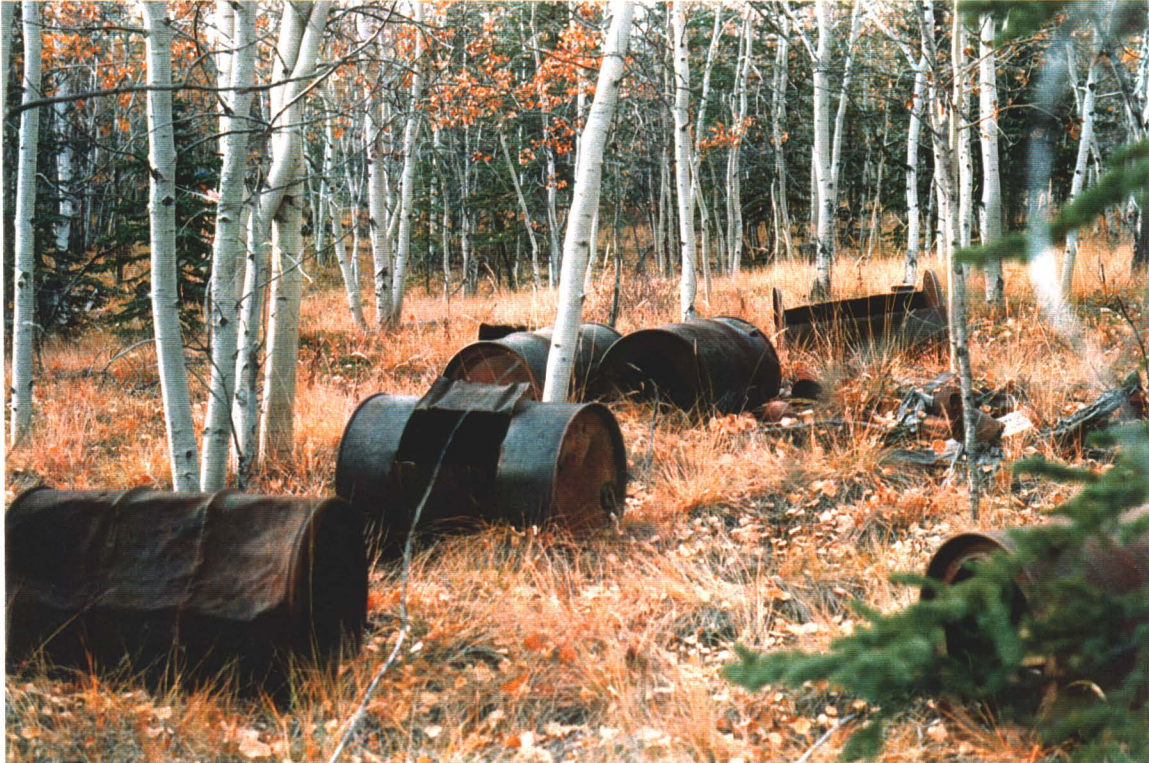
Site 3 - A

The surface garbage at this location consisted only of a group of six or more 45 gallon drums which had been modified for use as stoves and perhaps bathtubs in a stand of aspens. There was no evidence of any buried debris at this site.

- 6.1** The surface garbage and debris such as broken glass and sharp metal (Sites 3-A, 3-B, 3-C) should be removed and disposed of appropriately.
- 6.2** The standby generator slab and "well" (Site 4-B) should be removed. This work will require the use of loader with a backhoe. When this removal is being carried out, this location should be investigated for the presence of a buried fuel tank. The excavation on the north side of the slab should be filled and the site levelled.

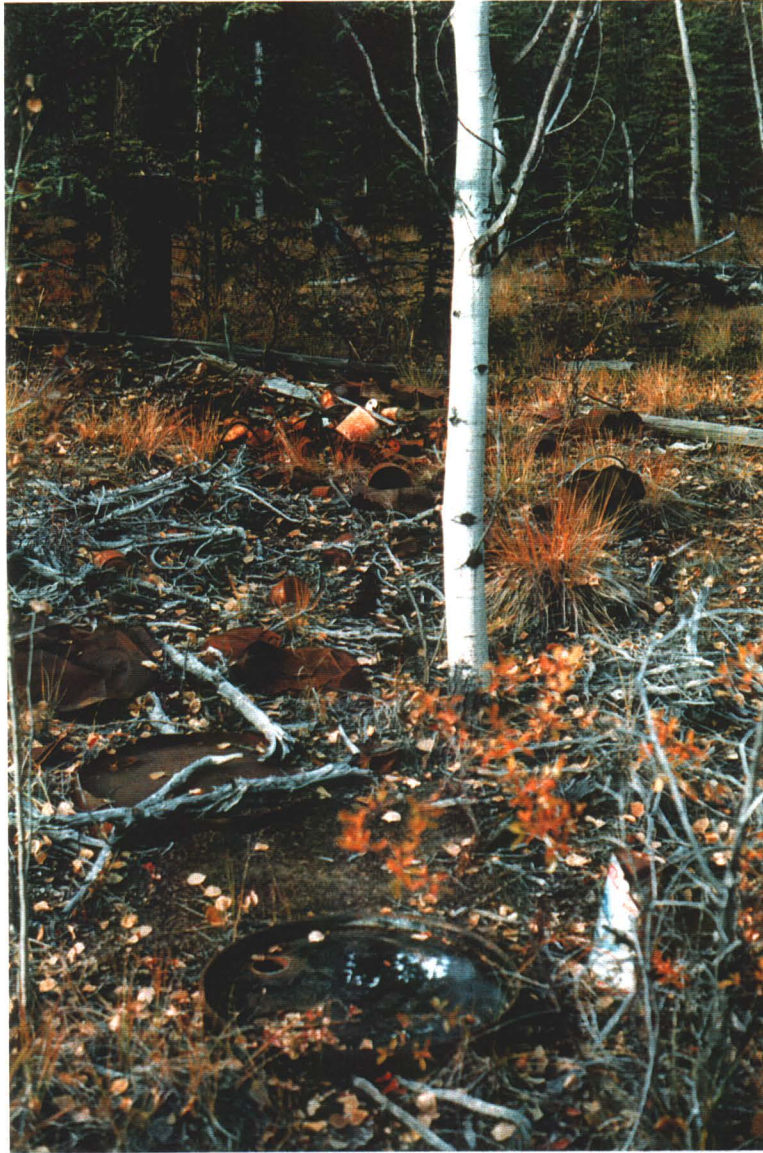
Site 3 - C

Surface garbage at this location included cans, bottles, cable, and oil drum tops at the base of a large mature white spruce. There was no evidence of any buried debris at this site.

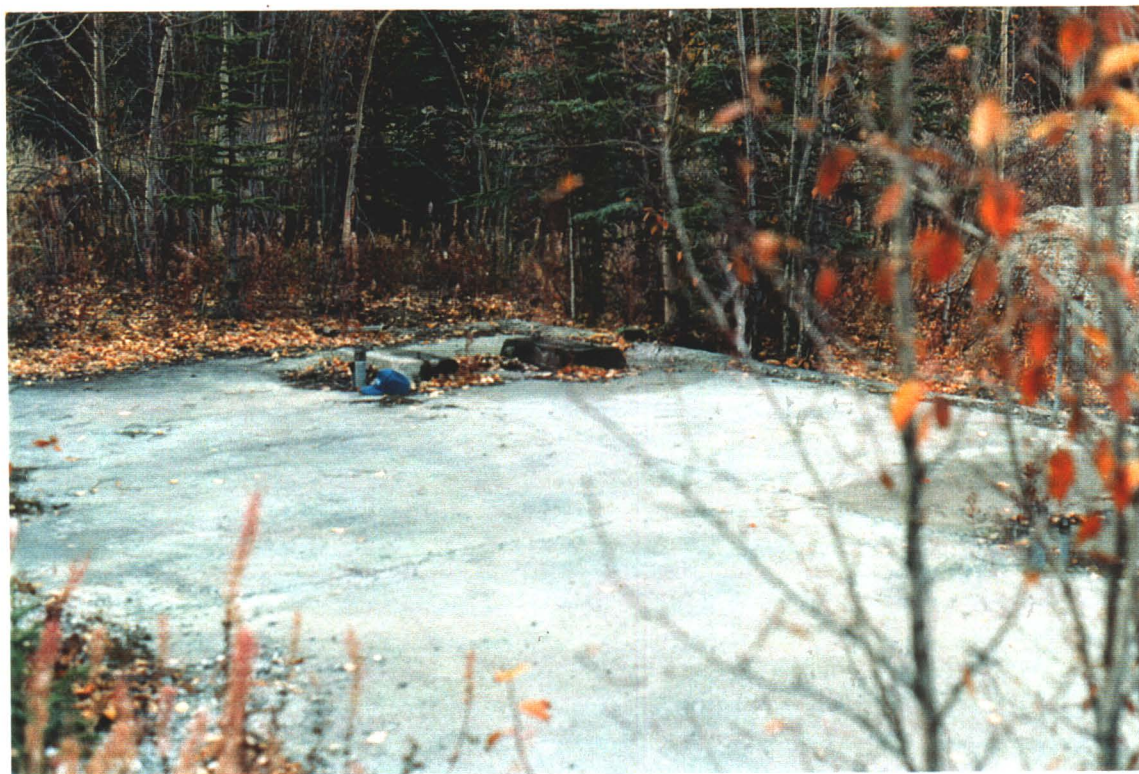
Site Test Pit 4 - B

The test pit at this site is immediately adjacent to the NW corner of the concrete slab of the former diesel plant building which itself is located 20 m. west of the fenced former repeater site. It would

appear that there may be a fuel tank buried beneath or adjacent to this slab. There is an old excavation on the north side of this slab surrounding a concrete "well," approximately 1.5 m. deep, at the bottom of which are visible copper lines, possibly leading to the fuel tank. The vertical pipe in this well may have been for filling the tank. (Not having anticipated a buried tank at this site we did not have with us the means to determine if the vertical pipe lead to a tank and, if so, were there petroleum products in it.) There was no soil discolouration in the test pit nor in the excavation although the concrete slab appears to be discoloured by petroleum products. There appears to be an oil sump in the slab adjacent to the engine mount bolts.

Slab foundation of generator building.

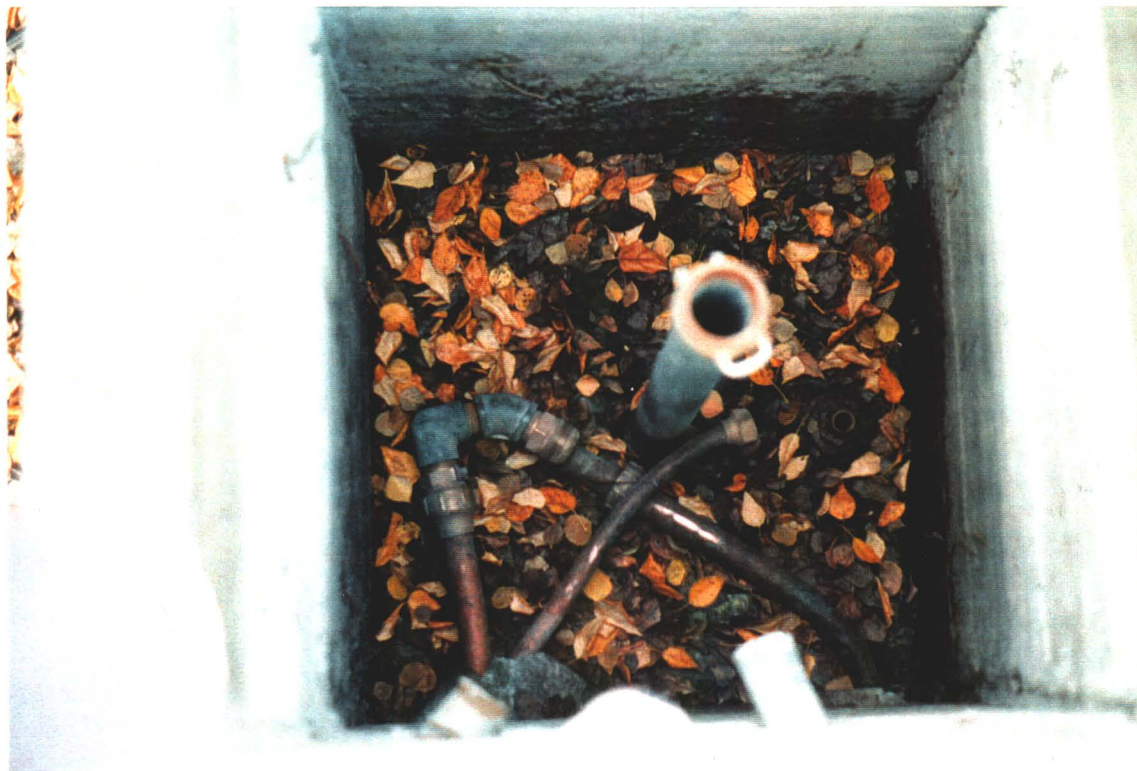
Concrete well with copper fuel lines.

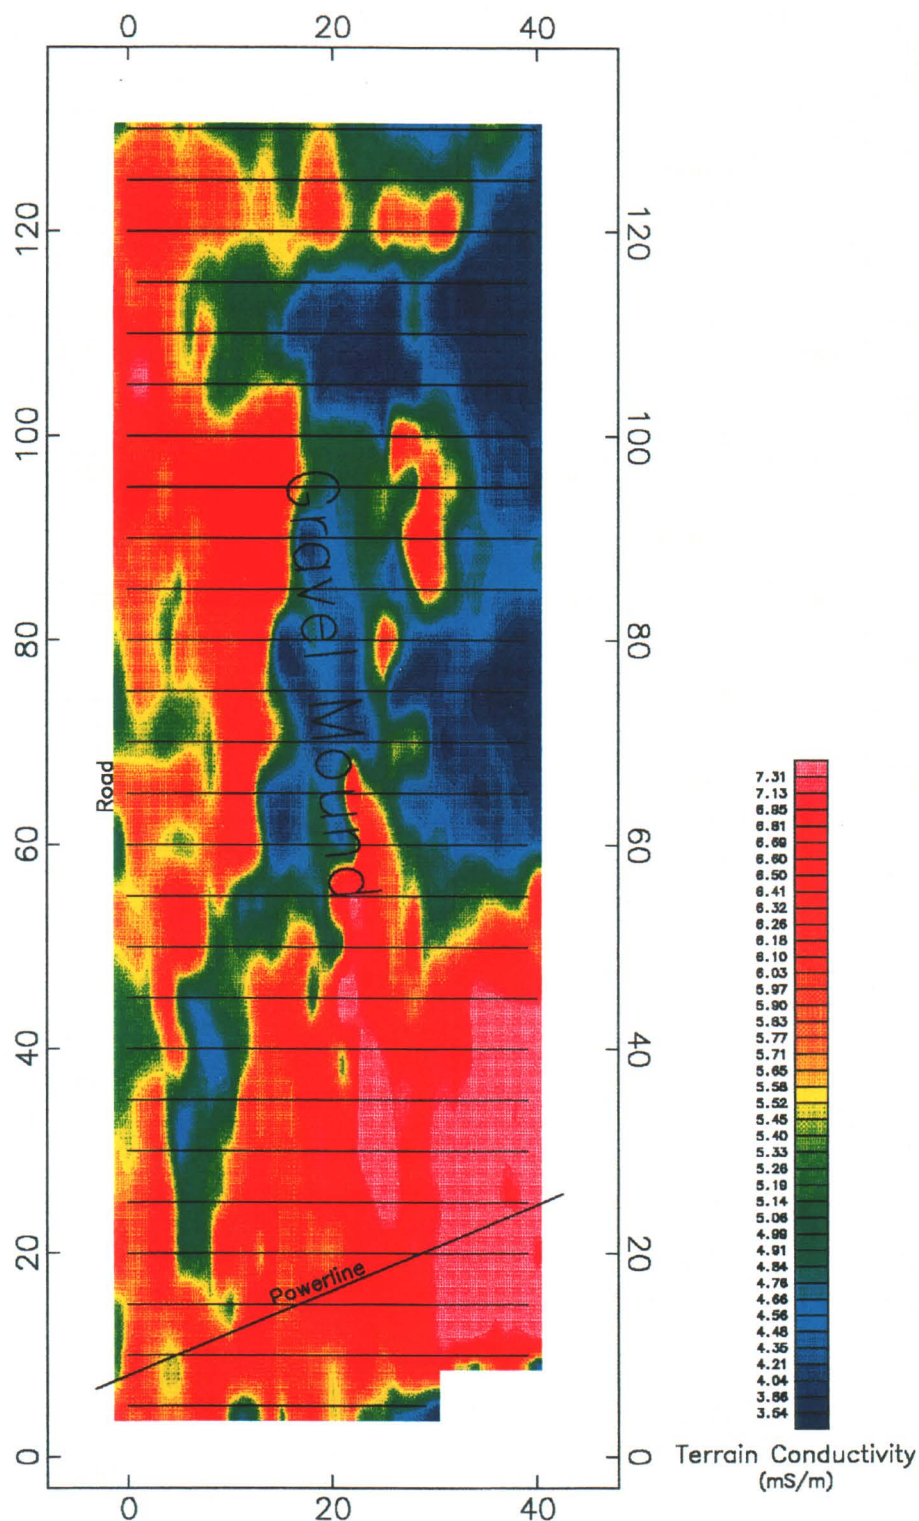
Figure 1a: Canyon Site MDA-1A

Figure 1a represents the terrain conductivity survey conducted over this site. Background conductivities appear to be in the 4 to 6 mS/m range. This is appropriate considering gravel conductivities are typically in the 4 to 15 mS/m range for gravely sands and silts. Elevated conductivities noted in the southern portion of the survey may be due to the influence of the powerline approximately noted on the Figure. The trend of the suspect mound is difficult to detect in this Figure, implying a mixed genetic nature comparable to the surrounding soils. A subtle north-south trend can be detected which is correlative with the long axis of the mound. No significant anomalies which would indicate the presence of buried metal are seen in the data.

1. No further work is required be taken at Sites MDA – 1A, B, C. Further investigation should be undertaken at Site 1A to determine the cause of the anomaly.
2. During causal geophysical surveys conducted after completing the survey of Site 1A, a large area of refuse was encountered. This area lies approximately half a kilometre northeast along the Old Alaska Highway from Site 1A. This area presented many geophysical anomalies representing both buried and surface debris. This area appears to either be an old army camp/s, or dump. Can middens and burnt building remains were seen though the forested area. Follow-up work should be conducted at this site to determine the extent of the refuse in this area

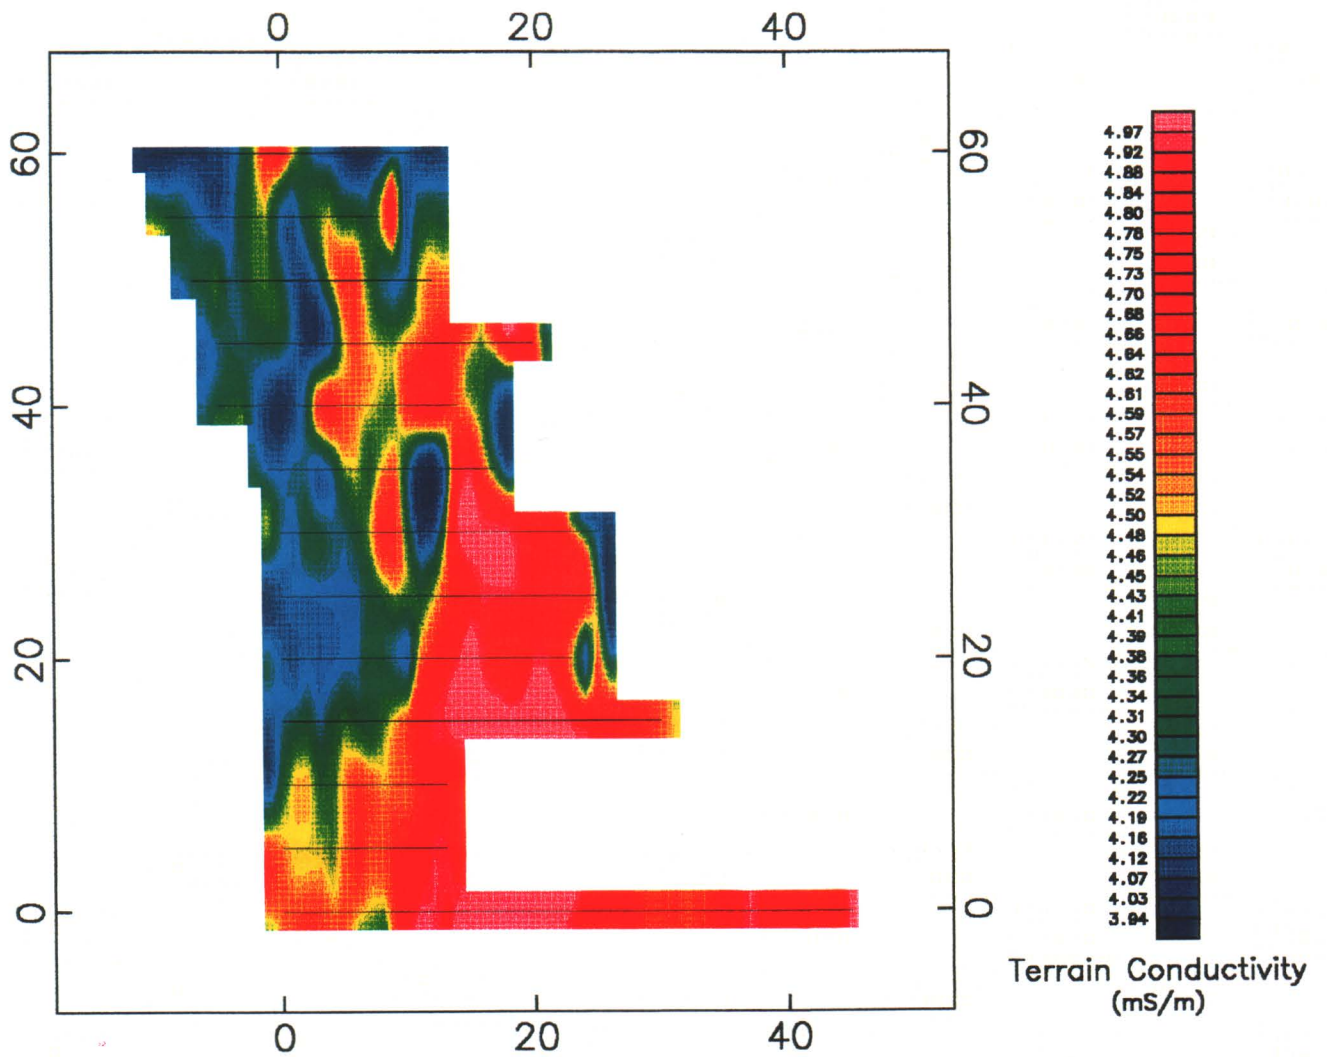
Figure 3a: Canyon Site MDA-3A
Terrain Conductivity

Figure 3a represents the terrain conductivity over this site. Again, terrain conductivities are low, in the 3-4 mS/m range which is in accordance with the soils in this area. A conductivity high can be seen in the lower right (northwest side) of the map; this corresponds with the shallow swale northwest of the clearing. This could be due to higher moisture content in the soils or perhaps finer grained soils. No significant anomalies are visible in this survey.

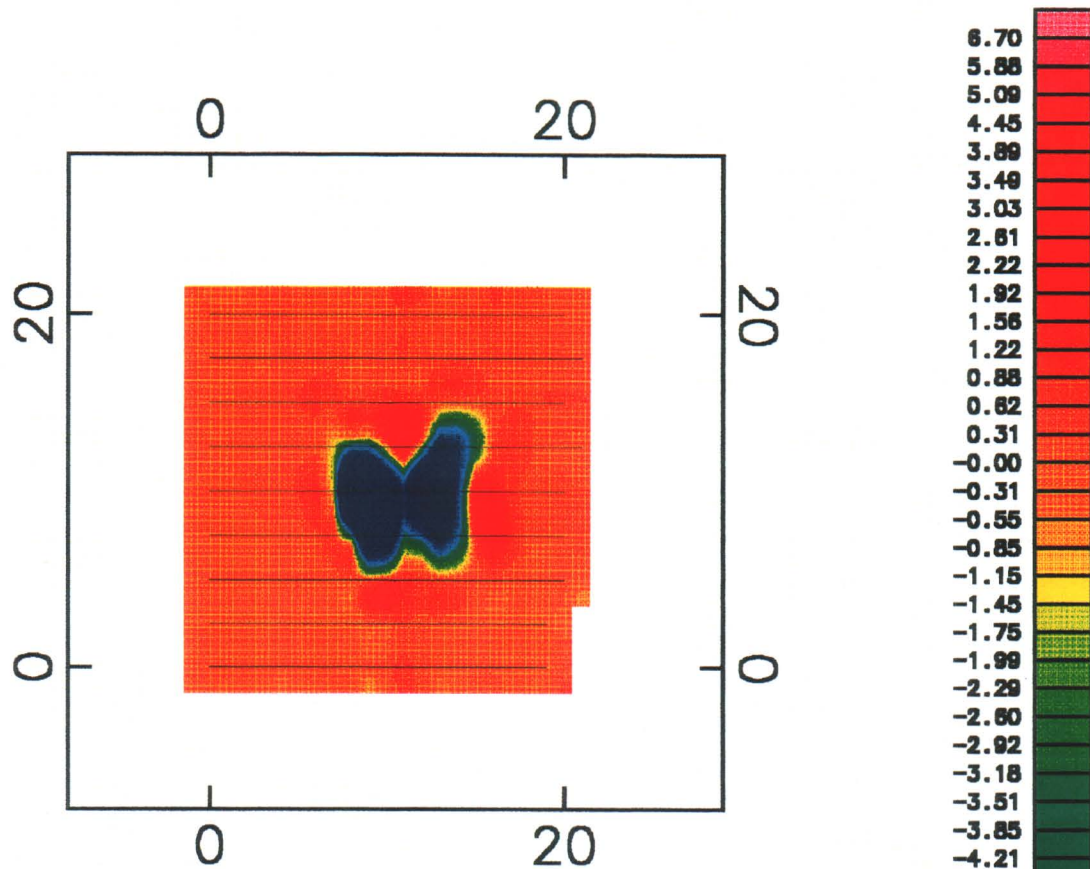
Figure 4b: Canyon Site 1A
In-phase Component

anomalies are present. For comparison, the major metal anomaly found at Canyon Site 1A is shown in Figure 4b; note the scale on the right hand side of the Figures.
