**Inventory of Equipment, Machinery,
Major Fixtures and Hazardous Materials
at the Destruction Bay Pumping Station,
Yukon Territories.**

**Prepared for
Indian and Northern Affairs Canada**

August, 1998

**Prepared by
Arctic Environmental Services Ltd., and KO KEN General Contractors**

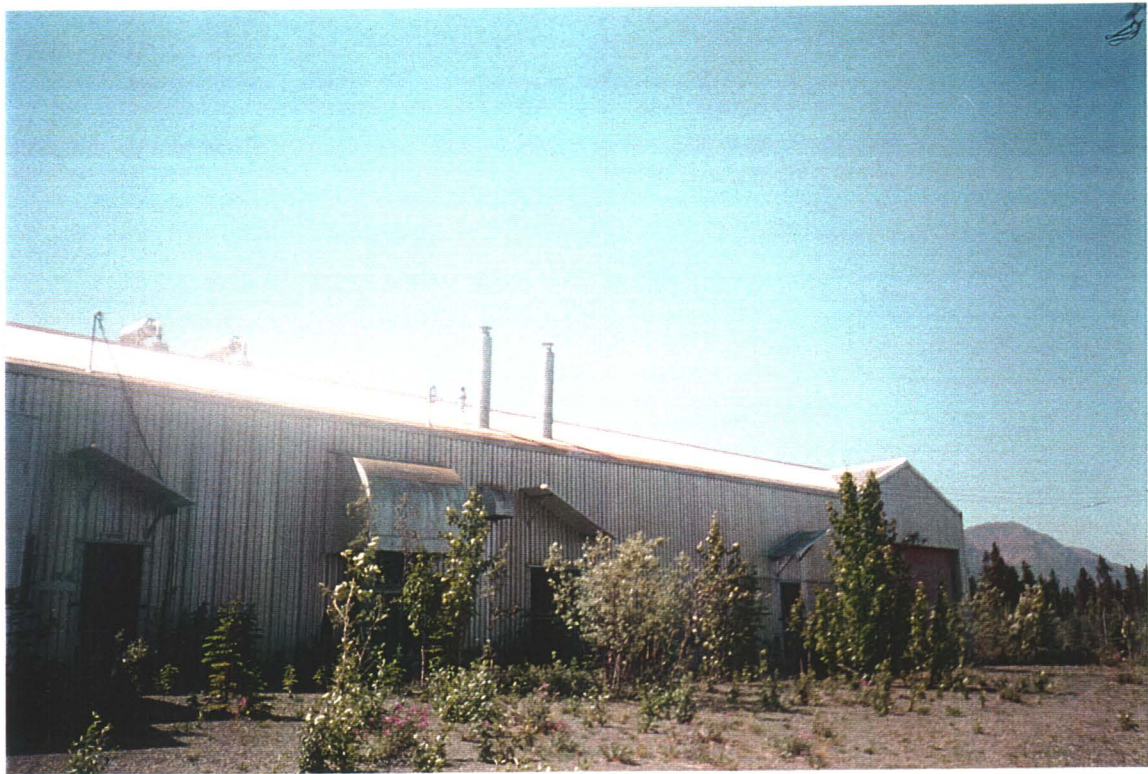
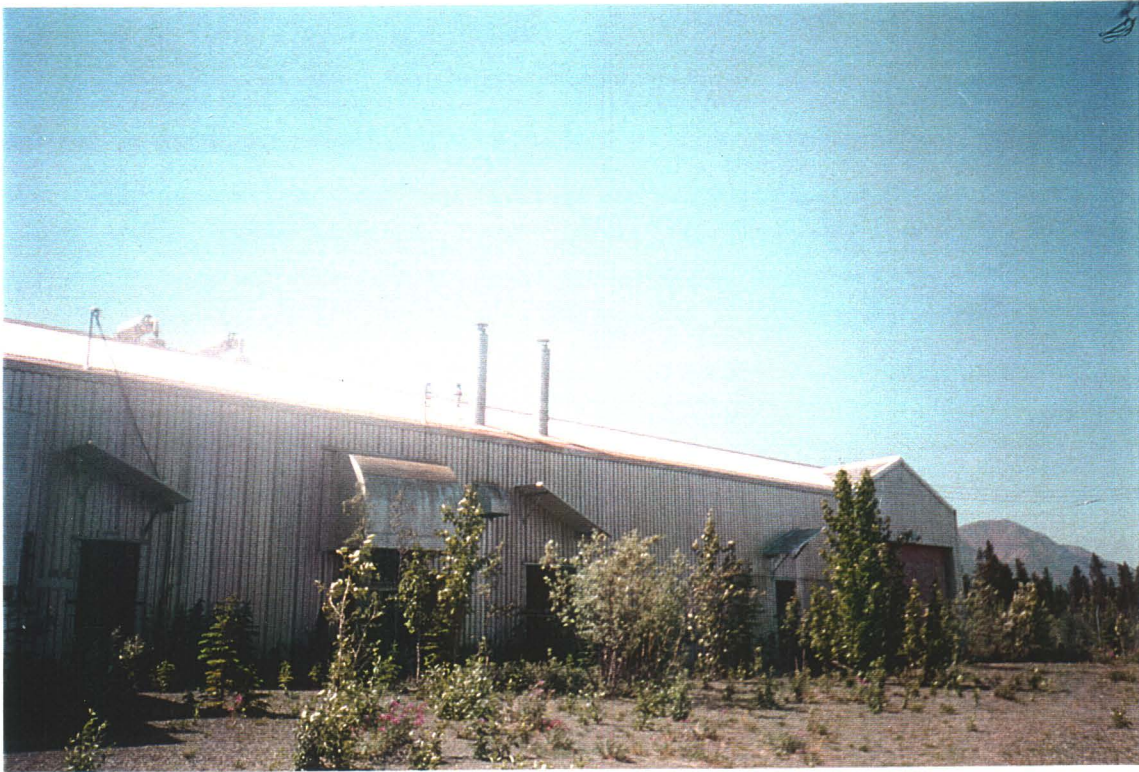
Front of main building. Note stainless steel ventilation structures, and asbestos-filled Generator Room stacks.

- Asbestos has been confirmed on pipe joints, exhaust stacks, boiler main steam lines, gaskets, transite pipe. All asbestos should be removed before any equipment is taken from the Station or modifications to the heating system are made.

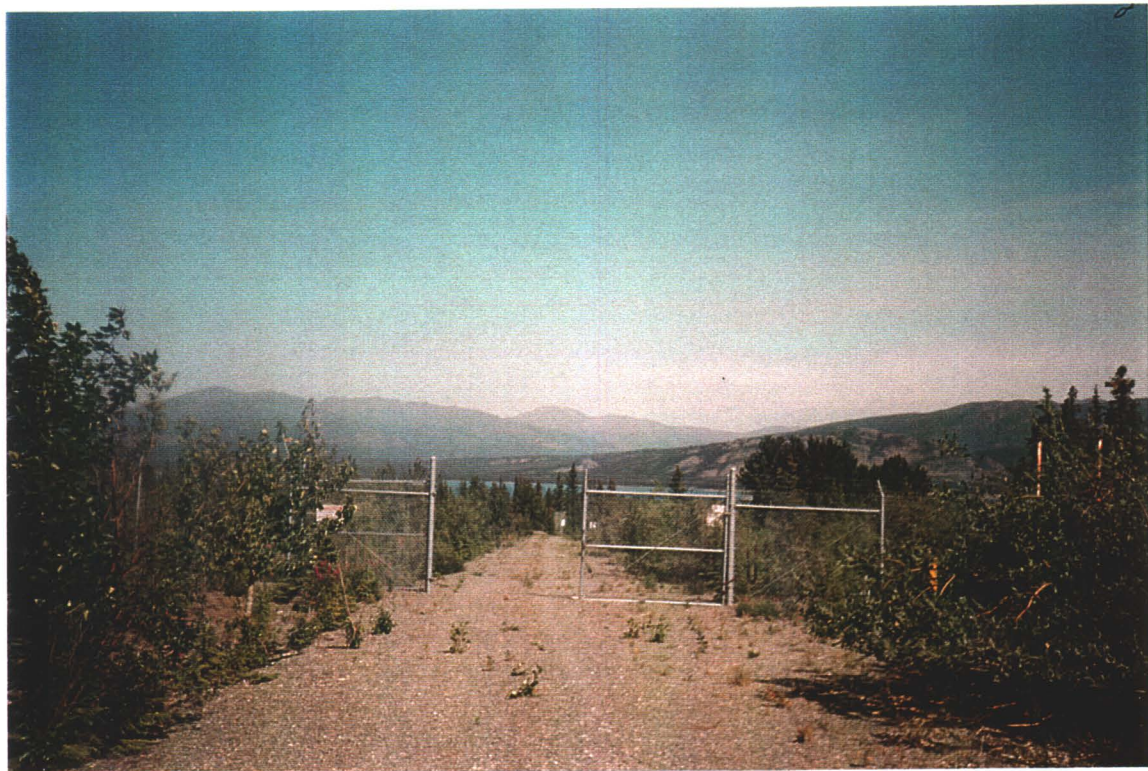
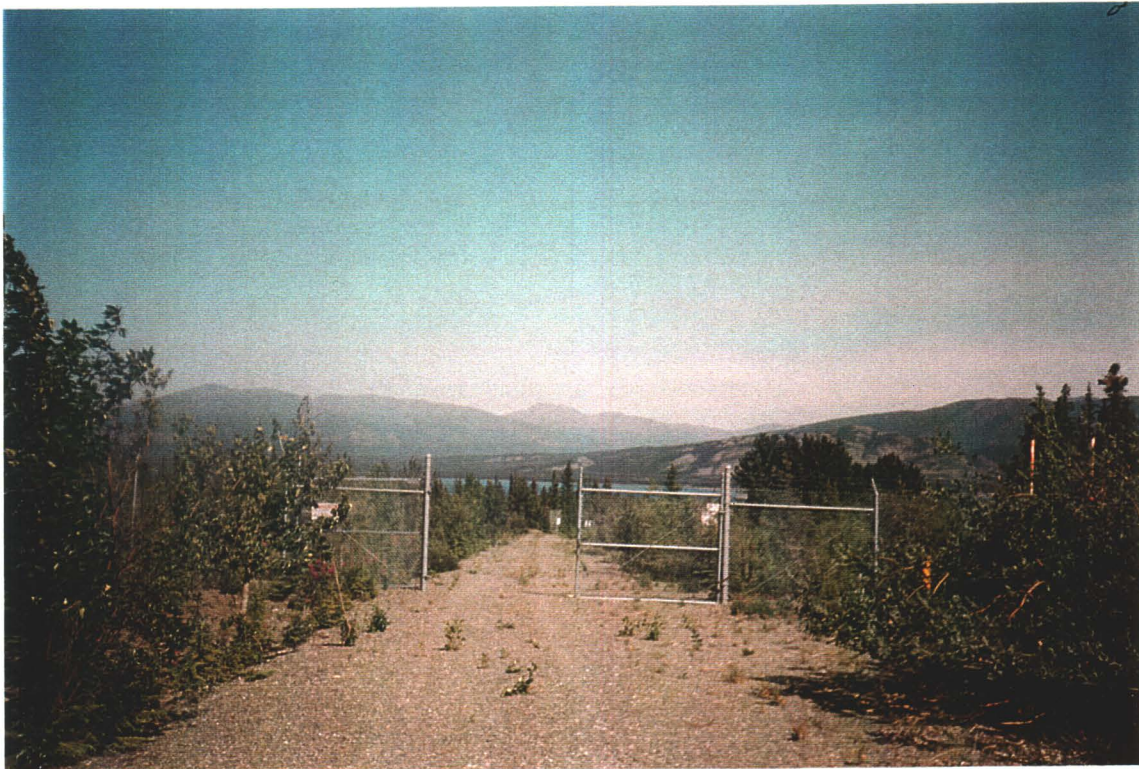
Location of two underground storage tanks and former pump island to the right of main gate.

- Two underground storage tanks remain on site and should be removed and properly disposed of.
- Old foundations and pumphouse structure should be removed.

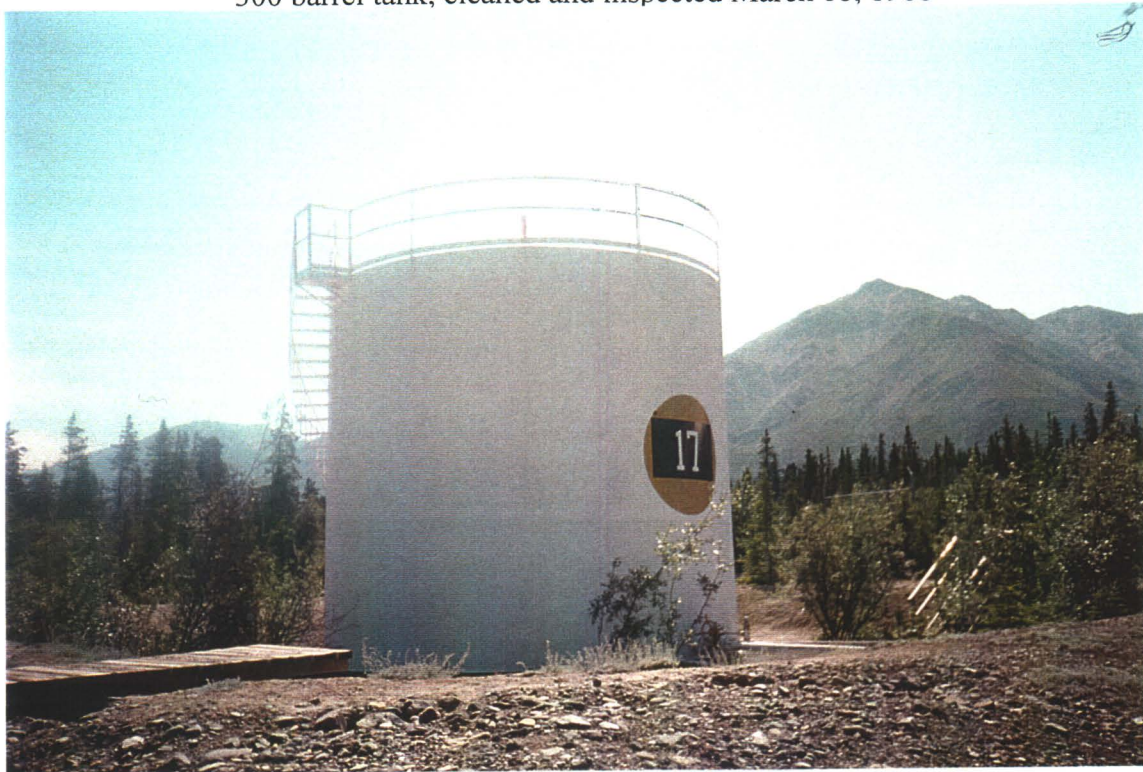
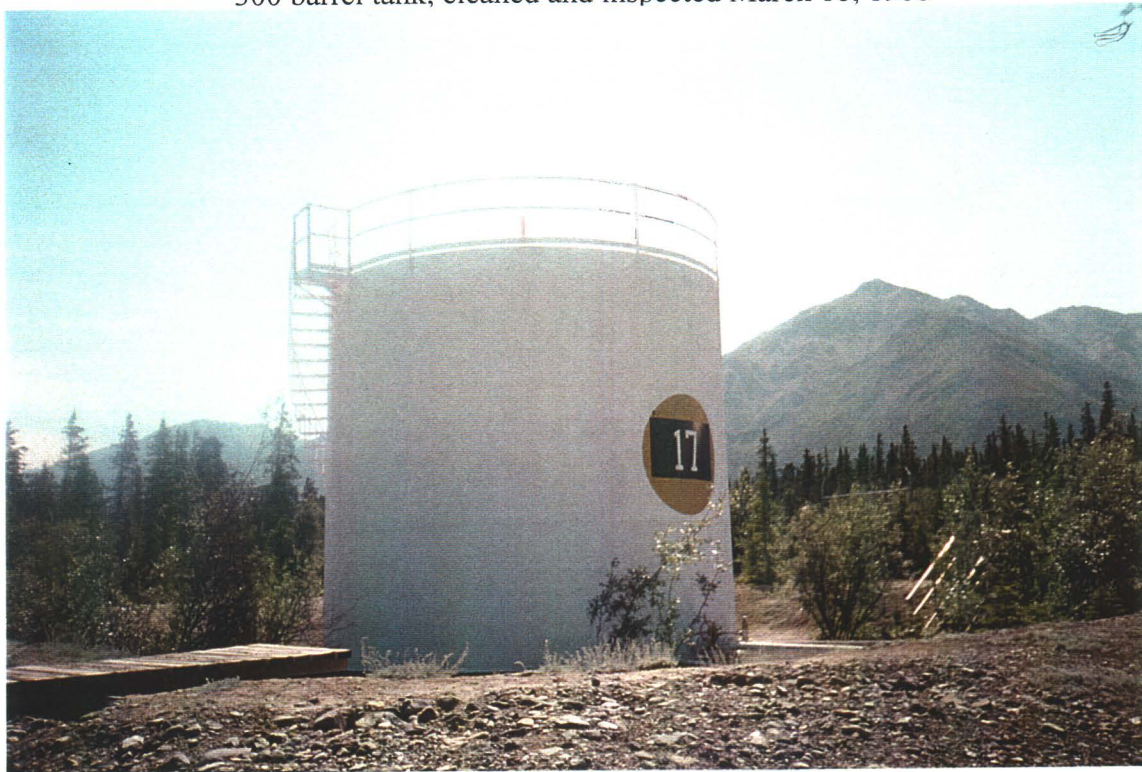
Main product tank, 1440 barrel capacity. Man-way loosely bolted, indicating entry following product removal.

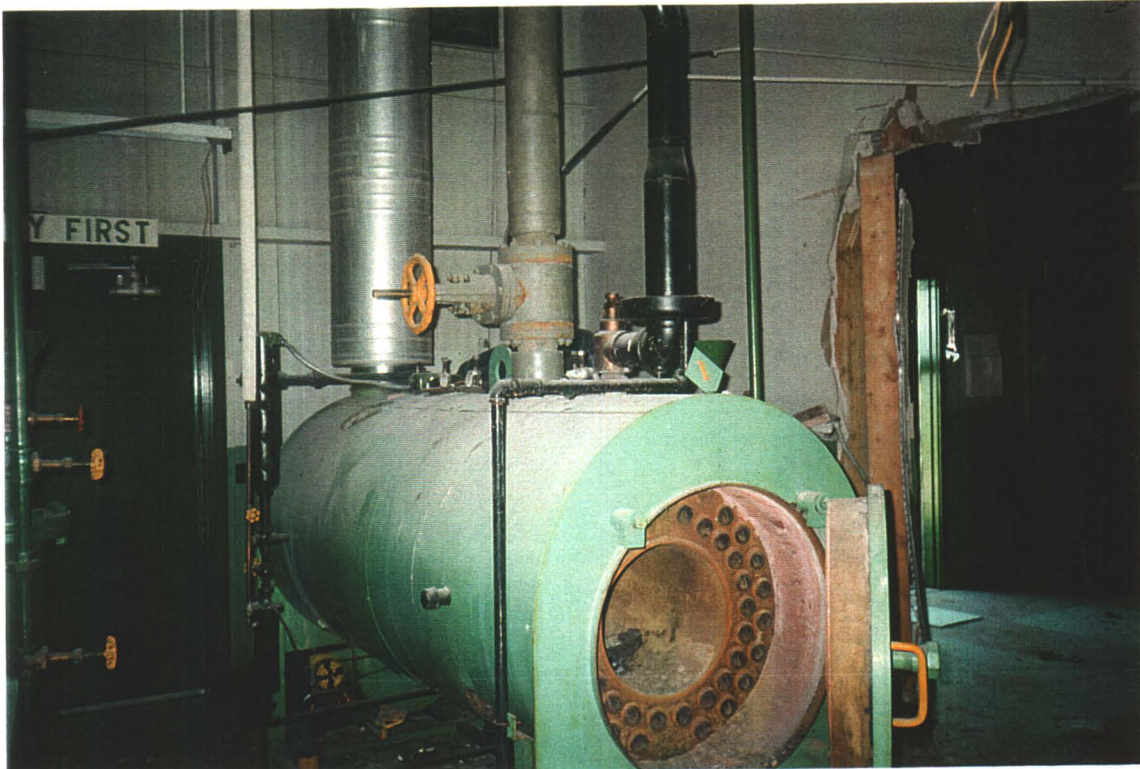
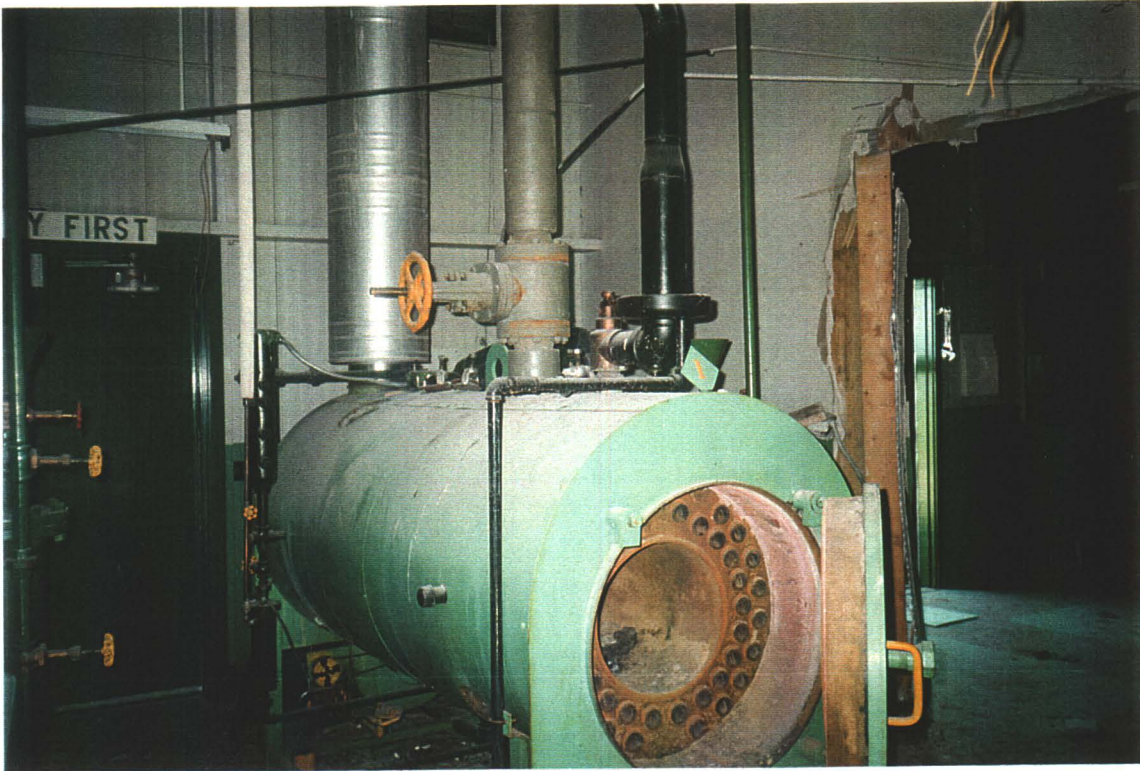
Boiler Room. Entry door, boiler # 1.
(note: asbestos gasket on door, all water/glycol lines are disconnected and drained)

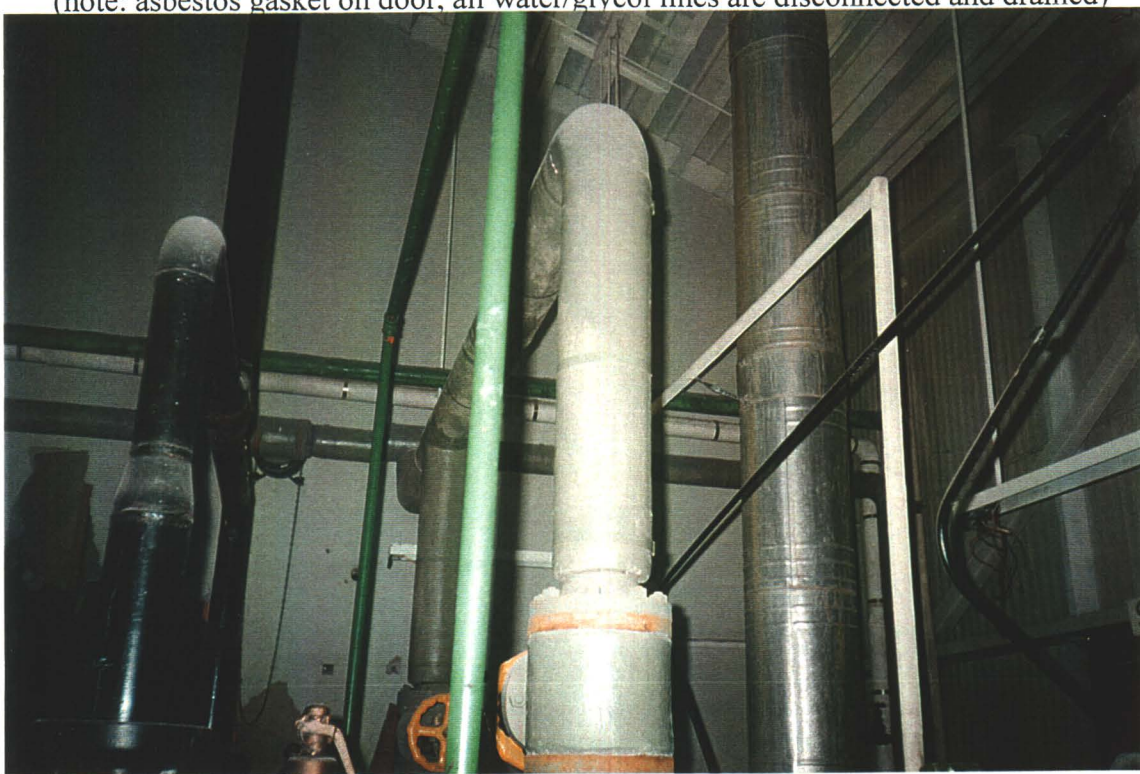
Boiler Room. Top of boiler #1.
(note: asbestos insulation is present in stack)

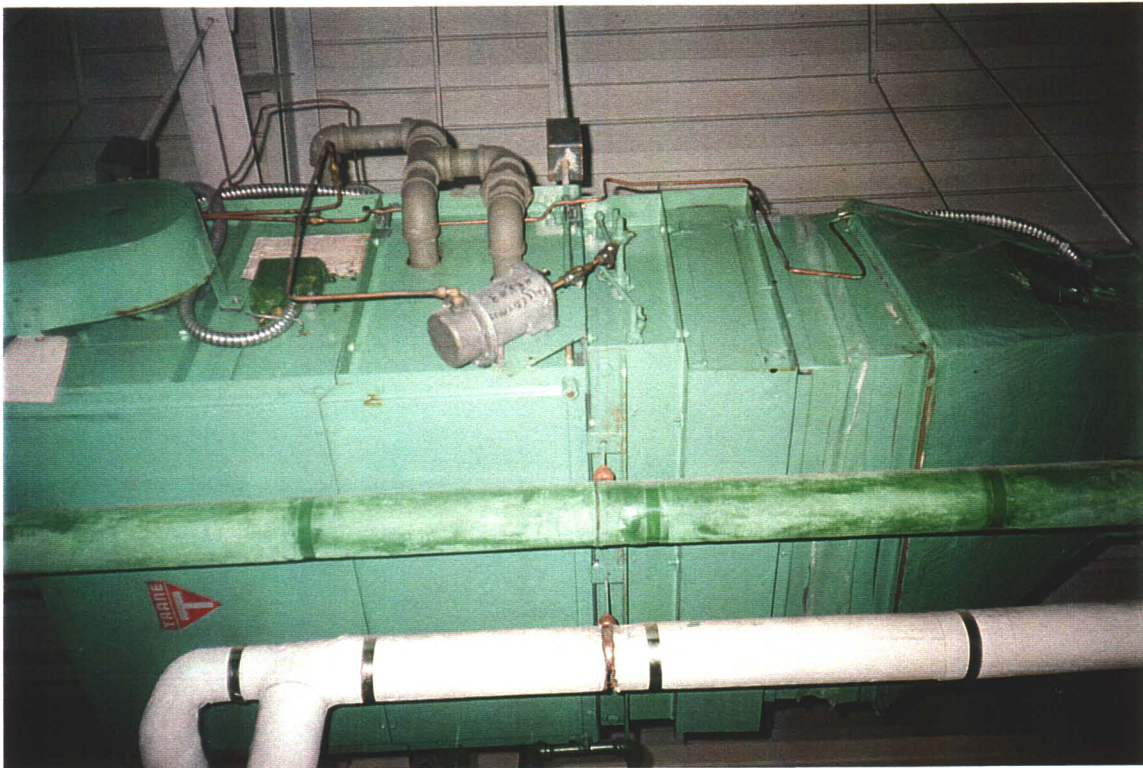
Boiler Room. Heat exchanger. Note asbestos knuckles on insulated lines.

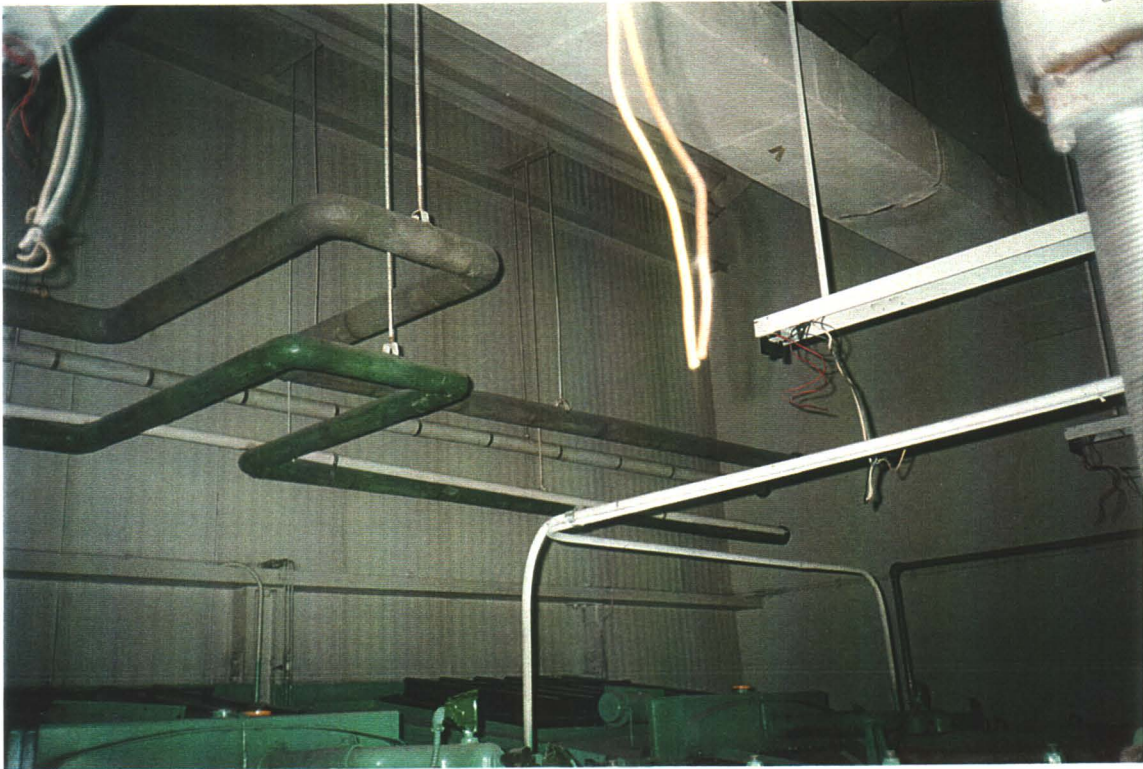
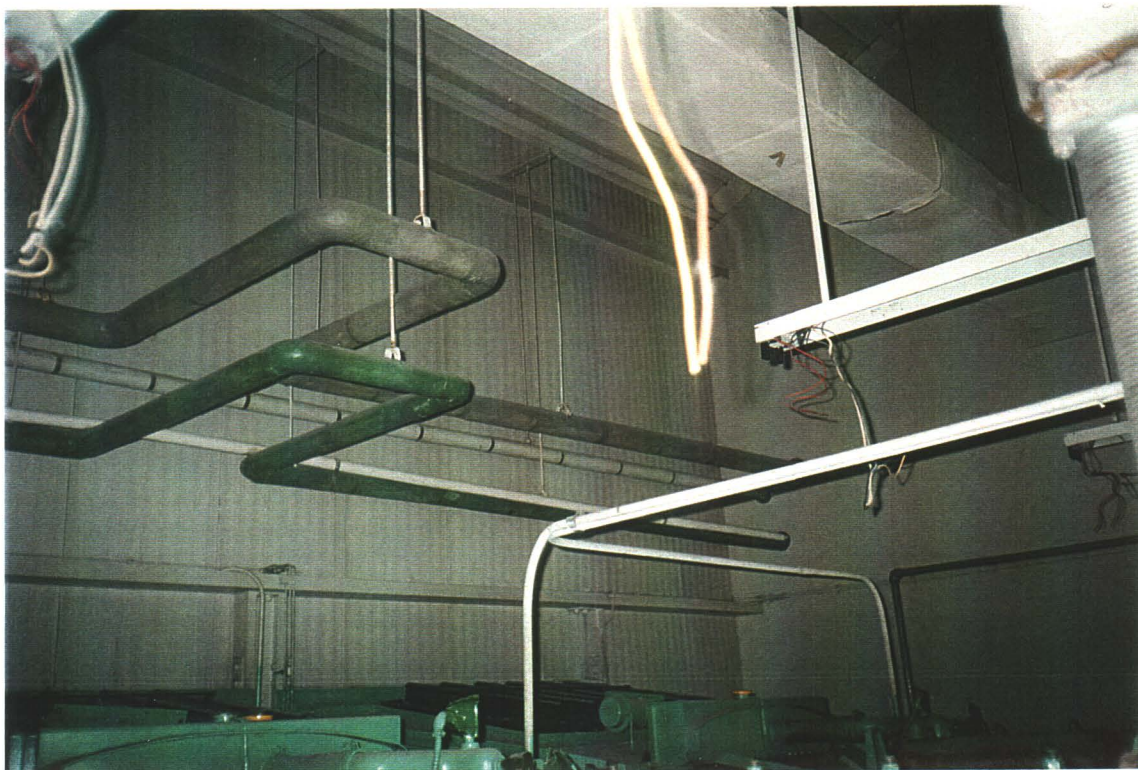
Generator Room. Confirmed asbestos locations on insulated pipe joints.

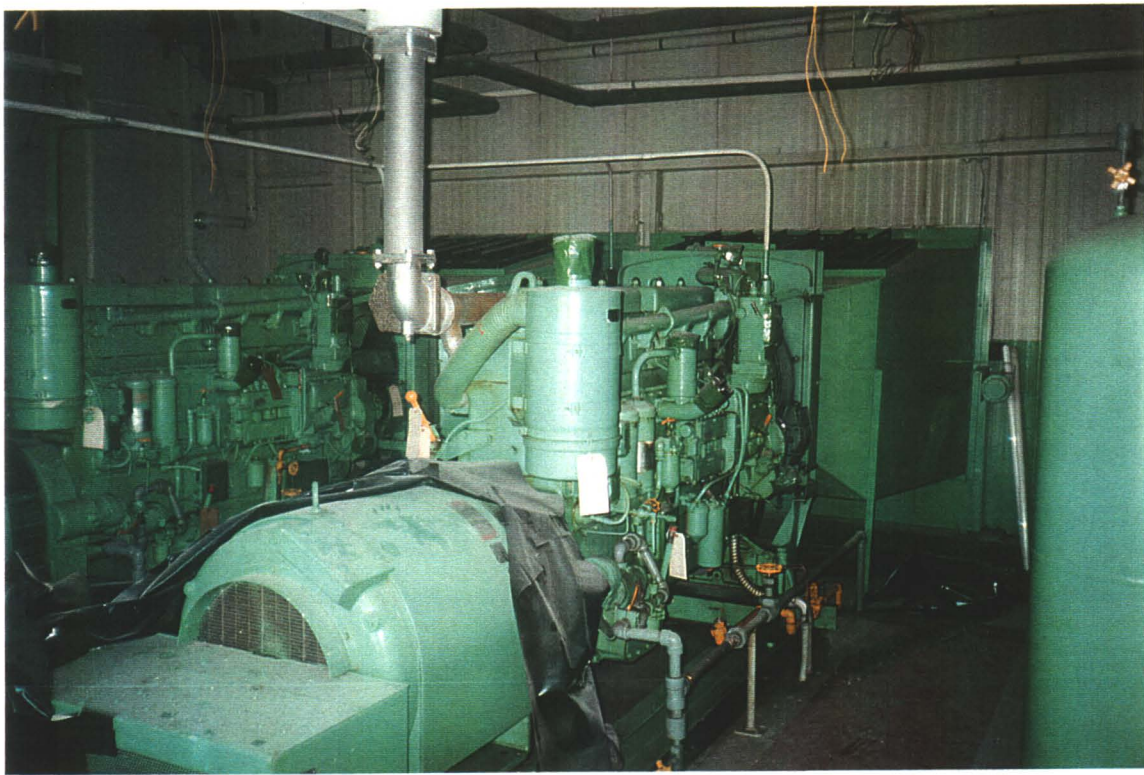
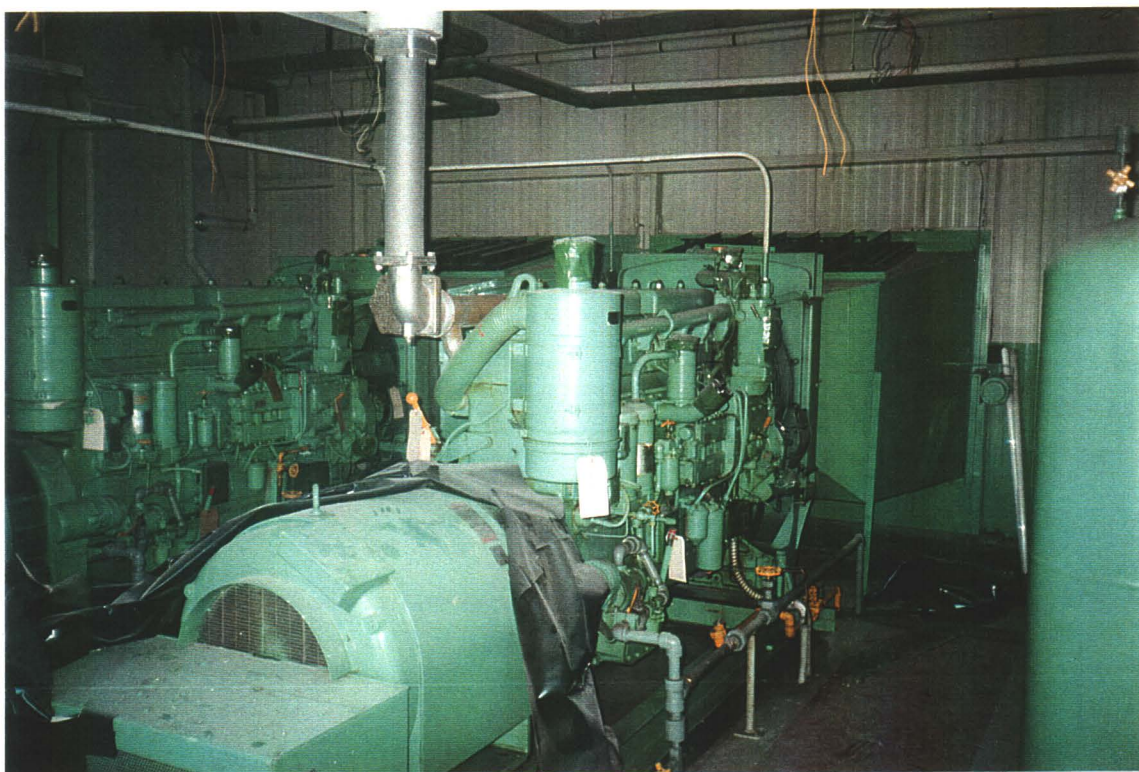
Generator Room. Generator Units. Stacks contain asbestos insulation.

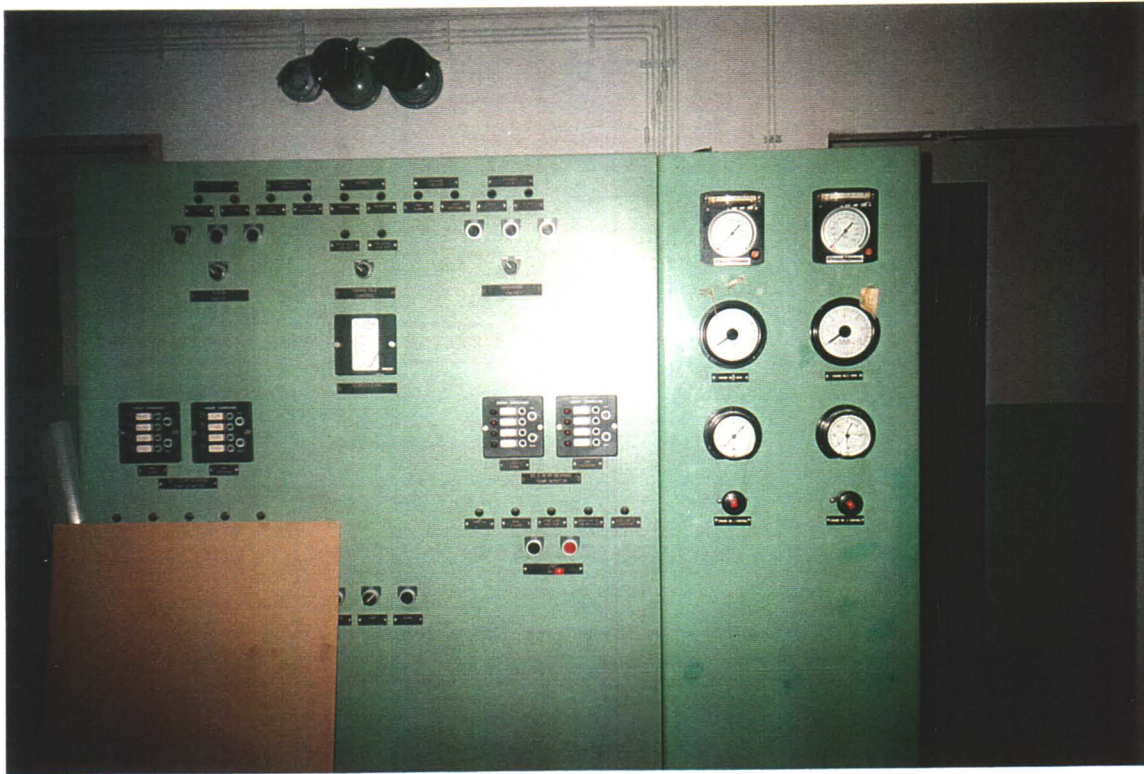
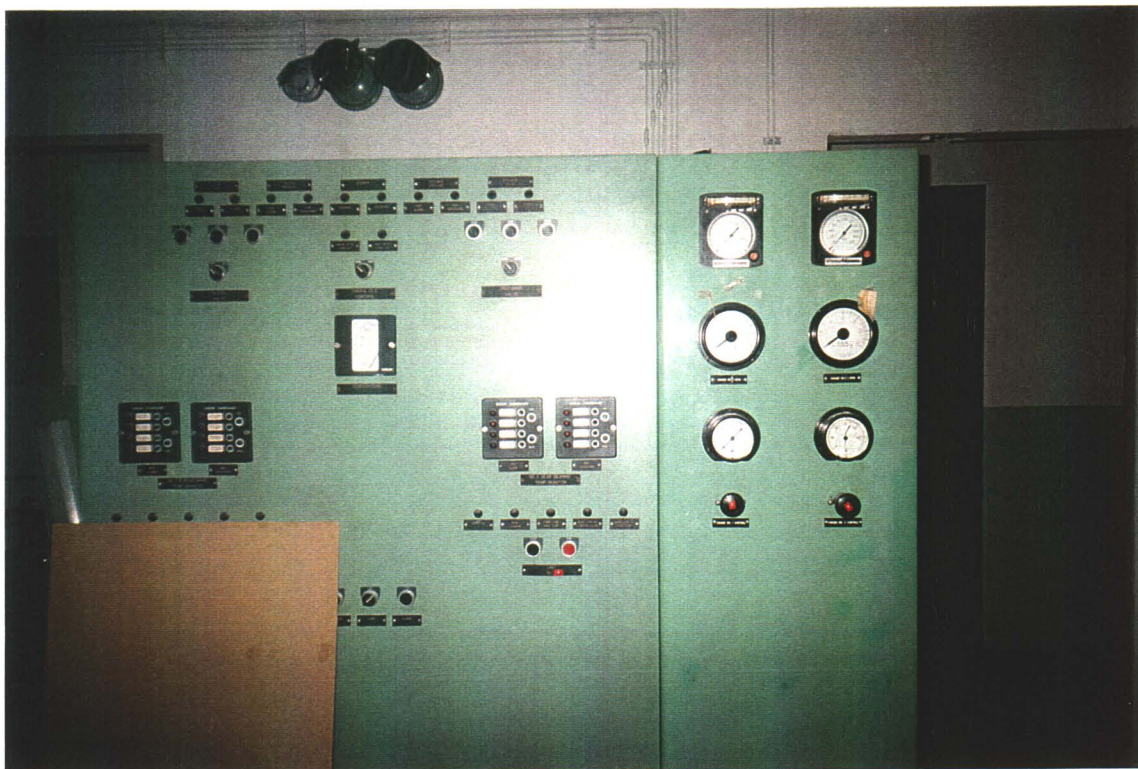
Office Room. Control Panel.
(note: contains at least one mercury activated switch)

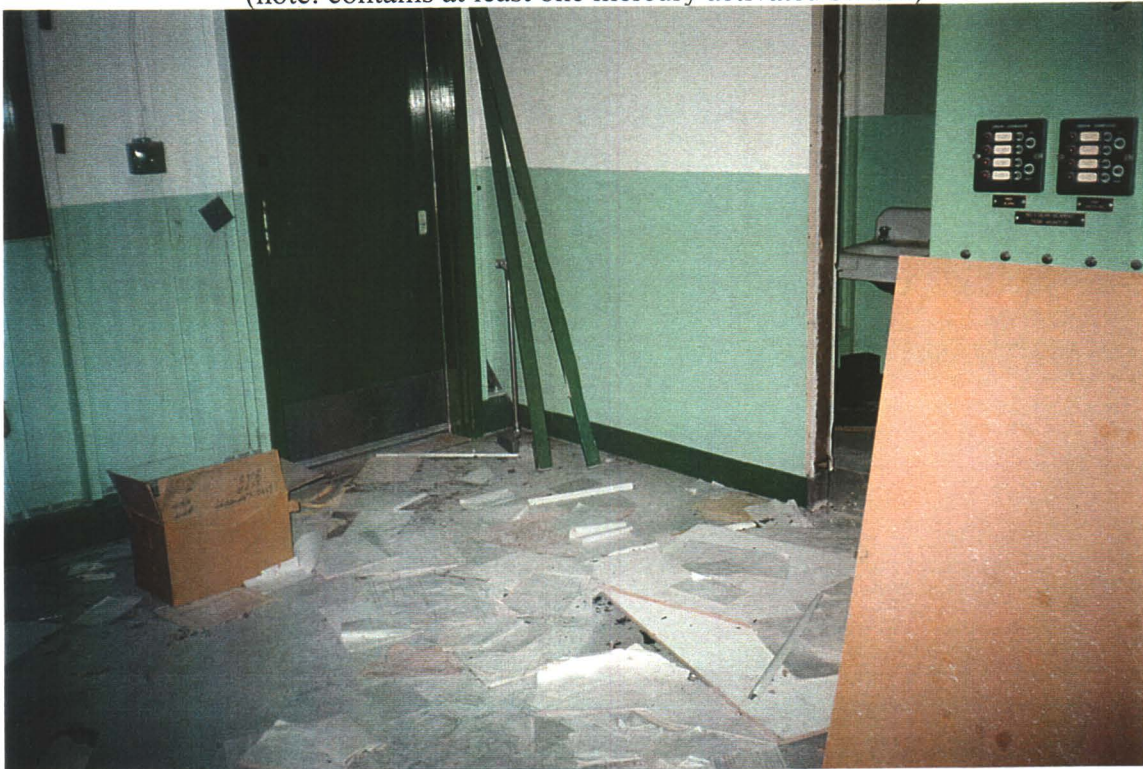
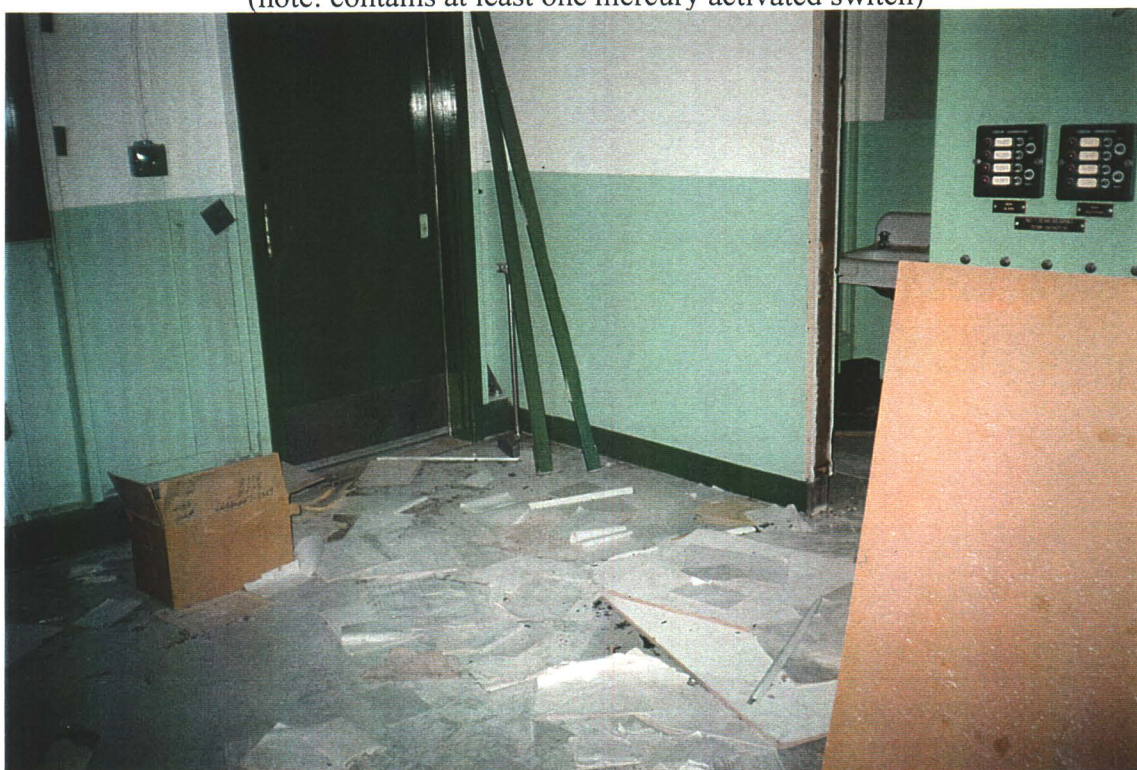
Office Room. Some vandalism is apparent

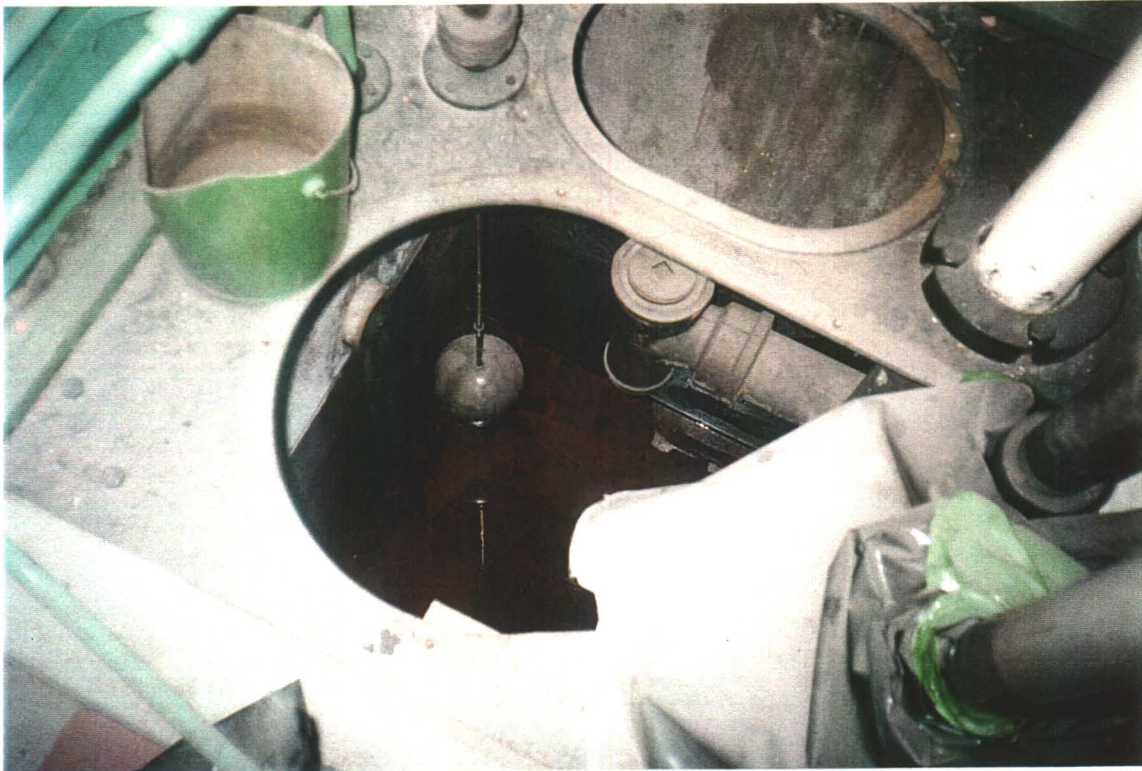
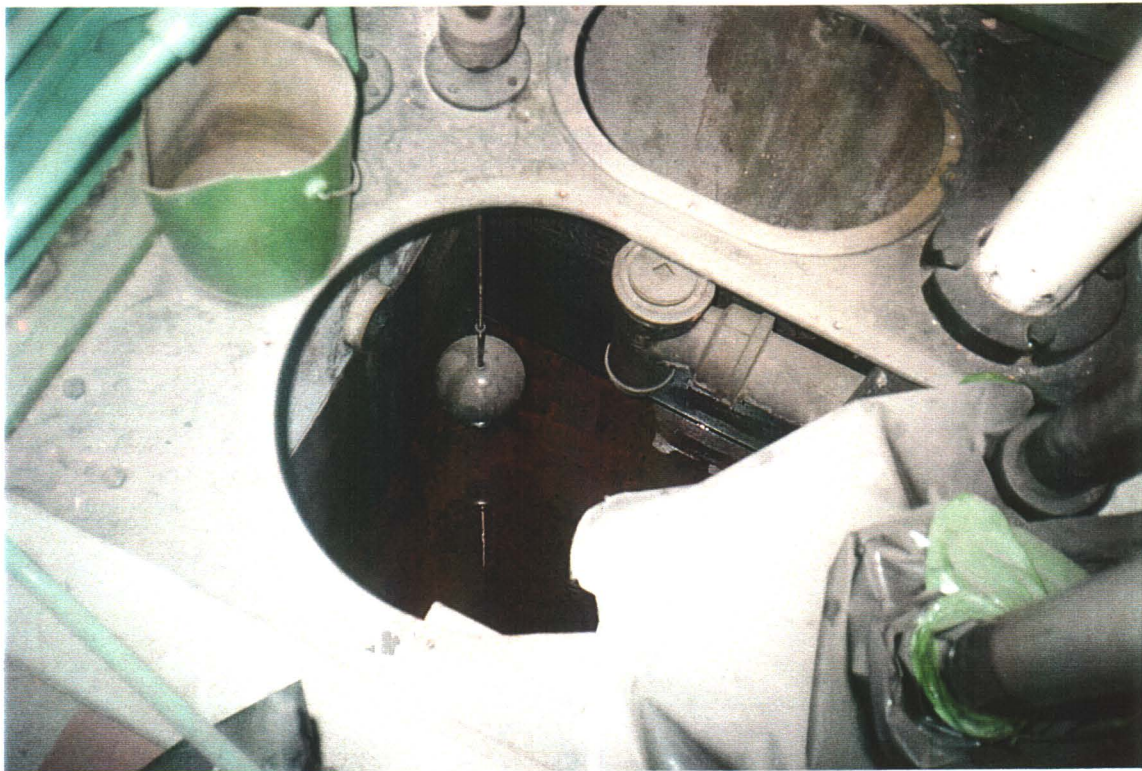
- All lines and sumps were drained of product when the Station was mothballed. However, the sump in the compressor room is now partially full of water.

Compressor Room. Sump and stored electric sump pump. Sump contains antifreeze.

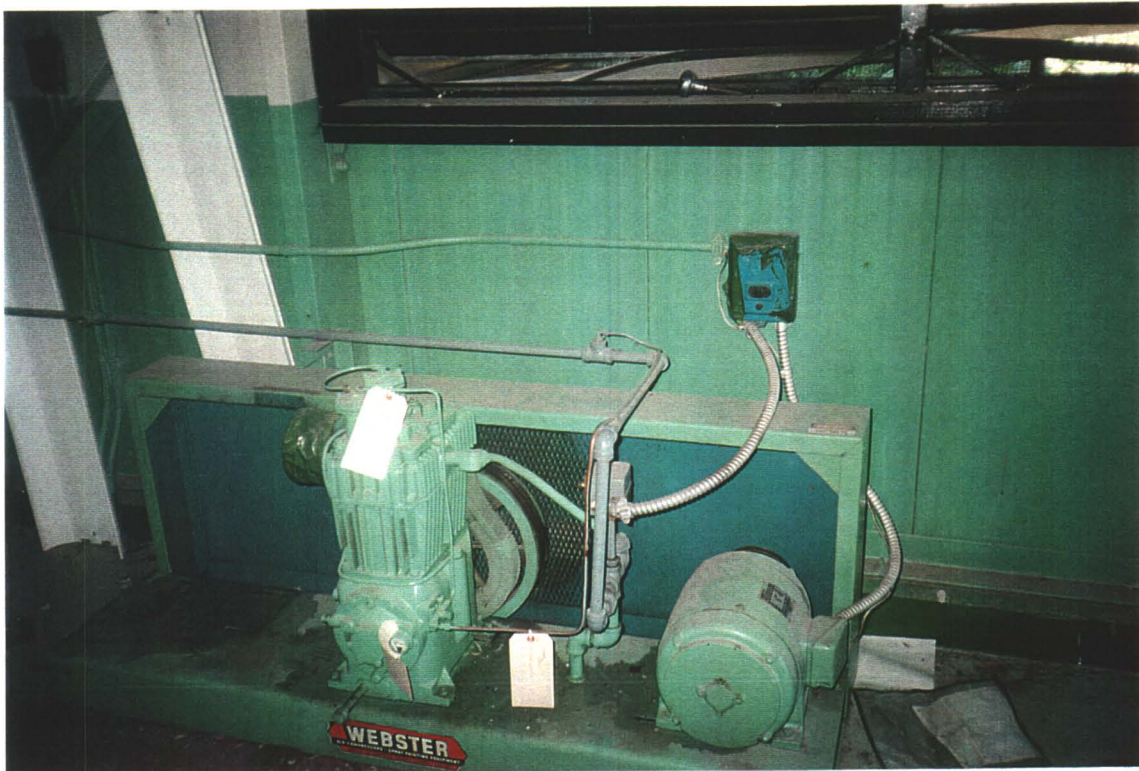
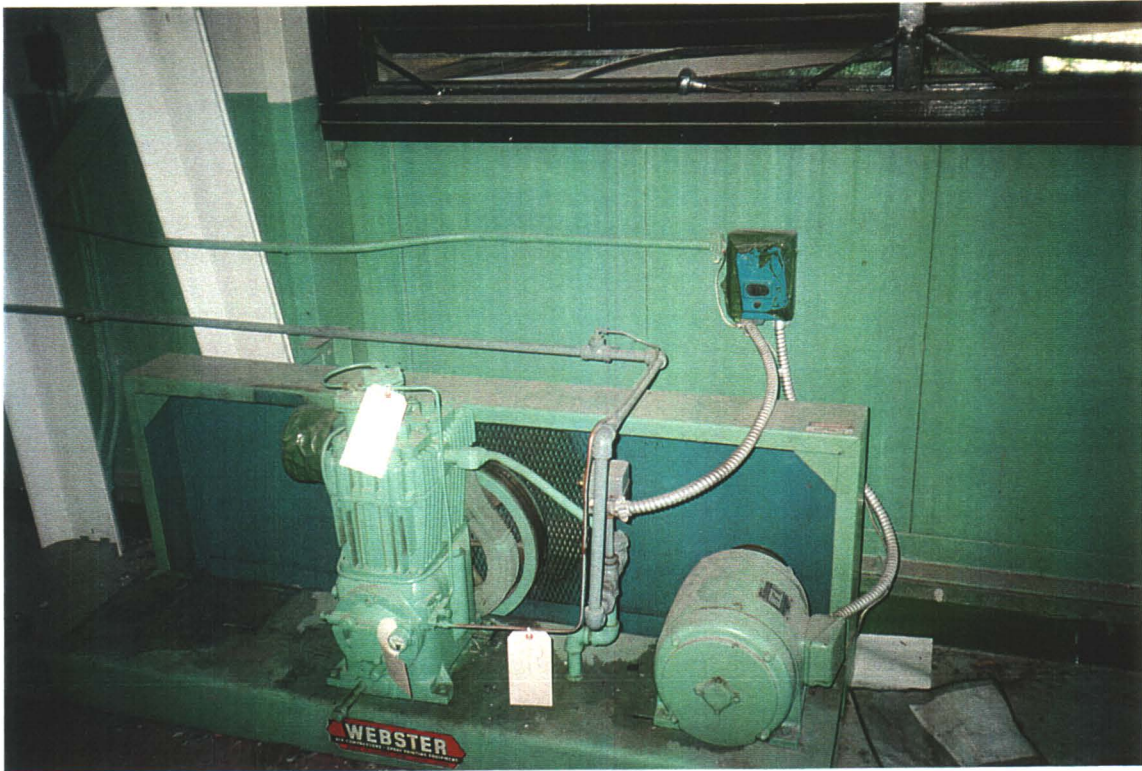
Engine Room. Compressor unit, complete with 440 3-phase power supply. Back-up piston engine has been removed from the facility.

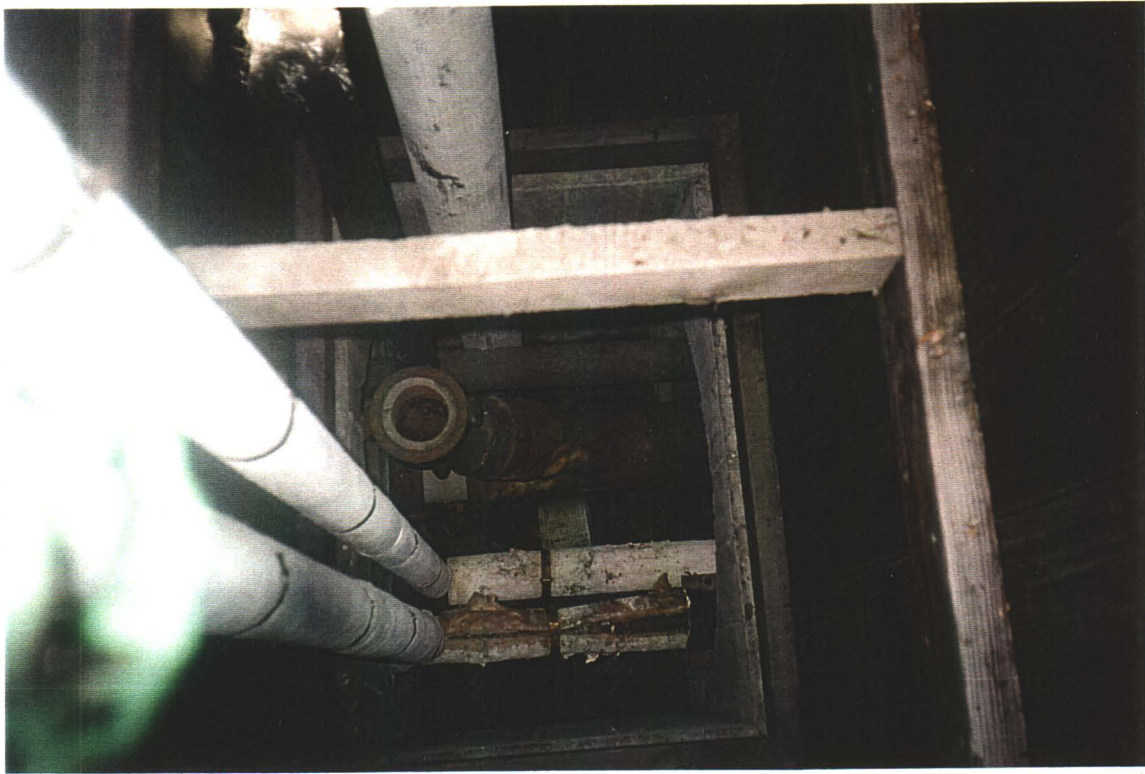
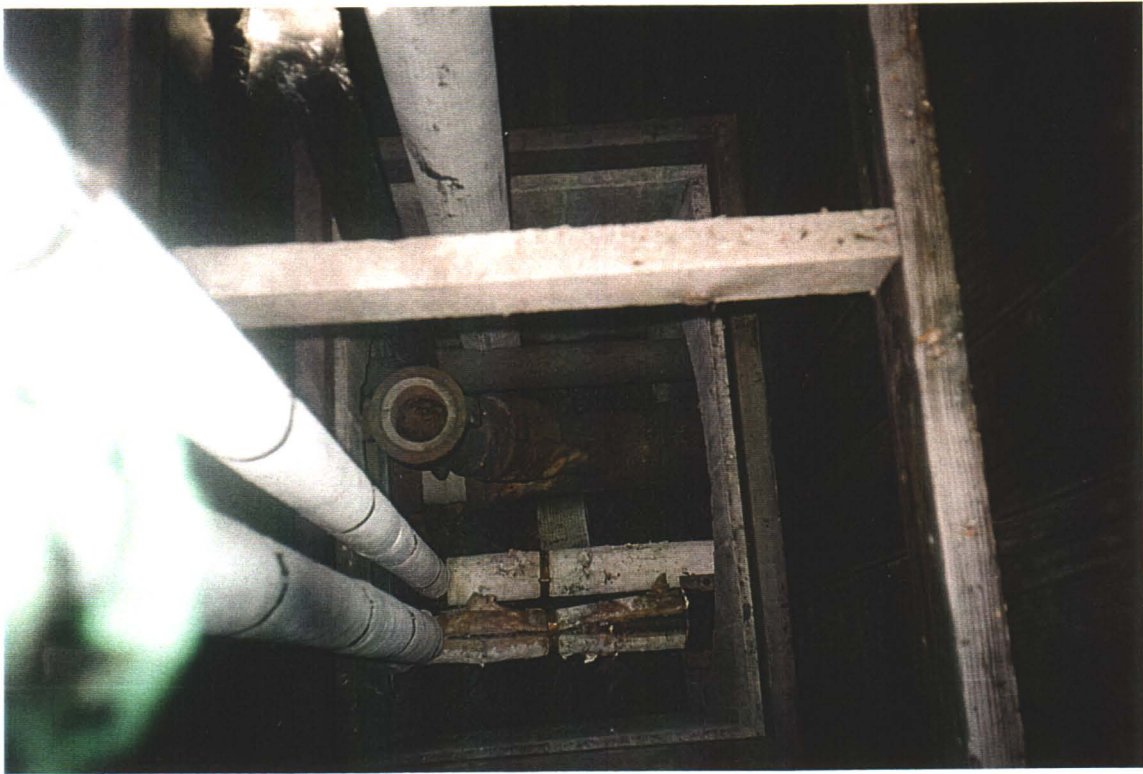
Typical services pit at each trailer stall (one of six).
(Note: transite asbestos pipe sewer connection)

- The utility pits, which formerly serviced trailer housing units. These pits have wooden covers but should be removed or filled in.
- One large pit near access gate should be filled in. Its purpose is unknown.
