**Inventory of Equipment, Machinery,
Major Fixtures and Hazardous Materials
at the Destruction Bay Pumping Station,
Yukon Territories.**

**Prepared for
Indian and Northern Affairs Canada**

August, 1998

**Prepared by
Arctic Environmental Services Ltd., and KO KEN General Contractors**

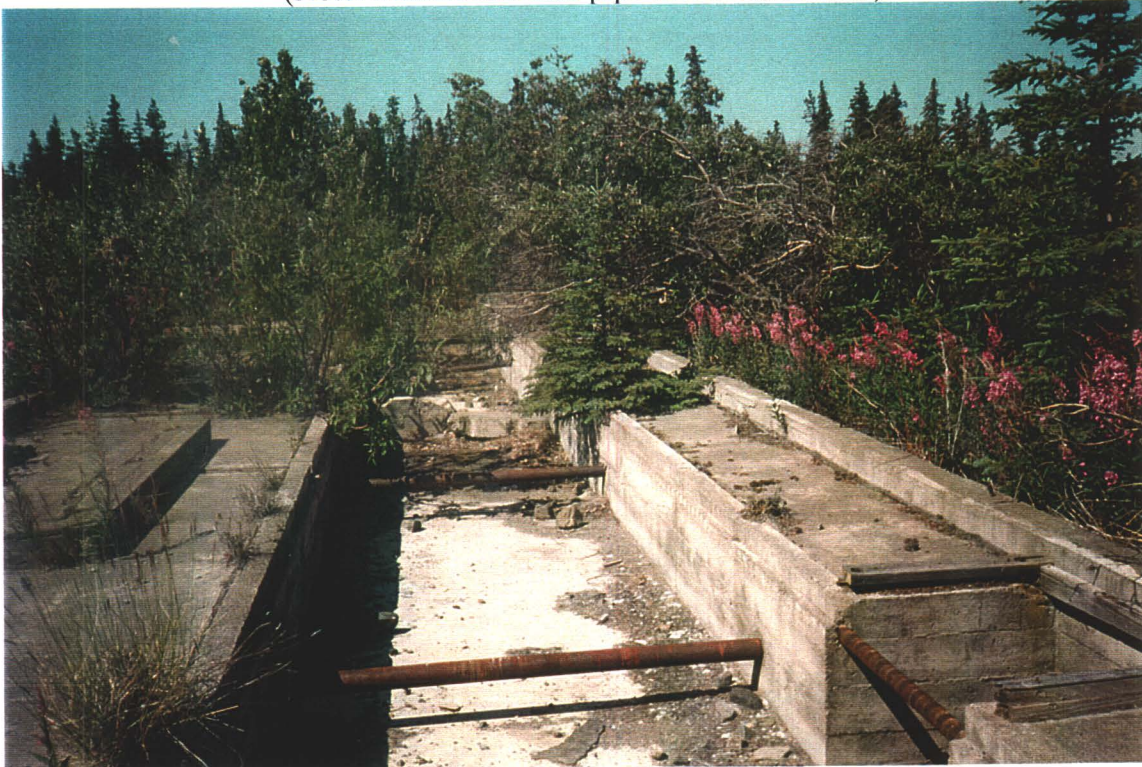
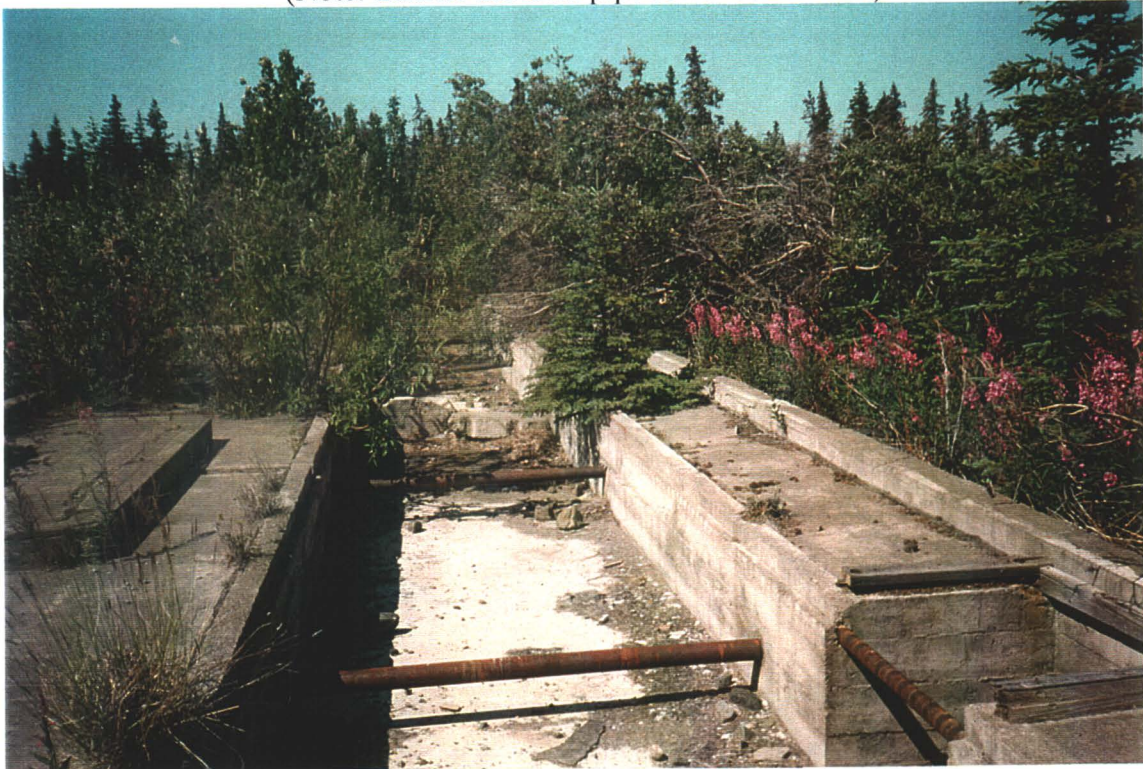
Foundations of old structure between former residences and Pump House.

- Two underground storage tanks remain on site and should be removed and properly disposed of.
- Old foundations and pumphouse structure should be removed.

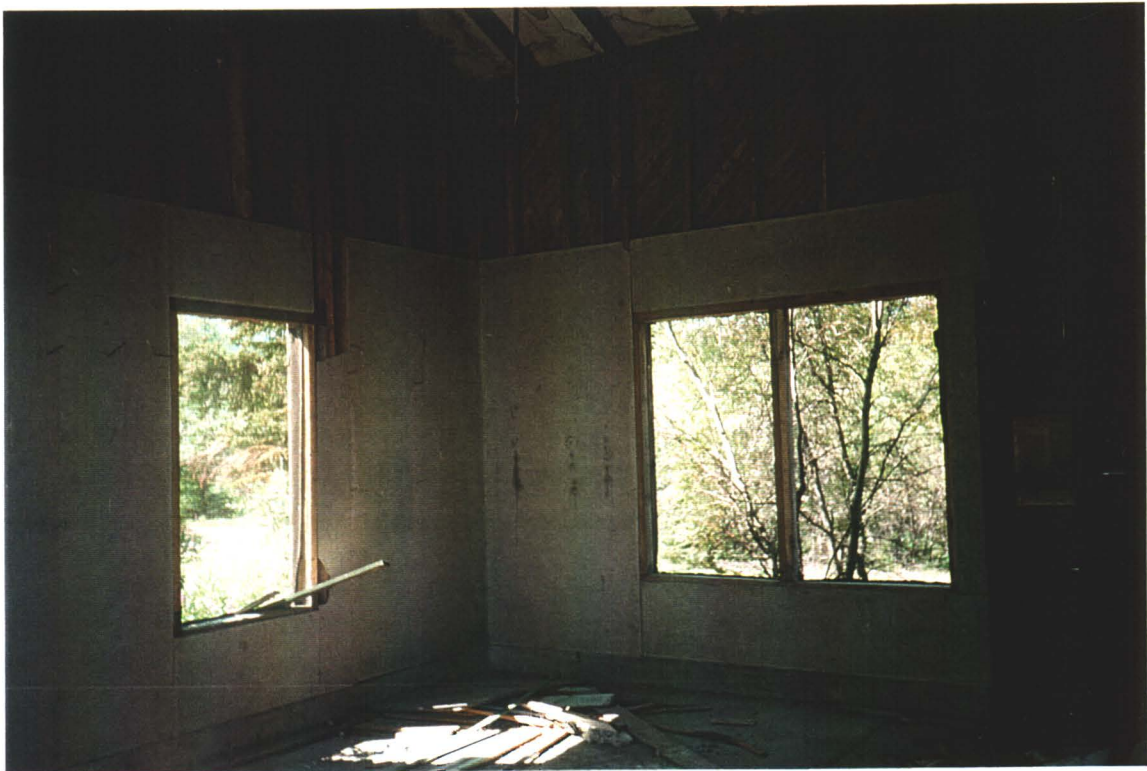
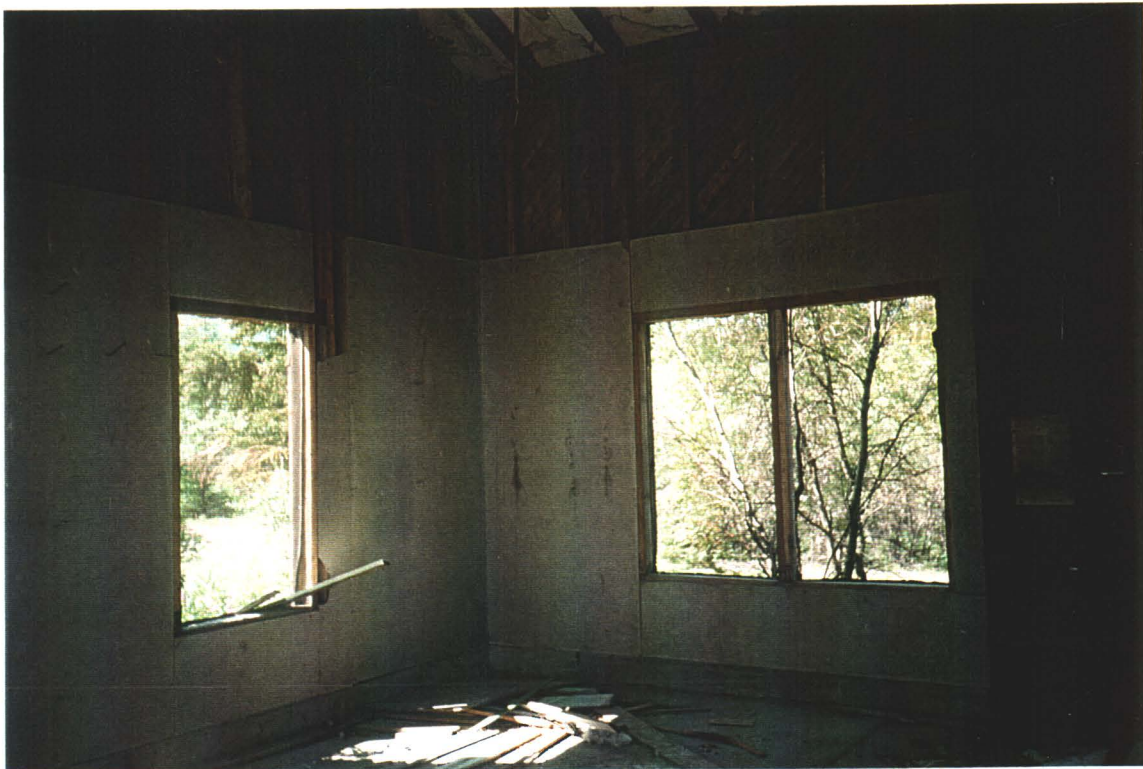
Pump House building interior. Note 5 sheets asbestos wallboard.

- Asbestos has been confirmed on pipe joints, exhaust stacks, boiler main steam lines, gaskets, transite pipe. All asbestos should be removed before any equipment is taken from the Station or modifications to the heating system are made.
