**Inventory of Equipment, Machinery,  
Major Fixtures and Hazardous Materials  
at the Haines Junction Pumping Station,  
Yukon Territories.**

**Prepared for  
Indian and Northern Affairs Canada**

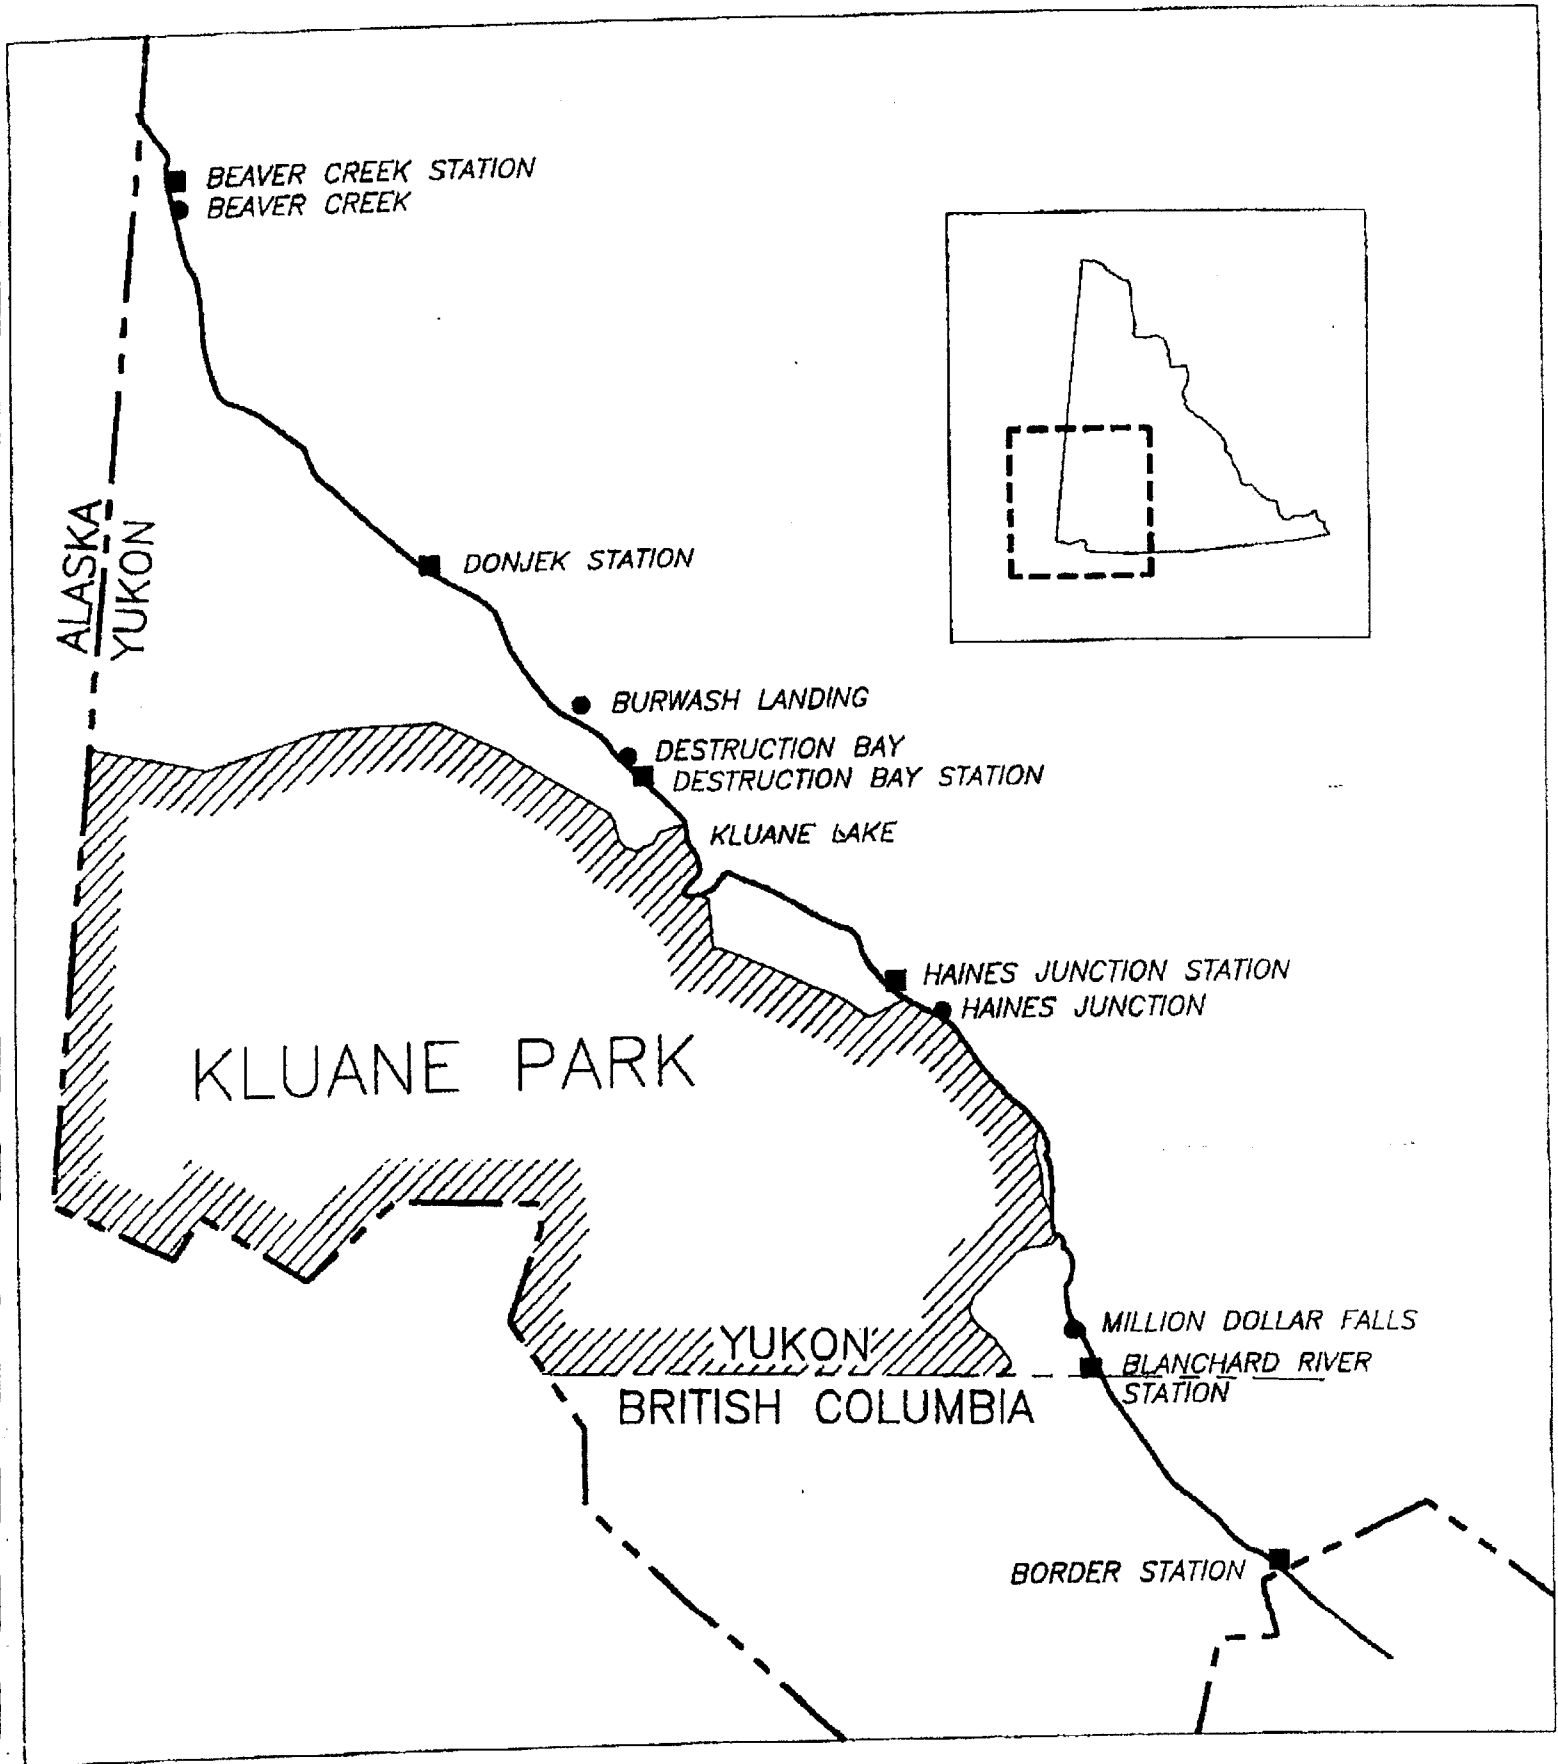
Figure 1 Site Layout

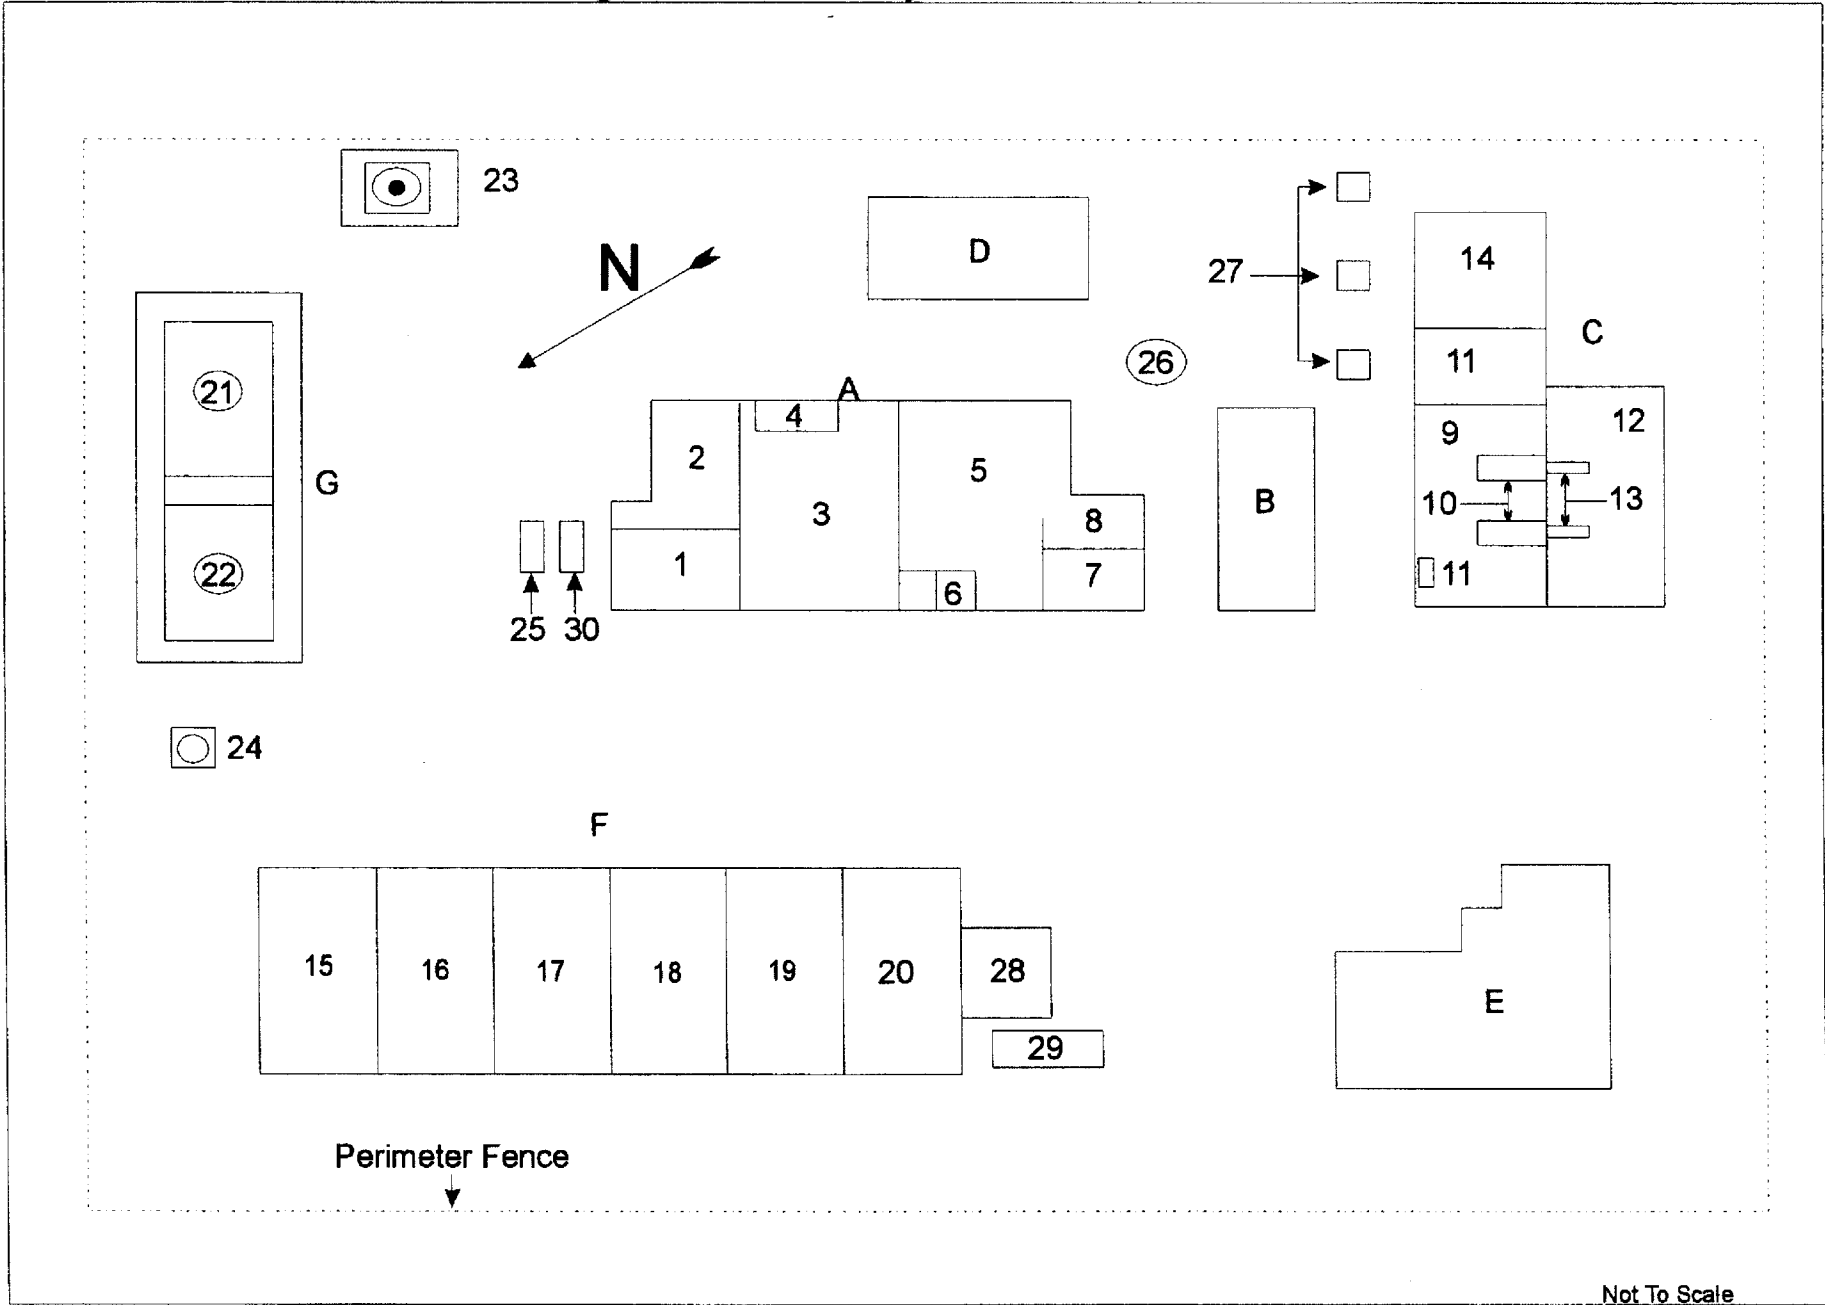
**Table 1 Buildings and Building Components**

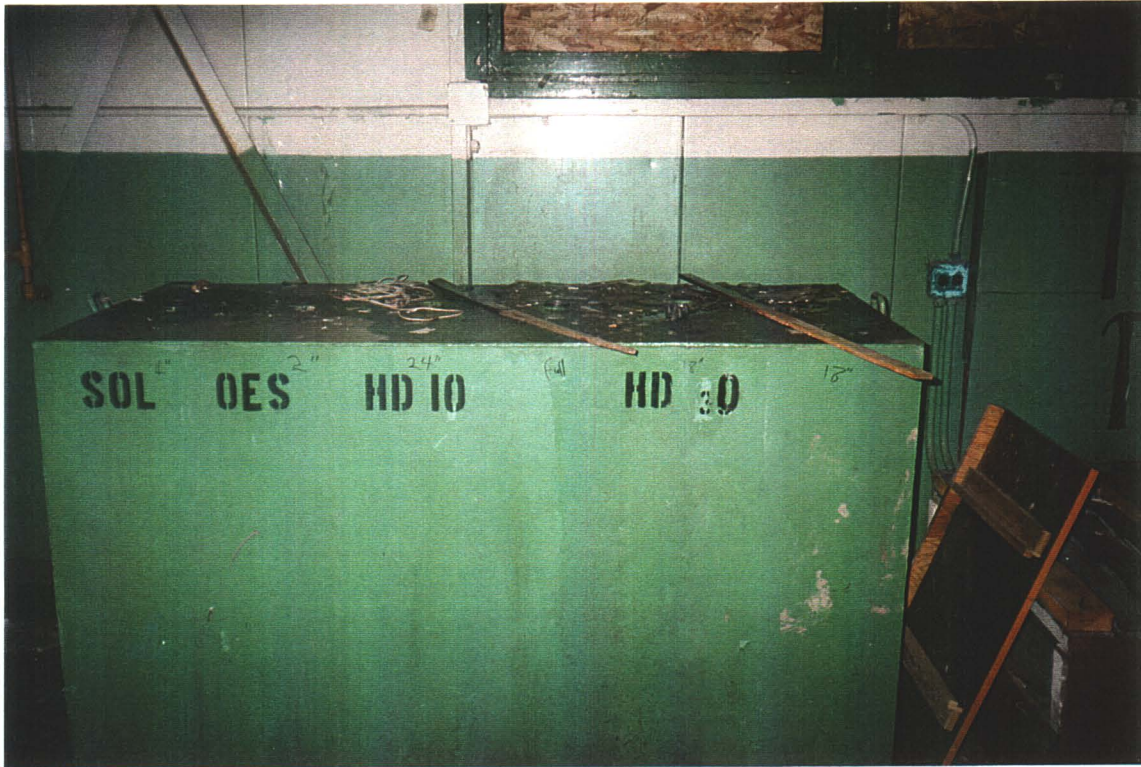
Main Building, Shop. Service fluid storage tank, intact with no leaks.

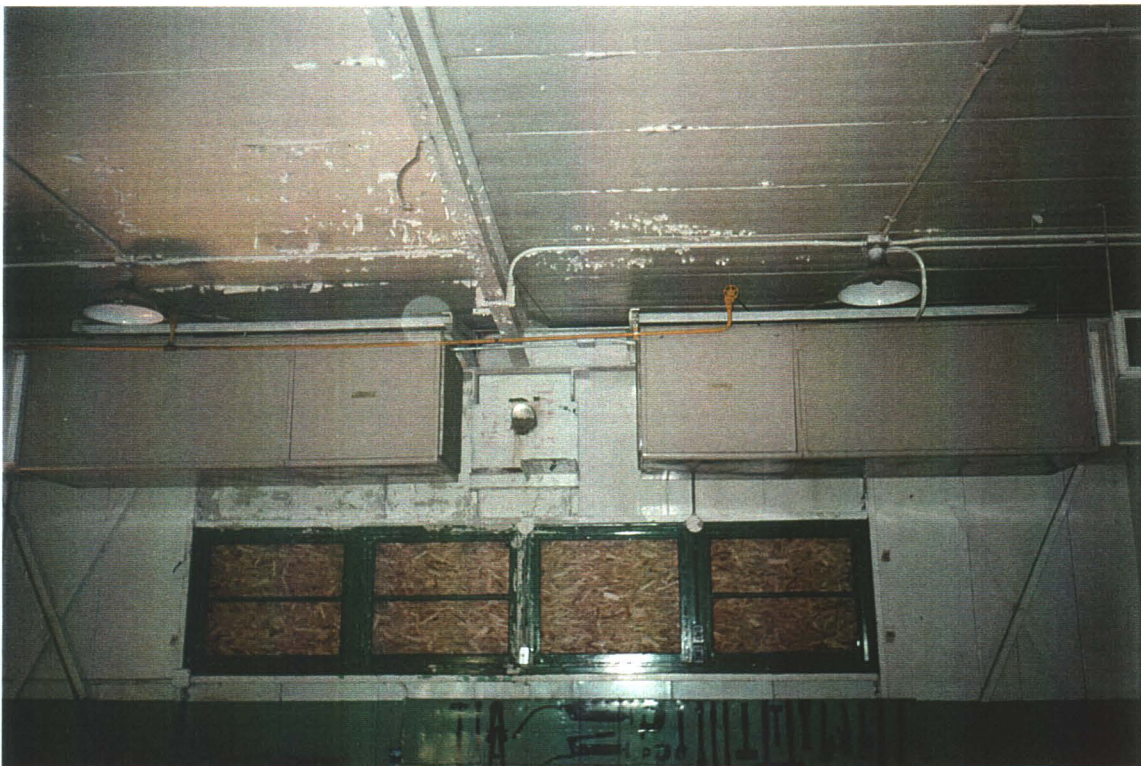
Main Building, Shop. Overhead heat exchanger.  
Note lead paint peeling from metal walls on building interior.

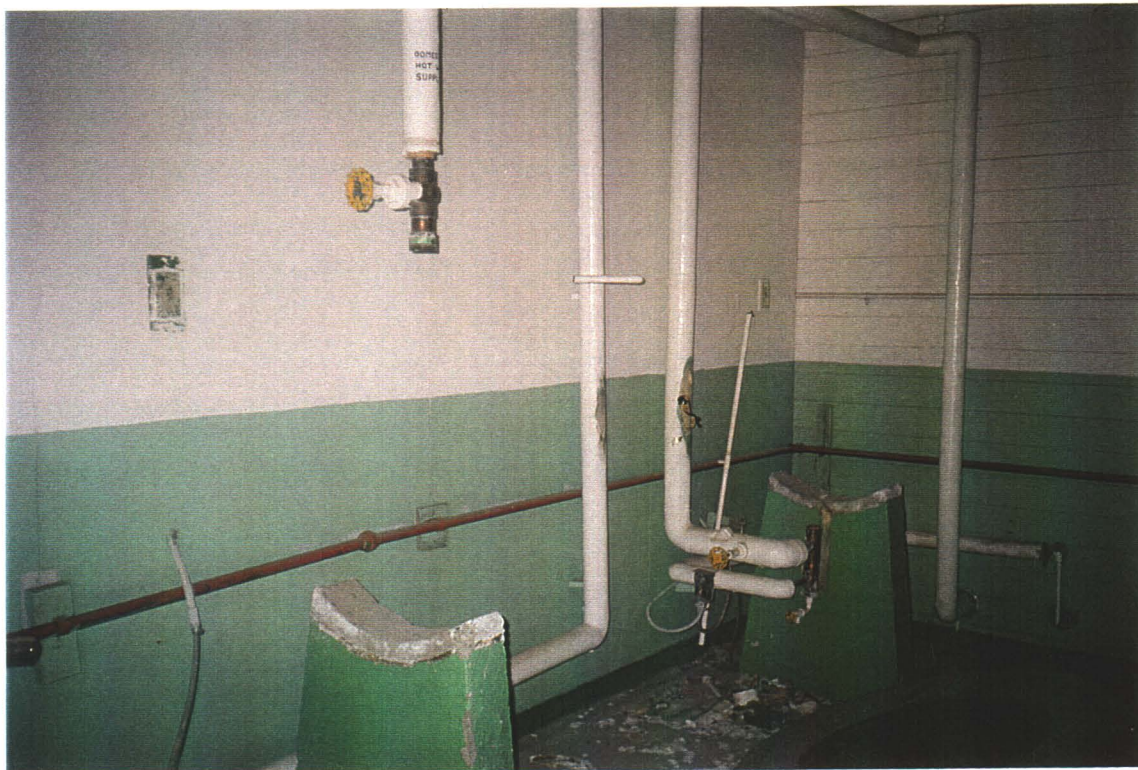
Multi-family Dwelling, Boiler Room tank is missing.

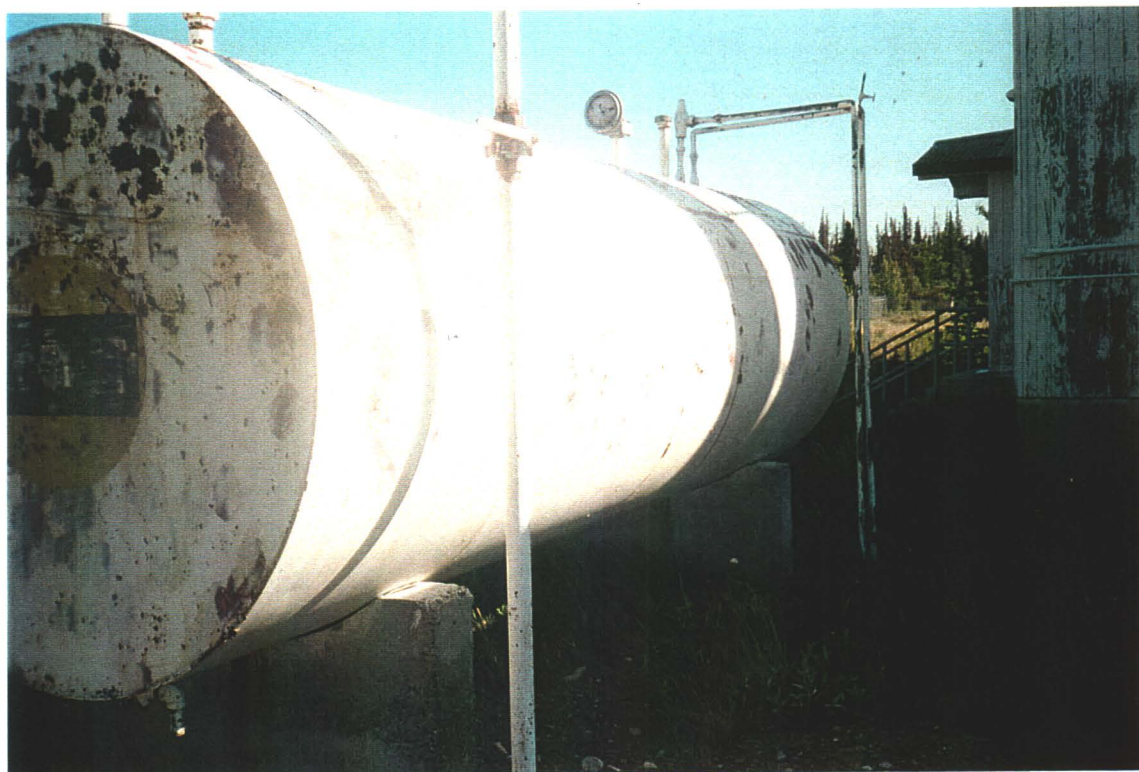
Multi-family Dwelling, exterior AST.
